Re: Contract No. 68-S0-01-01, Technical Direction Document No. 05-10-0004;
Minnie Moore Mine Removal Action Report

Minnie Moore Mine
Final Removal Action Report
Bellevue, Idaho
TDD: 05-10-0004

**FINAL MINNIE MOORE MINE REMOVAL ACTION REPORT
BELLEVUE, IDAHO**

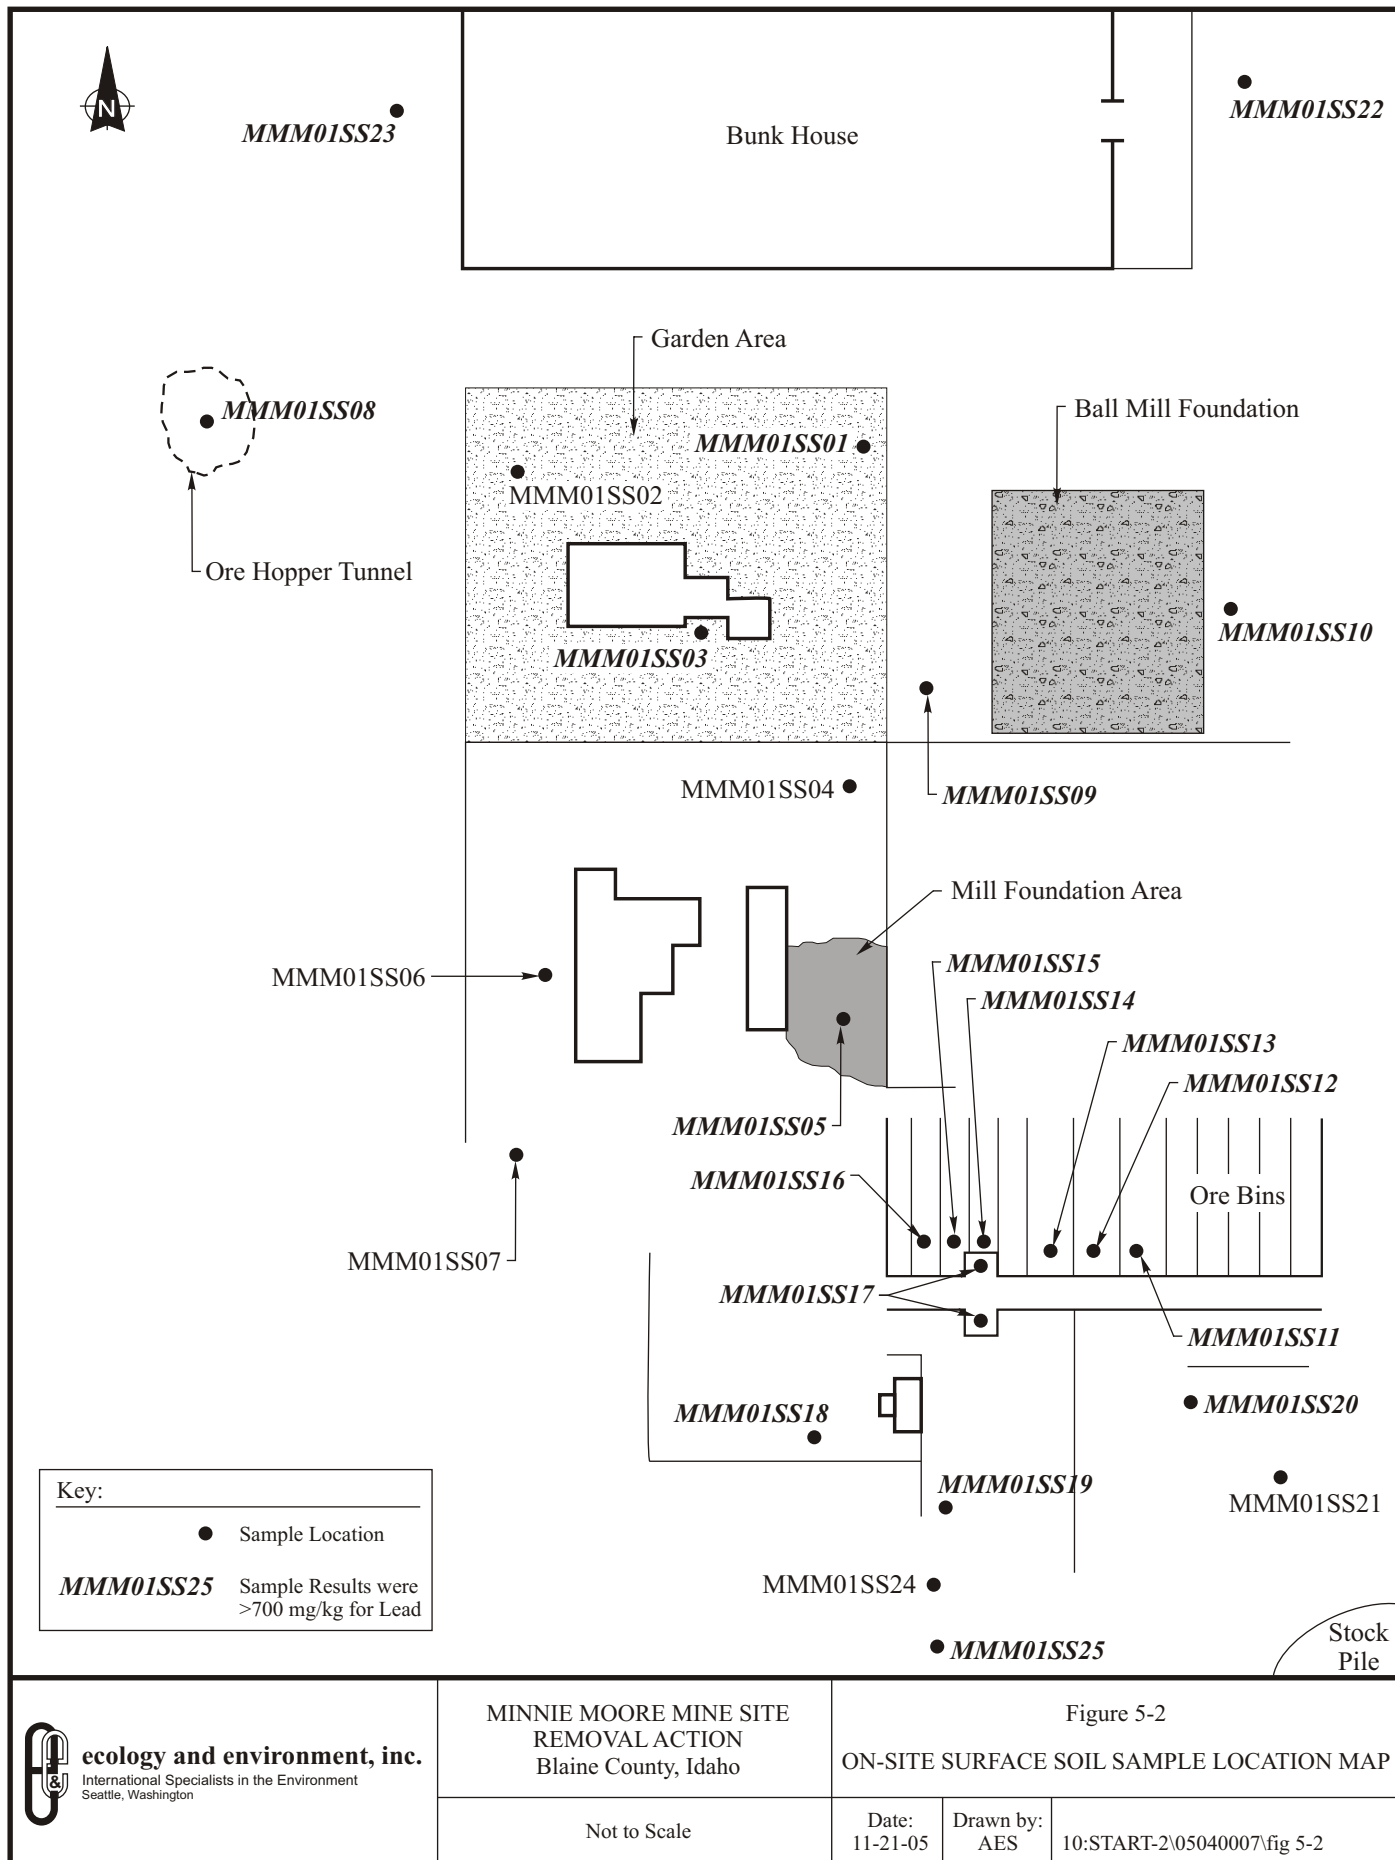
Previous analytical data of soil samples collected from the former mill area indicated high concentrations of lead. A total of 25 surface soil samples (MMM01SS01 through MMM01SS25) were collected from the area surrounding the former mill foundation, including two surface soil samples collected on the east and west sides of the bunk house. Figure 5-2 shows the approximate on-site surface soil sample locations.
