RESOURCE CONSERVATION RECOVERY ACT SUBTITLE - C INVESTIGATION

Former American Plating Corporation

4004 East Monument Street
Baltimore, MD

Inspection Date: Tuesday April 12, 2016

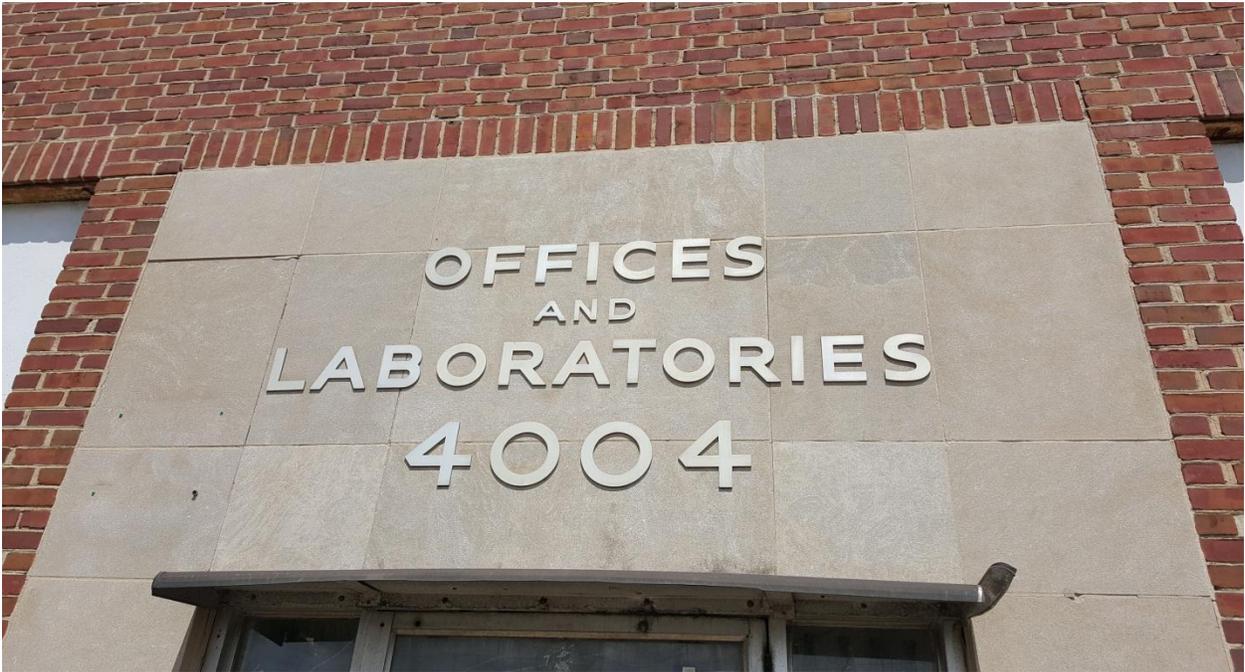
Photo 1 – Front of the former American Plating Corporation, now rented by Artur Nagy trading as Plating & Anodizing Sales

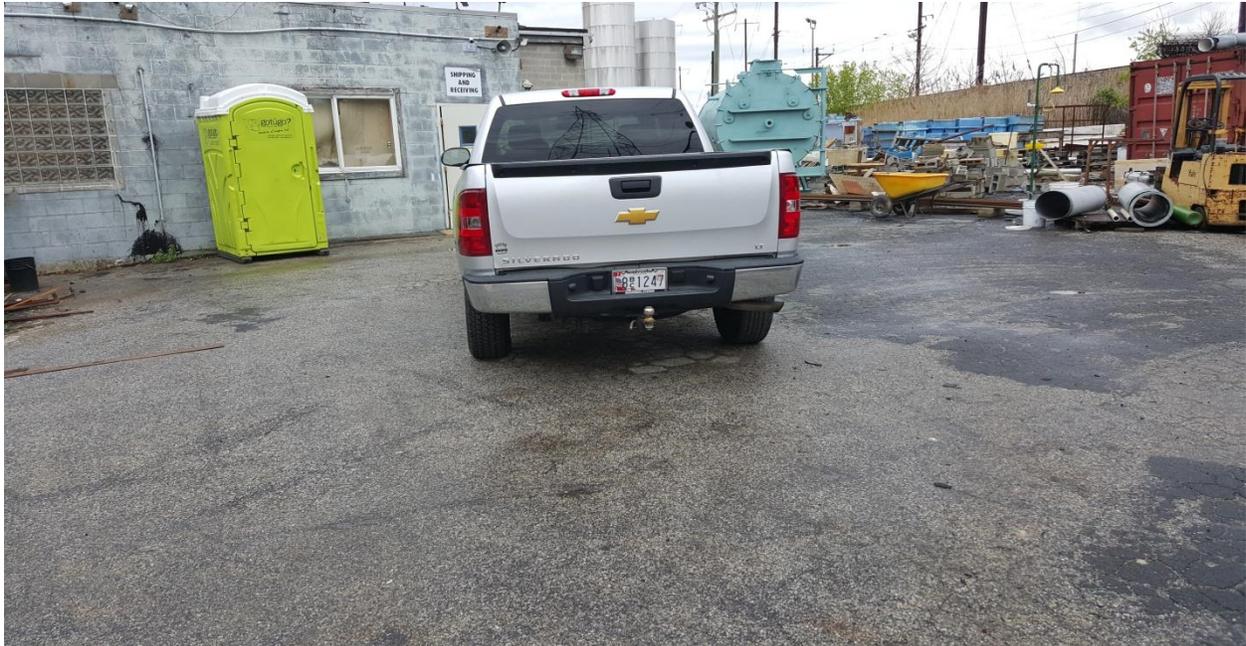
Photo 2 – Rear of the facility showing the office for Artur Nagy and materials outside of the warehouse

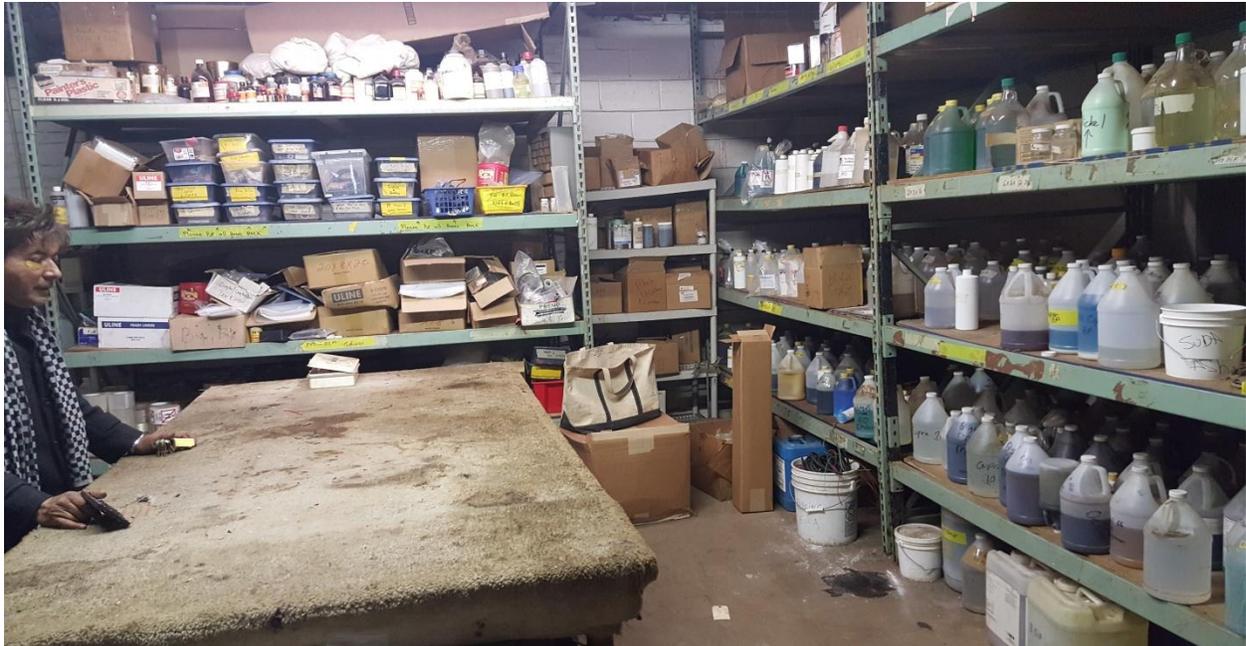
We walked into the Plating Shop where there were shelves containing various bottles and containers of chemicals, namely acids (see photo #4). Mr. Nagy claimed that everything he had was good used products. I asked Mr. Nagy if we could take photos and he said "yes." Mr. Nagy stated that even though the products were expired, he sells to customers, like the Navy's NCIS, for a discount of 33-70% off. He stated that the products, even though expired, still are effective. I asked Mr. Nagy about what he does for water and he said that he collects all water from the roof and treats it in his own treatment system and then re-uses the water. He said that his bills to the City of Baltimore for water are zero. (it was LMA's understanding that due to failure for Mr. Naumann to pay the overdue water bills, the City shut the water off). I asked Mr. Nagy how long he had been in the building and he said about 11 months. He said that he wants to buy the building from Mr. Naumann but does not want to be responsible for all the leftover products and waste from American Plating.

Photo 4 – Inside the Plating Shop showing Mr. Nagy standing next to his work table and the shelves containing what Mr. Nagy refers to as products.

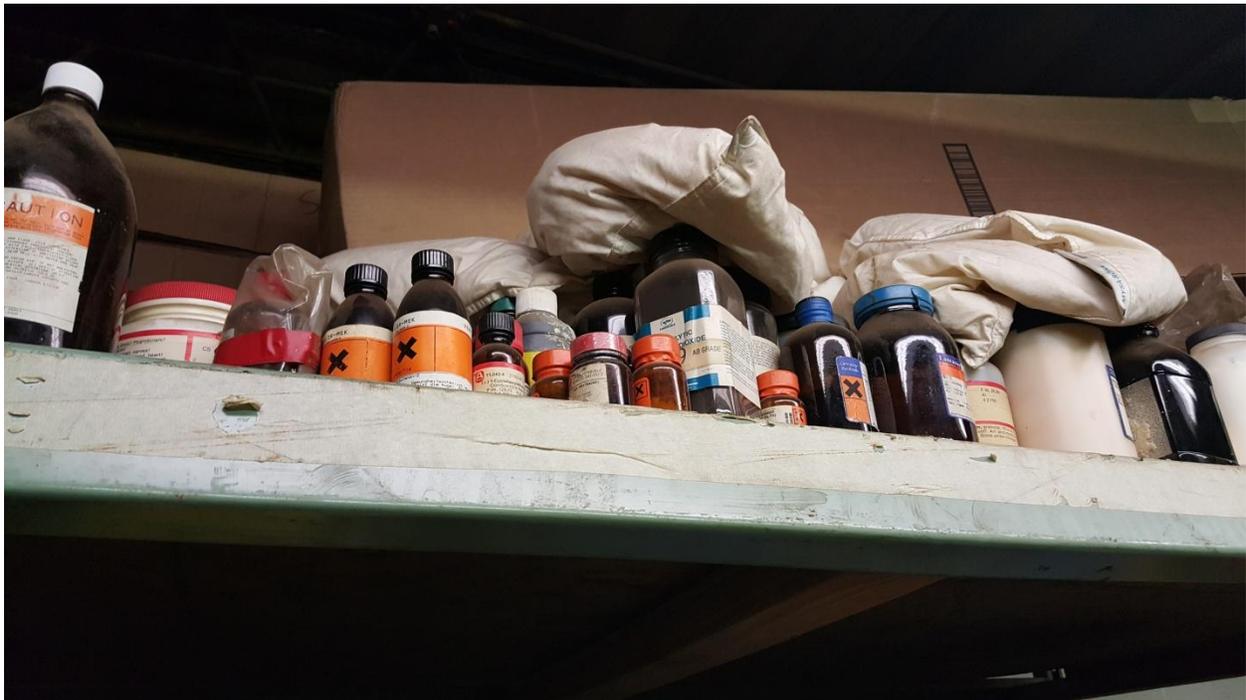
Photo 5 – Showing bottles that were not labeled “hazardous waste.” Mr. Nagy said that these bottles were for testing solutions and kits.

Due to the fact that Mr. Nagy stated that the waste and/or products from the former American Plating Corporation were not characterized, Plating & Anodizing Sales is potentially in violation of Code of Maryland Regulations 26.13.03.02 for failing to make a waste determination. Additionally, since the products within the building are expired and Mr. Nagy was unable to provide any documentation of having viable markets for his so called products, then Plating & Anodizing Sales may be in violation of definition of speculative accumulation. Additionally, due to the leaking roof, the Facility failed to design, construct, maintain, and operate to minimize the possibility of a fire, explosion, or any unplanned sudden or non-sudden release of hazardous waste or hazardous constituents’ to air, soil, or surface water which could threaten human health or the environment, in violations of COMAR 26.13.03.05(E) (1) (g) and COMAR 26.13.05.03 (B).

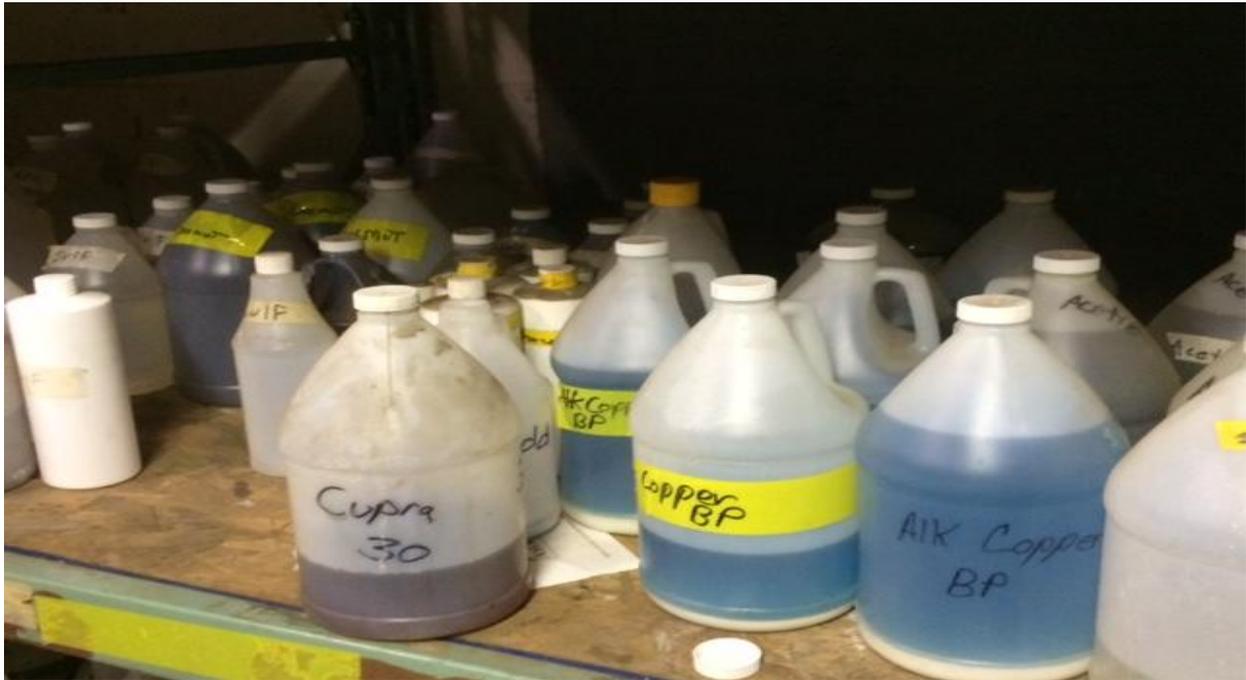
Photo 6 – Close-up of the so called “products”

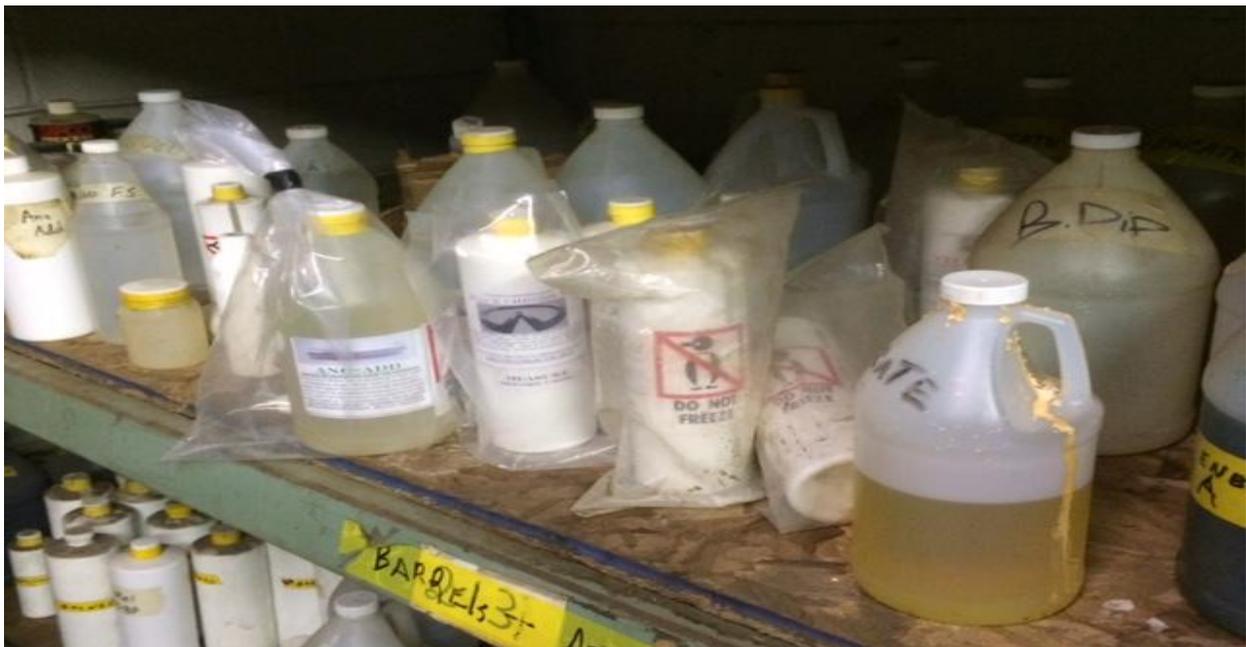
Photo 7 – More so called “products”

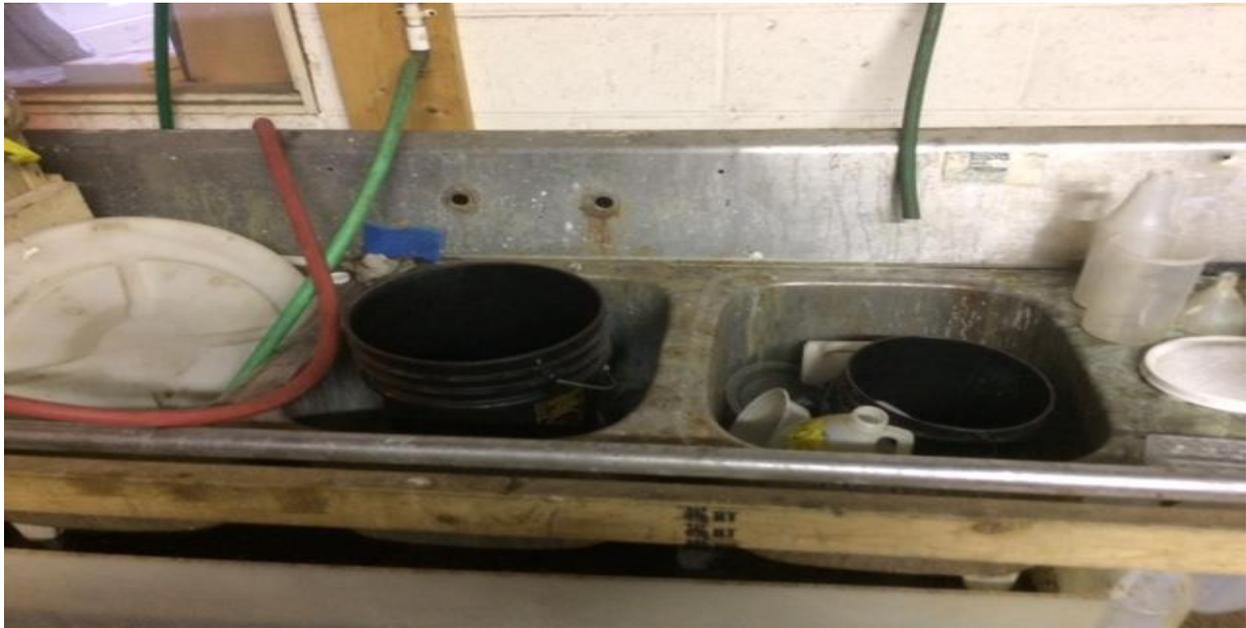
Photo 8 – Shows the sink that Mr. Nagy said he uses for dilutions and for cleaning up. Mr. Nagy said that the water he uses is collected from the roof and any waste water is reclaimed and cleaned through his water filtration machine (next photo).

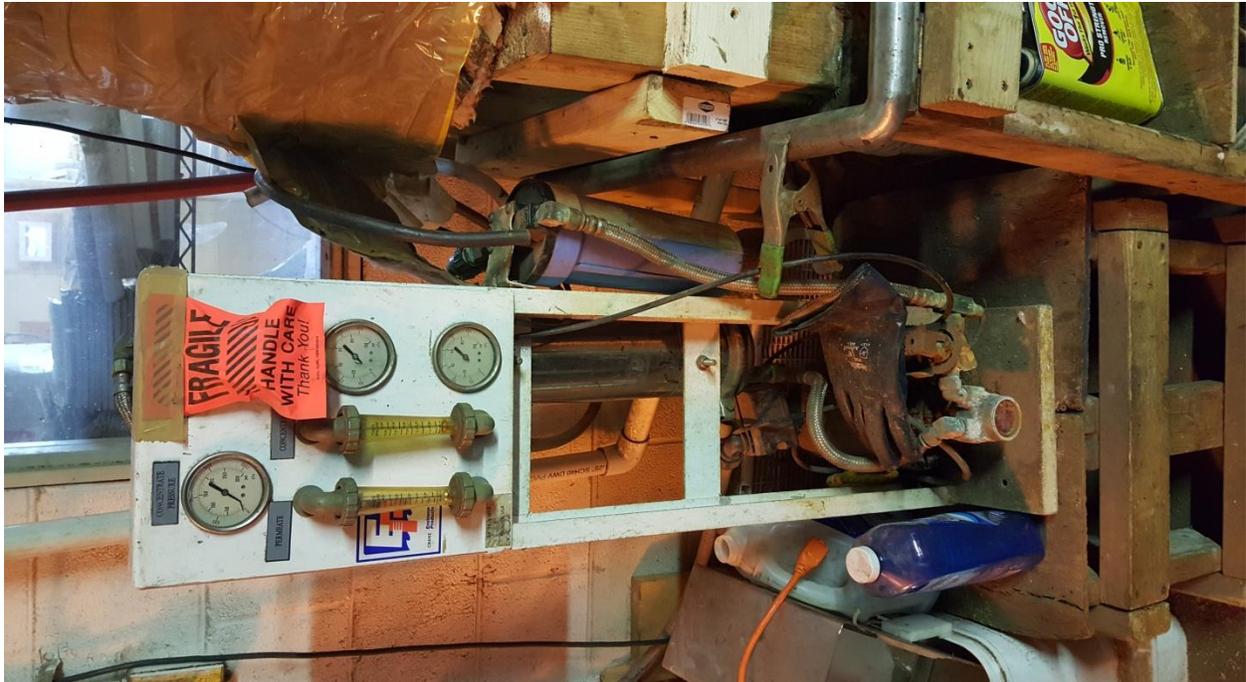
Photo 9 – Showing water filtration machine

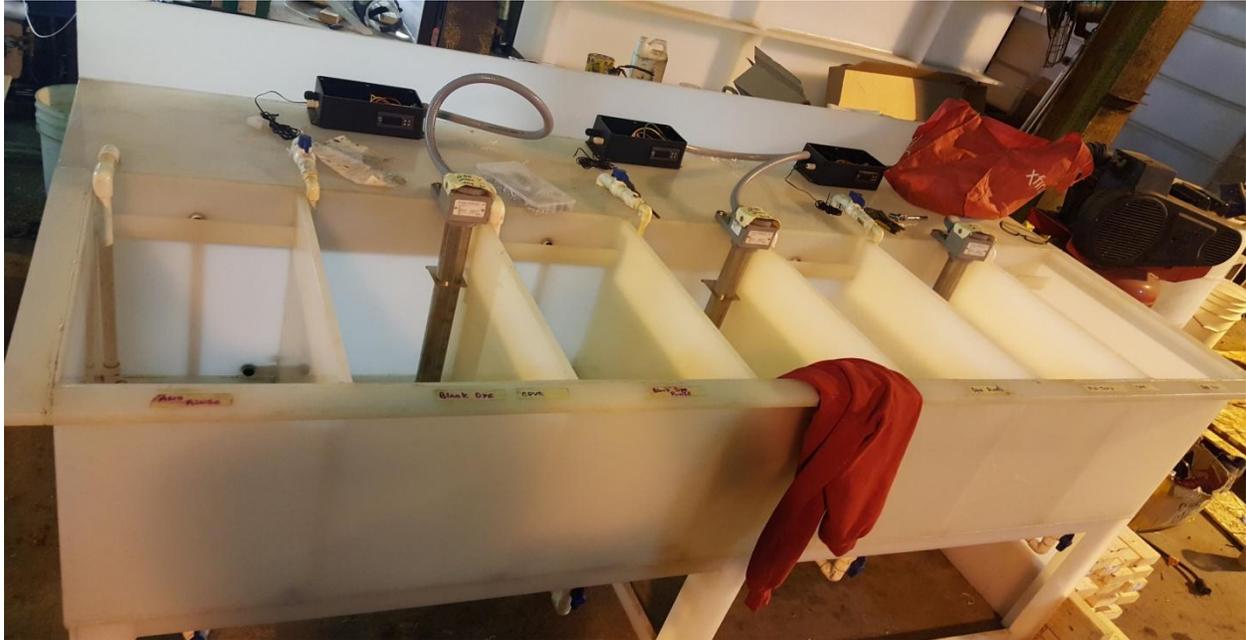
We next were taken to the part of the building where Mr. Nagy said he custom builds electroplating tanks. The tanks are made from fiberglass materials and heaters are placed in the bathing tanks (see Photo #10). The lights in the particular area were working. Mr. Nagy again stated that once he got his health in order, he would be selling more tanks.

Photo 10 – Showing custom built electroplating tanks

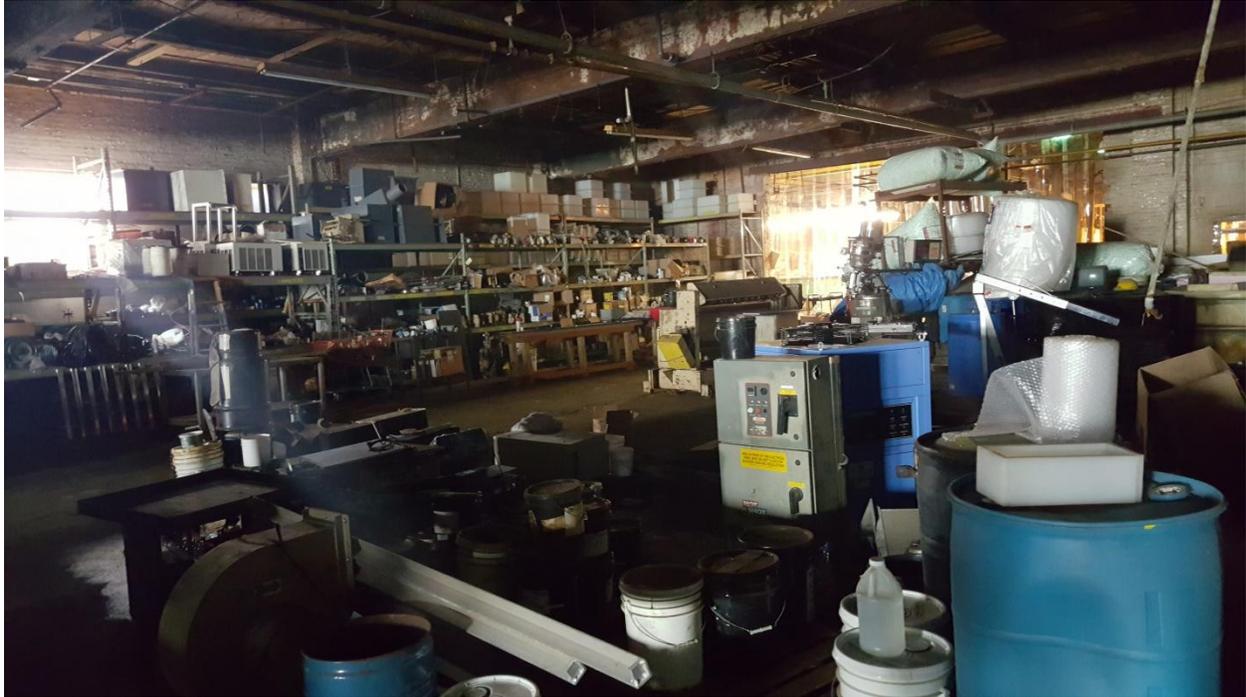
Photo 11 – Shows part of supply area for fiberglass to build custom electroplating tanks along with waste/products from American Plating

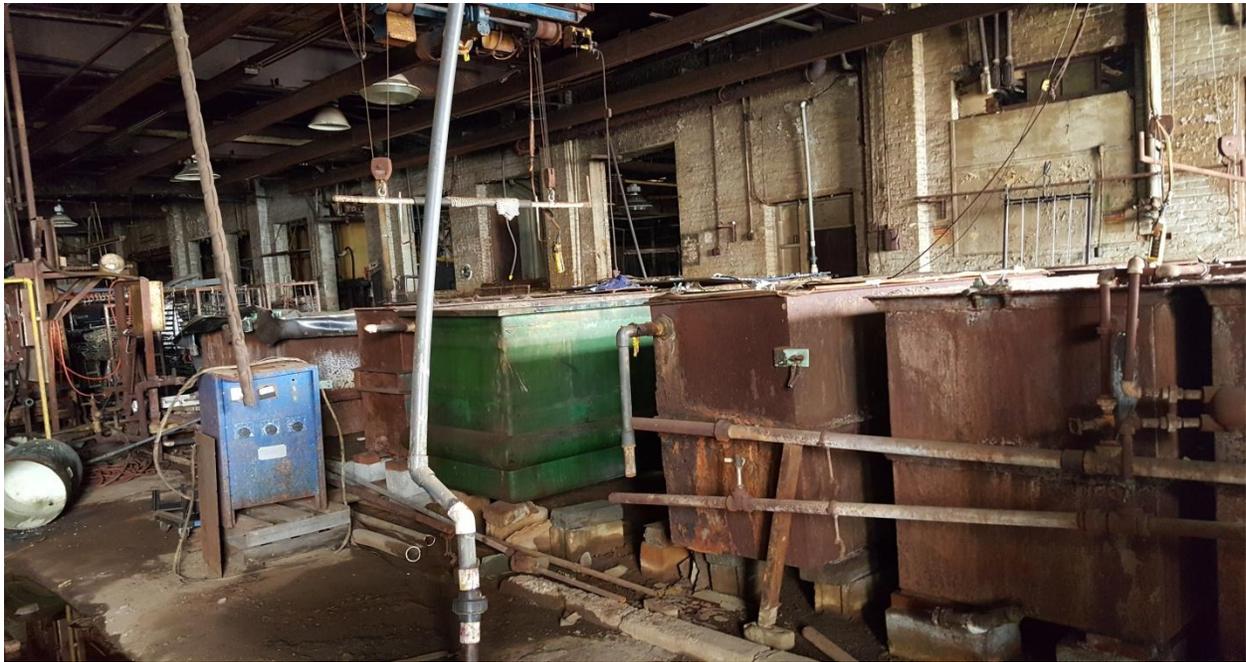
The next area we observed were large electroplating bath tanks that were once used by American Plating. All of the tanks were empty except 2 tanks. One was covered by a tarp (see Photos #12 & 13). Mr. Nagy said that the tanks contained cadmium dioxide solution. Another tank was uncovered and Mr. Nagy believed it was water only (Photo #14). The liquid was clear and was odorless.

Photo 12 – Shows former American Plating Company electroplating bath tanks

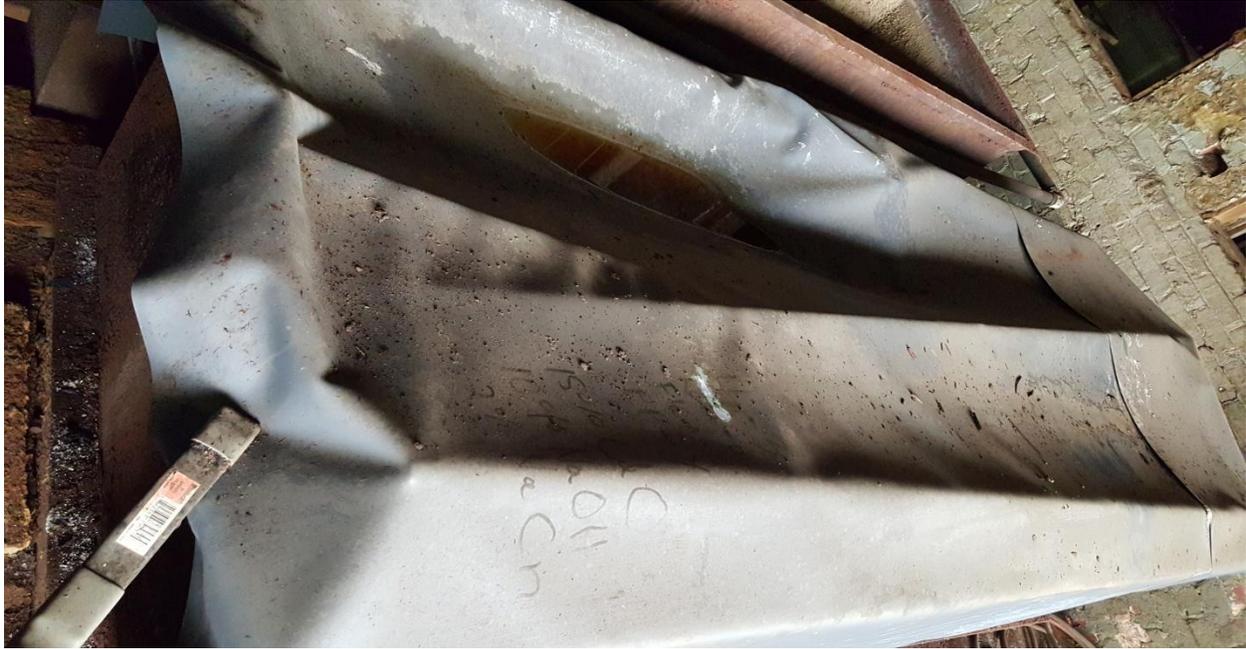
Photo 13 – The tank that supposedly contained cadmium oxide

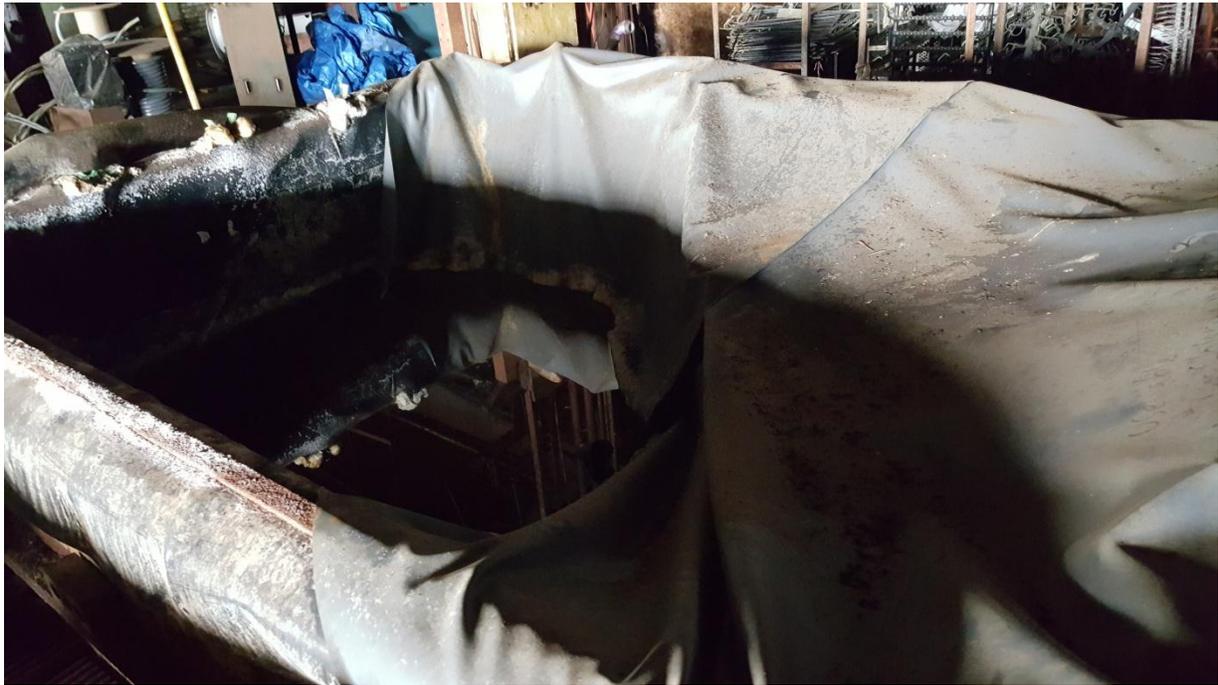
Photo 14 – Second bath tank that supposedly only contained water

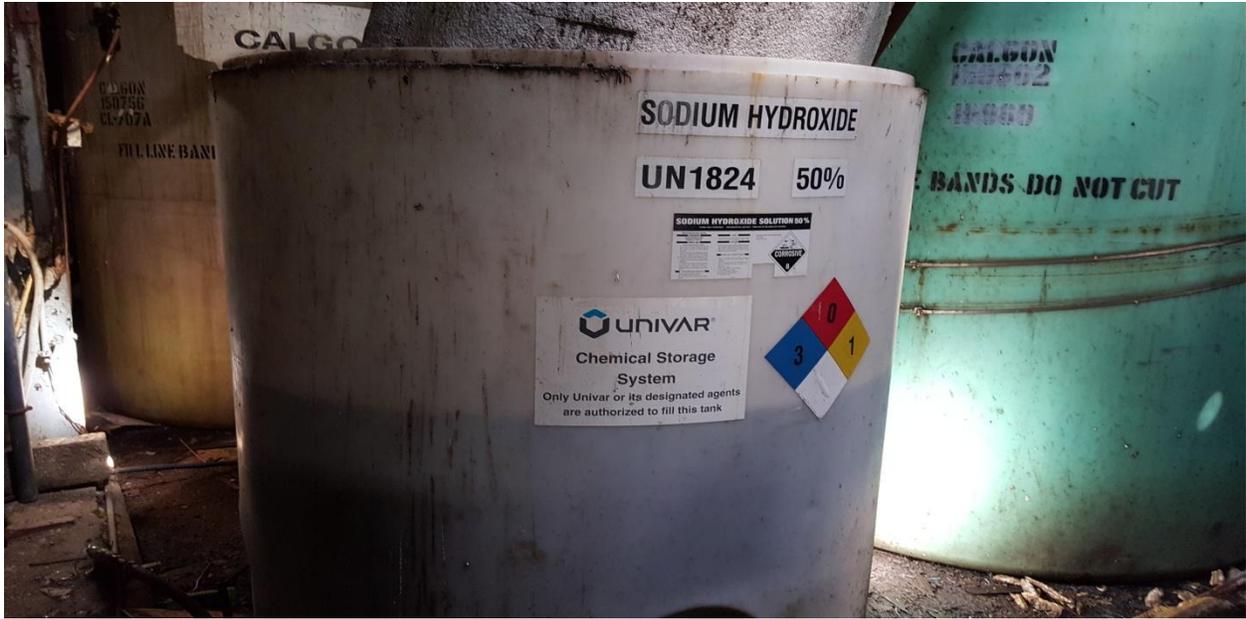
Photo 15 – Large tanks with so called “product”
