**Subject: Oil Pollution Act (OPA) Emergency Response Action Letter Report  
Aliceville Train Derailment  
Aliceville, Pickens County, Alabama  
Contract Number (No.) EP-W-05-054  
TDD No. TTEMI-05-002-0023**

## **SITE BACKGROUND**

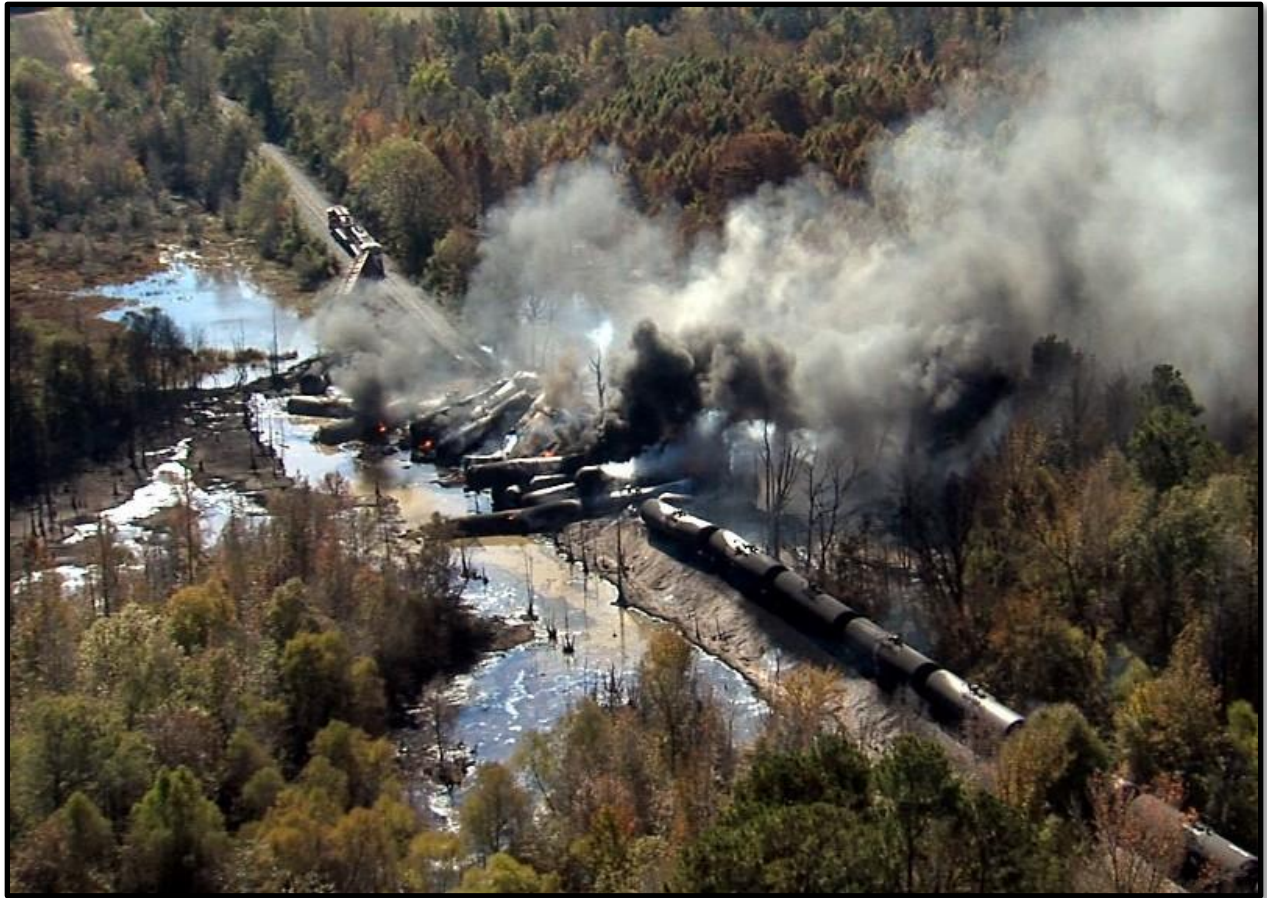
**OFFICIAL PHOTOGRAPH NO. 1**  
**U.S. ENVIRONMENTAL PROTECTION AGENCY**

**Subject:** Train derailment with ongoing fire and smoke.

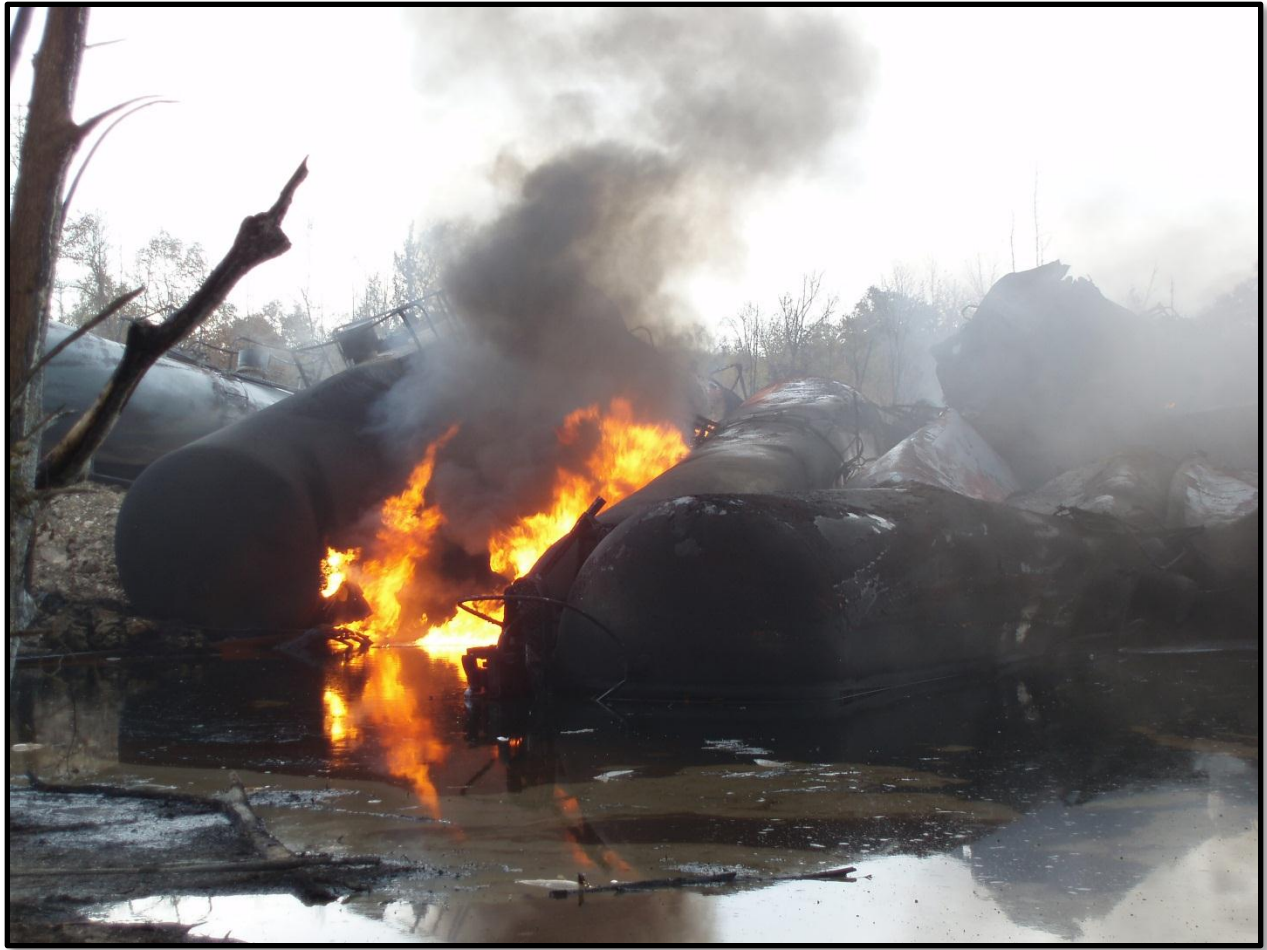
**OFFICIAL PHOTOGRAPH NO. 2**  
**U.S. ENVIRONMENTAL PROTECTION AGENCY**

**Subject:** Smoke and fire from burning oil inside railcars located along the edge of the rail line and wetland slough.

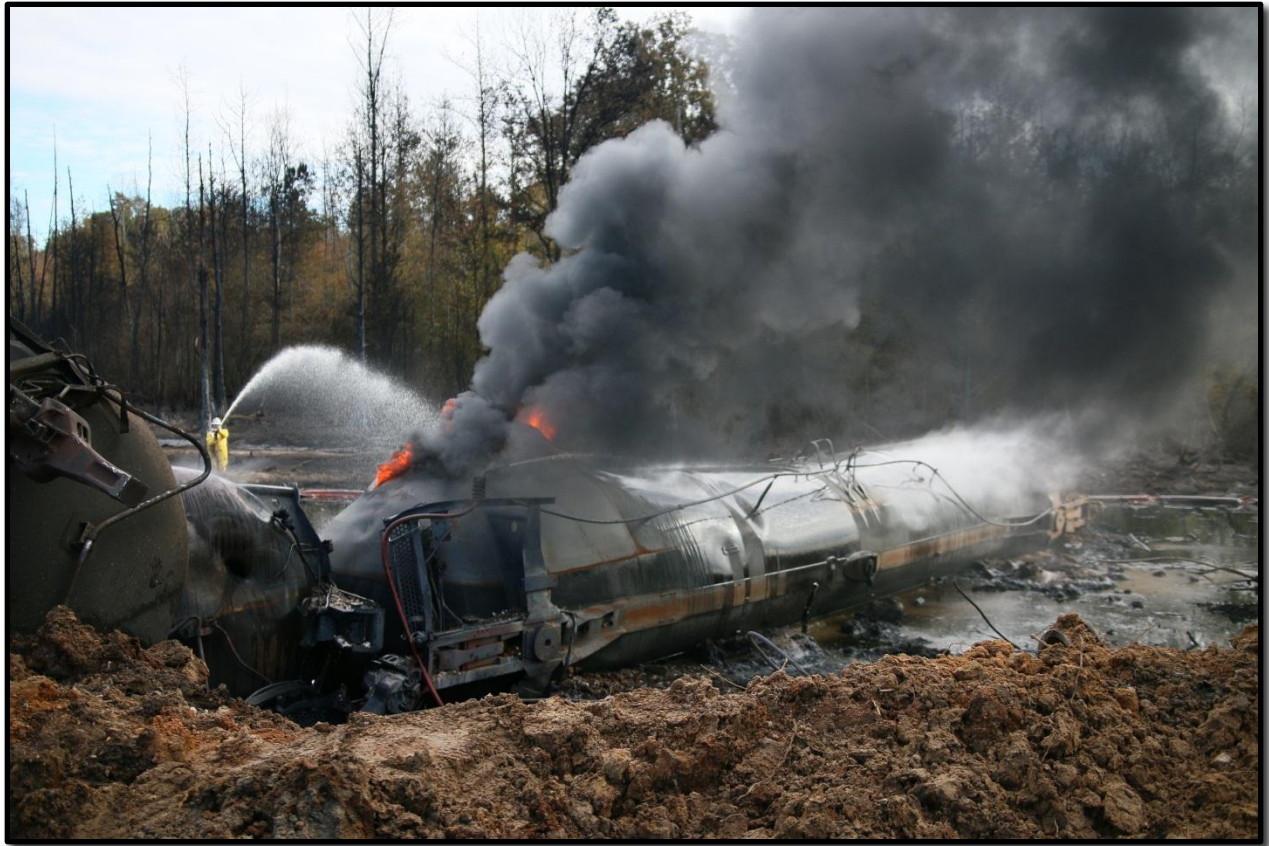
**OFFICIAL PHOTOGRAPH NO. 3**  
**U.S. ENVIRONMENTAL PROTECTION AGENCY**

<b>TDD Number:</b>	TTEMI-05-002-0023	<b>Location:</b>	Aliceville Train Derailment
<b>Orientation:</b>	West	<b>Date:</b>	November 10, 2013
<b>Photographer:</b>	Didi Fung, Tetra Tech	<b>Witness:</b>	United States Environmental Services (USES)
<b>Subject:</b>	Personnel spray railcars with water to keep them cool and to limit the spread of fire.

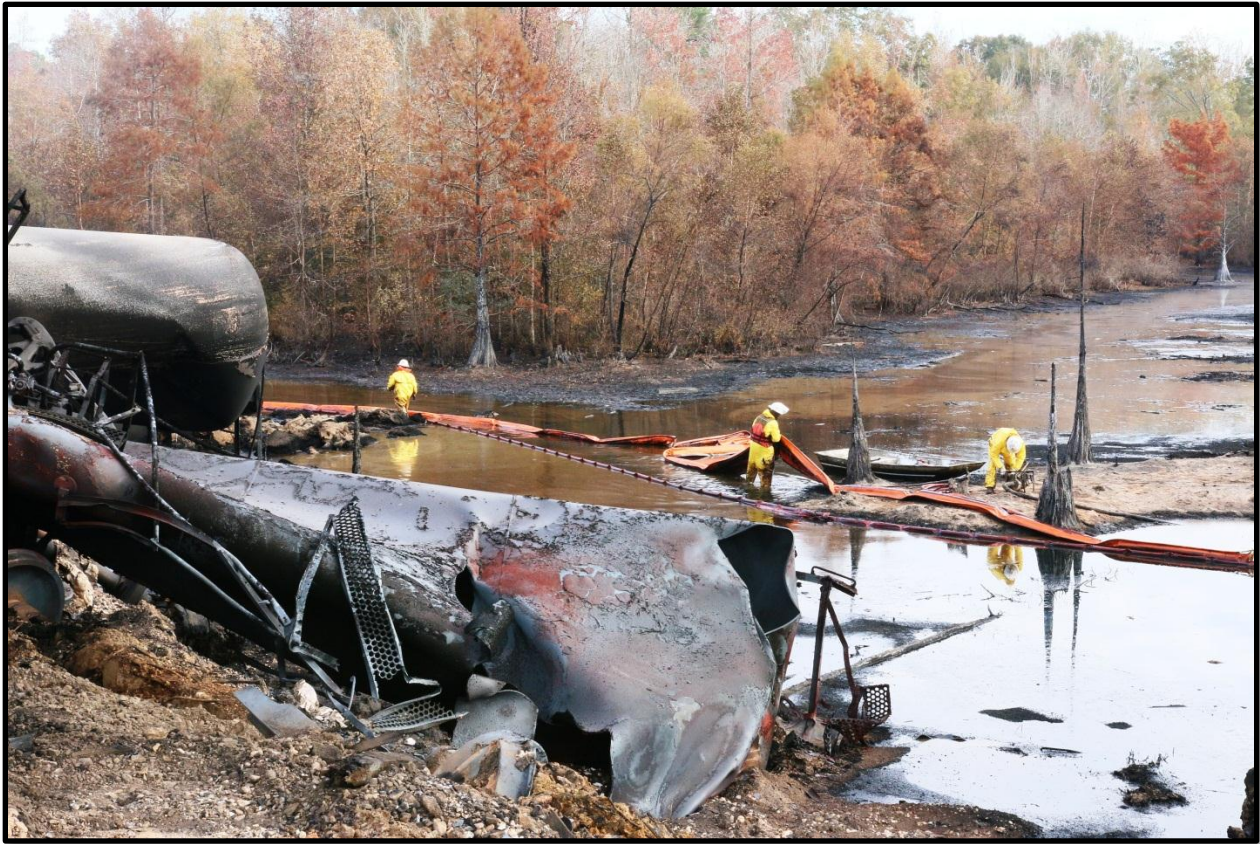
**OFFICIAL PHOTOGRAPH NO. 4**  
**U.S. ENVIRONMENTAL PROTECTION AGENCY**

**Subject:** Recovery teams set out containment booms to control the spread of oil discharged from the train derailment.

area, as well as impacted wetland areas. USES installed containment boom and absorbent materials in the wetland slough to corral and contain oil discharged from the railcars; and used water flushing techniques to free oil deposited on the wetland banks and vegetation. RJ Corman assessed the situation in preparation for re-railing and removing railcars.

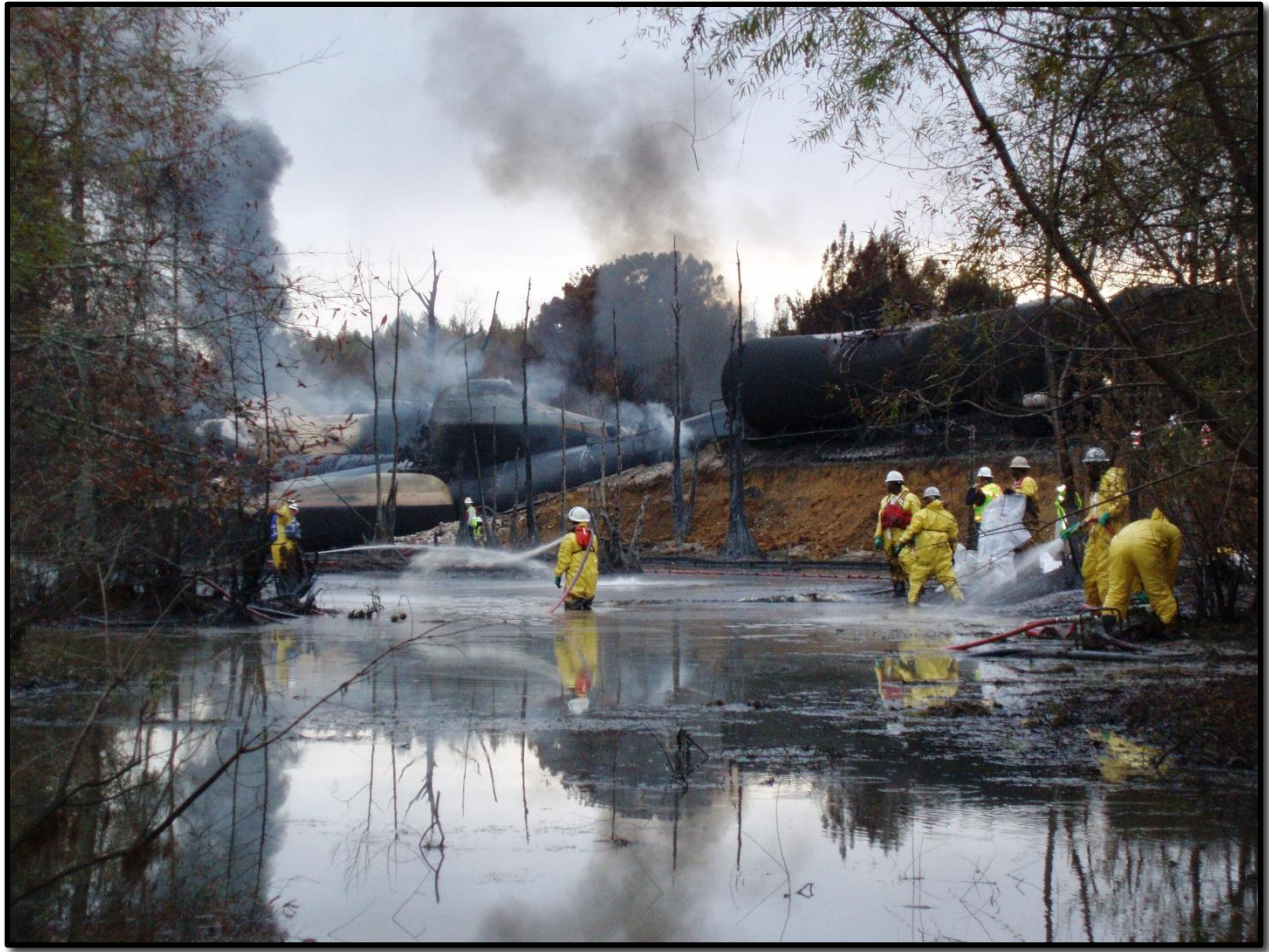
**OFFICIAL PHOTOGRAPH NO. 5**  
**U.S. ENVIRONMENTAL PROTECTION AGENCY**

**Subject:** Recovery teams use water flushing techniques to corral and contain oil released from the train derailment.

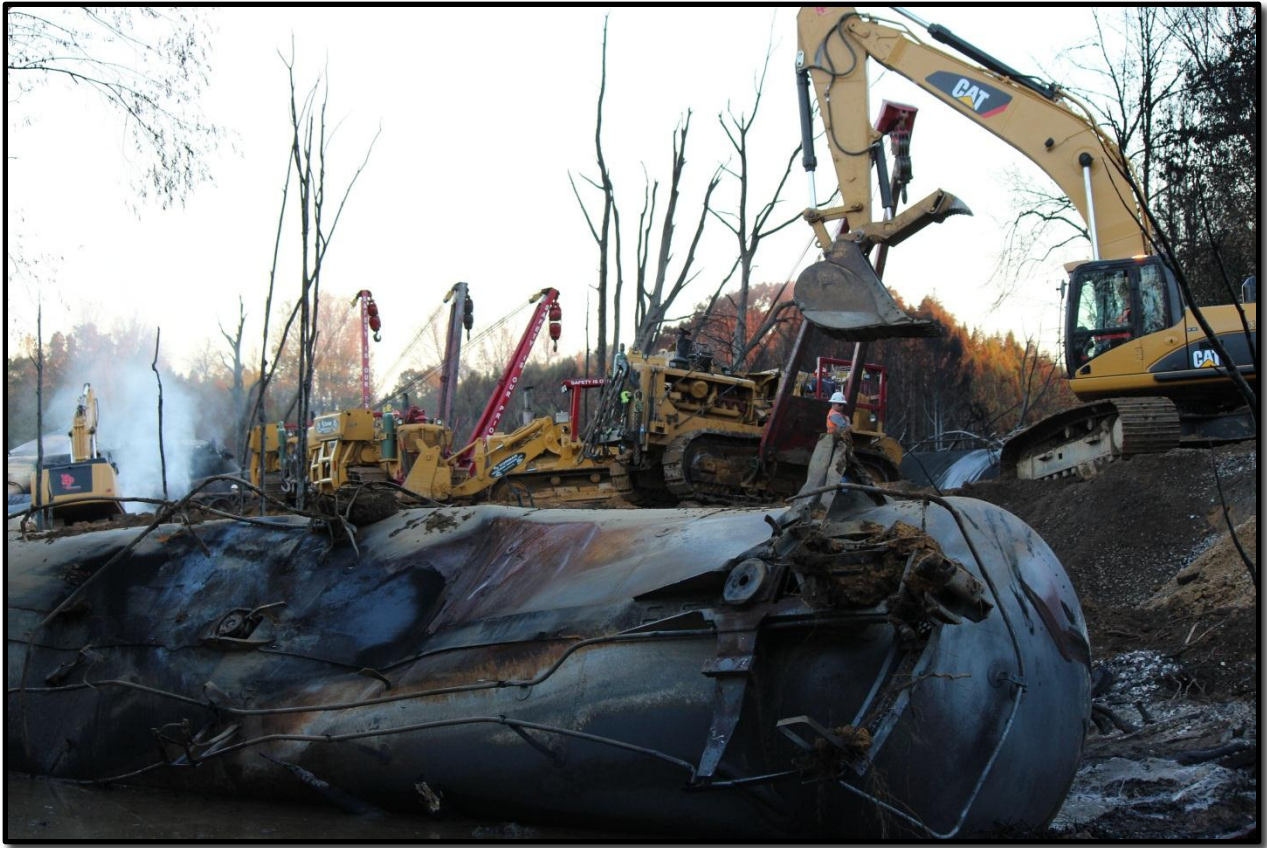
**OFFICIAL PHOTOGRAPH NO. 6**  
**U.S. ENVIRONMENTAL PROTECTION AGENCY**

<b>TDD Number:</b>	TTEMI-05-002-0023	<b>Location:</b>	Aliceville Train Derailment
<b>Orientation:</b>	Southwest	<b>Date:</b>	November 10, 2013
<b>Photographer:</b>	Chris Jones, Tetra Tech	<b>Witness:</b>	Helen Mayoral, Tetra Tech
<b>Subject:</b>	Wrecking and derailment crews working to clear damaged railcars from rail line.

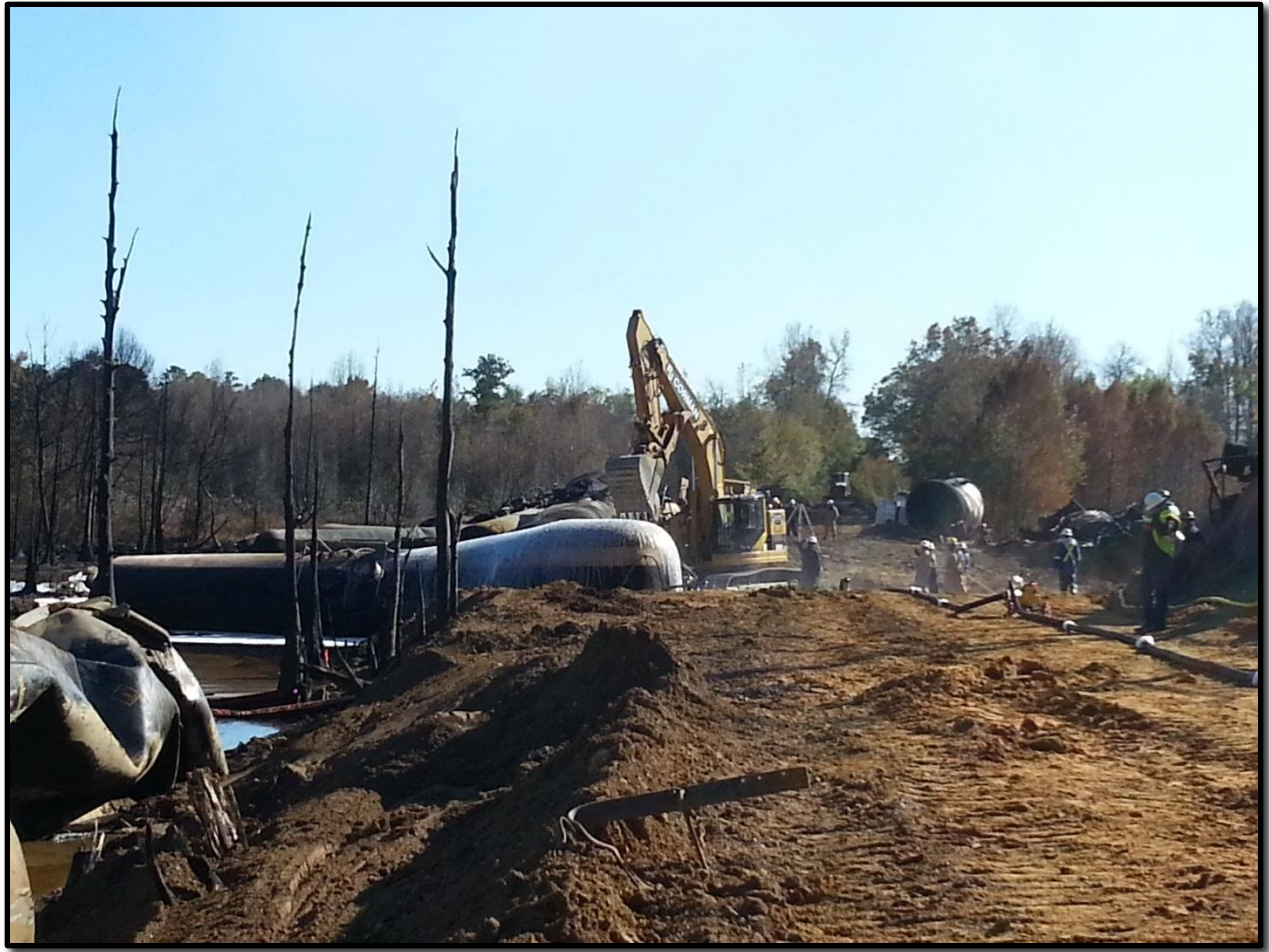
**OFFICIAL PHOTOGRAPH NO. 7**  
**U.S. ENVIRONMENTAL PROTECTION AGENCY**

**Subject:** Crews working to access the contents of one railcar in preparation for the transfer of crude oil remaining inside. Firefighting foam was sprayed on the railcar and equipment to minimize the potential for ignition.

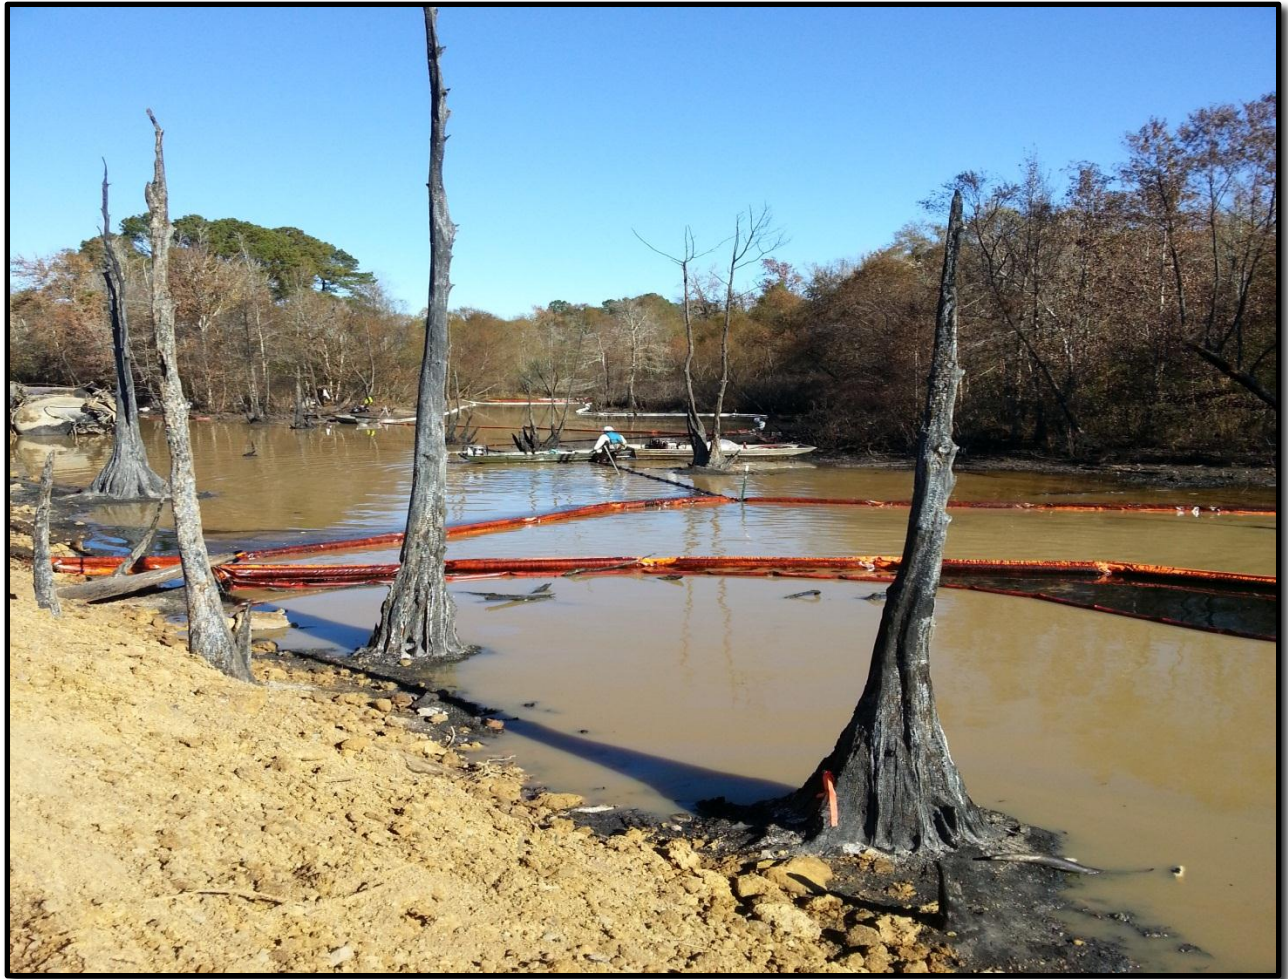
**OFFICIAL PHOTOGRAPH NO. 8**  
**U.S. ENVIRONMENTAL PROTECTION AGENCY**

<b>TDD Number:</b>	TTEMI-05-002-0023	<b>Location:</b>	Aliceville Train Derailment
<b>Orientation:</b>	North	<b>Date:</b>	November 13, 2013
<b>Photographer:</b>	Brain Croft, Tetra Tech	<b>Witness:</b>	Amber Skiles, Tetra Tech
<b>Subject:</b>	Recovery team setting up drum skimmer to recover oil discharged to the wetland slough along the eastern side of the rail line.

On November 14, USES began mechanical recovery of oil from the wetland slough using drum skimmers. One skimmer was deployed on the east side of the rail and collected approximately 840 gallons of oil, while two skimmers were deployed on the west side and collected approximately 1,260 gallons of oil. Vacuum trucks transferred recovered oil to frac tanks.

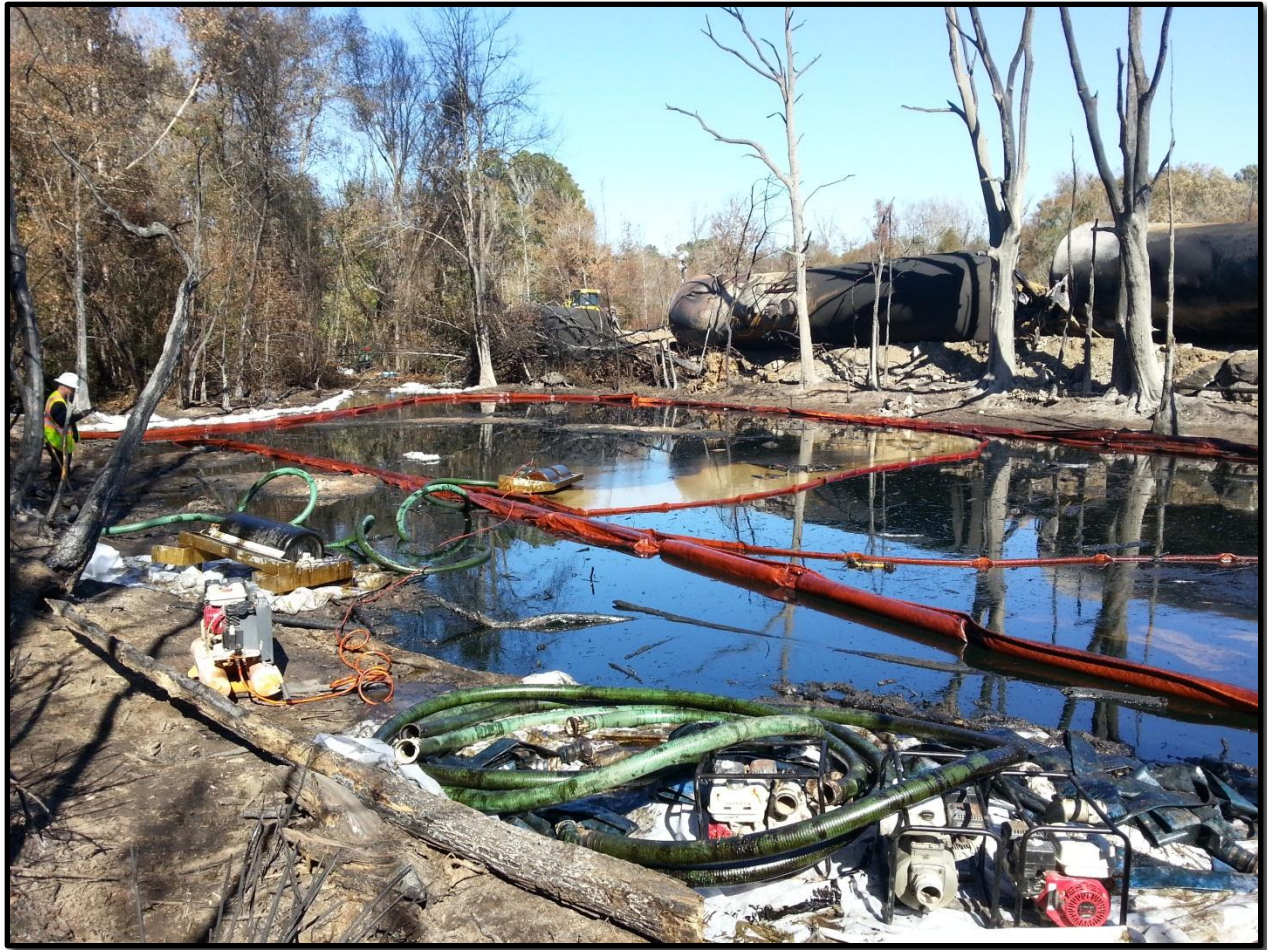
**OFFICIAL PHOTOGRAPH NO. 9**  
**U.S. ENVIRONMENTAL PROTECTION AGENCY**

<b>TDD Number:</b>	TTEMI-05-002-0023	<b>Location:</b>	Aliceville Train Derailment
<b>Orientation:</b>	Northeast	<b>Date:</b>	November 14, 2013
<b>Photographer:</b>	Brian Croft, Tetra Tech	<b>Witness:</b>	Amber Skiles, Tetra Tech
<b>Subject:</b>	Drum skimmer (center) deployed to recover oil from wetland slough along western side of rail line.

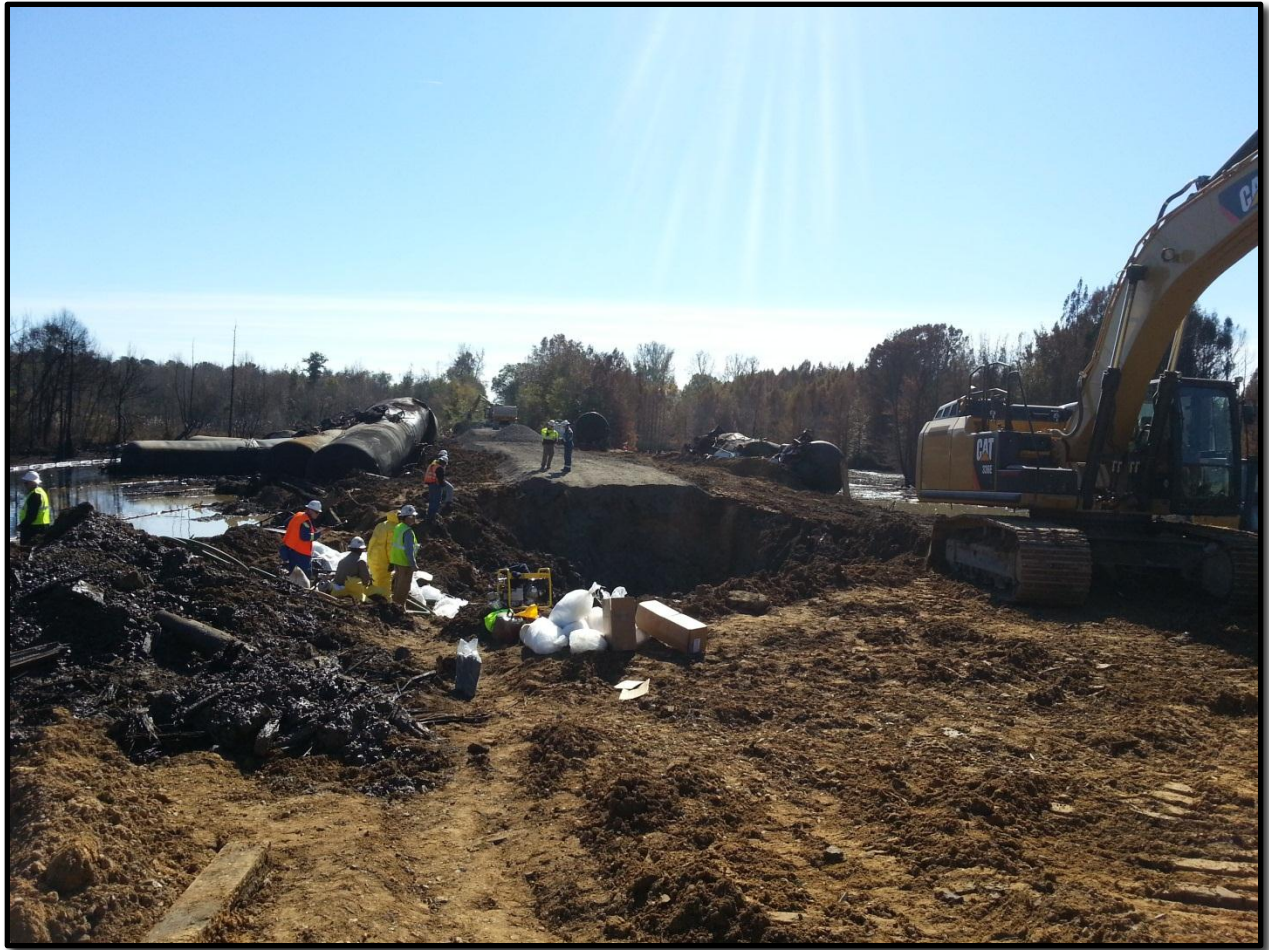
**OFFICIAL PHOTOGRAPH NO. 10**  
**U.S. ENVIRONMENTAL PROTECTION AGENCY**

**Subject:** Area of train derailment where trestle was formerly located.

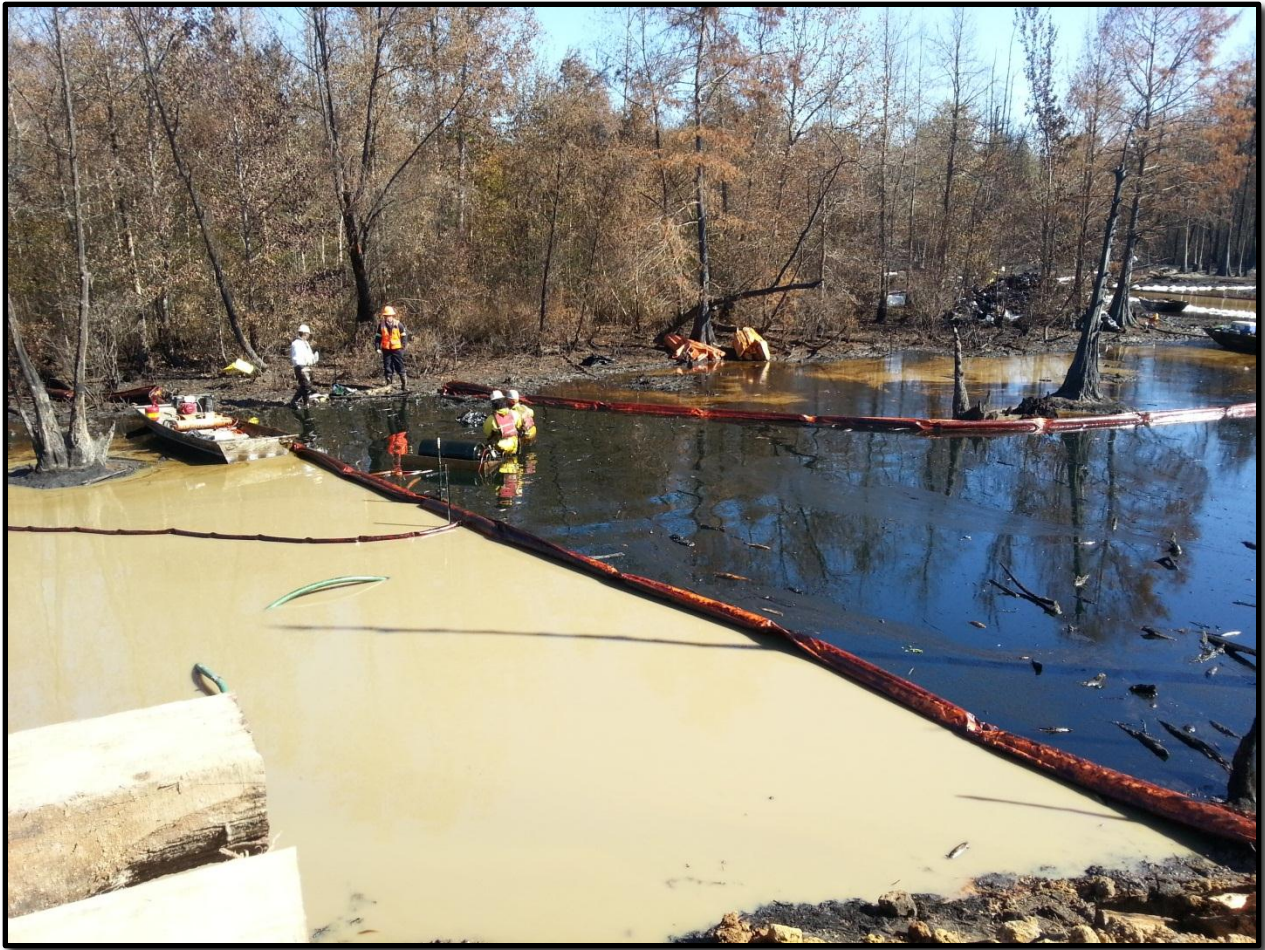
**OFFICIAL PHOTOGRAPH NO. 11**  
**U.S. ENVIRONMENTAL PROTECTION AGENCY**

**Subject:** Mechanical recovery (drum skimmer) of oil in progress in the wetland slough along the eastern side of the rail line.

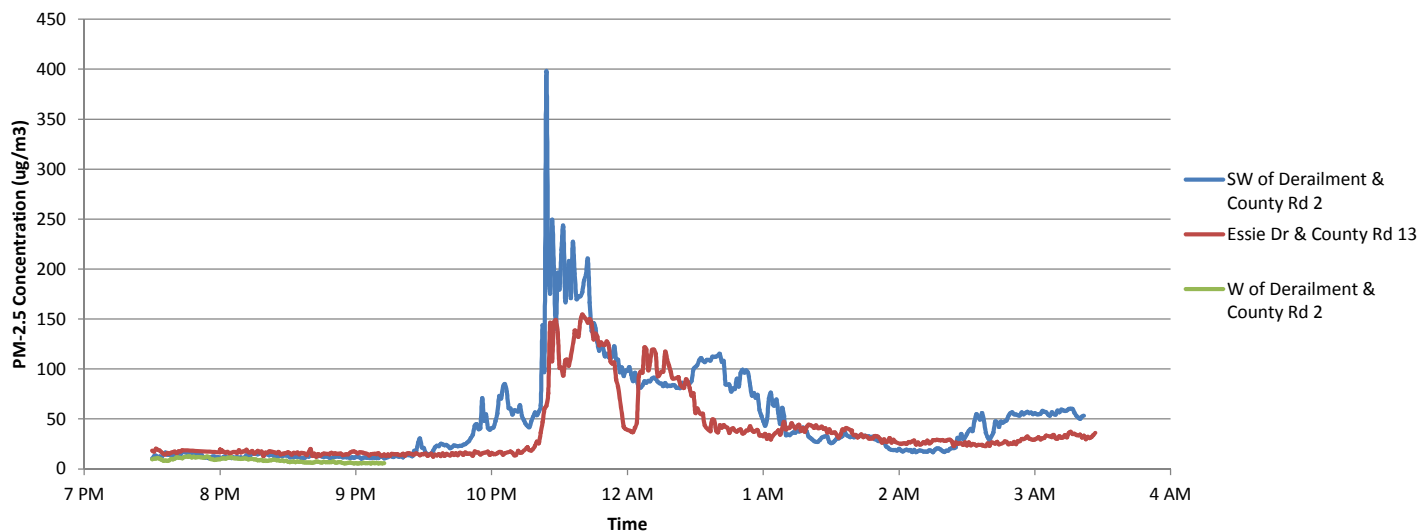
## DataRam Instantaneous PM-2.5 Values 11/08 night

The charts below summarize EPA monitoring data collected in 11/08 to 11/09 .

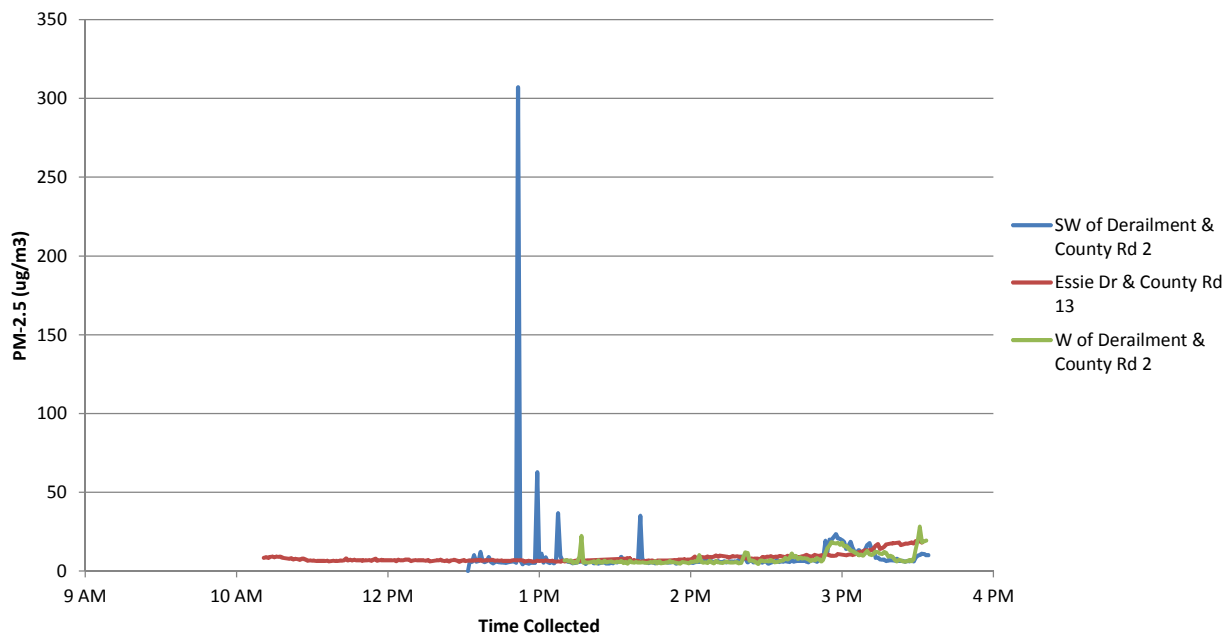
**DataRam Instantaneous PM-2.5 Values  
11/09 day**

The charts below summarize EPA monitoring data collected throughout 11/09 day.

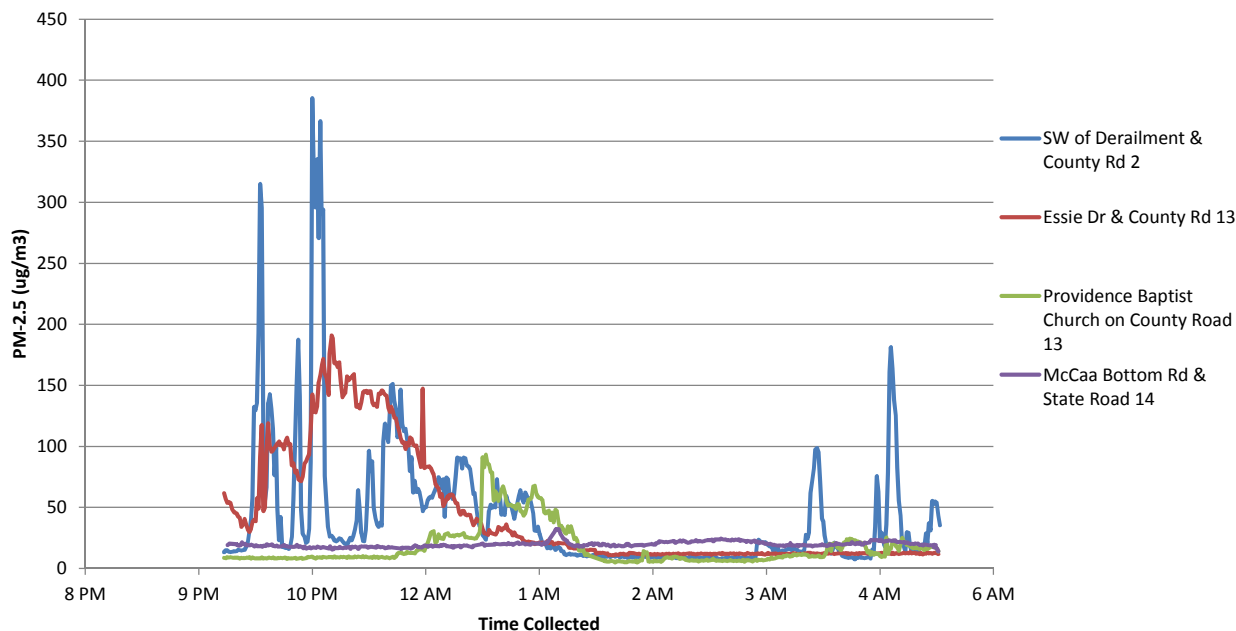
**DataRam Instantaneous PM-2.5 Values  
11/09 night**

The charts below summarize EPA monitoring data collected throughout 11/09 evening.

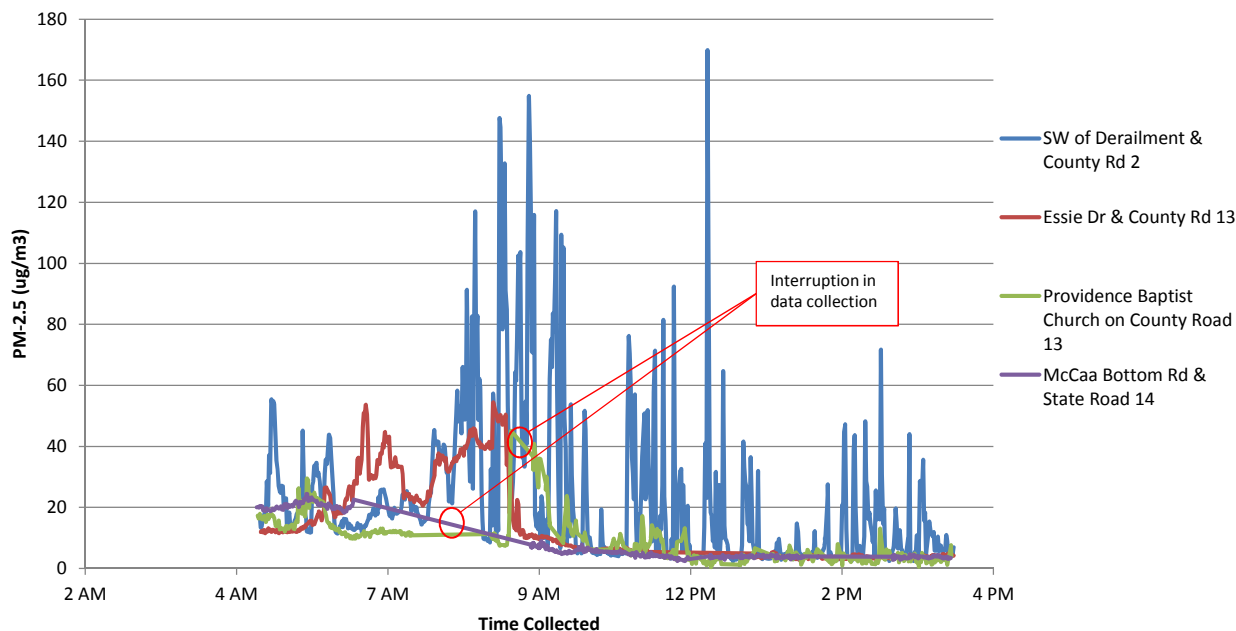
**DataRam Instantaneous PM-2.5 Values  
11/10 day**

The charts below summarize EPA monitoring data collected throughout 11/10 day.
