**TES IV
CONTRACT #68-01-7351
WORK ASSIGNMENT #99**

**RCRA FACILITY ASSESSMENT
OF
KUHLMAN DIECASTING COMPANY
STANLEY, KANSAS
EPA I.D. NO. KSD006325013**

**PREPARED BY:
JACOBS ENGINEERING GROUP INC.
LAKEWOOD, COLORADO
PROJECT NUMBER: 05-A-00599**

**DRAFT: APRIL 1988
FINAL: JULY 1988**

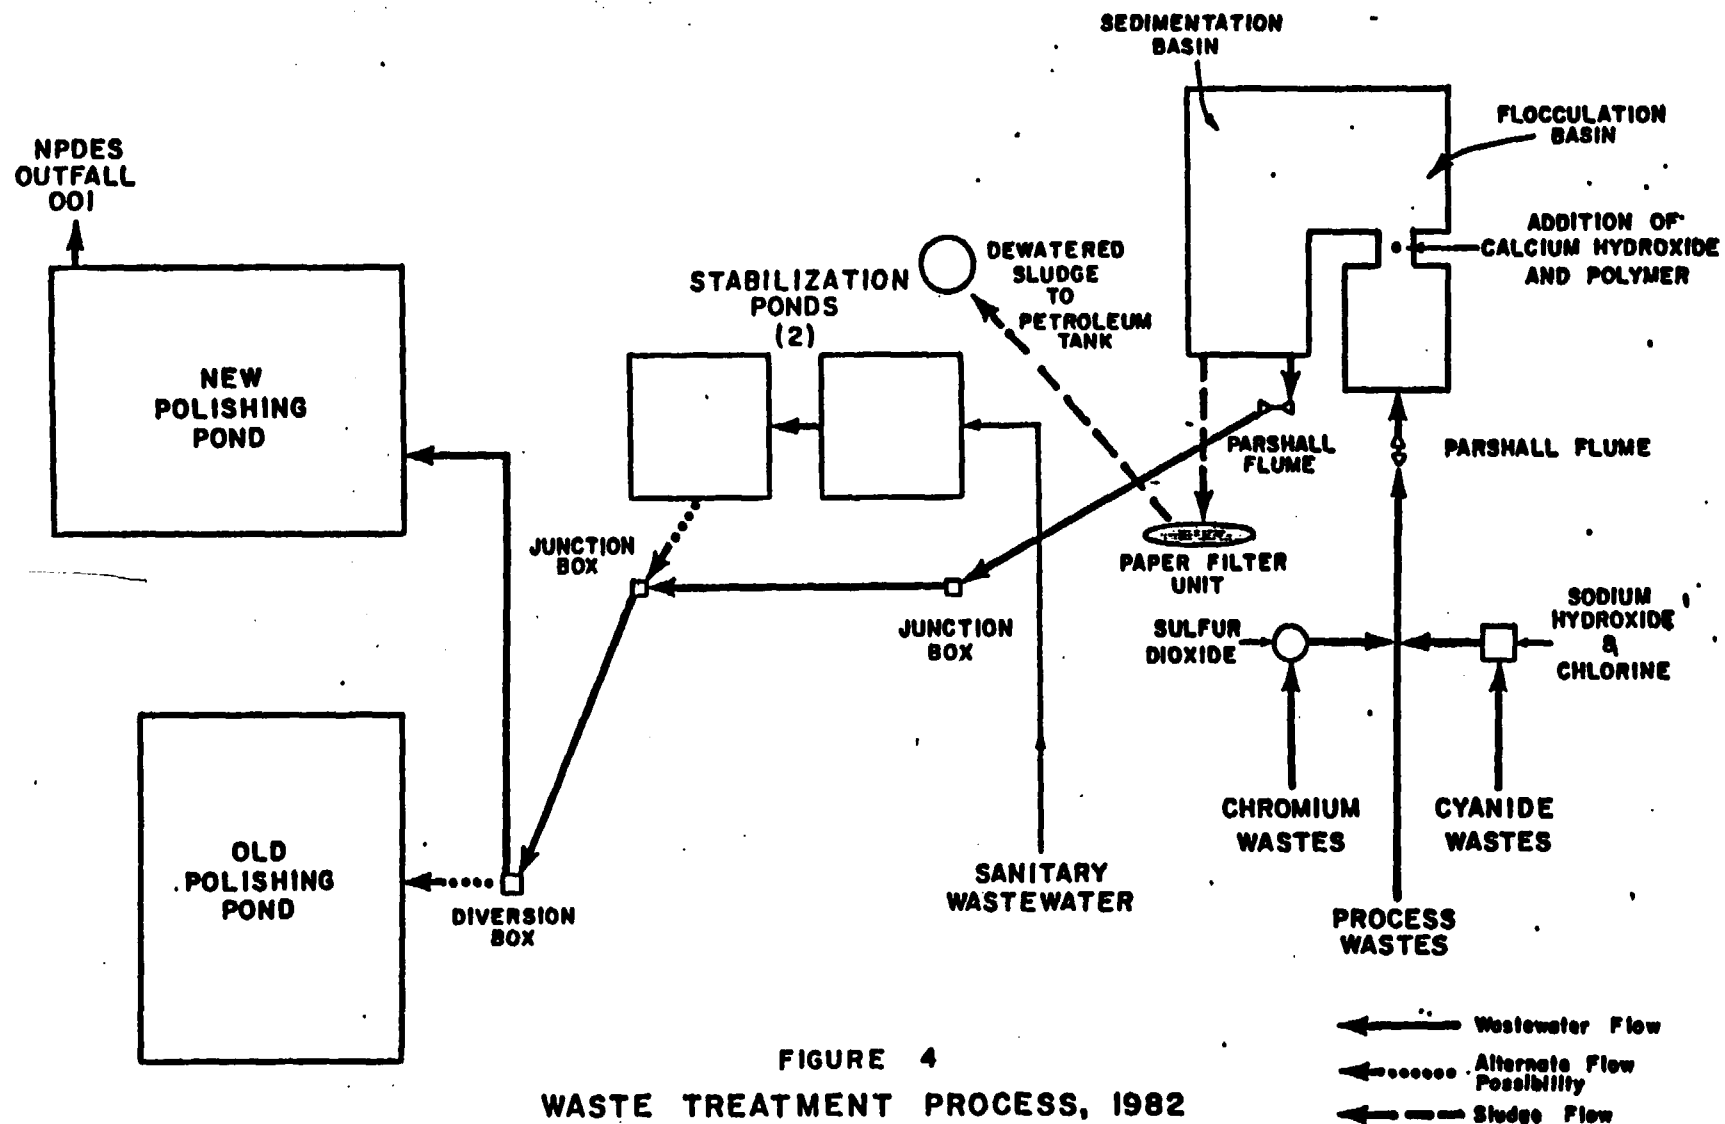
FIGURE 4
WASTE TREATMENT PROCESS, 1982
KUHLMAN DIECASTING COMPANY, INC.

(modified from Report of Compliance Monitoring Inspection, August 17- 20, 1982)

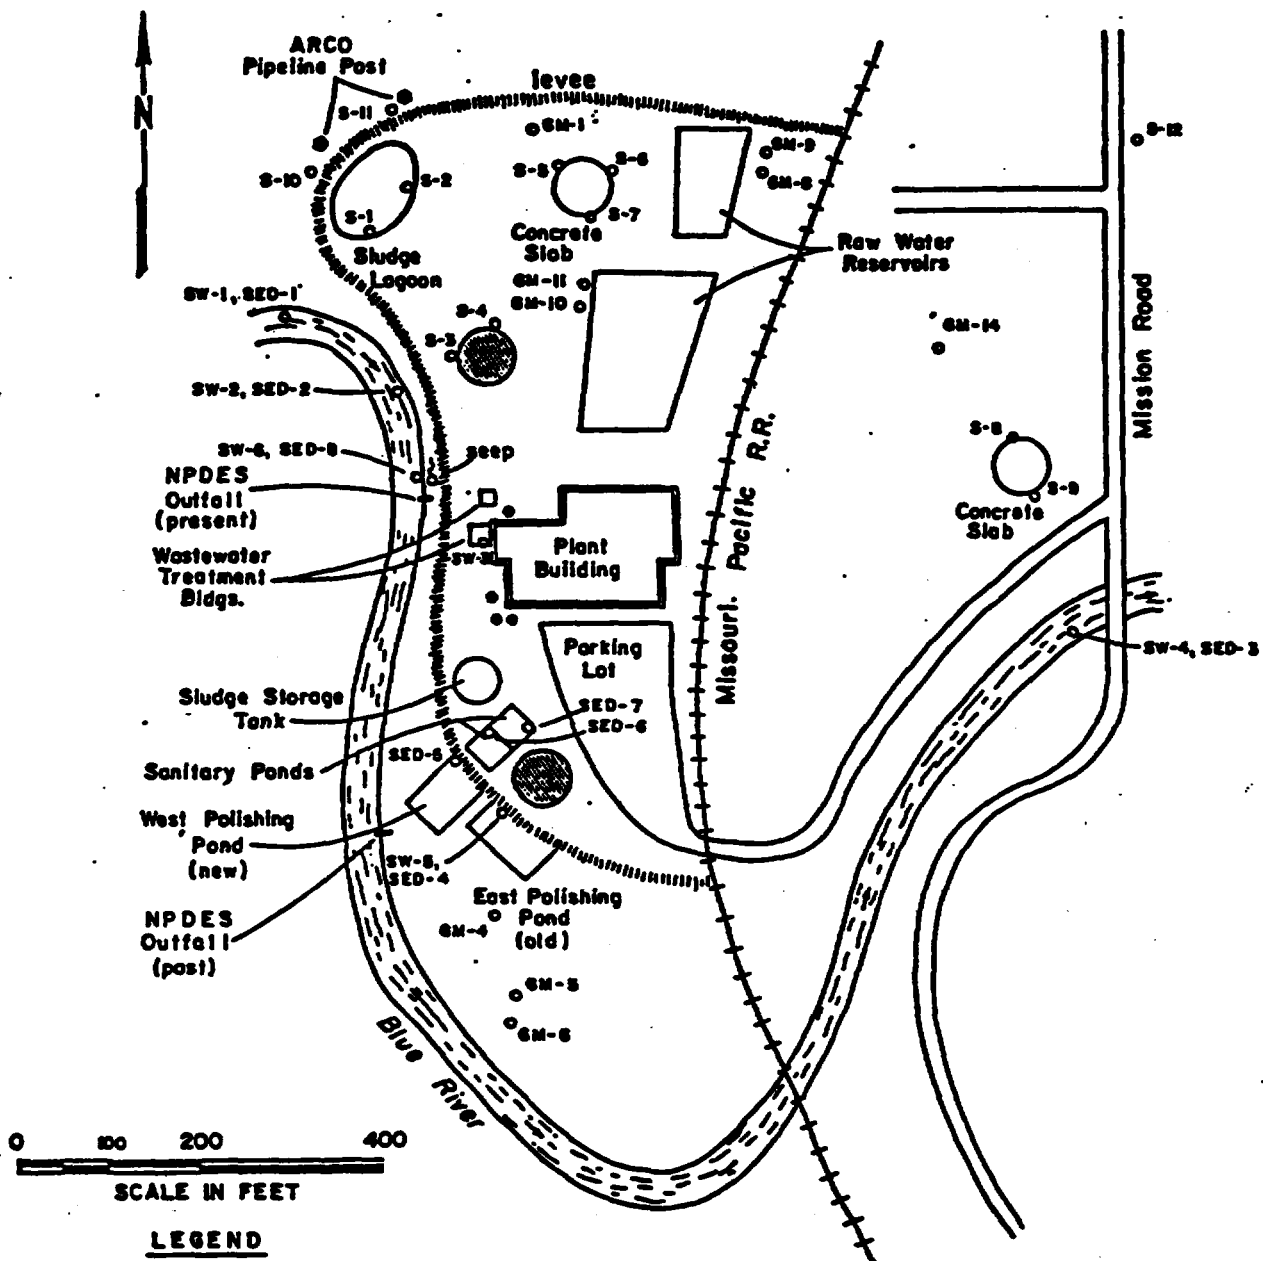
FIGURE 9
SAMPLE LOCATION MAP
KUHLMAN DIECASTING FACILITY

The SWMUs and potential areas of concern identified from reports, letters and other information during the PR and verified during the VSI and the SV are presented in Table 4. Figure 9 presents locations of each sample taken by Jacobs during the SV. A description of the sampling methodologies and the QA/QC procedures that were followed are located in Appendix V.

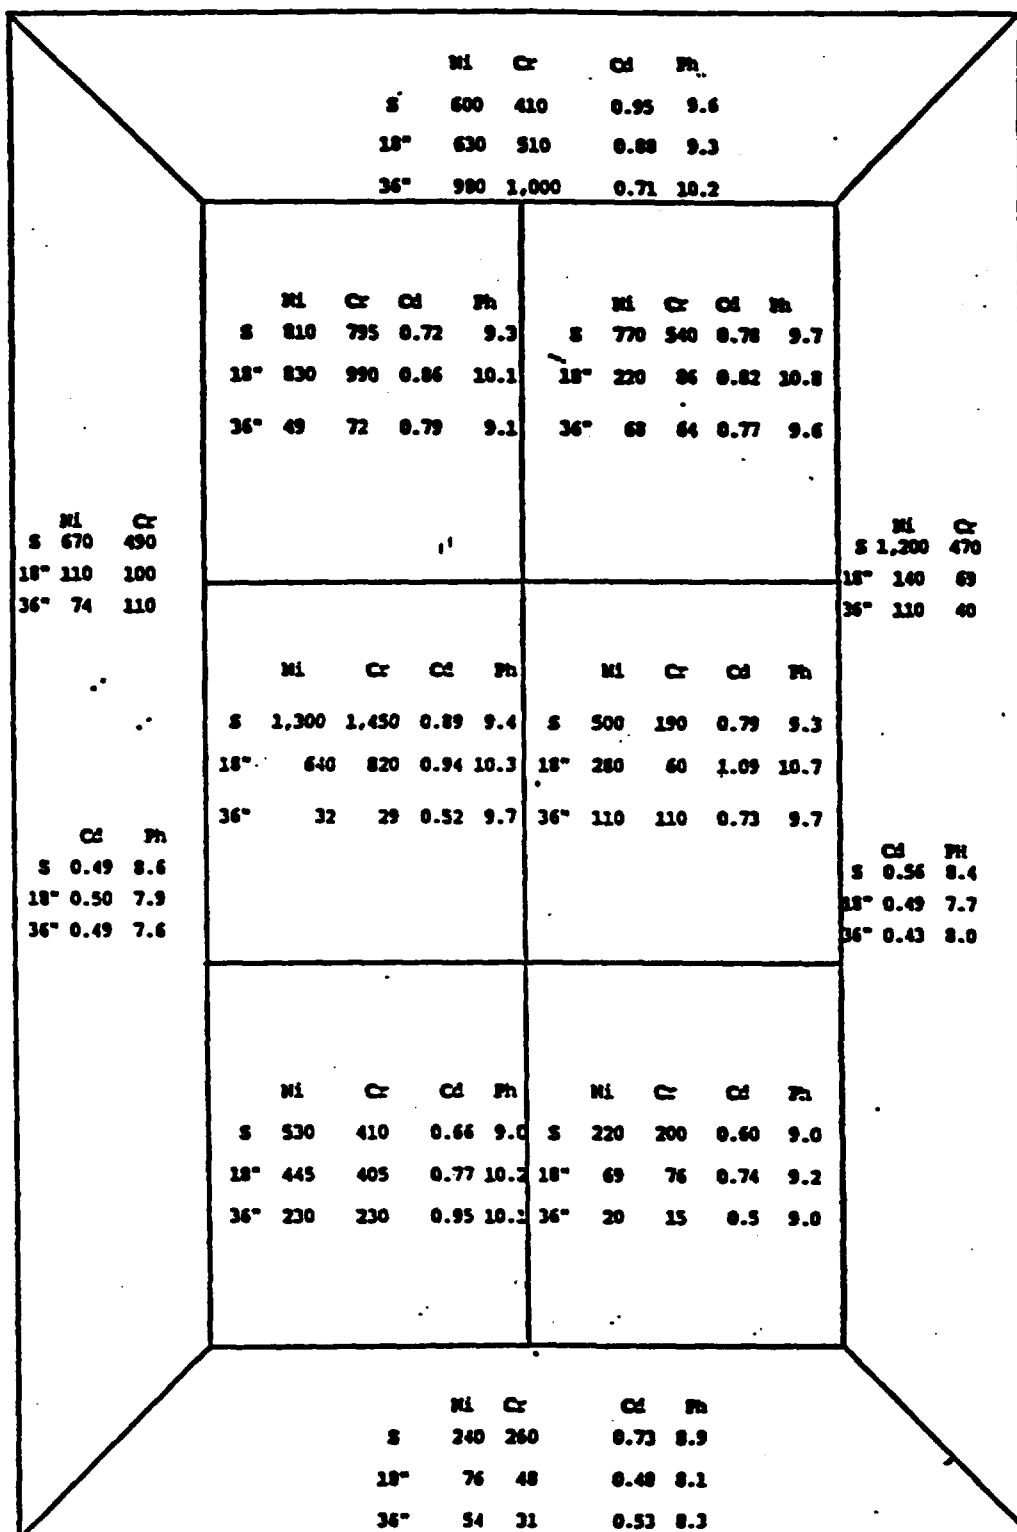
Figure 12 - EAST POND, MARCH 1984 SAMPLE RESULTS (mg/Kg)

One potential migratory pathway for the metal precipitate was through the unlined polishing ponds to the underlying soil. As evidenced from the ETI sampling (Figures 12 and 14), there is still a significant concentration of metals in the soil. At the time of the VSI the ponds were full of water (Appendix II, Photographs 16 and 17). According to water level measurements taken from monitoring wells GM-4, GM-5, and GM-6 during July and October 1984 (ETI of North America, 1985), the water table is within six feet of surface. Previous groundwater sampling by the facility has shown that the contents in the ponds have leached into the alluvial aquifer. Analytical data from 1983 and 1984 showed monitoring well GM-4 had a range of 35-169 ppb chromium and <25 to 194 ppb nickel. In addition, in 1984, monitoring wells GM-5 and GM-6 had a range of <10 to 550 ppb and <10 to 400 ppb chromium and 30-1100 ppb and 30-490 ppb nickel, respectively (ETI of North America, 1985).

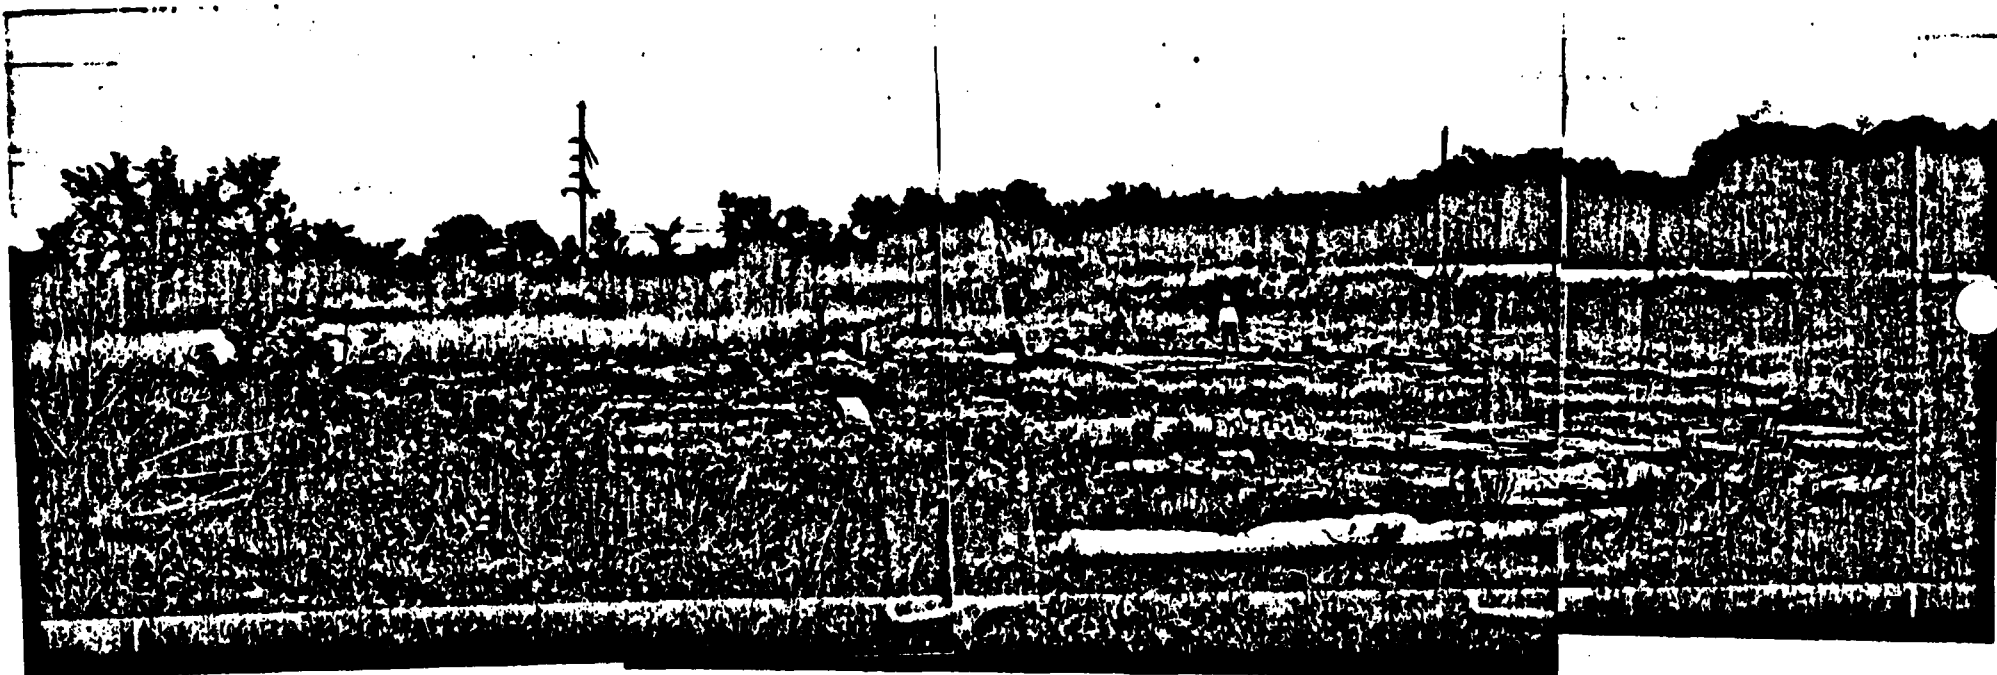
PHOTOGRAPH #11
OFFICIAL PHOTOGRAPH - JACOBS ENGINEERING

Subject: View of concrete slab at the entrance to the facility.
The slab was once a petroleum storage tank.
Mission Road and M. Mattione are in background.
Location: Kuhlman Diecasting Co., Stanley, KS

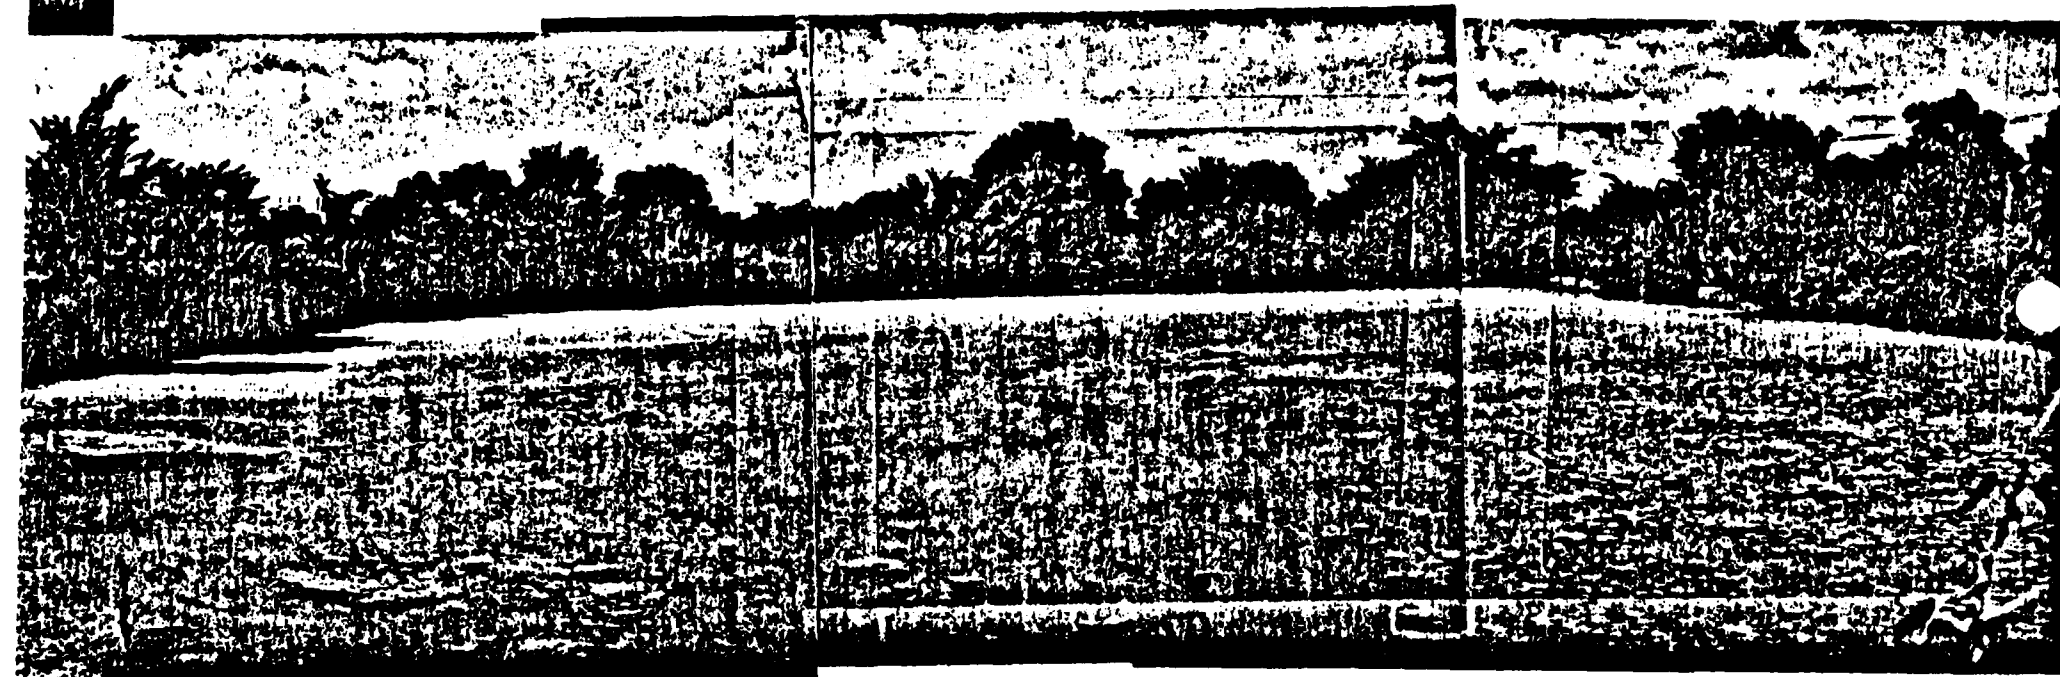
PHOTOGRAPH #19
OFFICIAL PHOTOGRAPH - JACOBS ENGINEERING

Subject: North view of the stagnant water reservoir located
just north of the facility. Note algal covering.

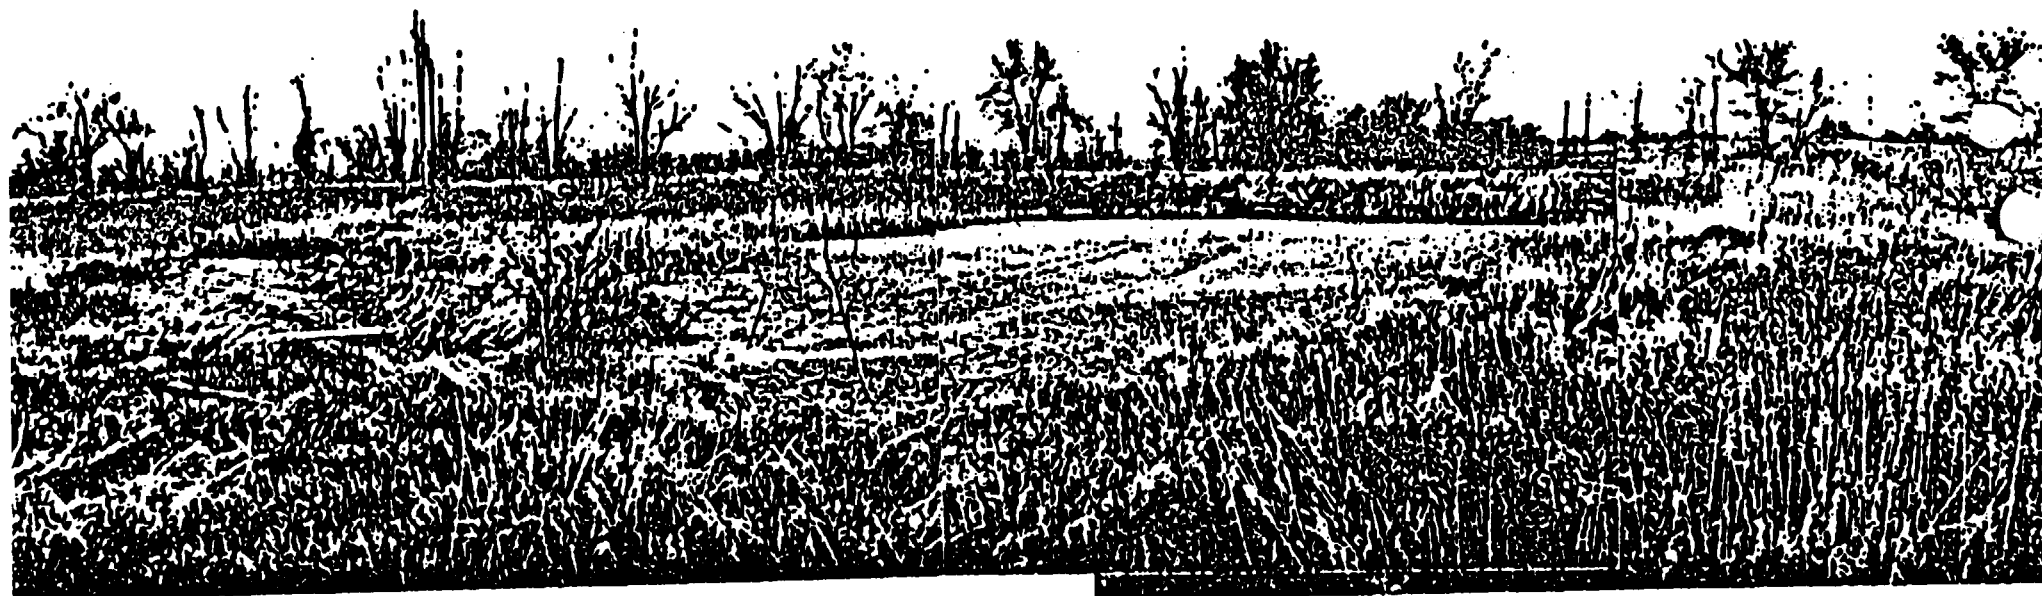
Interior view of the enclosure at left showing the plating sludge waste.

inactive plating sludge "evaporation" lagoon.

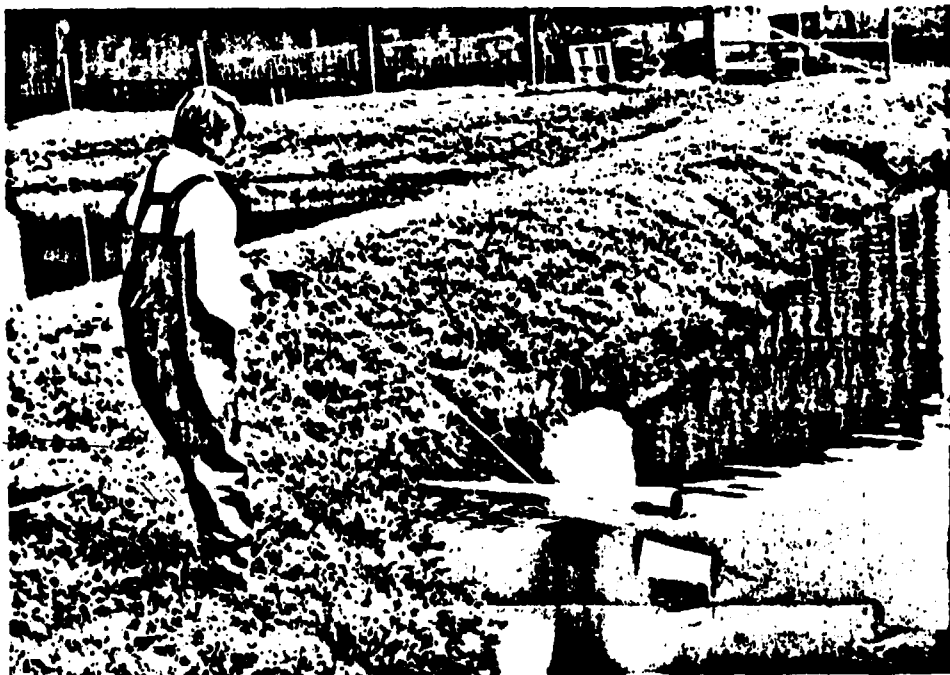
PHOTOGRAPH # 19
OFFICIAL PHOTOGRAPH - JACOBS ENGINEERING

Subject: Due to steepness of the banks and depth to the sludge, G. Czyzewski obtained SED-6 via a stainless steel bucket and rope from the NW corner of the south sanitary sewage lagoon.

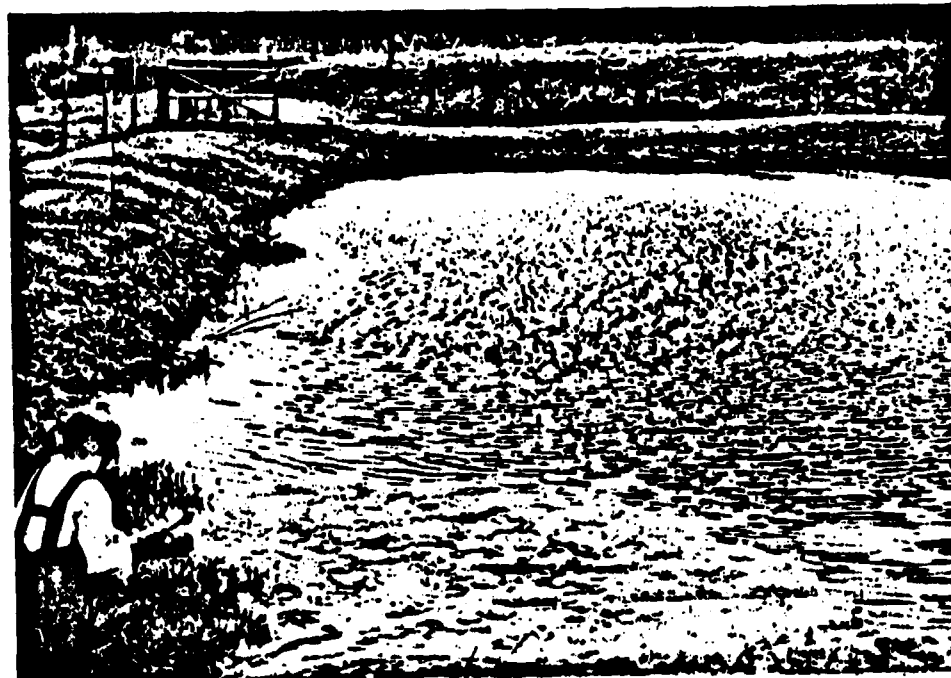
PHOTOGRAPH # 20
OFFICIAL PHOTOGRAPH - JACOBS ENGINEERING

Subject: G. Czyzewski obtaining sample SED-7 near discharge outlet in NE corner of the north sanitary sewage lagoon.
