RE: **Results of Follow Up Indoor Air and Outdoor Air Analyses**  
Leather Trimmings, LTD Building  
3110 Cullman Avenue, Charlotte NC  
WR Project Number: 03130430.03

As authorized by EnviroAnalytics Group, LLC (EAG) purchase order #2946 WithersRavenel (WR) has completed the collection of indoor air and outdoor ambient air samples from the Leather Trimmings building located at 3110 Cullman Avenue in Charlotte, NC. The indoor and outdoor air samples were submitted to ESC Lab Sciences (ESC) where they were analyzed for 1,1 dichloroethene (1,1 DCE), cis 1,2 dichloroethene (cis 1,2 DCE), trans 1,2 dichloroethene (trans 1,2 DCE), tetrachloroethylene (PCE), trichloroethylene (TCE) and vinyl chloride (VC) by EPA Method TO 15 Selected Ion Method (SIM). This report provides description and documentation of the sampling activities and the results of the laboratory analyses.

INDOOR AIR, AND AMBIENT AIR SAMPLING  
 LOCATIONS AND ANALYTICAL RESULTS

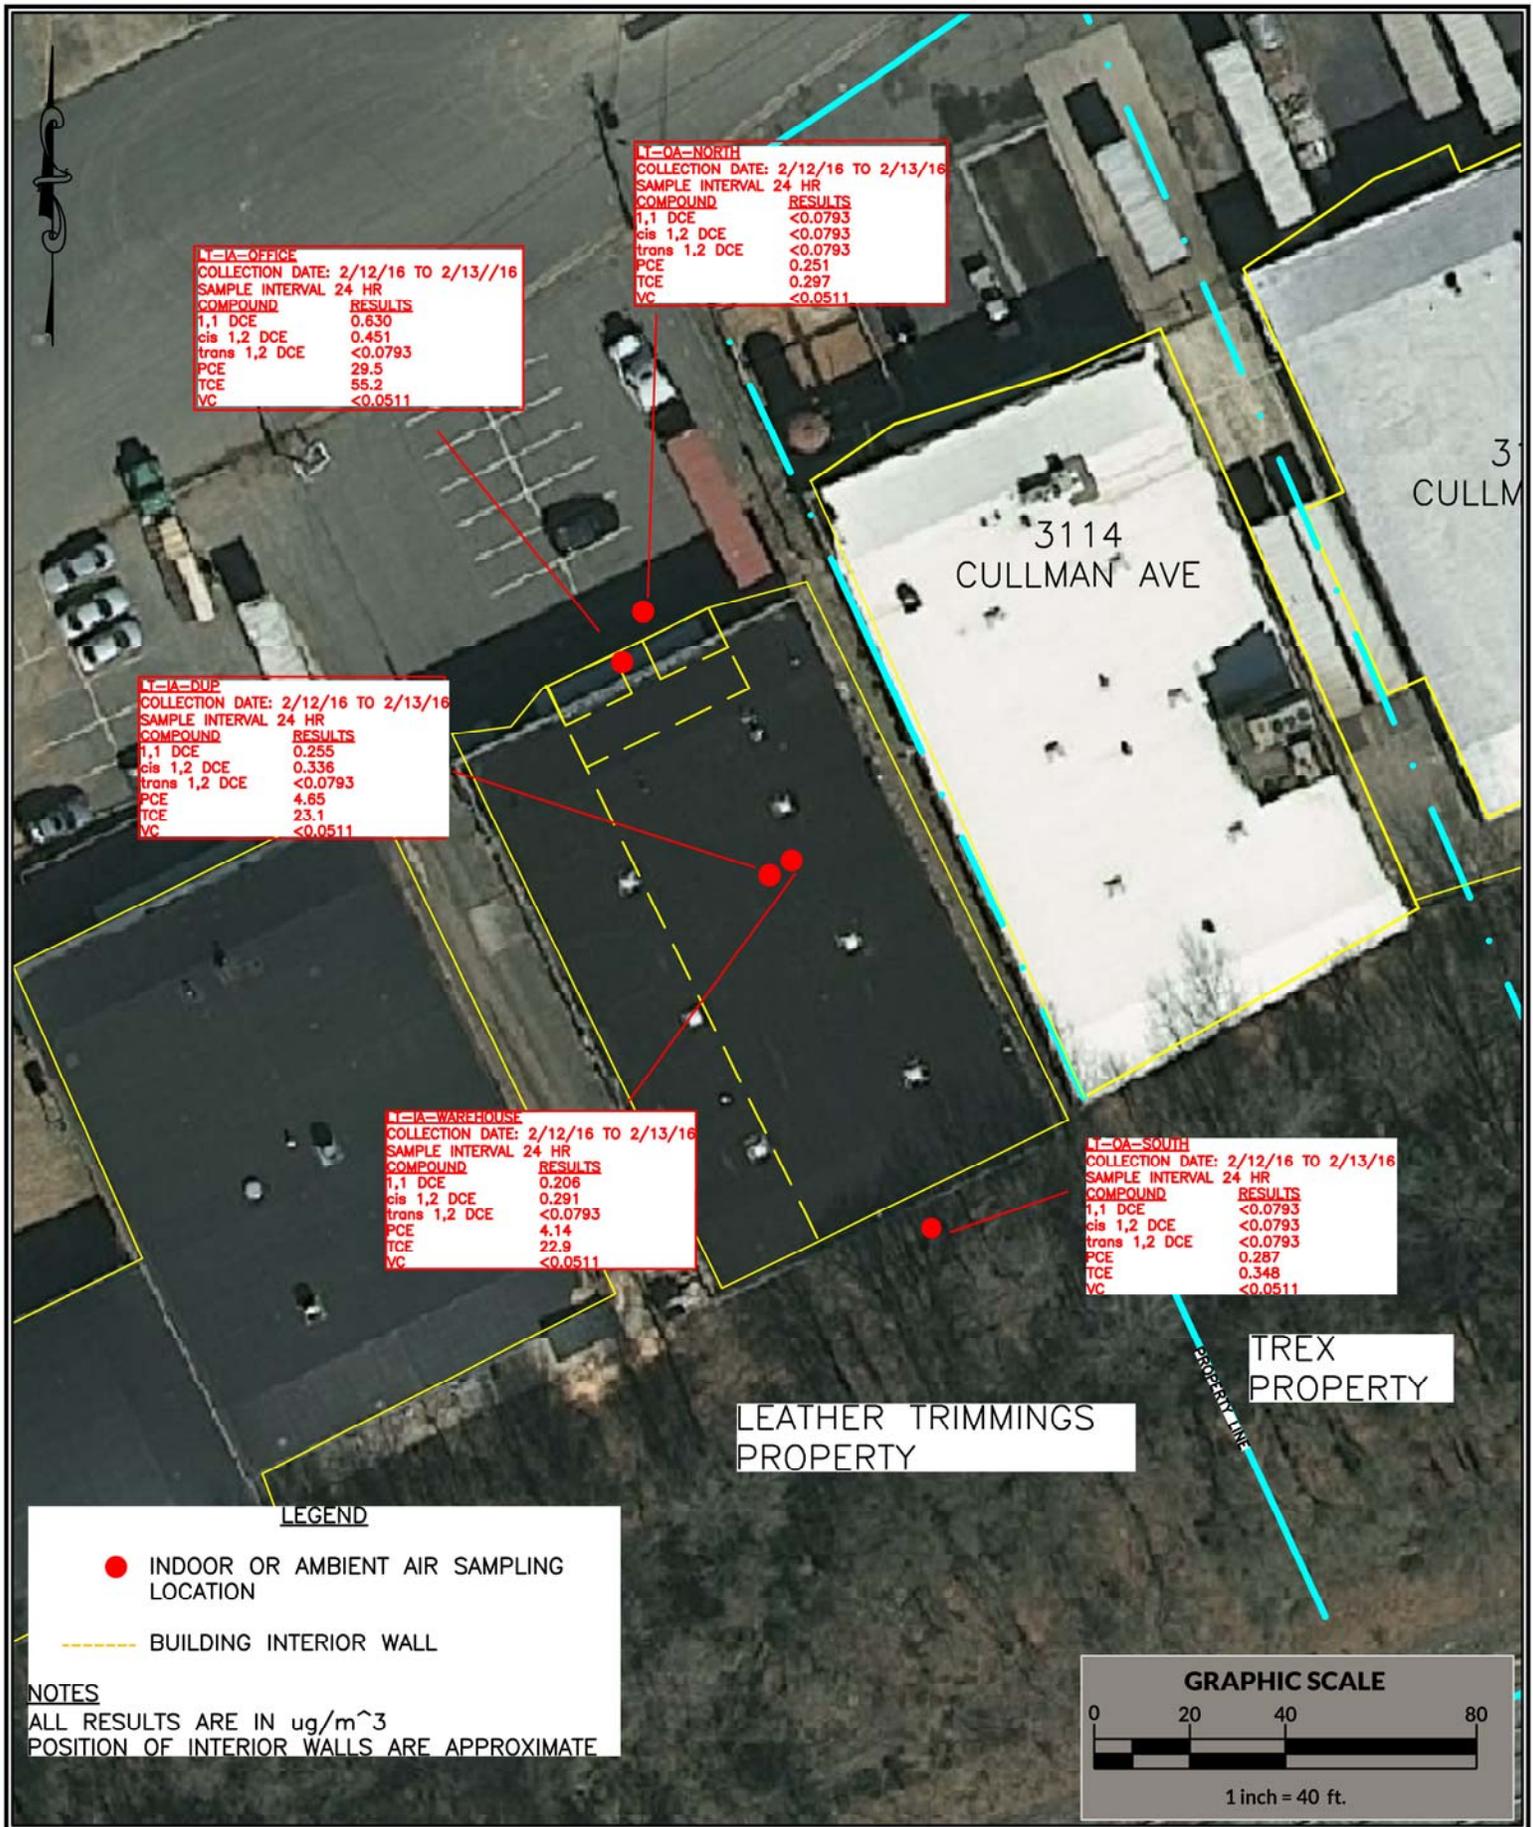
DRAWN BY: <b>CF</b>	SCALE: <b>1"=40'</b>	FIGURE NO.: <b>1</b>
APPROVED BY: <b>BB</b>	DATE: <b>2/23/2016</b>	PROJECT NO.: <b>02130430</b>

**LI-A-OFFICE**  
 COLLECTION DATE: 2/12/16 TO 2/13/16  
 SAMPLE INTERVAL 24 HR

COMPOUND	RESULTS
1,1 DCE	0.630
cis 1,2 DCE	0.451
trans 1,2 DCE	<0.0793
PCE	29.5
TCE	55.2
VC	<0.0511

**LI-OA-NORTH**  
 COLLECTION DATE: 2/12/16 TO 2/13/16  
 SAMPLE INTERVAL 24 HR

COMPOUND	RESULTS
1,1 DCE	<0.0793
cis 1,2 DCE	<0.0793
trans 1,2 DCE	<0.0793
PCE	0.251
TCE	0.297
VC	<0.0511

**LI-A-DUP**  
 COLLECTION DATE: 2/12/16 TO 2/13/16  
 SAMPLE INTERVAL 24 HR

COMPOUND	RESULTS
1,1 DCE	0.255
cis 1,2 DCE	0.336
trans 1,2 DCE	<0.0793
PCE	4.65
TCE	23.1
VC	<0.0511

**LI-A-WAREHOUSE**  
 COLLECTION DATE: 2/12/16 TO 2/13/16  
 SAMPLE INTERVAL 24 HR

COMPOUND	RESULTS
1,1 DCE	0.206
cis 1,2 DCE	0.291
trans 1,2 DCE	<0.0793
PCE	4.14
TCE	22.9
VC	<0.0511

**LI-OA-SOUTH**  
 COLLECTION DATE: 2/12/16 TO 2/13/16  
 SAMPLE INTERVAL 24 HR

COMPOUND	RESULTS
1,1 DCE	<0.0793
cis 1,2 DCE	<0.0793
trans 1,2 DCE	<0.0793
PCE	0.287
TCE	0.348
VC	<0.0511

During the February 12, 2016 site visit, WR deployed three individually certified six-liter summa canisters each equipped with 24-hour flow controllers inside the building at the approximate locations shown in **Figure 1**. One of the canisters was placed on a table in the northern portion of the building where two offices are located (sample ID LT-IA-Office). The doors to the office were closed to the rest of the building at the time the canisters were

These results are summarized by location in **Figure 1**, and the ESC analytical reports and chain of custody records are provided in **Attachment C**.

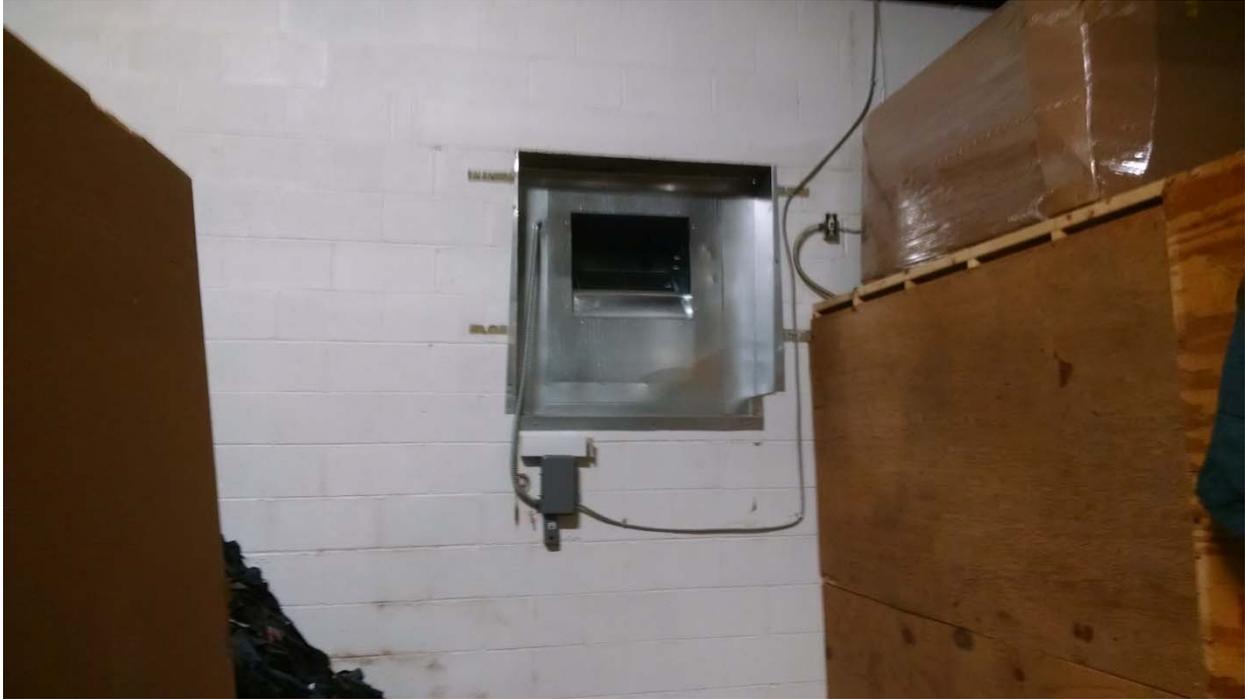
Photo #1: Positive pressure ventilation fan installed within the south wall of the  
Leather Trimmings facility.

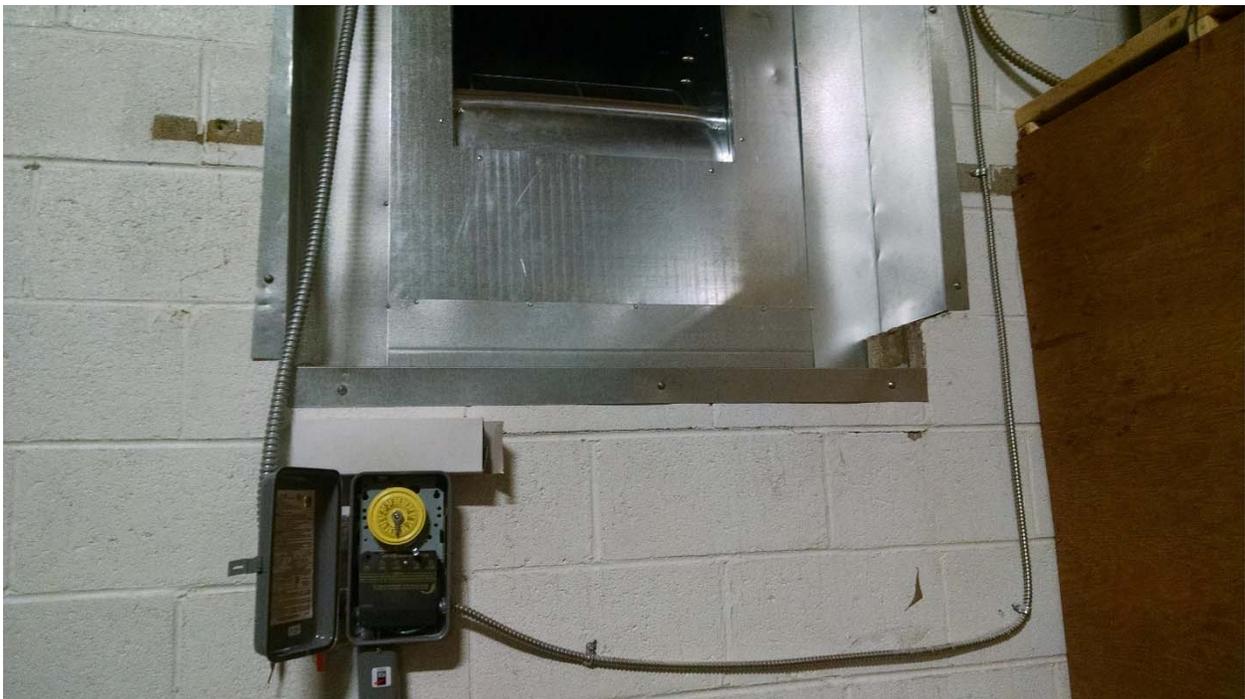
Photo #2: Thermostat control (lower left) for the positive pressure ventilation fan.

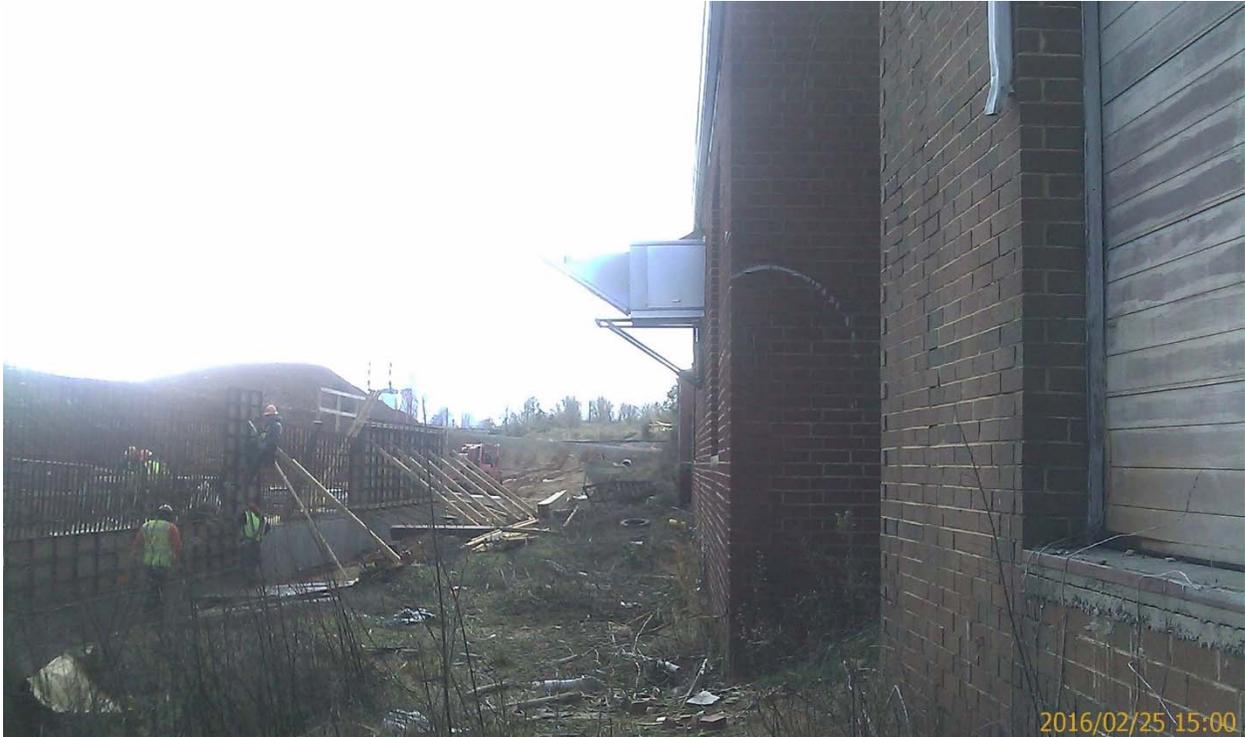
Photo #3: West looking view of new positive pressure ventilation fan.

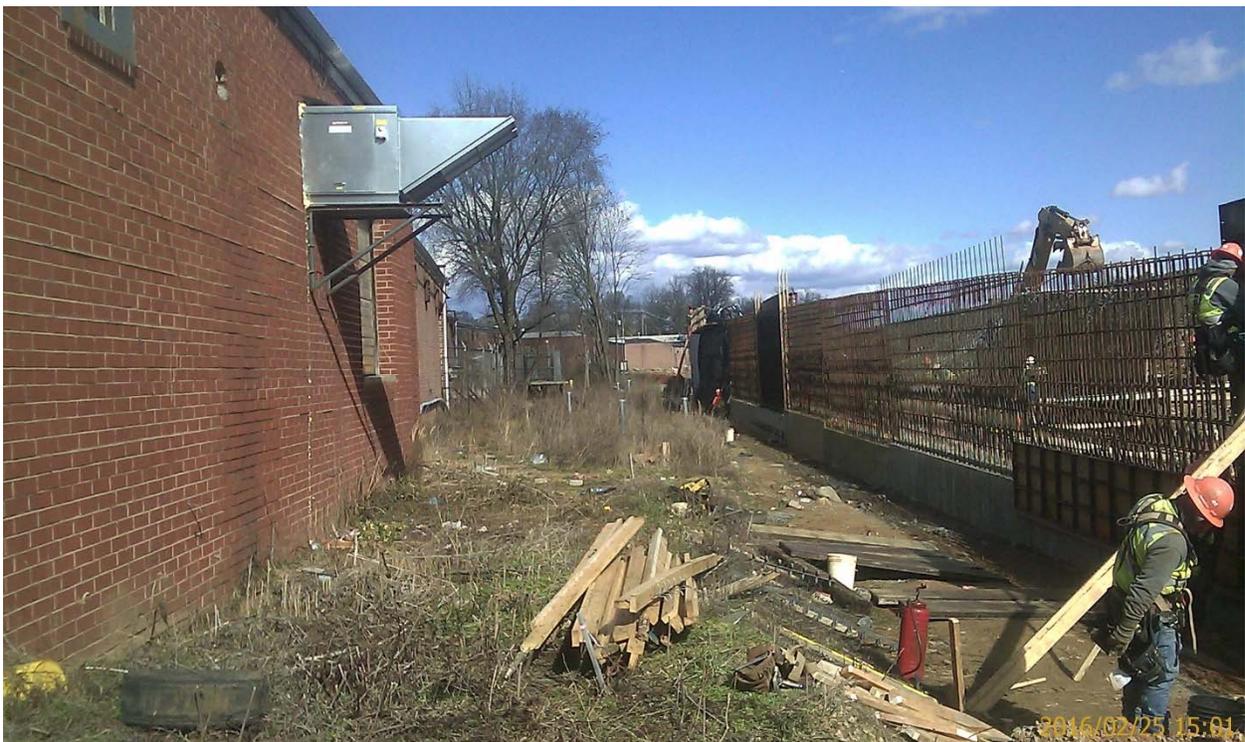
Photo #4: East looking view of positive pressure ventilation fan. Note rail construction activities to south (right side of picture).

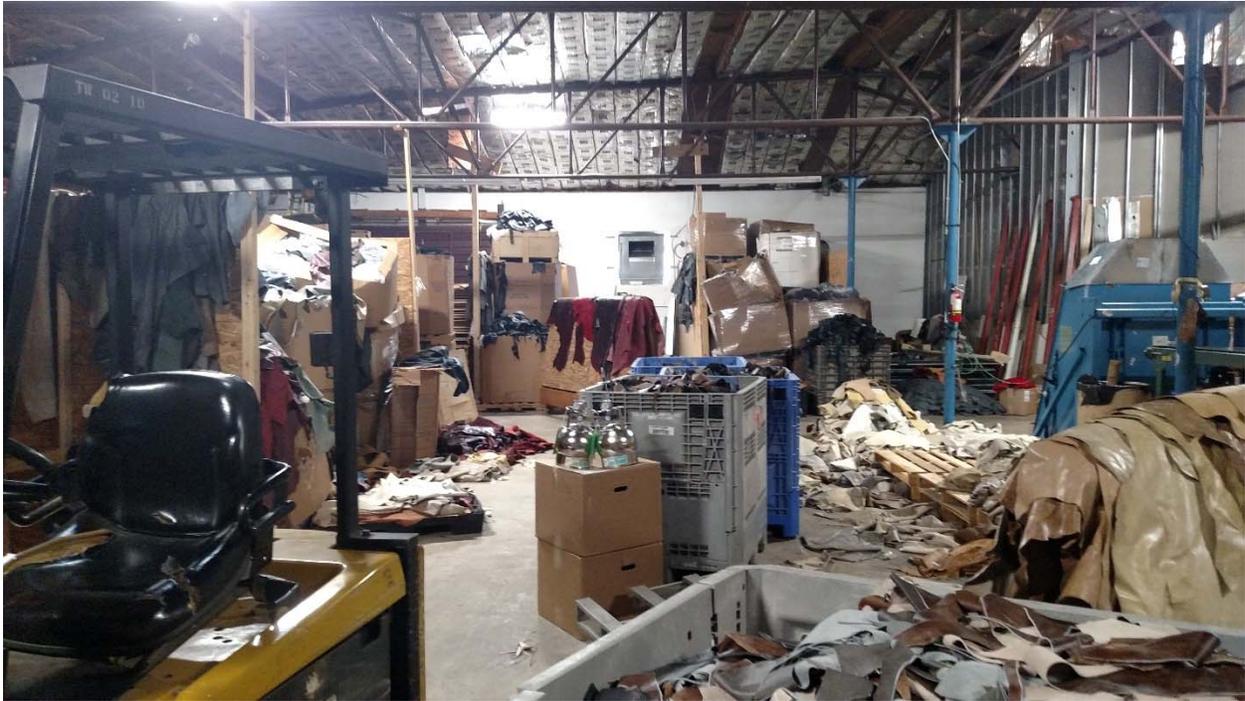
Photo #5: Duplicate summa canisters deployed in approximate center of Leather Trimmings warehouse. Positive pressure ventilation fan is in center of white wall in the background.

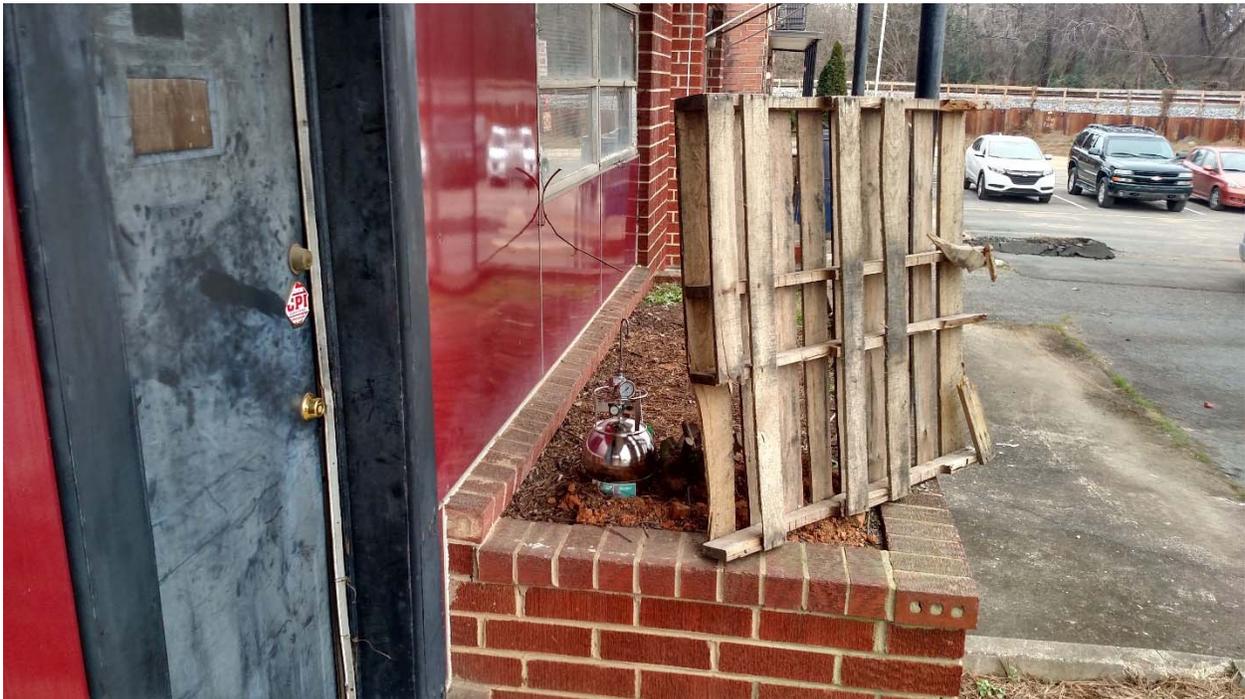
Photo #6: Summa canister deployed for collection of an ambient air sample on the north side of the Leather Trimmings building.

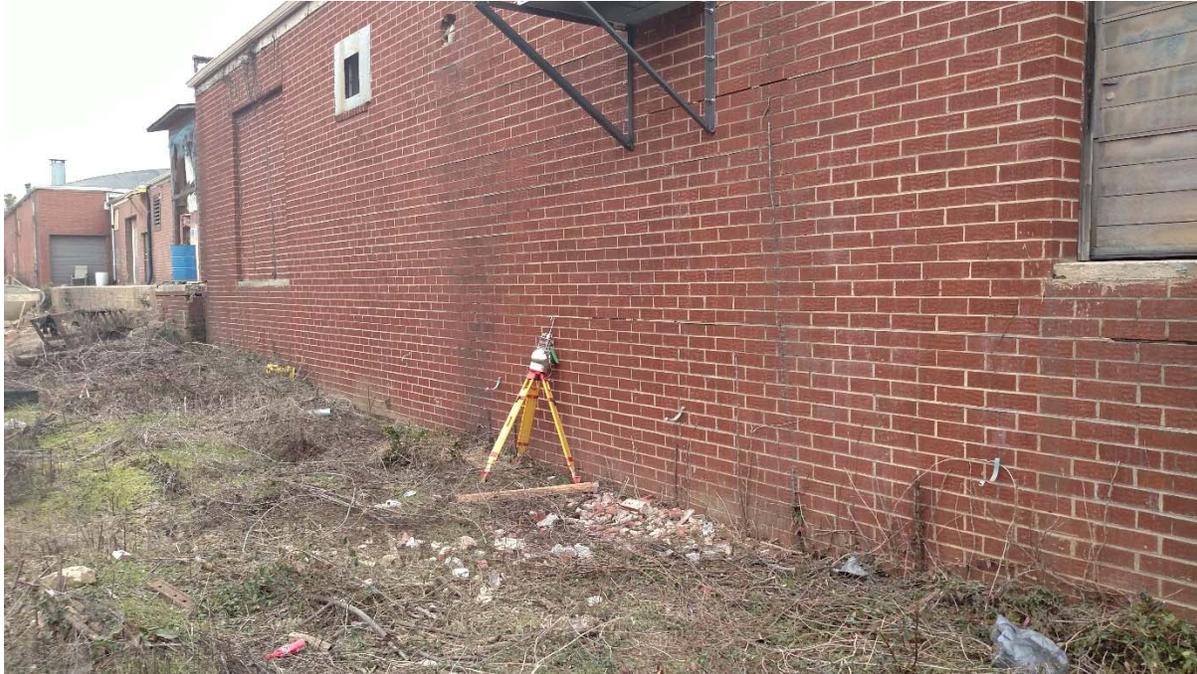
Photo #7: Summa canister deployed to collect an ambient air sample on the south side of the Leather Trimmings building.

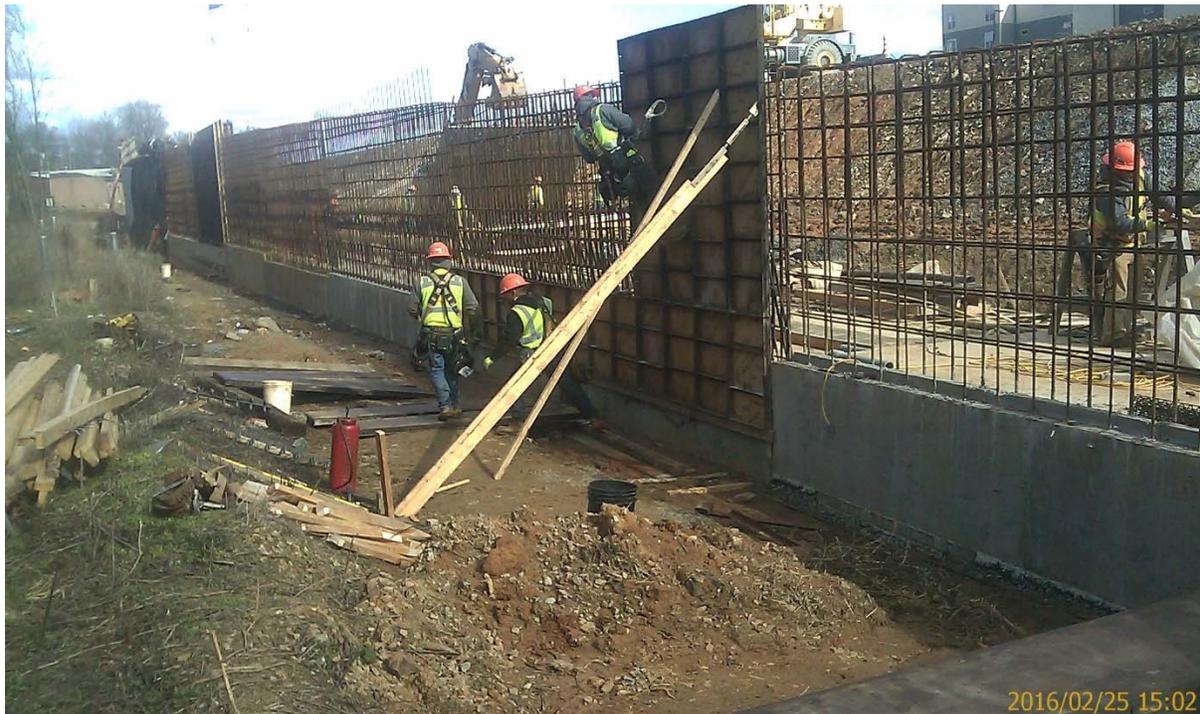
Photo #8: Retaining wall construction to south of Leather Trimmings building. Note the lack of exposed groundwater at this work location.
