Re: Trip Report for the Cottage Grove Mercury Response, Contract Number EP-S7-13-07, Technical Direction Document Number 16-03-004

TRIP REPORT

Cottage Grove Mercury Response

Cottage Grove, Oregon

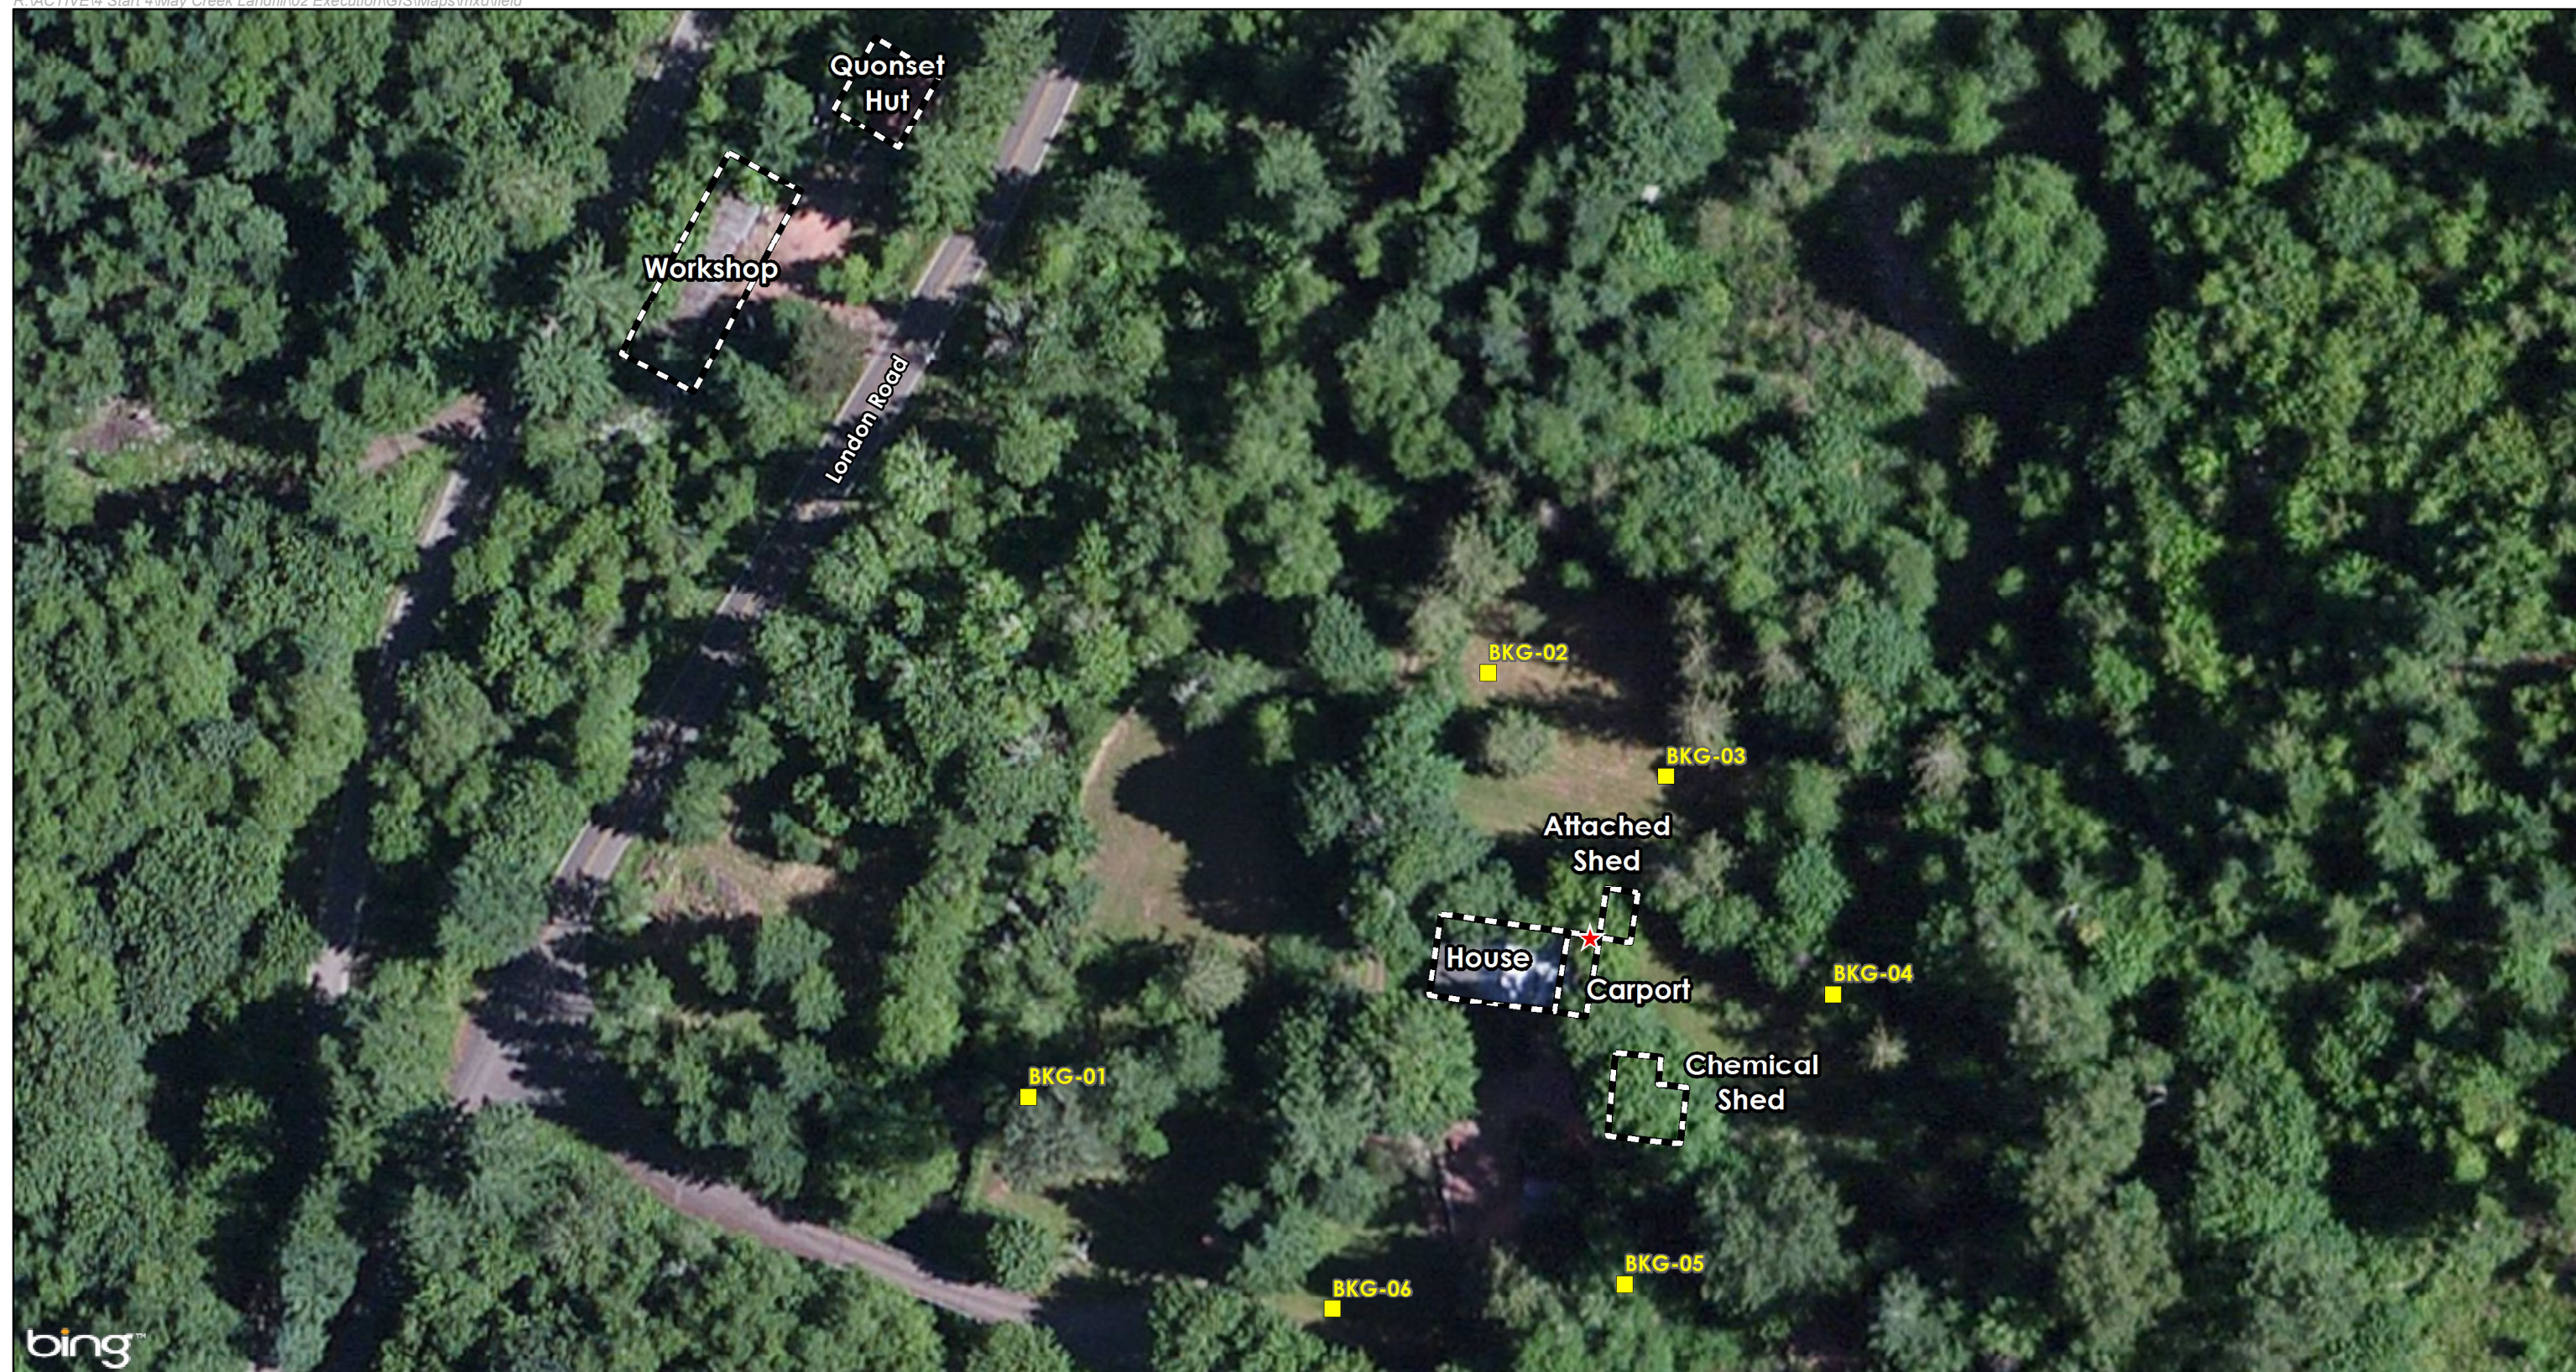
- ★ Spill Location
- Soil Samples*

*Sample locations are approximate

START identified six background locations for screening with the Lumex MVA (Figure 2). In accordance with the aforementioned heating technique, the average mercury vapor concentration in the headspace of heated background soil samples was 206 ng/m³ (Table 2). Due to the relatively low ambient outdoor temperature (approximately 60°F) and elevated relative humidity resulting in reduced volatilization of mercury vapor, EPA elected a soil screening level of 1,000 ng/m³ which was greater than three times the background concentration (618 ng/m³) but below the ATSDR threshold of 6,000 ng/m³.

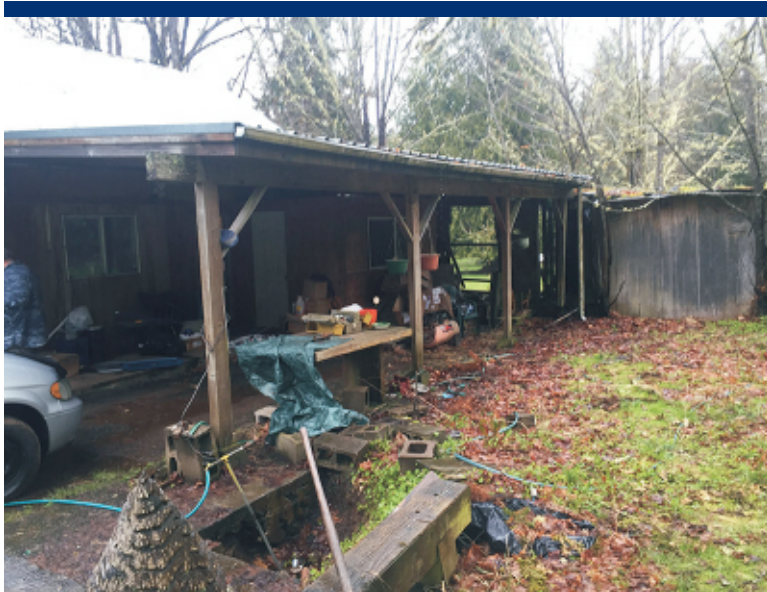
Photo 1 View of the spill site at the far end of the carport.

On March 8, START used the Lumex MVA to assess the spill area. Upon close inspection, visible mercury beads were observed amongst the soil, gravel, and organic material (leaf litter) in the carport area. ERRS deployed a mercury vacuum to remove visible mercury followed by hand tools for excavating soil and other material in the vicinity of the spill area. The spill occurred near a depression in the northeast corner of the carport, and mercury contamination was identified in the depression with the Lumex MVA. The depth of excavation below grade using hand tools ranged from 3 to 29 inches.

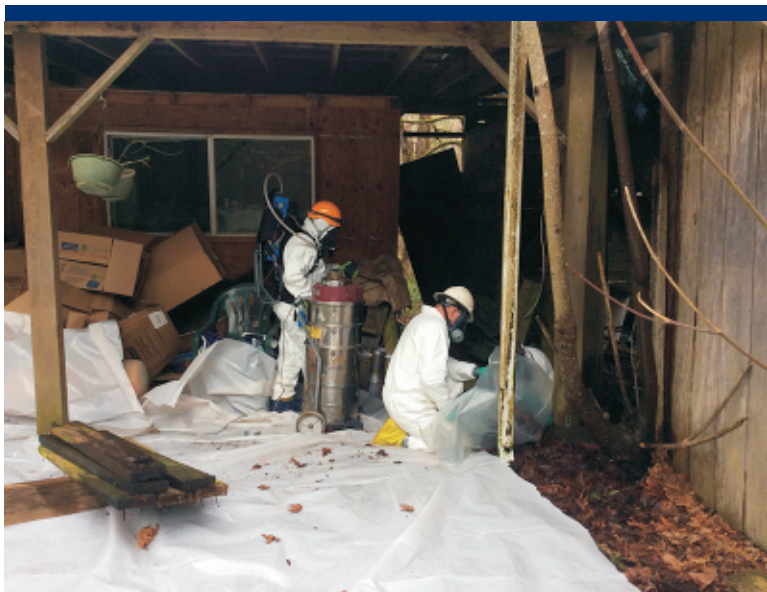
Photo 3 Excavating mercury-contaminated soil by hand in the carport.

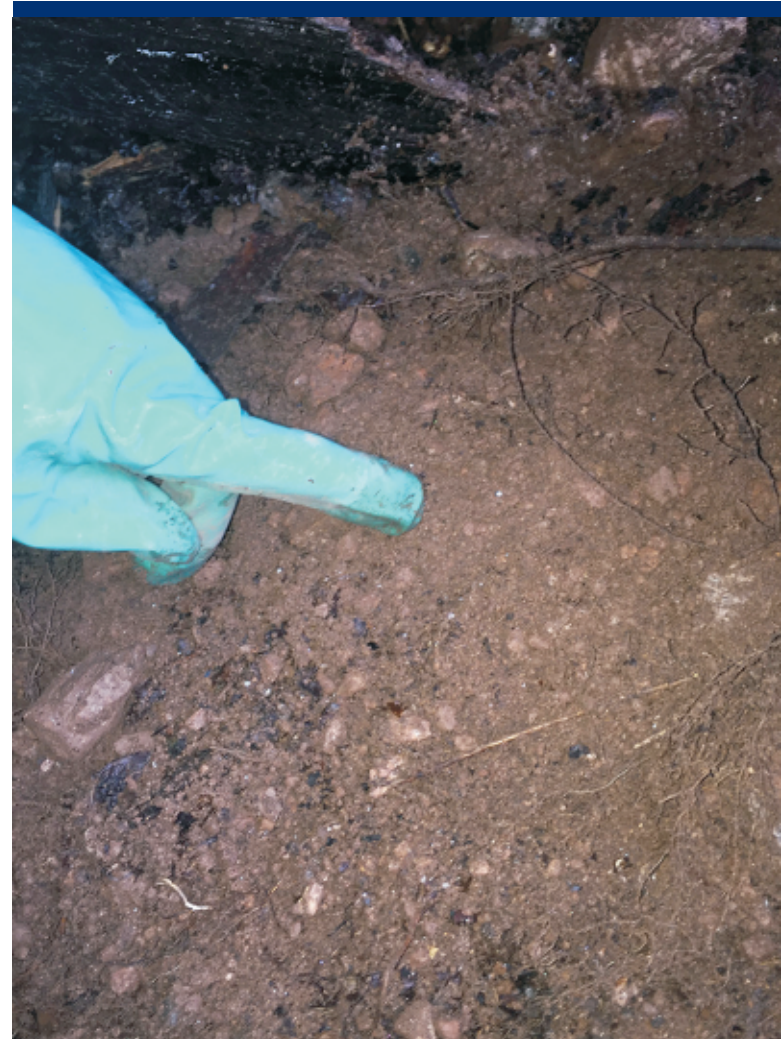
Photo 2 Visible mercury beads in the carport.

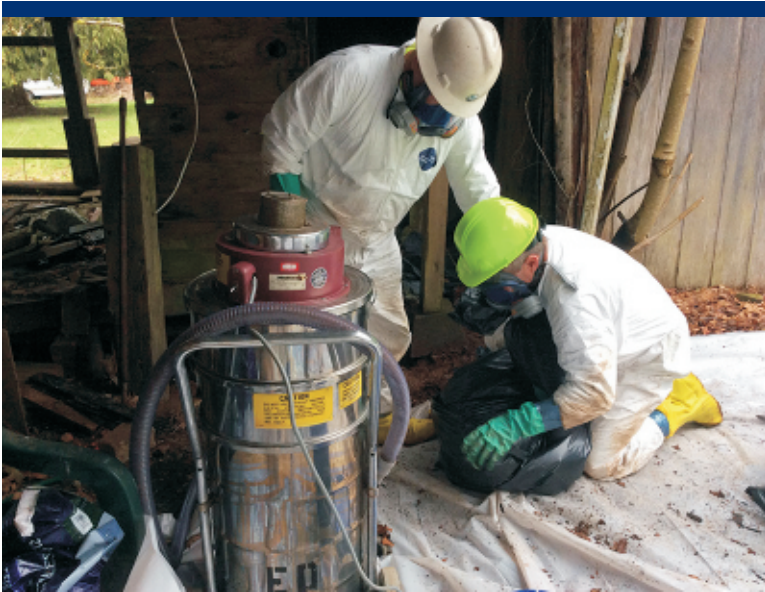
Photo 4 Excavating mercury-contaminated soil by hand in the carport.

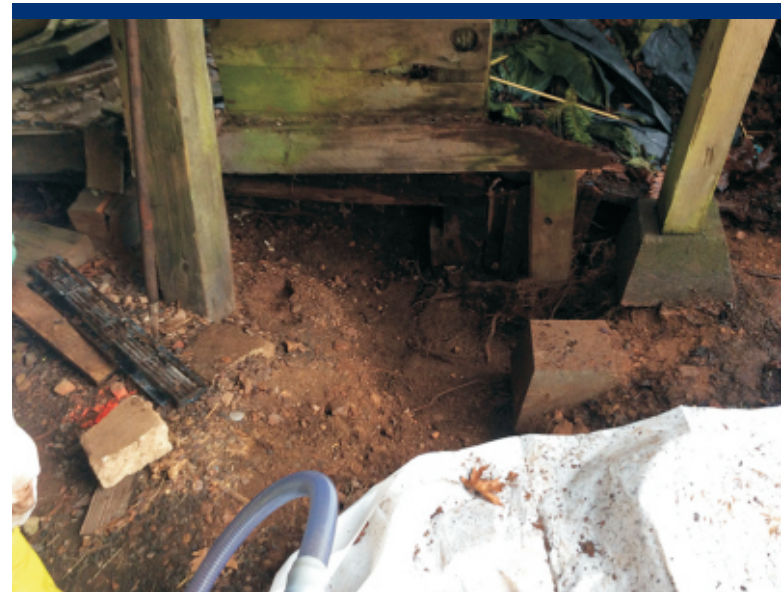
Photo 7 Excavated area in the carport, ranging from 3 to 21 inches in depth.

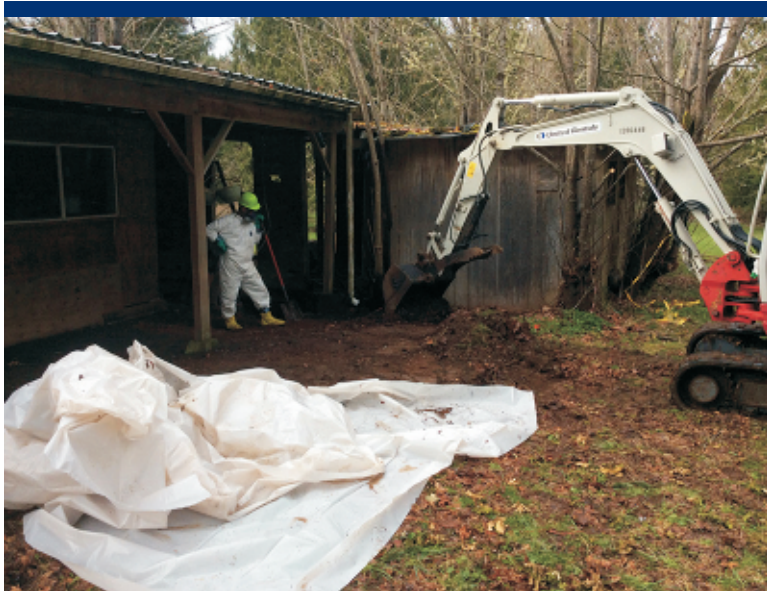
Photo 8 Excavating shallow soil and leaf litter outside the carport to a depth of 2 inches.

Upon follow-up screening with Lumex MVA, additional mercury vapors were intermittently detected in the area outside the carport. However, due to elevated humidity, relatively low temperatures, and a light breeze it was difficult to determine the source of the mercury vapors. ERRS arranged for delivery of a mini-excavator to the site and proceeded to excavate an area approximately 225 square feet to a depth of 2 to 4 inches below grade. Approximately three to five cubic yards of soil and material was excavated from around the carport and placed in a roll-off container.

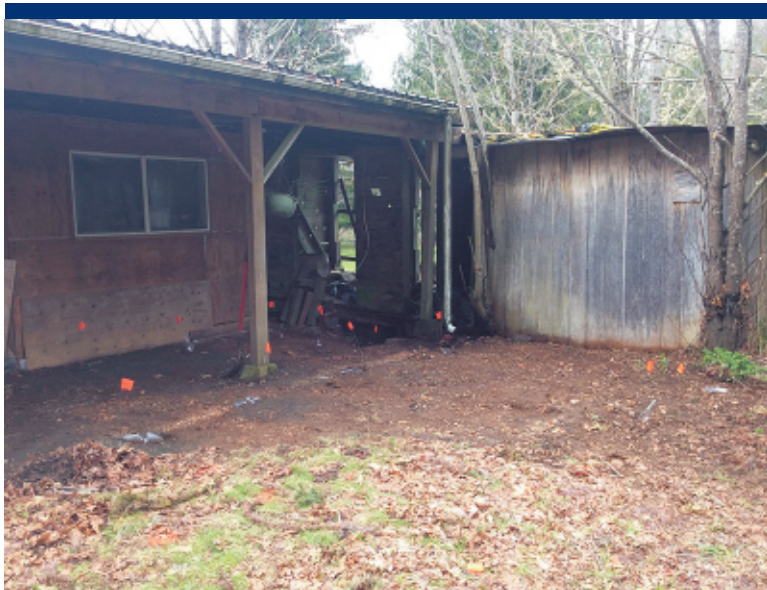
Photo 10 Pin flags denote locations for additional mercury vapor screening.

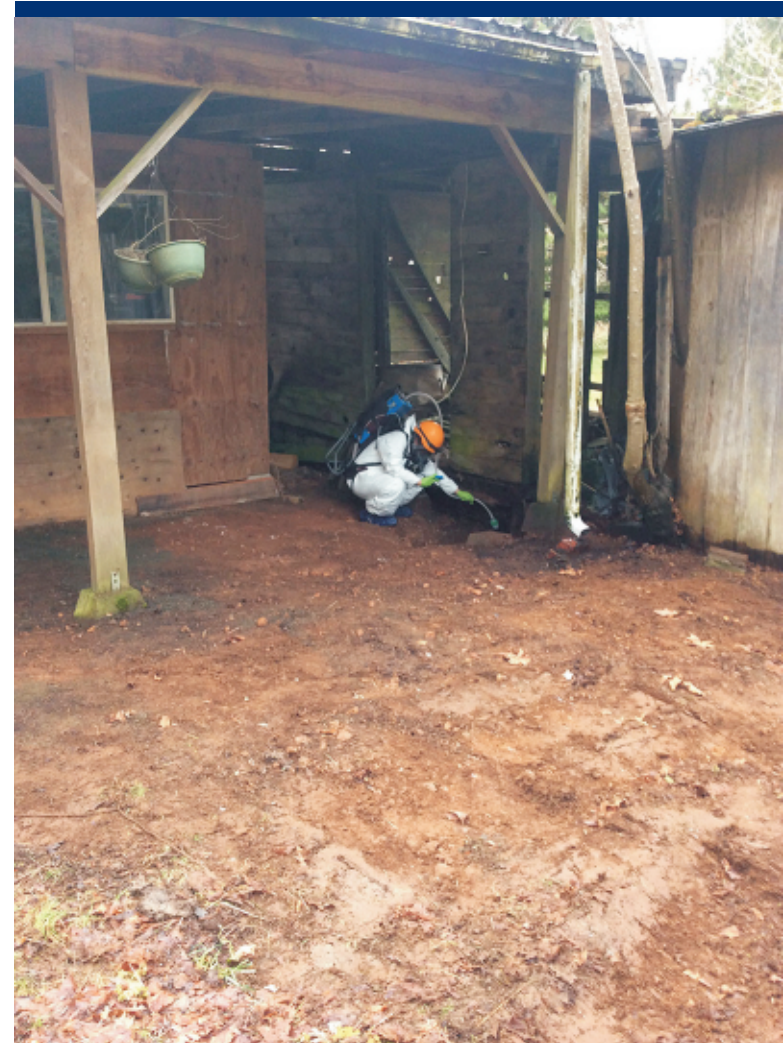
Photo 9 Screening excavated areas with the Lumex mercury vapor analyzer.

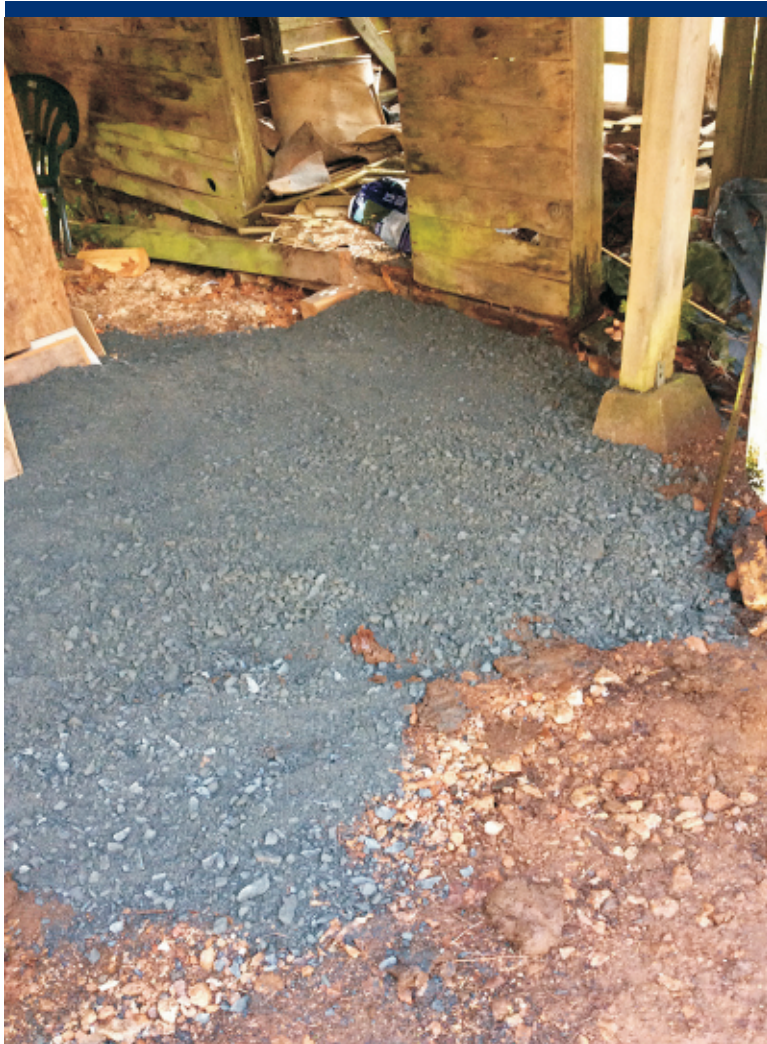
Photo 11 Backfilled excavated area in the carport with 3/4" minus gravel.

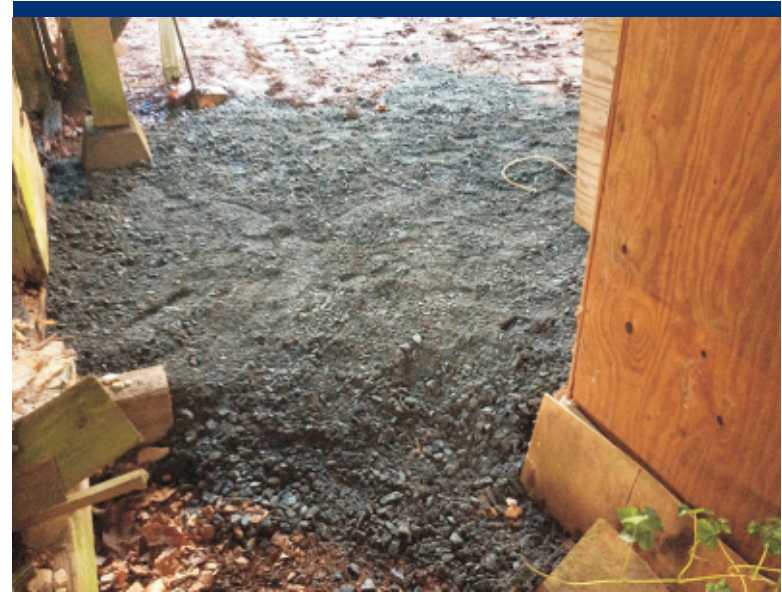
Photo 12 Backfilled excavated area near the carport with 3/4" minus gravel.

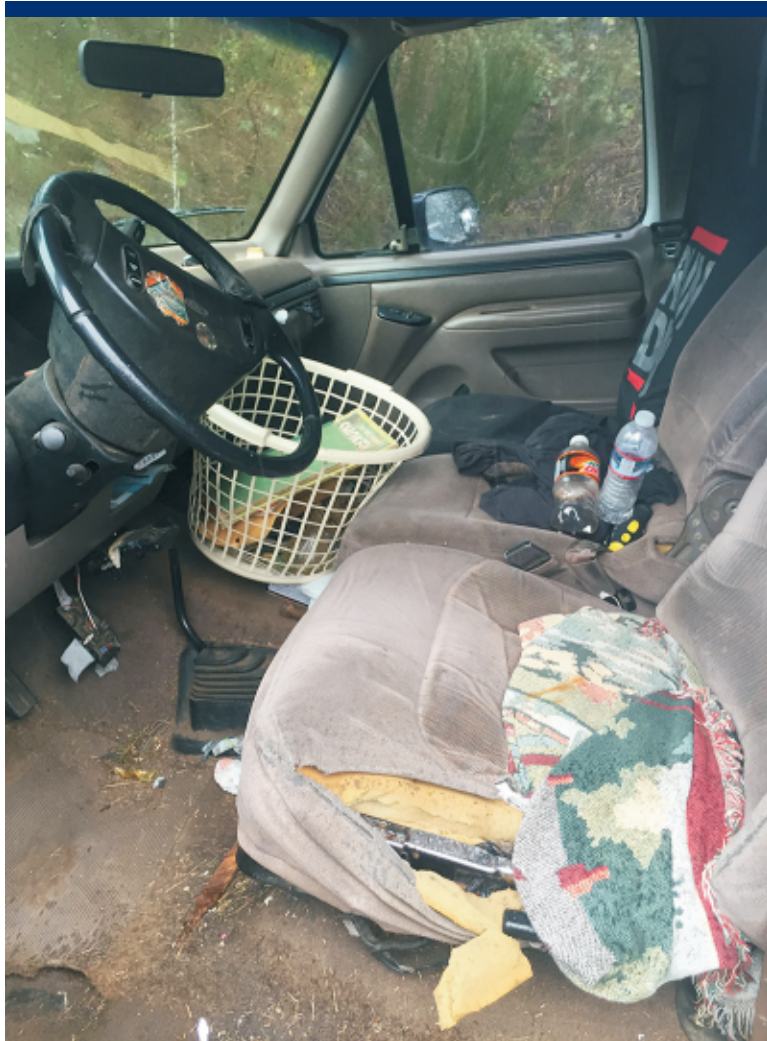
Photo 13 Interior of the truck before treatment.

On March 8, START deployed the Lumex MVA to screen the interior of pickup truck including the steering wheel, seats, foot pedals, and floor carpeting. The maximum concentrations were approximately 600 ng/m³ although localized weather conditions, including ambient air temperature of approximately 40°F and elevated relative humidity, were likely causing a low bias. Due to concern that elevated temperatures would increase volatilization of mercury contamination in the truck during summertime months, ERRS proceeded with the standard decontamination process of the truck including utilizing a mercury vacuum and repeated cycles of heat and ventilation.

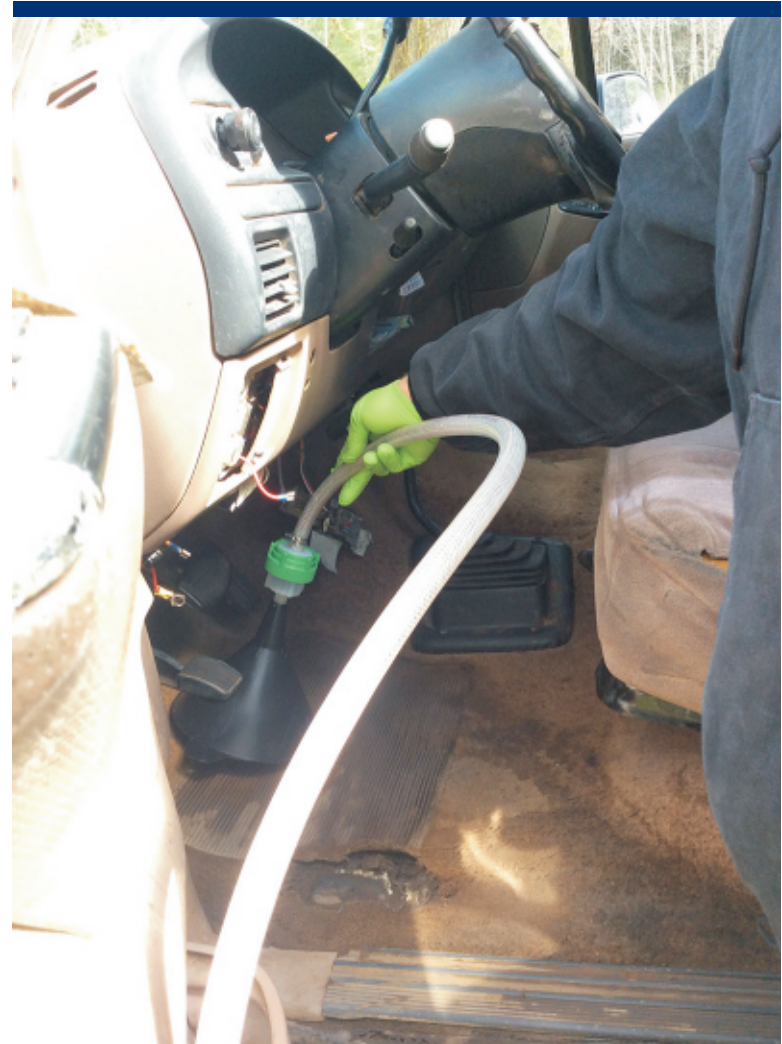
Photo 14 Screening the interior of the truck for mercury vapors.

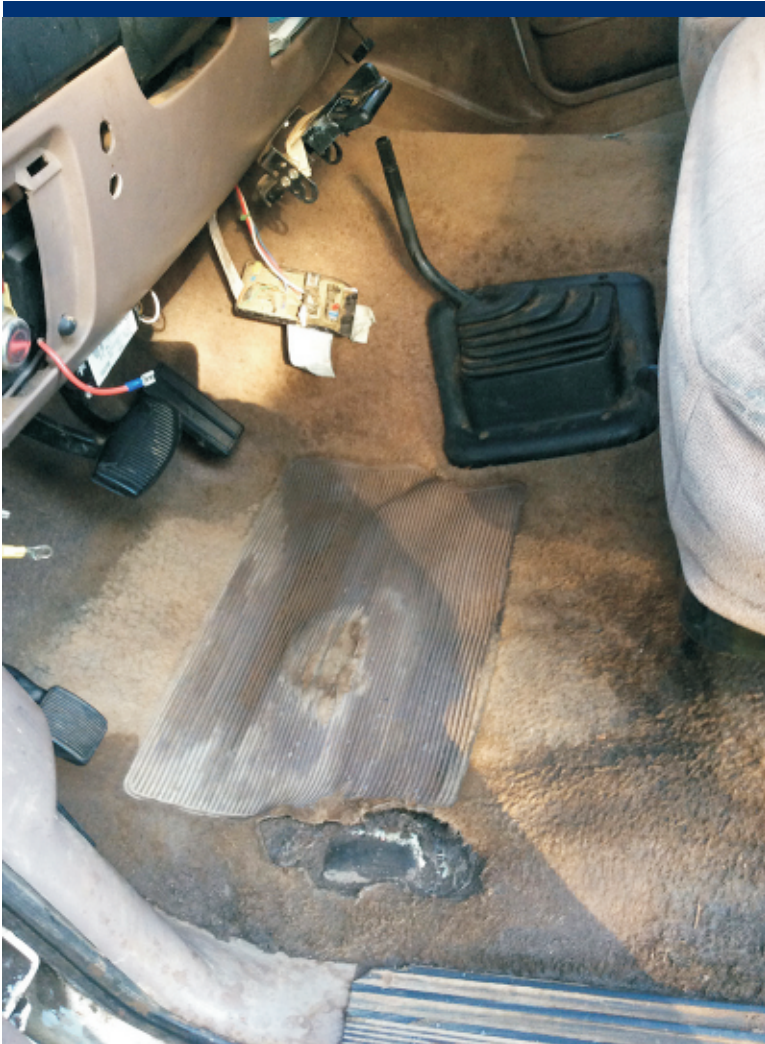
Photo 15 Interior of the truck after it was vacuumed and subject to heat/ventilation cycles.

The truck was rescreened on March 10 after the interior was vacuumed and an initial cycle of heating and ventilation. The maximum concentration of mercury vapors in ambient air was 2,000 ng/m³. Targeted screening with the Lumex MVA identified elevated concentrations on the floor and seat on the driver's side. Later that day the truck floor was treated with HgCS-102, a mercury cleaning solution for hard surfaces, followed by additional heating and ventilation. Follow up screening on March 11 showed reduced mercury vapor concentrations of approximately 550 ng/m³. No additional treatment was required, and Mr. Pooler was advised that mercury vapors in the truck were below Site-specific action level of 1,000 ng/m³.

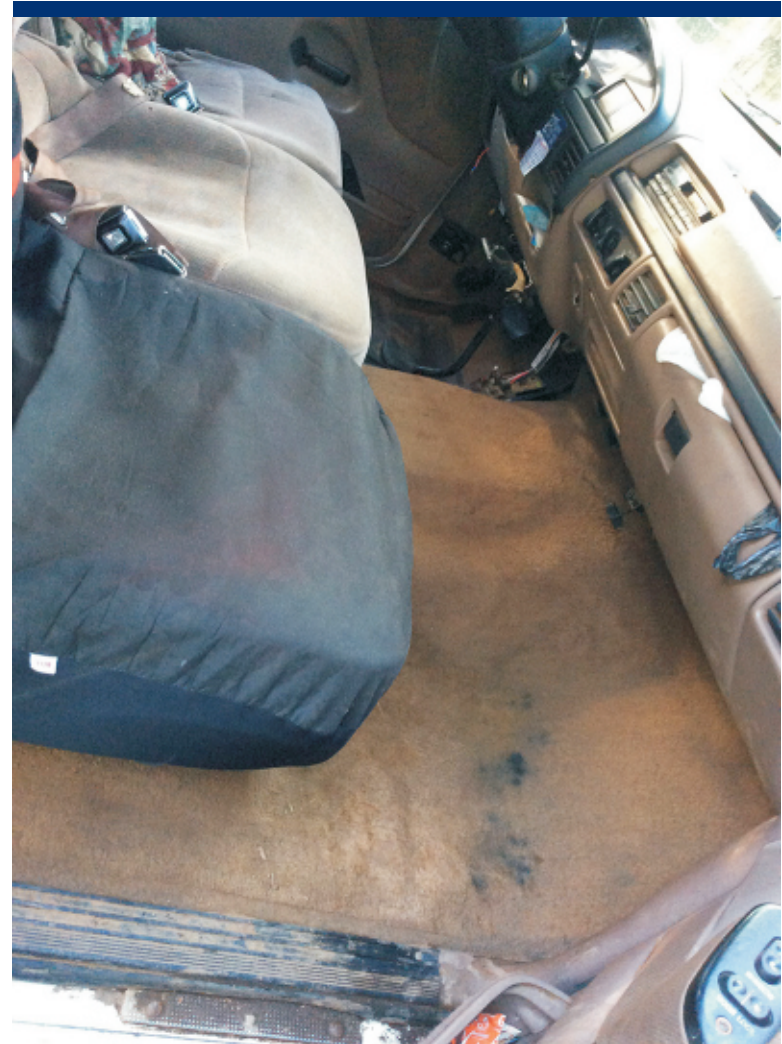
Photo 16 Interior of the truck after it was vacuumed and subject to heat/ventilation cycles.

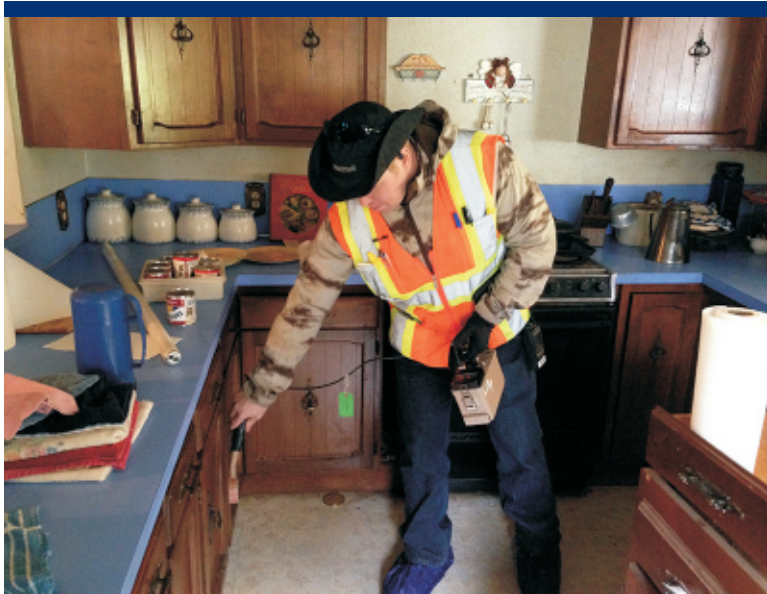
Photo 17 Radiation screening inside the primary residence.

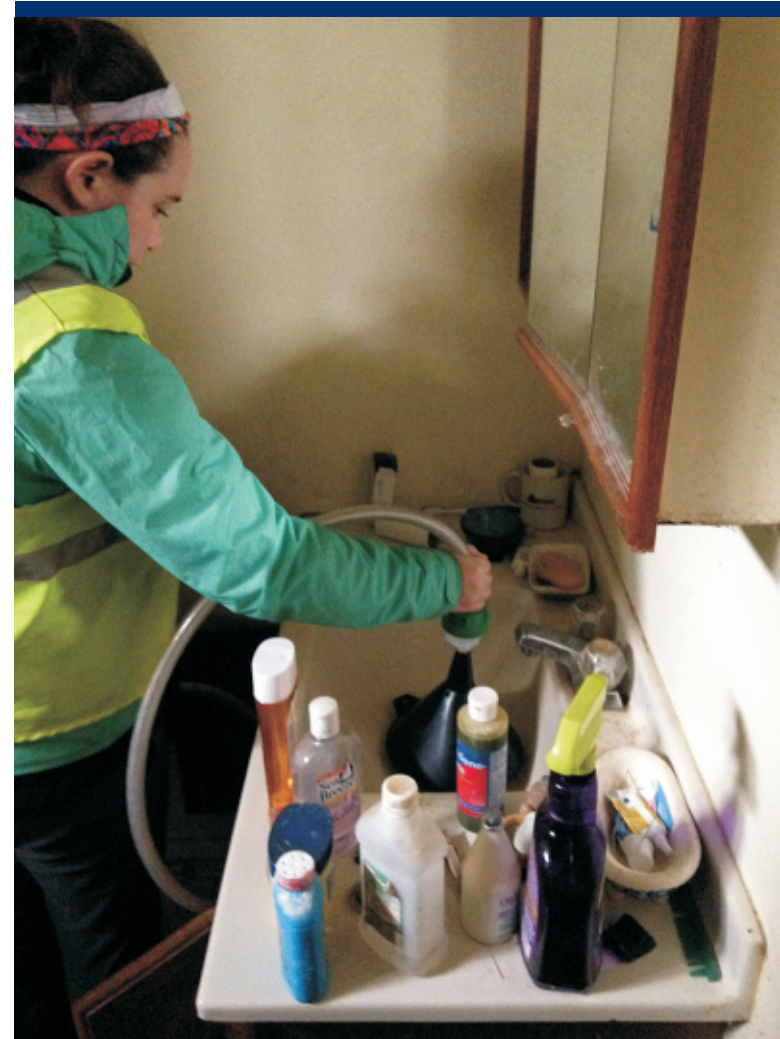
The primary residence (Matt Pooler's House) had elevated concentrations of mercury vapor in the bathroom sink exceeding 4,000 ng/m³; upon running hot water through the sink, the readings spiked to 18,000 ng/m³. Mr. Pooler reportedly washed his hands in this sink immediately after the mercury spill and these readings were not entirely unexpected. The drain and P-trap in the bathroom were removed,

Photo 18 Mercury vapor screening inside the bathroom of the primary residence before replacing P-trap.

cleaned and reinstalled. Additional screening with the Lumex MVA identified continued elevations of mercury vapors in excess of the action level for ambient air in residential settings. ERRS then replaced the drain and P-trap with new fixtures resulting in an immediate decrease of mercury vapor concentrations to approximately 600 ng/m³ which was below the action level. The remaining areas in the home including the kitchen sink, bathroom, and living room were all below the action level. No additional mitigation was performed inside the primary residence.

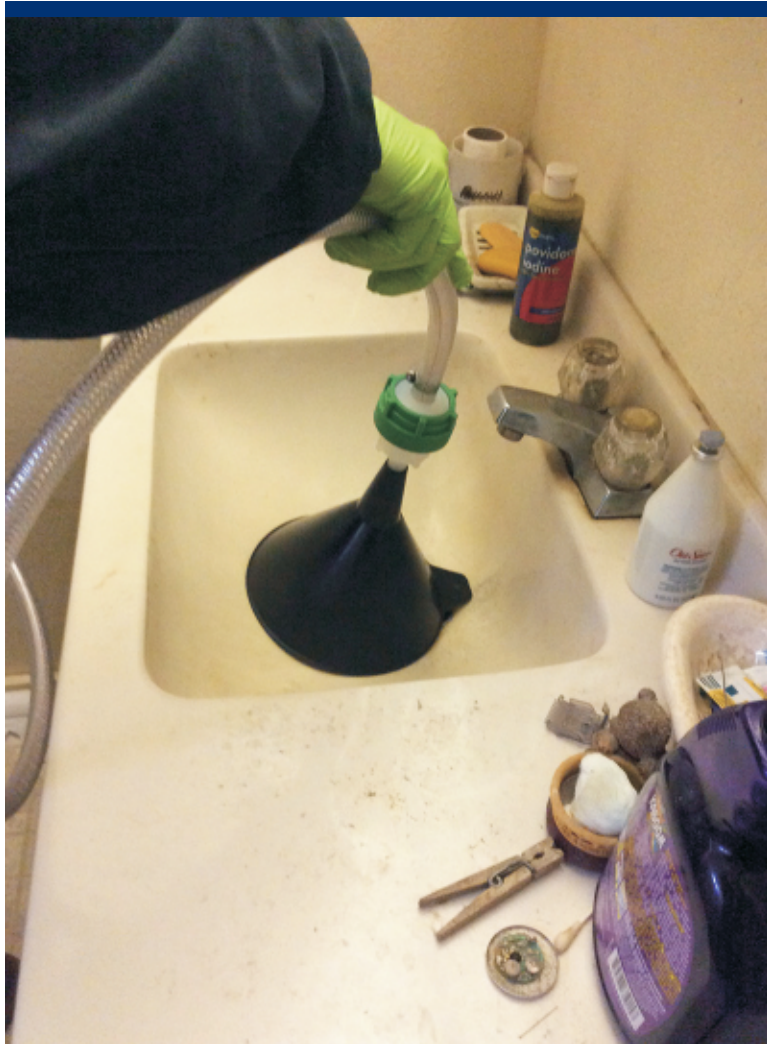
Photo 19 Mercury vapor screening inside the bathroom of the primary residence after replacing P-trap.

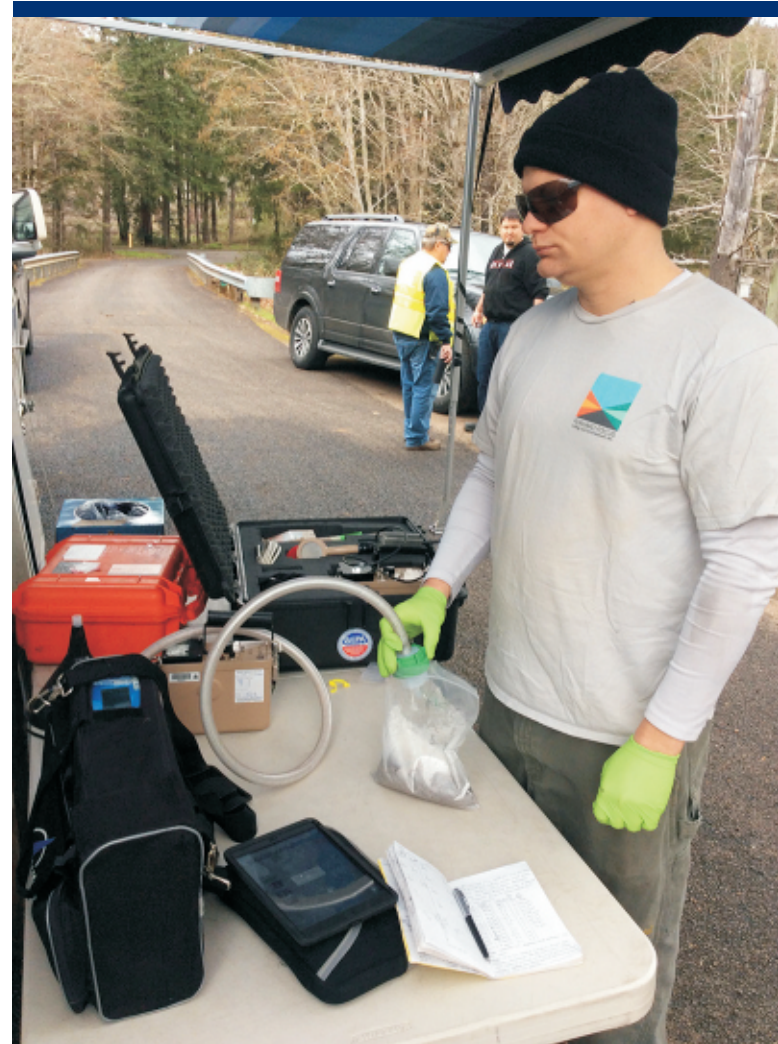
Photo 20 Mercury vapor screening of ex-situ soil from the excavated area after heating in accordance with EPA Region 10 Mercury Response Module.

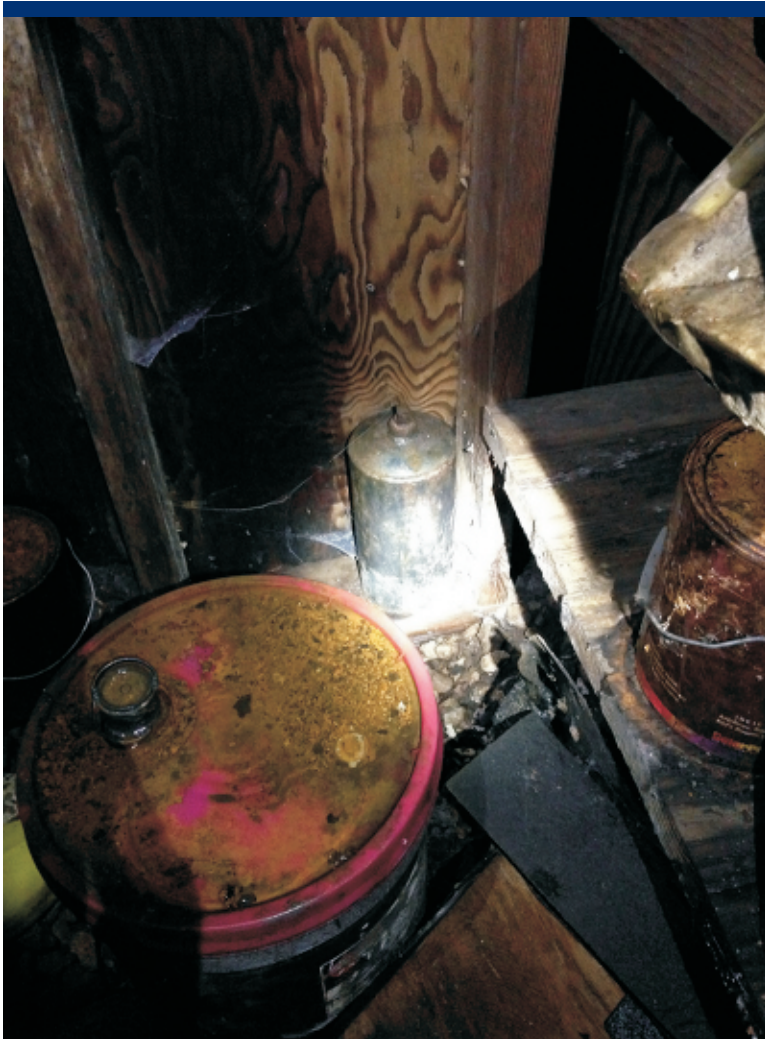
Photo 21 One mercury flask was found in a shed.

Mr. Pooler reported that additional containers of mercury were possibly stored on the property. During a subsequent survey of the Site, EPA recovered three flasks traditionally used to store and transport mercury. These flasks were found in a Quonset hut and workshop, and each flask had a volume of 2.55 liters with the ability to hold 76 pounds of elemental mercury at standard temperature and pressure. One flask was approximately 40% full of mercury, and the other two flasks were completely full of fluid that appeared to be hydraulic oil at the surface. Due to the density of mercury, ERRS expressed concern that a separate phase of mercury may reside at the bottom of these two flasks. All three containers were isolated and staged for transportation off site.

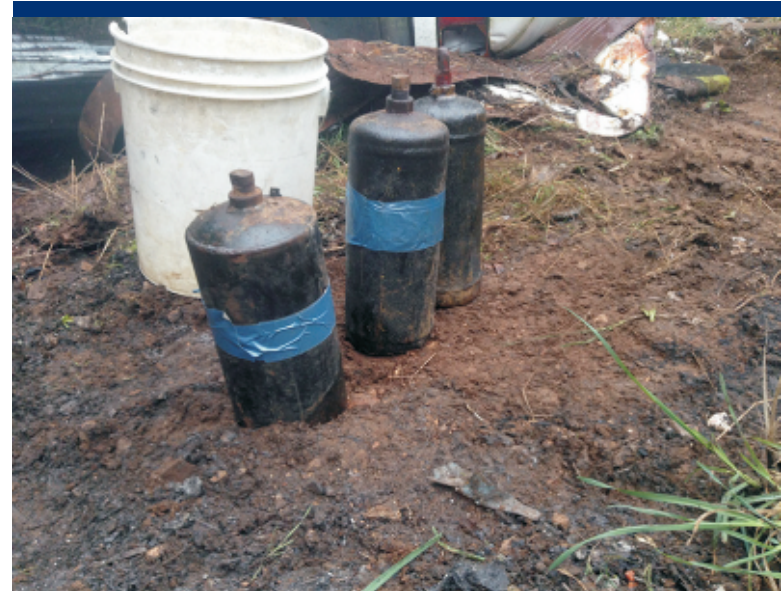
Photo 22 A total of three mercury flasks were found on site at various locations.

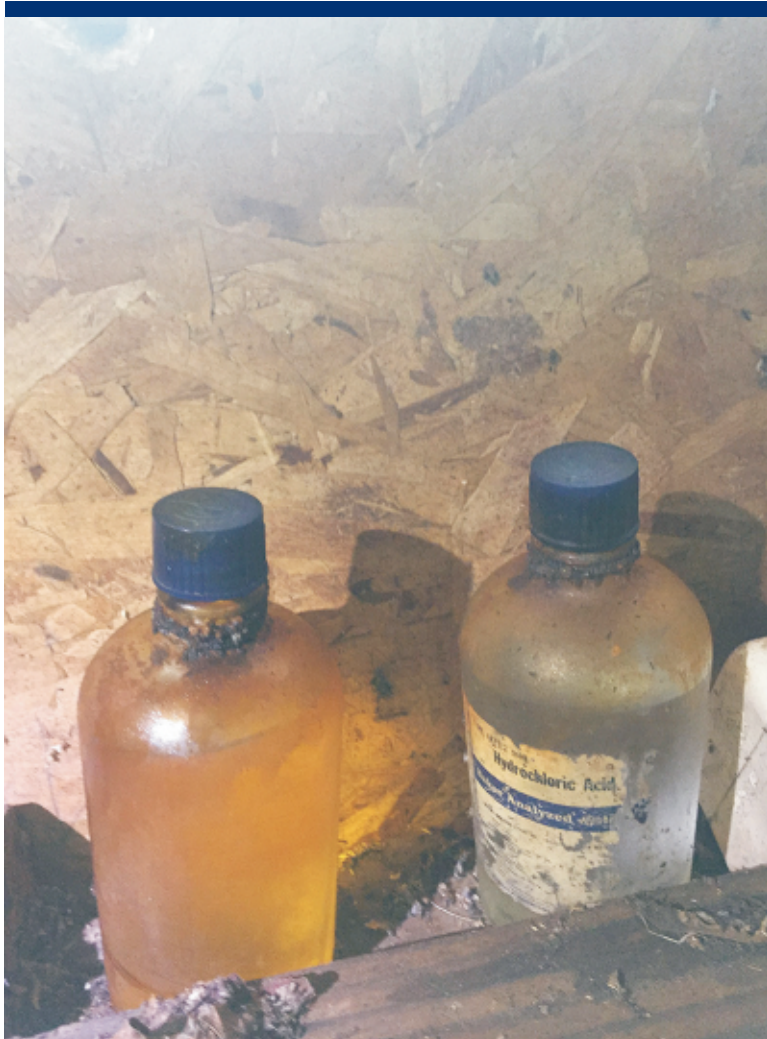
Photo 23 Two containers of chemicals were found on site; one container was labeled hydrochloric acid.

While on Site, EPA discovered additional chemicals including a 500 milliliter (ml) container of hydrochloric acid, a 500 ml container of nitric acid, a 250 ml container of barium dioxide, and a container of sulfur containing less than one kilogram of material. The containers were in poor condition, and Mr. Pooler provided permission for EPA to arrange for transportation and off-Site disposal of the chemicals.

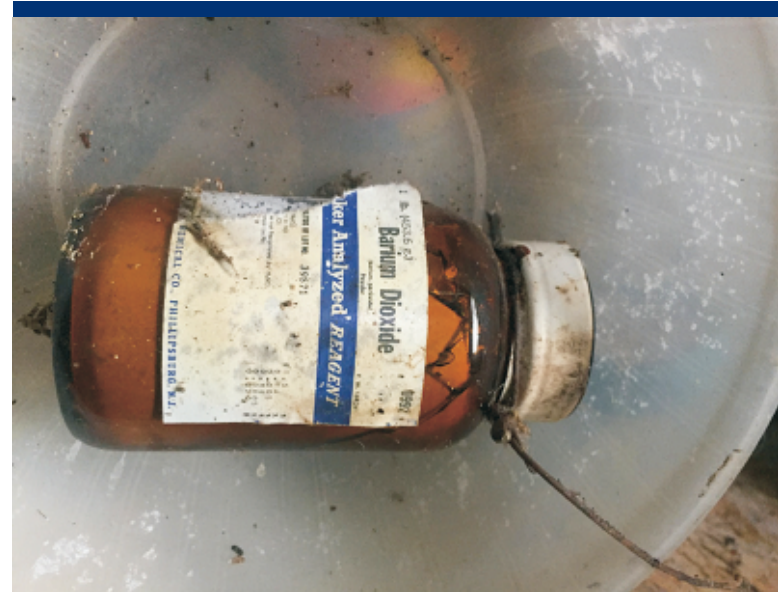
Photo 24 A container of barium dioxide was discovered on site.

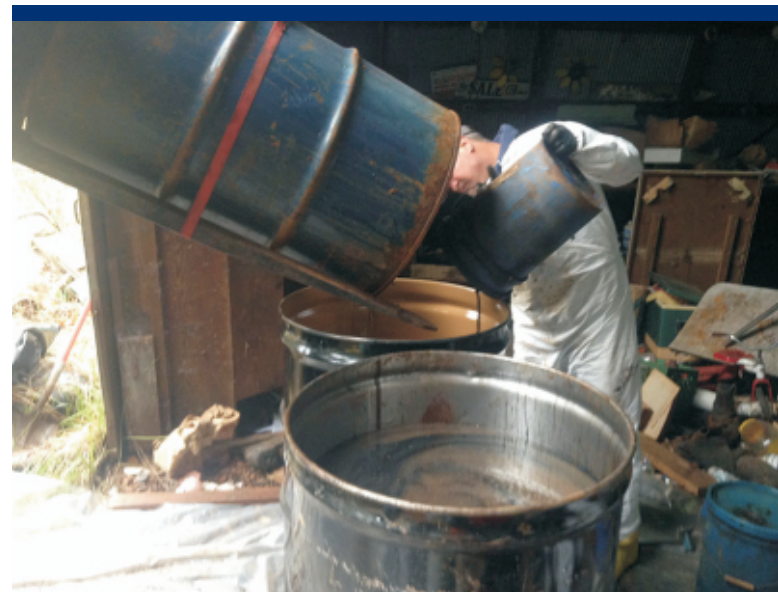
Photo 25 Automotive fluids were consolidated for transportation off site with permission from the property owner.

EPA also identified approximately 25 rusted, damaged, and leaking drums and/or buckets of automotive fluids. The containers were in dilapidated with evidence of rusting and leaking. With permission of the property owner, ERRS combined a total of approximately 100 gallons of automotive fluids into two new 85-gallon overpack drums. ODEQ agreed to arrange for transportation and disposal of the automotive fluids through their household hazardous waste program. The overpacked drums were stored in the locked Quonset hut pending confirmation from ODEQ, and the old drums were crushed and placed in the roll-off container.

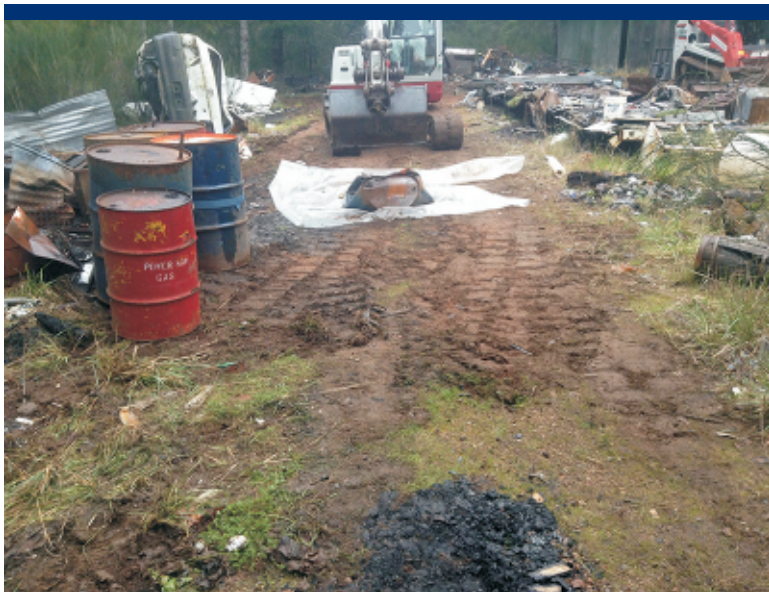
Photo 26 Containers in poor condition were flattened using the skid steer.
