**REMOVAL PROGRAM
AFTER ACTION REPORT
FOR THE
FAY STREET SITE
LOWELL, MIDDLESEX COUNTY, MASSACHUSETTS
15 JULY 2014 THROUGH 9 OCTOBER 2015**

U.S. Environmental Protection Agency
Region I
Emergency Planning and Response Branch
5 Post Office Square, Suite 100
Boston, Massachusetts 02109-3912

Weston Solutions, Inc.
Superfund Technical Assessment and Response Team IV (START)
101 Billerica Avenue, Building 5, Suite 103
North Billerica, Massachusetts 01862

January 2016

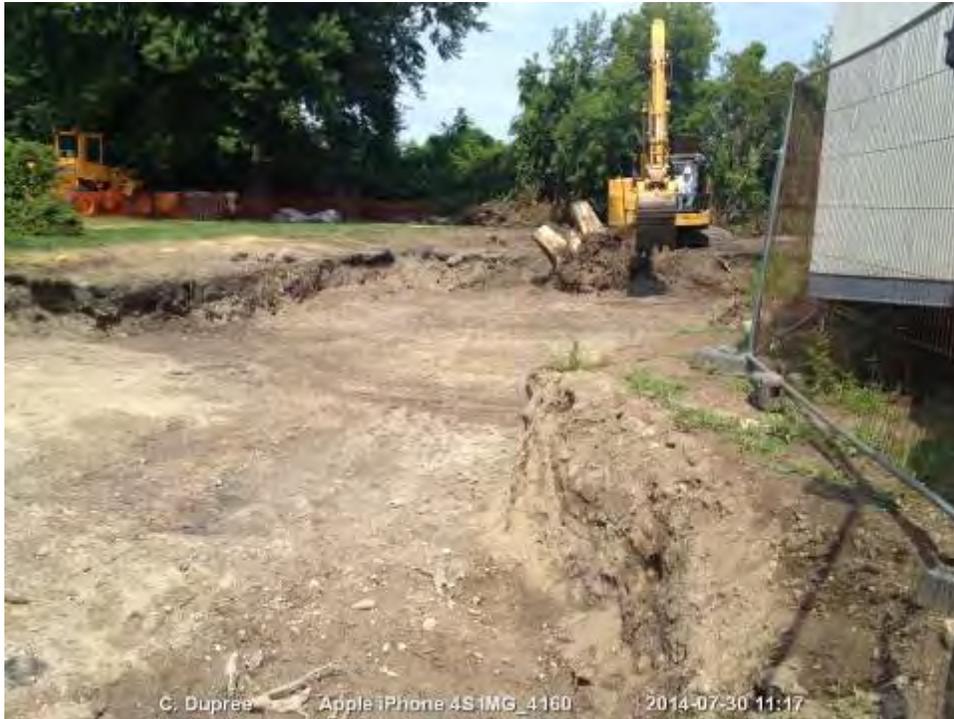
SCENE: View of the excavated eastern portion of Property F01 and tree stump removal. Photograph taken facing northwest.

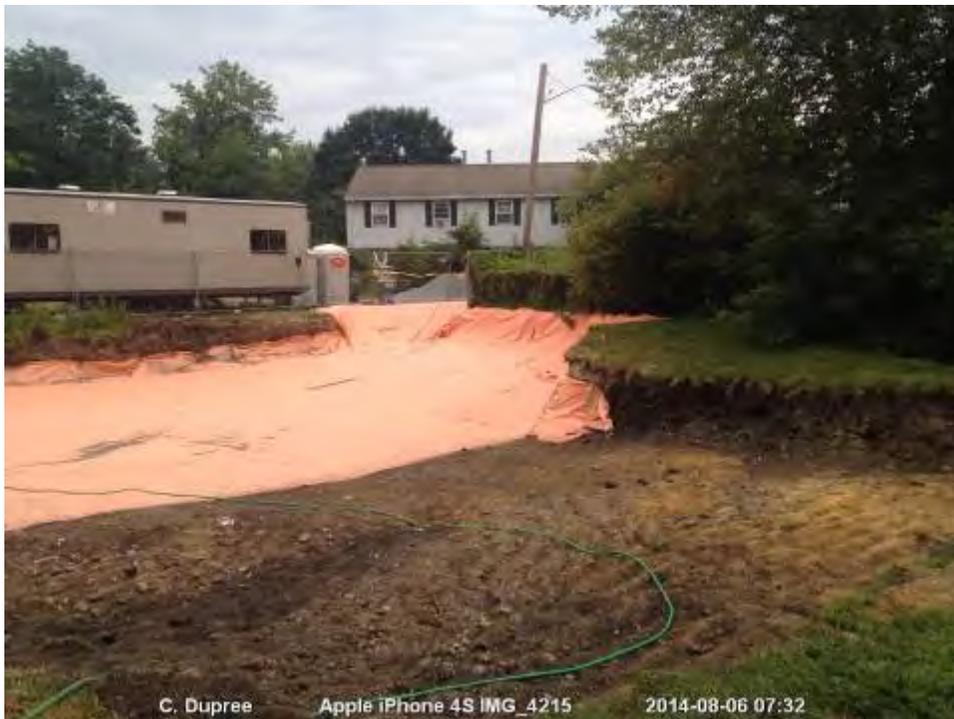
SCENE: View of the excavation on Property F01, lined with geotechnical fabric as a demarcation layer. Photograph taken facing southeast.

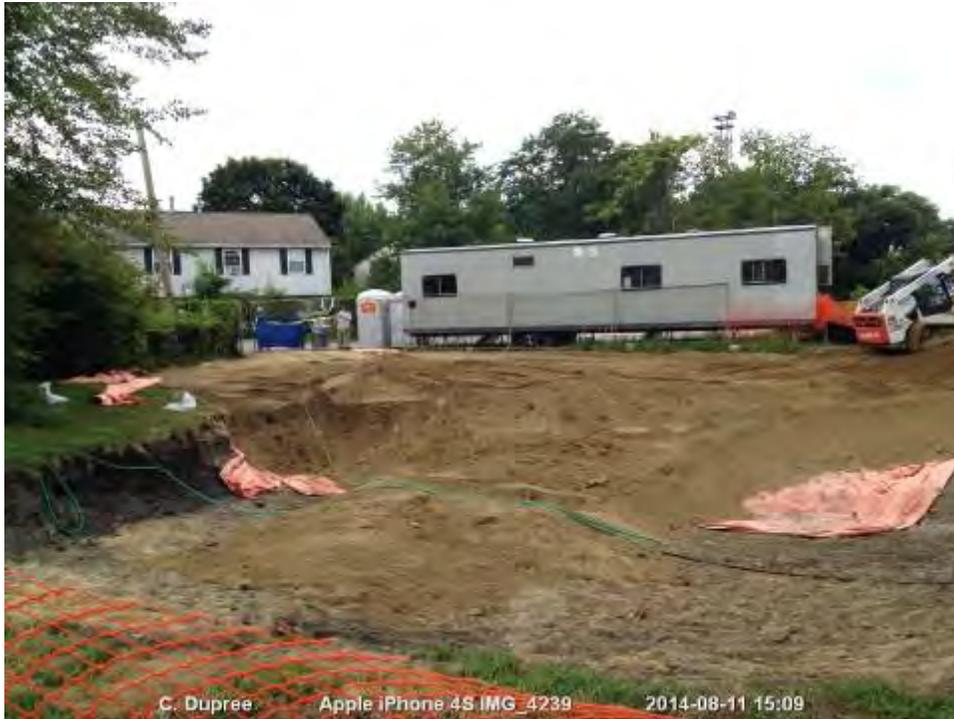
SCENE: View of the southeastern portion of Property F01 during backfilling activities. Photograph taken facing east.

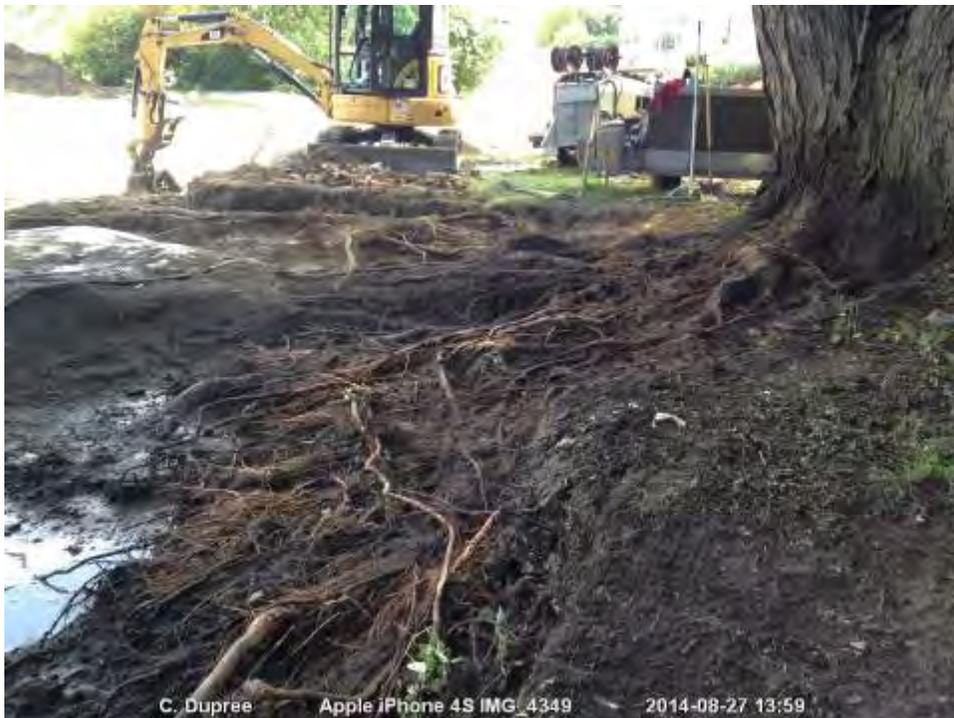
SCENE: View of the exposed tree roots of the silver maple located on Property F01. The roots were exposed using a vacuum truck to remove the soil. Photograph taken facing south.

On 7 August 2014, an arborist was on site to inspect and discuss the large silver maple located on property F01. It was determined that the soil surrounding the tree is contaminated, and will be removed with a vacuum truck, then backfilled immediately.

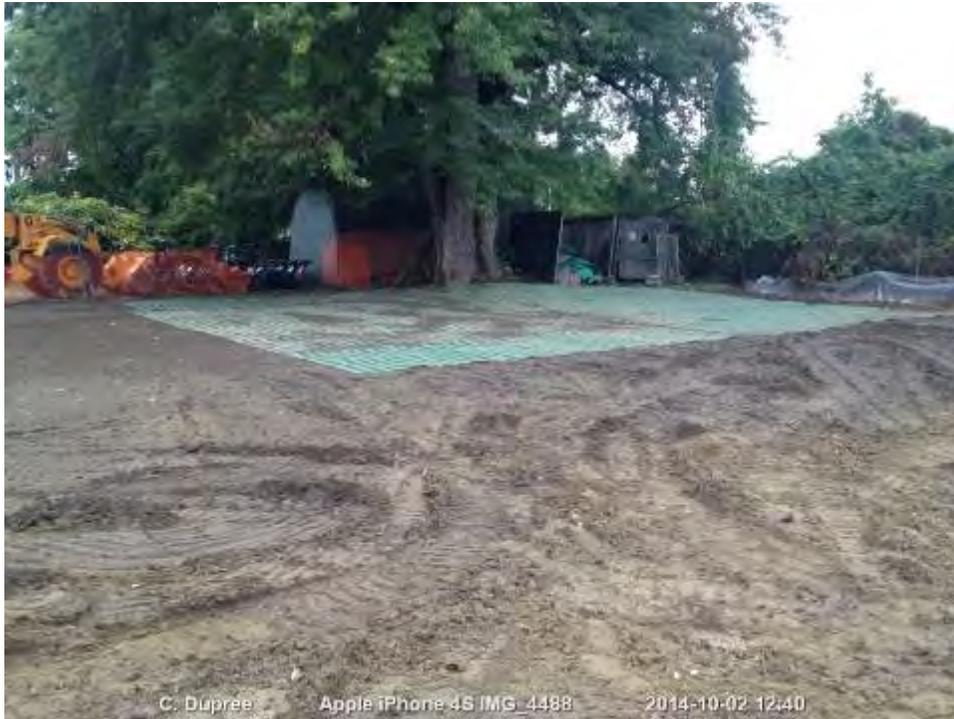
SCENE: View of the Grass Protecta[®] placed around the base of the silver maple on Property F01 to restrict access to the contaminated soil in the root system. Photograph taken facing northwest.

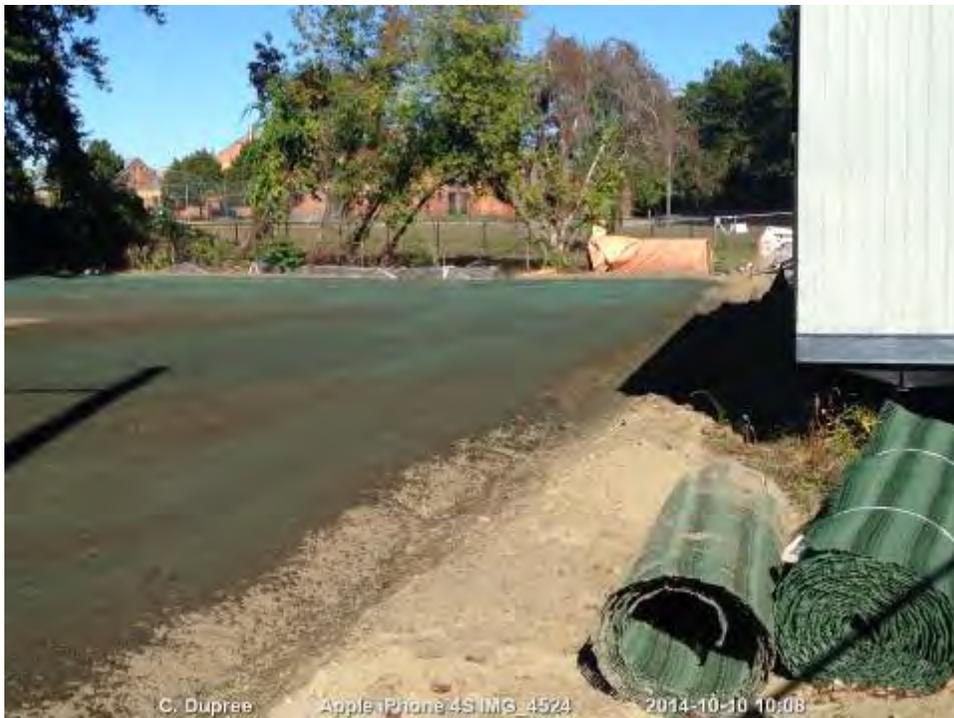
SCENE: View of Property F01 following hydroseeding activities. Photograph taken facing north-northwest.

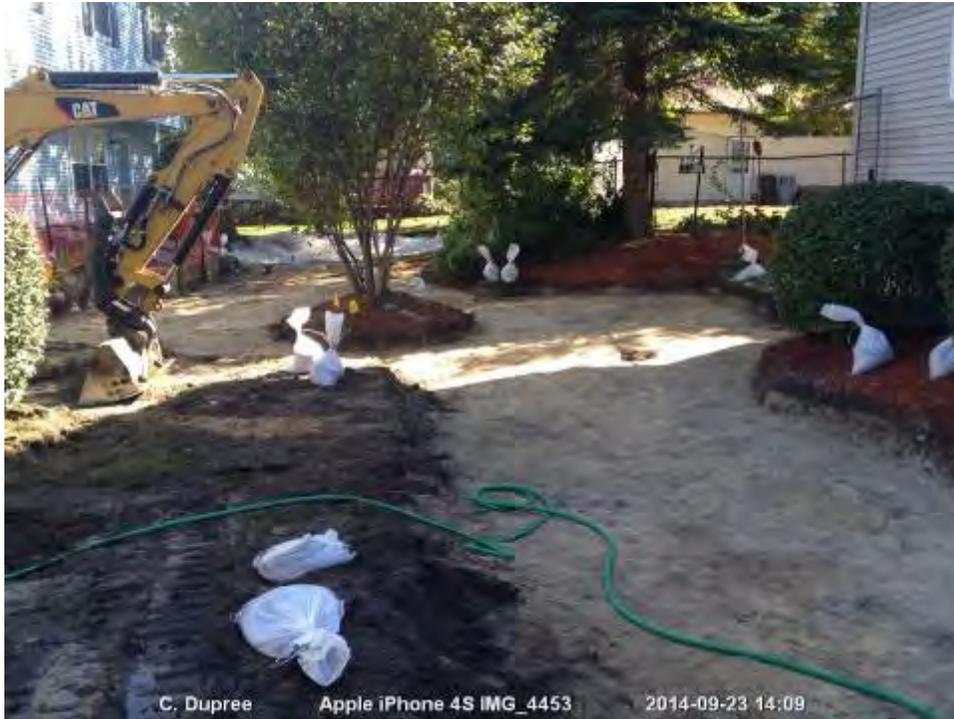
SCENE: View of Grids P100 through P150 on Property F03, near the completion of excavation to 6 inches below ground surface (bgs). Photograph taken facing south.

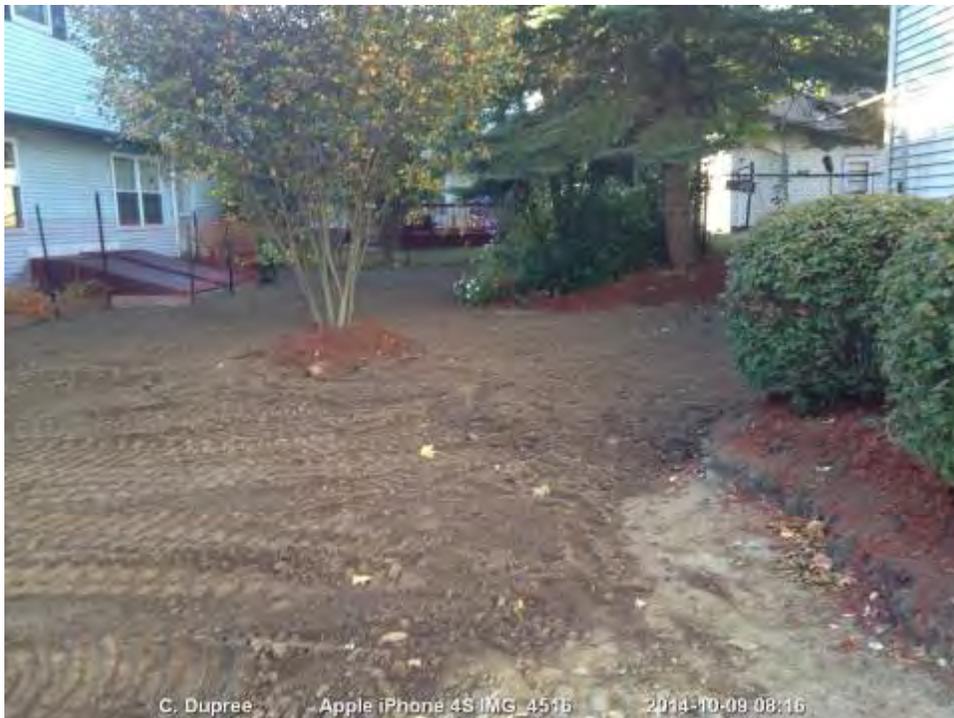
SCENE: View of Grids P100 through P150 on Property F03, backfilled with topsoil. Photograph taken facing south.

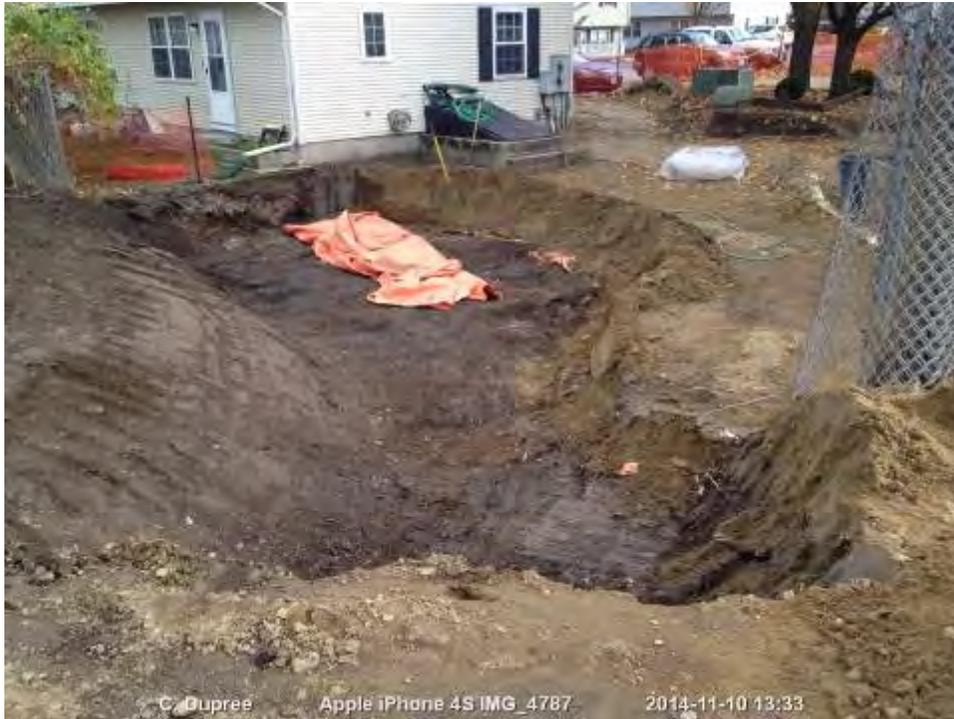
SCENE: View of the excavation of Grids P250 and R250 on Property F03. Photograph taken facing east.

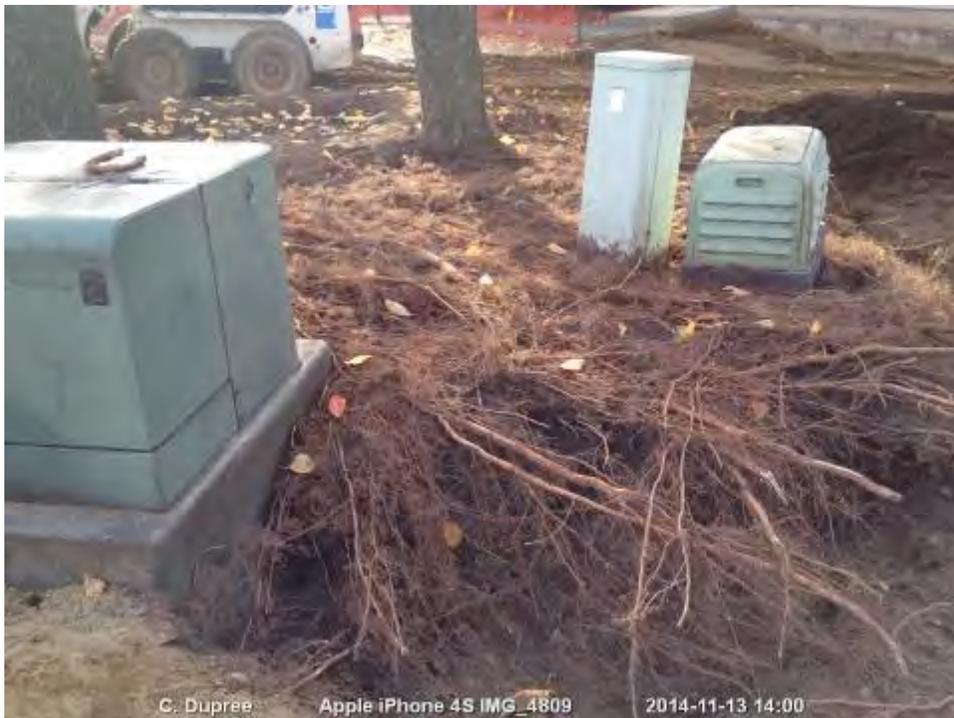
SCENE: View of the exposed roots of trees in Grid R200 on Property F03. The soil was removed from the root system using a vacuum truck. Photograph taken facing southwest.

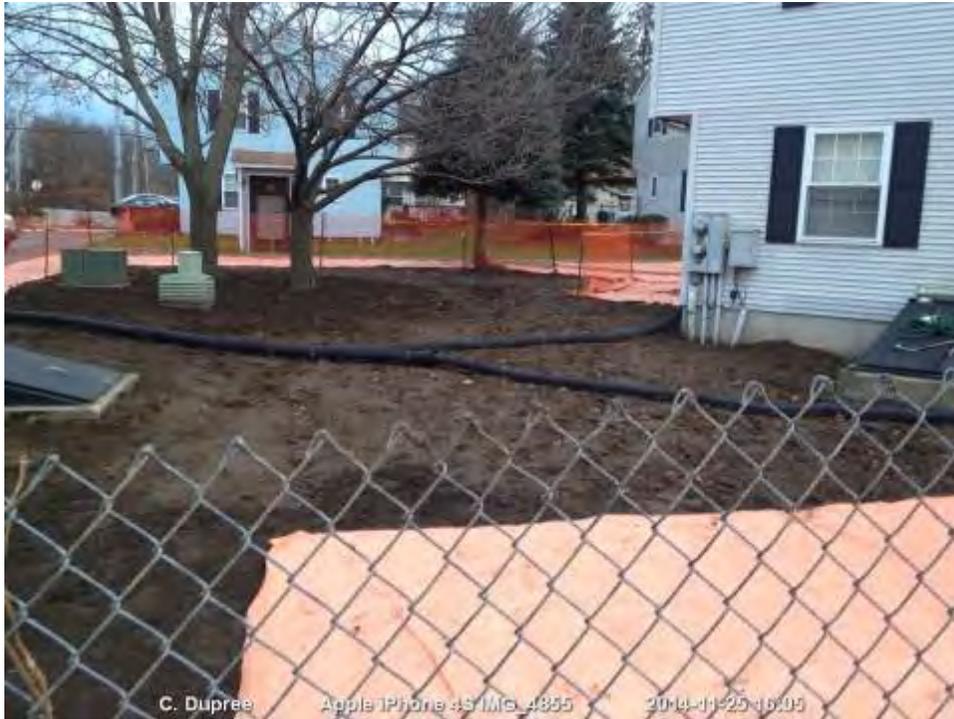
SCENE: View of Grids P175 through R250 on Property F03, at the completion of backfill activities. Photograph taken facing southeast.

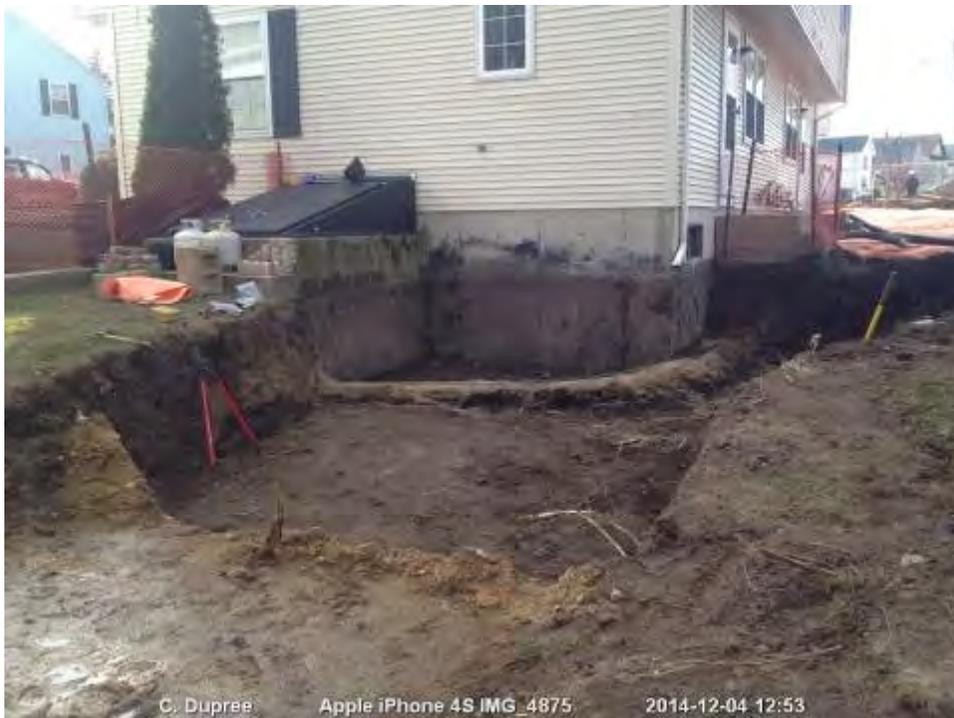
SCENE: View of the excavation of Grids U250 and V250 on Property F03. Photograph taken facing south-southwest.

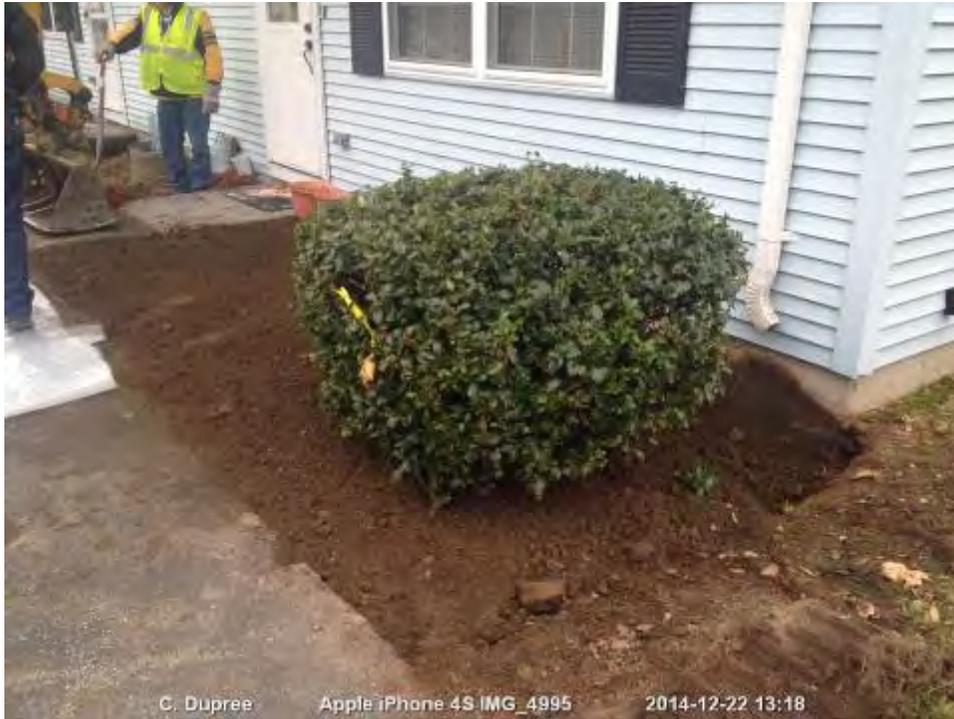
SCENE: View of Grid/excavation area T125N on Property F03, at the completion of backfill activities. The holly bush was re-planted in the original location after the soil had been removed from the roots. Photograph taken facing south-southwest.

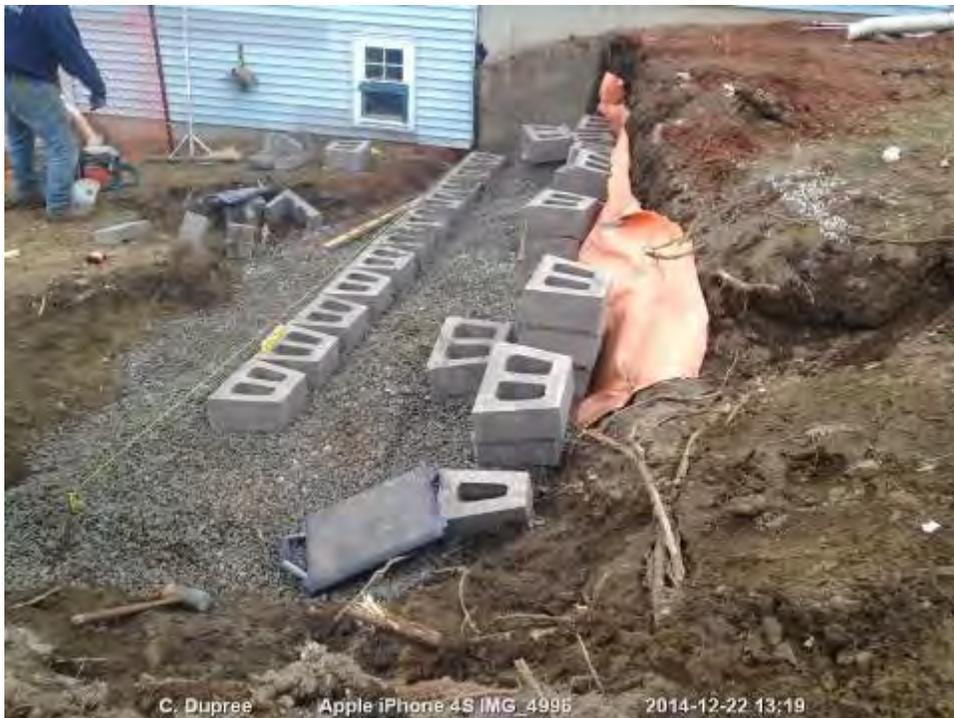
SCENE: View of the construction of replacement retaining walls in the northeastern corner of Property F03. Photograph taken facing east.

- Installing fence posts and chain-link fence on property F01.
- Spreading topsoil and installing sod on property F03.
- Installing retaining wall and access steps at condominiums 10 and 11 on property F03.
- Repairing downspouts of buildings of property F03.

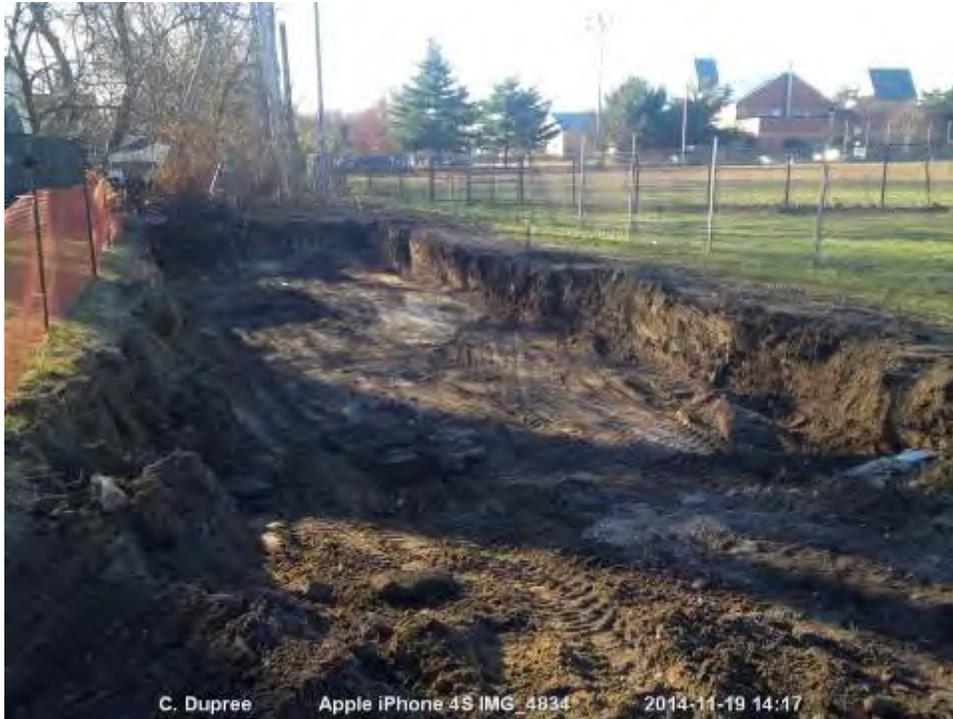
SCENE: View of the excavation of Property F02. Photograph taken facing west.

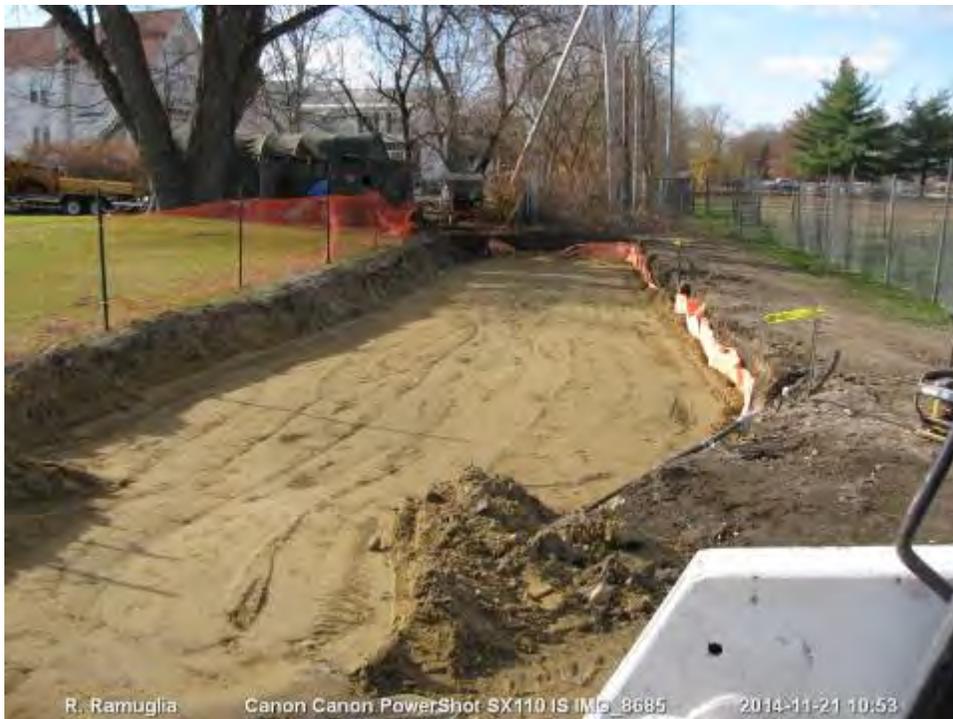
SCENE: View of the backfilled excavation on Property F02. Photograph taken facing west-southwest.

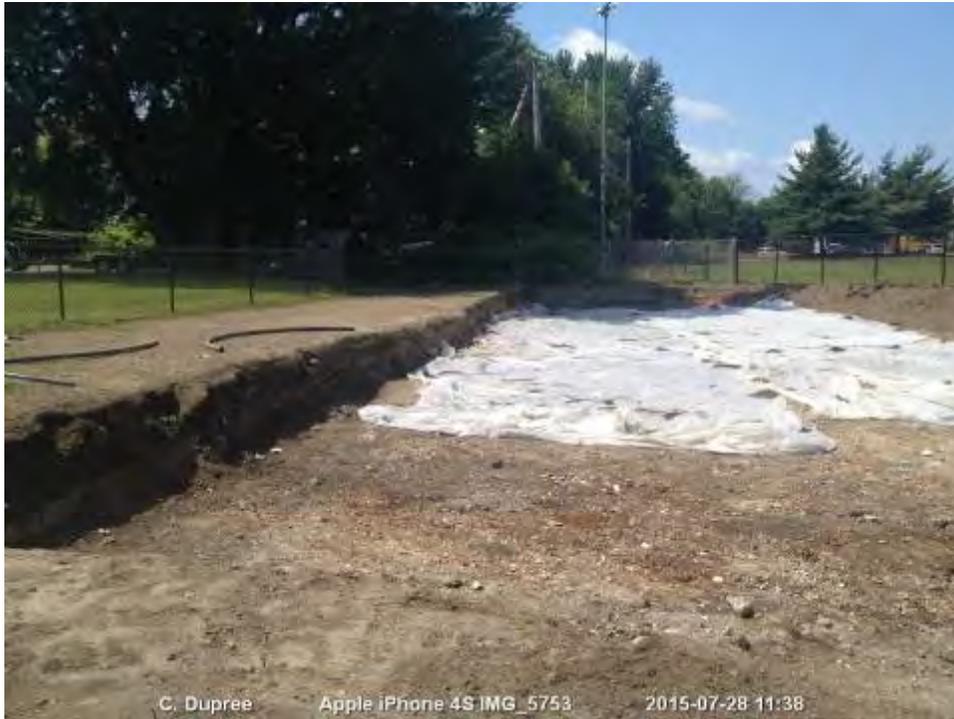
SCENE: View of the completed excavation of Grids A50, B50, and C50 on Property F02. Photograph taken facing west.

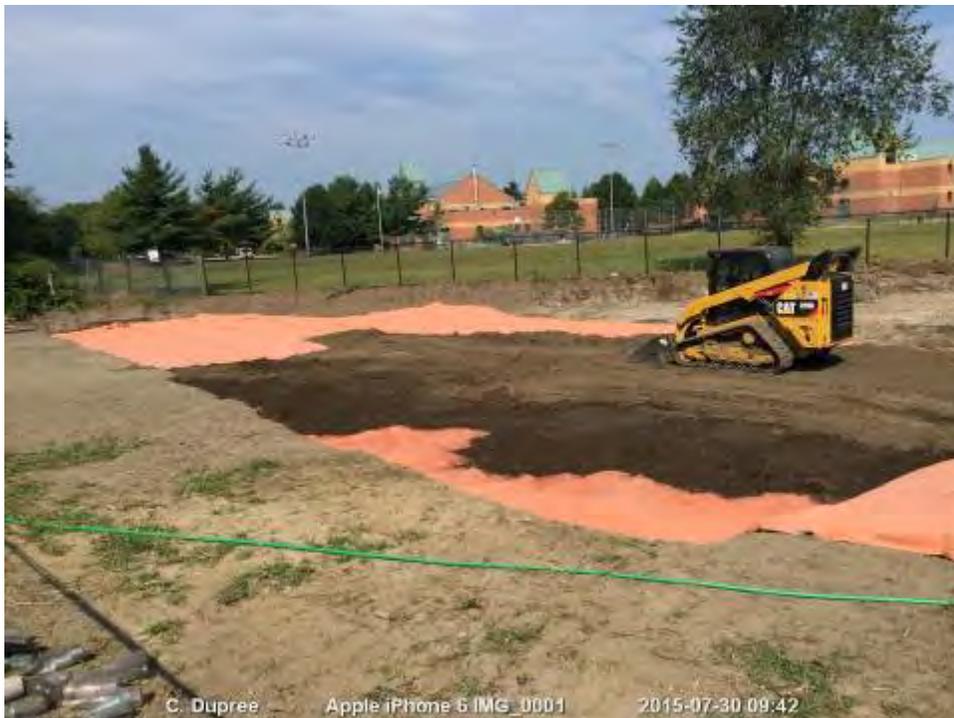
SCENE: View of Property F02 Grids A50, B50, and C50 during backfill activities. Photograph taken facing northwest.

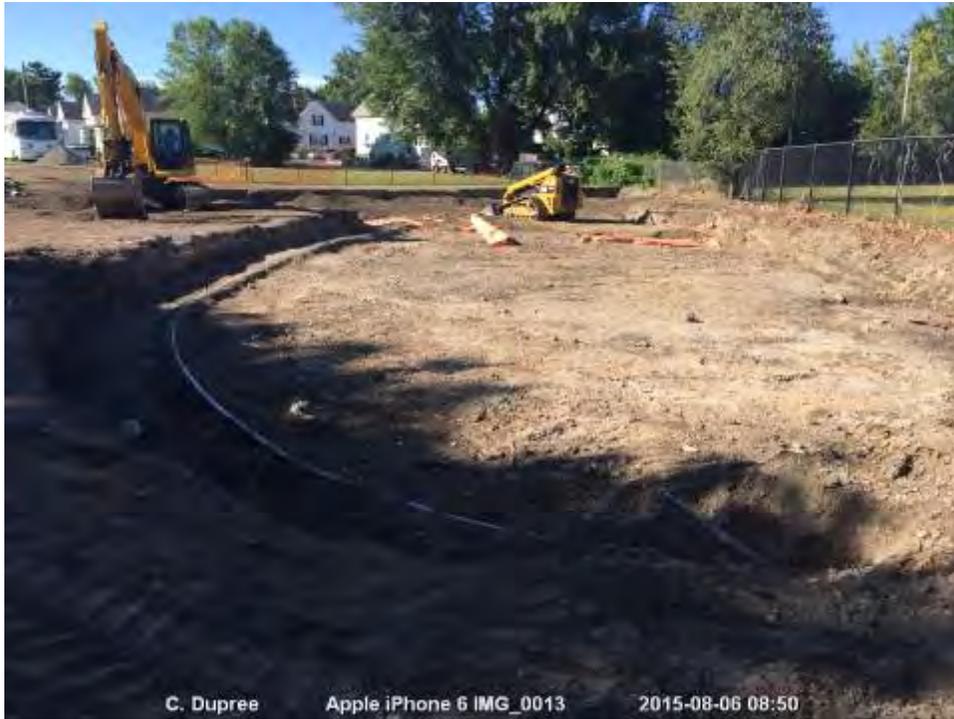
SCENE: View of the completed excavation of grids along the baseball field fence on Property F02. Photograph taken facing west-southwest.

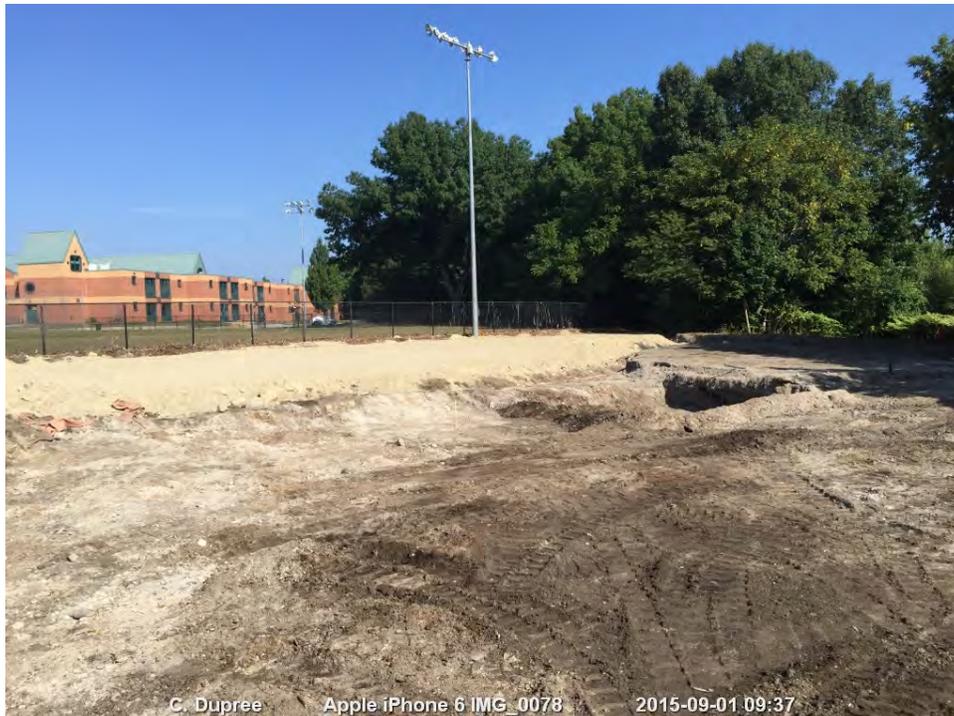
SCENE: View of the grids along the baseball field fence on Property F02 during backfill activities. Photograph taken facing north-northwest.

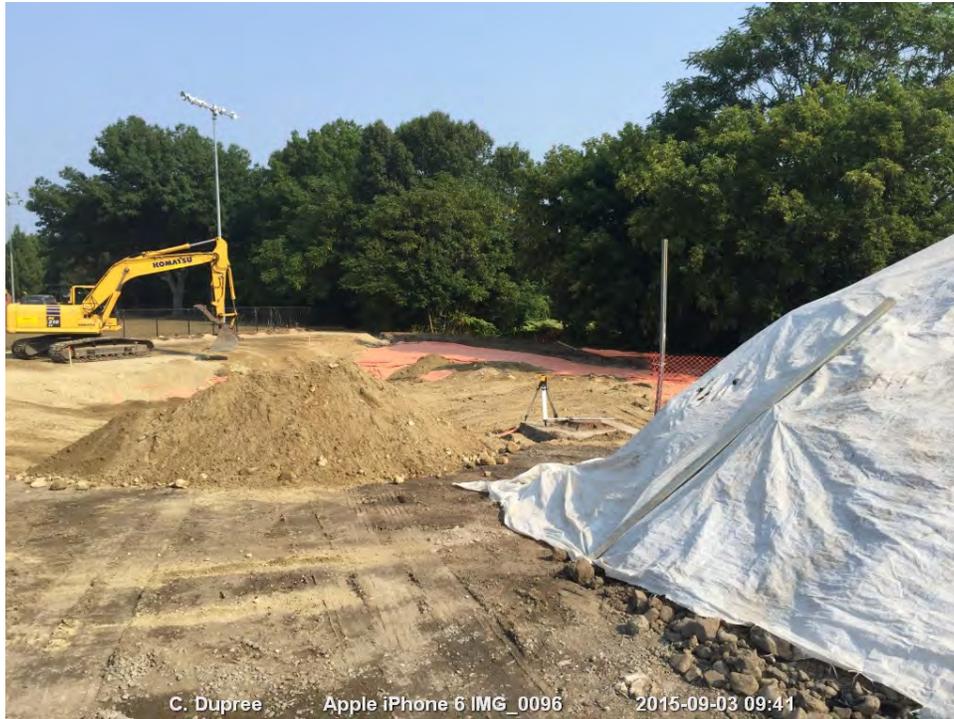
SCENE: View of backfill activities on Property F02. The disposal soil stockpile is on the right. Photograph taken facing north.

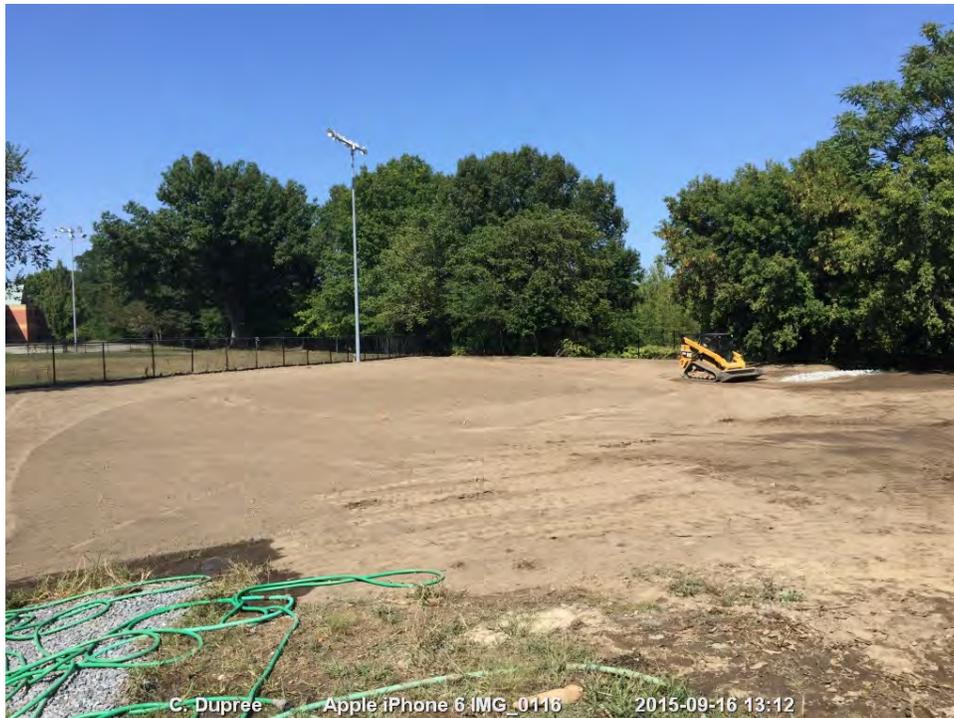
SCENE: View of Property F02 at the completion of backfill activities. Photograph taken facing north.

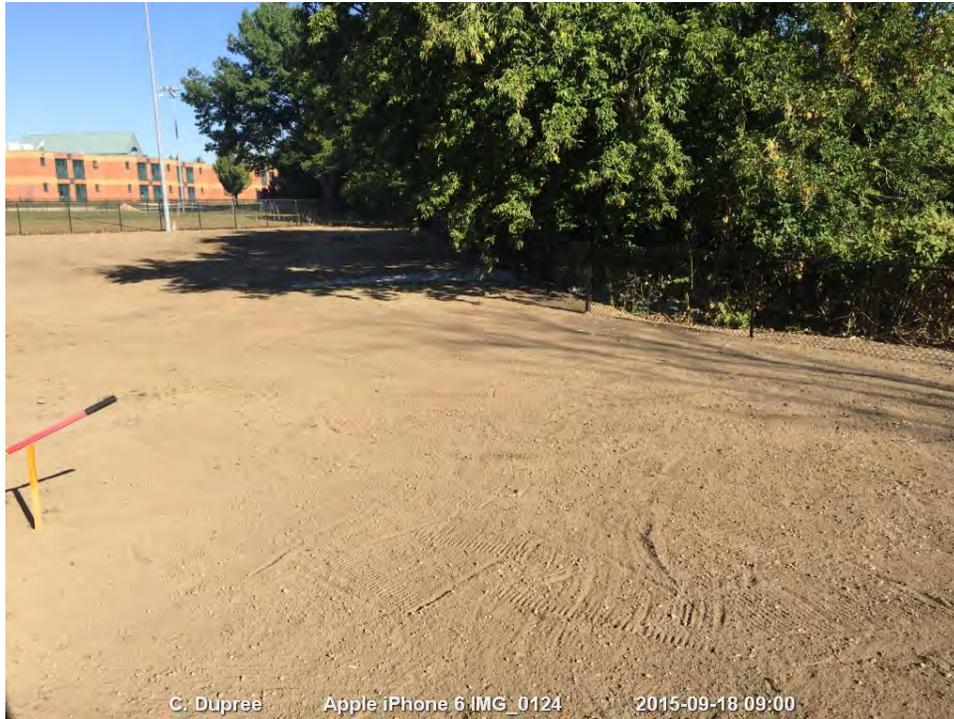
SCENE: View of property F02 at the completion of backfilling, with fencing installed along the eastern boundary. The baseball field is visible in the back left. Photograph taken facing north-northwest.

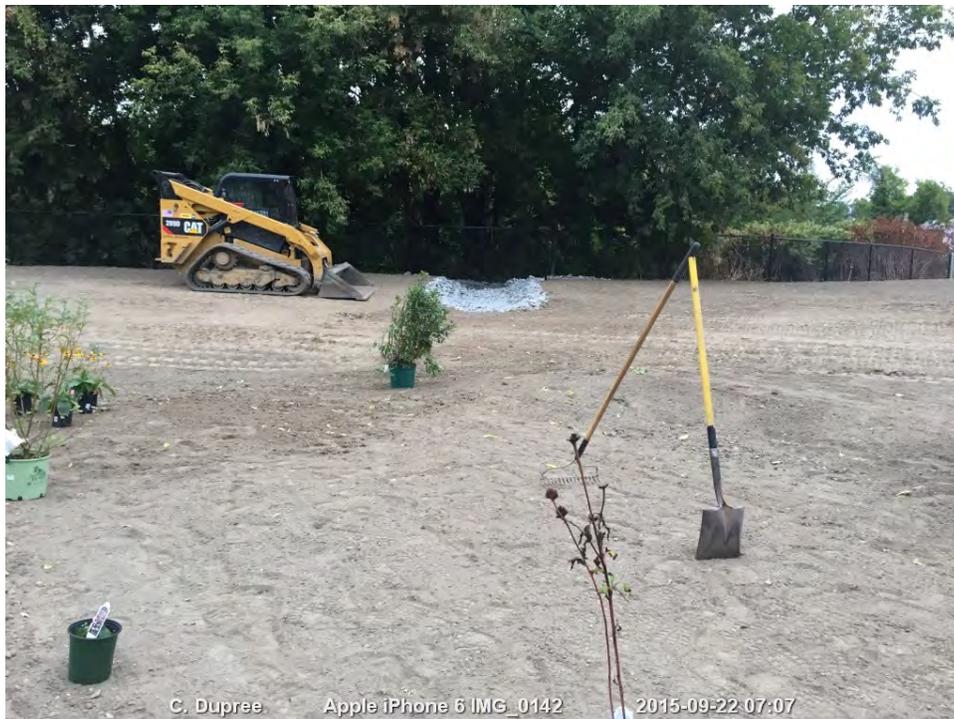
SCENE: View of the overflow channel on the eastern border of Property F02. Photograph taken facing east.
