RE: Contract No. EP-S7-06-02; Technical Direction Document No. 10-09-0008
Final 2012 Removal Action Report, Orofino Asbestos Site
Orofino, Clearwater County, Idaho

2012 REMOVAL ACTION REPORT

Orofino Asbestos Site
Orofino, Clearwater County, Idaho
TDD: 10-09-0008

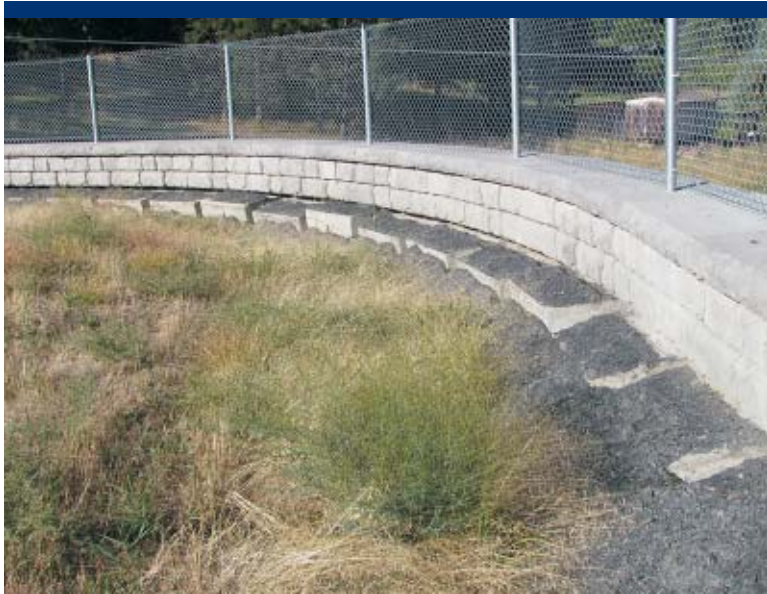
Photo 1 View of dry retention pond and wall before 2012 removal action.

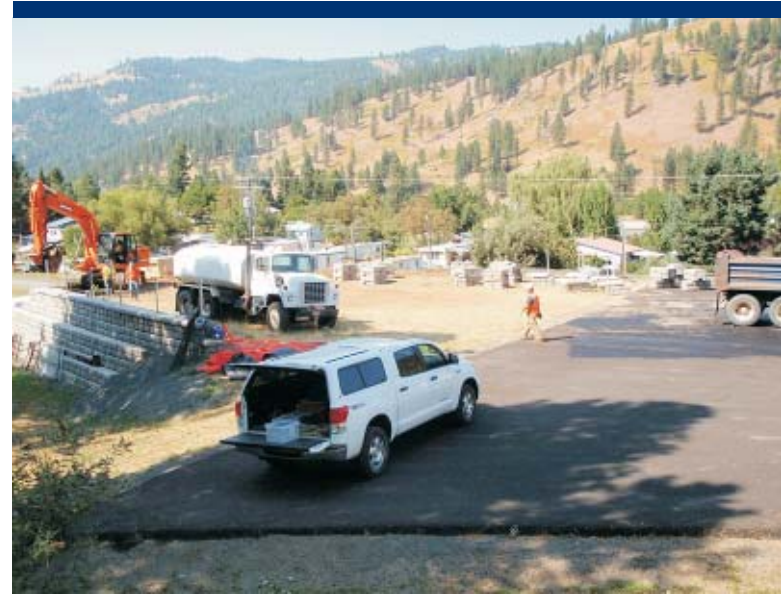
Photo 2 Heavy equipment is used to disassemble the wall by removing individual precast blocks.

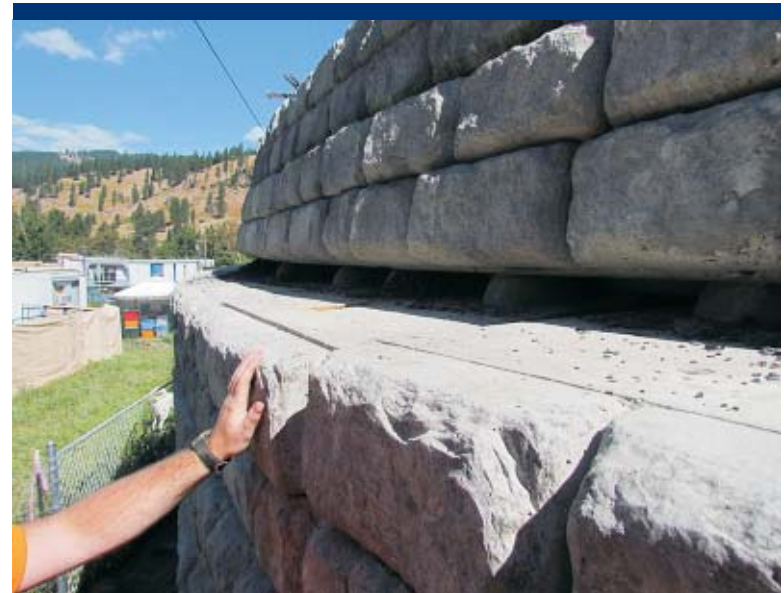
Photo 4 Close-up of retaining wall with shifted blocks before 2012 removal action.

In early 2012, representatives from the Church reported that some of the blocks in the curved, west section of the retaining wall had shifted. EPA investigated and determined that the likely cause of the shift in the blocks was settling of the backfilled soil. This settling caused large gaps between the individual wall blocks that, if not repaired, could potentially lead to the failure of the wall and allow the release of the asbestos-contaminated soil.

In early 2012, during an inspection of the wall by a representative of the Church, large gaps were discovered between the individual blocks that form the western curved portion of the retaining wall. It was determined that the gaps between the wall blocks were caused by settling in the soil behind the wall, which caused the blocks to shift backwards towards the soil. Because of this unanticipated settling, EPA returned to the Site to repair the wall to prevent further settling and to prevent the risk of wall failure and/or the release of the asbestos from behind the wall.

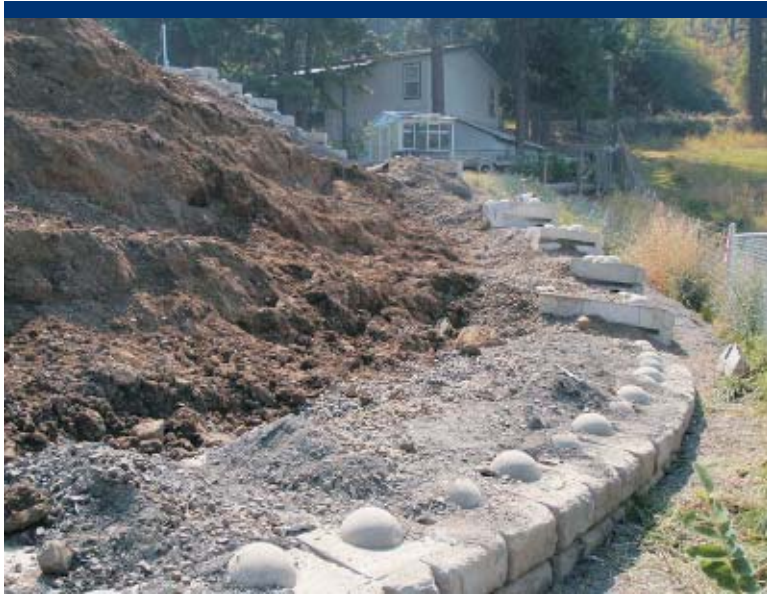
Photo 5 Dis-assembling of the west wall shifted blocks.

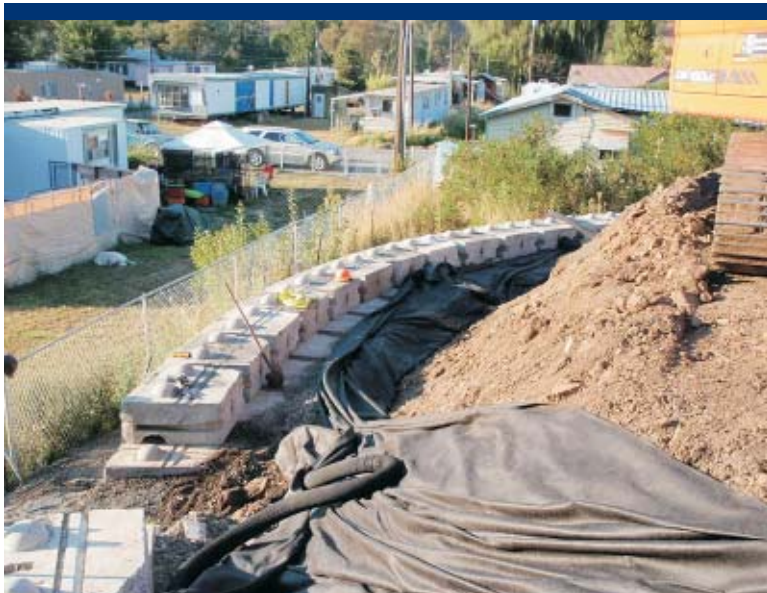
Photo 7 West wall being re-built.

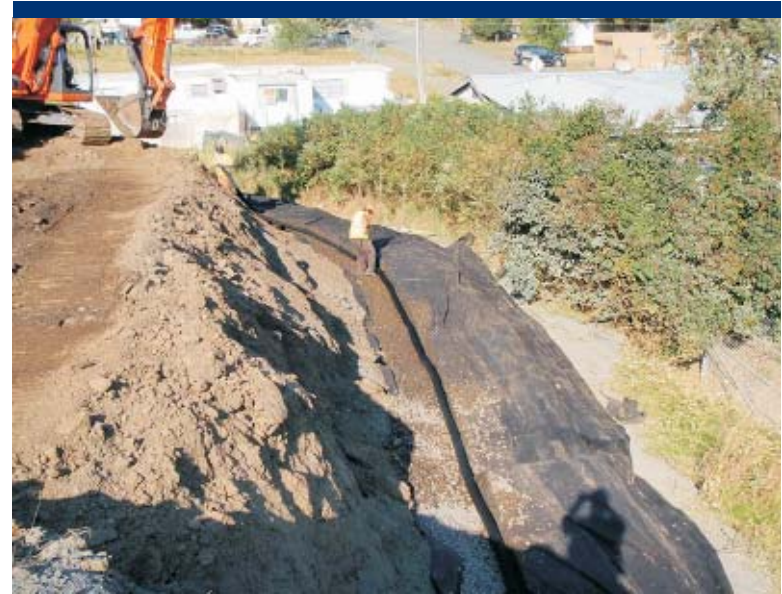
Photo 6 Base Blocks replaced with fabric liner.

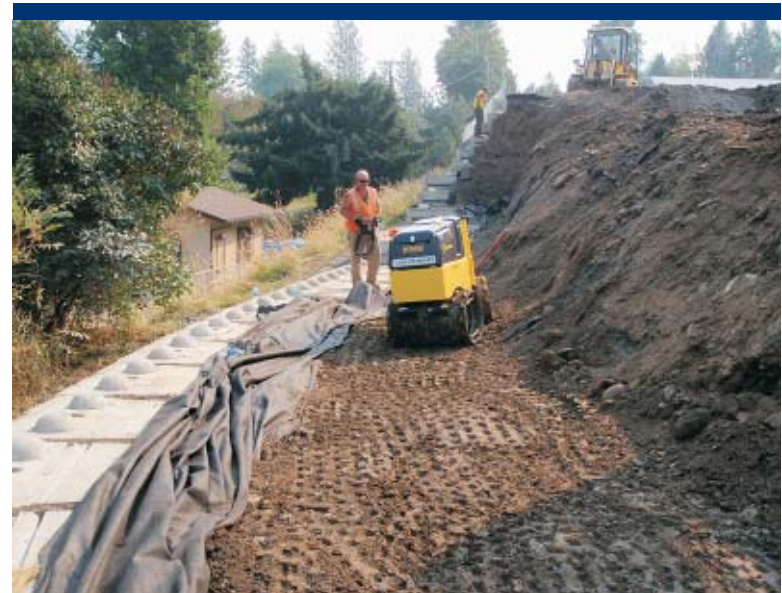
Photo 8 Compaction of asbestos-contaminated soil behind the wall.

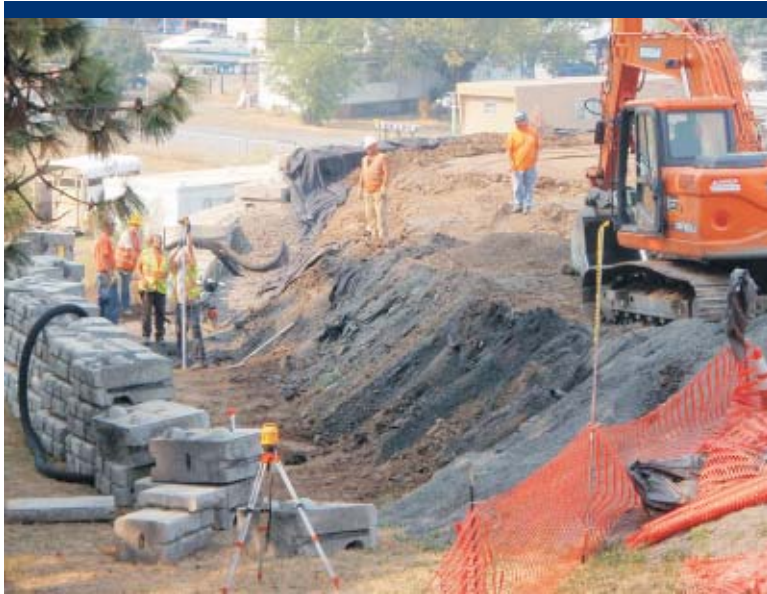
Photo 9 Measuring the base height for the southwest section of the wall.

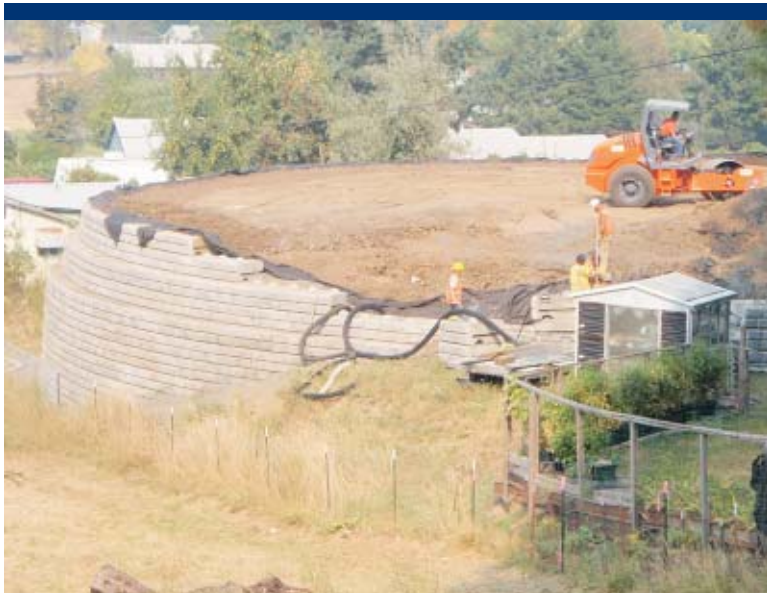
Photo 11 View of the rebuilding of the wall from the southwest.

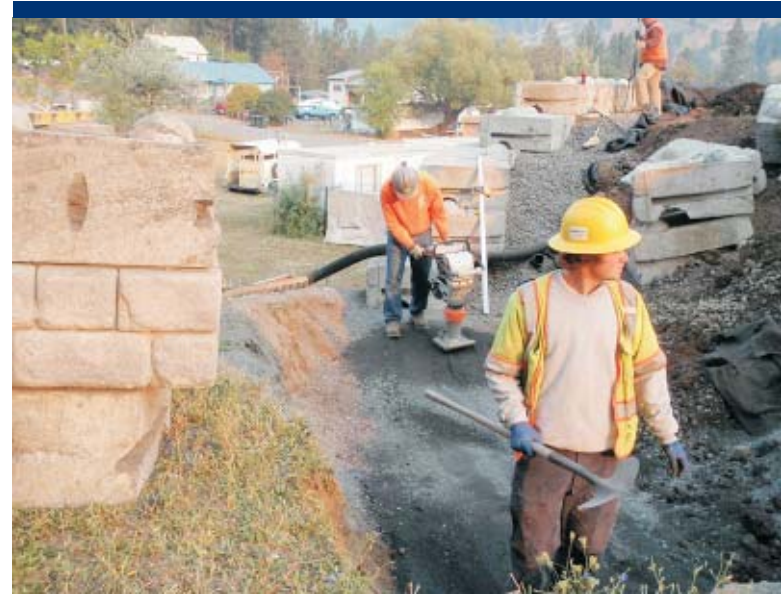
Photo 10 Compaction of base in preparation for the rebuilding of the southwest section of wall.

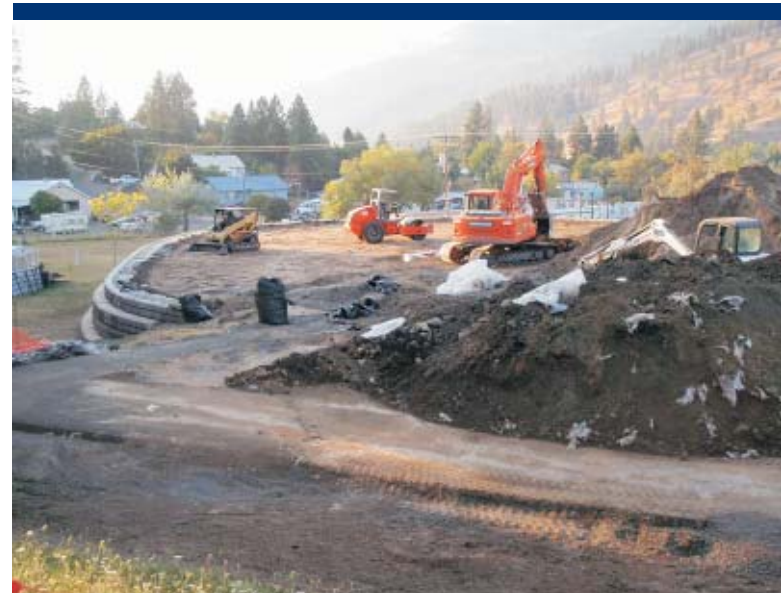
Photo 12 Southwest end of the wall.

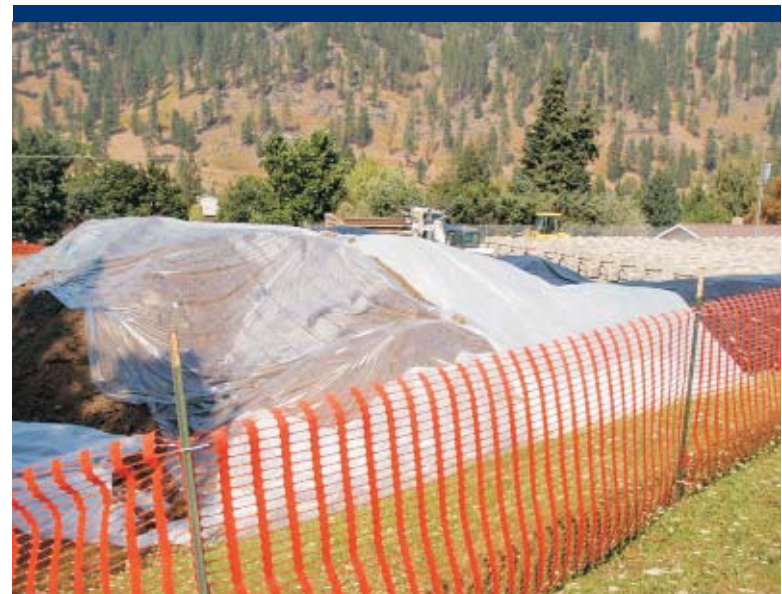
Photo 16 Asbestos-contaminated soil excavated from behind wall stockpile on-site with cover.

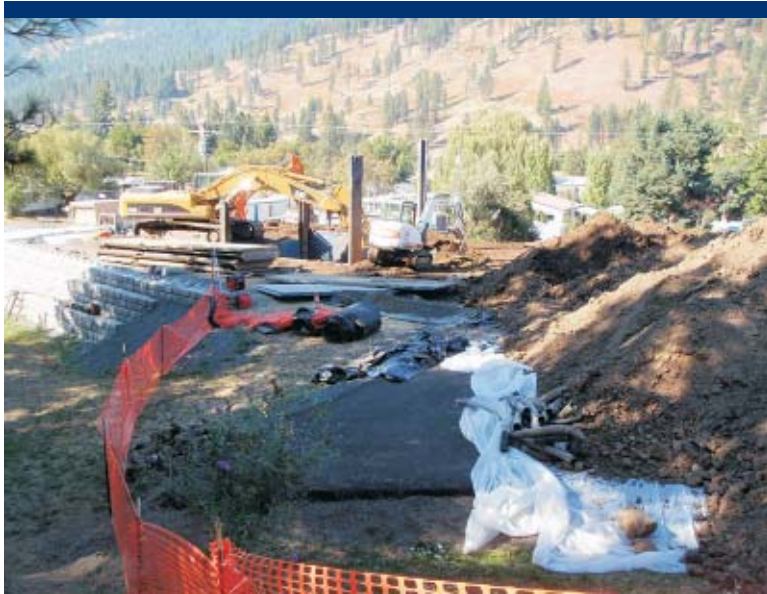
Photo 17 Excavation of drywell in background, with stockpile of asbestos-contaminated soil in foreground.

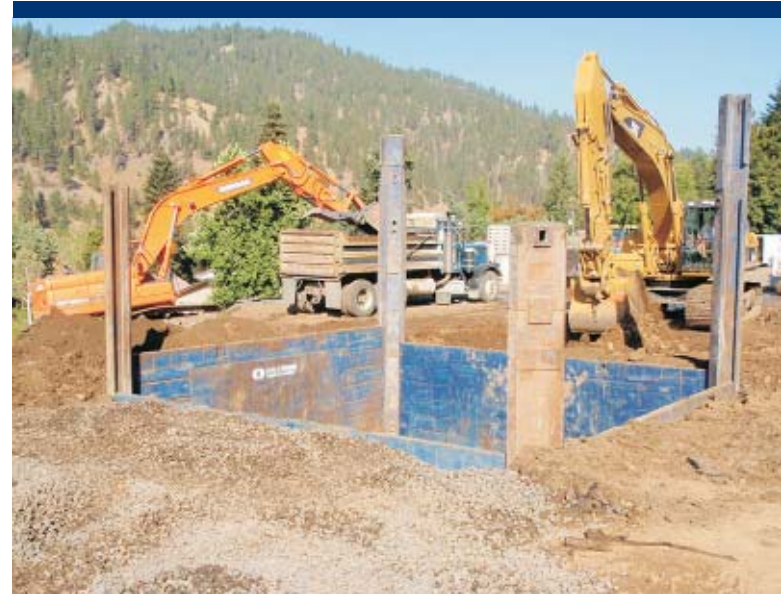
Photo 18 Close-up of dry will excavation and shoring.

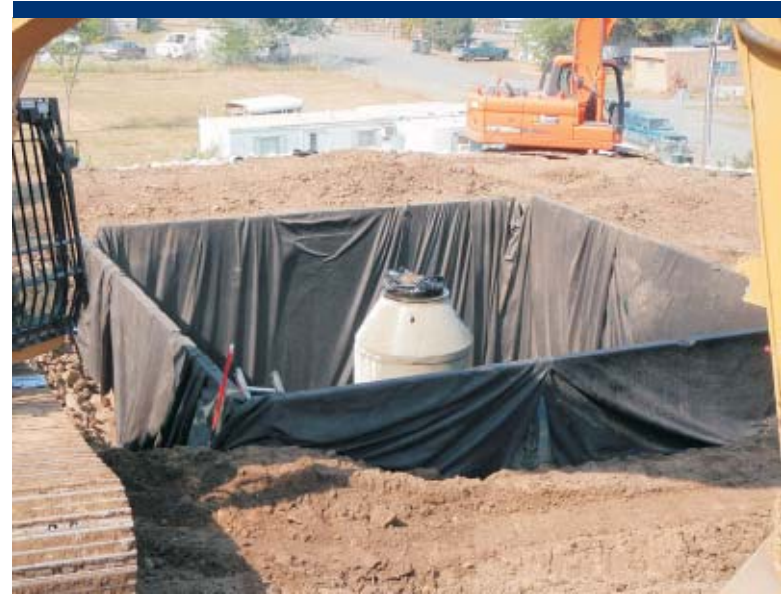
Photo 22 Installation of fabric liner around drain rock and dry well.

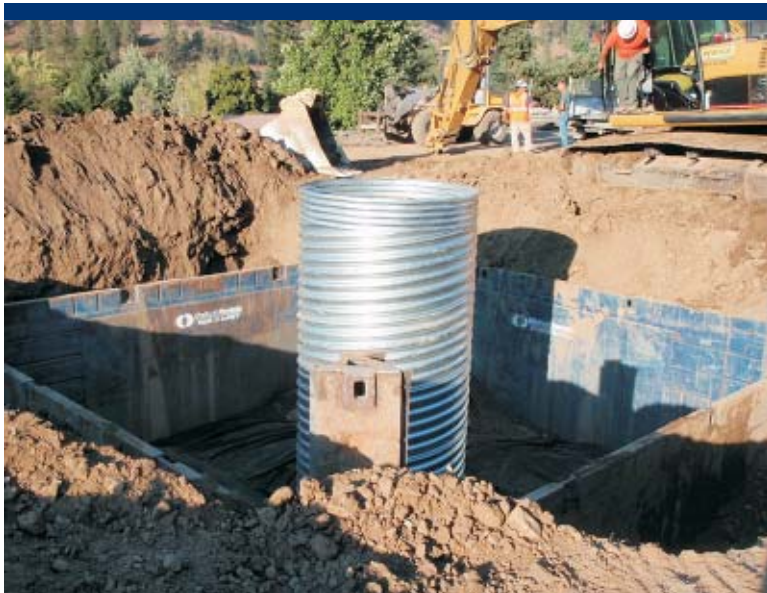
Photo 23 Installation of galvanized culvert around dry well for drain rock.

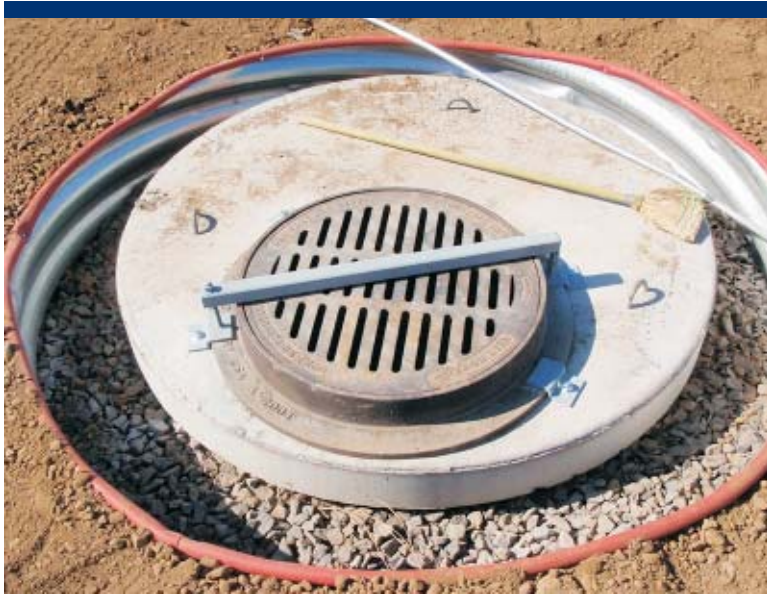
Photo 25 Dry well completed to the surface level.

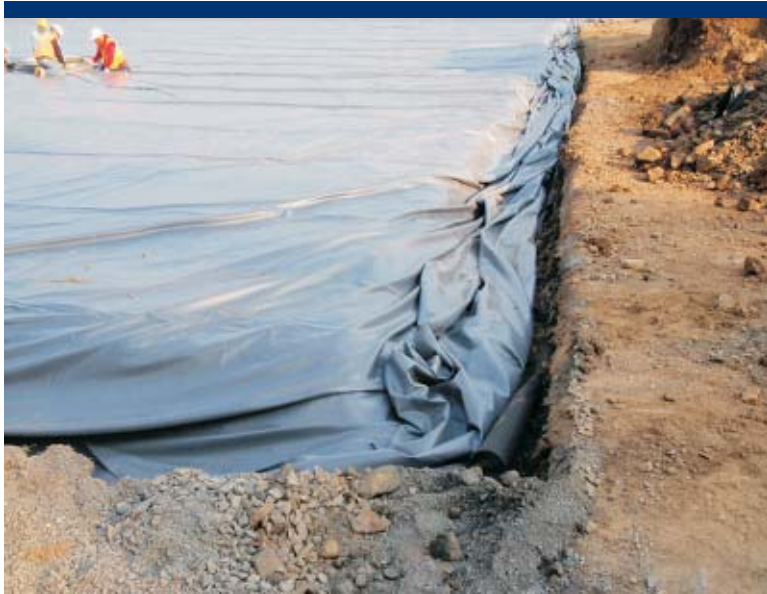
Photo 29 Installation of liner material at edge of soil retention basin and at the edge of the asphalt parking lot.

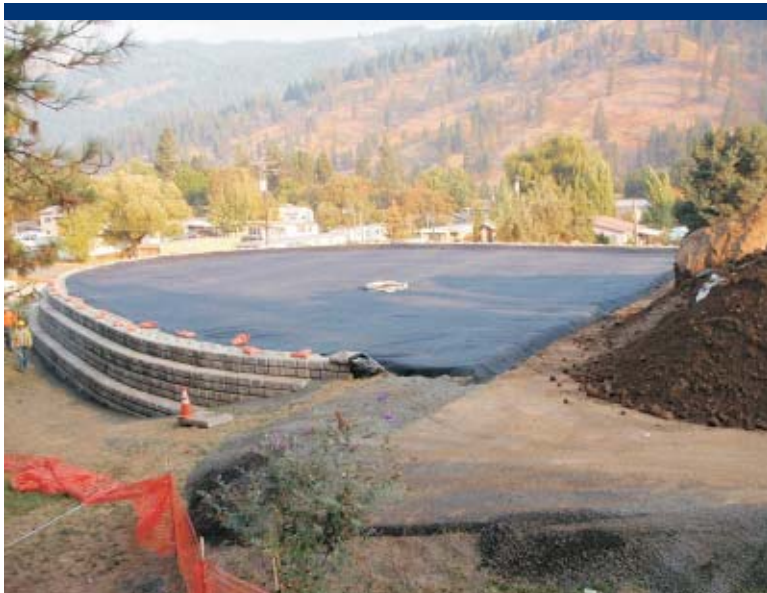
Photo 31 Final view of liner over asbestos-contaminated material before installation of asphalt and top soil.

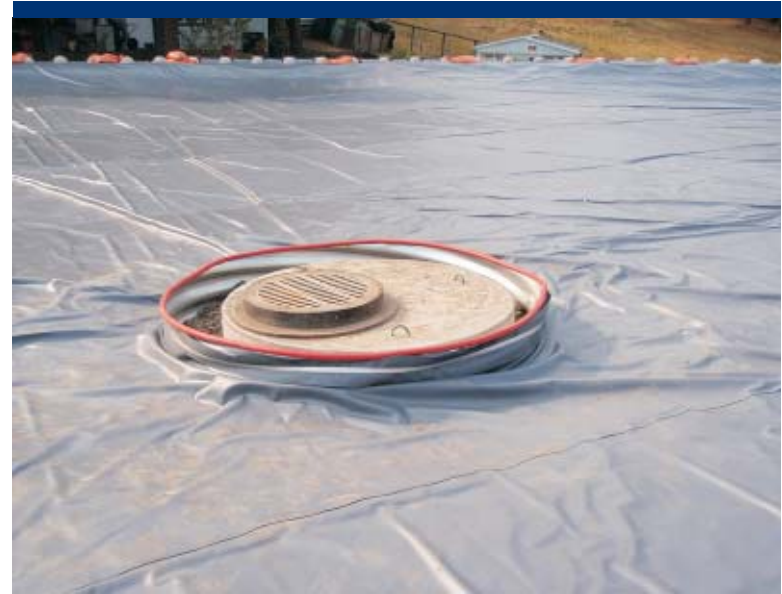
Photo 30 Liner material around surface of dry well.

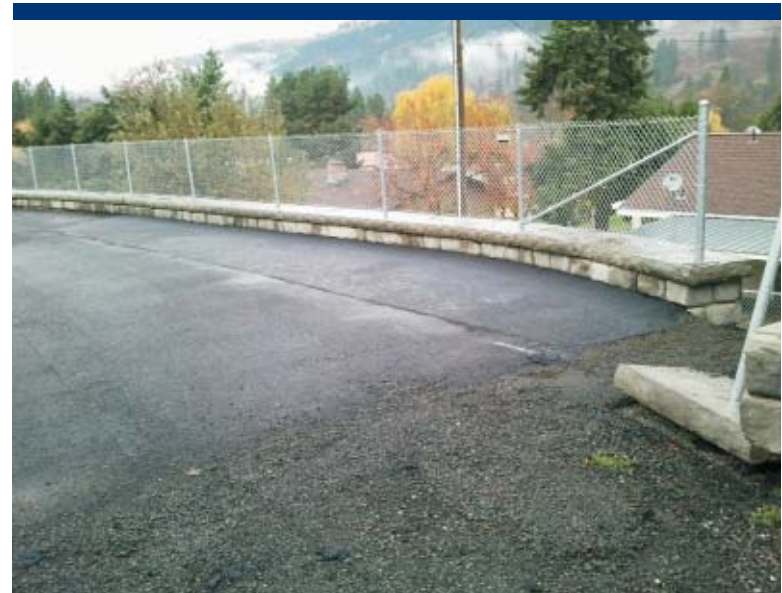
Photo 32 Completed retaining wall and chain-link fence with asphalt for parking area.

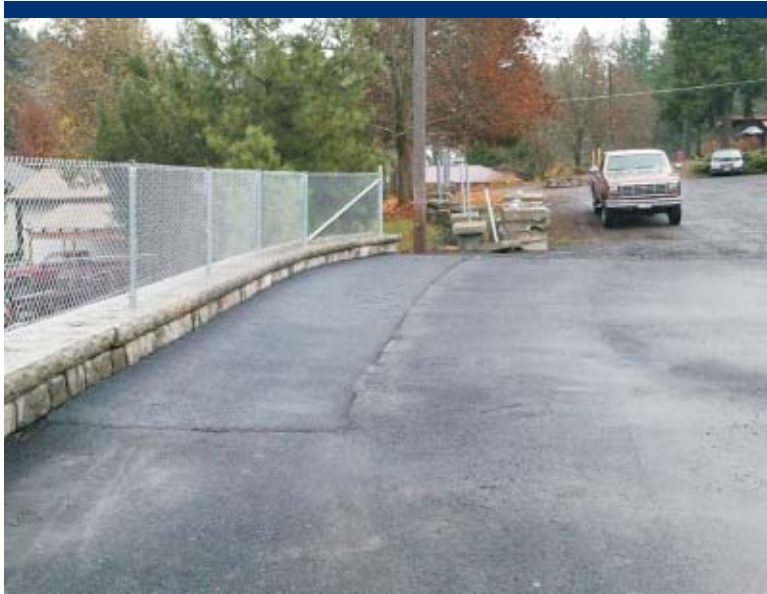
Photo 33 Completed retaining wall and chain-link fence with asphalt for parking area.

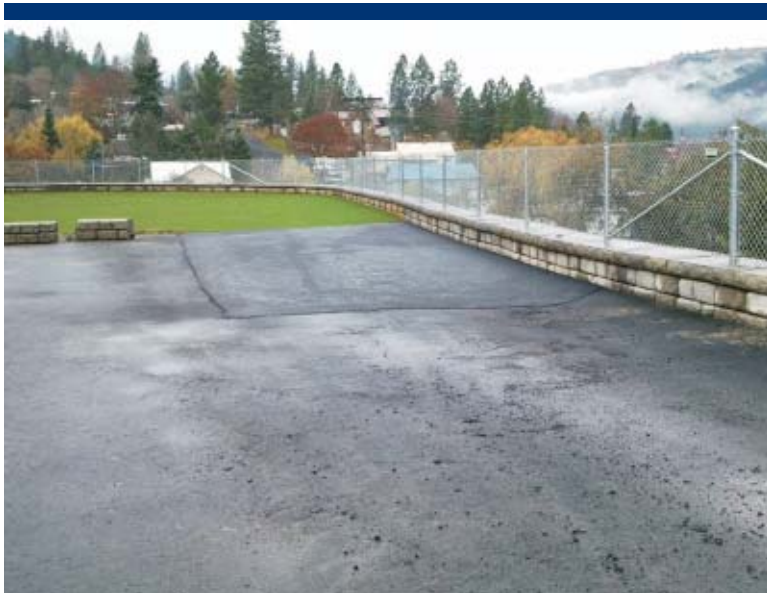
Photo 35 Completed asphalt parking area and grass dry retention basin.

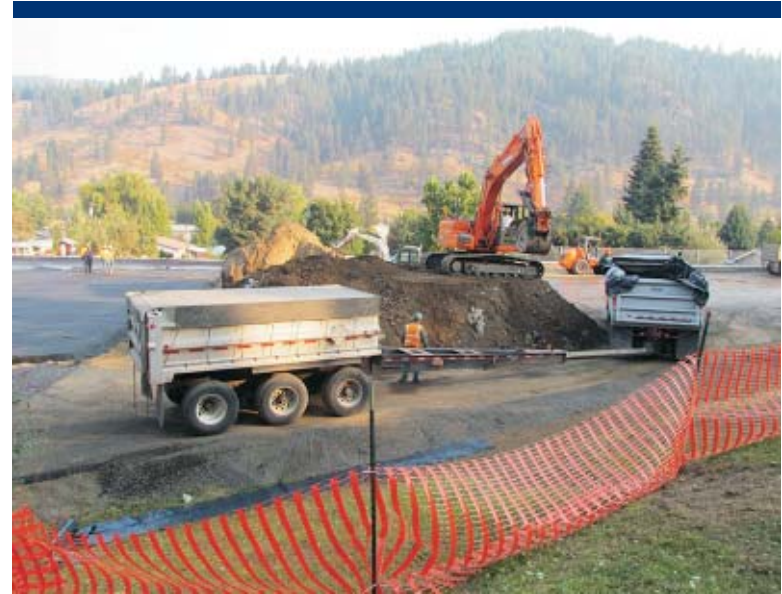
Photo 34 Loading of asbestos-contaminated soil into trucks for off-site disposal.
