**Subject: Final Removal Assessment Report
Terry Company Site
Dayton, Montgomery County, Ohio
Technical Direction Document No. S05-0001-16-06-001
SRS Contract No. EP-S5-16-01**

**REMOVAL ASSESSMENT REPORT
TERRY COMPANY SITE - RS
DAYTON, MONTGOMERY COUNTY, OHIO**

Final Report

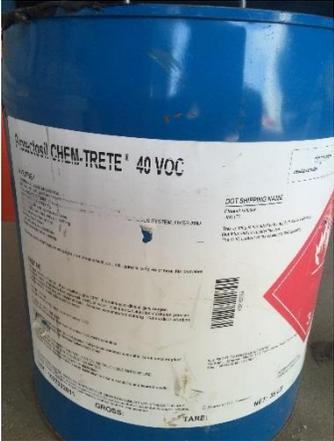
Sample Designation	TCS-05	TCS-07
Container Type	5-gallon plastic	1 Liter metal
Matrix	Liquid	Liquid
Label Information	Protectosil® CHEM-TRETE 40 VOC – Ethanol - Flammable

Field Screening Results		
Multi-Rae VOCs Reading	56 ppm	618 ppm
pH	N/A	N/A
Lab Results		
Flashpoint	< 66 °F	85 °F
pH	N/A	N/A
VOCs	U	N/A

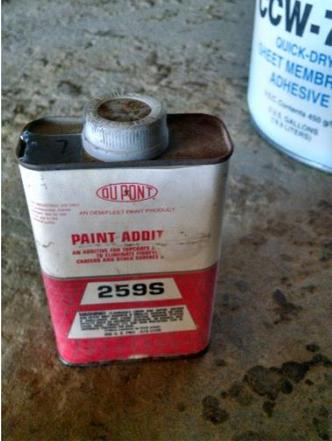
Paint additive

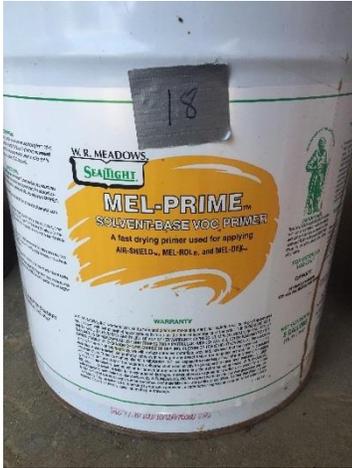
Sample Designation	TCS-18	TCS-20
Container Type	5-gallon plastic	5-gallon plastic
Matrix	Liquid	Liquid
Label Information	Mel-Prime™ - Solvent-base VOC Primer – Flammable

Qualipur 151 – Flammable

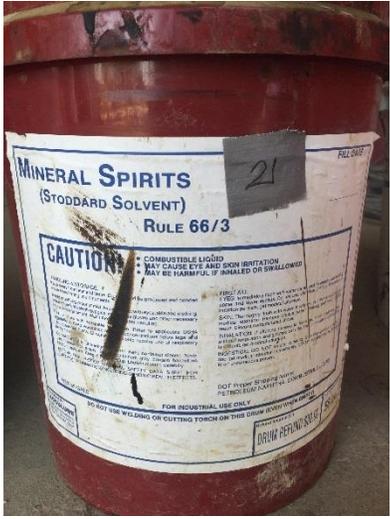
Sample Designation	TCS-21	TCS-23
Container Type	5-gallon plastic	5-gallon plastic
Matrix	Liquid	Liquid
Label Information	Mineral Spirits – Stoddard Solvent

Mineral Spirits – Stoddard Solvent

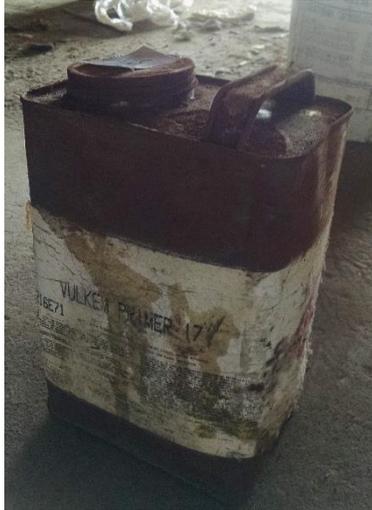
Sample Designation	TCS-24, TCS-24D (Duplicate)	
Container Type	1 Liter metal	5-gallon plastic overpack
Matrix	Liquid	Liquid
Label Information	Vulkem Primer 17

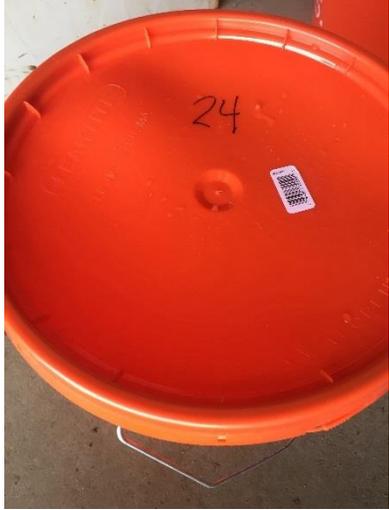
Re-containerized sample TCS-24 and TCS-24D

Field Screening Results		
Multi-Rae VOCs Reading	440 ppm	440 ppm
pH	N/A	N/A
Lab Results		
Flashpoint	96 °F	101 °F
pH	N/A	N/A
VOCs	N/A	N/A

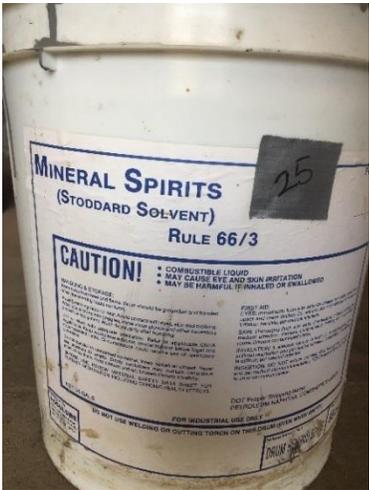
Sample Designation	TCS-25	TCS-27
Container Type	5-gallon plastic	5-gallon plastic
Matrix	Liquid	Liquid
Label Information	Mineral Spirits – Stoddard Solvent

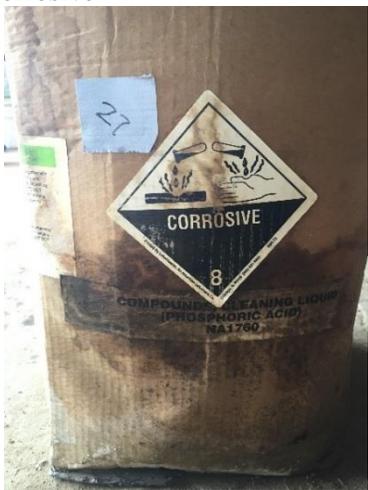
Special Truck & Trailer Wash – Corrosive

Field Screening Results		
Multi-Rae VOCs Reading	13 ppm	N/A
pH	N/A	1 SU
Lab Results		
Flashpoint	> 200 °F	N/A
pH	N/A	1.4 SU
VOCs	N/A	N/A

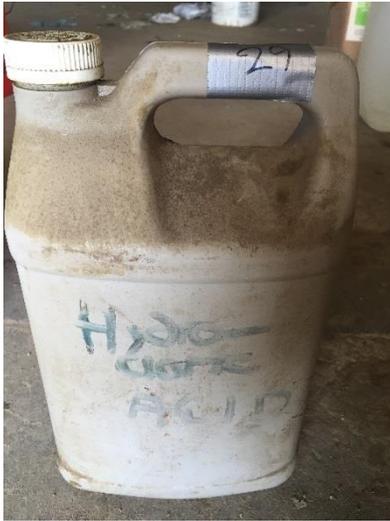
Hydrochloric Acid (handwritten)

EPA Hazardous Waste Number of D002. The pH results ranged from less than 1 SU to less than 1.6 SU. The lowest pH was documented in sample TCS-29 collected from container hand-labelled “Hydrochloric Acid”. Analytical results of sample TCS-36 collected from the 6,000-gallon tanker indicated a pH level of 9 SU. Analytical results of the four samples collected during this assessment did not indicate any detections of the site-specific VOCs.

Field Screening Results		
Multi-Rae VOCs Reading	N/A	N/A
pH	1 SU	<2 SU
Lab Results		
Flashpoint	N/A	145 °F
pH	1.4 SU	<1 SU
VOCs	N/A	N/A

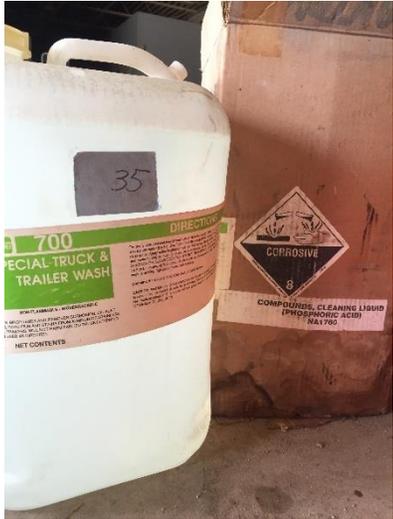
Sample Designation	TCS-34	TCS-35
Container Type	5-gallon plastic	5-gallon plastic
Matrix	Liquid	Liquid
Label Information	CHEM-TRETE® BSM-20 – Methanol, Ethanol - Flammable	Special Truck & Trailer Wash – Corrosive

Field Screening Results		
Multi-Rae VOCs Reading	165 ppm	N/A
pH	N/A	1 SU
Lab Results		
Flashpoint	< 74 °F	1.6 SU
pH	N/A	N/A
VOCs	U	N/A

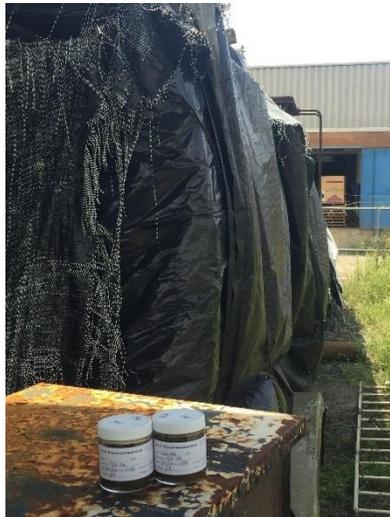
Sample Designation	TCS-36	TCS-37
Container Type	6,000-gallon Tanker	55-gallon metal drum
Matrix	Liquid	Liquid
Label Information	Unlabeled Tanker

Field Screening Results		
Multi-Rae VOCs Reading	N/A	440 ppm
pH	10 SU	N/A
Lab Results		
Flashpoint	N/A	96 °F
pH	9 SU	N/A
VOCs	N/A	U

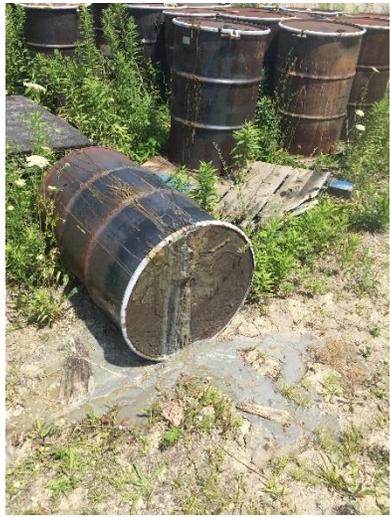
Unlabeled Drum

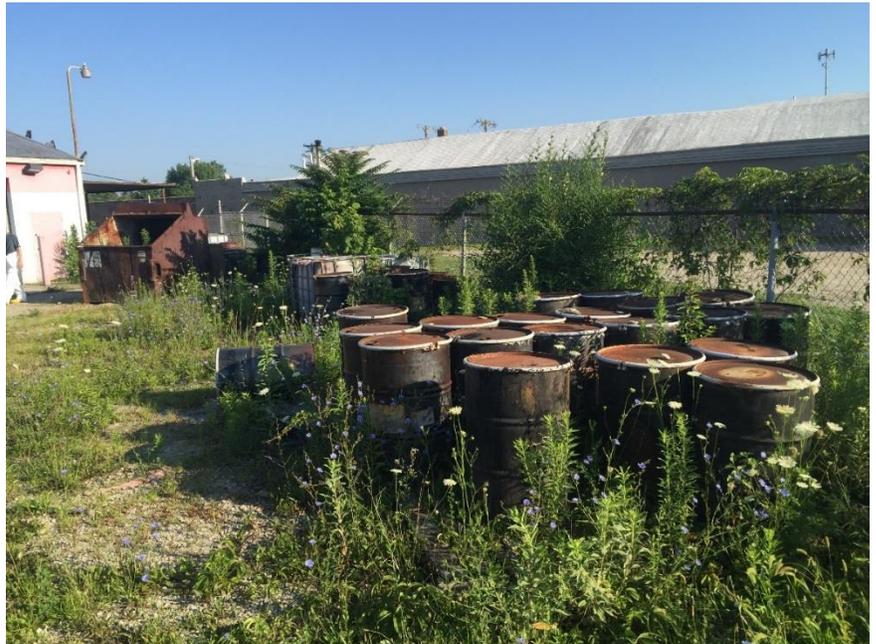
Official Photograph No.2:
Several drums staged outside
building at the Site facing north.

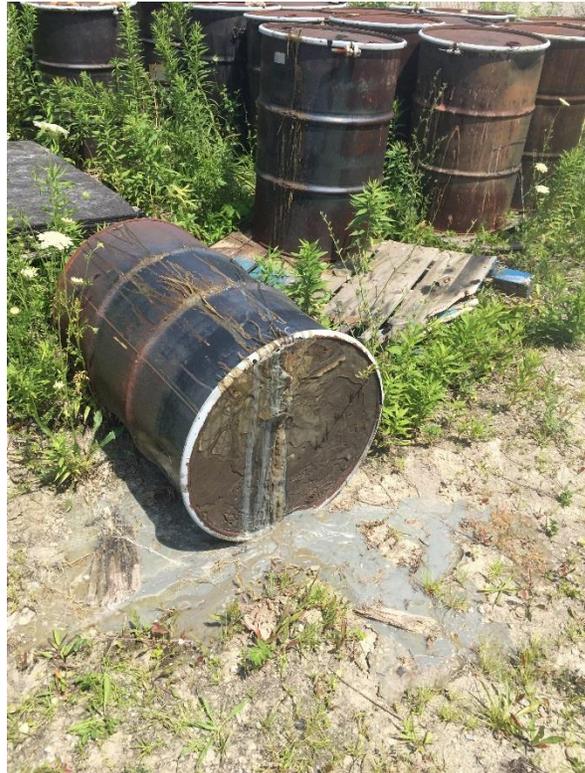
Official Photograph No.3:
Drum spill outside of the building at the Site, spill material has hardened into a wax-like substance.

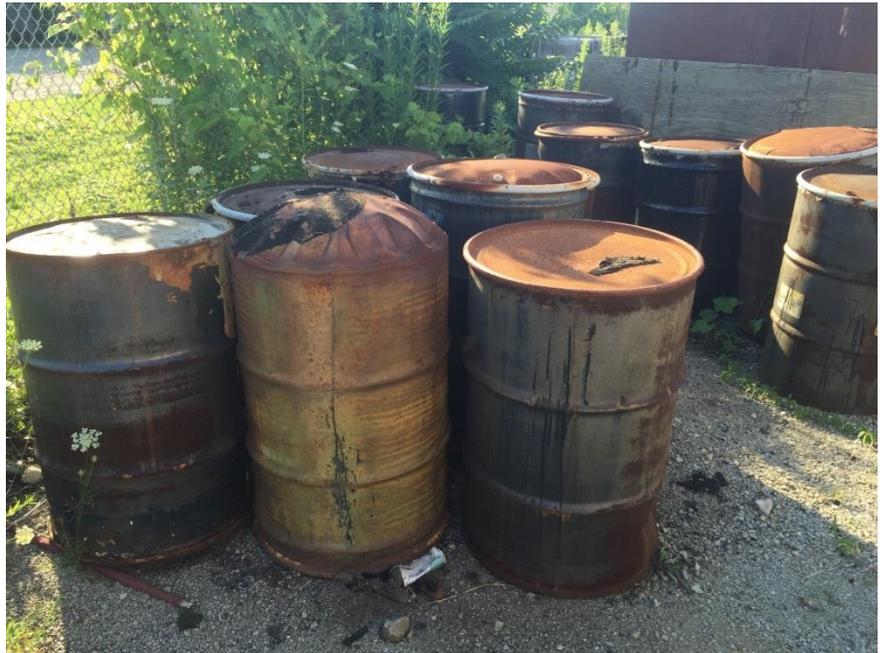
Official Photograph No.4:
Bulging drum staged near the north perimeter of the Site.

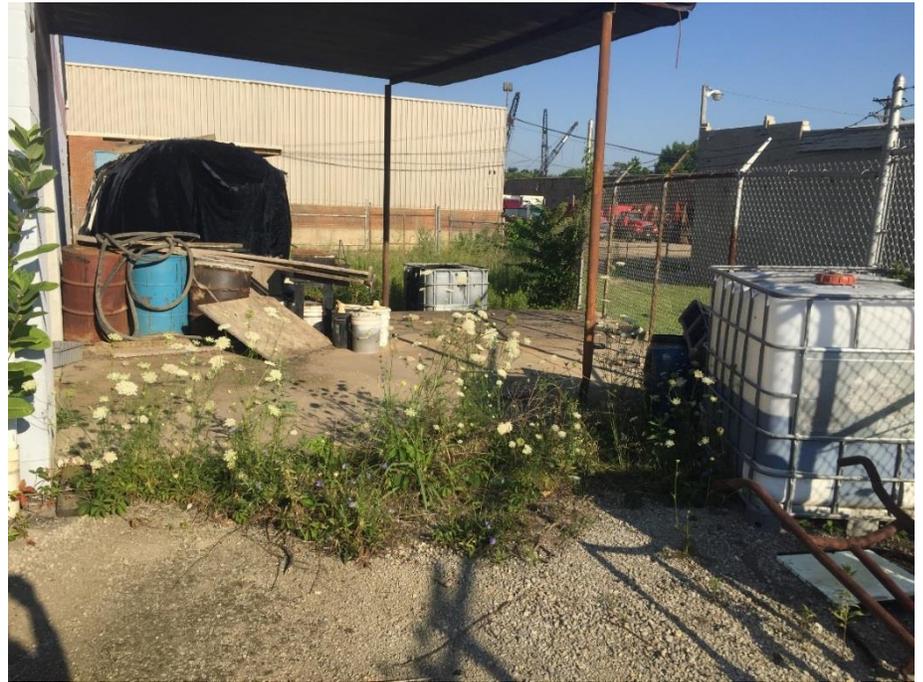
Official Photograph No.5:

6,000-gallon tanker and two totes near the north perimeter of the Site. Tanker and totes are approximately half full.

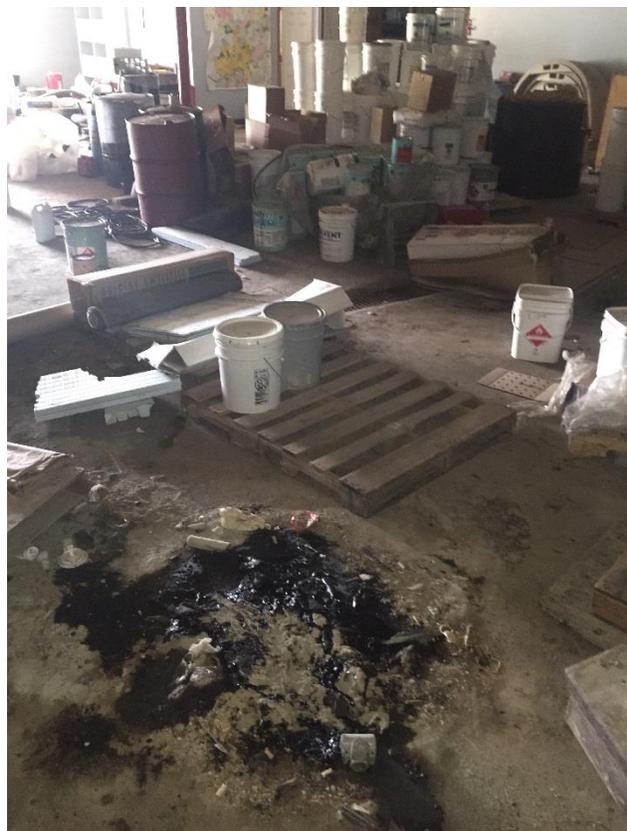
Official Photograph No.6:

There is nothing to prevent freezing and thawing of the contents in the drums and containers. Indoor drums and containers were noted to be open and deteriorated with spilled contents on the floor and in close proximity to floor drains which lead to the municipal sewer system. Forty-two deteriorated drums, in groups of five to ten, were located outside of the Site building. Several drums were noted as bulging due to summer heat and potential volatile organic contents. Additionally, an outdoor drum was observed overturned with its contents spilled on the surrounding soil, enabling contamination to migrate off-site following a rain event.

Spill inside the northern portion of the ground floor in the building at the Site. A floor drain which leads to the municipal sewer system is near the spill.

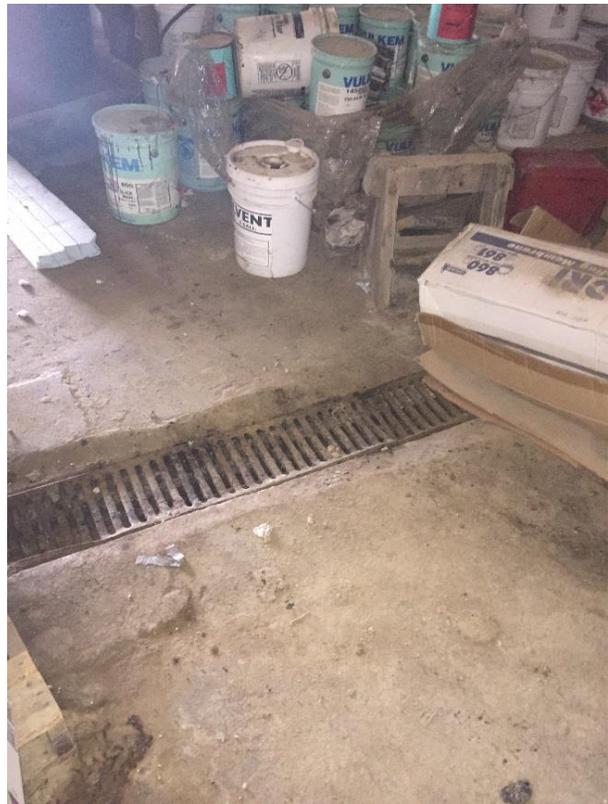
Official Photograph No.7:
Floor drain which leads to the municipal sewer system in the north portion of the building at the Site.

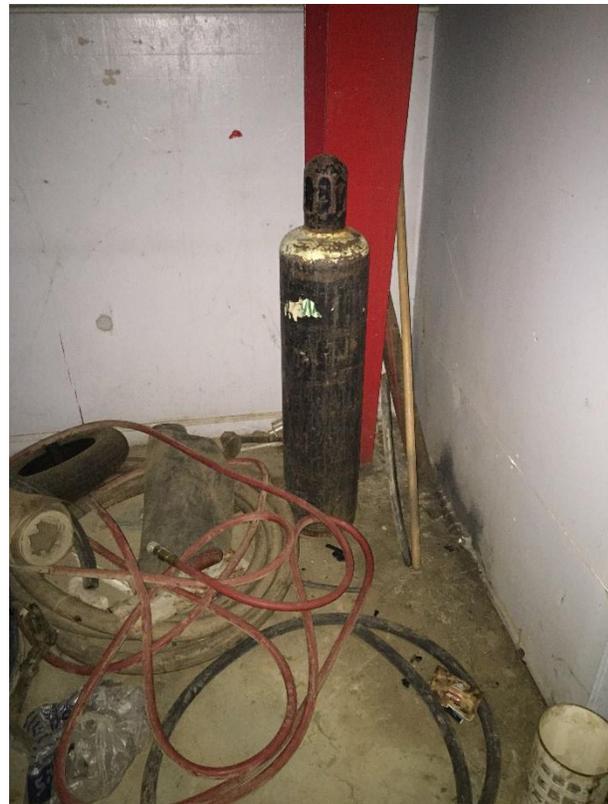
Official Photograph No.8:
One of the three compressed gas cylinders observed in the northern half of the building.

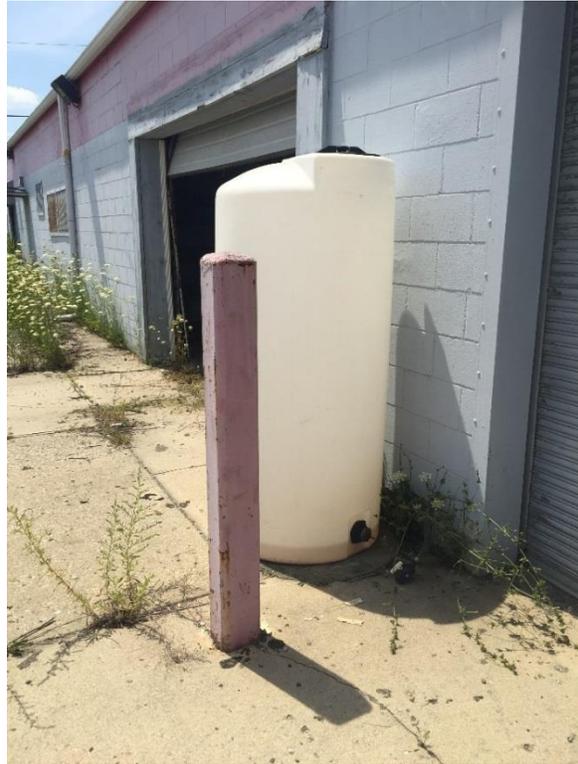
Official Photograph No.9:
Tote outside building at the Site.

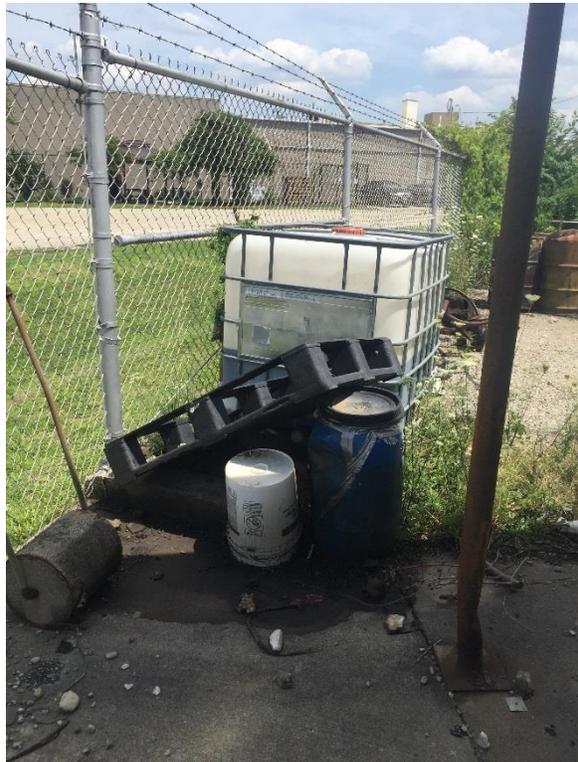
Official Photograph No. 10:
330-gallon tote at the north perimeter of the Site.

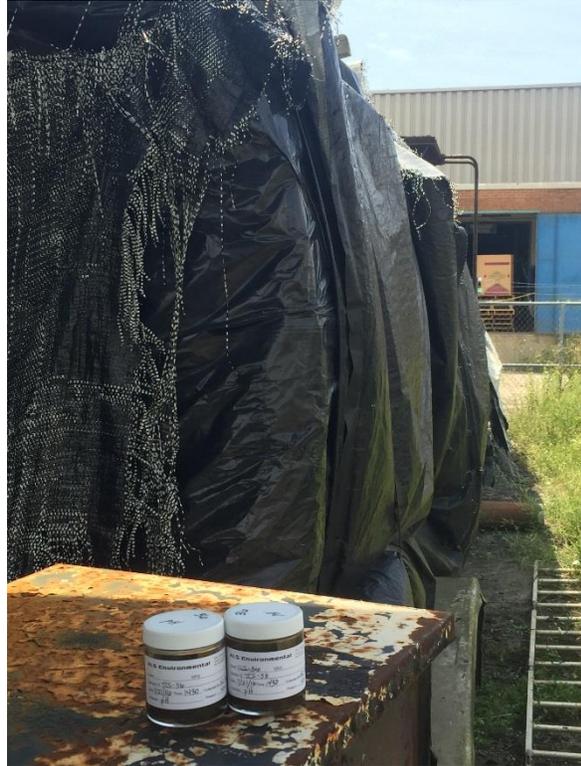
Official Photograph No.11:
6,000-gallon tanker located at the north perimeter of the Site.

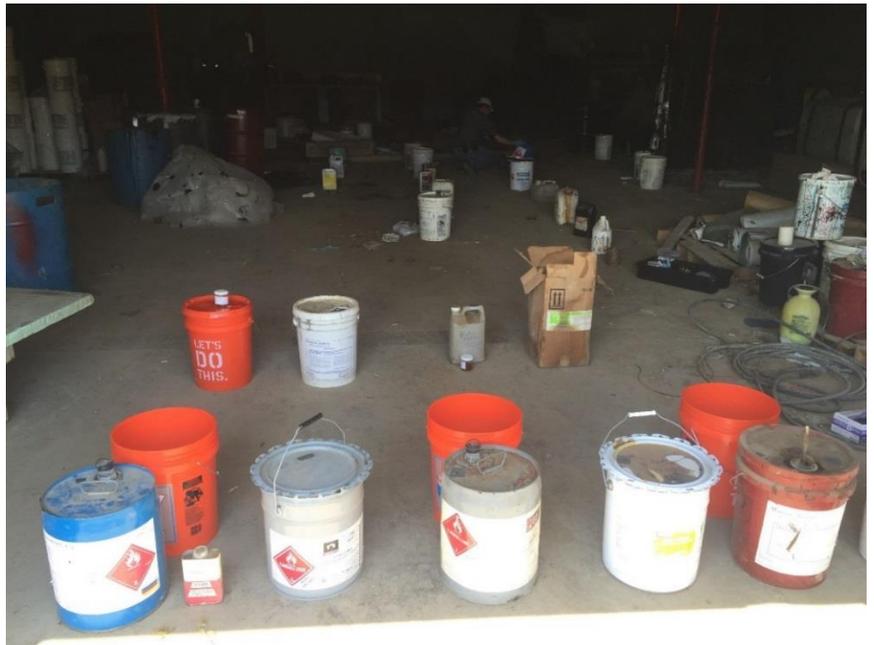
Official Photograph No.12:
Well ventilated staging area for containers to be sampled near the building's garage door.

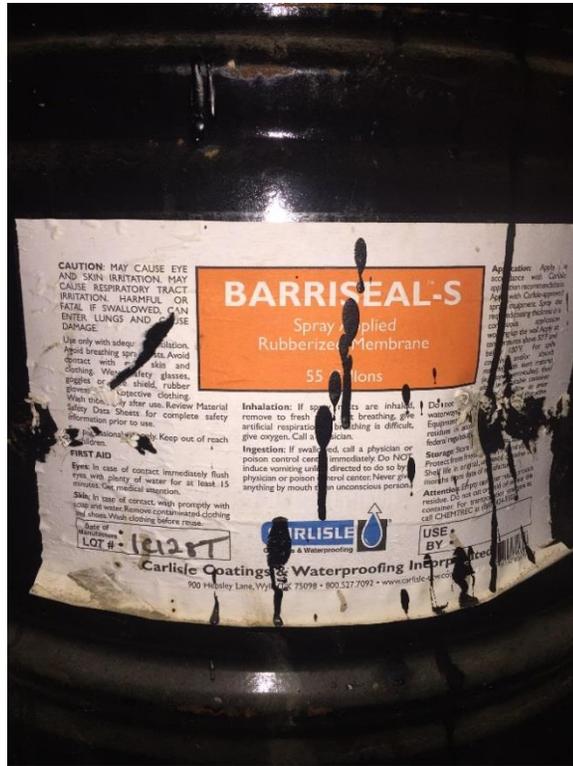
Official Photograph No.13:

places adjacent to floor drains which may lead to the storm water and municipal sewer system. Approximately eight 55-gallon drums located inside the building were labeled “Barriseal-S” and “Hydrocide 700B”. According to the “Barriseal-S” Material Safety and Data Sheet (MSDS), it is a water based asphalt emulsion (Carlisle Coatings and Waterproofing Incorporated, 2016). According to the “Hydrocide 700B” MSDS, it is a coating composed of asphalt petroleum (BASF Building Systems, Inc., 2006). Three compressed gas cylinders were also observed in the northern portion of the building. Groups of smaller containers of waste were located on shelves, cabinets, piles, and comingled with solid waste in storage areas. Puddles of water were observed inside the building on-site indicating potential roof leaks. Forty-two 55-gallon drums, four 330-gallon totes, and one 6000-gallon tanker were located outside the building near the northeastern perimeter of the Site. Drums outside the building were noted as rusted and deteriorated with contents spilled on the ground near an overturned drum. Several bulging drums were also observed outside of the Site building.

During container inventory, several 55-gallon drums were observed with the "Barriseal-S" label shown to the right.

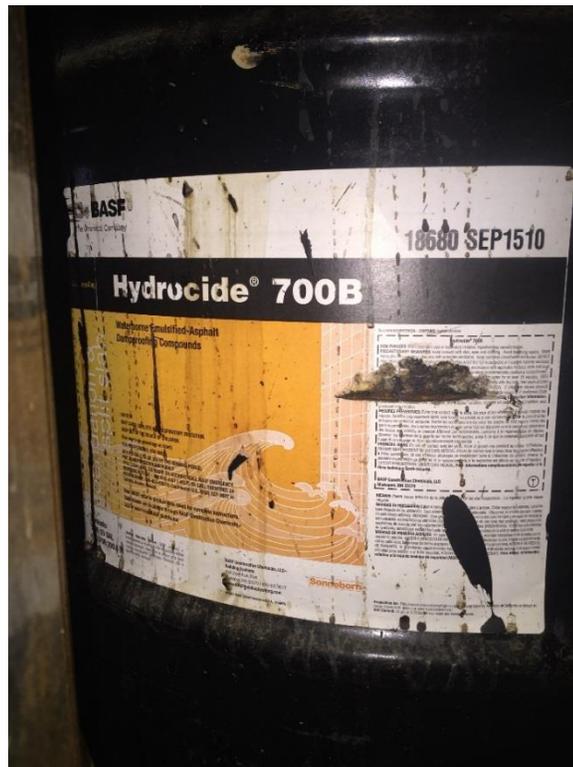
Official Photograph No. 14:

During container inventory, several 55-gallon drums were observed with the "Hydrocide 700B" label shown to the right.
