REMOVAL REPORT

BILLINGS PCE REMOVAL SITE
Billings, Yellowstone County, Montana

TDD No. 0805-11

OCTOBER 20, 2010

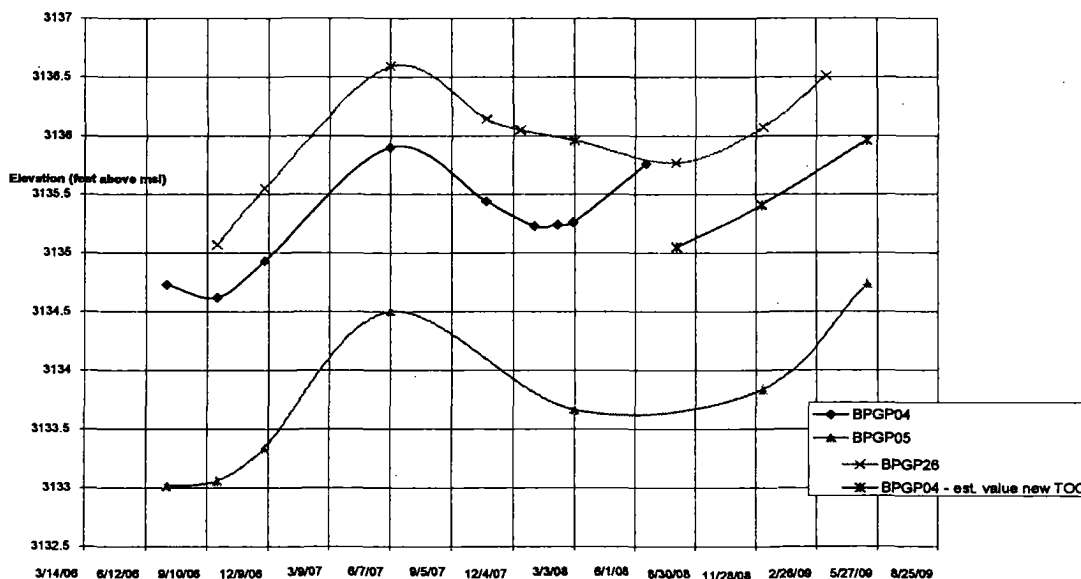
FIGURE A
Groundwater Elevations in Selected Wells (feet above mean sea level)

The depth to groundwater in the source area ranged from approximately 14 to 16 feet bgs. The groundwater elevations in wells near the source area are shown in the chart below. The groundwater elevations in well BPGP04 (NW corner 7th and Central) ranged from 3,134.62 feet above mean sea level (msl) in September 2006 to 3,135.9 feet above msl in June 2006. There is not enough temporal data to thoroughly illustrate season patterns (if present). There may be other factors related to water elevation changes that include infiltration from canals and irrigation.

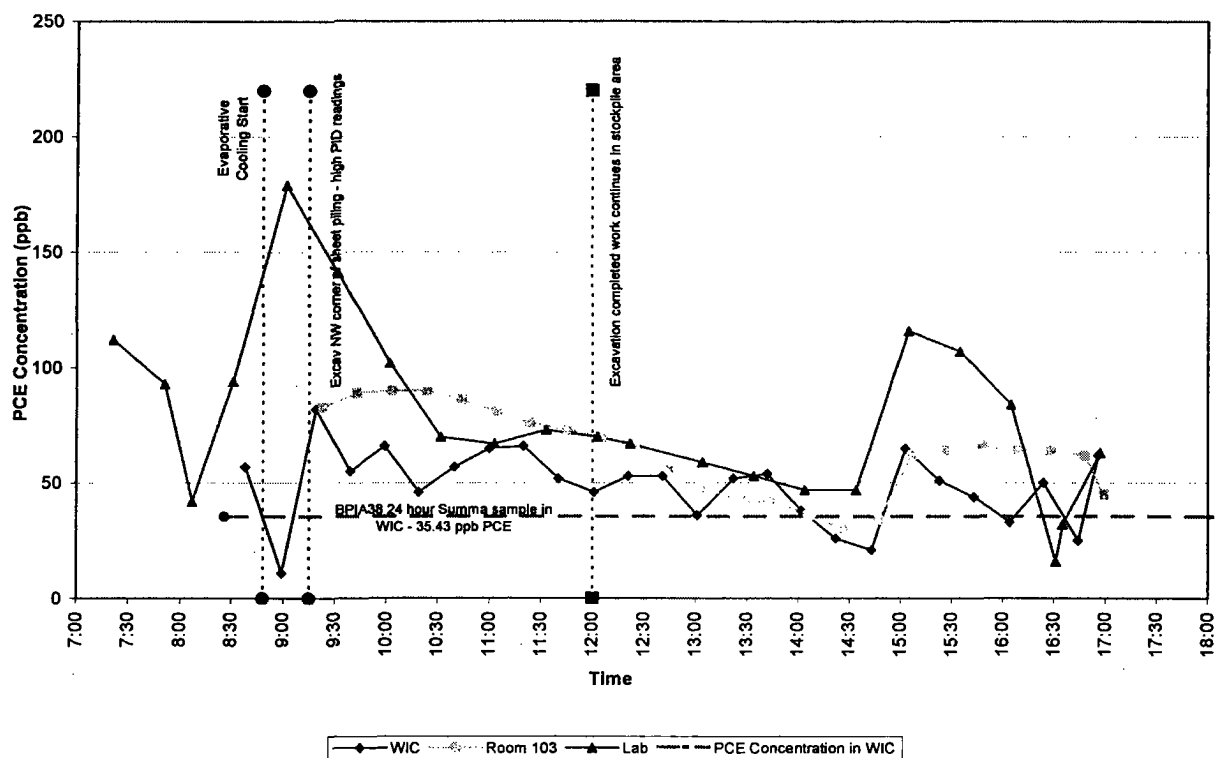
FIGURE C
PCE Concentrations in Building During Central Avenue Excavation
on September 15, 2008

A graph of the indoor air PCE concentrations and the control actions taken on September 15, 2008, is shown below. During the excavation of highly contaminated soil in the sheet piling containment cell, high PCE concentrations were measured with the Voyagers in 711 Central Avenue. The HVAC bypass system was turned on and a rapid decrease in the indoor air PCE concentrations resulted.

concentration was $240 \mu\text{g}/\text{m}^3$ in sample BPIA38, collected on September 15, as shown in Figure C below.

Indoor air samples were collected from inside the 711 Central Avenue building. The sample results are in Appendix A, Table 2. Two samples were collected just prior to the removal, and two were collected during the removal. The samples were collected using Summa canisters, which were submitted to a commercial laboratory for analysis via Method TO-15A. The samples were collected through a regulator over an approximate 24-hour period. The samples were collected on June 19, 2008, August 21, 2008, and September 15, 2008. The highest reported PCE
