## Rosebud Lift Station

### Photo Log

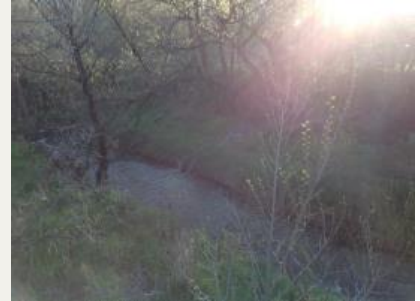
Description: View from the opposite side of Rosebud Creek from the discharge point showing the untreated water flowing over the riverbank and into Rosebud Creek.

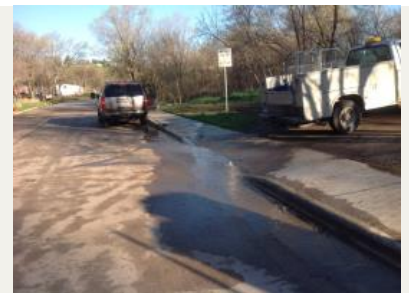
Description: Untreated water from an overflowing manhole.

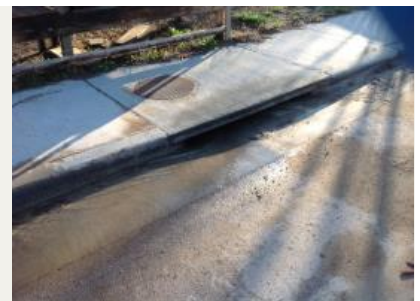
Description: Untreated water from the overflowing manhole running into the storm drain.

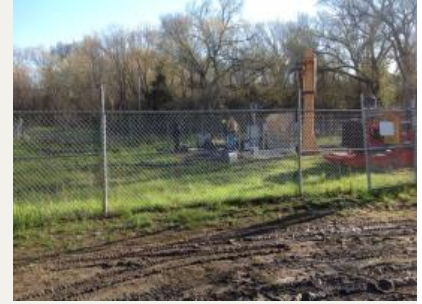
Description: Workers are moving untreated water from the lift station to a discharge point on Rosebud Creek so they can attach a temporary pump to the existing piping of the lift station.

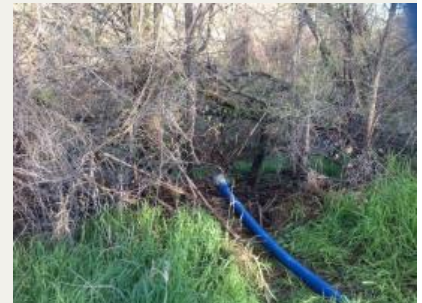
Description: Untreated water discharged from the pipe outlet running down the side slope of the vegetated riverbank and into Rosebud Creek.

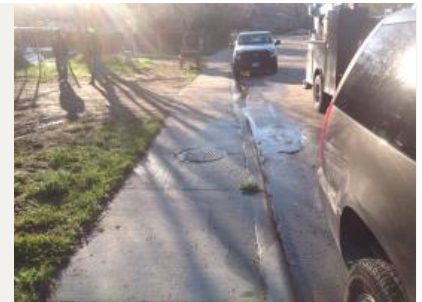
Description: Manhole no longer overflowing sewage due to transfer pump rerouting untreated water to Rosebud Creek.

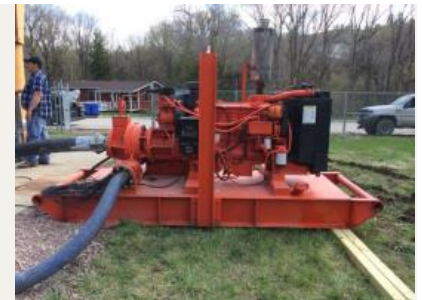
Description: Temporary pump brought in by EPA to bypass the lift station.

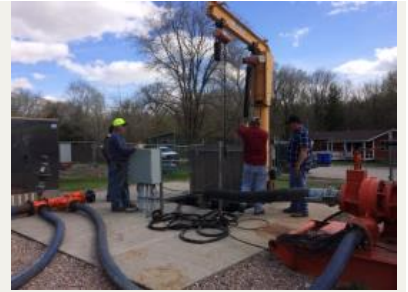
Description: Temporary bypass pump being installed.

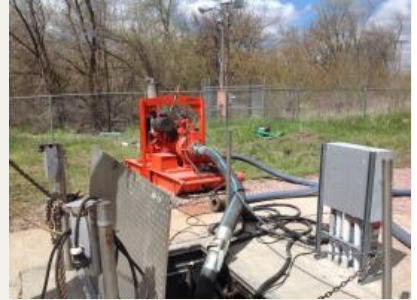
Description: Temporary diesel pump hooked up to bypass the lift station.

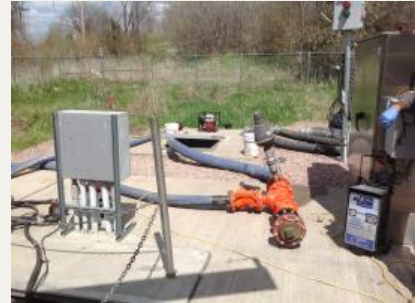
Description: Piping tee that is transferring water from the wet well to the outlet pipe in the dry well which connects to the next lift station.

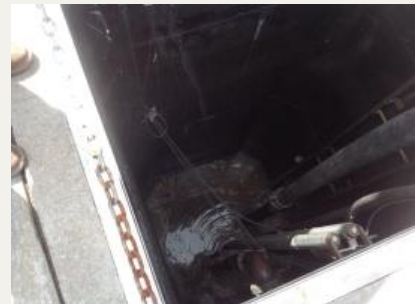
Description: View inside the wet well showing the temporary pump influent pipe and the level float positions required to activate the pump.

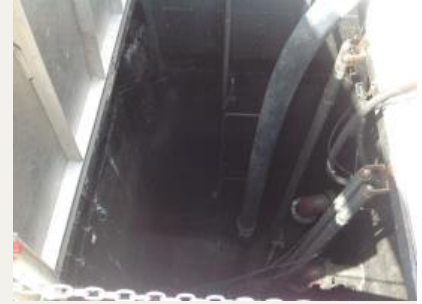
Description: Temporary pump inlet transferring untreated water from the wet well to lift station outlet. The water level can be seen at the bottom of the well after pump shut down due to low water level.

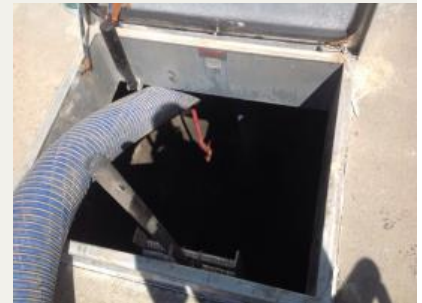
Description: Temporary pump outlet connecting to the lift station outlet in the dry well. The valve for the lift station outlet can be seen as the red bar.
