Re: Big 7 Mine – Draft Letter Report
Neihart, Cascade, Montana
TDD: 1708-01
DCN: W0514.1A.01407
WO#: 20408.012.001.0514.00

**FIGURE 1
SITE LOCATION MAP
BIG 7 MINE
NEIHART, CASCADE COUNTY,
MONTANA**

Photo Log

Project Name: Big 7 Mine	Site Location: Neihart, Cascade County, Montana	Project No. 20408.012.001.0514.00
------------------------------------	---	---

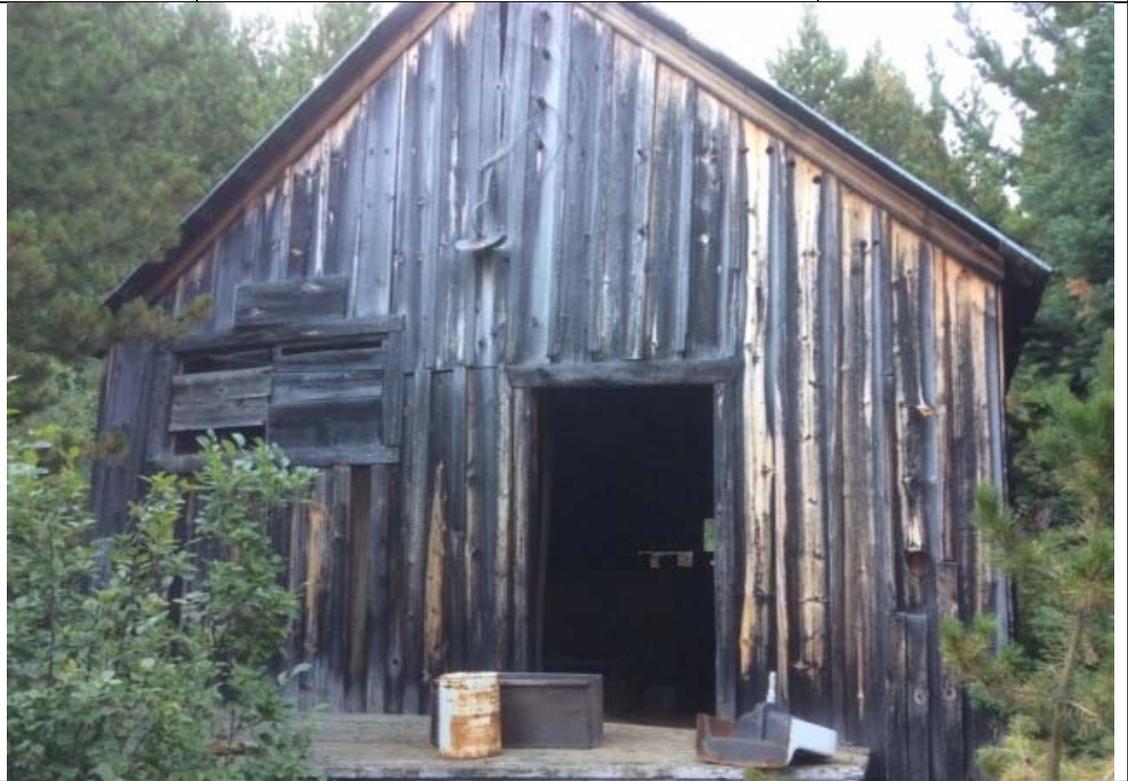
Photo No. 1	Date: 8/17/2017
------------------------------	---------------------------

Description: Lower Maintenance Building

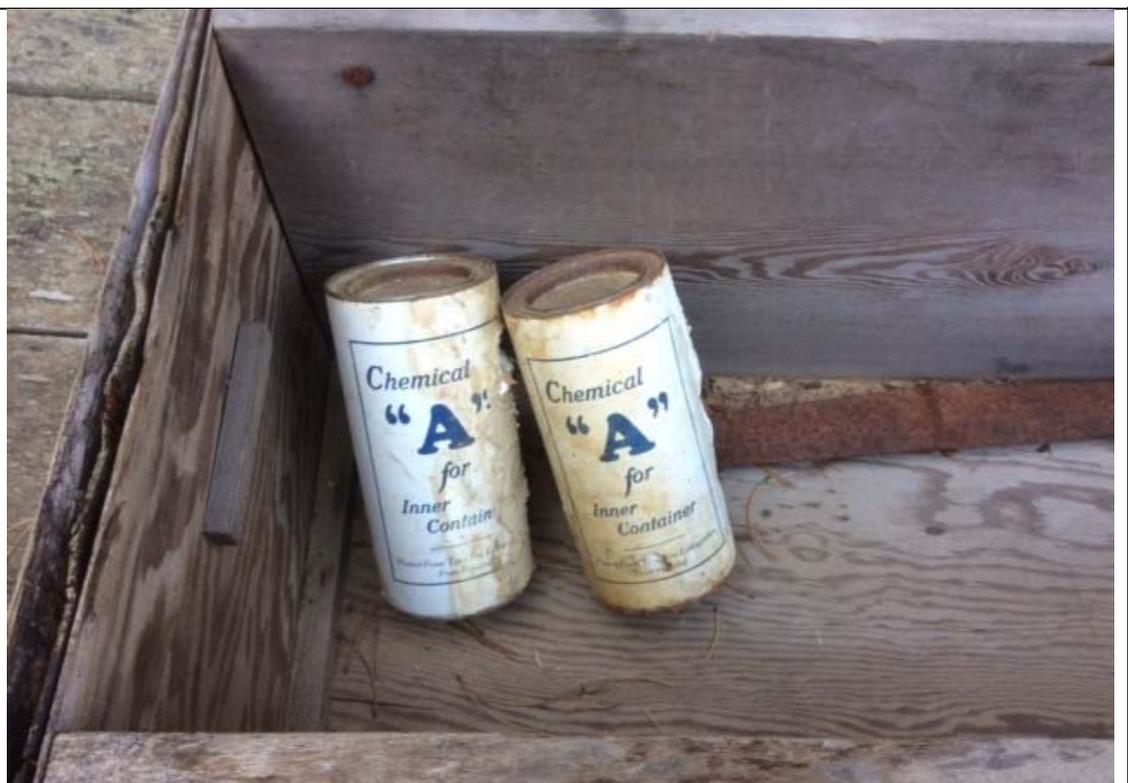
Photo No. 2	Date:
------------------------------	--------------

Description: Chemical "A" used to refill the inner container of a fire extinguisher. Found inside the Lower Maintenance Building.

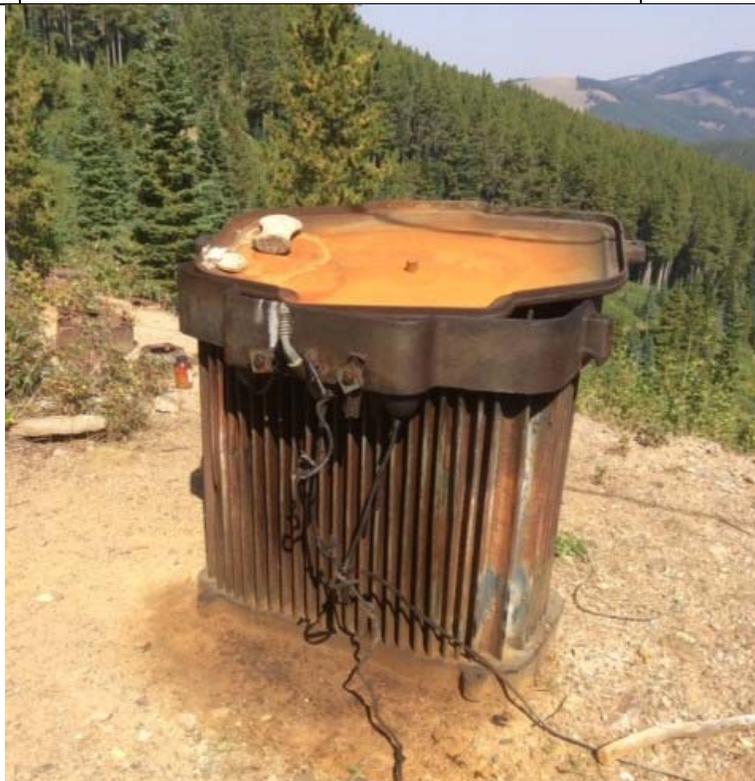
Photo No. 3	Date:
Direction Photo Taken: Northwest	
Description: Transformer #1. Hazclass results indicated water, and no PCB test was run.

The transformer at the big 7 mine appeared to be all water during the hazclass analysis. From what we could sample, it was one phase and was soluble in water, therefore we did not analyze it for pcbs. The transformers outside of the Moulten Yellow Jacket mine have greater than 20 ppm of pcbs, and both of the samples collected from inside the building are negative for pcbs.

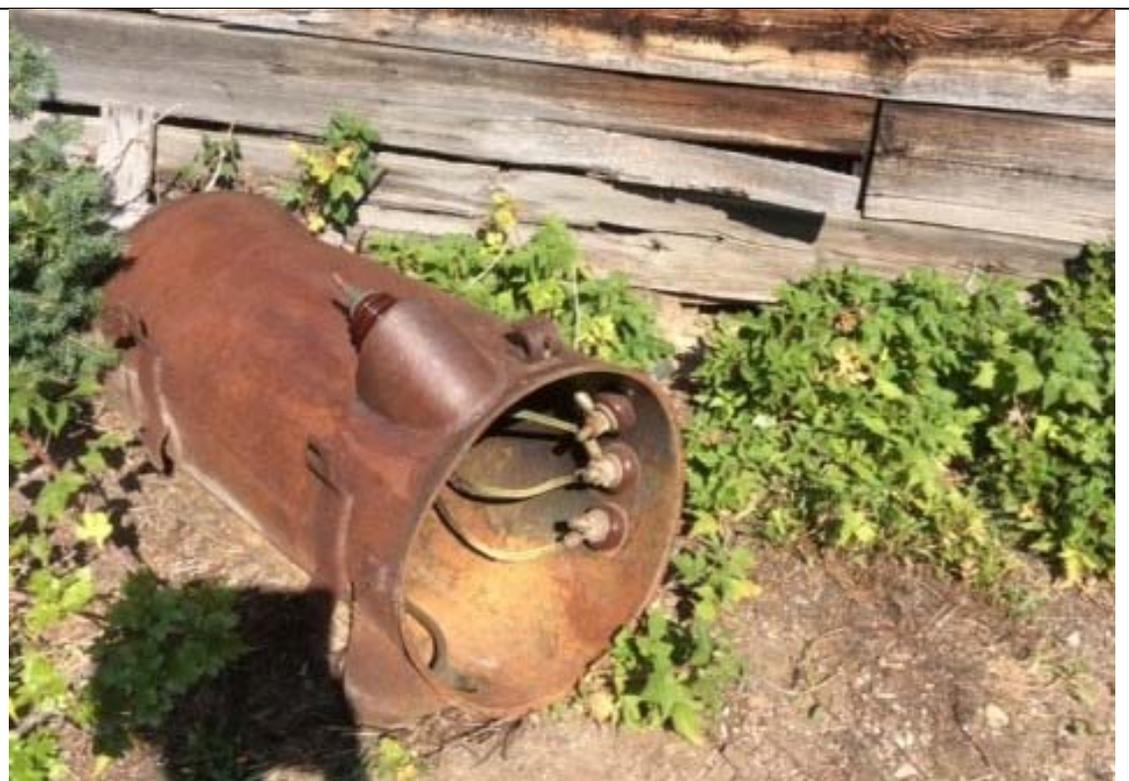
Photo No. 4	Date:
Direction Photo Taken: Down	
Description: Transformer #2. Empty, no oil was tested for PCBs.

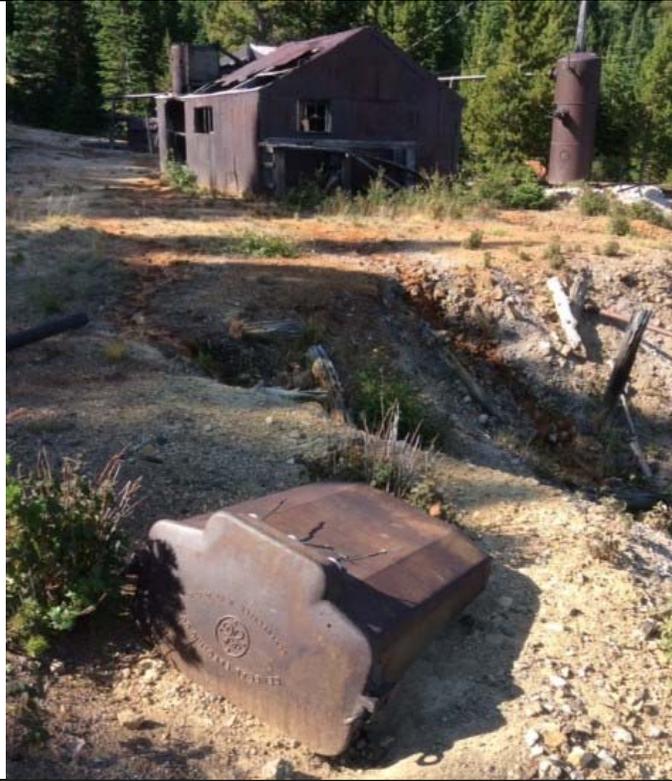
Photo No. 5	Date:
Direction Photo Taken: Southwest	
Description: Transformer #3. Was not sampled due to potential spillage of PCB contaminated oil.

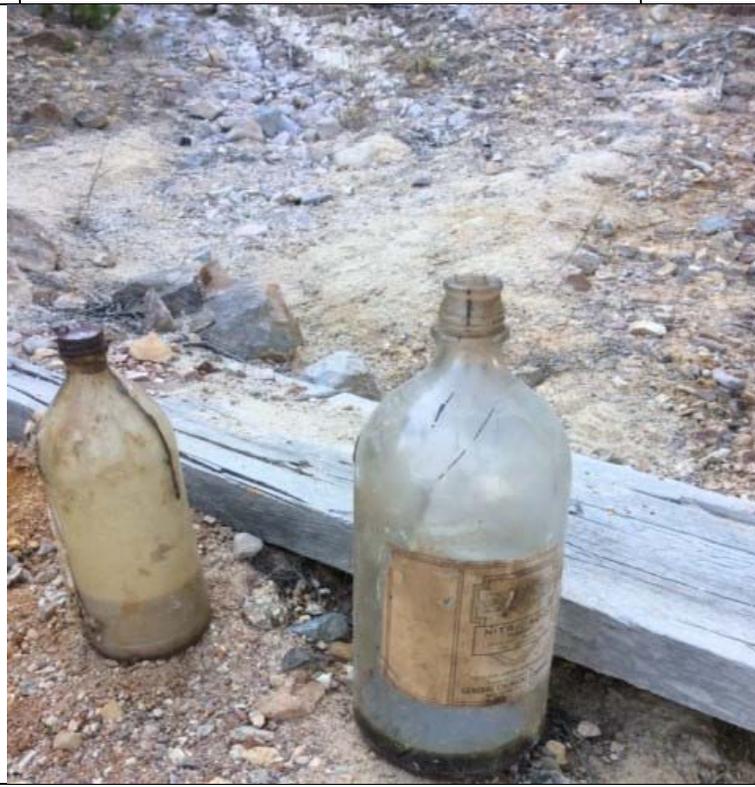
Photo No. 7	Date:
Direction Photo Taken: Down	
Description: Nitric Acid and glue found in the upper core house.

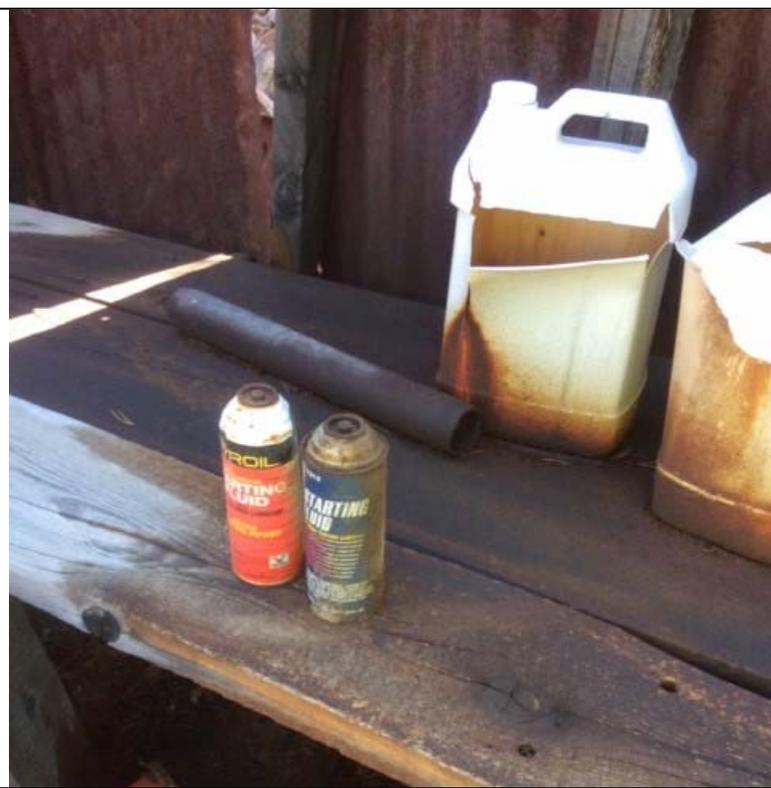
Photo No. 8	Date:
Direction Photo Taken: Down	
Description: Starting fluids found in the guard house. White containers are approximately 1/2 full of rain water.

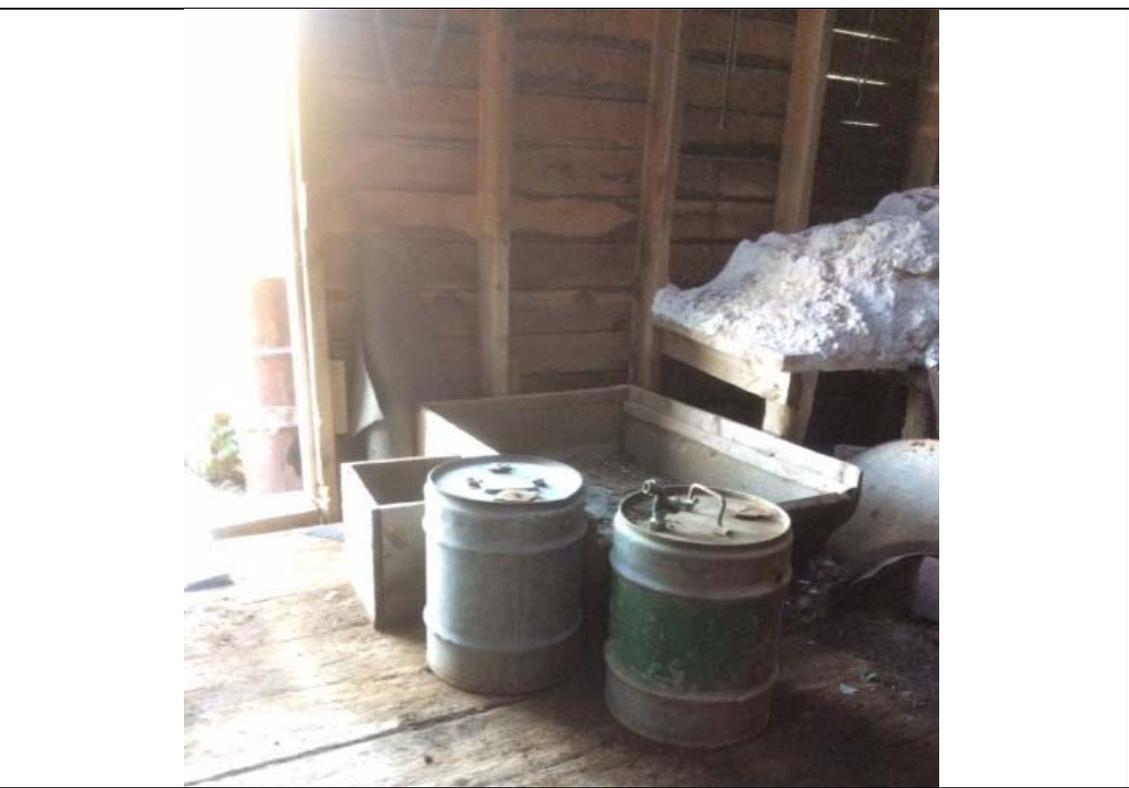
Photo No. 10	Date:
Direction Photo Taken: Northeast	
Description: Two carboys found within the Mill.

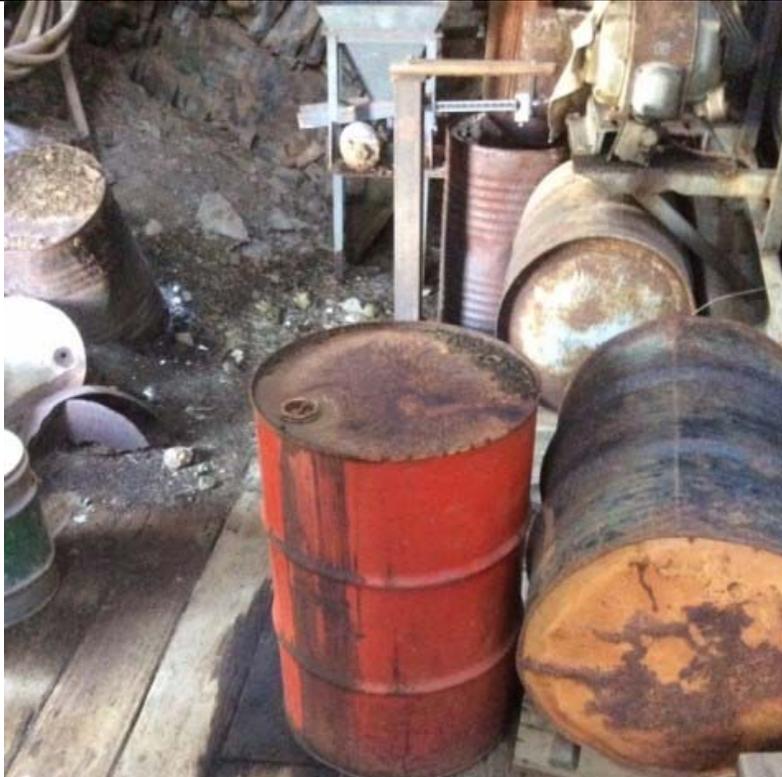
Photo No. 11	Date:
Direction Photo Taken: Down

55 gallon drums found within the Mill. Only the red drum contained any materials.

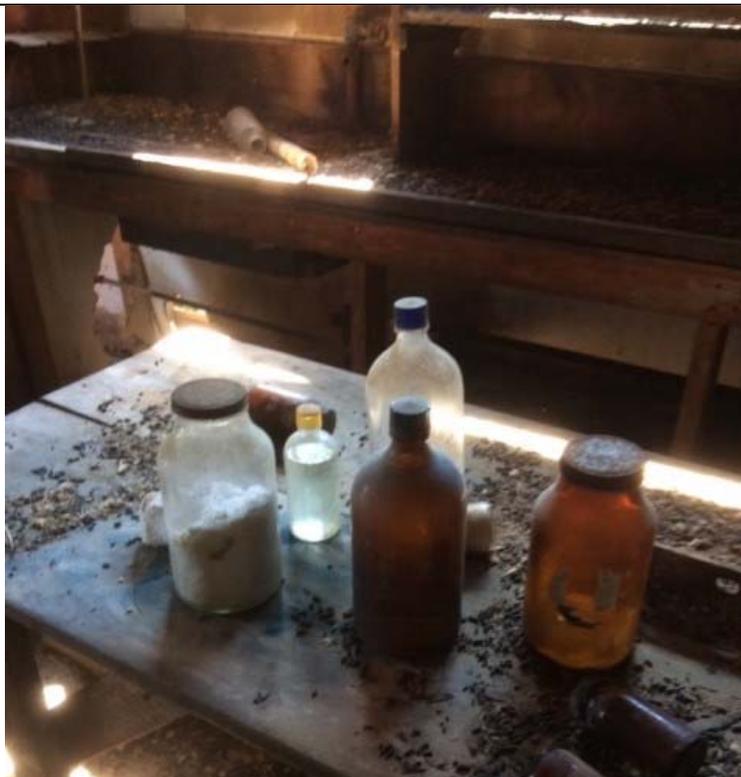
Photo No. 14	Date:
Direction Photo Taken: Down	
Description: Inside the Assay labs main room. Various unknown chemicals on a lab bench.

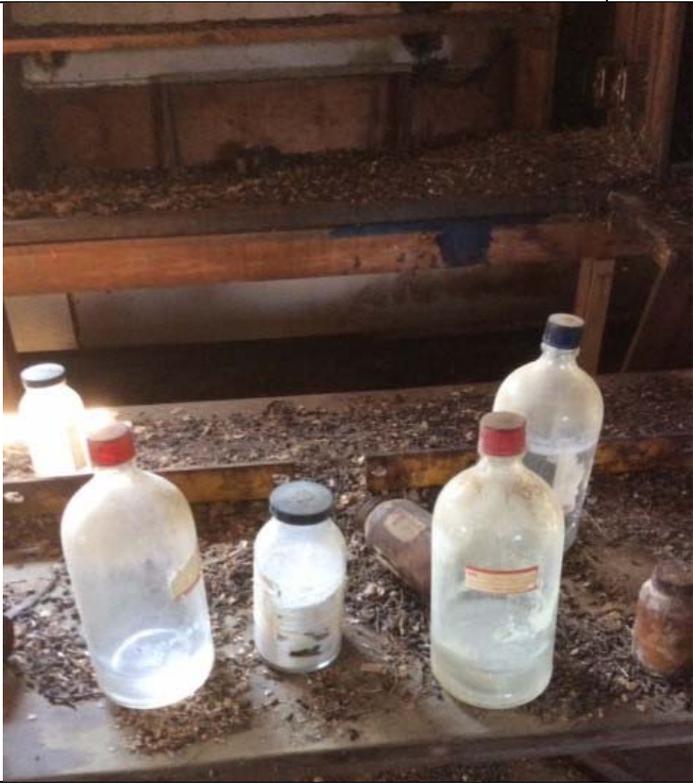
Photo No. 15	Date:

Direction Photo Taken: Down		
Description: Inside the Assay labs main room. Various unknown chemicals on a lab bench.

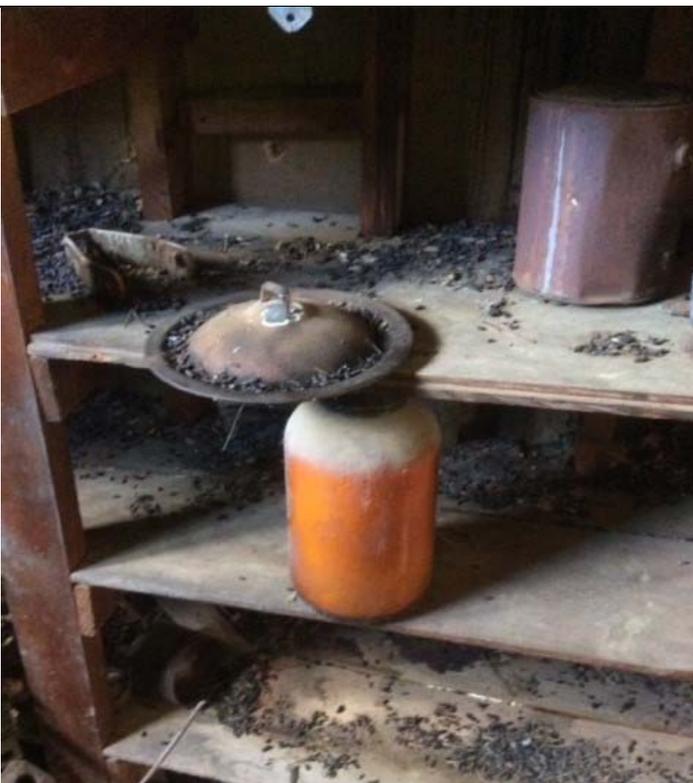
Photo No. 16	Date:

Direction Photo Taken: Down		
Description: Inside the Assay lab storage closet. Various unknown chemicals on the shelf.

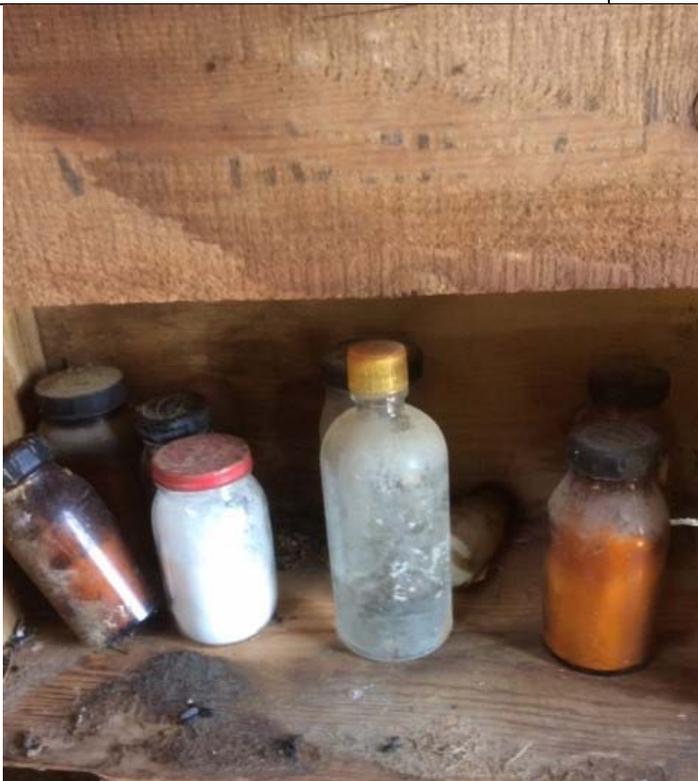
Photo No. 17	Date:

Direction Photo Taken: Down		
Description: Inside the Assay labs front room. Various unknown chemicals in a crate on ground.

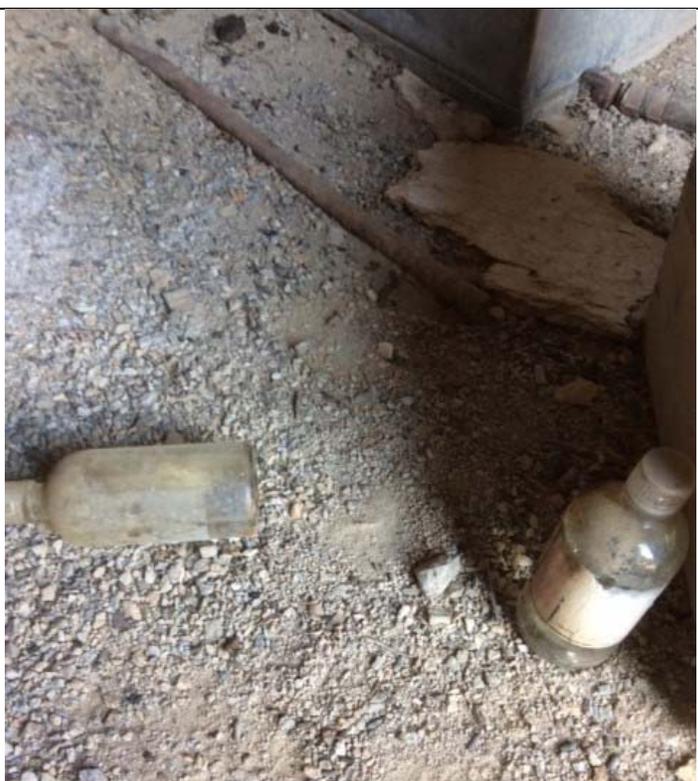
Photo No. 18	Date:

Direction Photo Taken: Down		
Description: Inside the Assay labs front room. Various unknown chemicals on the ground.

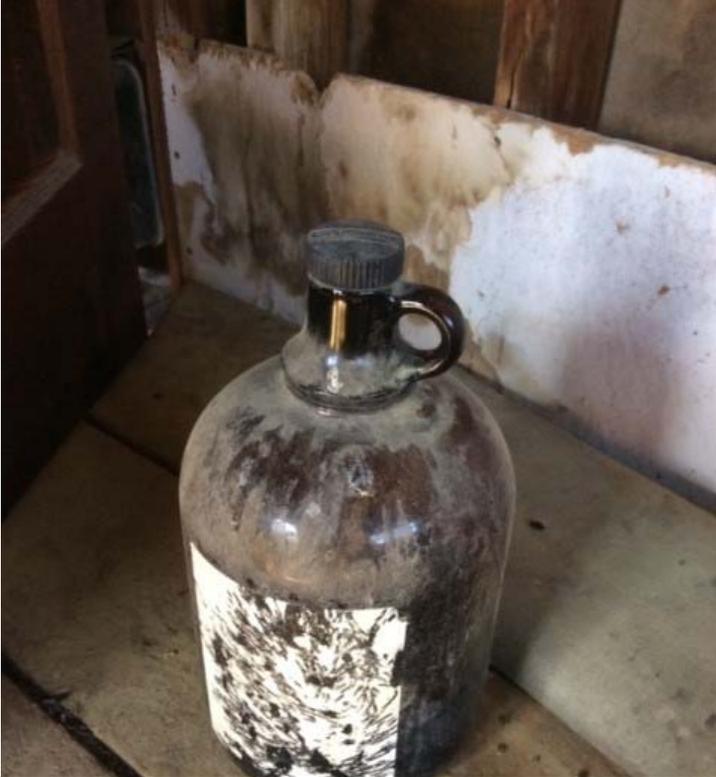
Photo No. 19	Date:

Direction Photo Taken: Down		
Description: Inside the Assay labs front room. Unknown chemical on a work bench.

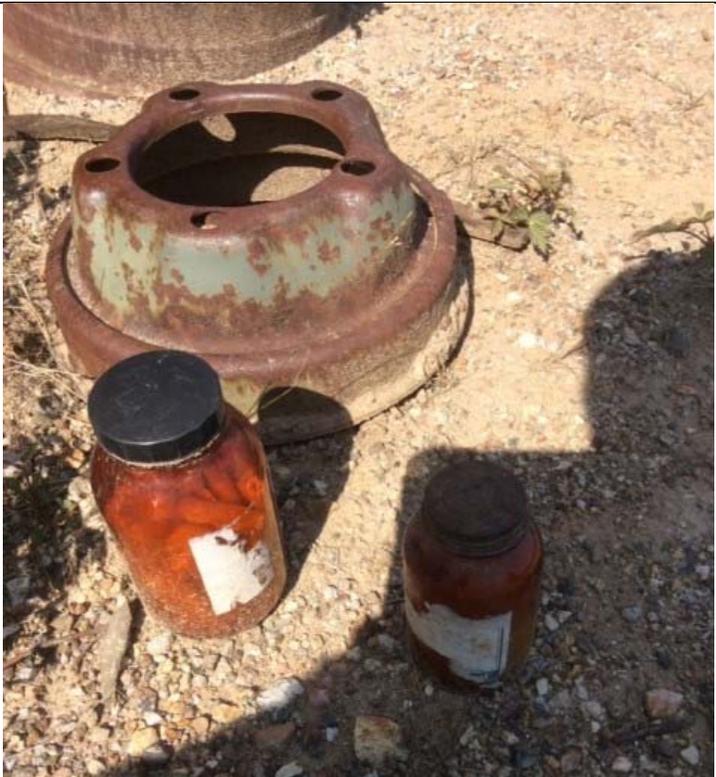
Photo No. 20	Date:

Direction Photo Taken: Down		
Description: Outside the Assay labs front room. Various unknown chemicals on the ground.

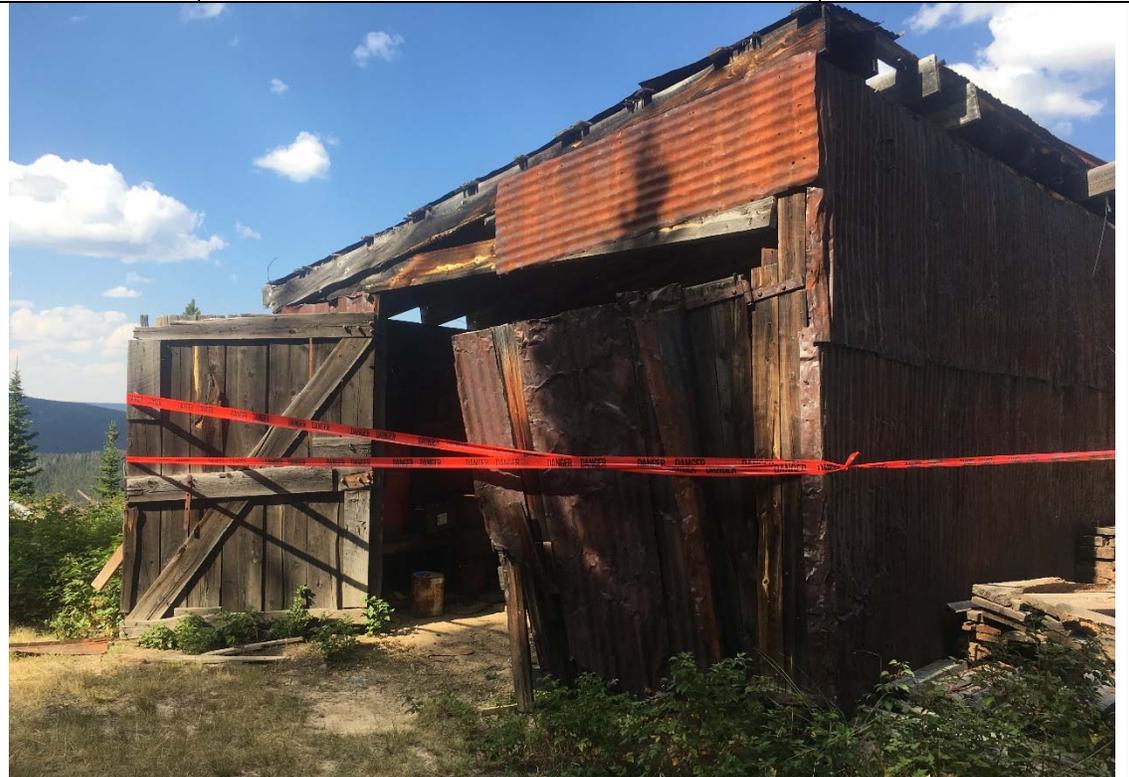
Photo No. 21	Date:
Direction Photo Taken: North	
Description: "Danger" tape around the Assay lab. Showing site conditions when EPA, START and ERRS departs the site.

Prior to departing the site, the assay lab was wrapped in “Danger” tape, and START collected samples from one transformer. START also collected samples from one transformer and two pieces of machinery located at Moulten Yellow Jacket (MYJ) mine. The Moulten Yellow Jacket mine is located approximately 4 miles from the Big 7 mine, and 1 mile from Niehart, Cascade County, Montana. Oil samples were transported back to Denver, and run for PCBs using Chlor-N-Oil tests. Below are the results of the Chlor-N-Oil tests.

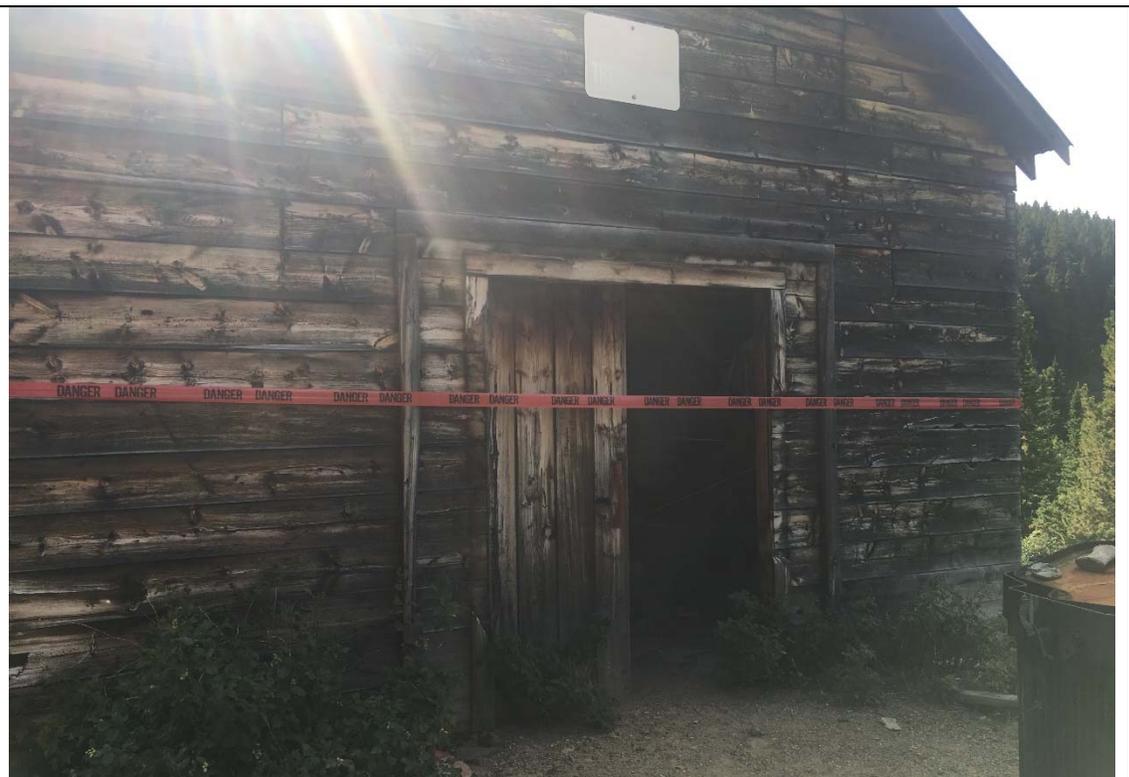
Photo No. 22	Date:
Direction Photo Taken: Southwest	
Description: "Danger" tape around the Assay lab. Showing site conditions when EPA, START and ERRS departs the site.

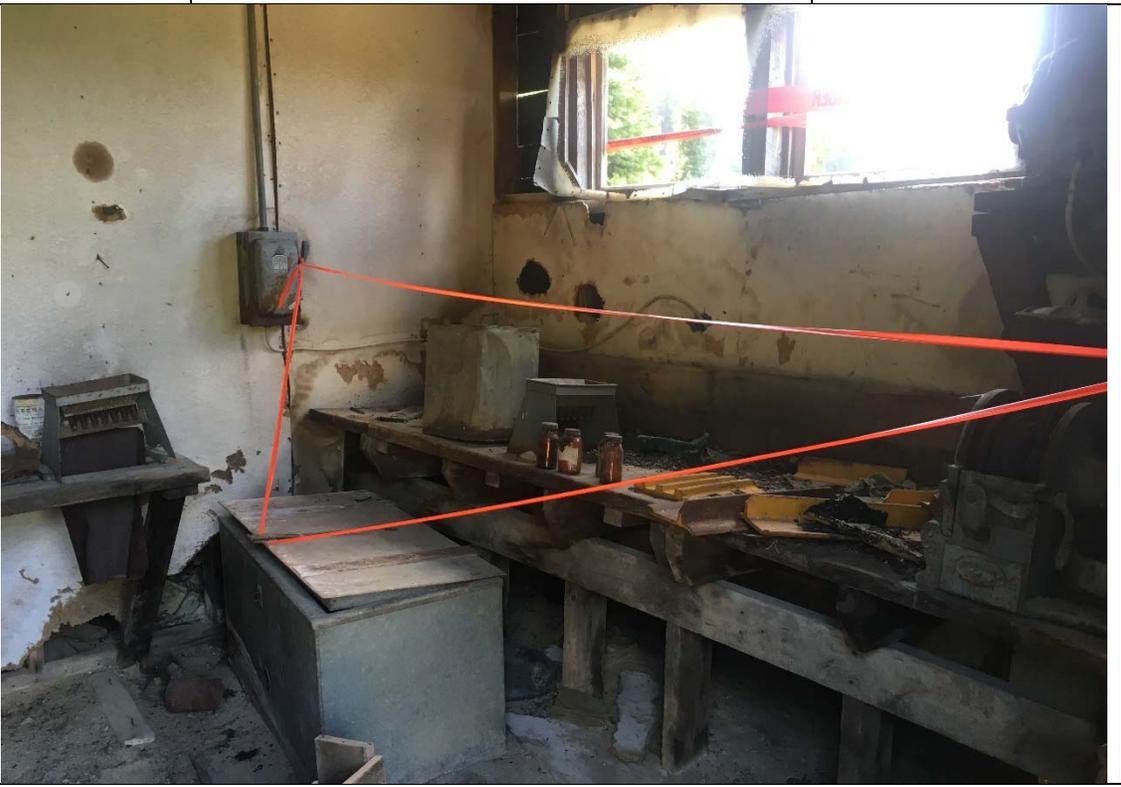
Photo No. 23	Date:
Direction Photo Taken:	
Description: "Danger" tape inside the Assay lab, and around the potentially explosive materials. Showing site conditions when EPA, START and ERRS departs the site.

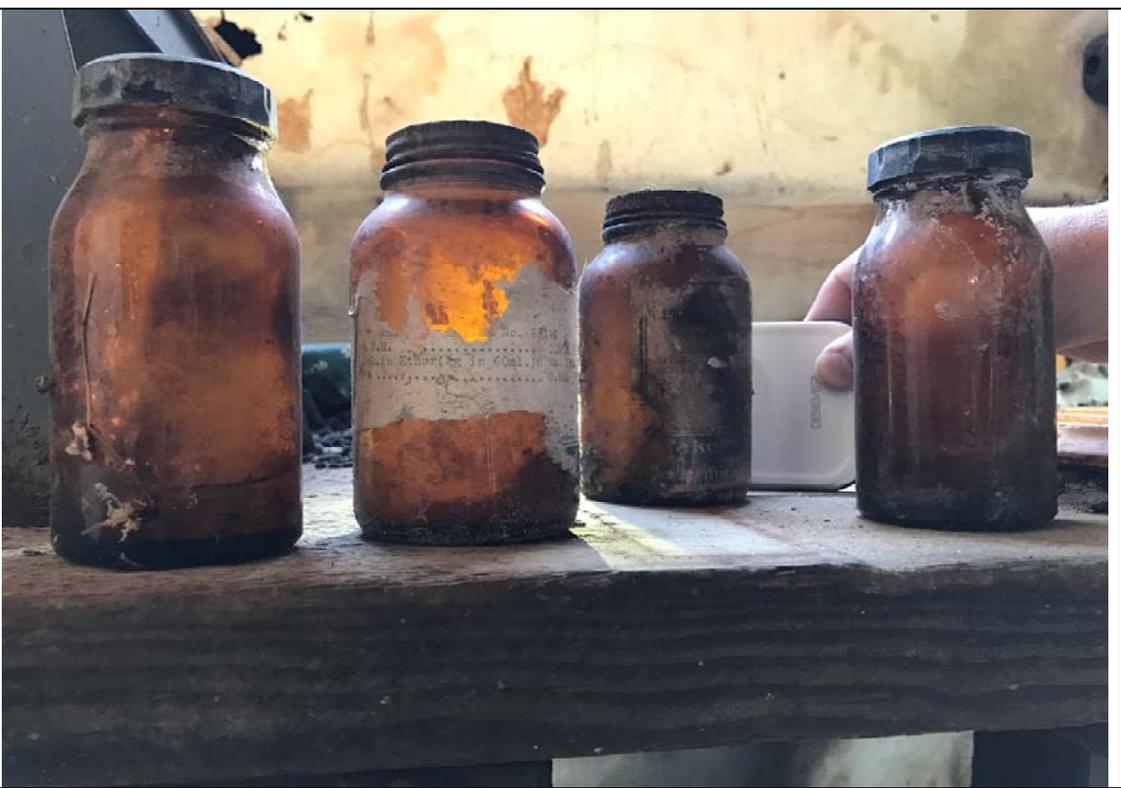
START sampled 43 unknown chemical containers in level B PPE. Four containers that were not sampled were deemed unsafe to open by START due to crystallization of the contents, or partial labels indicating the potential presence of reactive material. START sampled one of two containers of fire retardant “Chemical A”, used to recharge fire extinguishers that were found in their original containers. The table below shows the hazardous results of the 43 samples that were HazClassed by START. All results can be found in Attachment D.

Photo No. 24	Date:
Direction Photo Taken: Northwest	
Description: Potentially explosive materials. Two ~ 250 mL "Sol. In Ether" bottles. Two ~ 250 mL bottles of unknowns containing large crystals in and around the threads on the bottles.

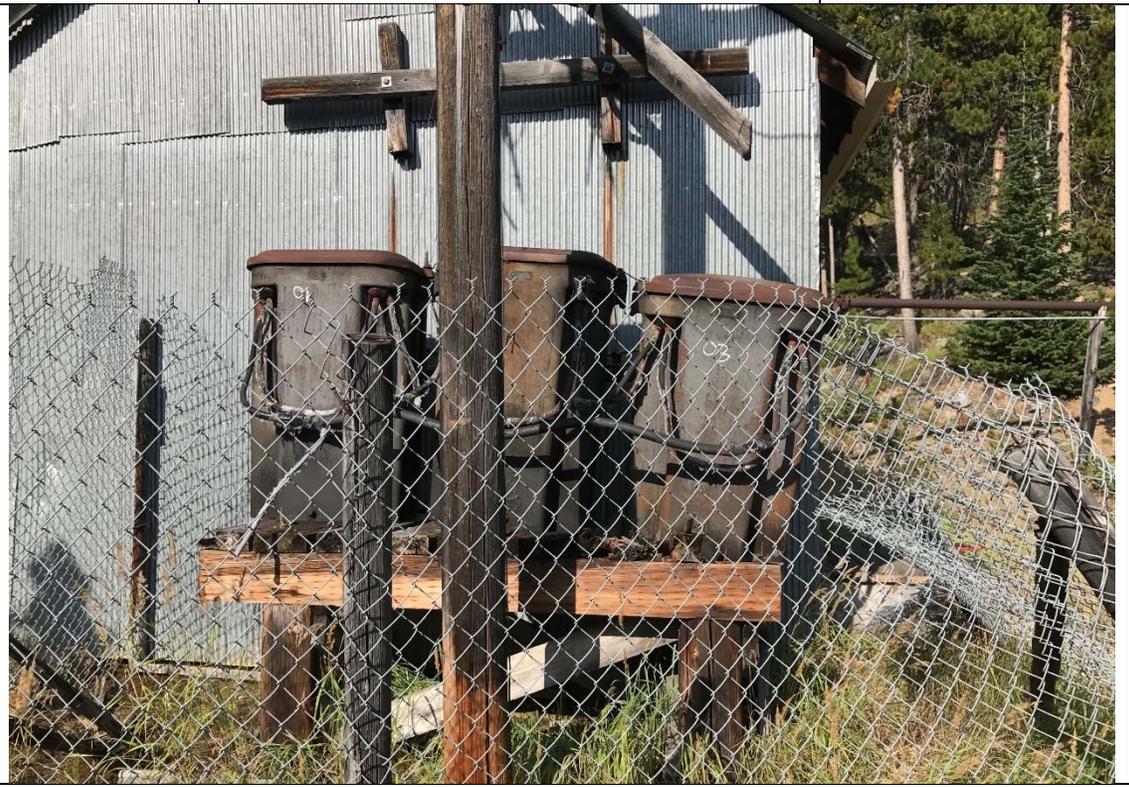
MYJ Transformer	MYJ Machine 1	MYJ Machine 2
Result	>20 ppm	<20 ppm	<20 ppm

Photo No. 25	Date:
Direction Photo Taken: Northeast	
Description: Three transformers located on the outside of a machine room at the Moulten Yellow Jacket Mine. Chlor-N-Oil test from Transformer #1 (far left) confirms PCBs above 20 ppm.

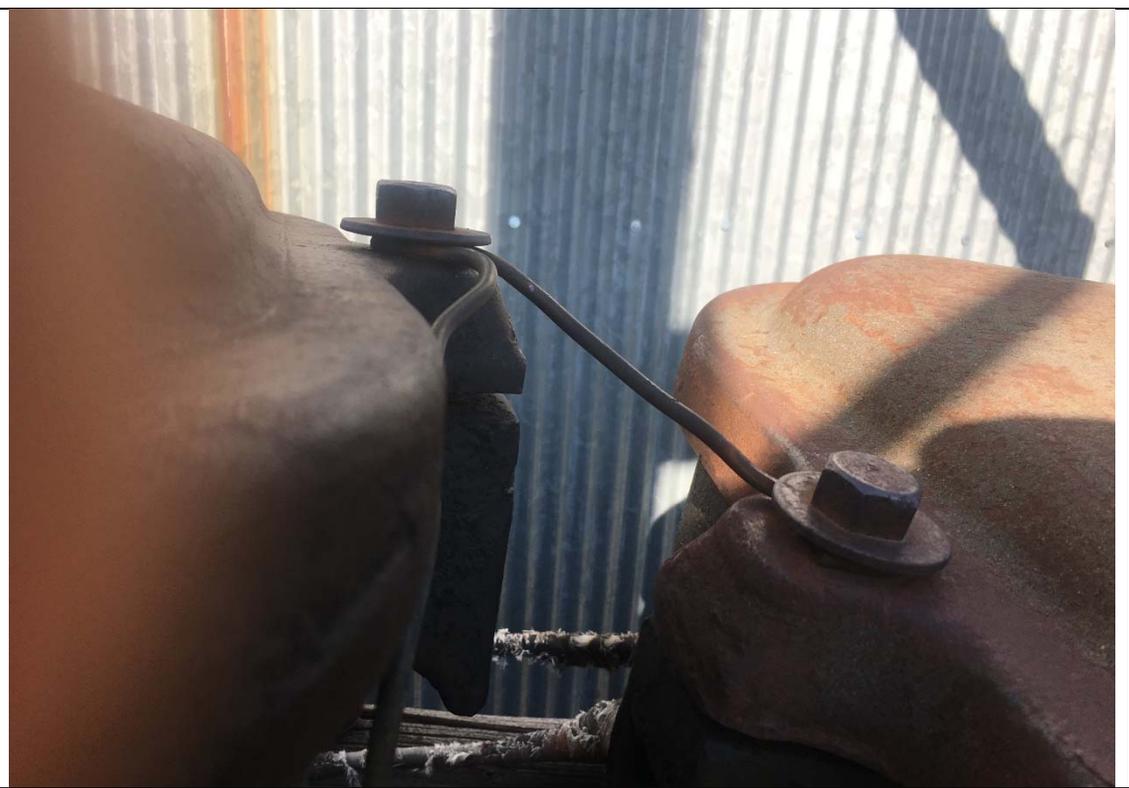
Photo No. 26	Date:
Direction Photo Taken: Northeast	
Description: Copper grounding wire holding up transformer #3. Transformer #2 is on the left of the photo, Transformer #3 is on the right.

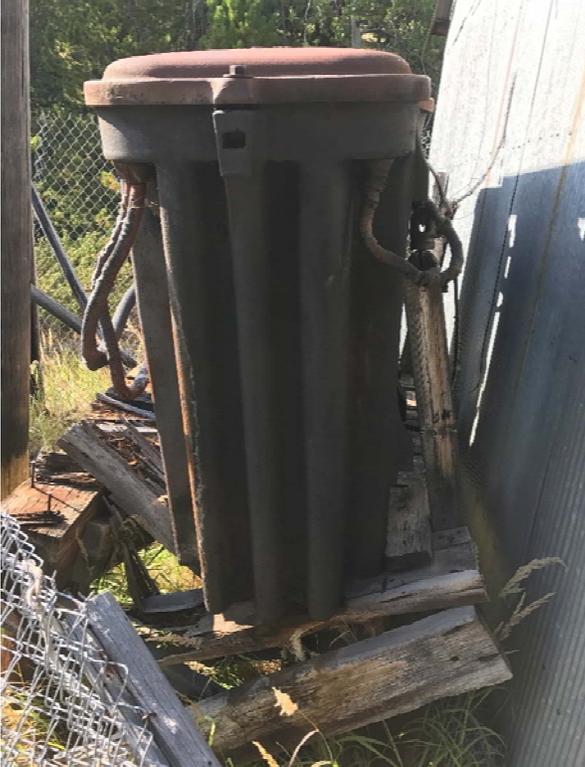
Photo No. 27	Date:

Direction Photo Taken: Northwest		
Description: Transformer #3 located on the outside of a machine room at the Moulten Yellow Jacket Mine. Cribbing under transformer is completely rotten. The transformer is held in place by a copper grounding wire attached to transformer #2.
