Snake River Watershed Plan

Pennsylvania Mine, Peru Creek

March, 2009

May, 2013 update

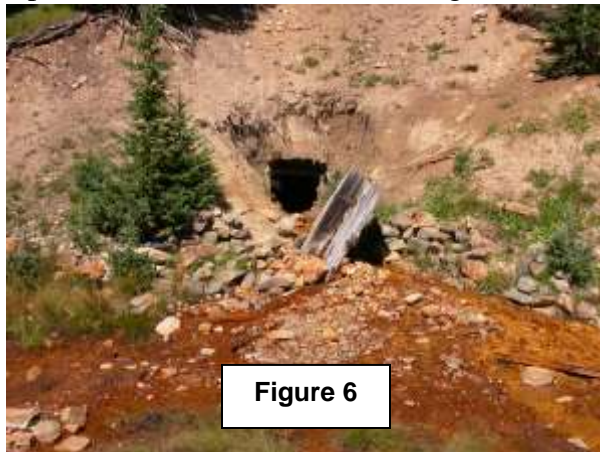
The next problem in the basin is an old mine. The name of the mine is in question, but has been referred to by the team working in the area as the Blanche Mine. It is located up an old road that takes off just before the Webster Pass road crosses the Snake River at the northern end of the upper Snake River valley and wetlands. The mine has a leaking adit which flow year round. During the summer much of the flow is down the road, reaching the Snake River in 2007. The remainder of the flow is across the parking area and down waste rock. In high flow periods, there is evidence of the flow going down the waste rock in several places. This mine, because of its access and the large flat, “parking area” around the mine will be a relatively easy clean up project. The waste rock can be easily pulled back to the natural slope and covered and revegetated. The flow from the adit needs to be directed to a passive treatment sulfate reducing bioreactor. There is room for such a facility below the

adit and waste rock. Figure 6 shows this mine site. Figure 7 shows the portion of the flow that goes over the waste rock.

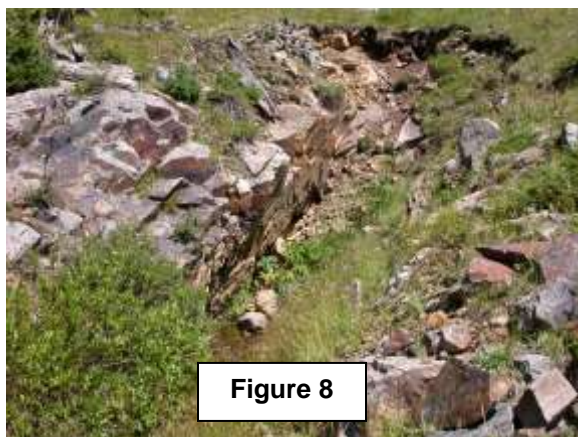
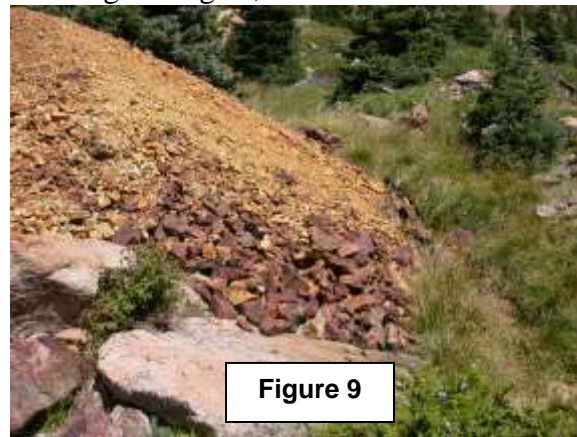
As the Snake River leaves the upper valley and heads downstream, there are two tributaries that flow into the Snake on the eastern side. These are not shown on the USGS Montezuma, CO topo map (1958), but are roughly below the Climax Mine, which is shown on the map. Also shown on the map are a number of old mine sites. Each of these sites has waste rock associated with it. At least one was flowing in August, 2007 and at least one has

flow in contact with waste rock. Figures 8 and 9 show adit flow and waste rock contact.

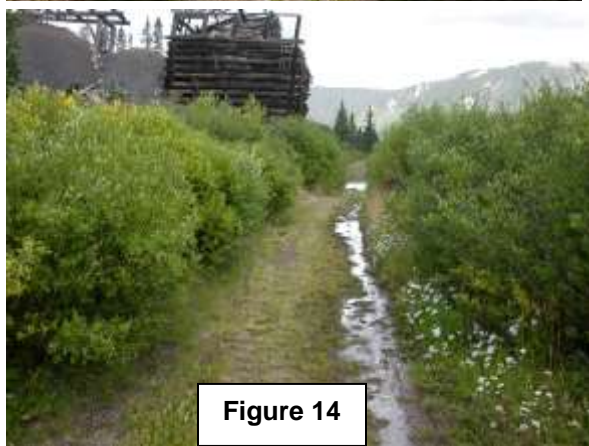
Figure 14

This mine north of the Burke-Martin Mine is shown in figure 14. The drainage shown is not from the mine, but from a seep in the mine area.

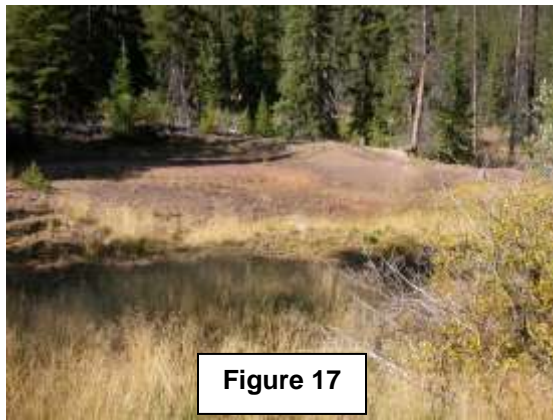
Figure 17 shows the lower end of this contaminated wetlands area. Figure 18 is flow from the contaminated area. This area is actively contaminating the Snake River.

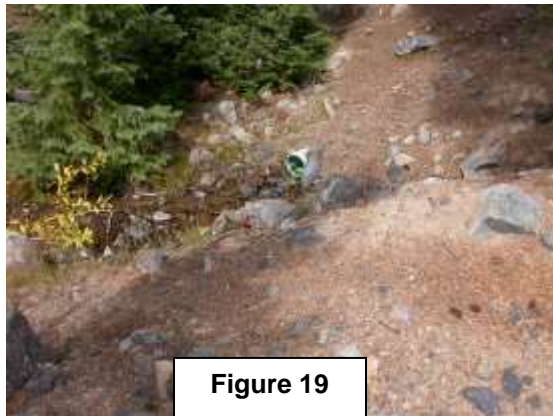
On the eastern side of the Snake River, in Montezuma and high on the hills above Montezuma are several other problem areas. At the south end of Montezuma is the New York Mine. This has been closed and waste rock scattered over a fairly large flat area. The adit is draining and a pipe was set up to get the flow off of the waste rock. The adit flow goes down the side of an access road to the main Montezuma road, then down the ditch to a culvert and to the Snake River. Figure 19 shows this draining adit and Figure 20 shows the flow down the access road to the main road.

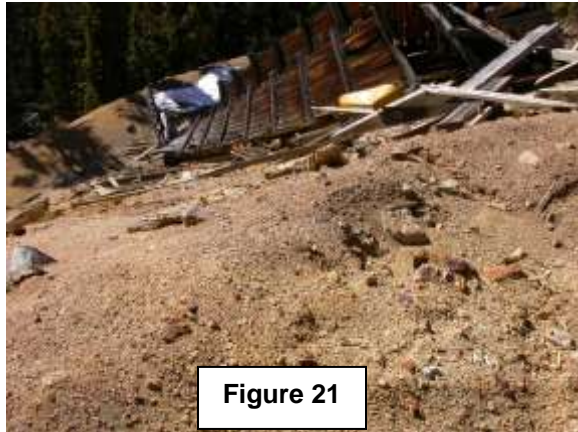
Figure 21 shows one of the upper mines waste rock. Figure 22 shows the adit flow from the mine north of the Morgan Mine. Figures 23 and 24 show the closed Morgan Mine and the waste rock pile associated with it.

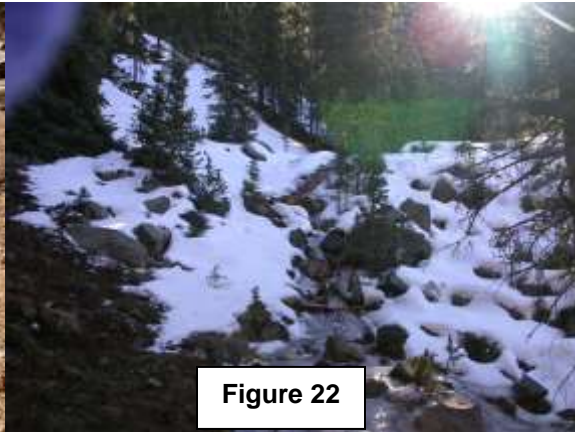
Figure 22

Below the Morgan Mine, to the north, is another mine with a significantly draining adit. This mine has significant disturbance around it. There is room for a passive treatment system of the adit flow and to consolidate waste rock. There are seeps in the area and field measurements suggested their water quality to be low. This is an area where water quality improvements are possible.

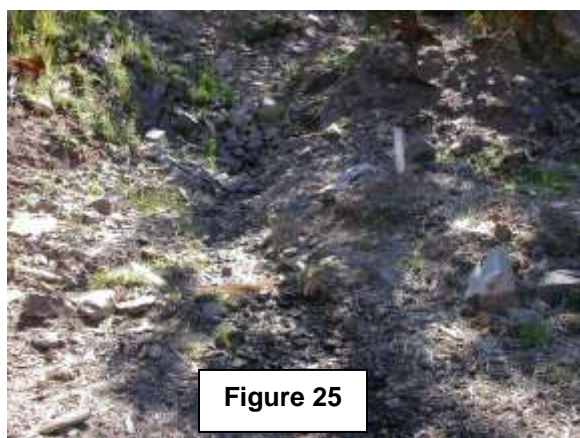
On the east side of the basin are a number of old mines. The state has closed several adits from these mines. Most are dry, especially the higher ones, but some still have small flows from the old adits, even when closed. There is considerable waste rock, including some that is eroding. However, most of the mines on the east side are high enough, that waste rock flow is still, like most flow, seeping into the ground on benches and actually flowing into the creek via seeps and wetlands flow near the actual stream. Figure 25 shows an adit still flowing some after closure and Figure 26 shows some of the waste rock high on

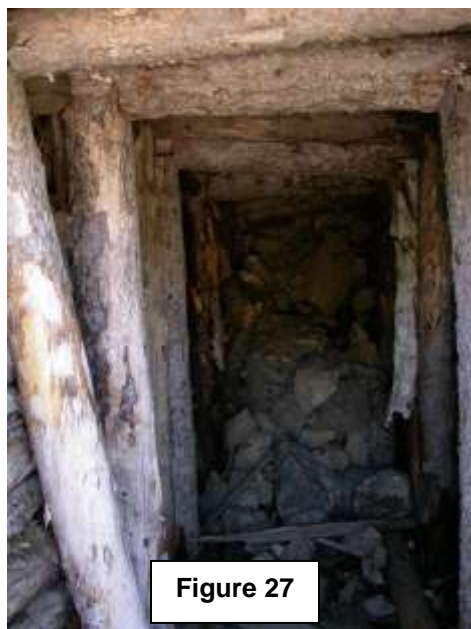
Still on the eastern side, but further south is the Upper and Lower Radical Mines. These are below an upper lake on a small bench. What flow there is from this lake is toward these mines. These are dry and so isolated that it is difficult to see how much can be done to lessen their impact on water quality. Figure 27 shows the old adit and Figure 28 some of the waste rock.

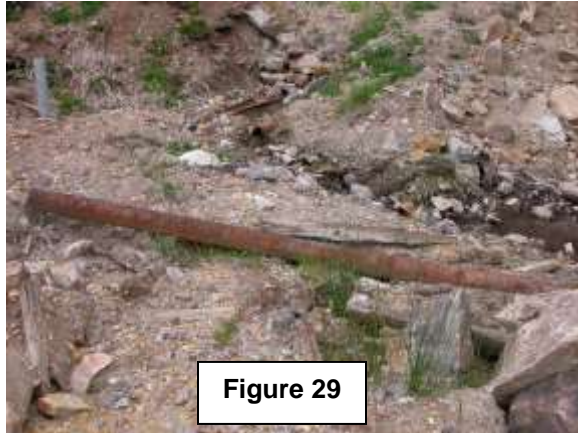
On the western side of the basin is the Upper and Lower Chatauqua Mines. Both have significant waste rock piles that are eroding. The Lower Chatauqua Mine has a draining adit that has water flowing over waste rock. Both are relatively easily accessible and moving waste rock from flow areas is possible. Figure 29 shows the Lower Chatauqua Mine adit flow. Figure 30 shows the eroding waste rock at the Upper Chatauqua Mine.

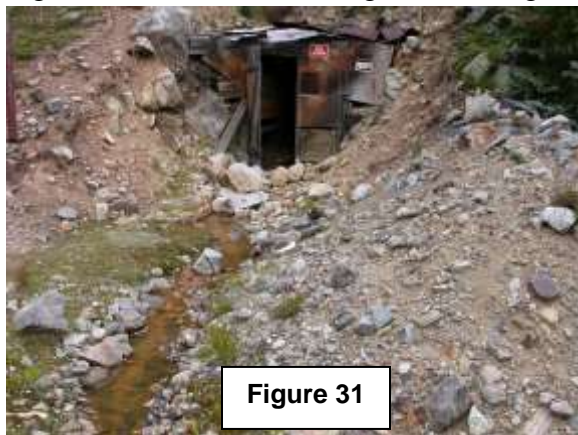
About one quarter mile from the confluence there is another draining adit. This adit is on private property and some efforts have been made to keep the flow on the property. The efforts are somewhat successful late in the season. However, flow from the adit goes directly into the stream in the early summer runoff season. Just down the road from this mine is another draining adit that flows directly out from the bottom of a waste rock pile. Flow is then down the west side drainage ditch of the road and directly into the Snake River. Figure 31 shows the draining adit and Figure 32 shows the flow from the bottom of the waste

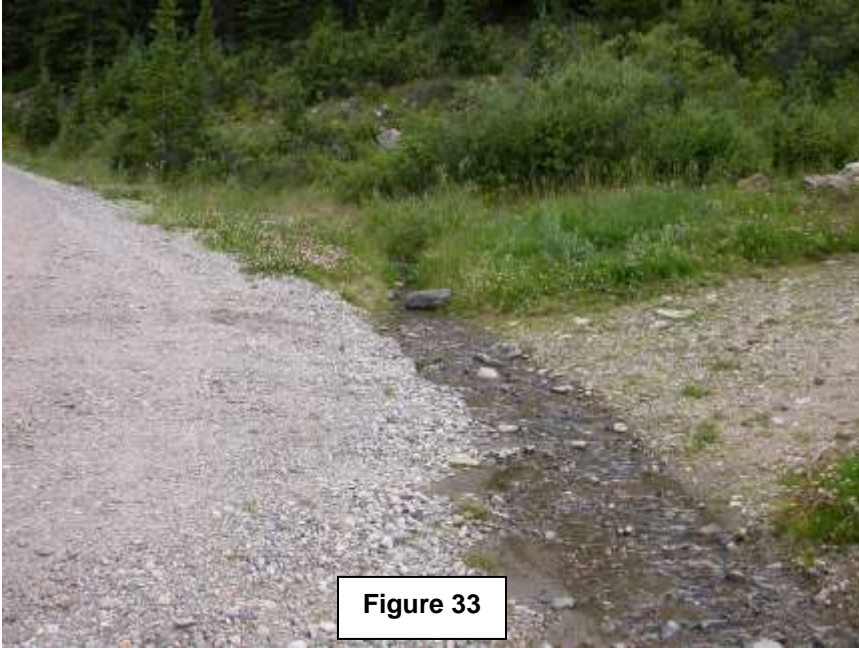
rock pile. The flow in Figure 32 was significant in both 2007 and 2008. Figure 33 shows the flow just before it enters the Snake River as it crosses the road to the Superior Mine complex.

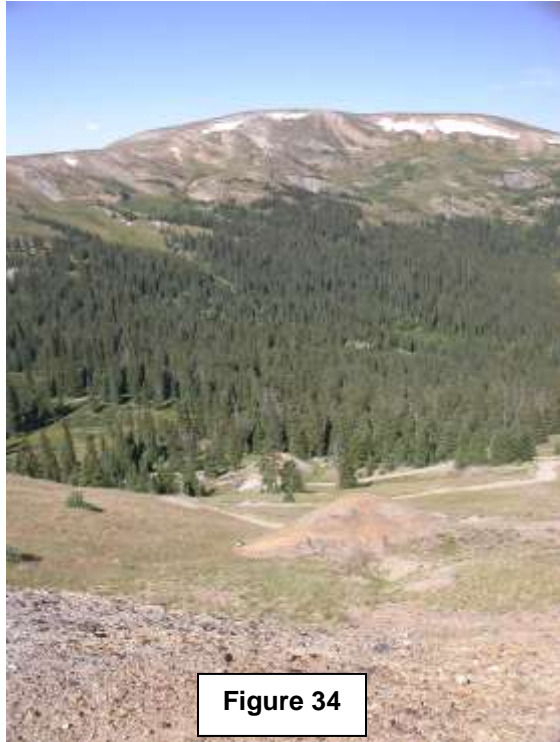
There are a number of old mines with significant waste rock in the upper eastern reaches of Sts. John Creek. The adits are all dry and the waste rock erosion small. Lower, the Wild Irishman mine has a draining adit and significant waste rock. The flow from the adit is along the north side of the waste rock. Figure 34 shows the lower half of the upper waste piles and Figure 35 shows the Wild Irishman Mine adit flow. In figure 34 the Wild Irishman Mine is the lowest waste pile shown. Figure 36 shows the flow of the adit on the north side of the waste rock pile.

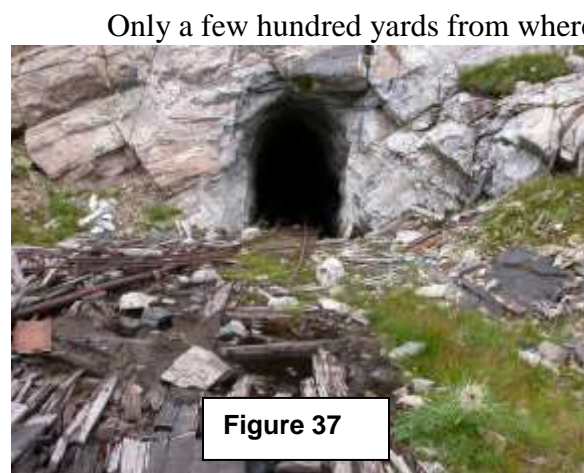
owned and a cabin of sorts has been built below the mine area. This mine is actually just north of the Wild Irishman Mine in a sub-drainage that starts only a few hundred yards north of the Wild Irishman Mine. Figure 37 shows this draining adit. There is considerable waste rock in the area. Flow is across the waste rock and then down to an eastern tributary.

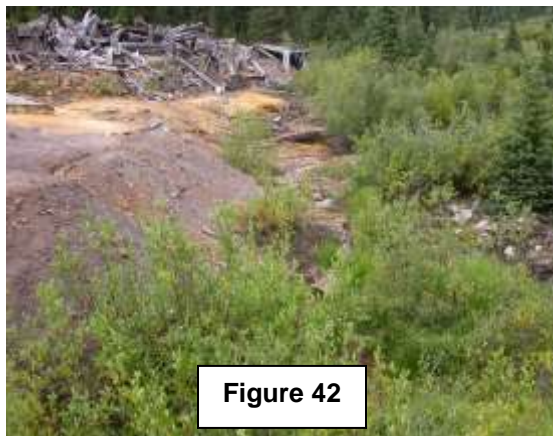
Figure 42 shows the seepage from the stream. This seepage goes on into an area of considerable tailings and eroded waste rock. This is shown in Figure 43.

The Colorado Department of Reclamation Mining and Safety (CDRMS) is in the middle of a project to make significant impacts at the Sts. John site. The water seeping from the stream into disturbed areas is being collected in a large french drain and prevented from seeping into disturbed areas. The tailings are being collected and removed to a dry area on site consolidating all of the tailings into a single area. The wetlands area where much of the tailings resided prior to removal is being restored to a functioning wetland without tailings. Figure 38 shows the Sts. John Mine adit. Flow splits, with the majority going north and the rest heading across waste rock to the south. Figure 39 shows the north flow and Figure 40 shows the south flow. Figure 41 shows the north flow near its confluence with Sts. John Creek in August, 2007. The remediation work provides a better course for the adit flow.

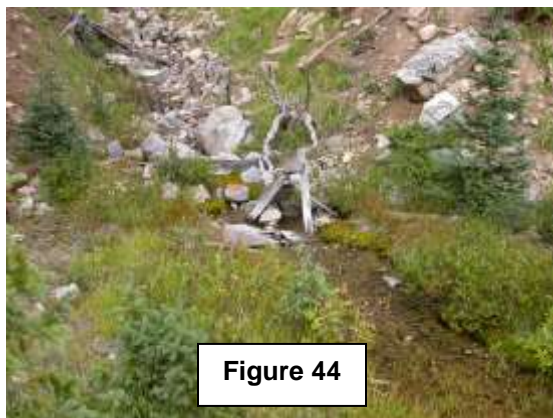
Not far below the Sts. John Mine, the creek enters a wide meadow. On the west side of the meadow is the Marlin Mine, with a draining adit and eroding waste rock. In the meadow, the creek meanders through significant tailings. Figure 44 shows the Marlin Mine and figure 45 shows some of the tailings in the meadow.

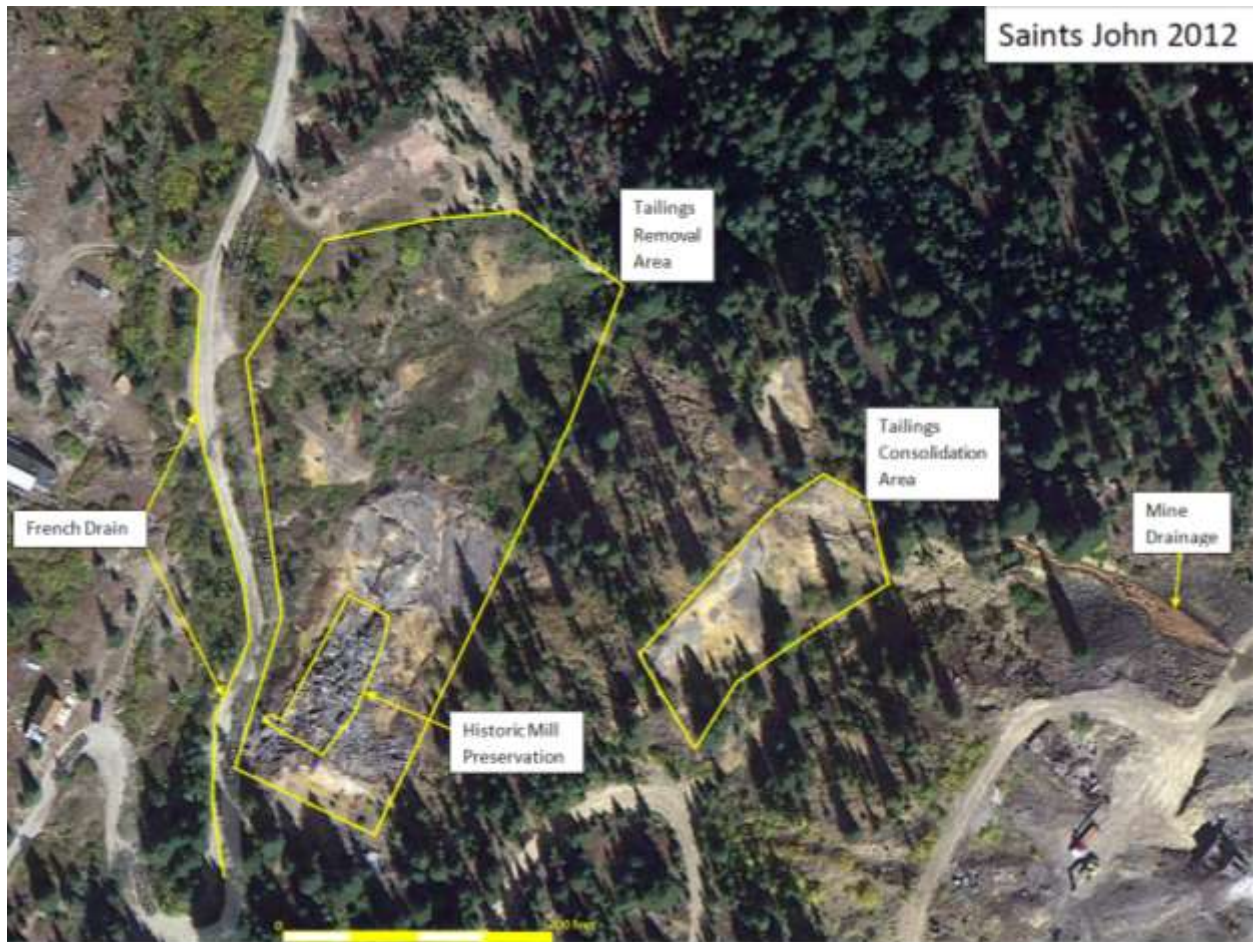
Figure 39 B shows the remediation plan for the Saints John mine and mill complex. The north area of the tailings removal area is the principal wetland area to be restored. The tailings consolidation area is shown. It was a dry upper tailings area thus allowing the consolidation. The area of the french drain is also shown. This project is expected to be largely completed in the summer construction season of 2013. While this project will not affect directly the water quality of the flowing adit, it will improve stream water quality by controlling the flow of water over tailings and the flow input from the tailings contaminated “wetland” area that is being restored. The project goal is a reduction of three pounds per day of zinc going into Sts. John. While this will be difficult to measure immediately after the project is completed, it is a good example of how water quality can be improved without active treatment of adit flow.

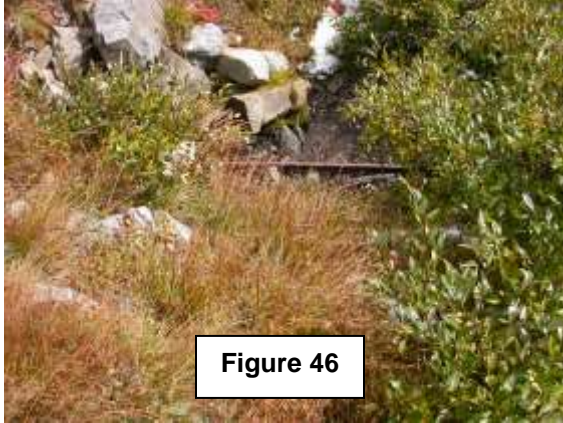
Figure 46

The first problem in Peru Creek is near the headwaters in Horseshoe Basin. There are several piles of waste rock. At least one is draining. Figures 46 and 47 show this leaking adit and the associated waste rock. Not far from this point, just below the lake shown in figure 47

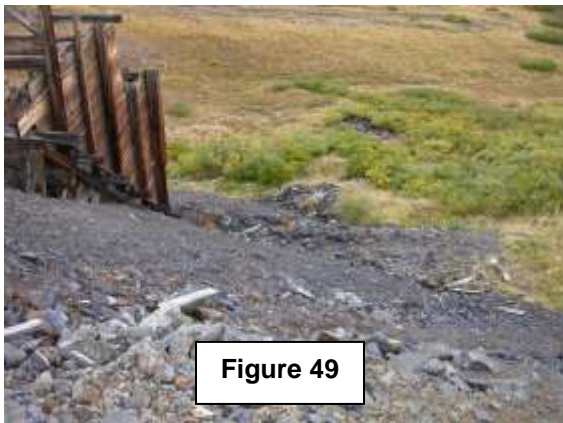
Figure 49

the stream goes by the toe of a waste rock pile. This is shown in Figure 48. A few hundred yards below this point, just below what appears to be one of the Vidler Tunnel diversions is the Paymaster Mine. This mine has considerable waste rock that is eroding. It is in this area that one of the western tributaries emerges and when it joins the mainstem, aluminum precipitation begins. There is also an open shaft just tens of feet south of the Paymaster Mine waste rock (Figure 49). The open shaft is shown in Figure 50. It is surrounded by a man-made rock wall.

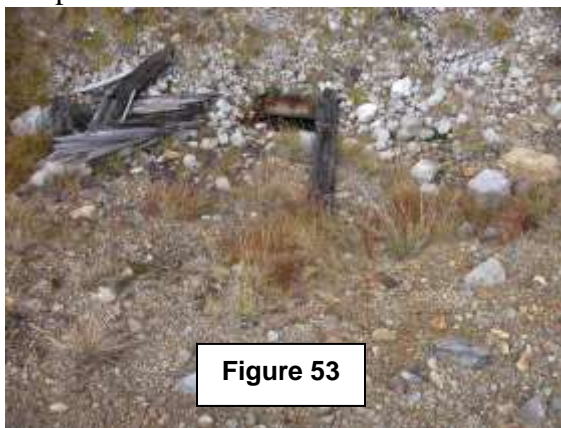
Figure 53

Just below this point in the stream, near where the road crosses Peru Creek, is another old mine with waste rock and an open shaft. The waste rock is spread over a large area and is eroding. The shaft appeared to be dry, but is a physical hazard. The waste rock is shown in Figure 52 and the shaft is shown in Figure 53.

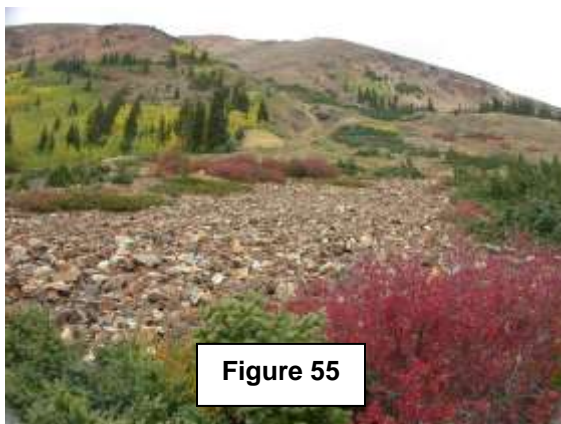
On around the hill downstream from the Shoe Basin Mine (the stream flow here changes from south to west) there are a number of old waste rock piles. Some are in natural drainages and have expected erosion associated with them. The adits in most appear dry, although there is one, to be discussed later well down the basin with a draining adit. Figure 55 shows one such waste rock pile.

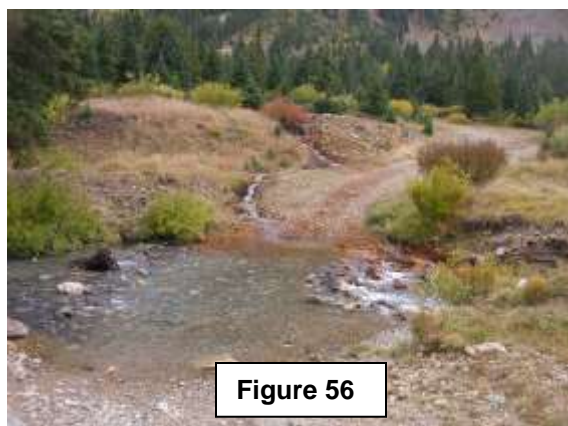
underway in 2008 and planned in 2009 to better understand this serious problem. In addition to the adit and waste rock at the main level F opening, there are serious issues associated with the tailings from the mill at the site. The milling was several hundred vertical feet lower and west of the now flowing adit. Just above the mill was the level C opening. This area has significant waste rock issues, as well. The tailings have been sluiced and/or eroded into a major wetlands area. This wetland was shown in the 1980's to be heavily polluted. Work was underway in 2008 to better understand the impact flow from the tailings area has on the stream. Figure 56 shows the current Pennsylvania Mine flow into Peru Creek and Figure 57

shows an aerial view of the waste rock area. Also shown in Figure 56 is some of the waste rock from the area above the mill near the level C opening. Figure 58 shows more of this level C waste rock and figure 59 shows the Pennsylvania Mine adit flow.

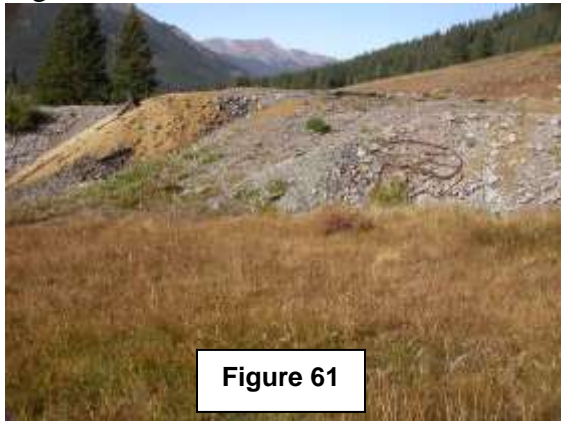
Downstream from the Pennsylvania Mine about a half mile, on the northern slope is another old mine (Rothschild Tunnel). This mine has significant waste rock issues and a draining adit. It is the waste pile discussed earlier concerning numerous waste rock piles on this northern slope. Figure 60 shows the adit and Figure 61 some of the waste rock.

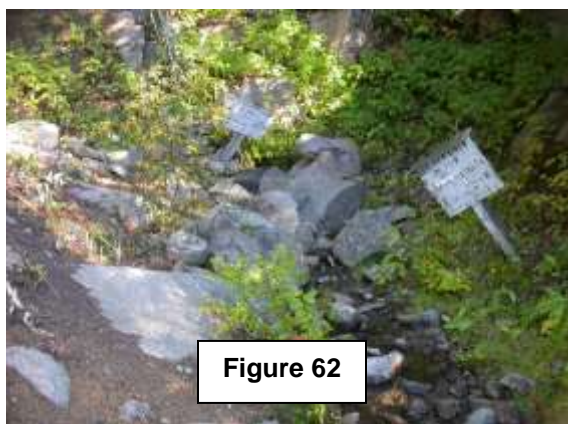
On downstream, there continues to be old mines on the north slope. Figure 62 shows one of these, the Silverlode Mine. Figure 63 shows another one, just west of the Maid of Orleans Mine. The Maid of Orleans Mine has been listed as having a draining adit in past studies (Munroe, 1999). The owners have allegedly closed the adit. A small spring remains. This is an area of private property.

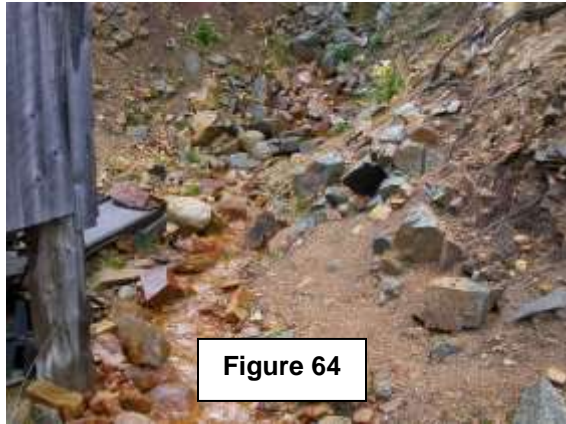
Snake River, is the Jumbo Mine. This mine has significant waste rock. The adit is draining and in September, 2008 there was flow from the bottom of the waste rock pile. Figure 64 shows the flowing adit and figure 65 shows some of the waste rock. Waste rock from this mine is just a few tens of yards off of the stream.

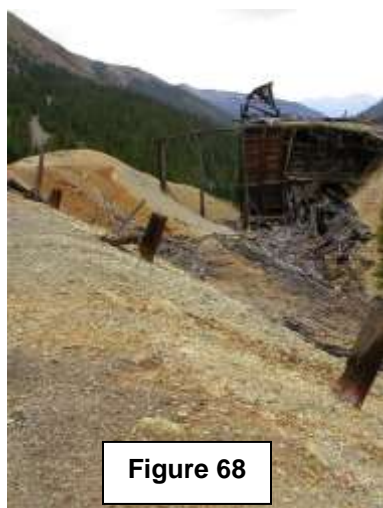
waste rock piles. However, the waste rock piles are still a problem. Figure 68 shows more of the

waste rock in this area.

The waste rock in this area should be removed to a repository and not consolidated on site. There are serious questions about the level of contact with water from the adit and the waste rock below the surface. This is not a good site for on site treatment.

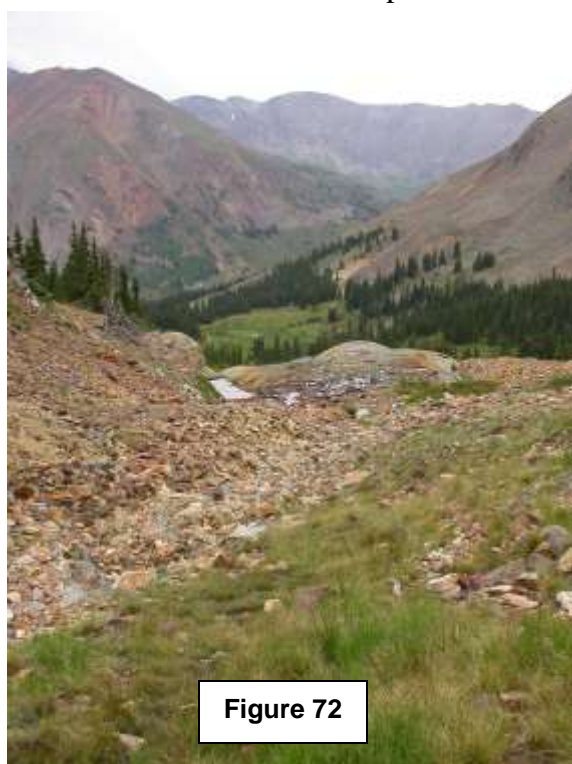
Figure 72

During most of the year, Cinnamon Gulch originates with flow from the Silver Spoon draining mine adit. Very shortly after the flow surfaces, it crosses waste rock. Drainage in the immediate area crosses waste rock. While the water from the mine is not good, the flow across the waste rock is making it worse. This waste rock is high in minerals as is almost all of the waste rock in the gulch as shown in the recent work by the CDPHE (Rudolph,2008). Figures 72 and 73 show the origination of flow and the above stream waste rock. Just below where the Silver Spoon Mine

The 319 grant has led to work at three areas in Cinnamon Gulch. The first is at the Silver Spoon Mine (Figures 72 and 73 above.) At the Silver Spoon Mine the waste rock in the drainage channel was added to the waste rock not in the channel and the channel was lined with limestone. In impermeable liner was placed in the channel and the sides were riprapped. The waste rock pile was covered with limestone. The picture to the right shows Cinnamon Gulch at the Silver Spoon Mine. The gulch frequently only flows with mine effluent. Compare this to figure 72 above.

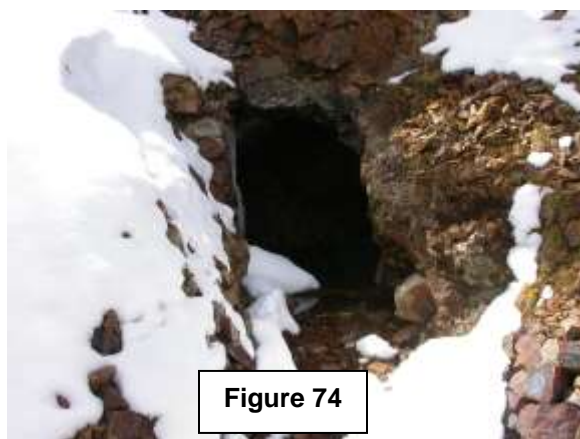
breaks through the waste rock, at an elevation of about 11,600 feet, is a series of adits. The adit adjacent to the road has been closed by the state. All that remains is a waste pile. The other adits in this series remain open and have been rated by the Colorado Geological Survey as environmental hazards. Some of these open adits flow continuously and some only part of the time. There are waste rock piles below the

adits over which water from the adits flow. Figure 74 shows one of these open adits. Figure 75 shows the waste rock pile from the closed adit below the Silver Spoon.

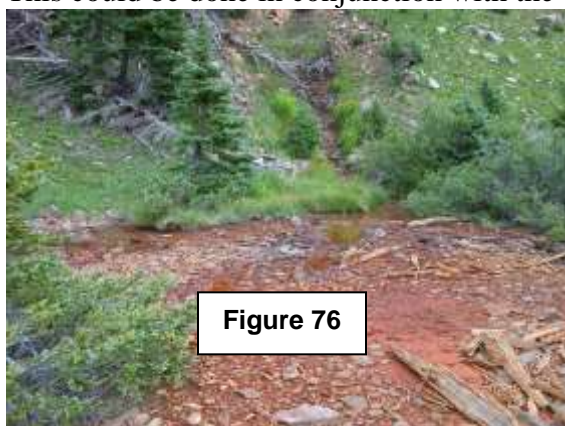
Figure 76

areas on the east side of the wetland. In addition to the draining adit, there is waste rock in contact with the adit flow. Figures 76 and 77 show two views of this area. The adit flow needs to be treated with a passive treatment system and the waste rock needs to be removed. This could be done in conjunction with the

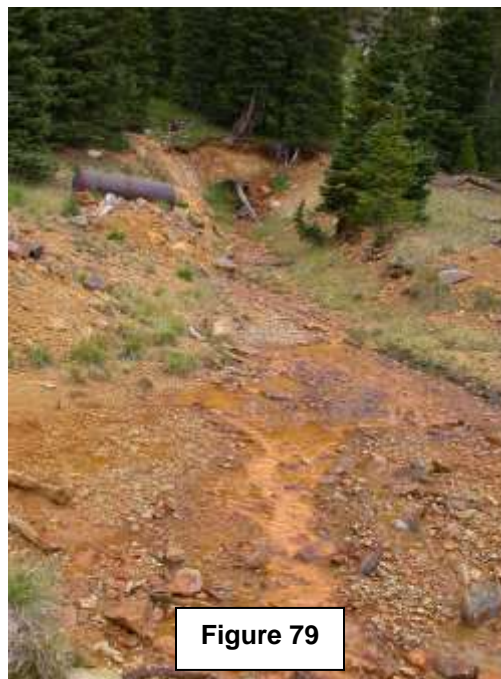
Figure 79

The second Delaware Mine site has large waste rock disturbed area. The waste rock has been spread over a wide area by a dozer. Flow from the adit comes down an area by the waste rock. Some of the flow splits off and goes over the waste the rock. Some of the flow continues down a channel to a pond. Water from the pond seeps into the creek. Figures 78 and 79 show these problems.

The water from the adit needs to be treated in a passive treatment system. That will not happen until there is a change in the Clean Water Act. Therefore in the short term it would be better to clean up the waste rock and clean out the pond

and use the pond for oxidation and settling. The pond can be removed when a water treatment system is finally built.

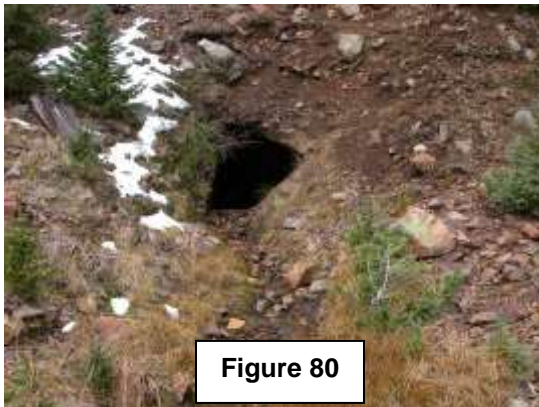
On the west side of the drainage, approximately across from the Delaware Mine is another draining adit. This adit has some waste rock issues, as well. The adit is still open and presents a physical hazard. Figure 80 shows this adit.

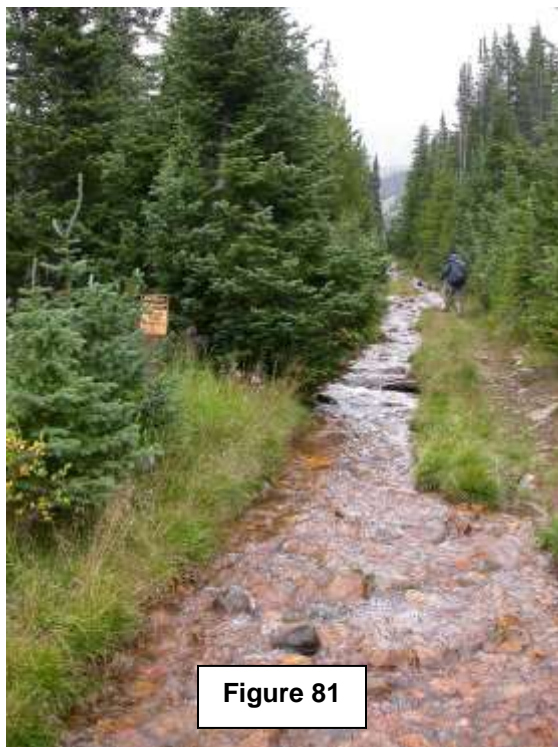
Figure 81

Silver Mine tailings area which has become a wetland area. Cinnamon Creek needs to be channelized from this point 50 yards above the road to Peru Creek. The Brittle Silver Mine has draining adit, waste rock, and tailings issues which all affect water quality. The tailings area has not been assessed to date. Figures 81 and 82 show the road flow issue and the Brittle Silver Mine issues.

Cinnamon Gulch split into three separate streams in the area where it crossed an old mining road. The western most “channel” ran down the road and ultimately across the tailings from the Brittle Silver Mine. See figure 81 above. Approximately 200 feet of Cinnamon Gulch was rerouted to the original channel along the old mining road. This prevents the stream from affecting the tailings area of the Brittle Silver Mine. The picture below shows the reroute.

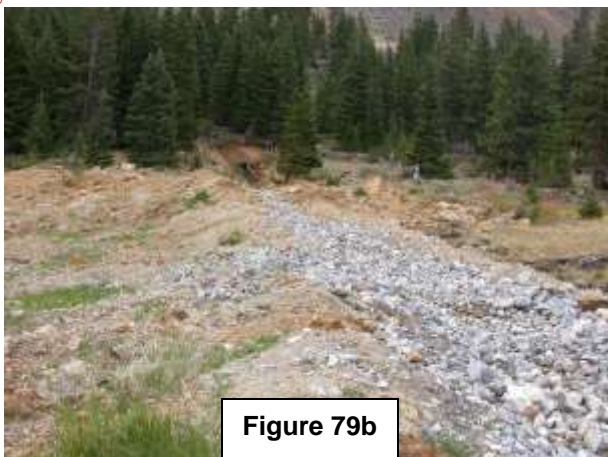
Figure 79b

Significant activities also occurred at the Delaware Mine. The effluent from the mine flowed to an old pond. The pond was cleaned out and the flow channel to the pond was lined with limestone. A new culvert was placed below the road to keep the water flowing to the pond. Waste rock was cleaned up from around the site and all of the waste rock was consolidated at the east end of the disturbed area and covered creating one onsite repository. The disturbed area was revegetated and large boulders were placed along the road to keep vehicles off the reclaimed area. Figures 78 and 79 above show the before condition. The two pictures below show comparable after

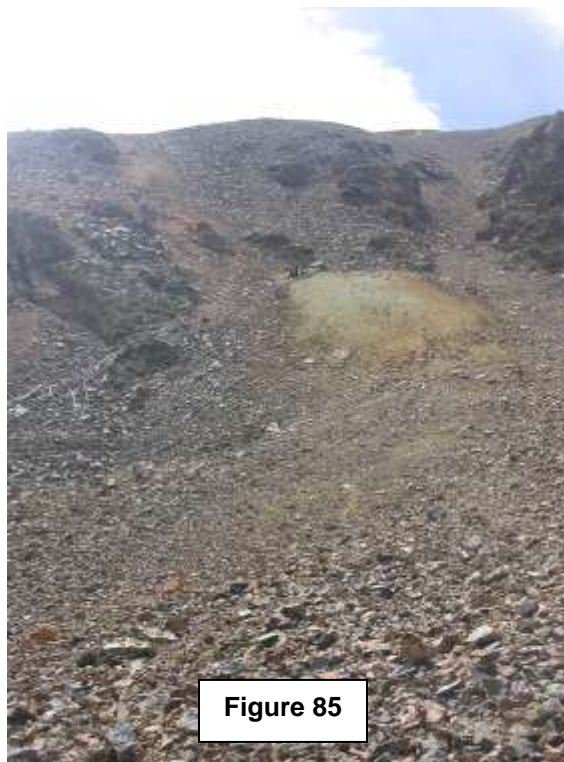
At the headwaters of Warden Gulch is the Allen Emory Mine. This mine is on the steep slopes at the end of the cirque. There does not appear to be a draining adit. However, there is considerable waste rock that is eroding. Dealing with this waste rock at the existing slope angle will be very difficult. North of the main drainage origination, and lower in the basin, west of the main flow there are several waste rock piles. All appear to be dry and all are, to some extent, eroding. One the south side of headwaters area there is another mine, high on the steep slope with considerable waste rock. This mine is in an area of unconsolidated rock on the surface and expected high mineralization. Doing anything to this waste rock would be very difficult and would most likely gain little. Figure 83 shows the Allen Emory Mine. Figure 84 shows a typical example of the waste rock piles on the northwest side of the drainage. Figure 85 shows the mine on the high south slope.

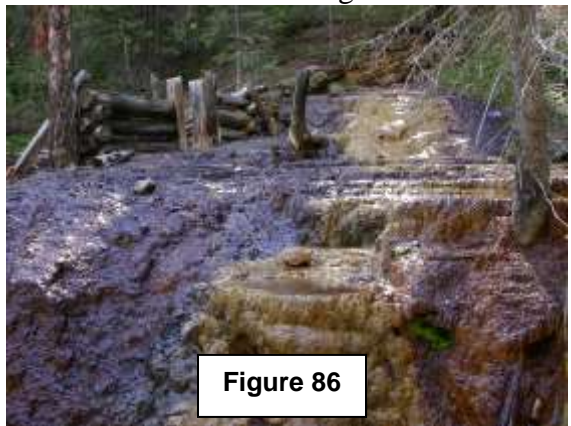
Figure 86

A few hundred yards above the confluence, where the road to the Allen Emory Mine approaches the stream is an old mine. The mine adit is draining and the water from the adit has created ferricrete deposits on the banks of the stream. There is room to the north to treat the adit flow with a passive sulfate reducing bioreactor. The waste rock and ferricrete need to be removed to a repository, although there might be enough room to consolidate them onsite and cover them. Figures 86 and 87 show two views of this mine.

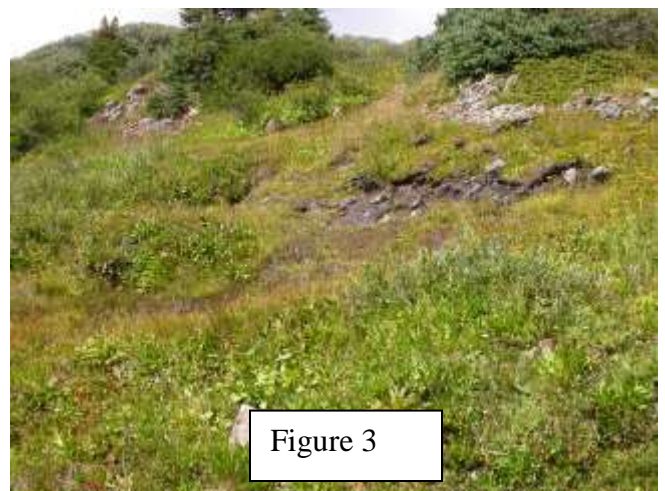
The flow that originates the stream is essentially seeps at the lower end of the “wall” below the upper bench. Figure 3 shows a typical seep that begins the stream in the upper western portion of the basin. Figure 4 shows the upper basin, below the wall of seeps, looking north. The river at this point is essentially a wetland of seeps and ponds. Not all of the seeps are of high quality. Figure 5 shows part of the flow from one seep that show considerable degradation.

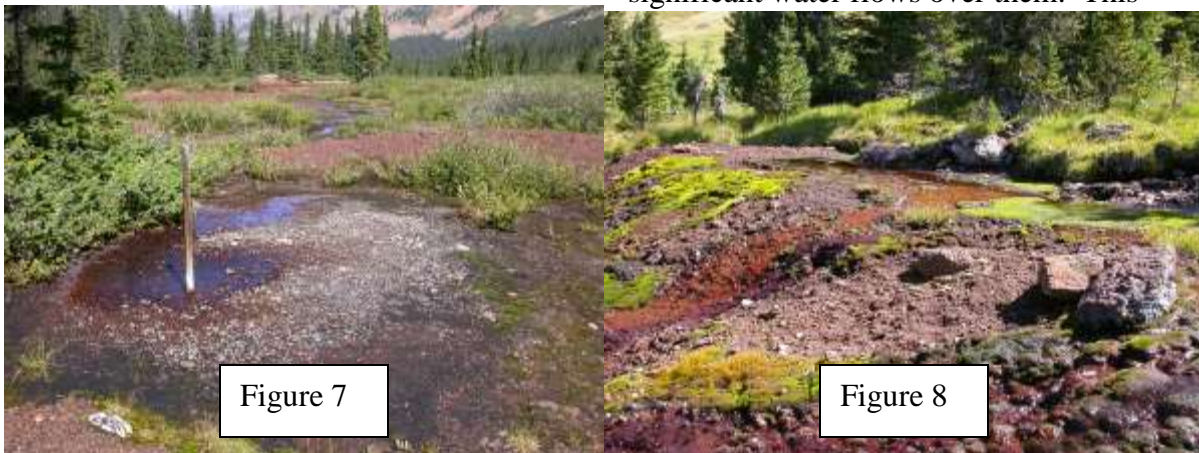
The area north of this tributary, before reaching the second tributary, appears to be one of the major areas of water quality degradation. Visually, it is difficult to separate the natural problems from those worsened by man. There is an upper bench, a sloping area and the wetlands below. In the lower portions of the sloping area there are many seeps. Some of these seeps immediately cross areas disturbed by past mining activity. Claim markers and exploration pits are visible in these denuded area. The average particle size of the rocks is very small. The minerals in the area are known to contain disseminated pyrite. Limited sampling in the eastern tributaries and an understanding of the geology of the area suggests that the water from the seeps is acid before reaching the disturbed areas. There is also every reason to believe the acid water flowing across the disturbed areas is further degrading the water quality. The flow between tributaries one and two on the east side appears to be as great as the flow in the two tributaries and appears to be of very low water quality. Figures 7 and 8 show two of the seep areas between the two tributaries. Figure 7 shows that the disturbed areas are quite large and significant water flows over them. This

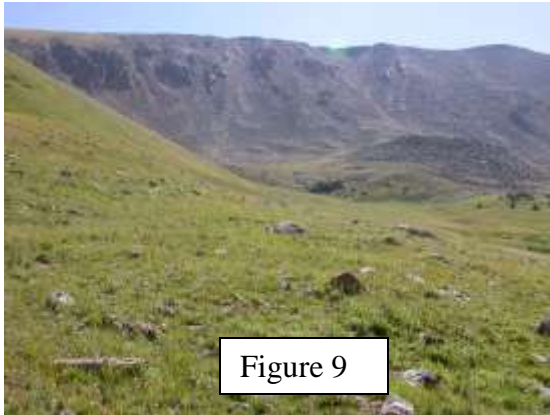
Tributary number two going north on the east side of the Snake, north of the area of seeps and visible water quality problems originates high on the continental divide. Figures 9, 10 and 11 show this tributary. Figure 9 shows the upper portion of the tributary. The flow originates around to the left of the grassy slope on the left of the

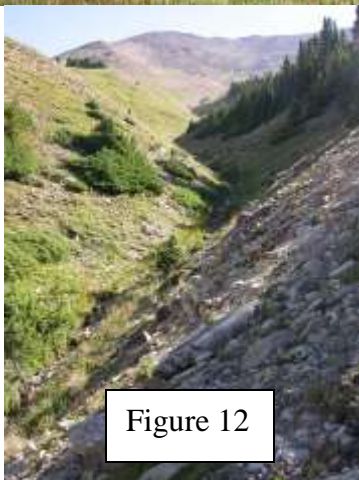
There are two other eastern tributaries shown on the USGS topographic map for the area. Both originate from seeps, well below the continental divide. Figures 12 and 13 show the headwaters of these two tributaries. Figure 12 is the headwaters of tributary 3, counting from Webster Pass and Figure 13 is tributary number 4. Both of these tributaries enter the Snake in via

the wetlands in the main valley. The Tokash thesis (Tokash, 2003) data again shows these two tributaries to have very low pH values which is consistent with the geology of the headwaters of these two tributaries.

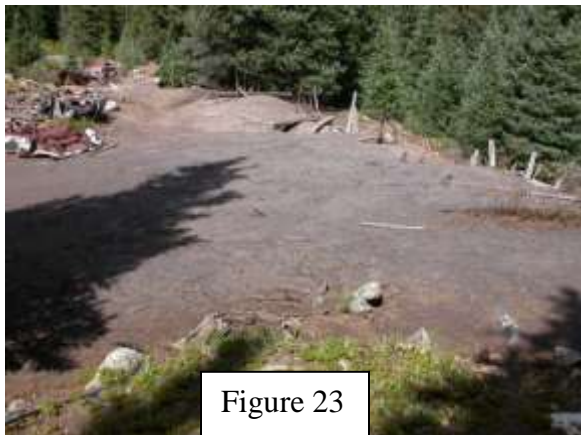
Figure 23

flowing out of a pipe onto tailings or waste rock and then across other disturbed land to the Snake River. The source of the water is an adit higher on the mountain. Figures 23 and 24 show some of the disturbed land and the discharge. Figure 24, which shows the discharge, is from a distance and makes the actual discharge from the pipe difficult to see. There is another mine, just to the north of the Burke Martin mine with a leaking adit. Flow from this adit is low and the water goes into the waste rock and ground water, not directly into the Snake River. Just south and west of Montezuma there are two other mines a few hundred yards above the stream. These are north of the Burke Martin mine, but south of town. One of these mines has significant disturbance of land in the area of the mine, but both mines were dry and no sign of flow in August, 2007.

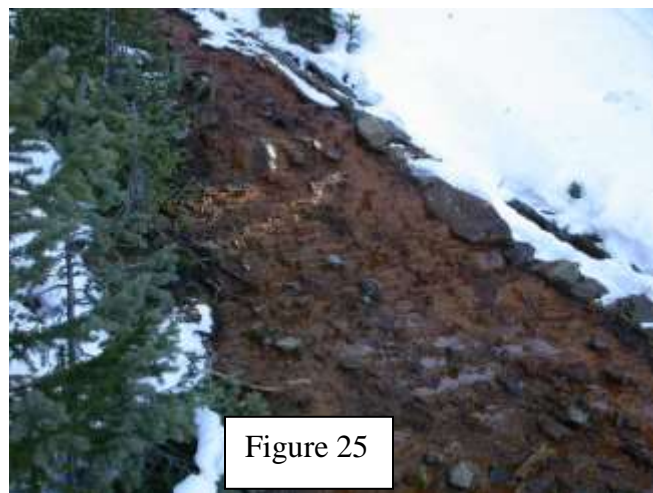
Figure 25

the mine shown in Figure 25, usually as ground water, also flows toward the Snake River. Because much of the area was patented from mining claims there is considerable private

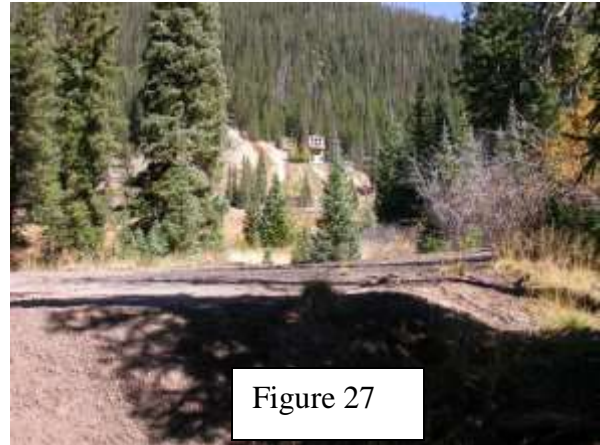
Figure 27

land and a number of houses have been or appear ready to be built in this general area. Figures 26 and 27 show this area. Figure 27, which shows the house and pipe discharge

was taken from distance and does not clearly show the discharge. Anyone familiar with the area has seen the house and the discharge. In this area there are a number of seeps on the west side of the stream and flow from one reasonable significant tributary. This area is below the road to the Hunki Dori mine as that road goes along roughly on contour around a ridge from Bear Mountain. There are a number of seeps and small flows that cross this road and flow down to the Snake in this area. Figure 28 shows one of the larger flows into the Snake in this area. There are

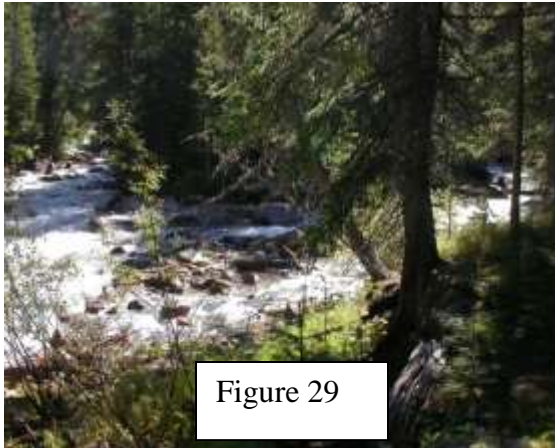
Nothing happens to affect water quality from the road crossing at the Peru Creek parking lot to the confluence with Peru Creek. Peru Creek is the major tributary and its waters have a low pH and high metal concentrations. As with the confluence with Deer Creek, this confluence has signs of aluminum precipitation with the white staining on the rocks below the confluence. The Snake River is causing the pH to rise in the waters coming from Peru Creek resulting in the precipitation of aluminum. Figure 29 shows the confluence of Peru Creek and the Snake River and Figure 30, taken a few hundred yards below the confluence shows the aluminum precipitation with the white staining on the rocks. In this area below the confluence there are still seeps feeding the stream along the way as there were in the upper reaches of the Snake and its tributaries.

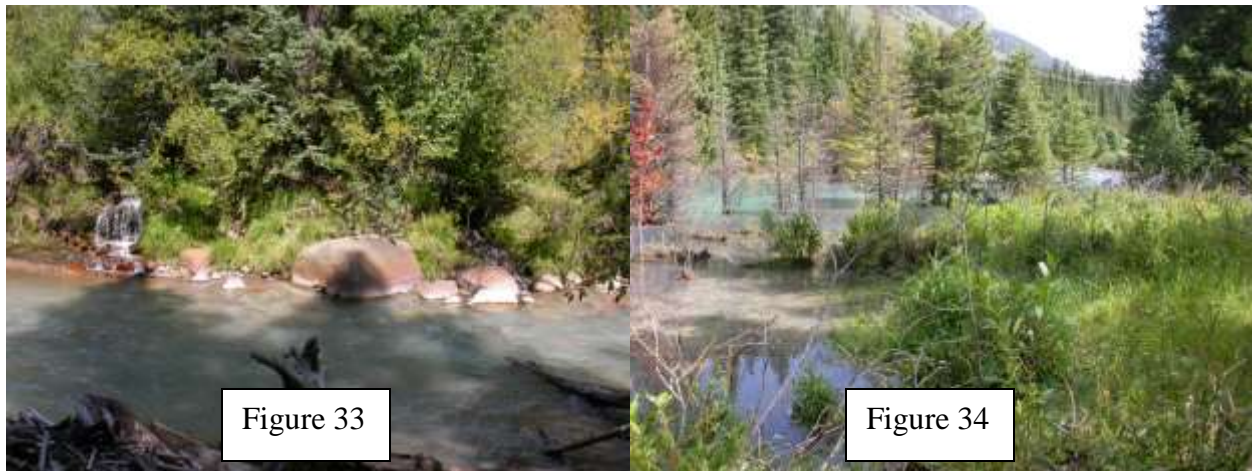
A few hundred yards below this pond stream flow from a tributary north of the Snake enters the river. This is flowing from a drainage east of Porcupine Mountain and crosses the Montezuma road in a culvert. Figure 33 shows this tributary entering the Snake River.

Not far below this small tributary obstructions have created another natural dam in the stream which has resulted in a number of dead trees. This is shown in Figure 34. This is just before the developed area of Keystone. A few hundred yards downstream there is a bridge at the entrance to Settlers Creek. Just below that flow from Jones Gulch enters the Snake. While there are mines in the upper Jones Gulch area, they appeared to be dry in September, 2007 with no sign of flow into Jones Gulch. Figure 35 shows the flow from Jones Gulch entering the Snake River in the Keystone area.

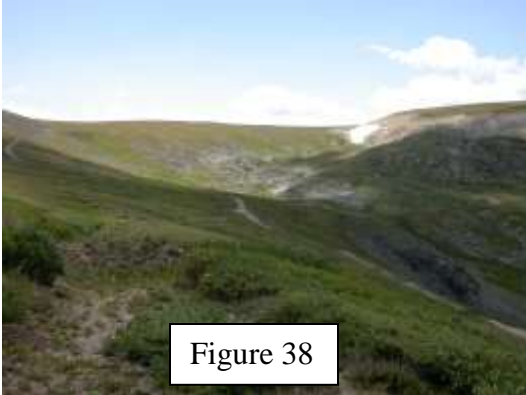
The Deer Creek drainage originates just to the west of the upper Snake River drainage, separated by Teller Mountain. The creek originates from seeps below an upper bench, high above treeline. Figure 38 shows the upper portion of the drainage. Figure 39

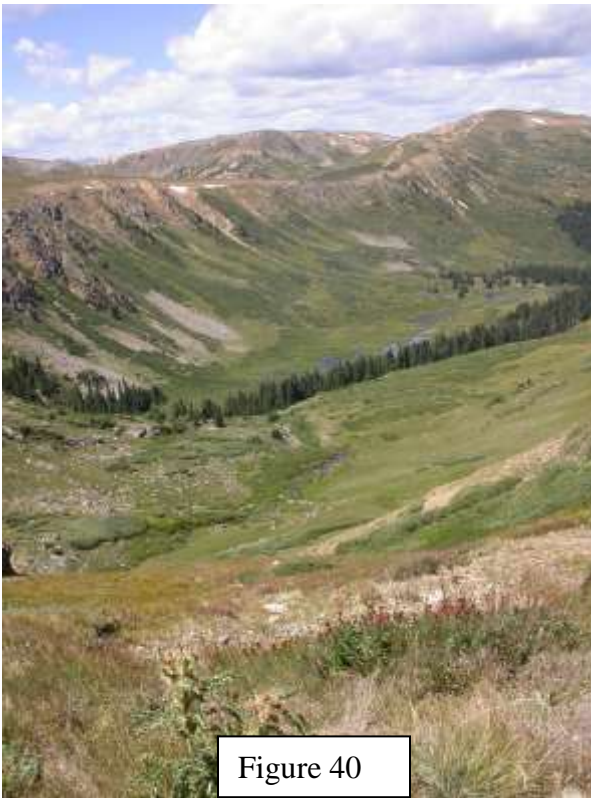
Figure 40

is taken just to the right or west of Figure 38 and shows the first pond and the area of initial seeps in the flow of the creek. Looking further to the west, downstream is Figure 40. There was one waterfall on the north facing (left) slopes seen in Figure 40. As the stream flows from west to north, a lot of seeps in the treed areas on the south facing slopes feed the creek. In particular, as you come around Radical Hill, there are many seeps. The rocky area above the seeps infiltrate the water from melting snow and feed the seeps lower on the mountain.

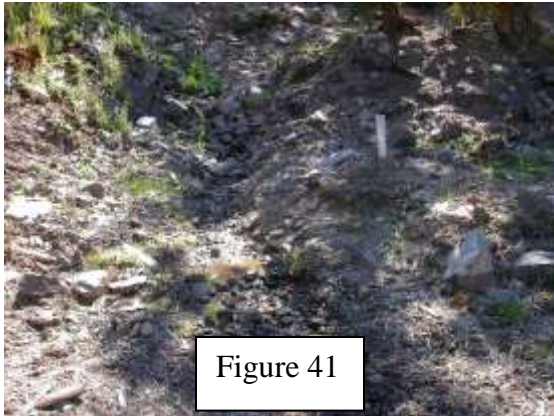
close to the only tributary on the east side of the drainage, it does not appear to flow into the drainage. Figure 41 shows the closed, but leaking Arabelle Mine adit and Figure 42 shows the eastern tributary nearby. While there are many mines on the eastern flank they are far removed from the stream, are basically dry, and pose no real water quality issues.

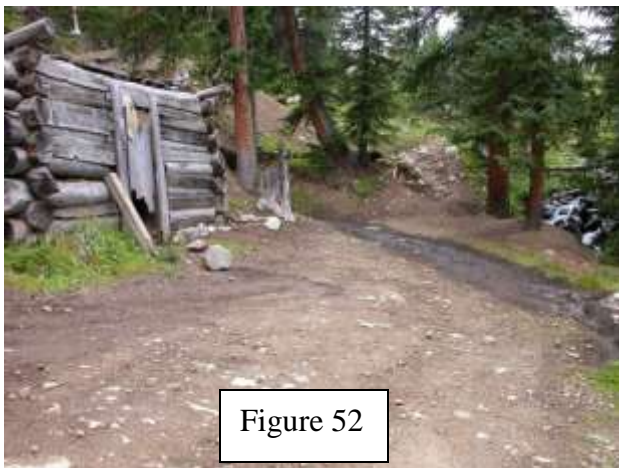
Figure 52 shows this leaking adit. The eastern tributary flows via a number of subtributaries from the higher bench south of the Wild Irishman Mine. This mine also has a leaking adit, but the flow does not appear to reach any perennial flowing tributary. The flow
