Snake River Watershed Plan

Pennsylvania Mine, Peru Creek

March, 2009

May, 2013 update

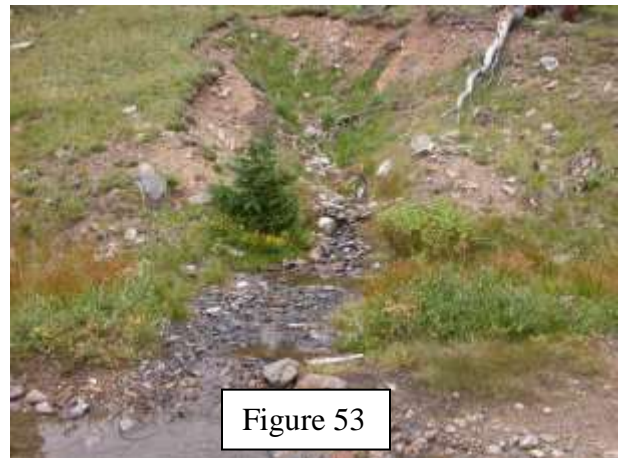
disappears into the ground and ultimately reaches surface flow via some seep or springs lower on the mountain. Figure 53 shows the

flow from the Wild Irishman Mine. A third mine in the basin also has a leaking adit. It is north from the Wild Irishman mine and down a small subdrainage. This is one of the tributaries feeding the eastern tributary that is the majority of the flow of Sts. John Creek. This mine is shown in Figure 54. The General Teller Mine, above the Wild

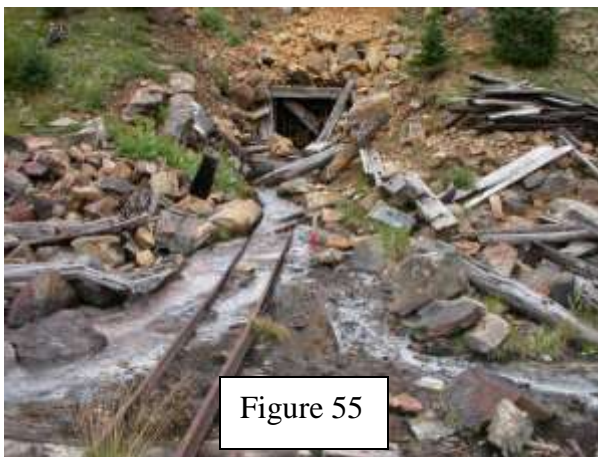
Figure 55

still used. This site changes the chemistry of the stream. The old Sts. John mine site has both leaking adit problems and tailings/waste rock contamination problems. EPA has sampled the adit flow twice in 2007. Flow was 0.68 cfs in July, 2007 and 0.38 cfs in September, 2007. The pH was 6.2 in July and 6.0

in September. Manganese was 12-16 mg/l and zinc was 6.5-8.4 mg/l. Figures 55 and

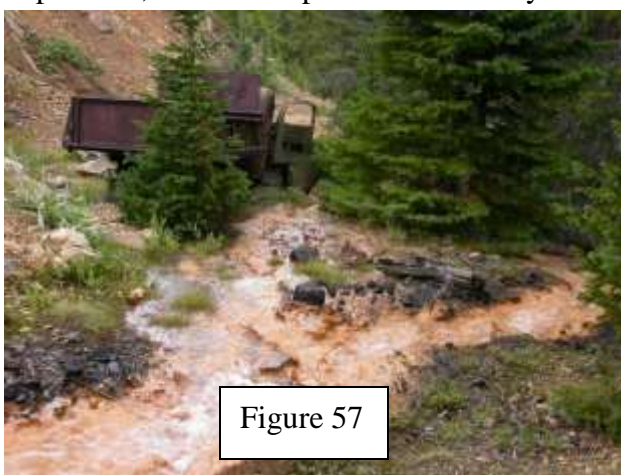
Figure 57

56 show the adit flow and some issues around the old mill site, where it appears that some flow from the stream is seeping into disturbed areas and affecting water quality. In addition to the two problems shown, there are a number areas where water flows across waste rock or old tailings. These issues too, need to be addressed. The adit flow splits near the adit, with a minor portion flowing south across disturbed areas and the majority flowing north, reaching the creek via a very circuitous path. Figures 57 and 58 show two

views of the northern route to the creek in August 2007.

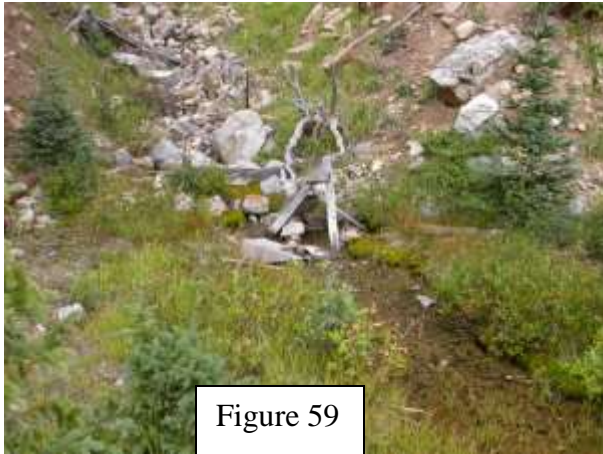
Sts. John Creek below the Sts. John mine flows into a large meadow that is filled with old tailings. To the west of the meadow is another mine, the Marlin Mine, with a leaking adit. At the north end of the meadow the stream crosses the road that goes to the Hunki Dori mine and Grizzly Gulch. The USGS sampled above and below this wetland in 2001. The pH both times was 6.6 su. The manganese increased from 0.286-0.728 mg/l and the zinc increased from 0.39-0.548 mg/l. Figure 59 shows the Marlin Mine leaking adit as it emerges and figure 60 shows the flow as it crosses a flat area and drops toward the stream. Figure 61 shows some of the tailings in the meadow.

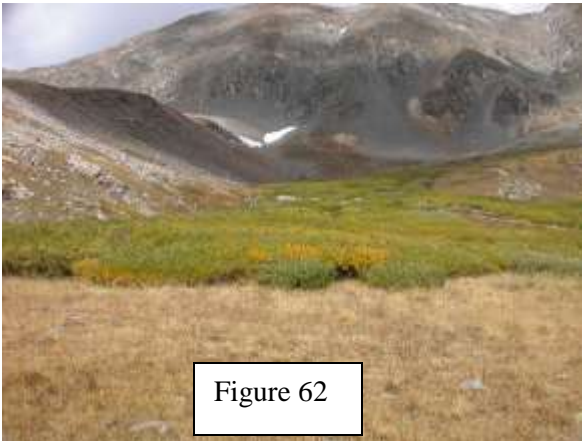
in the upper basin, is on the divide between the eastern and western headwaters. Flow originates from two high lakes just east of Grays Peak. Flow from these upper lakes comes down a steep rock embankment to a high bench in what is called Horseshoe Basin. Figure 62 shows this embankment. The flow

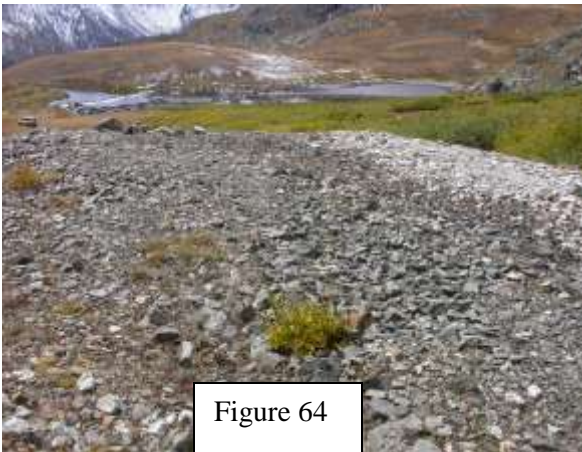
Figure 64

The waste rock from this adit is shown in figure

64 as is another lake, flow from which enters Peru Creek lower in the basin. Figure 65 shows the overall upper basin. There is flow down a number of channels on the right or west in the figure. There are also a number of old mines along the west side. The east side of the upper basin is best shown in Figure 66. In this photo the Vidler Tunnel, through which upper basin water is diverted to the eastern slope is clearly shown. Most of the flow in the upper eastern tributary is captured by the Vidler Tunnel diversion.

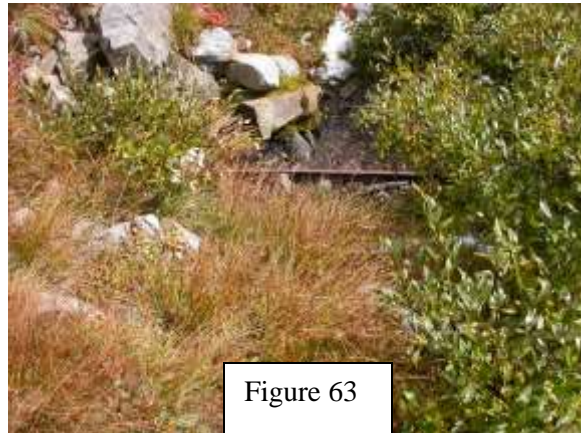
Figure 63

is coming down about where the shadow begins. There are other seeps and springs below the upper slopes. There are also flowing adits, as the one shown in figure 63.

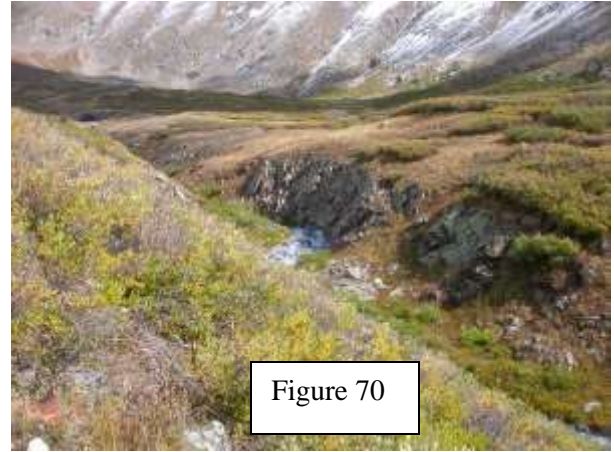
“canyon”. Figure 69 shows the confluence and Figure 70 shows the canyon. In all of this part of the stream the rocks are stained white from aluminum precipitation.

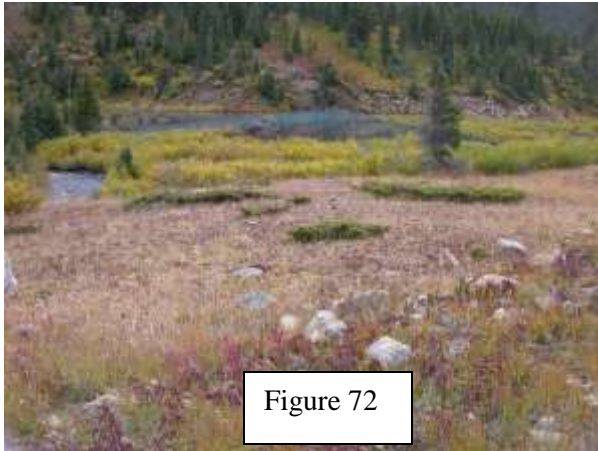
ground. During periods of higher flow it will still reach the stream. Just below the Shoe Basin Mine, high above the road, is a waste rock pile. The stream gradient increases some, but there is still primarily wetland and beaver ponds. Figure 72 shows the stream a few hundred yards below

the Shoe Basin Mine. In this general area there are seeps entering the creek from the south. The north side has steep slopes above the road with occasional waste rock piles. Some are in hazardous positions relative to avalanches and other sources of erosion inducing natural hazards such as the pile shown in Figure 73.

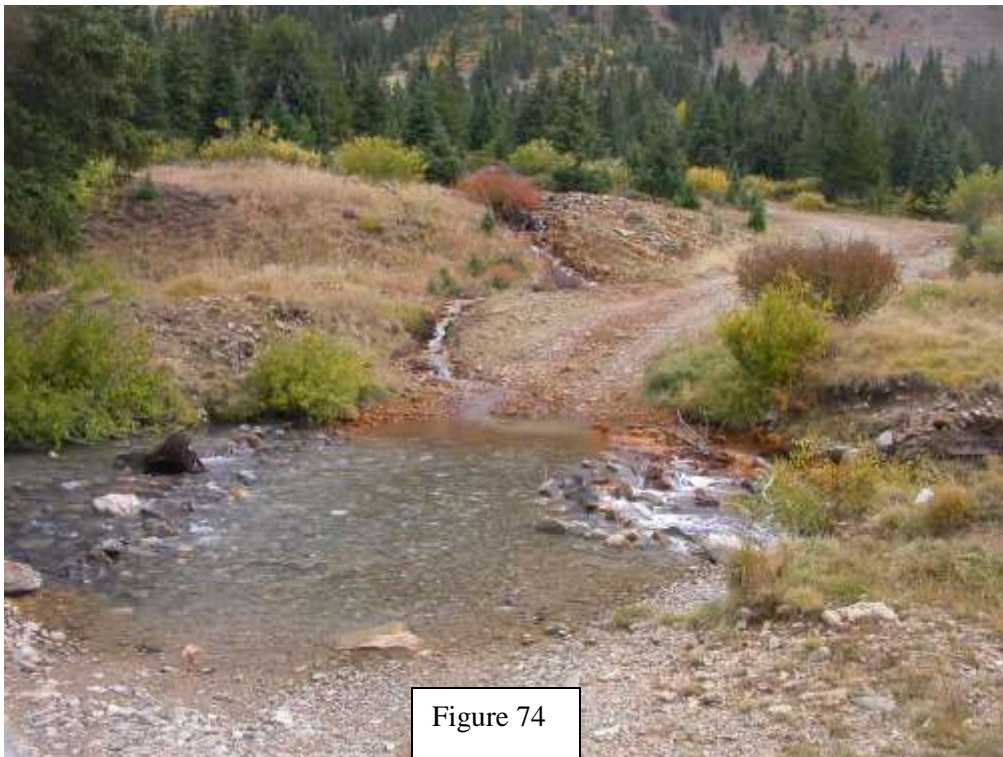
The stream gradient again lessens as the Pennsylvania Mine area is reached. Figure 74 shows the effluent from the mine reaching the stream. Just below this there are significant wetlands on both sides of the stream. The wetlands on the south contain the tailings from the Pennsylvania Mine milling activity. Figure 75 shows these wetlands.

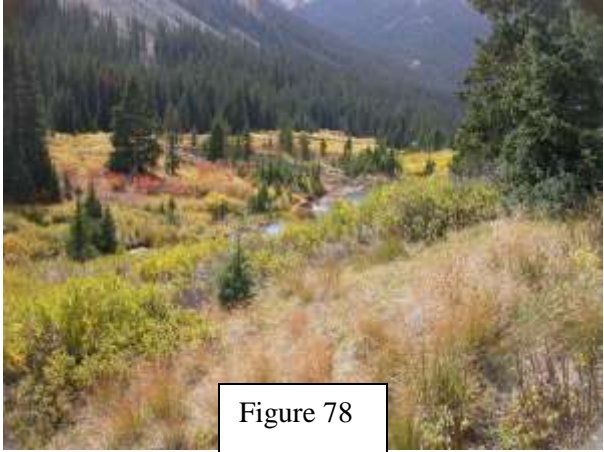
Figure 78

slopes on both sides give way near the stream to wetlands that contribute to flow through seeps and springs. Figures 78 and 79 show the stream in this area. There are avalanche chutes on the north side and at least one leaking adit and significant waste rock pile. However, most of the flow is underground not surfacing until the wetlands area.

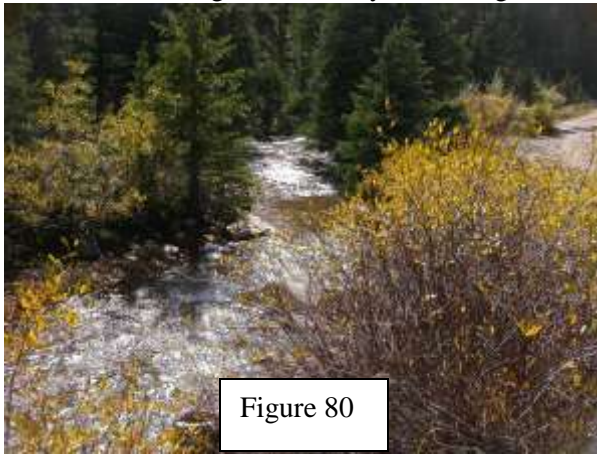
Below the wetlands area, Peru Creek heads into a canyon and the gradient increases. Along this canyon there are significant seeps into the creek on the south side of the stream. Figure 80 shows the stream heading into the canyon and Figure 81 shows one of the seeps.

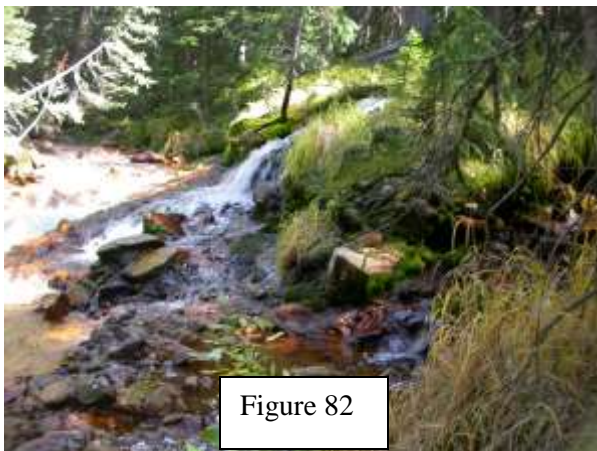
Below the canyon, Warden Gulch flow enters Peru Creek. Water quality is a problem with flow from Warden Gulch and iron staining is heavy just below the confluence for several hundred yards. Figure 82 shows the confluence of flow from Warden Gulch.

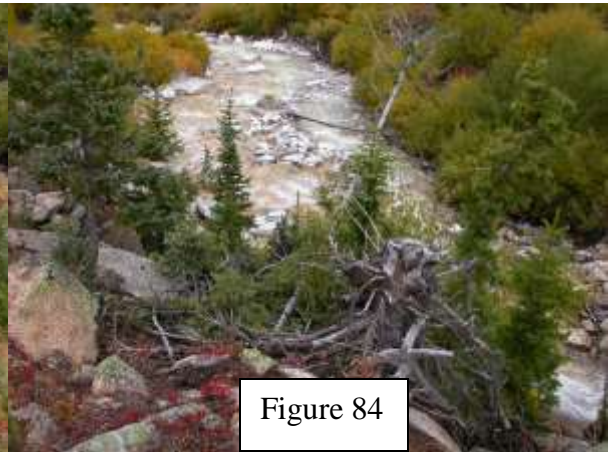
Peru Creek flows north for a short distance and then turns again west. Gradient again lessens and a generally flat area with wetland exists in the general area of the old town of Chihuahua. The road to Warden Gulch crosses the stream in this area. The creek again turns to the northwest briefly until the confluence of Chihuahua Creek. This water is of high quality and again creates precipitation of metals in the stream. Figure 83 shows the confluence of flow from Chihuahua Gulch and Figure 84 shows

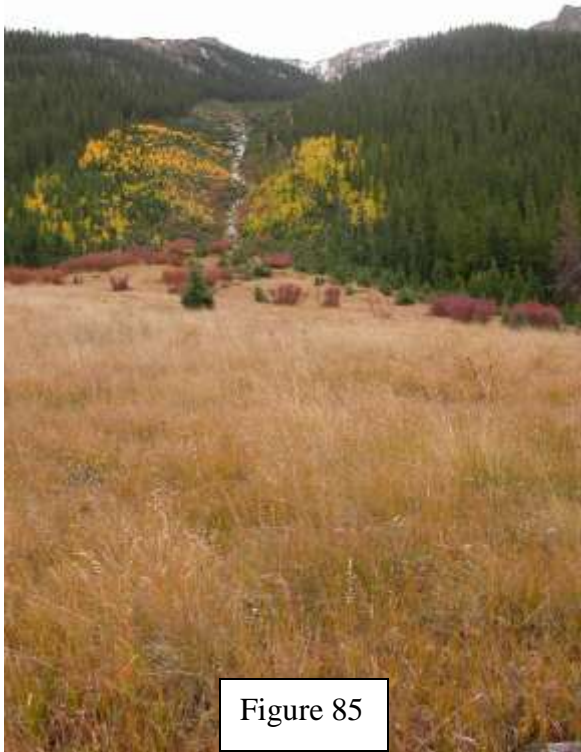
The south side of the creek has the normal steep slopes and wetlands areas at this point. The north side over the next quarter mile will have the same steep slopes/avalanche chutes and lower wetlands. Figure 85 shows the south side wetland area below an avalanche chute and Figure 86 shows the north side wetlands in the area of the Orleans Mine. There is a flowing adit just west of the Orleans Mine. That and seeps from the steeply sloped avalanche chute above provides flow that keeps the road permanently wet in this area.

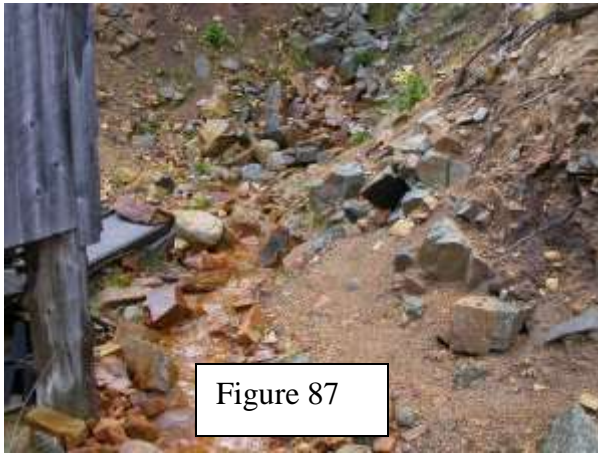
rock. There is also flow from the toe of the waste rock and strong evidence of recent flow on the east side of the waste rock. The adit flow crosses the road to the mine and heads down a wetland area before tumbling down a steep cliff into Peru Creek.

Figure 87 shows the adit flow which flows down the west side of the waste rock and Figure 88 shows the significant pile of waste rock.

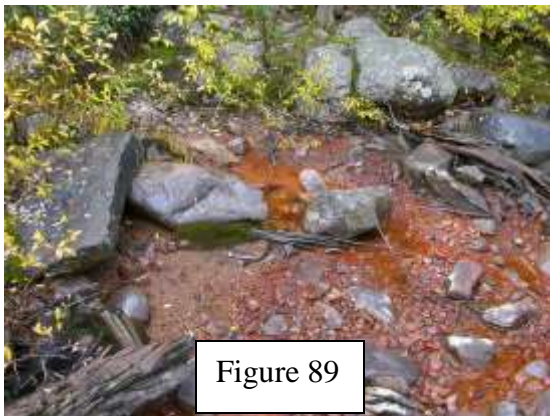
Peru Creek crosses the road just below where this mine effluents enters the stream. In the first quarter mile below the road, Peru Creek has significant wetlands on both sides of the stream. There are seeps and springs along and near these wetlands. Figure 89 shows one of these seeps on the south side of the stream. Figure 90 shows some old beaver activity in this same area.

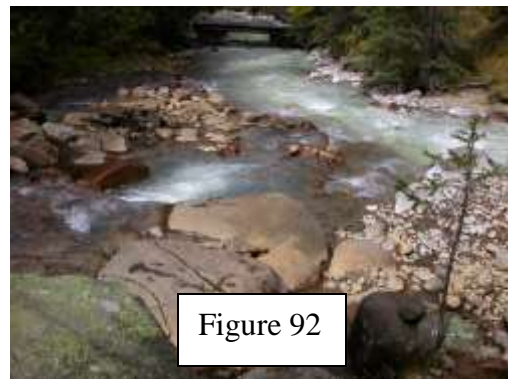
Below the wetlands, Peru Creek goes through a steep canyon with high walls on both sides. As the creek emerges from the canyon it comes to its confluence with the Snake River. Figure 91 is a view of the creek in the canyon and Figure 92 shows the confluence.

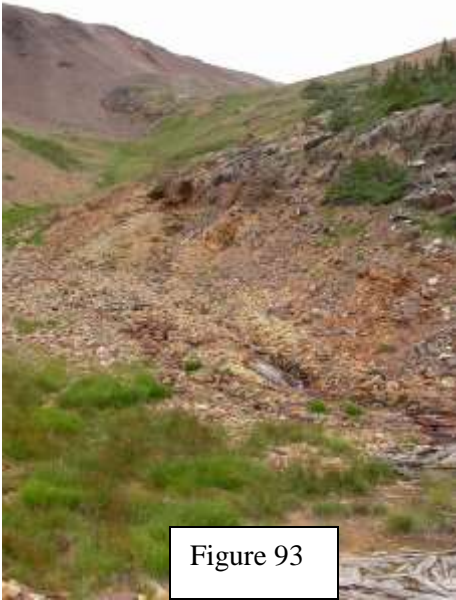
The main channel of flow comes from the saddle between Brittle Silver Mountain and Silver Mountain. However, most of the year, flow actually originates at the Silver Spoon Mine. Figure 93 shows this upper basin and the adit area of the mine. Flow from the adit nearly immediately flows across old waste rock on a level area below the mine. Figure 94 and figure 95

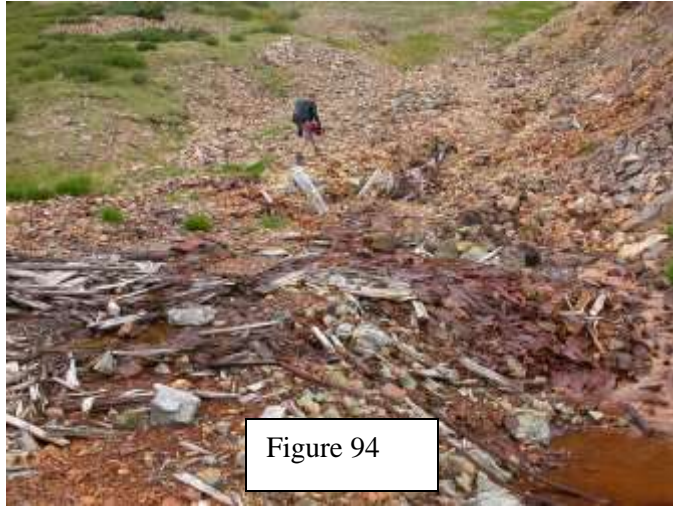
Figure 94

show waste rock piles from the mine where water flows through and around them. Figure 96 shows this same view from above. There is a flow channel to the east of the waste piles that also flows over mine waste and there are other waste piles just below the flow channel on the west side.

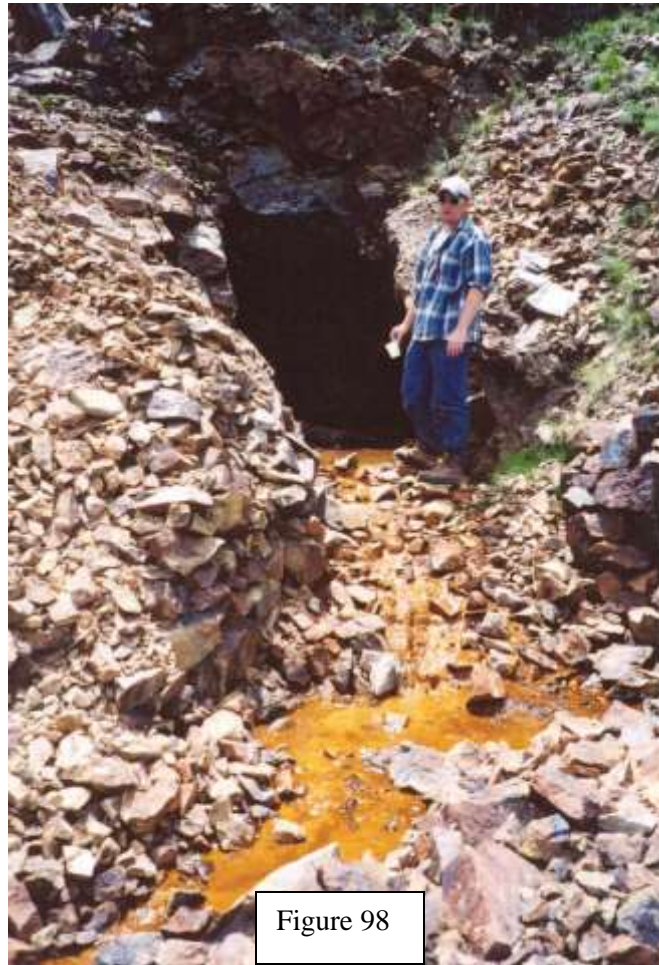
of mines at about 11,600 feet. These are discussed in detail in Wood, 2005. “Four separate adits discharge water along the Rich Ore Lode, including adits #100, #101, #103, and an adit that was not inventoried in 1993. In July of 2001, the combined flow from the four adits was measured at about 4.5 gpm. The pH ranged from 3.16 to 3.58, and conductivity ranged from 287 to 611 $\mu\text{S}/\text{cm}$. In October of 2001, only one of the four adits was flowing (adit #100), at a rate of about 1 gpm. Standing water was present at the other three. The pH ranged from 2.91 to 3.21, and conductivity ranged from 464 to 593 $\mu\text{S}/\text{cm}$.” (Wood, 2005). Figure 97 shows the general area of these adits from the road. The photo is looking west. Figure 98 shows one of these adits, referred to in previous studies (Wood, 2005) as

adit #103. Figure 100, from the Wood report, shows the schematic of the area downstream of adit #103. There is evidence of a state closed adit at about 11,600 feet elevation on the road to the

The Wood report stated: “Three of the five inventoried adits (#100, #101, and #103) along the Rich Ore Lode were assigned EDRs of 2, indicating “significant” environmental degradation. The remaining two were assigned EDRs of 4, indicating “slight” environmental degradation. Adits #100 through #104 were assigned physical hazard ratings of 3, indicating “potential danger.” The physical hazard ratings are based on the fact that these adits are partially to completely intact, and entrance is not impeded.”

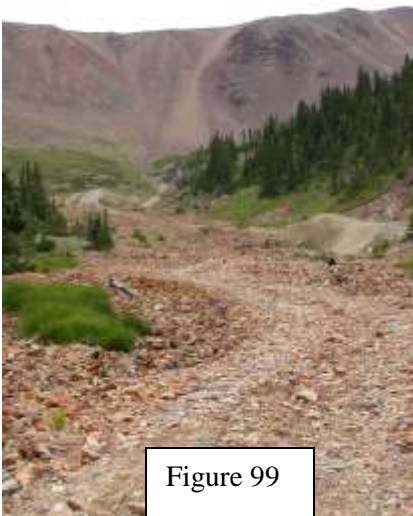
Silver Spoon. The other adits, leading to #103 are at the same elevation moving off to the west. Figure 99 shows the beginning of this trend along the main road. You can see a waste pile at the road. The others are around to the right or west. All were flowing or showed signs of recent flow in 2007. The lack of flow in 2001 was probably due to 2001 being the beginning of two low flow years. Water from a pool just inside the open adit flows onto the bench and down the southern side of the upper lobe of the waste-rock pile.

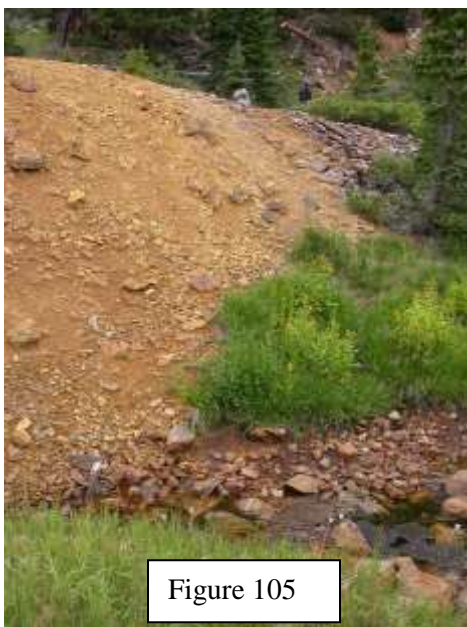
Figure 105

The flow in the “main channel” is mostly fairly straight down the drainage from south to north. In the middle of the upper portion of the gulch there is flow originating from a number of seeps along the eastern edge of the upper valley. Some are in areas where there appears to be waste rock. Others are just seeps at the bottom of a steep sloped area as we see in all of the Snake River basin. Above the eastern side of the basin is an area of highly altered rock and the zone referred to as the Montezuma shear zone. This area produced water of low pH and high dissolved metal content. Seeps have significant iron staining. The combined flows from the seeps and adits form an eastern tributary of Cinnamon gulch. Figures 101, 102, 103 and 104 show four of these “seep” or adit discharges. Several of the leaking adits on the east side flow through or directly adjacent to waste rock piles. Figures 105 and 106 give examples.

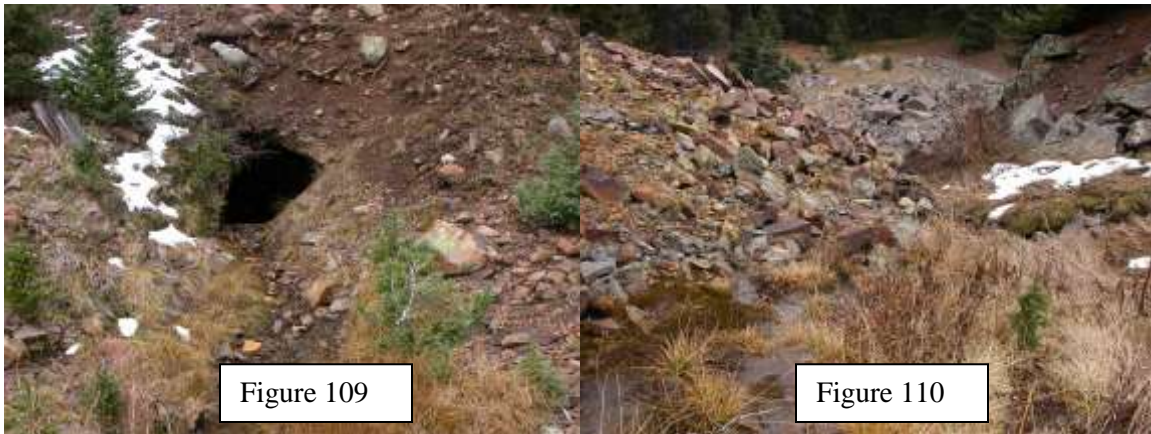
Figure 109

To the west of the dam, several hundred feet above the valley floor is another leaking adit (Little Nell). This adit is still open and the water from it flows over waste rock on its way down from the adit. Figures 109 and 110 show this adit flow from the mine and down the rocky channel below.

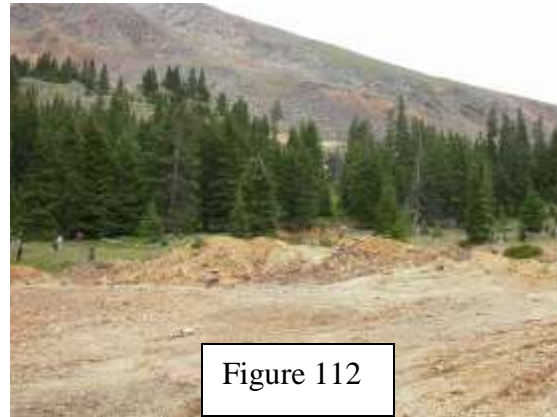
Figure 112

Just below the old dam, above the creek on the east side is the collapsed adit from the Delaware Mine. This adit is flowing and the waste rock from the mine has been spread over a fairly large area. Water from the adit flows partially down a channel and into a pond and partially over the waste rock. The pond itself may be on waste rock. There are several seeps into the stream below the pond. This site is one of the primary candidates for improvement. There is a zone of dead trees below the waste rock, indicating runoff from the pile is toxic to vegetation. Figures 111 and 112 show the adit of the mine and some of the waste rock.

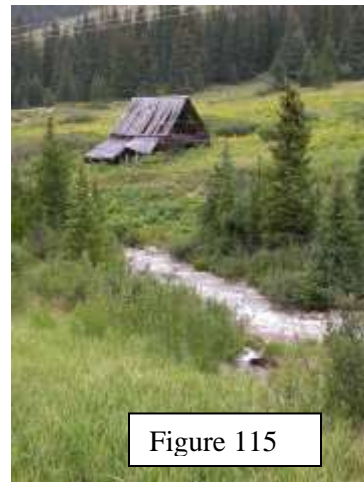
Below the Delaware mine the creek begins to drop at a more rapid pace. Over the next several hundred yards it crashes through timber and has made a number of channels. The flow in each channel varies by year. At least three separate channels emerge on the road that cuts across the channel near the Brittle Silver Mine. The road comes out of the old Pennsylvania Mine mill area. The western most channel ends up running down this road, below the Brittle Silver Mine most years. The flow down the road will break on down toward Peru Creek in different places, but ends up providing flow across the tailings from the Brittle Silver mill. Figure 113 shows the western most fork of Cinnamon Creek flowing down the road. Figure 114 shows some of the flow heading down from the road toward Peru Creek. Figure 115 shows the confluence of this western fork with Peru Creek.

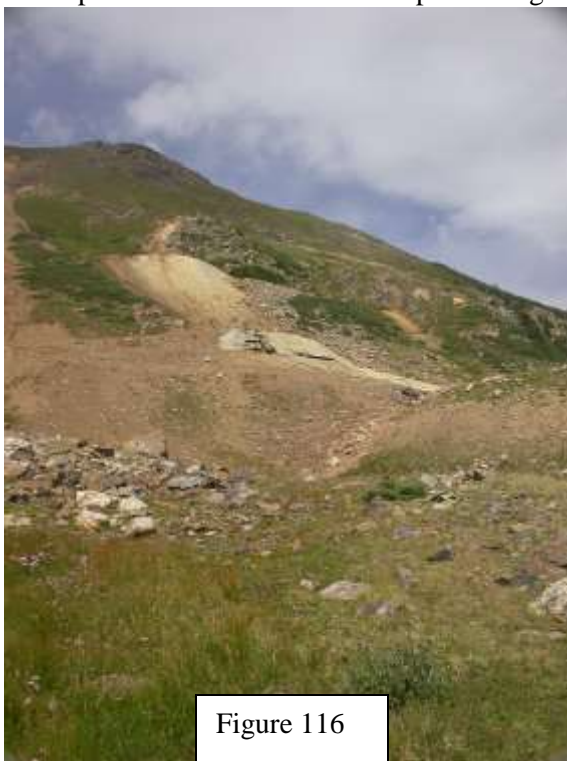
Flow in the upper part of the basin is shown on the USGS topo map as originating on the eastern part of the basin. This is not correct. Flow originates at the lower end of a western drainage below steep sides of a glacial valley. At the end of the valley is the Allen Emory mine. North of the end of the valley is a bench, below Morgan Peak, where there are a number of small waste rock piles at about 11,900 feet elevation. These were all dry in August, 2007. There is a road up to the Allen Emory mine. This road traverses south at about 11,600 feet elevation to about 11,800 feet elevation just below these mines as it approaches the end of the valley. Figure 116 shows the end of the valley and the Allen Emory mine and figure 117 shows one of the other waste piles. There are other waste piles along the road.

The initial flow in August, 2007 began from a stream at the point where the picture in figure 116 was taken. Figure 118 shows this spring and figure 119 shows a spring just below, where flow in the channel actually begins.

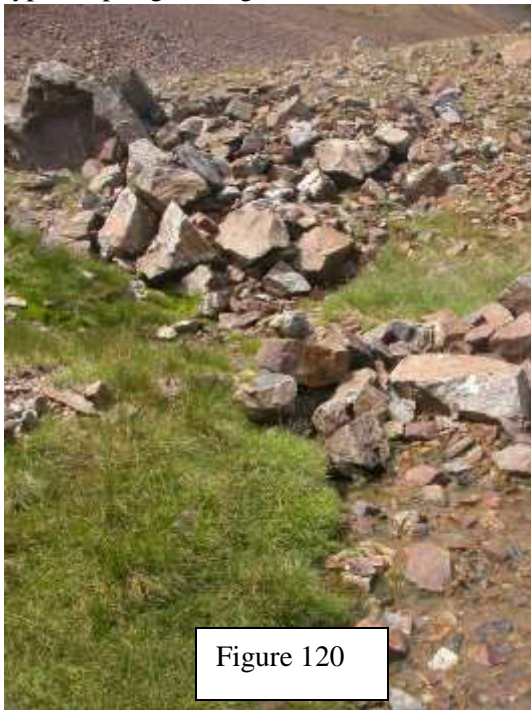
Figure 120

As the “stream” proceeds down the drainage there are many seeps and springs. Some are in the channel area and some are more at the base of the steep slopes on the south. In this part of the basin, which is very rocky, flow comes and goes from the surface. Figures 120 shows another typical spring and figure 121 shows the surface flow, coming and going in the rocks.

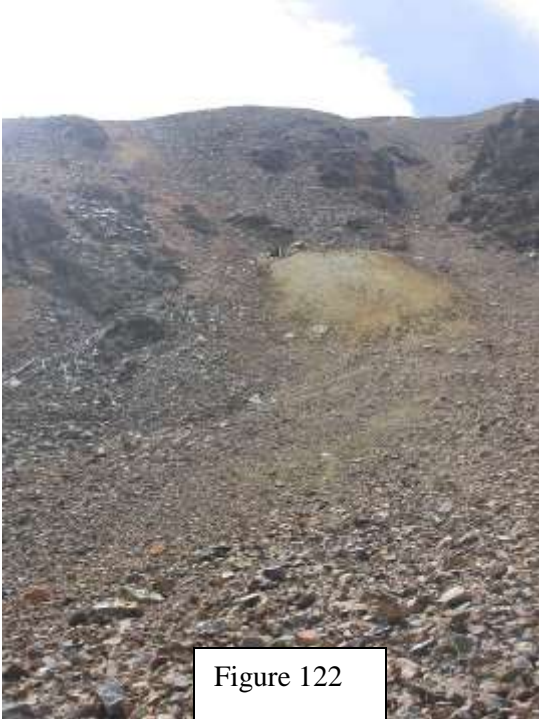
In the middle of this part of the drainage there is a mine high on the south slope. The waste rock is eroding significantly. However, like the Allen Emory mine, the waste rock is on such a steep slope that stopping the erosion would be nearly impossible. Snow melt in this area also tends to go straight into the rock. At the base of this area there is a significant seep or spring which flow alone for a while before joining the existing flow. As the drainage area approaches the place on the USGS topo map that shows an eastern trib, there are several flow channels and the stream takes on a look of flowing through wetland. This is an area where flow is increasing from the many seeps in the area. Figure 122 shows the mine on the south slope and figure 123 shows the flow coming from below the mine where the steep slopes meets the valley floor.

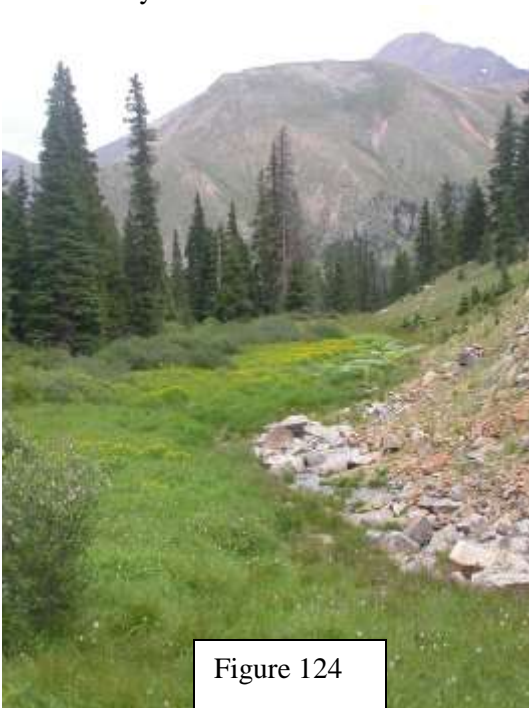
The wetlands in this area are quite lush and productive. From here the stream begins to drop at a much steeper grade. It crosses the road to the Allen Emory mine and drops into a canyon. Figure 124 shows the lush meadows and figure 125 shows the stream as it begins to drop into the canyon.

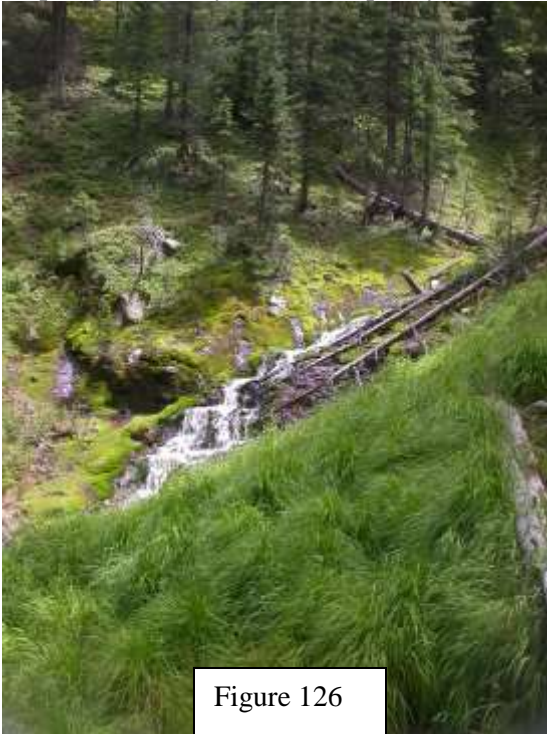
The stream flows down the canyon and is joined by an eastern tributary. This eastern tributary is draining an area of heavy mineralization and hydrothermal alteration. Water quality is naturally low. At the point this tributary joins the mainstem, there is also a significant spring that adds flow to the stream. Just below this point there is a seep of particularly bad water quality

that has killed all the vegetation in the area of the seep. Figure 126 shows the eastern tributary and figure 127 shows the spring. Figure 128 shows the stream just below this confluence and the seep of particularly low water quality.

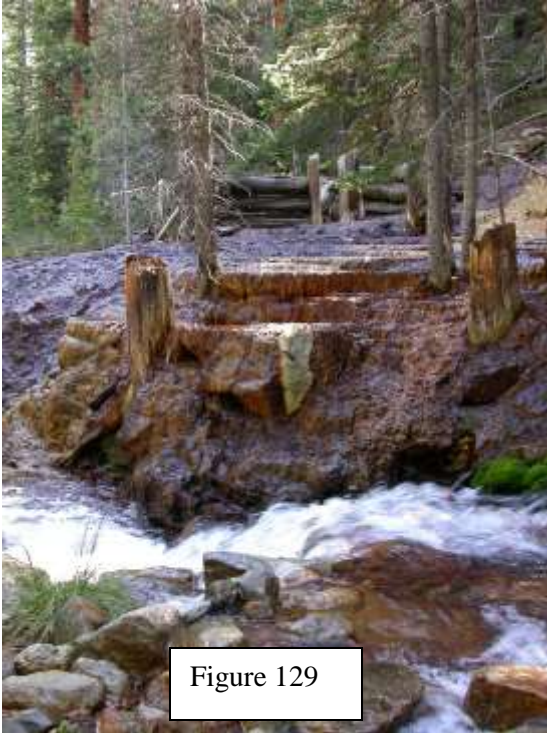
Figure 129

Just a couple of hundred yards below this confluence, where the Allen Emory mine road comes right to the edge of the stream is an old mine. This mine has a leaking adit, waste rock, and ferricrete deposits on the bank. It is a significant source of bad water to a stream with already low water quality. Figures 129 and 130 show this mine. Figure 131 shows the Warden Gulch sampling site just above its confluence with Peru Creek. This is about a quarter of a mile below the mine. Figure 132 shows the confluence of Warden Gulch flow with Peru Creek.

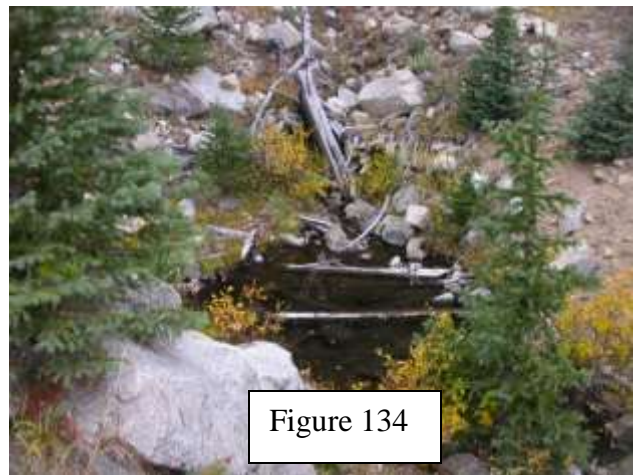
Shortly below this point is the Hunki Dori mine. That mine adit is flowing and constitutes a significant tributary in the gulch. Figure 134 shows the flow from the adit. The USGS sampled Grizzly Gulch in October, 2001. The pH was 6.6 and the metal content was generally low. A sample collected in 2008 and analyzed by River Watch confirms the quality is generally acceptable. As the flow proceeds downstream it joins an eastern tributary and then flows down the gulch. The flow from the gulch joins the Snake in the western part of the flat land associated with the Roberts tunnel access portal.

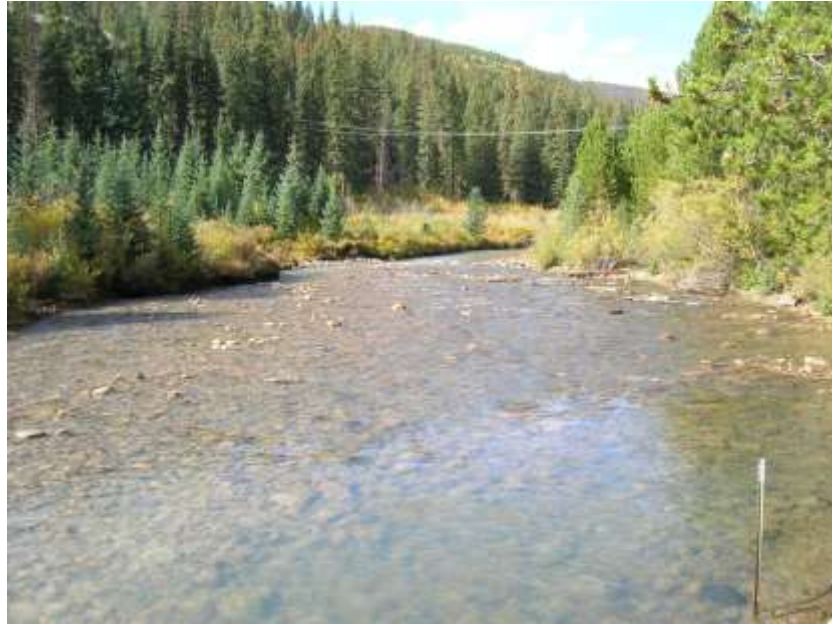
The Snake River at the North Fork confluence (Figure 1) provides quality riffle habitat for both trout and macroinvertebrates. Trout will utilize these types of habitat for spawning, egg

incubation, and initial fry rearing locations. Critical to any trout population is food available; typically, this type of riffle habitat (Figure 1) would be an ideal location for the production of a diverse and abundant community of macroinvertebrates, resulting in a significant food source for trout. During this visual survey, a number of trout were observed in the North Fork side of the confluence (Figure 2.); in the absence of poor water quality conditions in the Snake River side of the confluence, we would expect to have trout present also.

Figure 1. Excellent Riffle Habitat at the Snake River & North Fork Confluence.

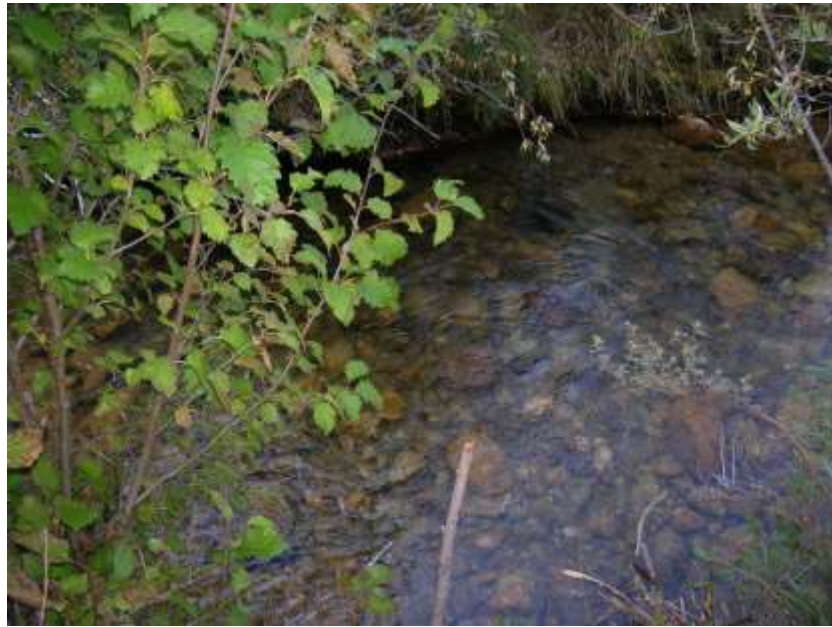
Figure 2. North Fork at the confluence of Snake River.

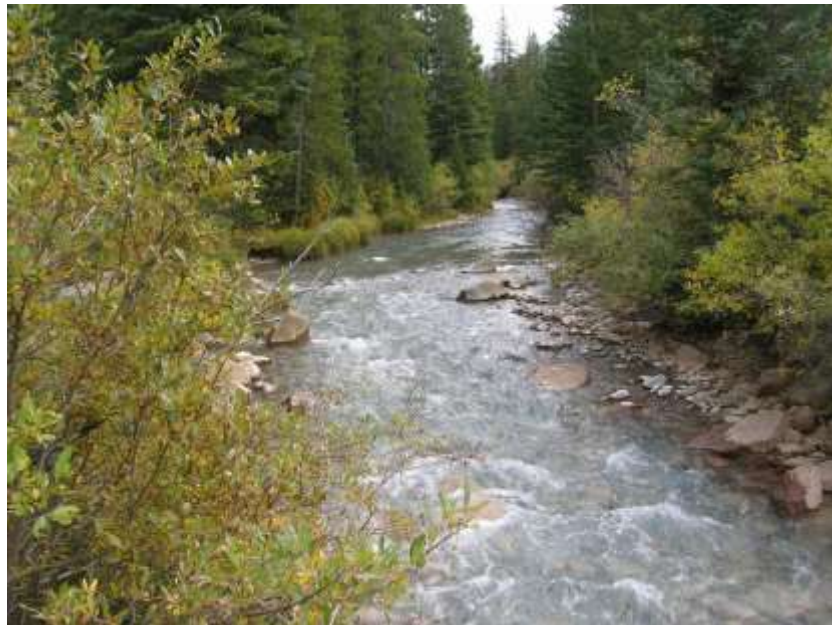
The Snake River from the North Fork confluence upstream to the confluence with Deer Creek provides a good mixture of runs and high and medium grade riffles (Figure 3). In addition, a number of pool habitats types were evident during the survey (Figure 4). Based on these limited visual surveys the Snake River provides good to excellent physical habitat for trout.

Figure 3. Excellent Trout Habitat, Snake River.

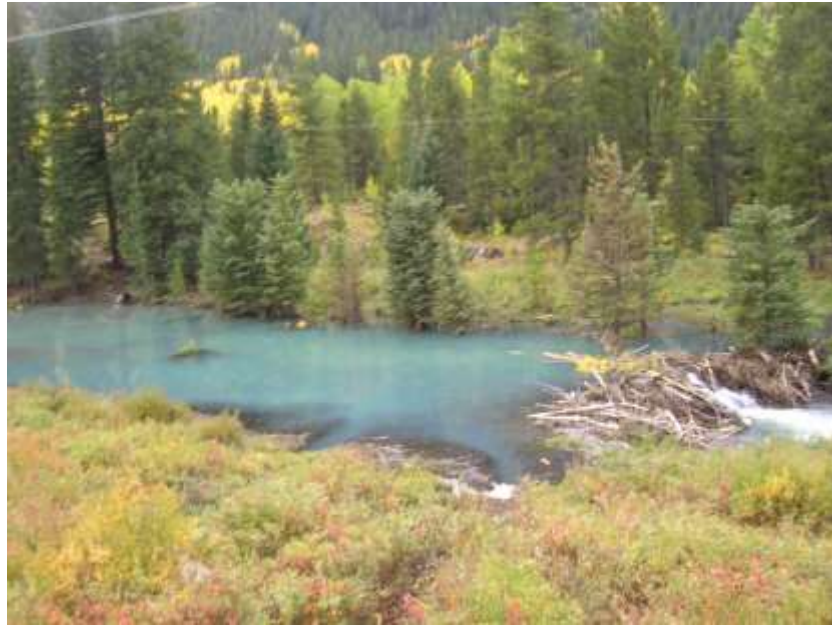
Figure 4. Beaver Pond Pool Providing Cover Refugia For Trout .

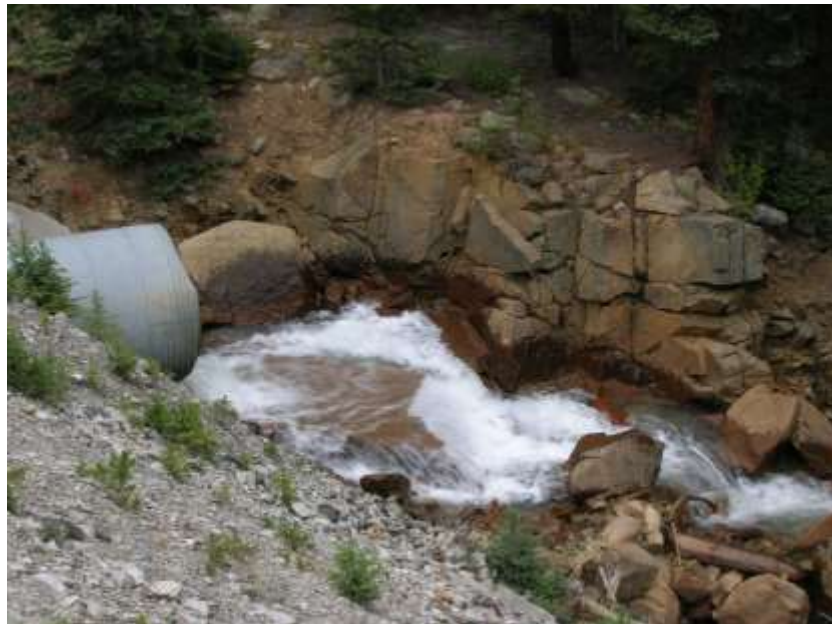
The only problem we noted on our survey was the culvert and associated habitat at the road crossing, just upstream of the Peru Creek confluence (Figure 5), maybe impassable to trout moving upstream. Due to the narrow channel and high gradient in this stream section, it is probable that the culvert poses a potential barrier to trout movements. The overall height of the culvert from the stream bed and the lack of pool for fish to rest and jump from would result in trout not being able to freely move upstream during normal or low flow conditions. During high flows, the velocities inside the culvert may be extreme, thus inhibiting fish from swimming through the culvert.

Figure 5. Culvert Barrier on the Snake River

In conclusion, based on our visual evaluation of the Snake River we found abundant habitat types that would be excellent for a trout population, particularly, in the stream section downstream of the culvert (Figure 5). If water quality conditions in this stream section were improved to within the tolerance limits of trout, even on a seasonal basis, then we would expect to see trout population. If conditions were greatly improved, then a sustaining trout population could be maintained in this section.

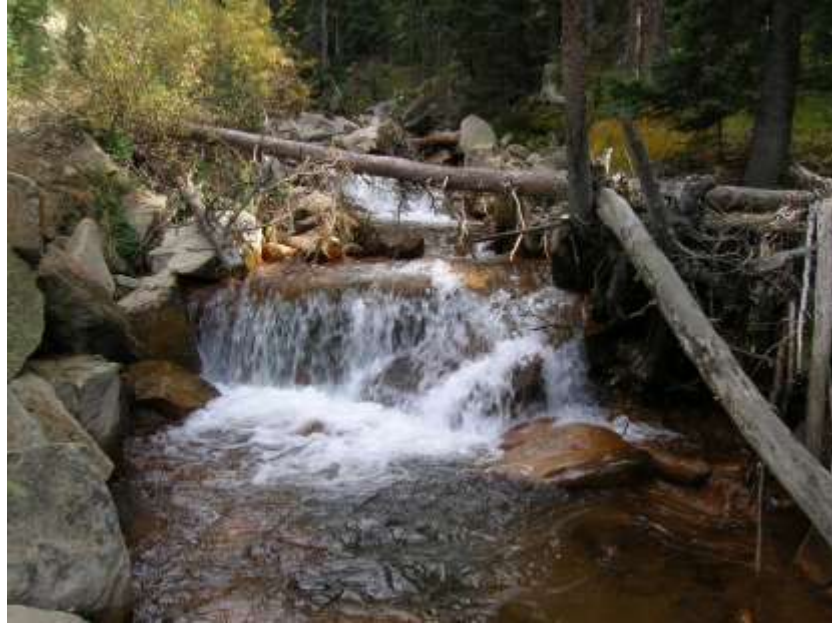
Peru Creek is heavily impacted from poor water quality conditions which will prohibit a trout population for many years, if conditions improved significantly in this stream, and then abundant physical habitat would be available in the form of riffles and high gradient riffles with associated plunge pools (Figure 6).

Figure 6. Typical Step-Pool or Plunge Pool on Peru Creek.
