Re: Contract Number: EP-S7-13-07
Technical Direction Document Number: 14-06-0006
Final 2016 Removal Action Report, Bonanza Mine Site, Nonpariel, Oregon

2016 REMOVAL ACTION REPORT

**Bonanza Mine Site
Nonpareil, Oregon
TDD: 14-06-0006**

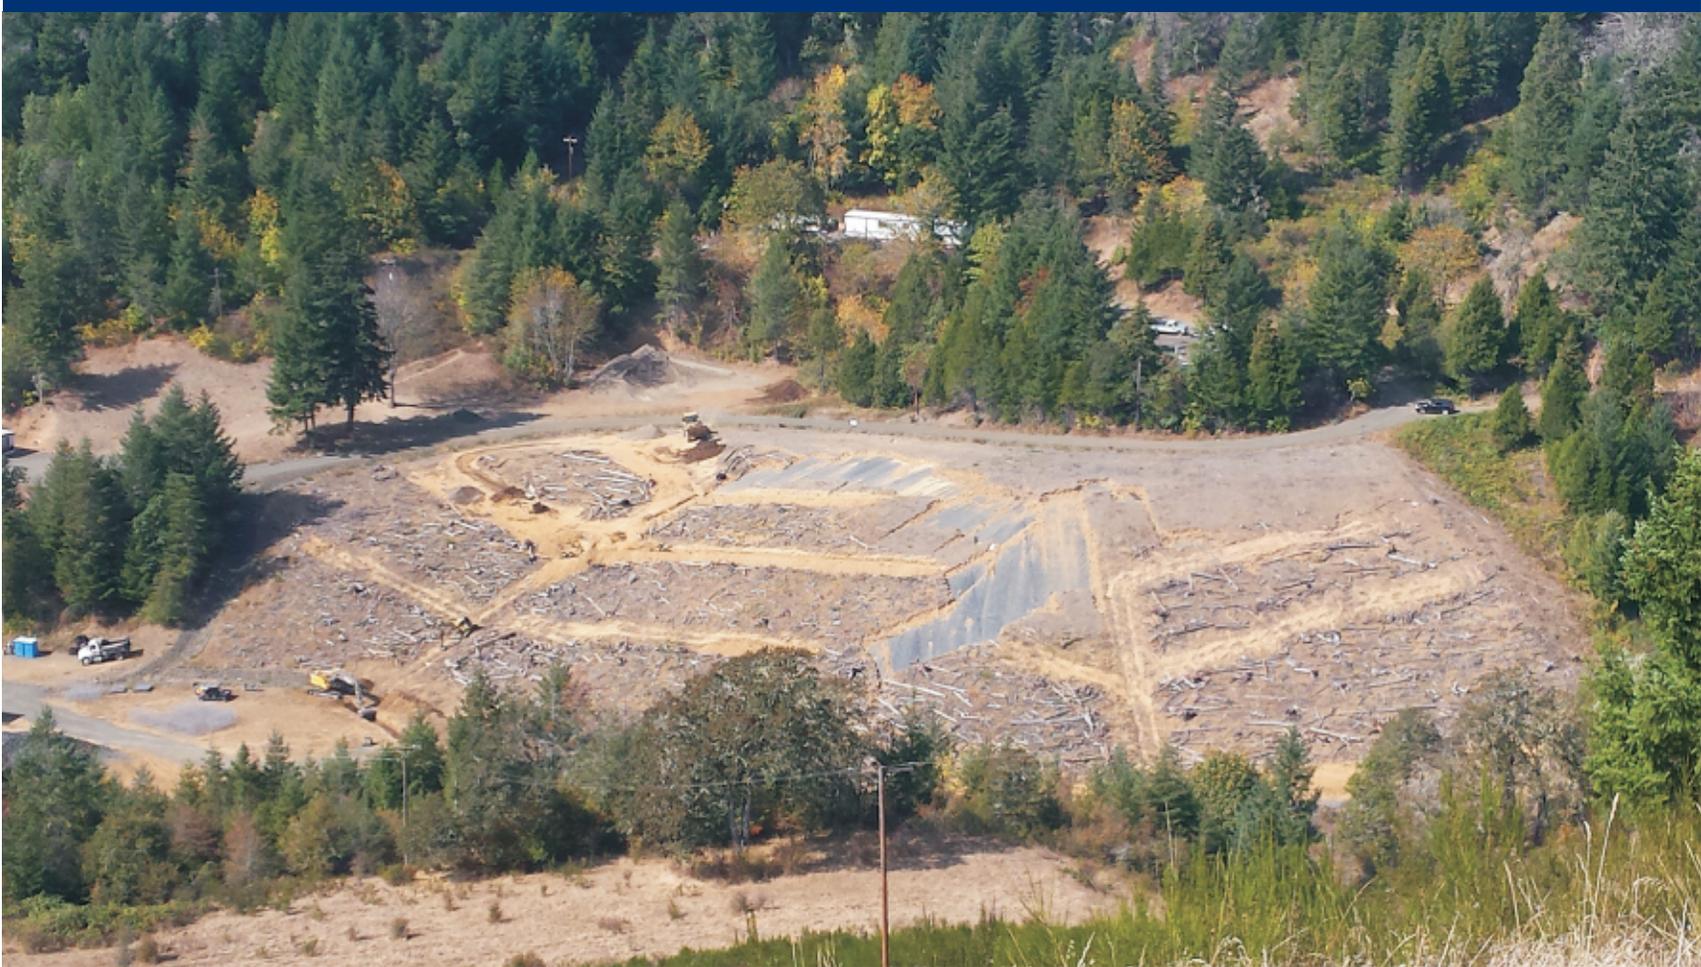
Photo 1 View of repository, showing areas cleared for subsurface drain installation.

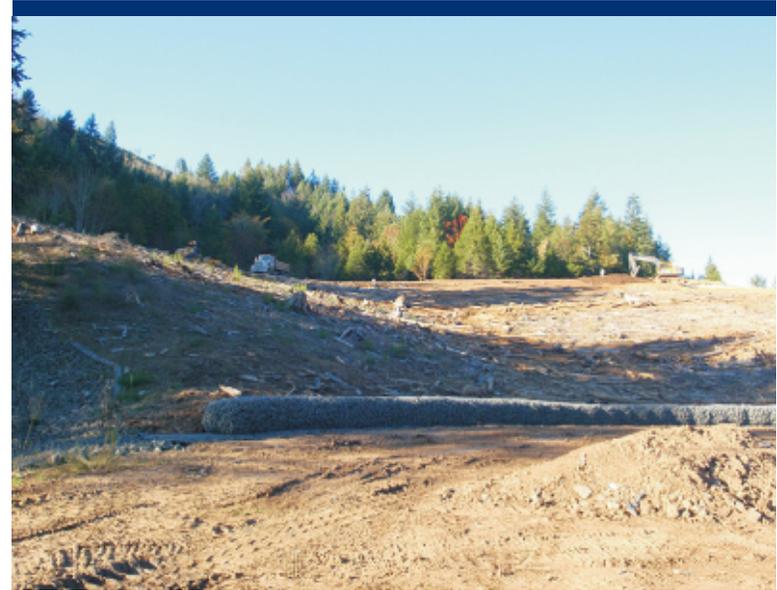
Photo 11 Southwestern end of gabion wall.

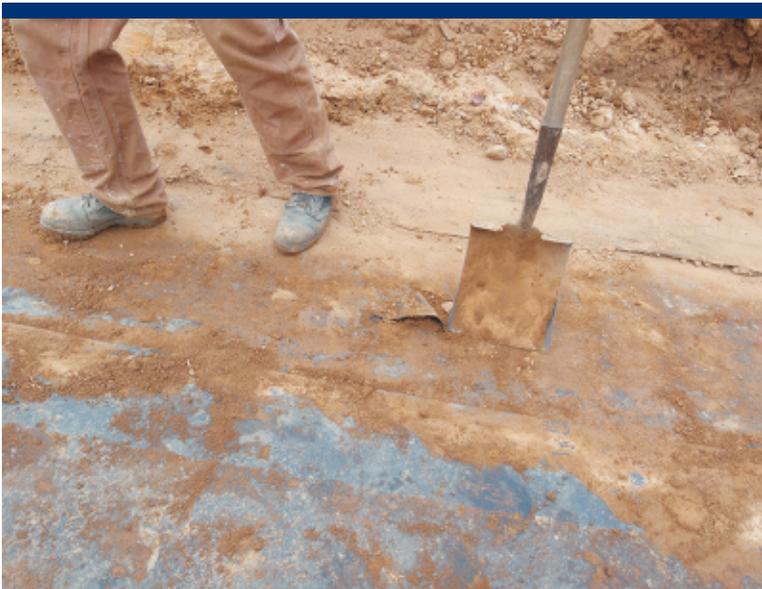
Photo 12 Tear in LLDPE, prior to repair.

During the Removal Action in September 2017, START and ERRS identified several punctures in the exposed areas of the LLDPE liner which were subsequently patched. Based on discussions with the residents living near the site, and on the discovery of an apparent home-made sled on the liner that consisted of a board attached to a skateboard with numerous exposed nails, it appeared that the local children had been sliding down the exposed LLDPE cover, which likely caused the damage.

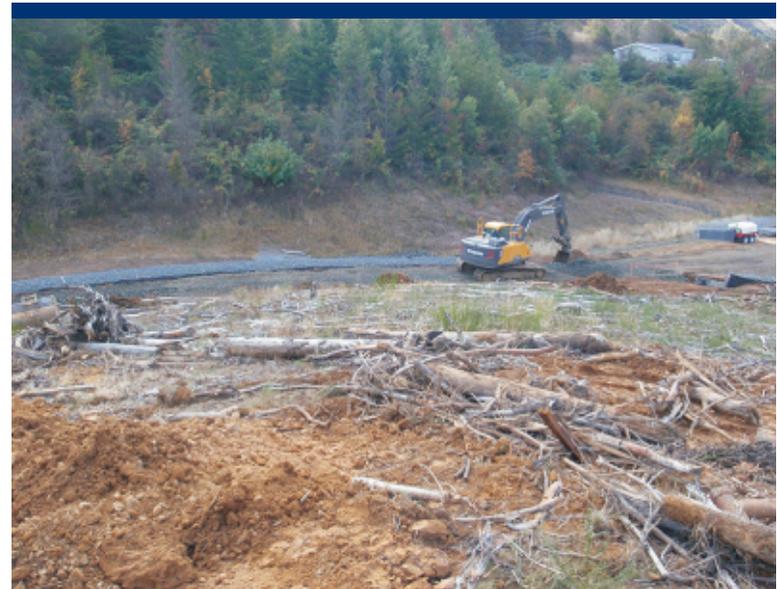
Photo 13 Backfilling behind gabions.

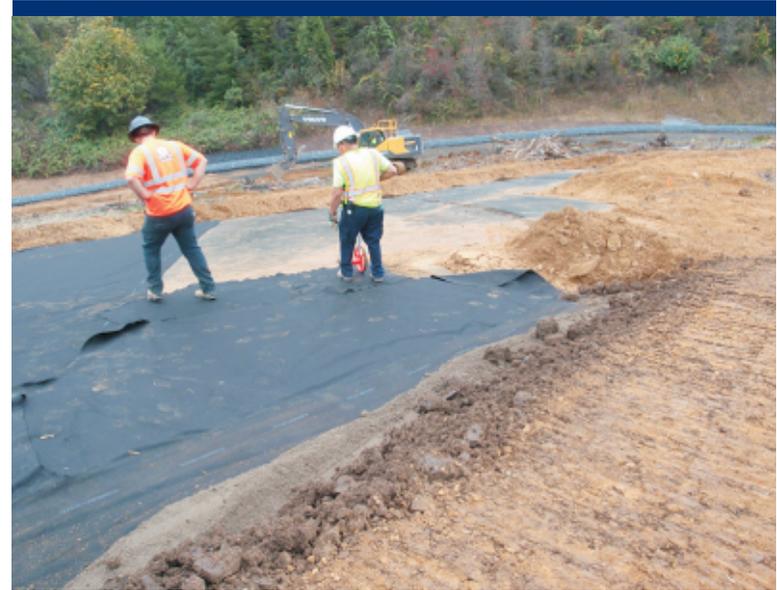
Photo 15 Placing geotextile.
