RE: Contract No. EP-S7-13-07; Technical Direction Document No. 14-06-0006
Bonanza Mine Site – DRAFT After Action Report and Alternatives Analysis

**DRAFT AFTER ACTION REPORT AND
ALTERNATIVES ANALYSIS**

**Bonanza Mine Site
Nonpareil, Oregon
TDD: 14-06-0006**

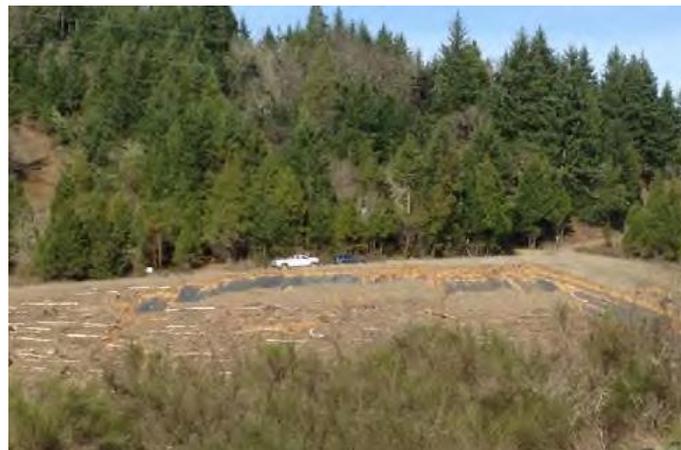
Photo 2-1: Slide areas.

The south face had less area of vertically exposed liner and the slide had occurred in the southern direction along the orientation of the underlying drainage layer seams. Starting from the upper location of the

south face slide, the northeast face had slid to the east along the orientation of the underlying drainage layer. The northeast face had more exposed liner since it had slid a greater distance toward the repository toe. Upon both slide faces, the zone of depletion (the area where cover material slid leaving it lower than the original ground surface) removed both the cover soil and the GDC drainage material down to the LLDPE liner. A zone of accumulation (the area at the bottom of the slide where cover material accumulated above the original ground surface) was observed below each of the slide areas as mounding of soil deposited in a

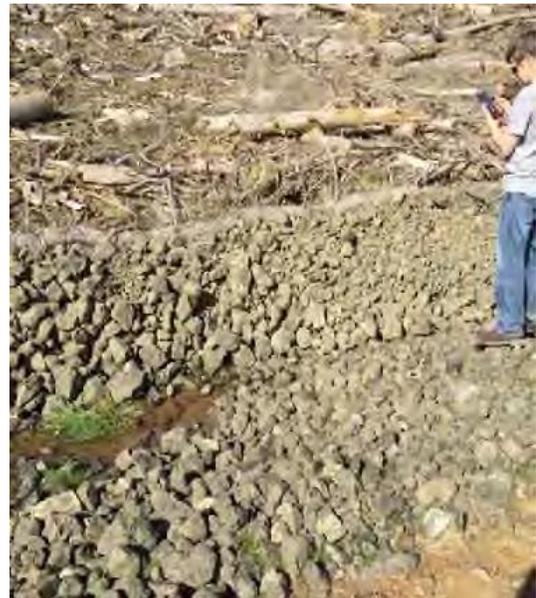
Photo 2-2: Toe drain seep below the southeast face of the repository

START also identified one seep within the toe drain of the southeast face of the repository (Photo 2-2). The seep had eroded a hole within the rock channel and appeared to have been flowing for a long period based on the amount and size of vegetation clusters downgradient. Flow from the seep was draining through a second culvert pipe that passes beneath the driveway to Residence 3. START measured the flow coming from this pipe using a 5-gallon bucket and determined it to be approximately 17.5 gallons per minute. This flow represents drainage from the south and southeast faces of the repository and the identified seep. There was no water flowing from the culvert that drains the Mill Area during the Site inspection. By January 25, surrounding weather stations had measurable precipitation for 22 of the 25 days in January. Selected rainfall and temperature data for weather stations near the Site are included in Appendix B and discussed in the next section.

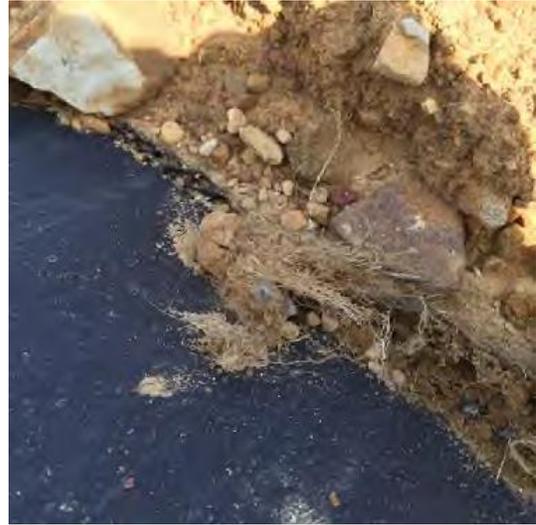
Photo 2-3: Repository cover soil consisting of an earth-rock mixture

The soil observed along the edges of the slide consisted of an earth-rock mixture (a mixture of cohesionless and cohesive soils, gravels, and cobbles) (Photo 2-3). This cover soil had been sourced from an on-Site location near the EPA Command Post.

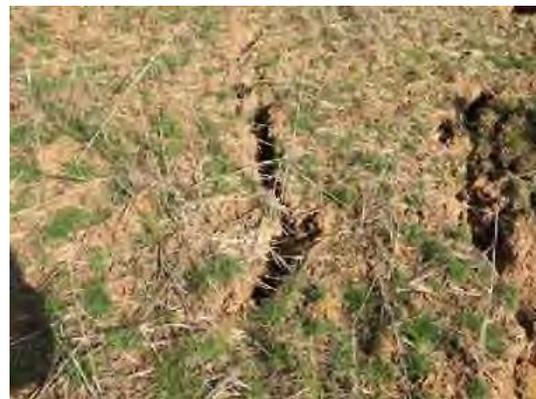
Photo 2-4: Vegetation density on the repository cover

During the February Site inspection, it was noted that vegetation was sparse across much of the repository cover. A large percentage of the vegetation appeared to have died off over the winter. Small patches of perennial vegetation were present but were not at a density that was providing full coverage (Photo 2-4). During the removal action, as a result of project schedule, budget constraints, and limited availability of suitable import top soil, the planned 6-inch top soil cover was eliminated and replaced by additional on-Site borrow soil material to serve as the final surface cover. A 16:16:1 fertilizer pellet blend was applied to the soil surface, and a turf grass seed mix was broadcast over the repository. The slash that was preserved and

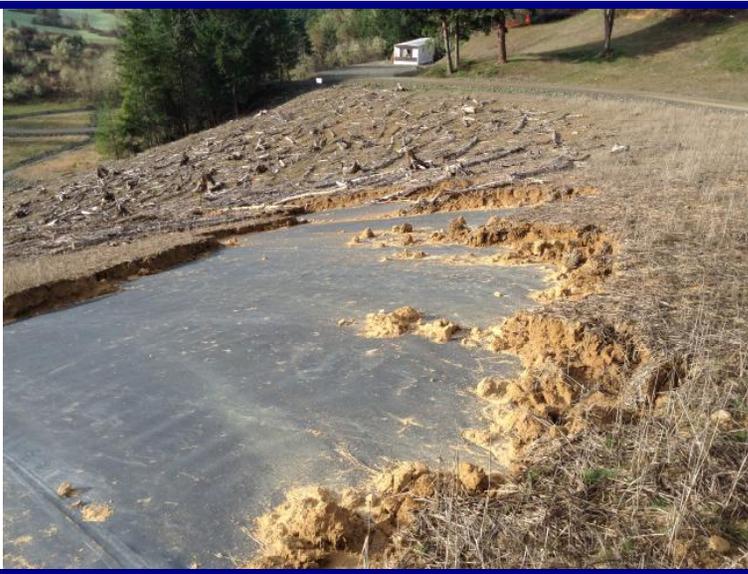
325.jpg Date: 2/25/16 Time: 08:07 Direction: Southwest

Western, upslope area of repository where cover soil and drainage layer has slid, exposing linear low-density polyethylene (LLDPE) liner. (E&E photograph.)

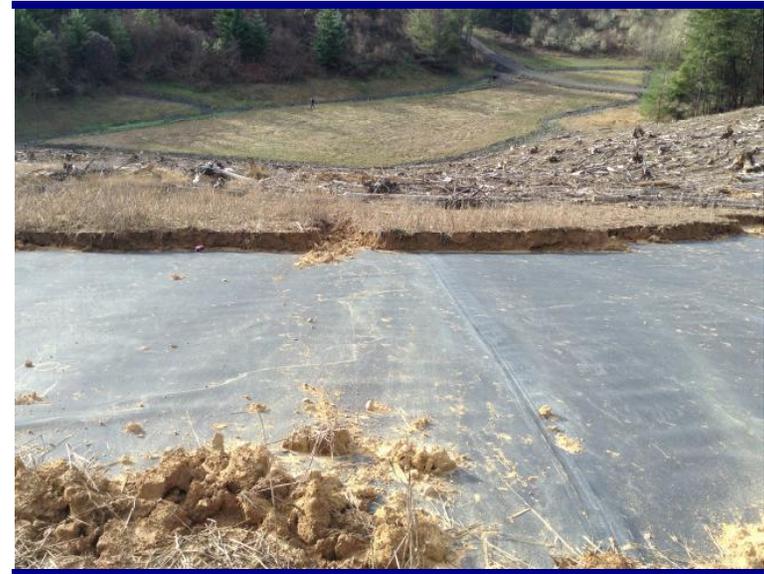
326.jpg Date: 2/25/16 Time: 08:07 Direction: Southeast

Exposed LLDPE liner. (E&E photograph.)

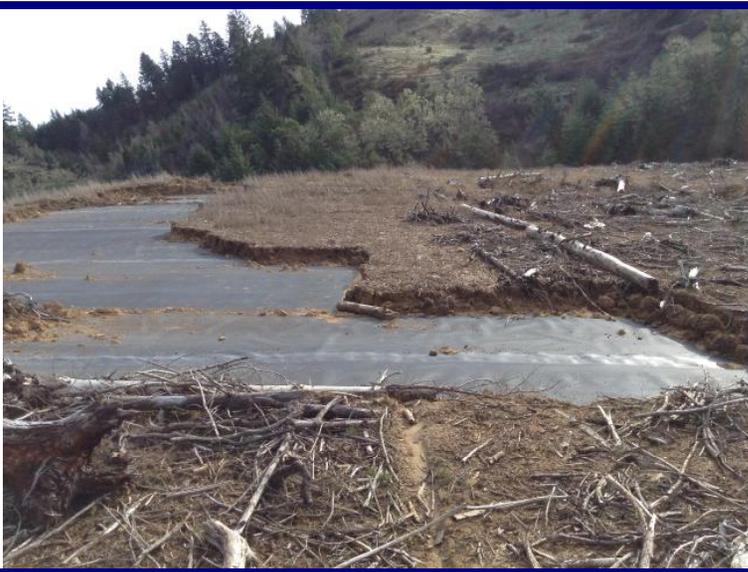
334.jpg Date: 2/25/16 Time: 08:09 Direction: Northeast

Exposed LLDPE liner in upper slope of northwestern side of repository. (E&E photograph.)

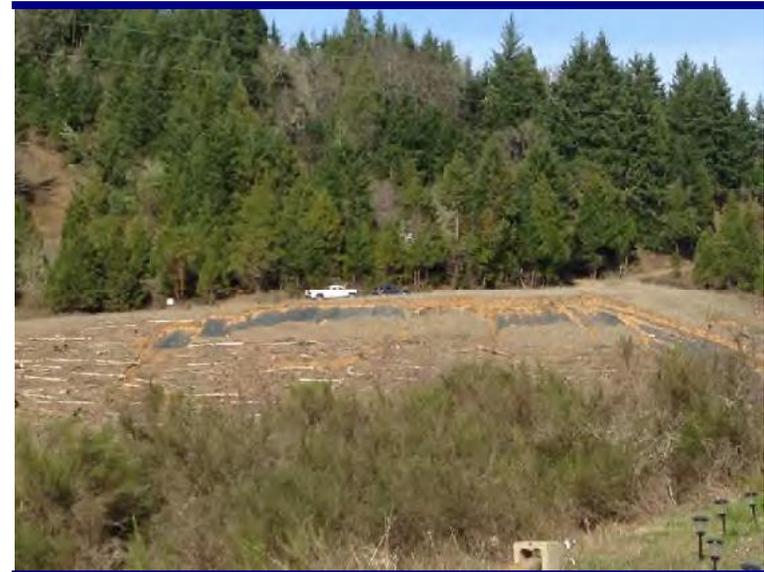
IMG9216.jpg Date: 3/1/16 Time: 10:54 Direction: Northwest

Eastern side of repository, with areas of exposed LLDPE liner on upper slope. (E&E photograph.)

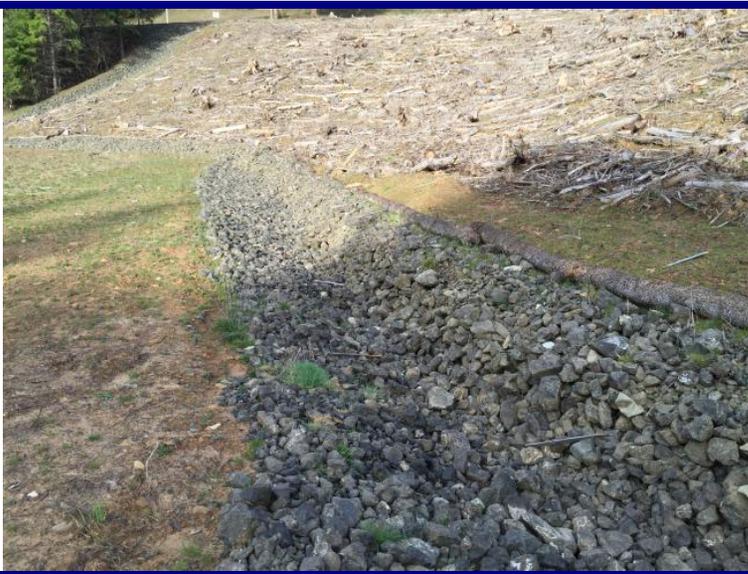
IMG_0245.jpg Date: 3/1/16 Time: 10:08 Direction: West

Toe drain ditch at bottom of repository, western side. Note the side of the rock-lined ditch nearest the repository has steepened due to slope movement. (E&E photograph.)

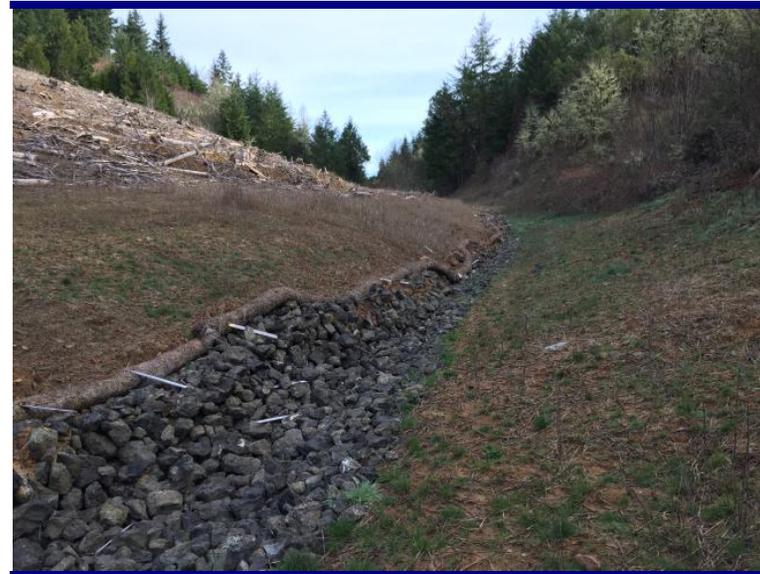
IMG_0254.jpg Date: 3/1/16 Time: 10:12 Direction: Northwest

Alternate view of toe drain ditch at bottom of slope, western side of repository. (E&E photograph.)

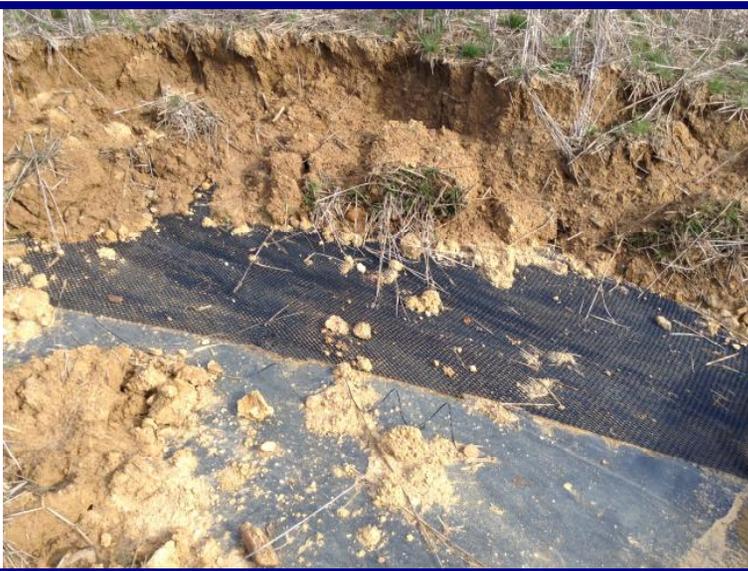
360.jpg Date: 2/25/16 Time: 09:18 Direction: East

Exposed LLDPE liner and drainage layer after slope displacement. Note that filter fabric component of drainage layer is not present at this location. (E&E photograph.)

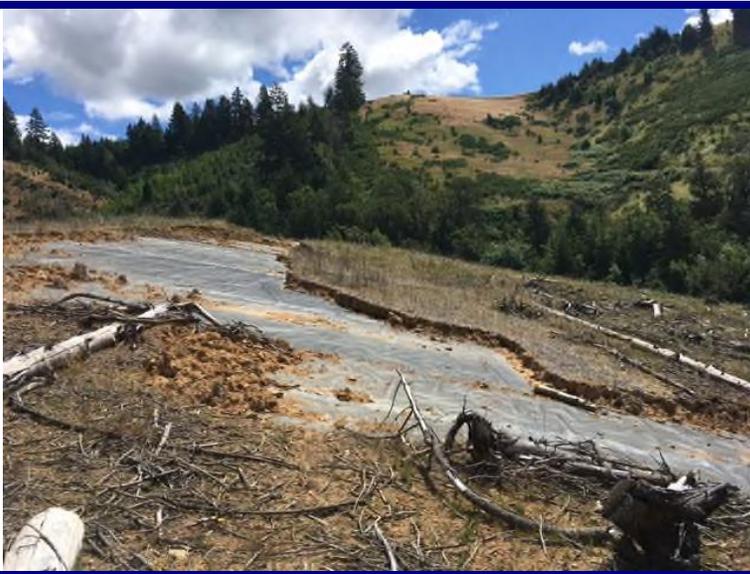
IMG_0456.jpg Date: 6/24/16 Time: 11:09 Direction: Northeast

Exposed LLDPE liner observed in June 2016. There appears to be little or no change in the area of exposed liner from conditions seen February 2016. (EPA photograph.)

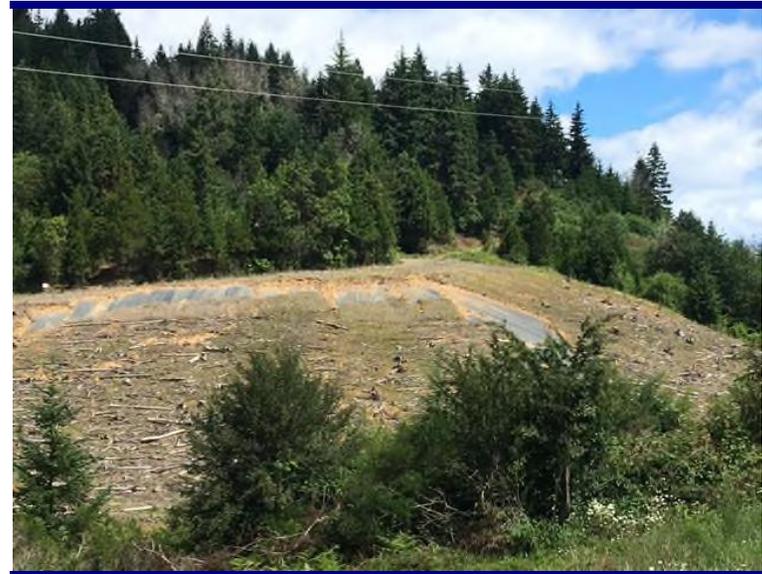
IMG_0473.jpg Date: 6/24/16 Time: 11:29 Direction: North

Repository with exposed LLDPE liner observed in June 2016. There is little or no apparent change from conditions observed in February 2016. (EPA photograph.)

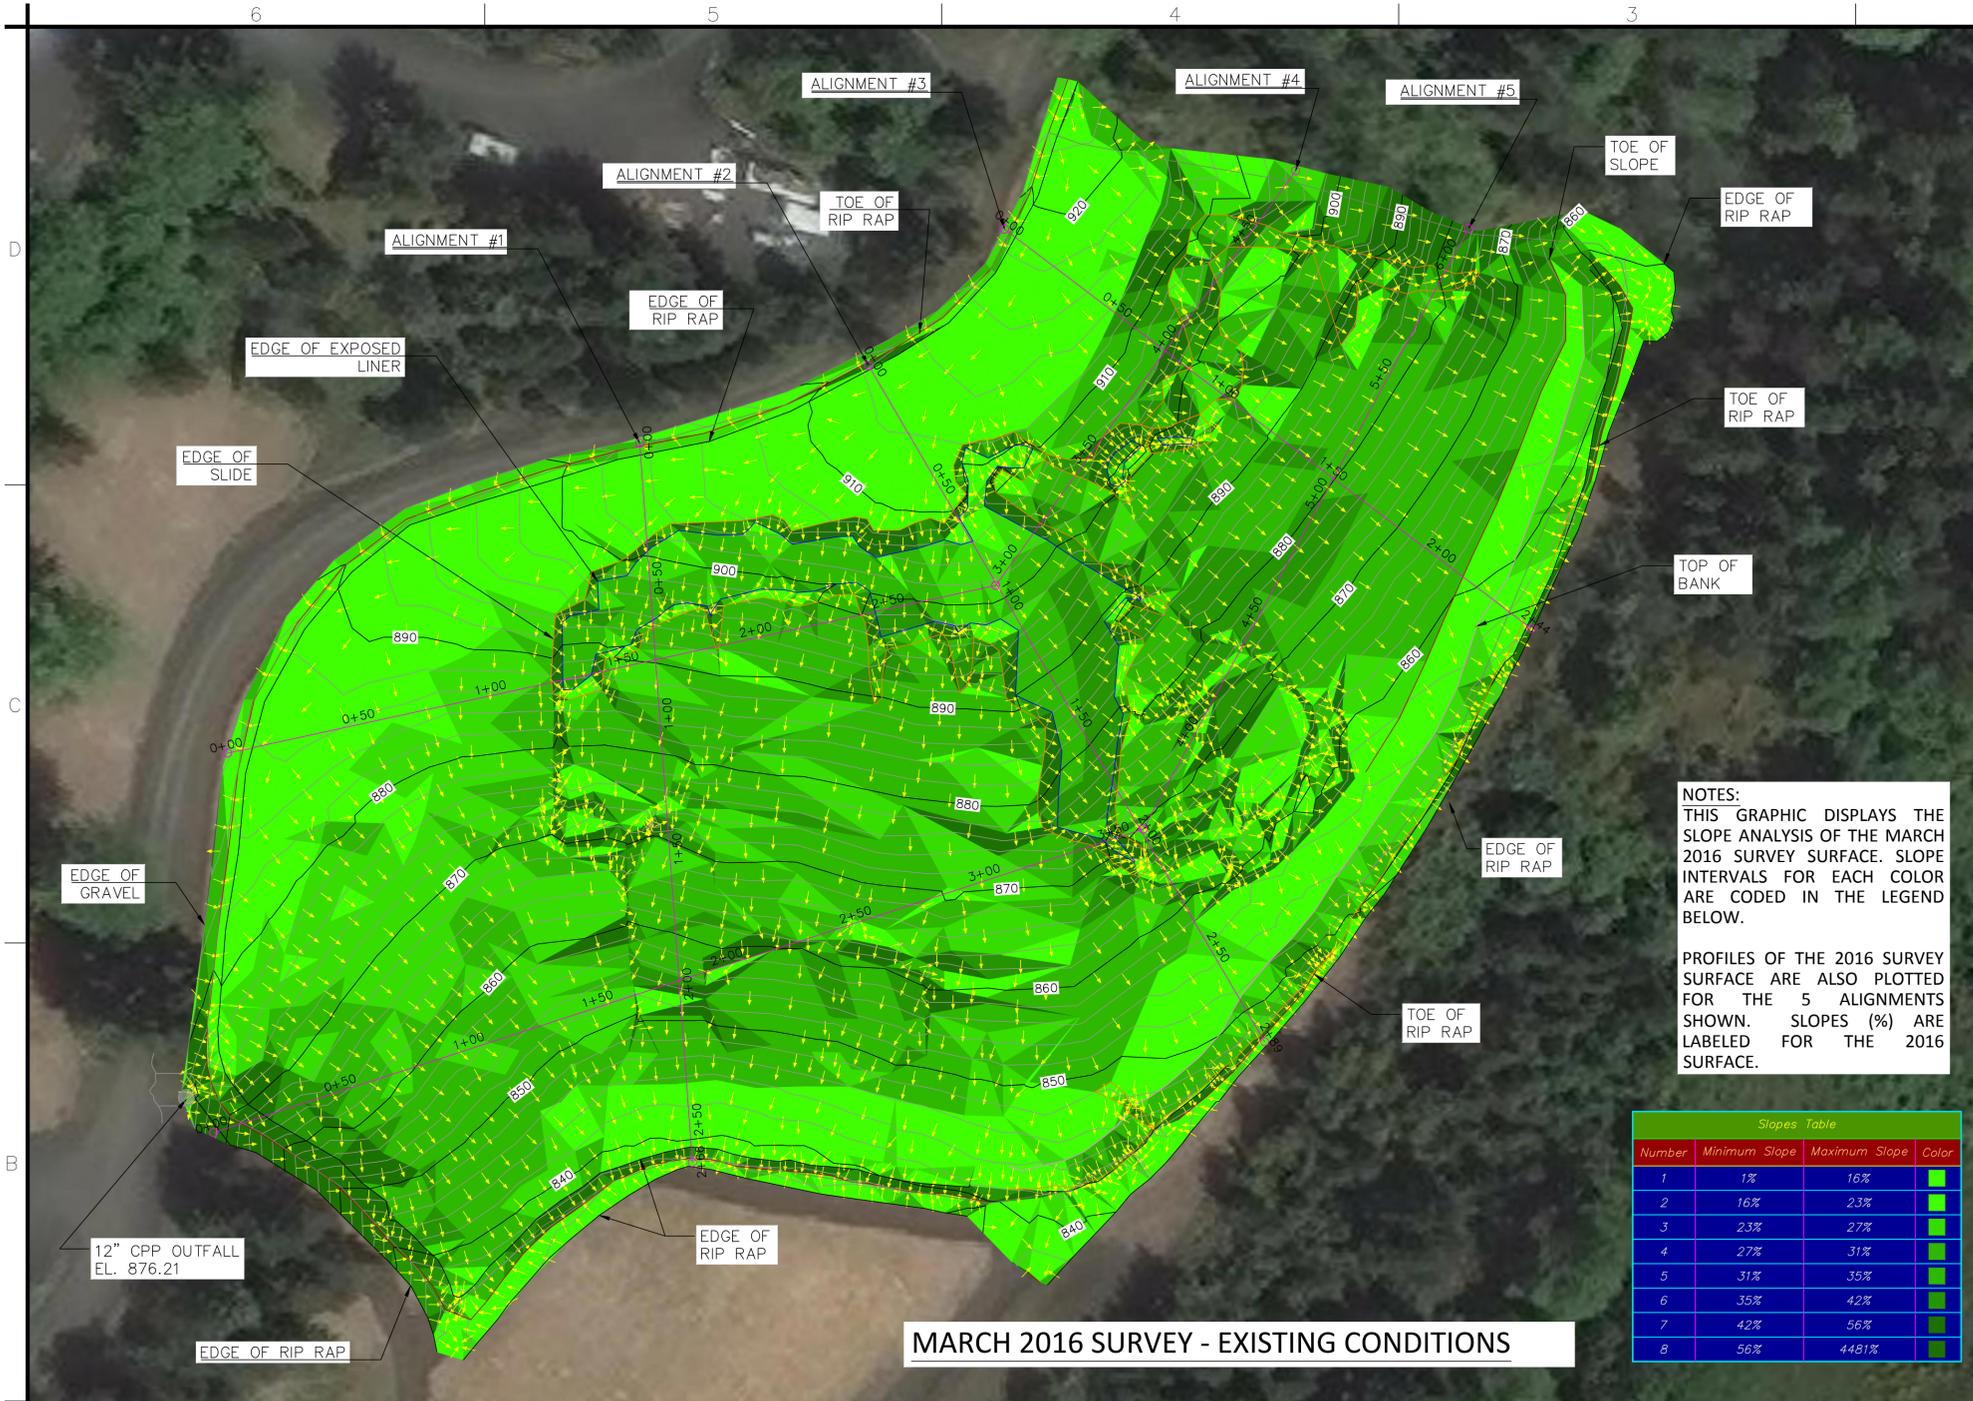
MARCH 2016 SURVEY - EXISTING CONDITIONS

A topographic survey of the repository surface was conducted on March 21, 2016 by Centerline Concepts Land Surveying, Inc. (Centerline), Oregon City, Oregon. The survey was performed in order to provide additional information on the repository surface following the slide. Centerline tied the survey into previous surveys that they had performed at the Site. Throughout 2014, Centerline performed six separate surveys to support the removal action. The initial survey was performed in June 2014 to prepare an existing conditions map of the waste rock and calcine piles. START used this information to design the on-Site repository. During construction of the repository, Centerline performed three additional surveys to assess its size and scope. Specifically, the increased area of the repository required a concomitant increase in repository liner material. A boundary survey was prepared in mid-October during the search for potential on-Site borrow source material and to assess potential locations for the replacement of manufactured homes. Centerline performed a record (as-built) survey upon conclusion of the 2014 removal action to document Site conditions, drainage features, and utilities. Topographic surveys from June 2014 (initial conditions survey), November 2014 (record survey), and March 2016 (post-slide survey) are presented in Appendix D.

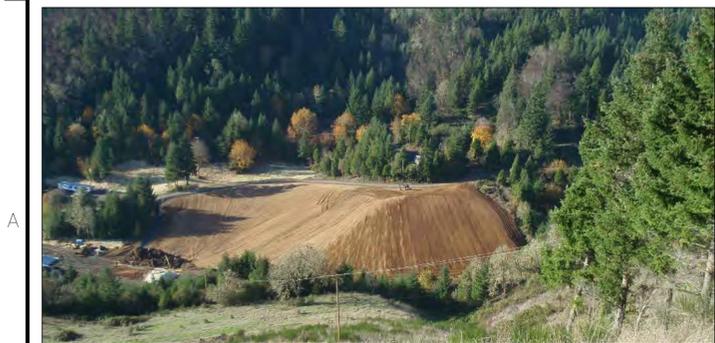
PHOTOGRAPH OF REPOSITORY COVER NEAR COMPLETION, NOVEMBER 5, 2014.
