**EPA R6 and ERT Dive Team Operations
SUMMARY REPORT
Cap Assessment and Sampling Activities
San Jacinto Waste Pits
Channelview, TX
September 6 to 15, 2017**

The current investigation, conducted by U.S. EPA Region 6 and ERT dive teams during September 11 to 15, 2017, was designed to safely conduct diver assessment of TCRA Cap integrity. The diver survey focused on the northwest area of the armored cap and the cap slope area, where the underwater cap slopes at about a 1.5:1 ratio down toward the outer boundary of the cap. During the diver assessment, discussions with the RPM led to implementation of a joint EPA-PRP diver surficial sediment sampling event. The purpose of the sampling was to determine if any areas identified as AOIs, or exposed soft sediment with no rock/cap material present underneath, may contain dioxins or furans from waste material, which could migrate off-site and into the environment.

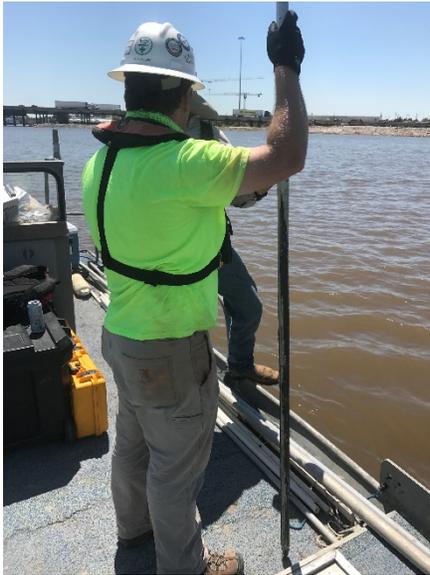
September 7, 2017

Anchor contactor with 18ft probe that was used for initial probing operations. Sediments on probe are thick and grey in color.

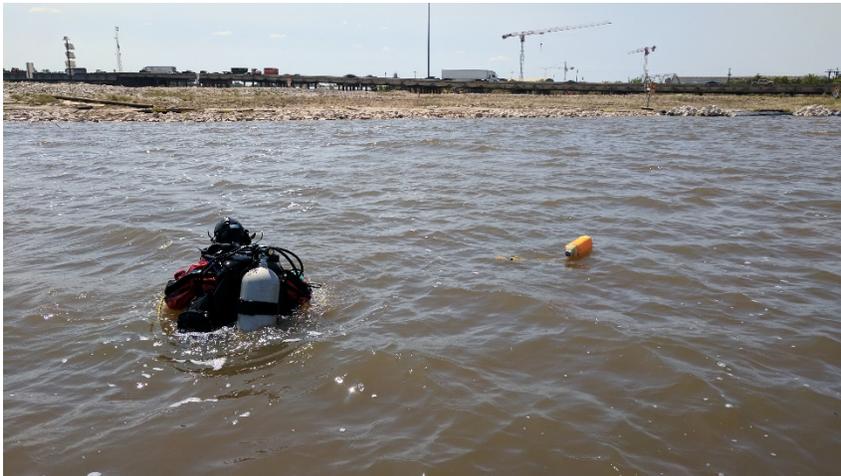
September 11, 2017

EPA Diver doing initial inspection of Probing AOI locations 146a and 146b.

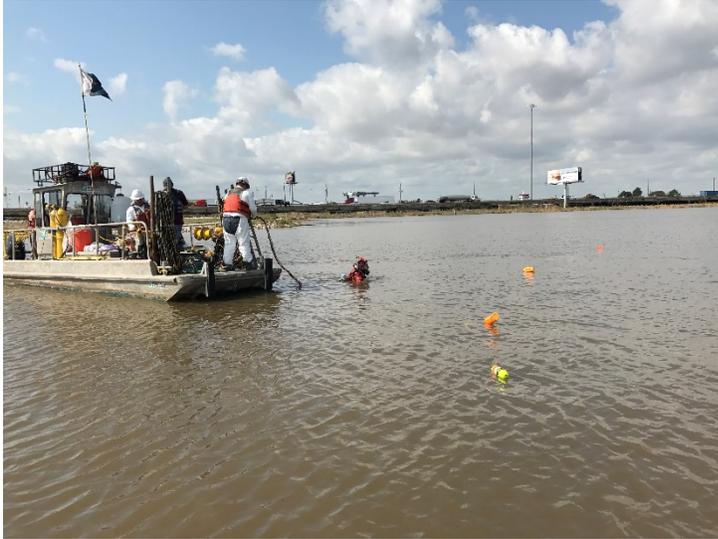
September 15, 2017

Orion diver headed to first sampling location. The three locations closest to diver are sample locations 20, 21, and 22, and are considered to be on-the-cap. The buoy furthest out is location 23, and is the corresponding off cap river sediment sample location for sample 20.

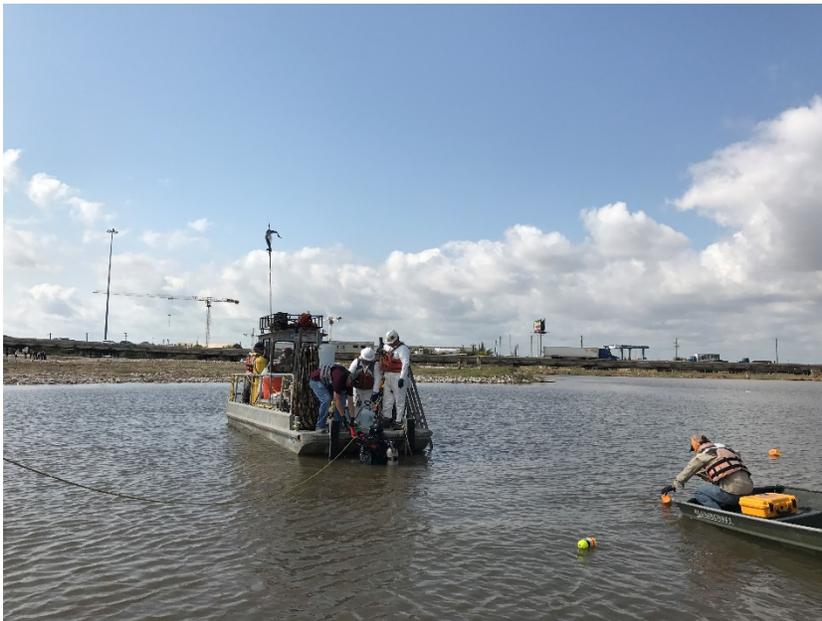
September 15, 2017

EPA diver is delivering sample to contractor's boat. Additional contractor on john boat is confirming buoy location after sampling, to ensure samples were taken in original location.

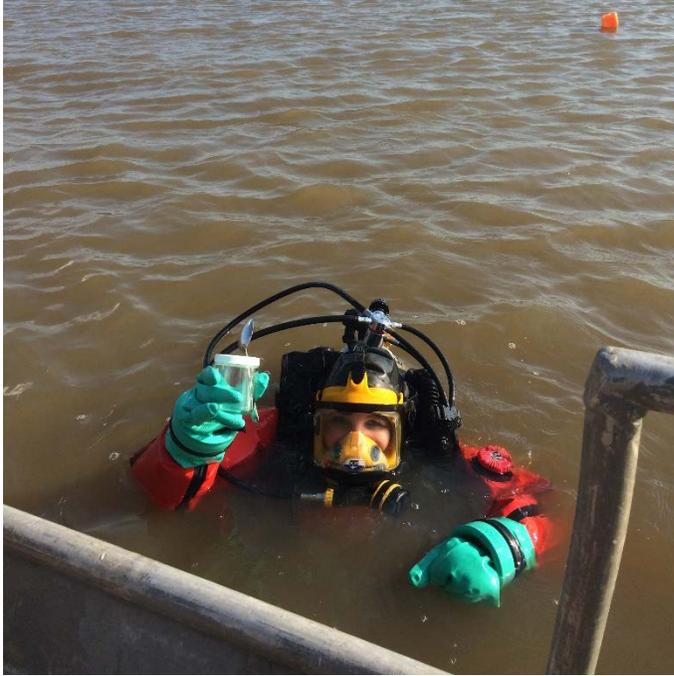
September 15, 2017

EPA diver with empty sampling container and spoon used to collect sample.

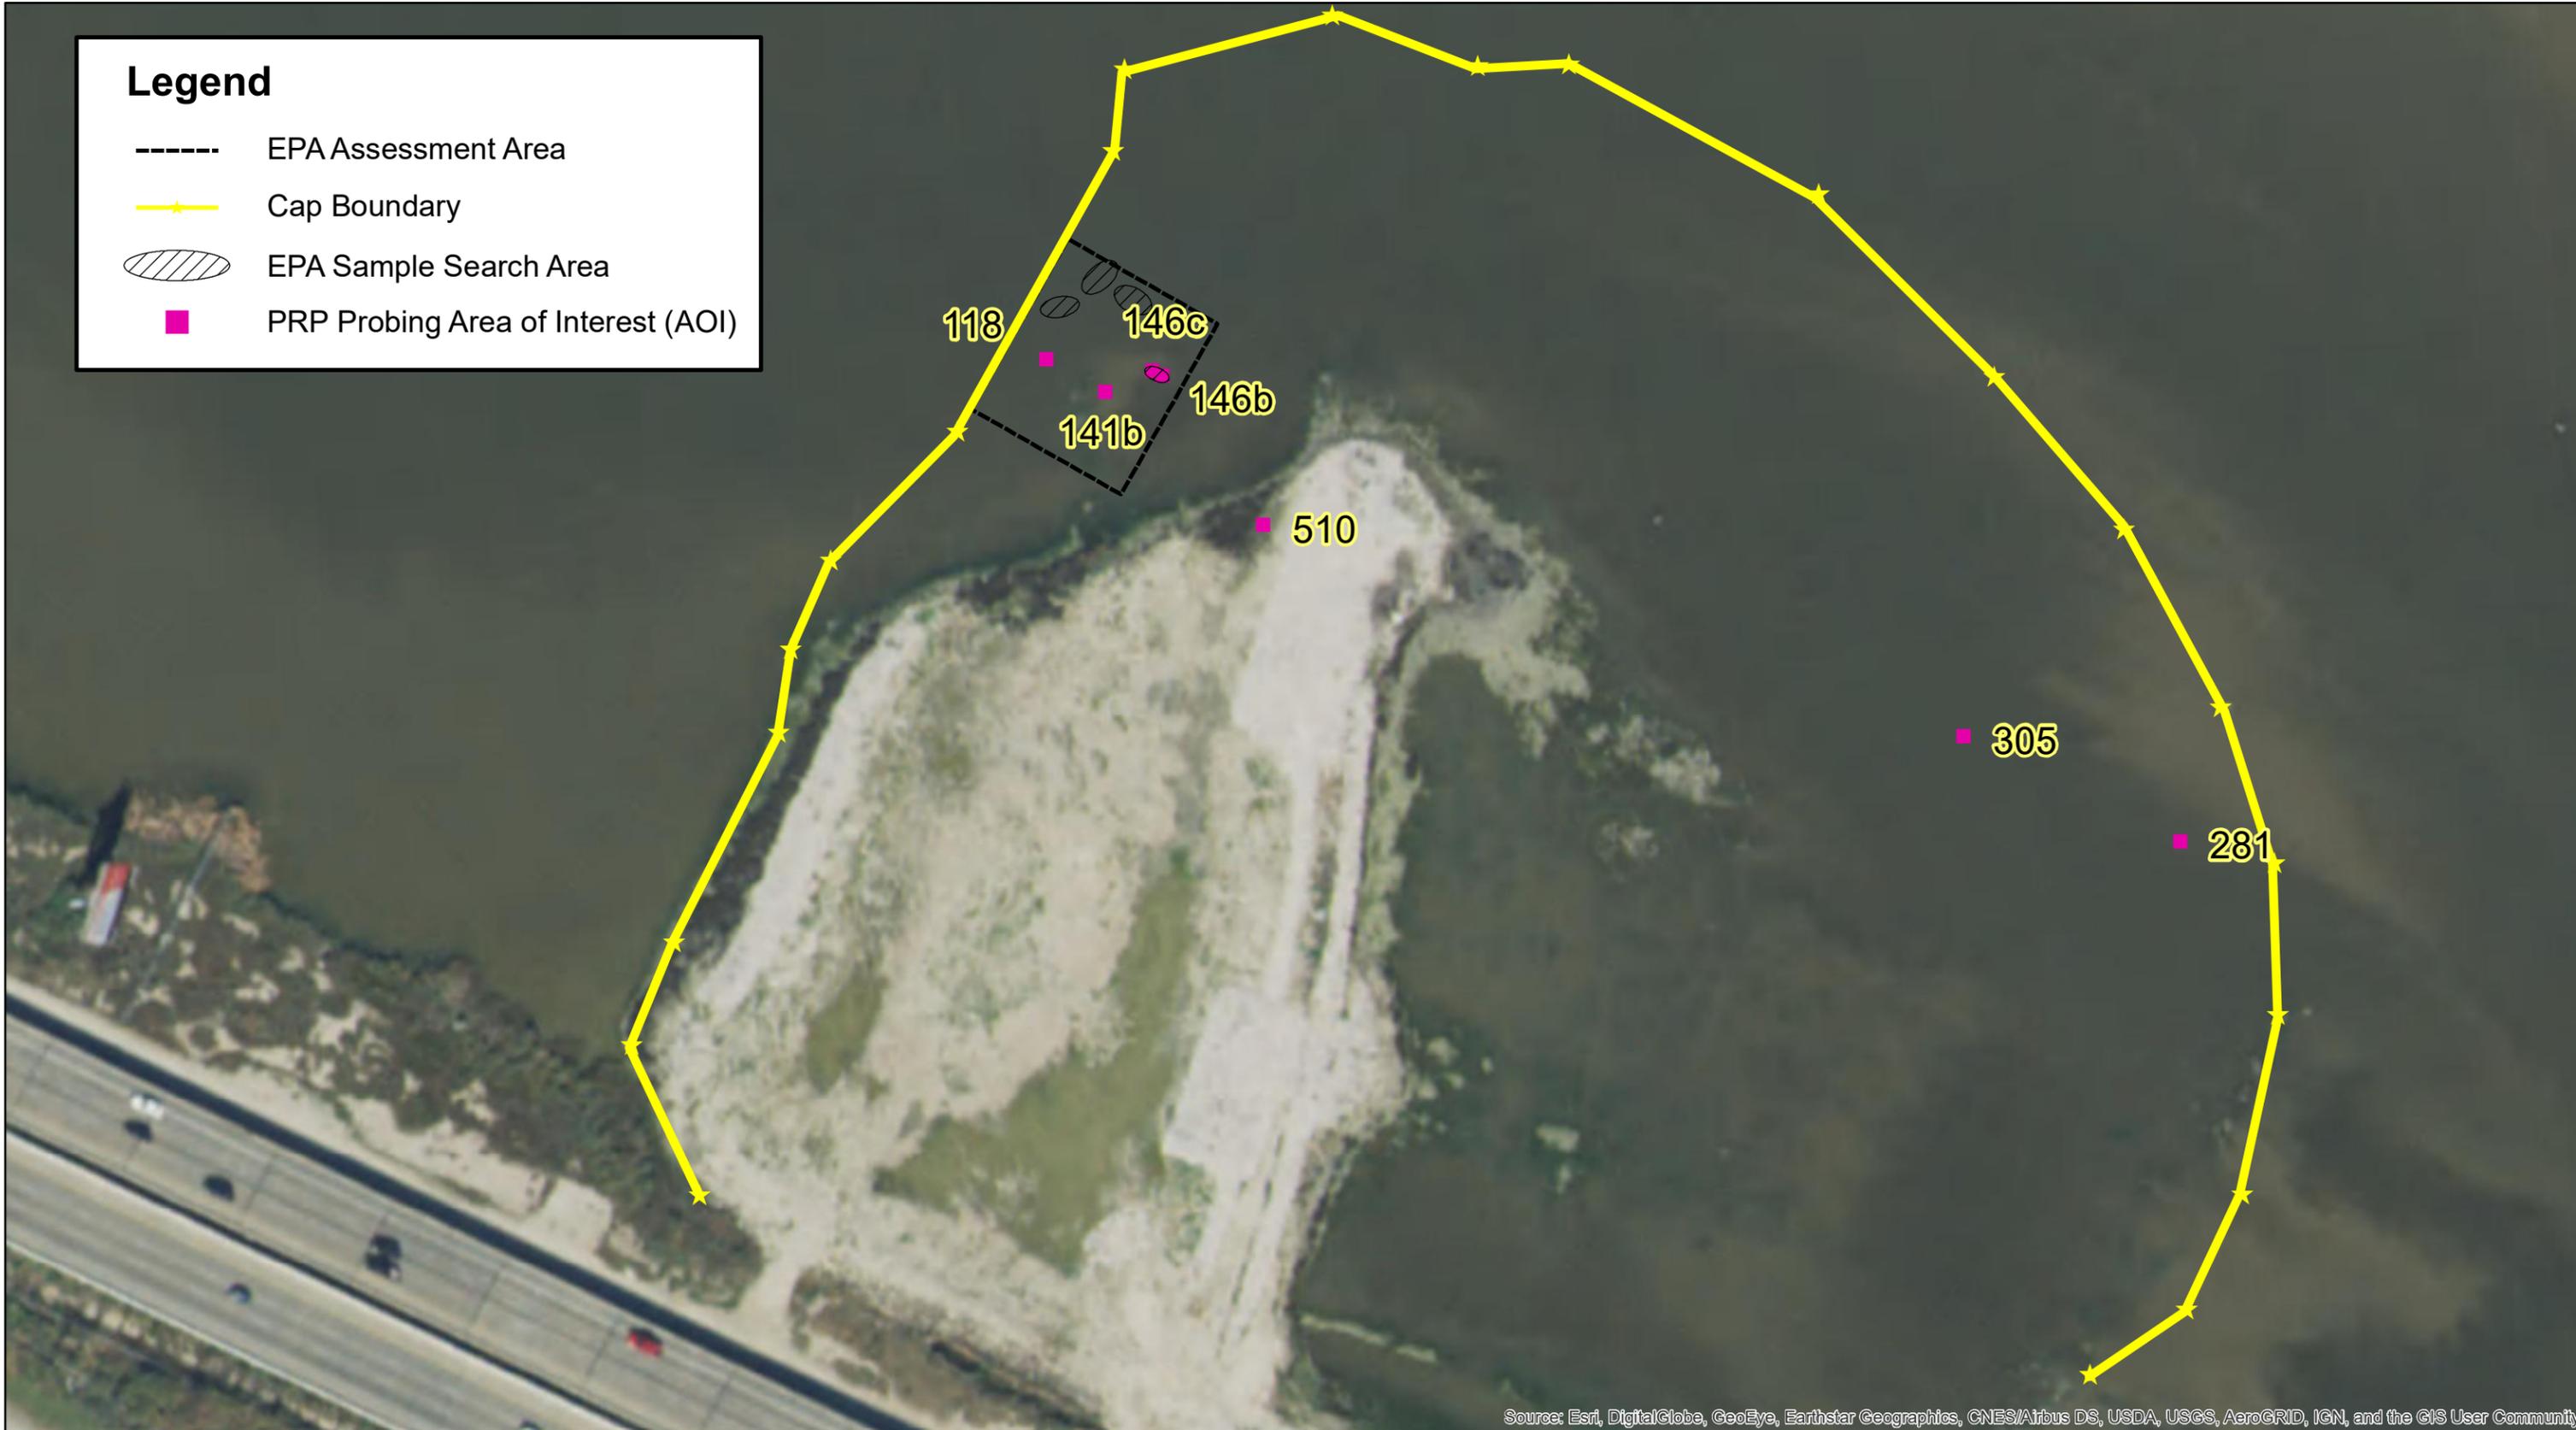
Figure 1
Map of Probing AOIs and EPA Assessment Areas
San Jacinto Waste Pits
Channelview, TX

The EPA Dive Team, using Probing AOIs provided by the PRP's subcontractor, assessed a 100 x 100 foot portion of the northwestern portion of the cap as defined as the EPA Assessment Area (Figure 3). Multiple Diver AOIs were identified within EPA Assessment Area, which contained areas of exposed sediments (potentially landfill waste material) with no or intermittent armor stone coverage. The Diver AOIs did not appear to be depositional areas since no armor stone could be felt at depths up to 4 feet below the sediment surface and they were typically near areas containing surficial armor stone of varying thicknesses.

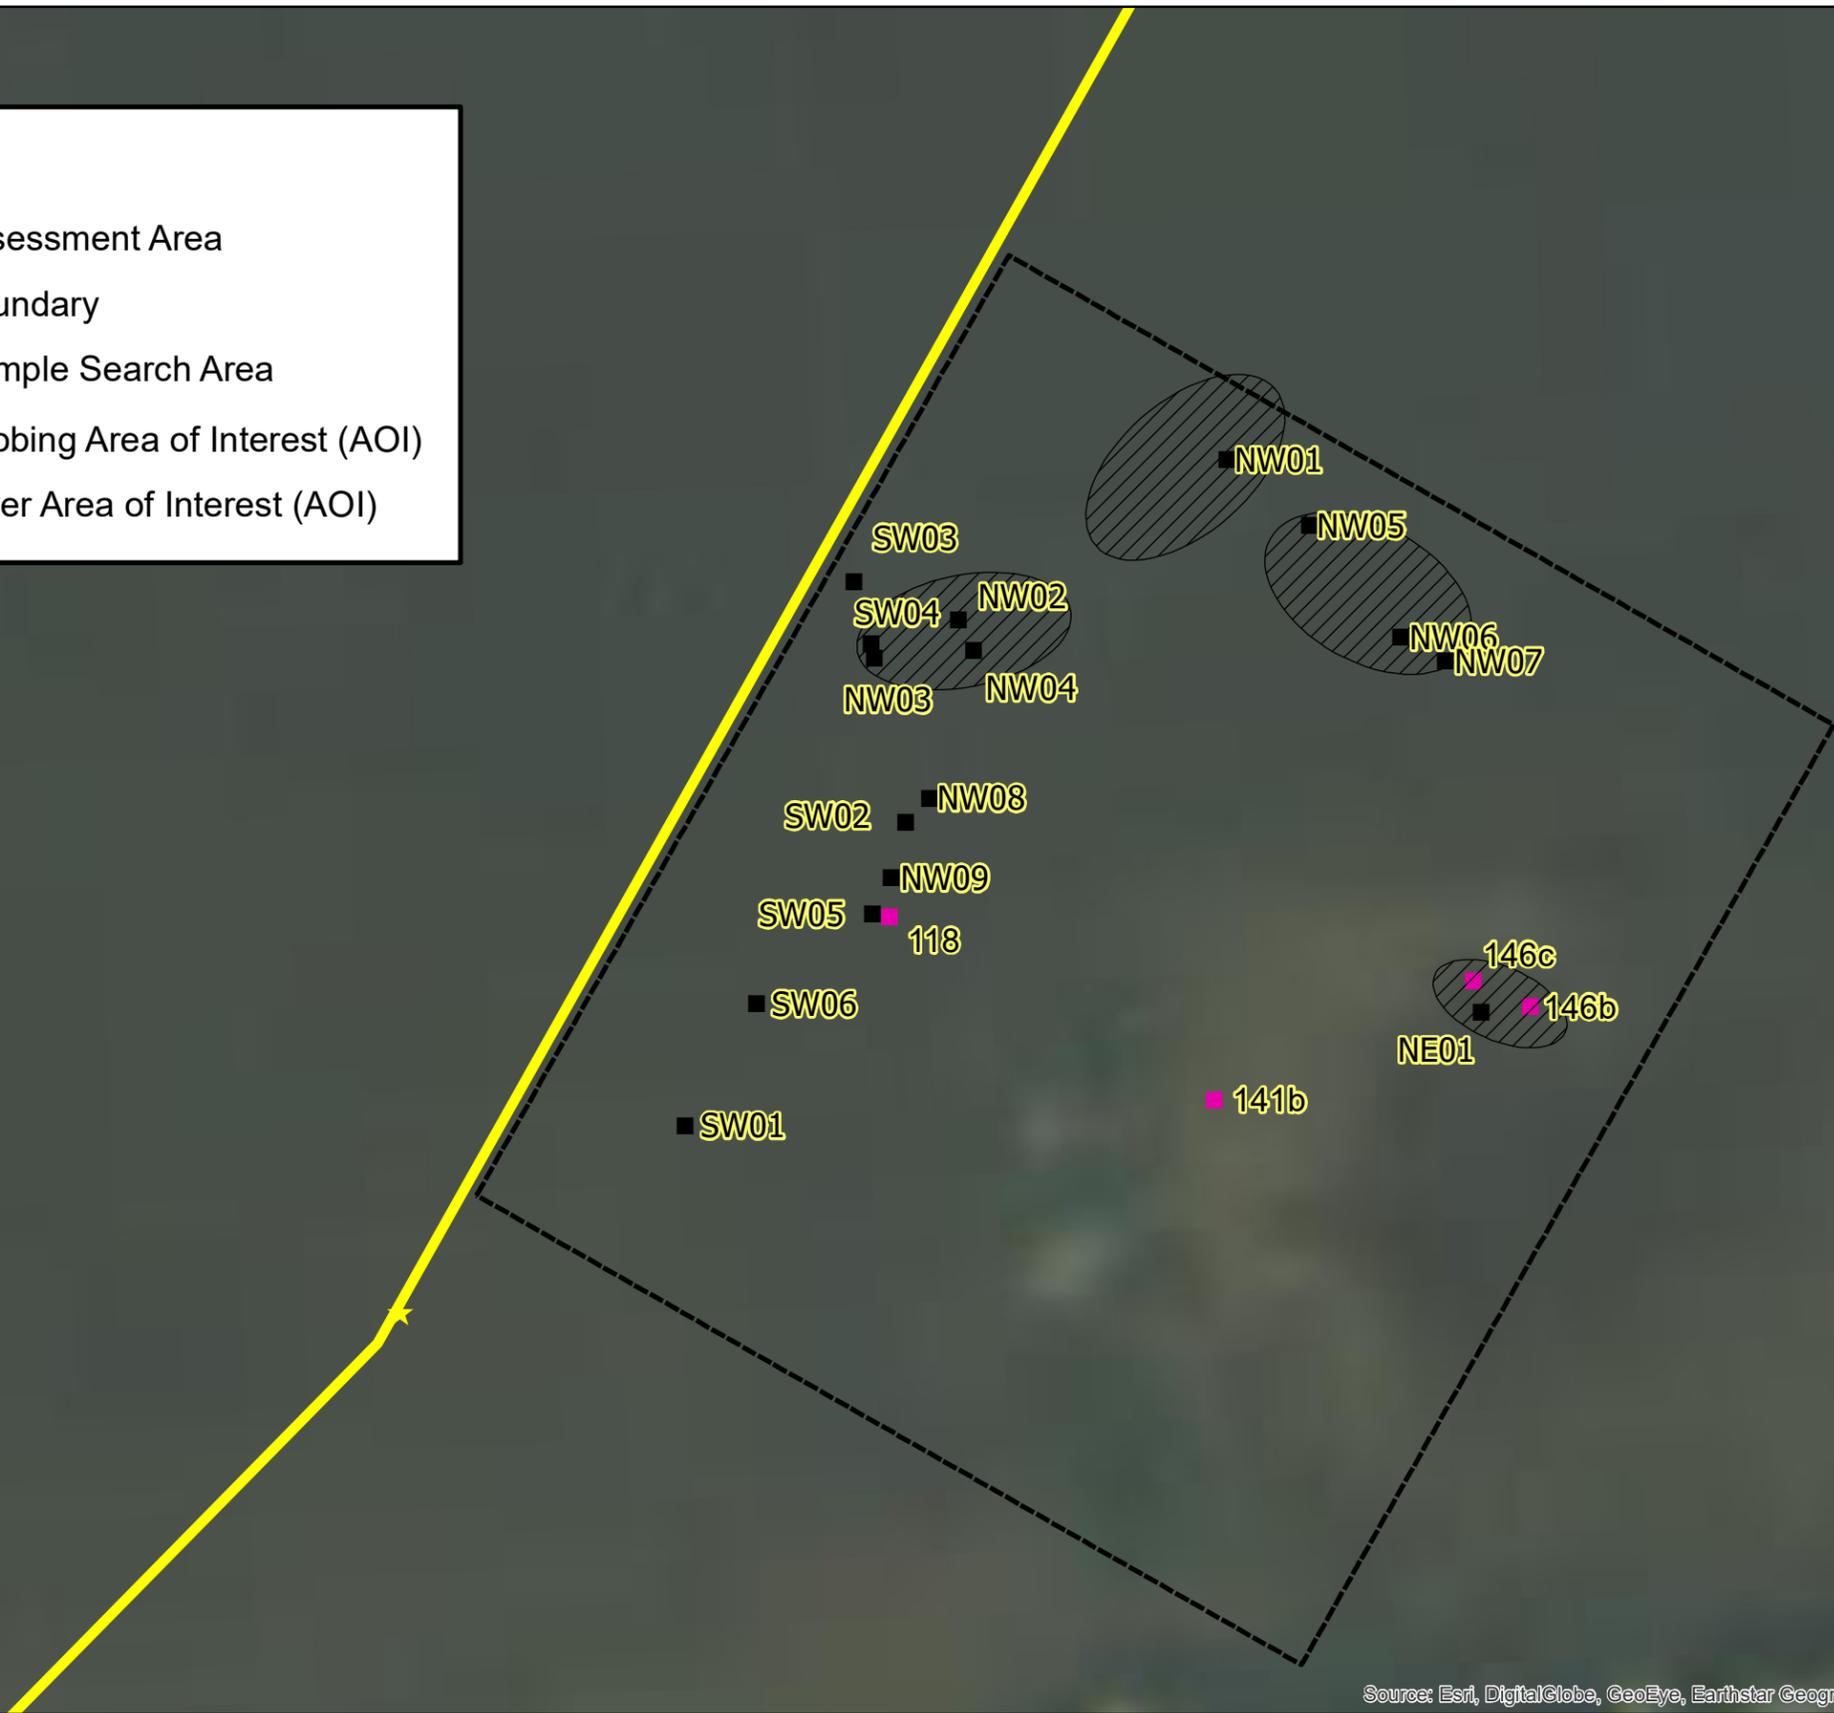
Figure 2
 Probing and Diver Areas of Interest (AOI)
 San Jacinto Waste Pits
 Channelview, TX

southeastern corner was on the shoreline and most of the water in that quadrant was very shallow, but the deeper sections of that quadrant were assessed during the dives made on the west and east corners. Figure 2 shows the EPA Assessment Areas along with the EPA Diver AOIs. Diver descriptions for these AOIs are summarized in Table 3. During this survey, the divers observed that both the top and slopes of the cap contained varying thicknesses and coverages (complete/intact, intermittent, none) of armor stone. If there were significant gaps in the cap, the diver chose a possible area for sampling and a GPS point was taken. If there were multiple gaps in a larger area, one GPS coordinate was taken to be a representative sample of that area. At the base of the slope and extending into the river, the armor stone was found to be intact with up to 4 feet of what assumed to be depositional material on top of it. The thickness of the overlying sediments tended to be the thinnest near the base of the slope and generally got thicker heading away from the slope.

AOI	EPA Diver Description
SW01	1 inch of gravel, and then 4 feet soft material with no refusal. Other areas around this point have 2 ft. of soft material with refusal on hard rock. Next to oyster slant.
SW02	4 feet of exposed soft material with intermittent oyster growth on top of soft material. Variable area. 2x2.
SW03	Base of slope.
SW04	Base of Slope. No refusal.
SW05	Base of slope.
SW06	Couple of feet from base of slope on incline. 2 areas of exposed soft material with no refusal.
NW01	Hole with exposed soft material with solid rock around, no refusal. This is a large area. Other areas near this point with superficial layer of intermittent oyster rock. Exposed soft material with no refusal throughout this area.
NW02	8-10 inches of rock over soft material.
NW03	Large rock scattered on top of 1-2 inches of type A rock. Below is soft material, no refusal.
NW04	Top of slope. 4-6 inches of type A and then soft material. Large rock intermittent.

NW05	1 inch type A rock over soft material, no refusal. Rock is intermittent.
NW06	Gap in large rock. Some type A rock intermittent over exposed soft material. Other areas around have 4-6 inches of type A rock and then soft material. Going down slope.
NW07	Intermittent big rock over exposed soft material, no refusal. Other areas near this point have refusal at 1ft under soft material.
NW08	1 ft. soft material on hard rock at base of slope.
NW09	Base of Slope
NE 01	2x2 area of exposed soft material. Could be larger area, could not reach. Solid oyster reef on either side of this area.

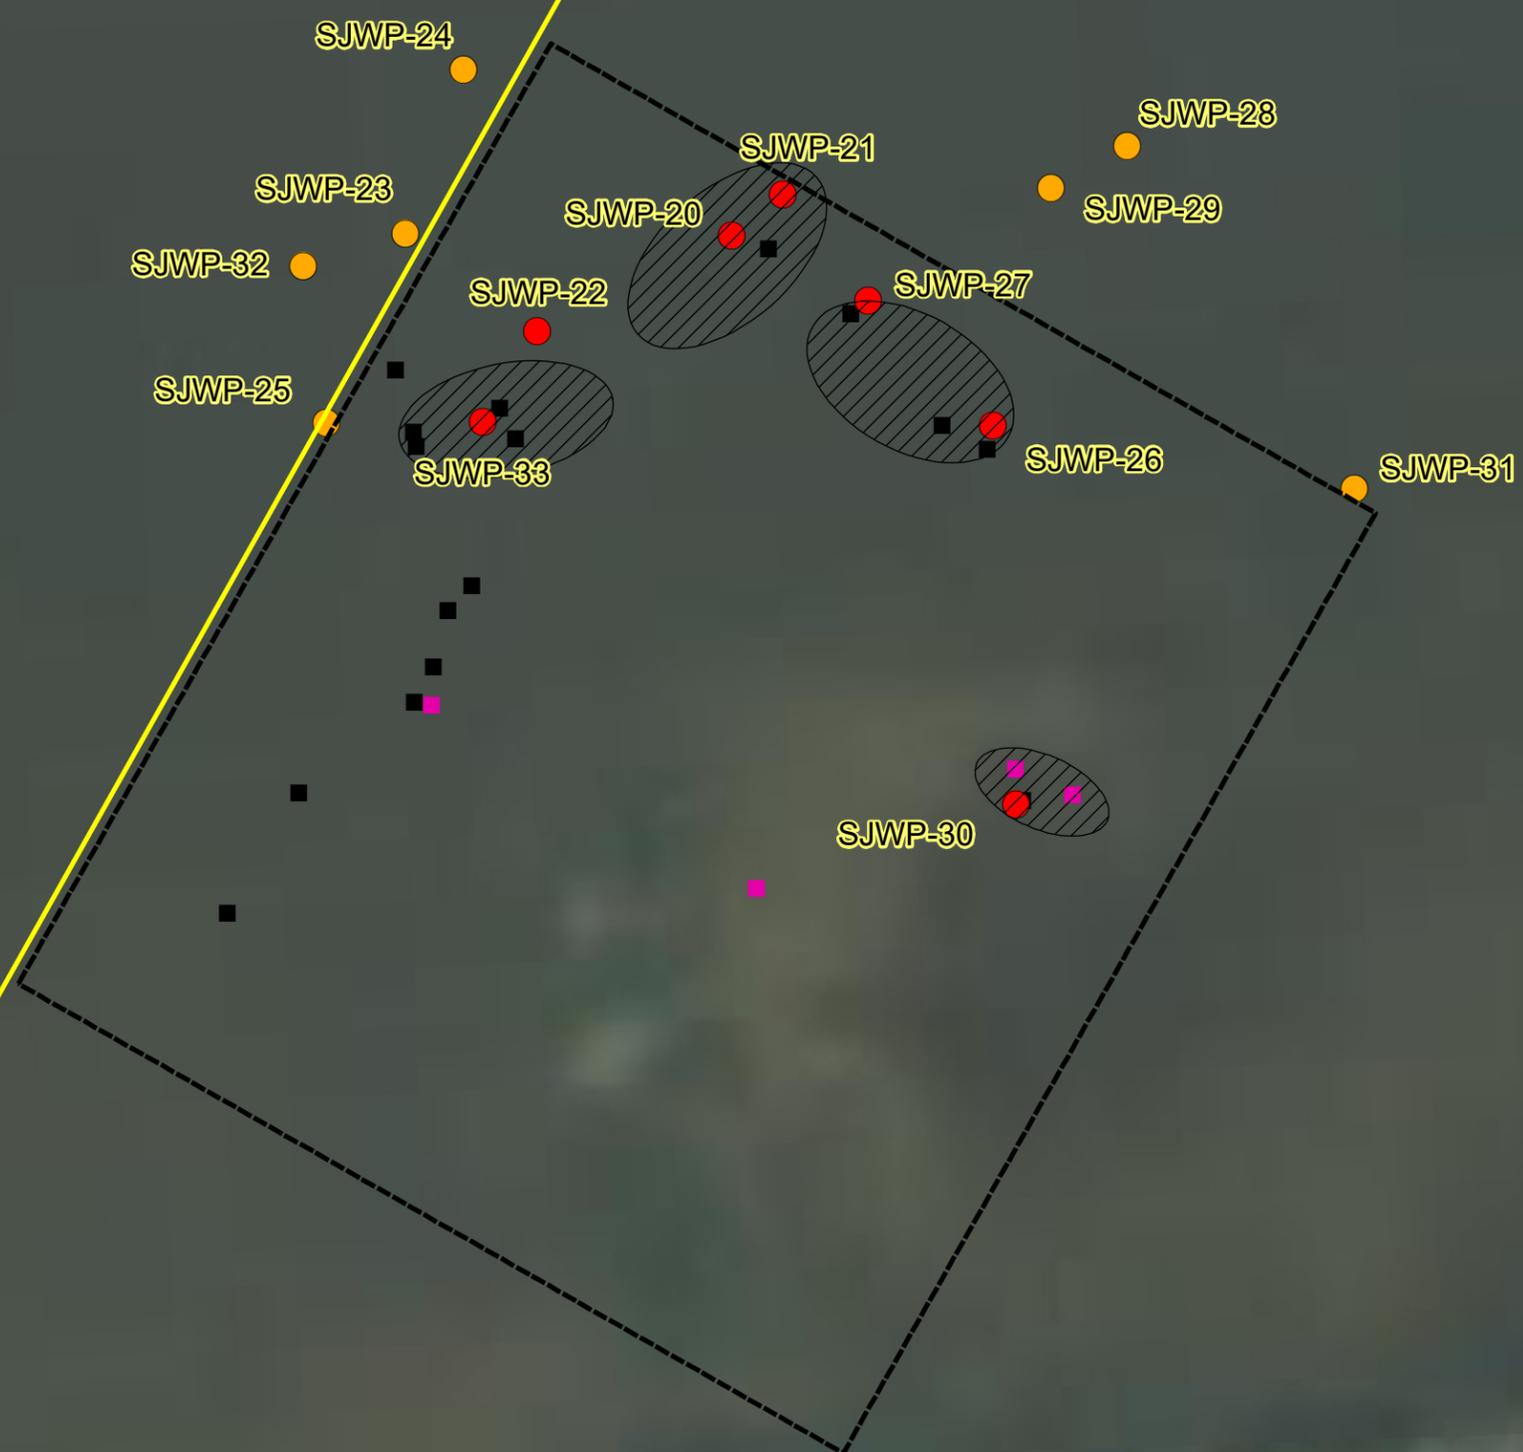
Figure 3
 Sample Location Map
 San Jacinto Waste Pits
 Channelview, TX

Diver observations made during dives on September 11th and 13th was reviewed by the EPA. Based on the review of this data, four EPA Sample Search Areas were identified (Figure 3). These areas contained multiple Diver and/or Probing AOIs. Due limited visibility and limitations GPS accuracy and precision it was important to initially target areas that contained exposed sediments rather than just try and go to specific points to collect samples.

In addition to the targeted sediment sample collected (as described above) a second sediment sample was collected from a nearby location that was from the base of the slope outward. These samples were collected in assumed depositional areas that were below the base of the slope. These locations were typically characterized by a few inches to greater than a 4-foot layer of soft depositional sediments that were overlying a harder material that was interpreted to be the armor cap. These samples were collected to assess whether waste materials from the site may have been mobilized during the storm and redeposited in these depositional areas. Sample locations and descriptions of these locations are summarized in Table 4. A total of 7 on-the-cap locations and 7 below base of slope sample locations were collected, for a total of 14 field sample locations. Figure 3 contains the sediment sample locations.

Sample #	Description of Area
20	2x2 soft area surrounded by type A rock with intermittent larger rock. Buoy placed by the soft material to sample. Sand in some areas further away.
21	2x2 intermittent type A rock. Area sampled is soft material exposed to water.
22	1x1 foot opening. Intermittent gravel on top of exposed sediment. Surrounding area has type A rock and intermittent large rock.
23	Possible disposition down slope from sample 20.
24	Possible disposition down slope from sample 21.
25	Possible disposition down slope from sample 22.
26	2x2 section. Some intermittent type A and oyster shells but mostly barren at surface.
27	Muddy texture with intermittent small rock. 2x2 area. Sediment exposed to surface.
28	Possible deposition down slope from sample 26.
29	Possible deposition down slope from sample 27.
30	1.5x 1.5 clay area next to 1.5x1.5 sand area surrounded by areas with type A rock.
31	Intermittent area of soft sediment exposed with some type A rock. On slope.

32	Possible deposition down slope.
33	Possible deposition down slope.
