**Subject: Removal Assessment Report
C&H Mineral Building - RS Site
EPA Contract No.: EP-S5-13-01
Technical Direction Document No.: S05-0001-1711-007
Document Tracking No.: 2255B**

**REMOVAL ASSESSMENT REPORT
FOR
C&H MINERAL BUILDING – RS SITE
52986 HIGHWAY M-26
HUBBELL, HOUGHTON COUNTY, MICHIGAN**

Waste Pile Photograph Log
Hubbell Processing Area – Mineral Building
Hubbell, Michigan

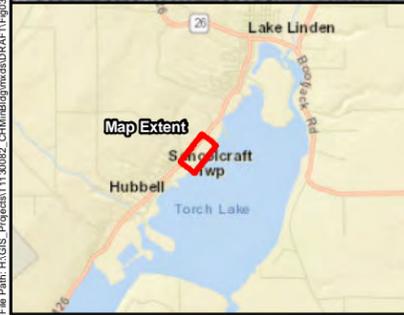
Figure 3
Waste and Debris Pile Locations

The waste piles and stack debris are depicted on Figure 3 in Appendix A. Table 1 presents an inventory of the waste and debris piles along with a depositional history based on aerial photography review. The mining era waste piles include ladles and other tools suggesting the origin was C&H industrial complex operations such as the smelter.

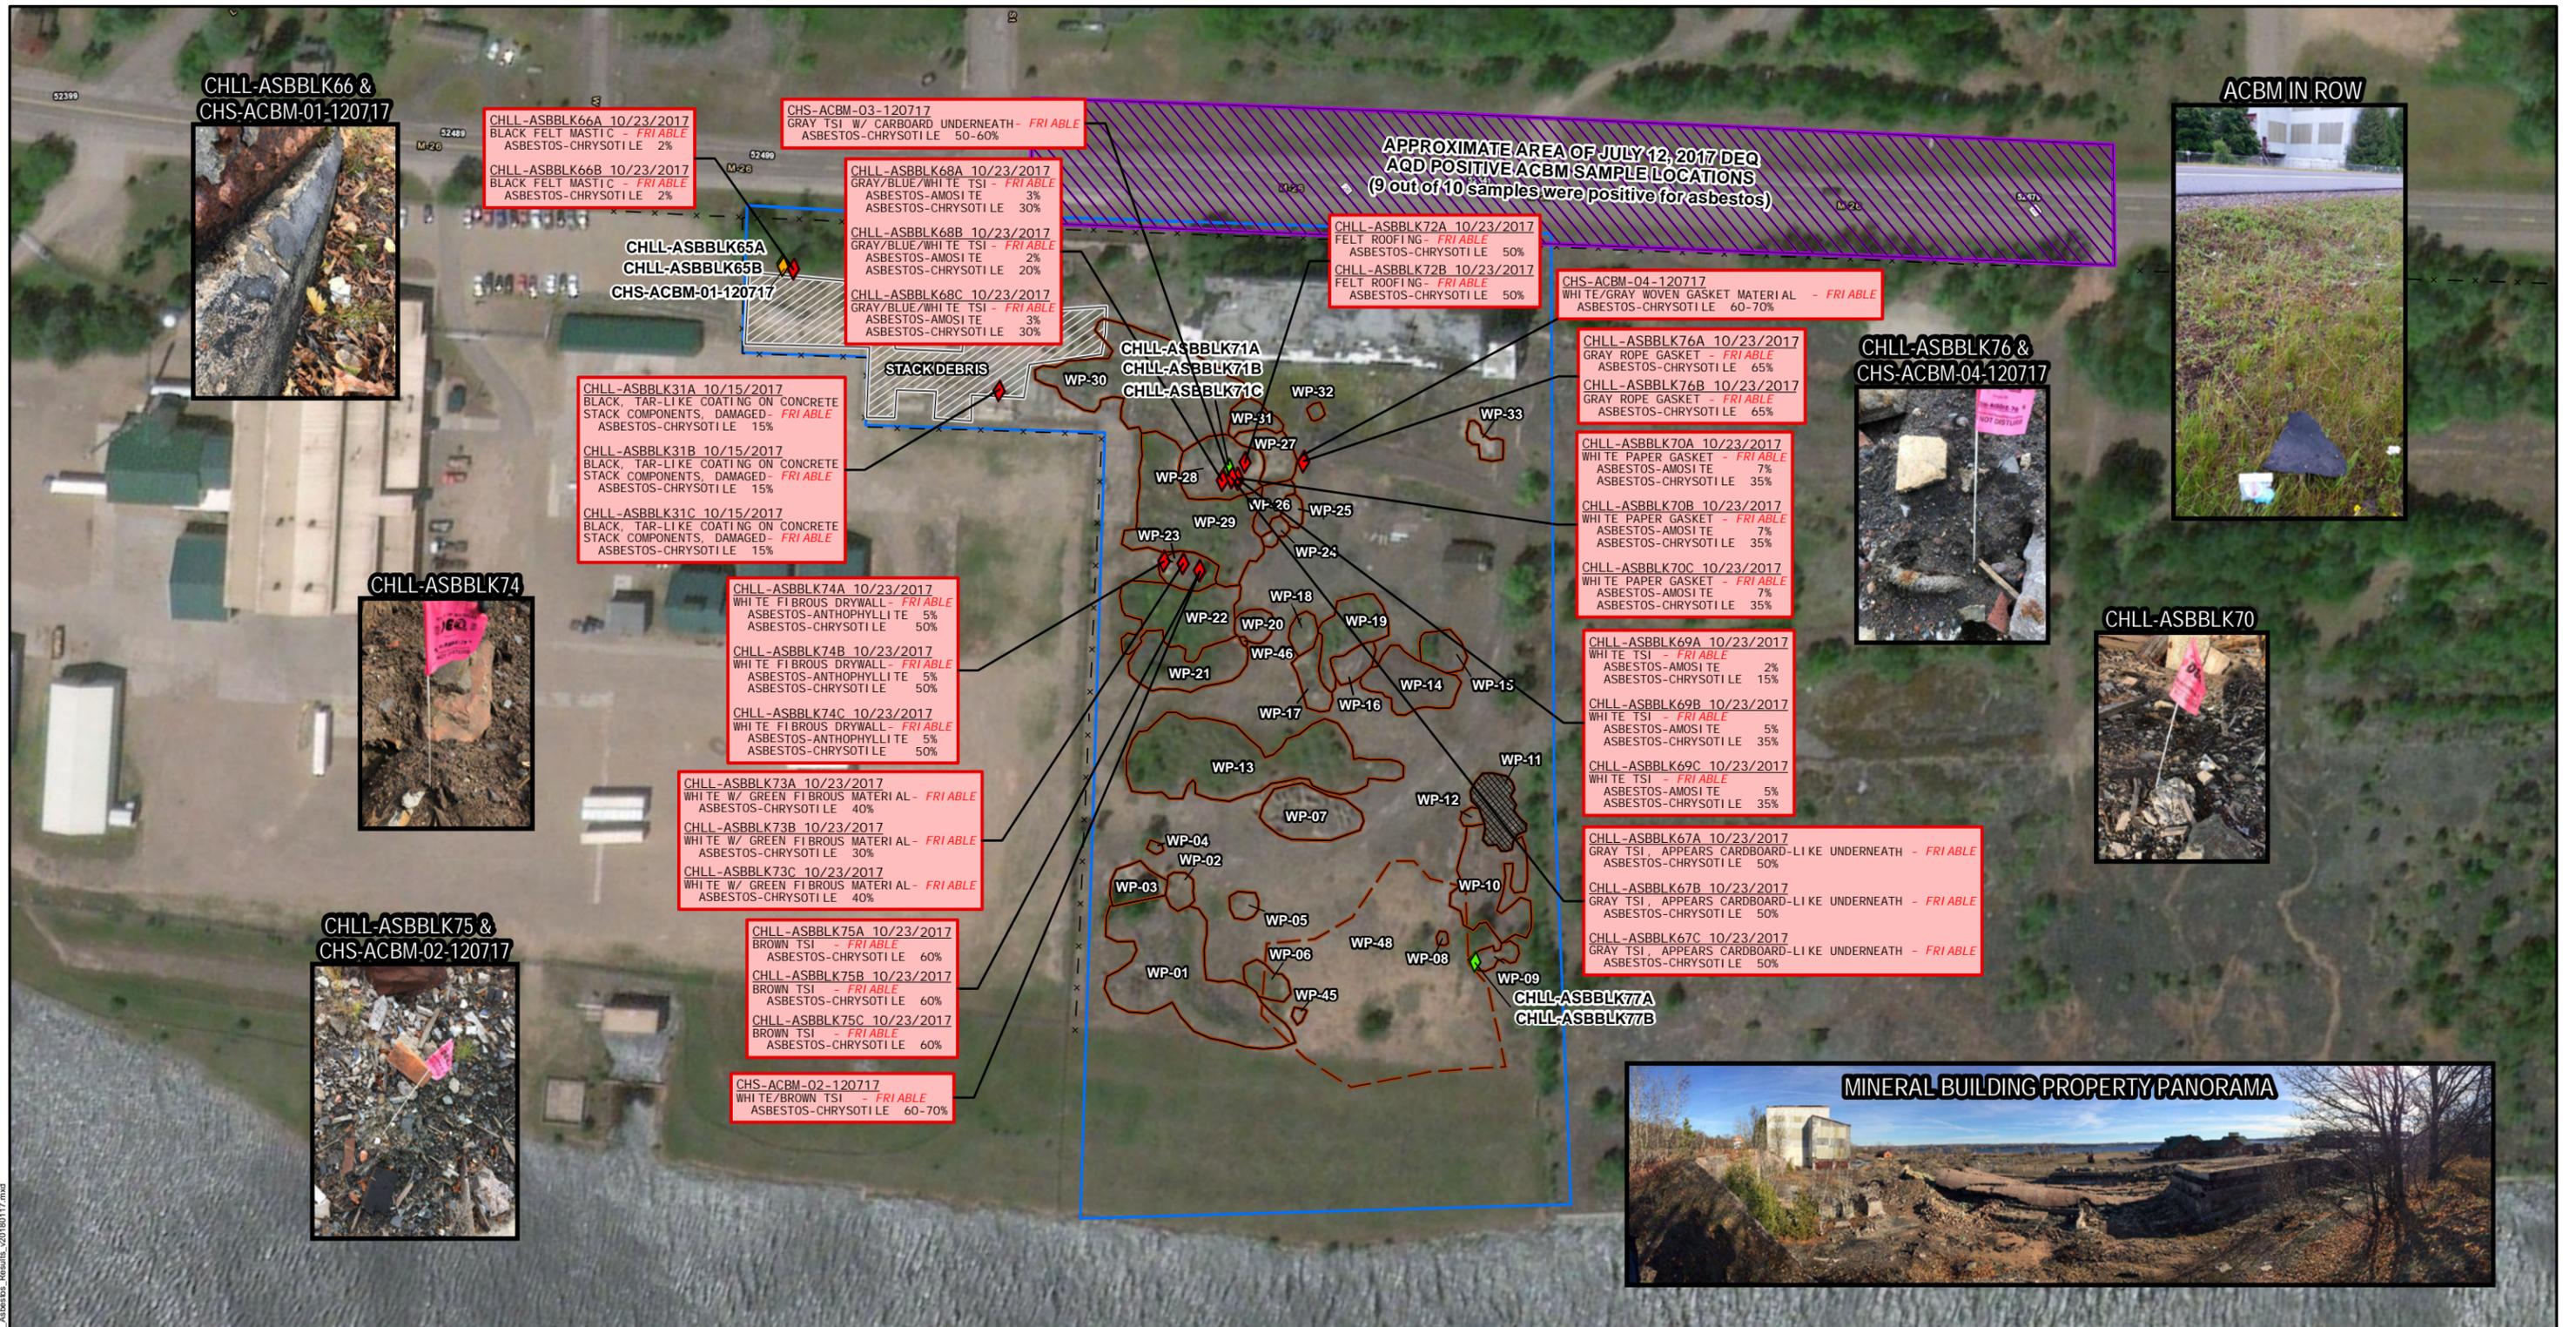
Figure 4
Asbestos Analytical Results Map

| <p>Notes:</p> <ul style="list-style-type: none"> - Sample locations positive for asbestos and not shown were removed in 2016. - Non-detect samples from 2014 are not shown. - Asbestos Containing Material (ACM) are materials containing greater than 1% asbestos, as defined and regulated by the EPA per 40 CFR Part 61, Subpart M and MIOSHA/OHSA 29 CFR 1926.1101 | | |

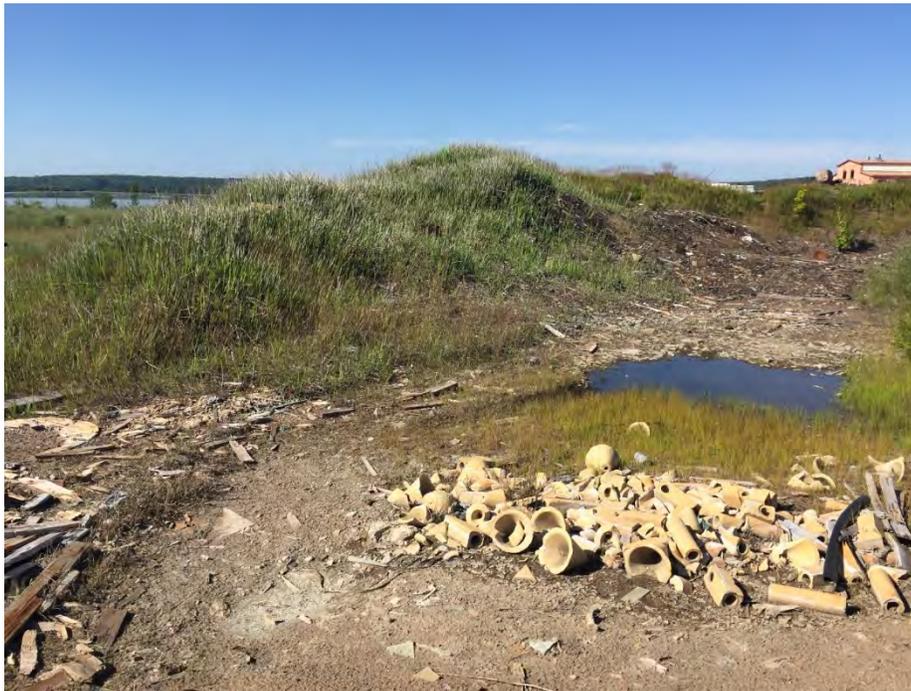
Photograph 1: Waste Pile 45 (WP-45) in the foreground (a small pile of refractory) with WP-01, containing soil, slag, and concrete in the background. The material appears to be “industrial” in nature. Photograph by J. Chrestensen, July 20, 2016.

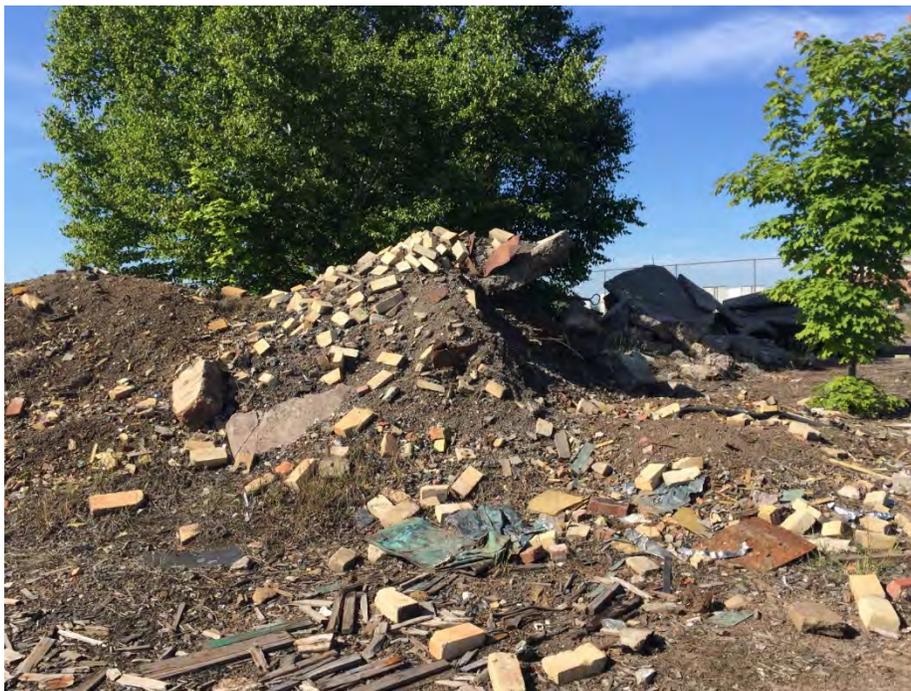
Photograph 2: WP-02 containing fire brick, metal, wood, concrete, and old appearing debris mixed with soil. Photograph by J. Chrestensen, July 20, 2016.

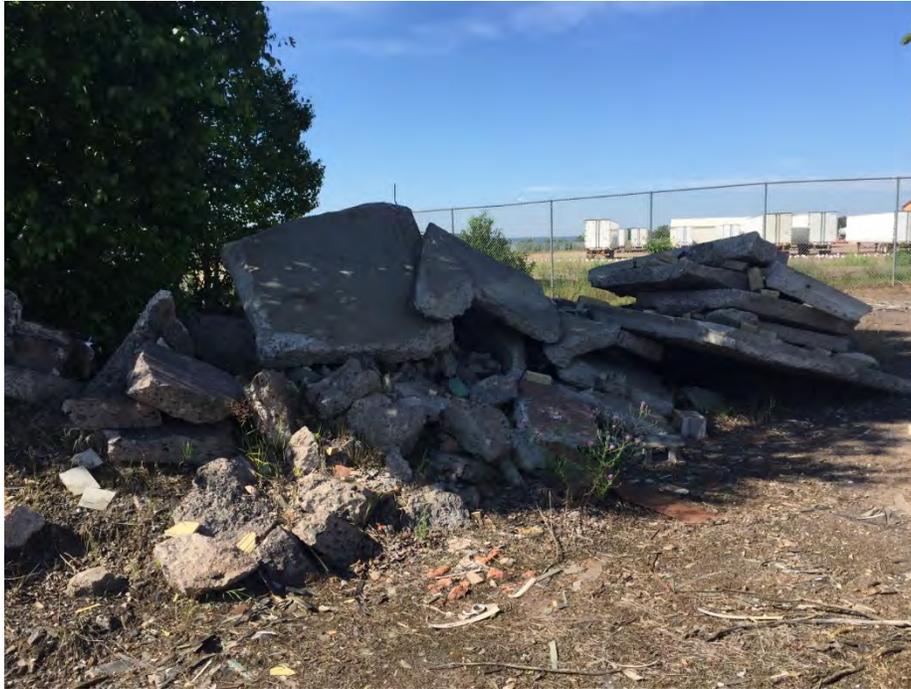
Photograph 3: WP-03 containing concrete slabs. Photograph by J. Chrestensen, July 20, 2016.

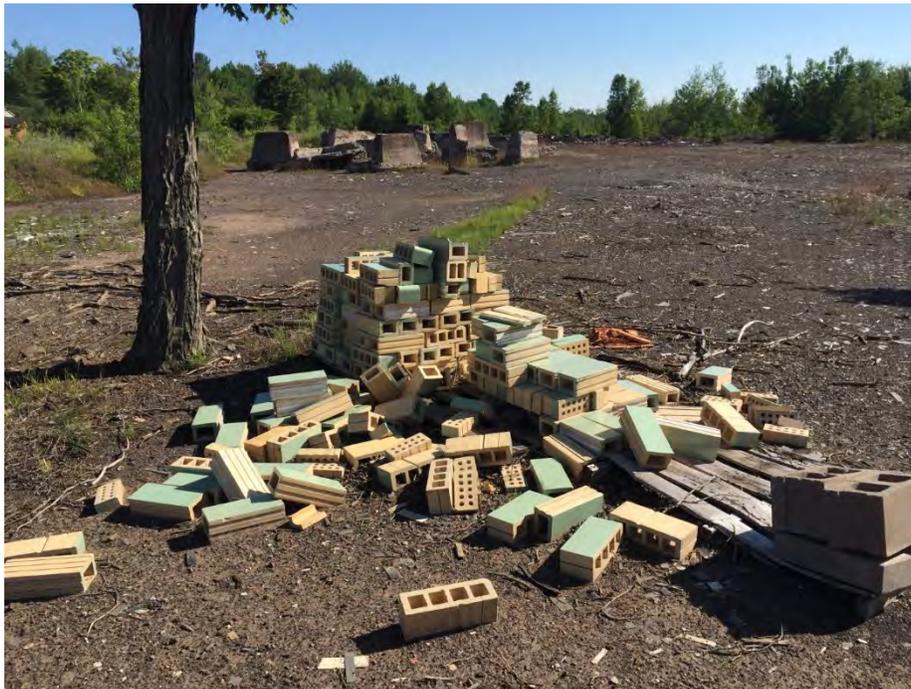
Photograph 4: WP-04 containing refractory. Photograph by J. Chrestensen, July 20, 2016.

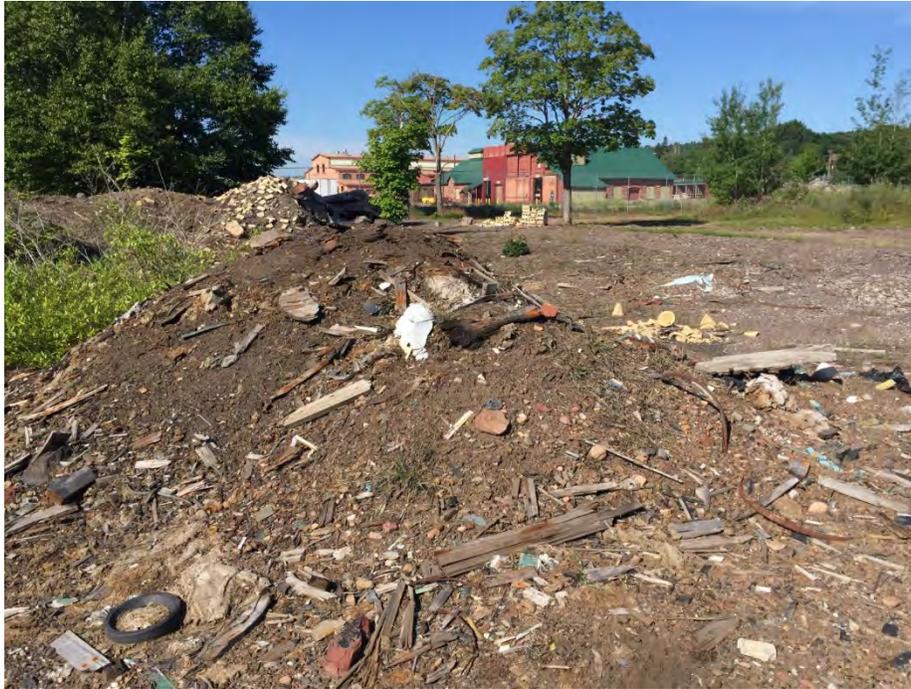
Photograph 5: WP-05 containing soil, rusted metal, wood, and corrugated paper. The material appears to be “industrial” in nature. Photograph by J. Chrestensen, July 20, 2016.

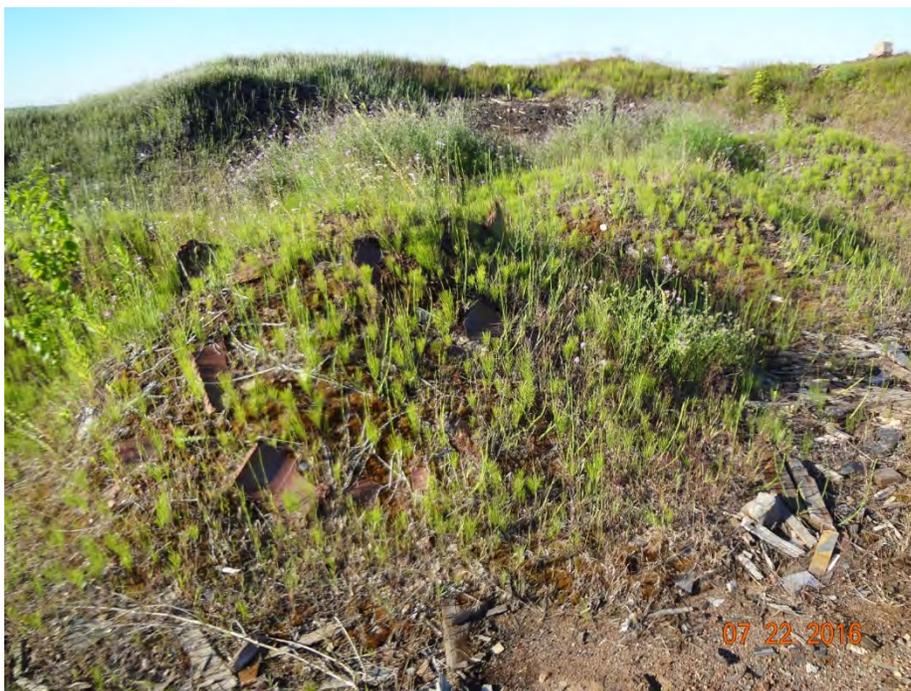
Photograph 6: WP-06 containing soil and clay pipe pieces. Photograph by MDEQ-GSU, July 22, 2016.

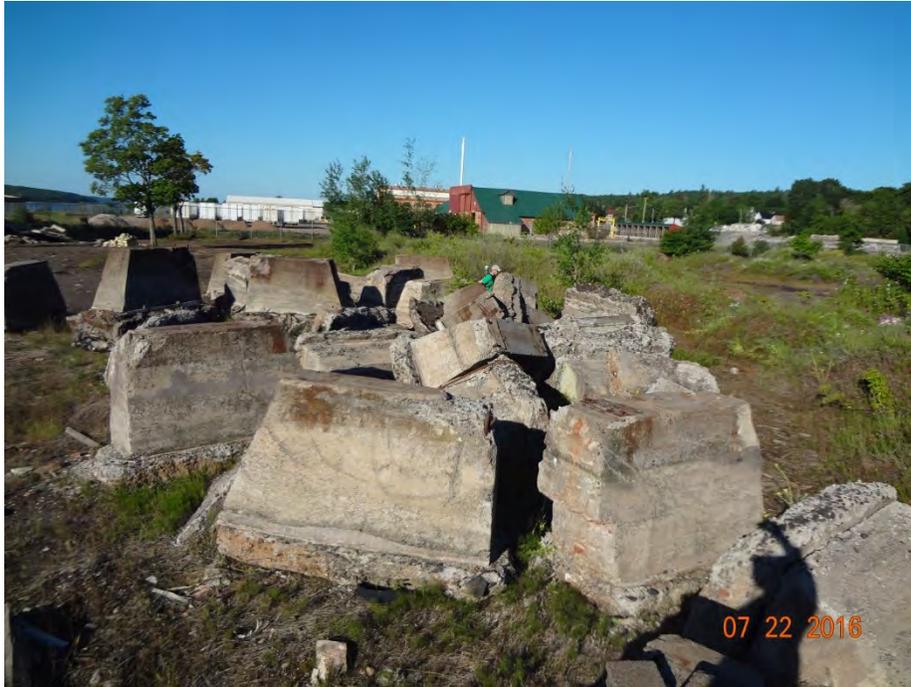
Photograph 7: WP-07 containing large concrete pieces (footers and base supports). Photograph by MDEQ-GSU, July 22, 2016.

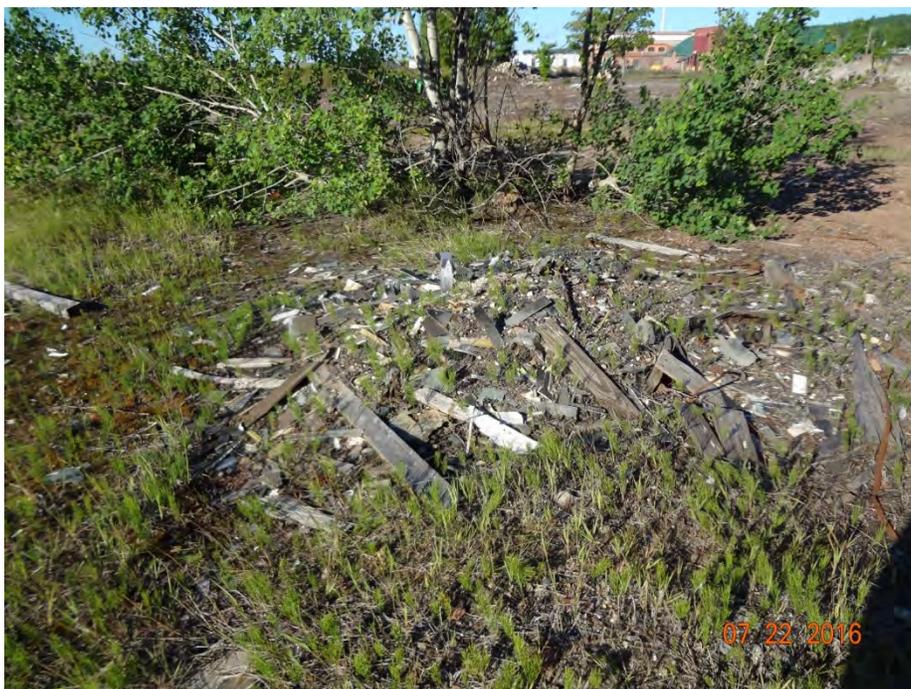
Photograph 8: WP-08 containing primarily wood, steel, and circuit board debris. Photograph by MDEQ-GSU, July 22, 2016.

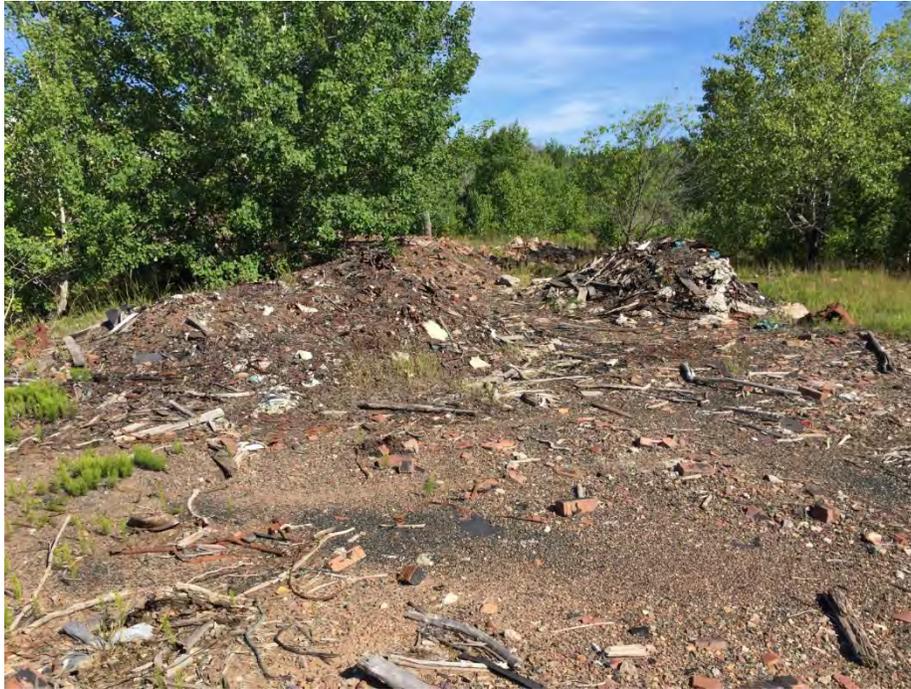
Photograph 9: WP-09 containing soil, rusty metal, fiberglass cloth, and charred wood. The material appears to be “industrial” in nature. Photograph by J. Chrestensen, July 20, 2016.

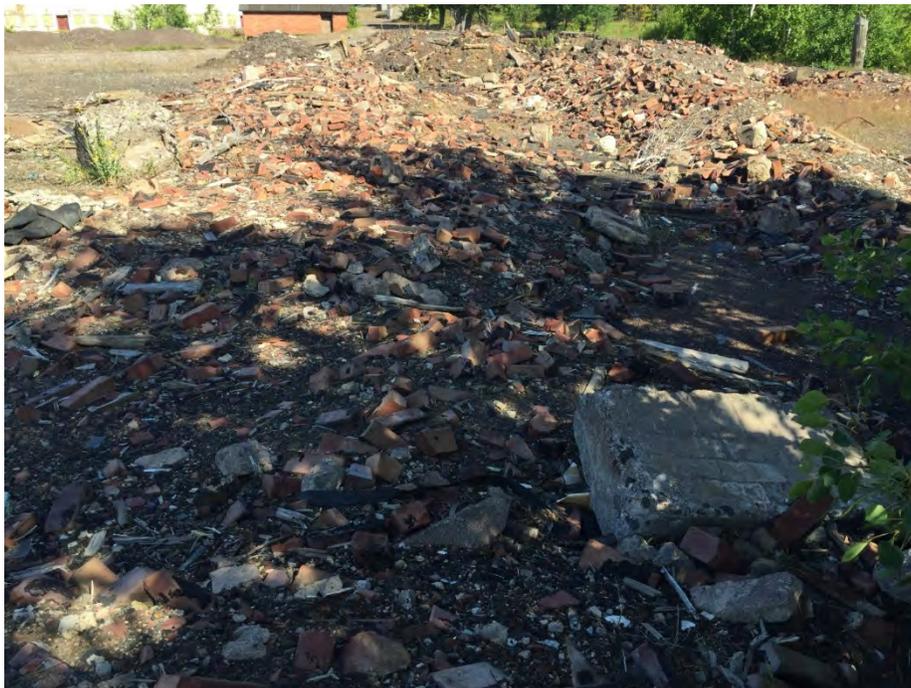
Photograph 10: WP-10 containing fire brick, much of which has a partial black coating, along with concrete, metal, and wood pieces. Photograph by J. Chrestensen, July 20, 2016.

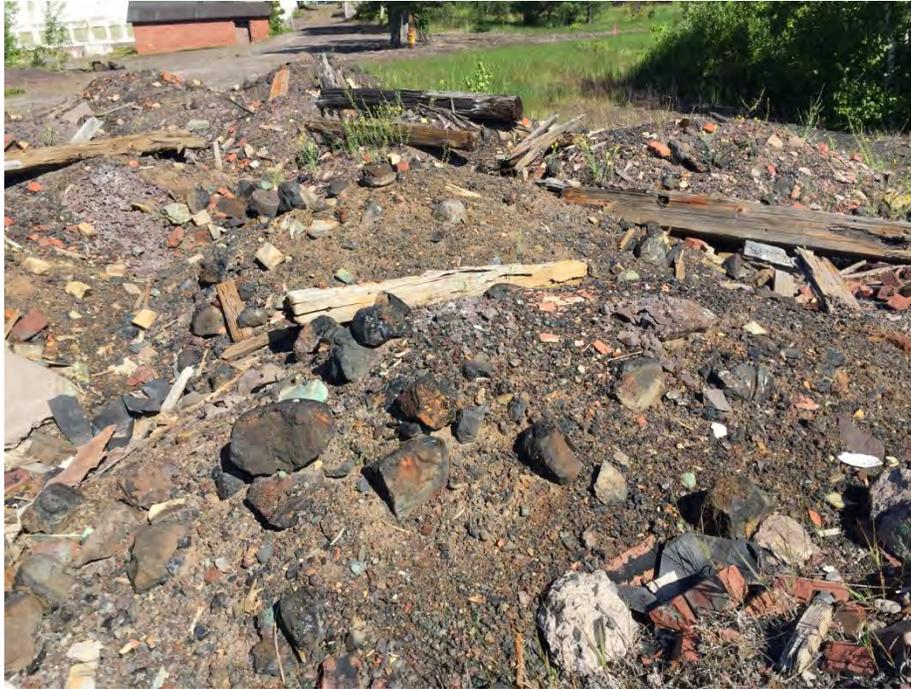
- Waste Pile WP-11 (approximately 112 tons), a Toxic Substances Control Act (TSCA) waste which contained 100 parts per million (ppm) PCBs and a Resource Conservation and Recovery Act (RCRA) hazardous waste due to a Toxicity Characteristic Leach Procedure (TCLP) result of 110 milligrams/liter (mg /L) lead was transported off-site for disposal during 2017. SI results indicated that additional remaining waste piles contain leachable lead concentrations in excess of the TCLP limit, total PCBs less than TSCA criteria, and friable ACBM (greater than 1% asbestos).

Photograph 11: WP-11 containing soil, slag, brick, concrete, metal, and wood timbers. Photograph by J. Chrestensen, July 20, 2016.

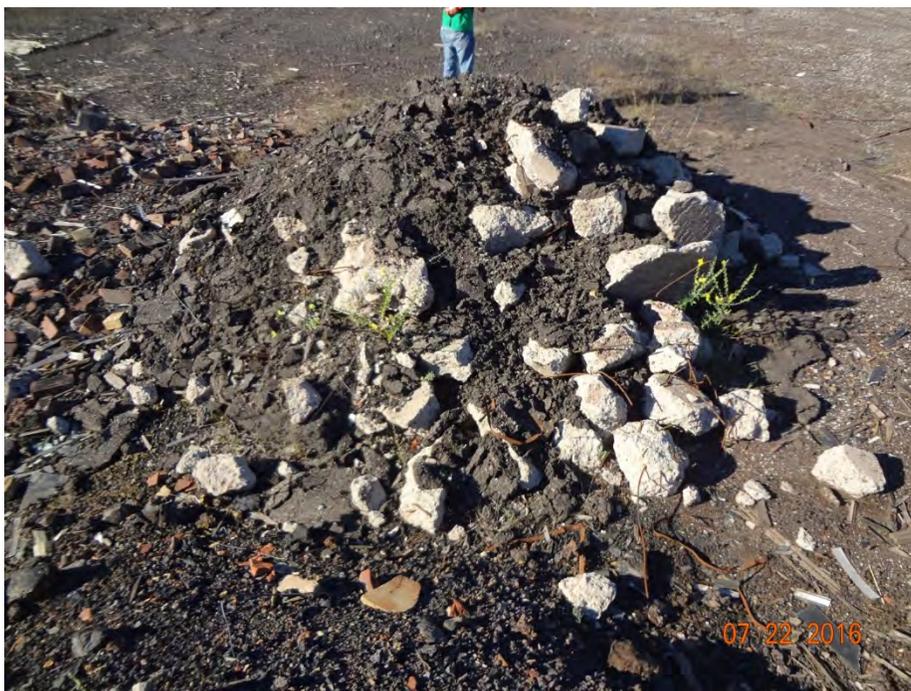
Photograph 12: WP-12 containing asphalt and concrete. Photograph by MDEQ-GSU, July 22, 2016.

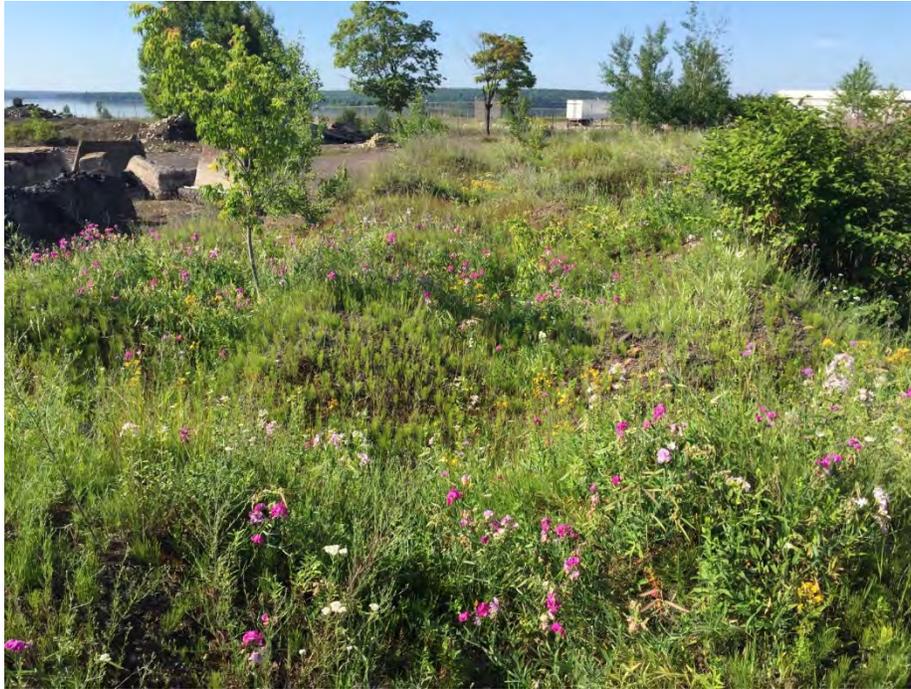
Photograph 13: Looking south across WP-13 which contains gravel and some minor amounts of asphalt and concrete. The material appears to be from road work. Photograph by J. Chrestensen, July 20, 2016.

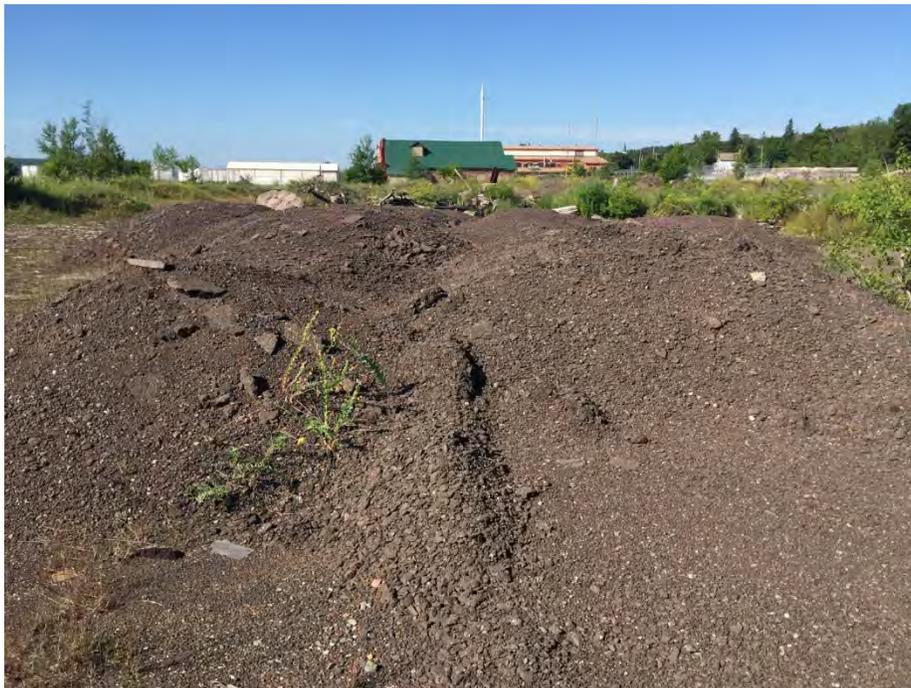
Photograph 14: WP-14 containing milled asphalt. Photograph by J. Chrestensen, July 20, 2016.

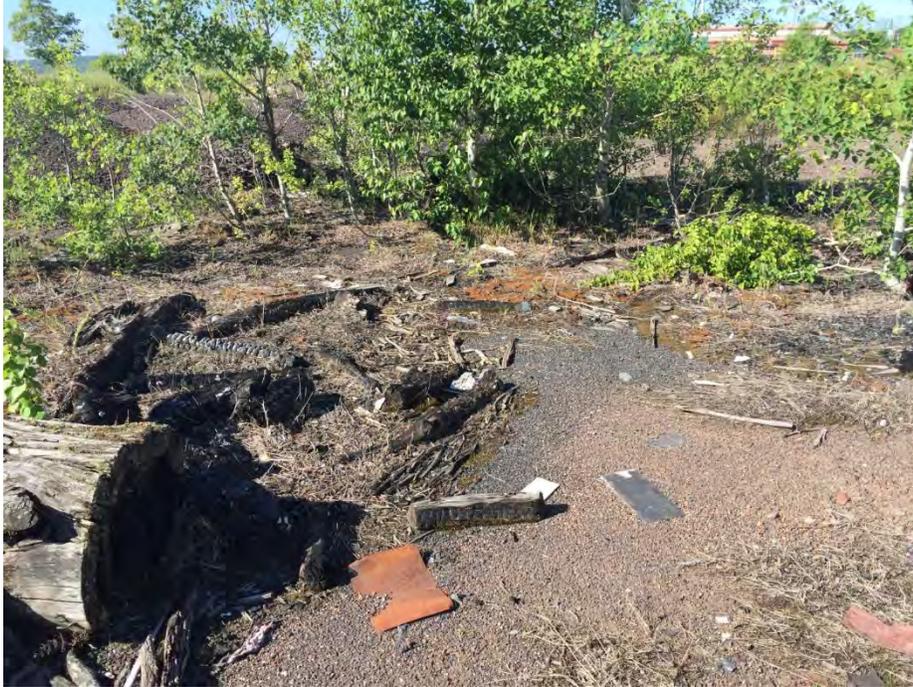
Photograph 15: WP-15 containing burnt wood, metal, and miscellaneous surface debris. Photograph by J. Chrestensen, July 20, 2016.

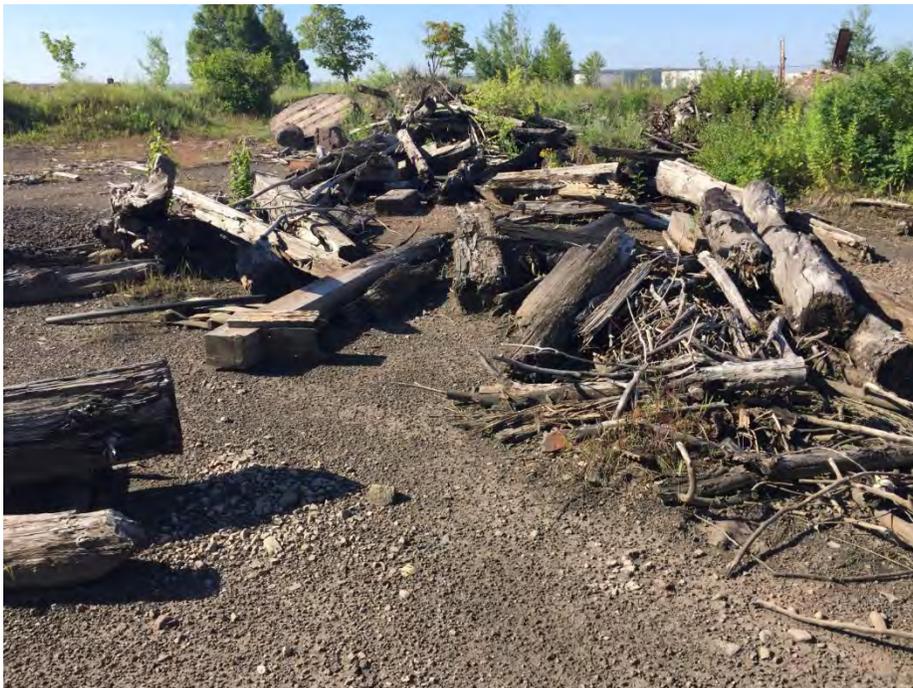
Photograph 16: WP-16 containing logs and timbers. Photograph by J. Chrestensen, July 20, 2016.

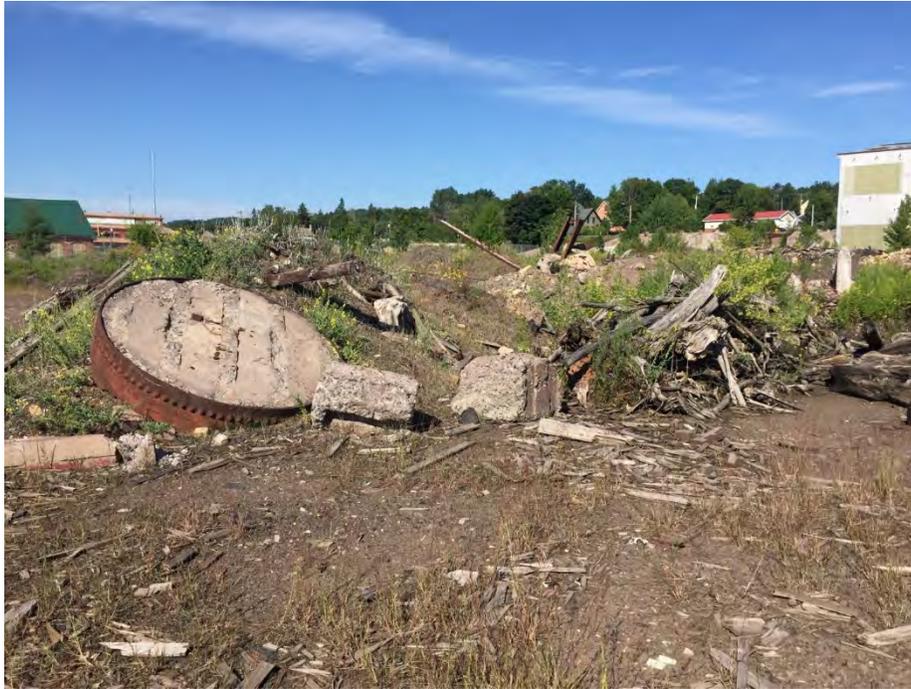
Photograph 17: WP-17 containing concrete pieces, wood, bricks, slag, and metal mixed with soil. The material appears older in nature. Photograph by J. Chrestensen, July 20, 2016.

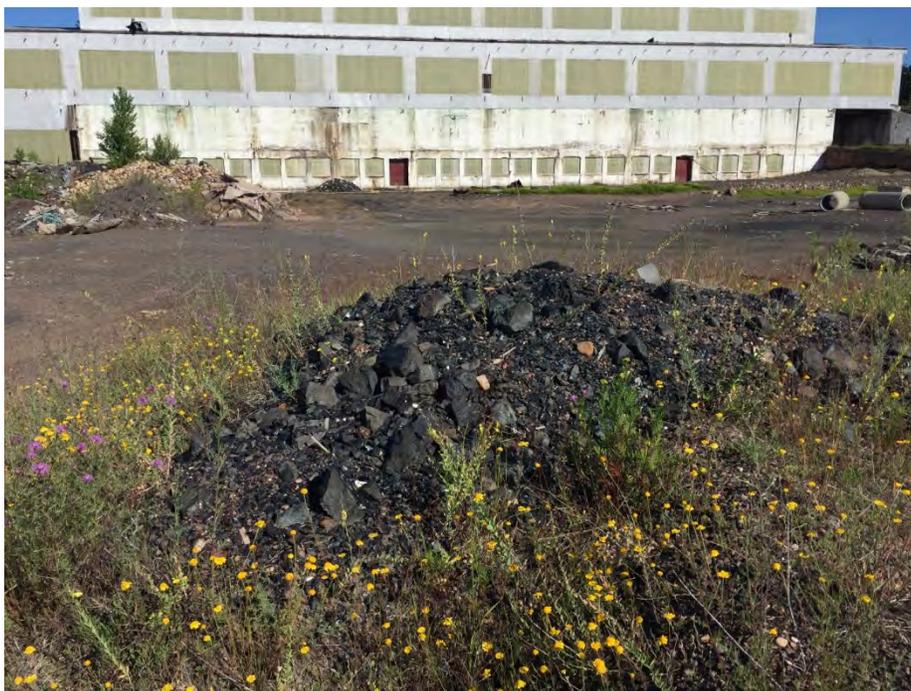
Photograph 18: WP-18 containing mostly slag with some soil and gravel. Photograph by J. Chrestensen, July 20, 2016.

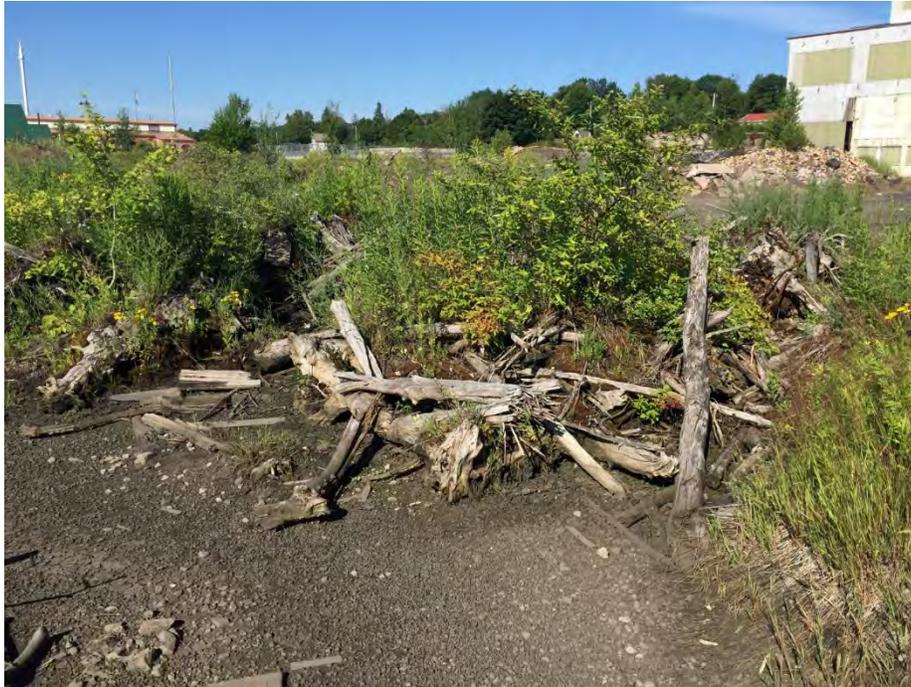
Photograph 19: WP-19 containing wood, stumps, and soil. Photograph by J. Chrestensen, July 20, 2016.

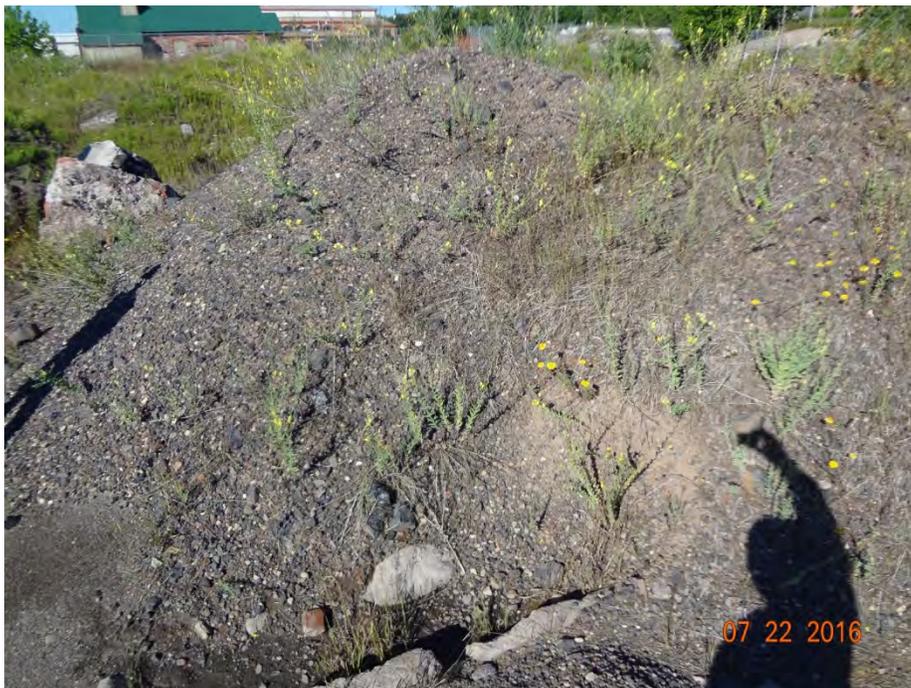
Photograph 20: WP-20 containing slag and gravel. Photograph by MDEQ-GSU, July 22, 2016.

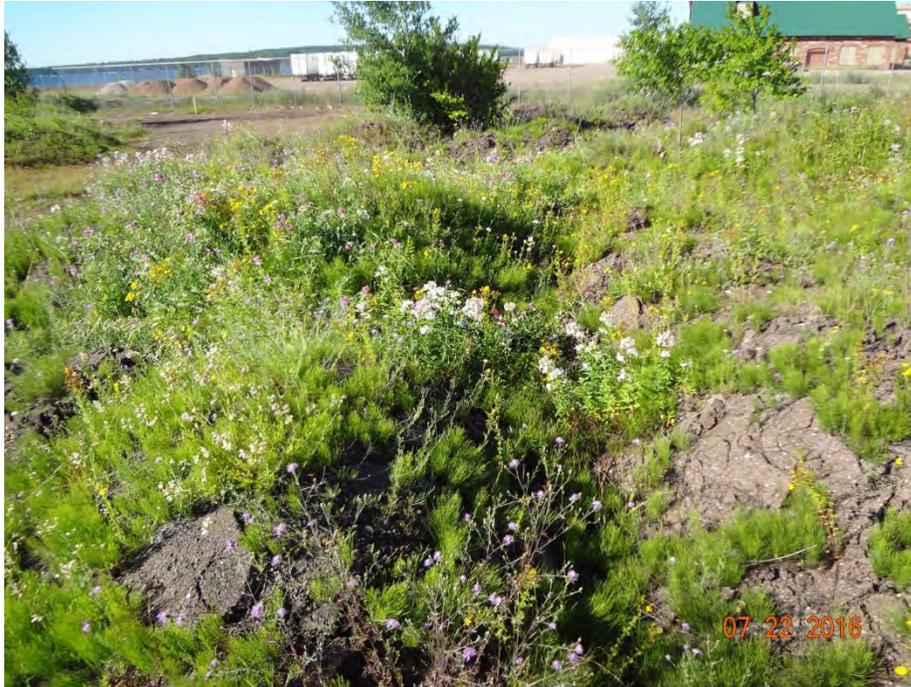
Photograph 21: WP-21 containing primarily asphalt with an area of gravel, soil, and concrete. Photograph by MDEQ-GSU, July 22, 2016.

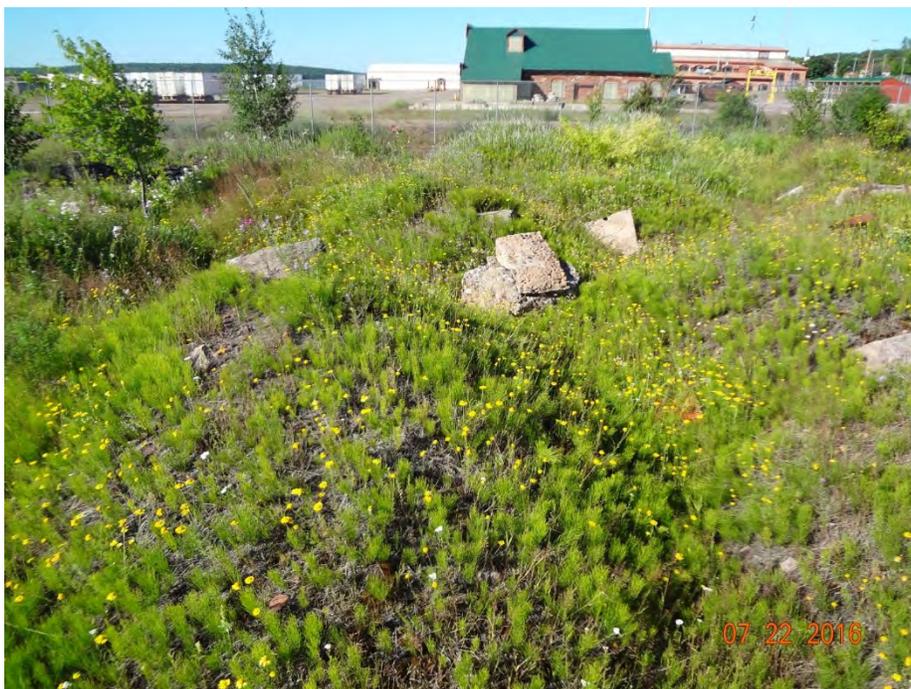
Photograph 22: WP-22 containing mostly soil and stamp sand with concrete pieces and some steel. Photograph by MDEQ-GSU, July 22, 2016.

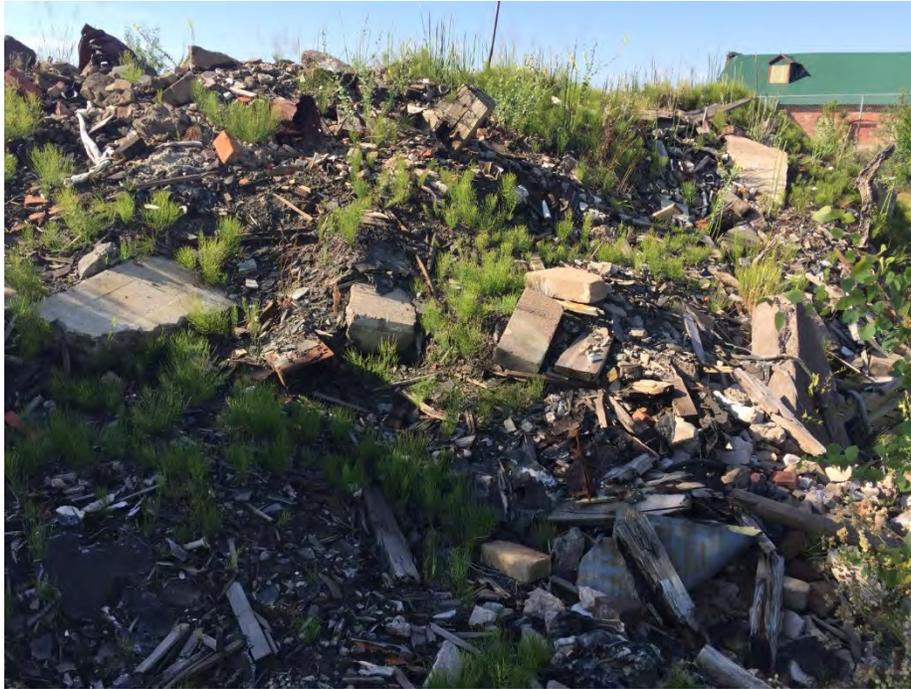
Photograph 23: WP-23 containing soil, concrete, roofing, metal, and other industrial appearing debris.
Photograph by J. Chrestensen, July 20, 2016.

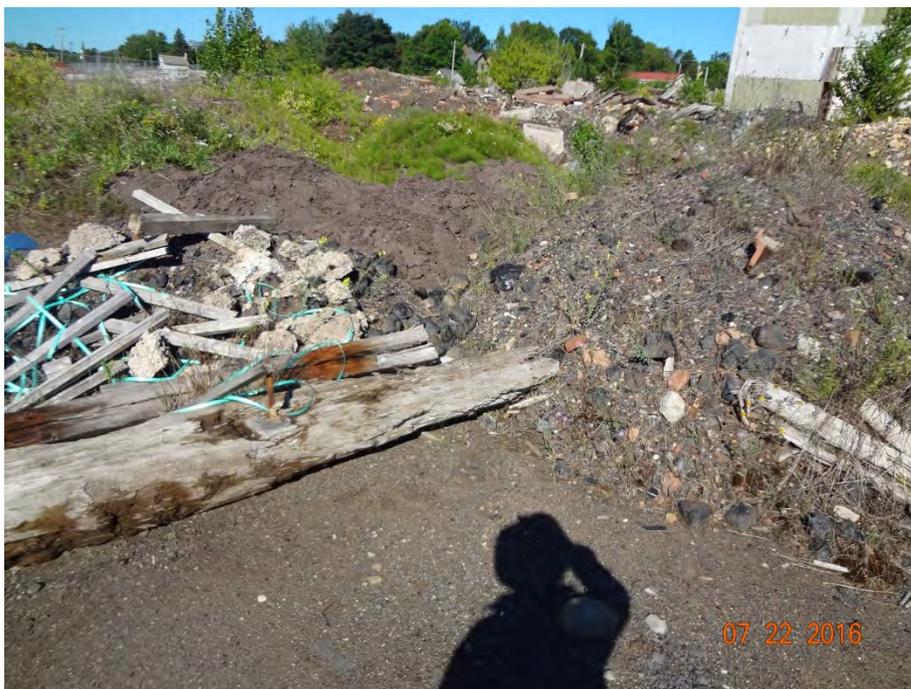
Photograph 24: WP-24 containing slag, gravel, wood, concrete, clay pipe pieces, cable, and wire. The asphalt in the background is WP-26. Photograph by MDEQ-GSU, July 22, 2016.

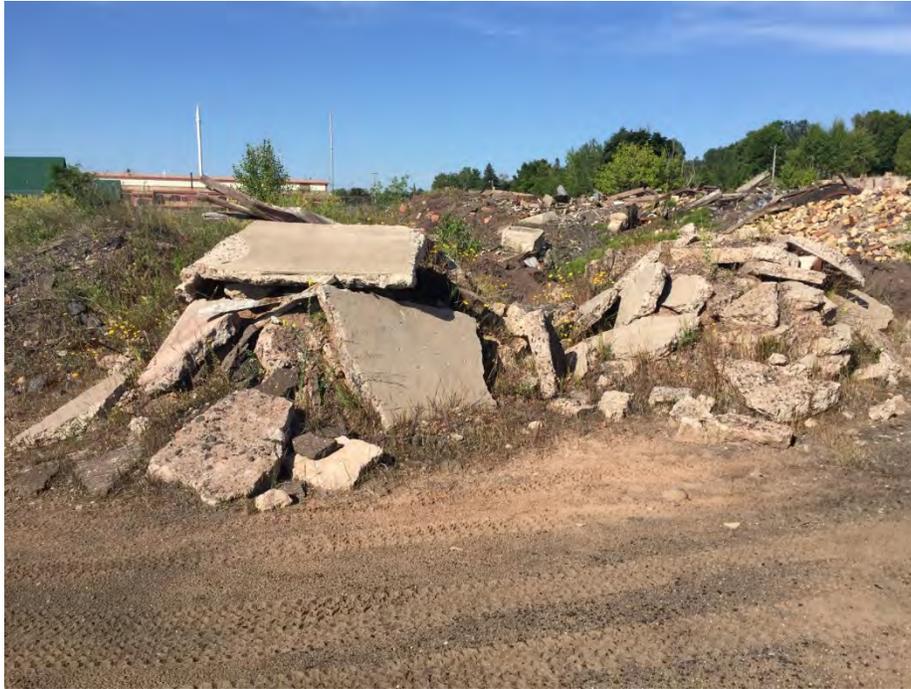
Photograph 25: WP-25 containing concrete slabs. Photograph by J. Chrestensen, July 20, 2016.

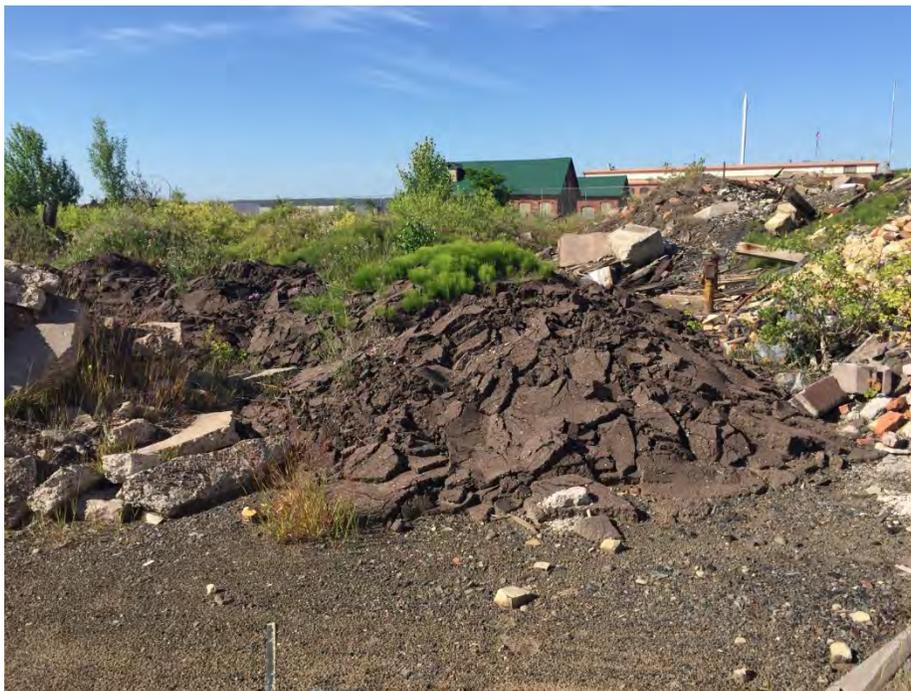
Photograph 26: WP-26 containing asphalt pieces. Photograph by J. Chrestensen, July 20, 2016.

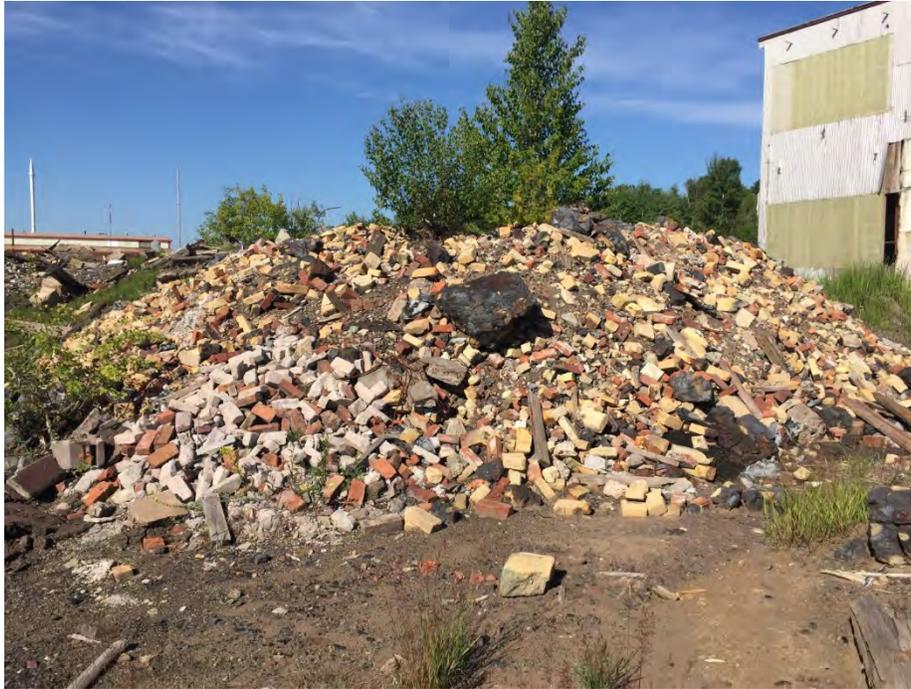
Photograph 27: WP-27 containing fire brick, slag, steel, and concrete pieces. The material appears older in nature. Photograph by J. Chrestensen, July 20, 2016.

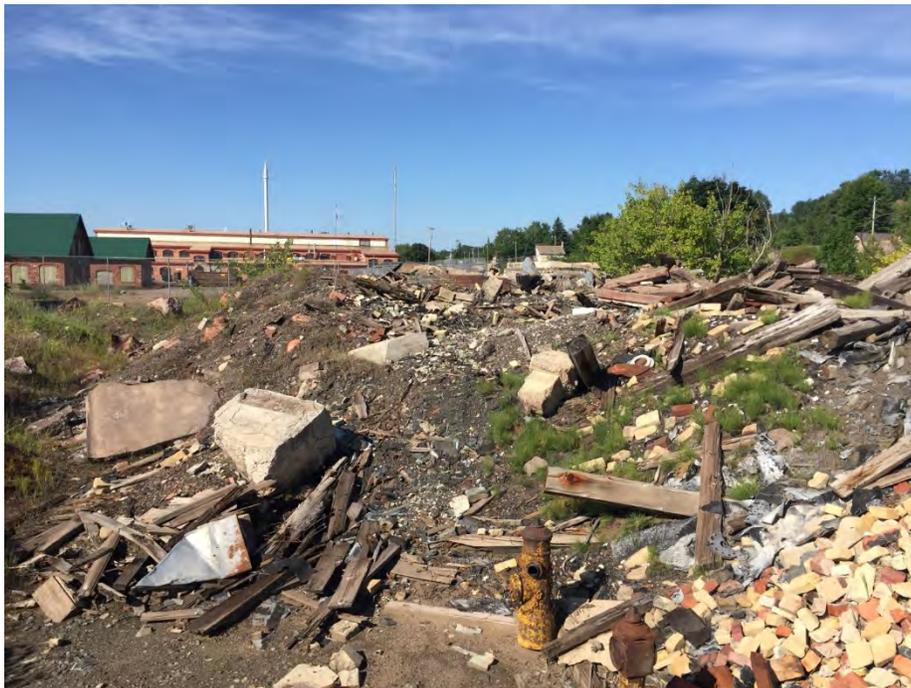
Photograph 28: WP-28 containing concrete, wood, metal, soil, fire brick, and transite pieces. The material appears older in nature. Photograph by J. Chrestensen, July 20, 2016.
