**Subject: Removal Assessment Report
C&H Mineral Building - RS Site
EPA Contract No.: EP-S5-13-01
Technical Direction Document No.: S05-0001-1711-007
Document Tracking No.: 2255B**

**REMOVAL ASSESSMENT REPORT
FOR
C&H MINERAL BUILDING – RS SITE
52986 HIGHWAY M-26
HUBBELL, HOUGHTON COUNTY, MICHIGAN**

Waste Pile Photograph Log
Hubbell Processing Area – Mineral Building
Hubbell, Michigan

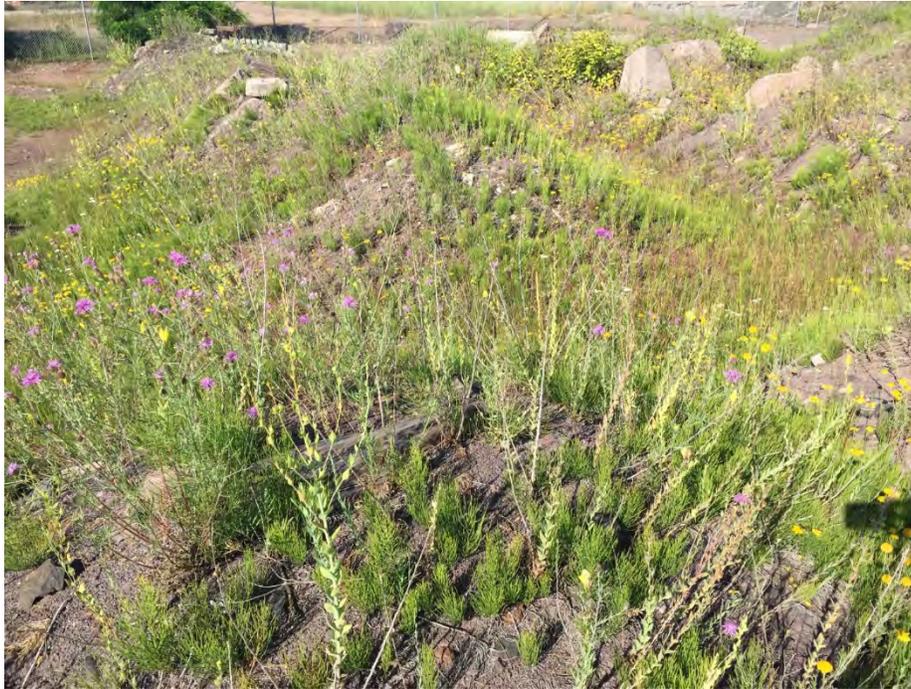
Photograph 29: WP-29 containing soil, stamp sand, concrete bases, and steel pieces. Photograph by J. Chrestensen, July 20, 2016.

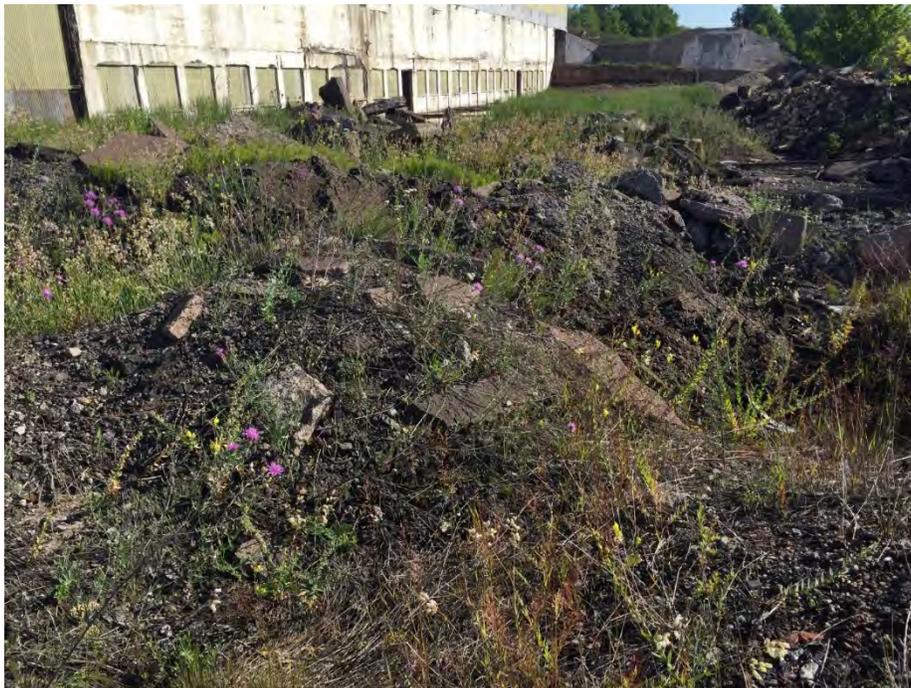
Photograph 30: WP-30 containing gravel, soil, concrete, and asphalt pieces. Photograph by J. Chrestensen, July 20, 2016.

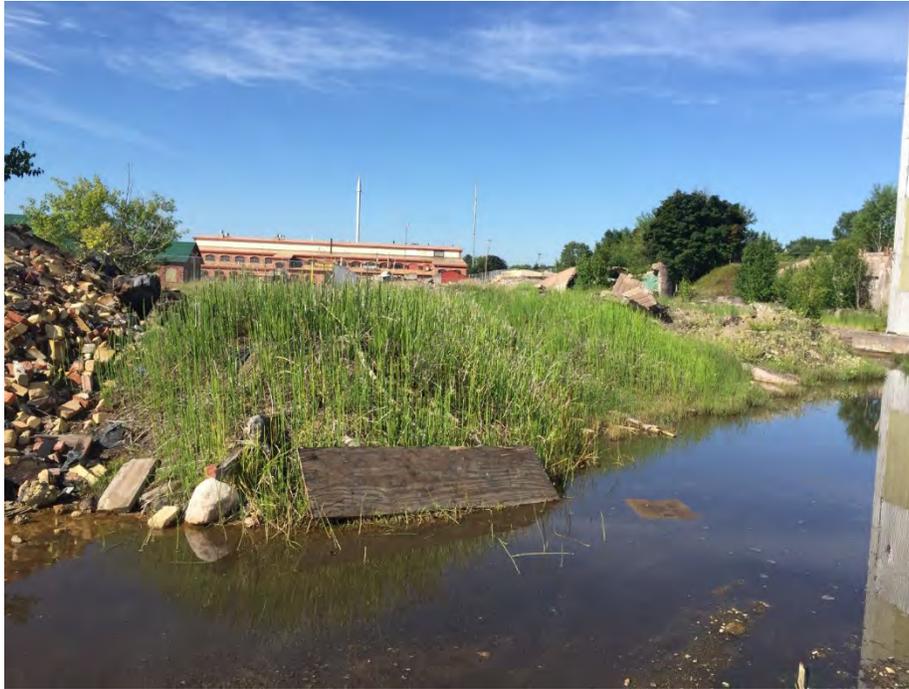
Photograph 31: WP-31 containing soil with metal and wood pieces. Photograph by J. Chrestensen, July 20, 2016.

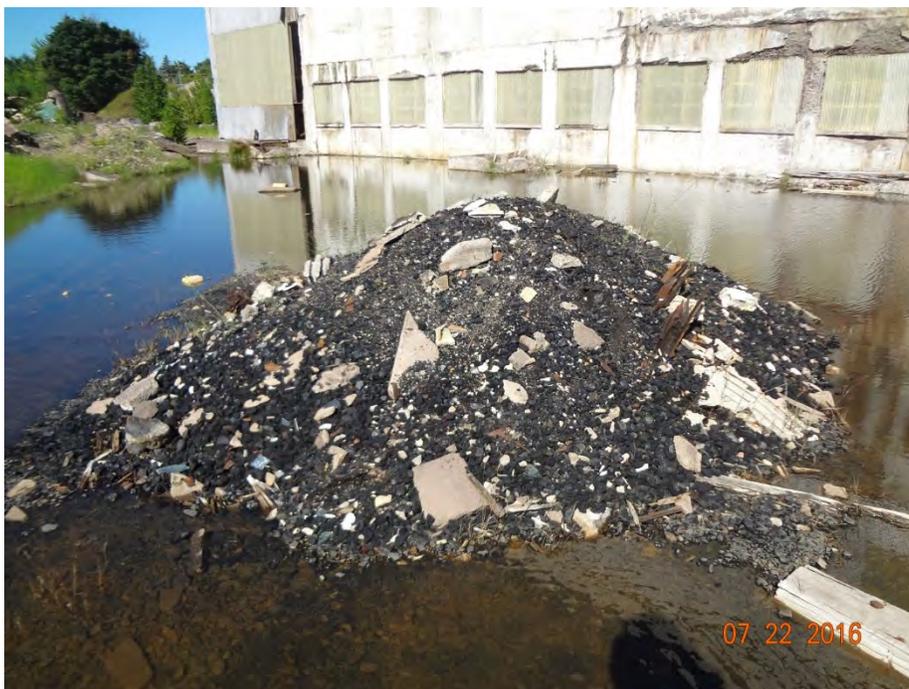
Photograph 32: WP-32 containing primarily coal, slag, and concrete refractory. Photograph by MDEQ-GSU, July 22, 2016.

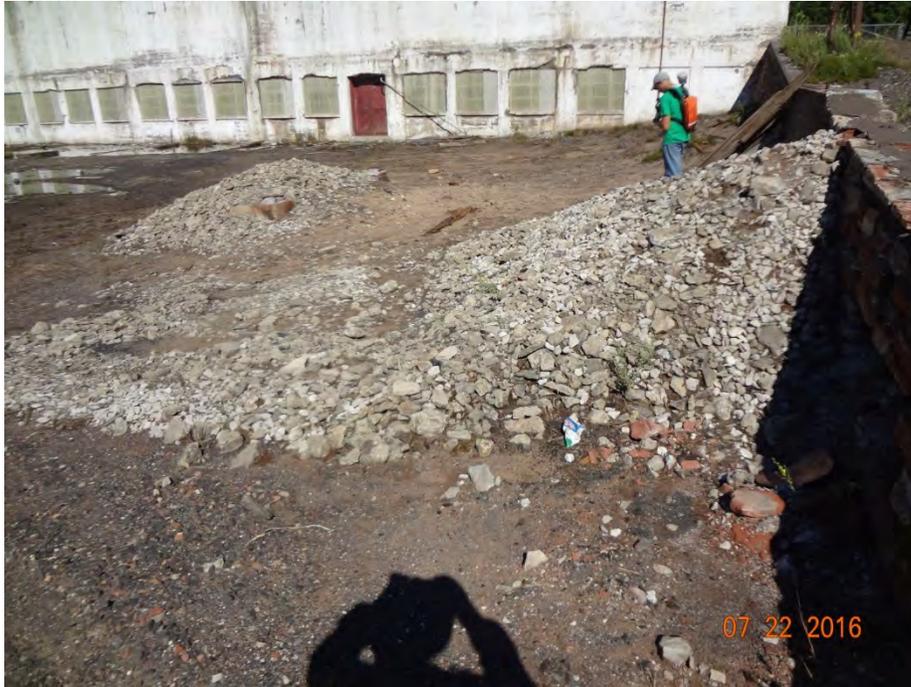
Photograph 33: WP-33 containing limestone. Photograph by MDEQ-GSU, July 22, 2016.

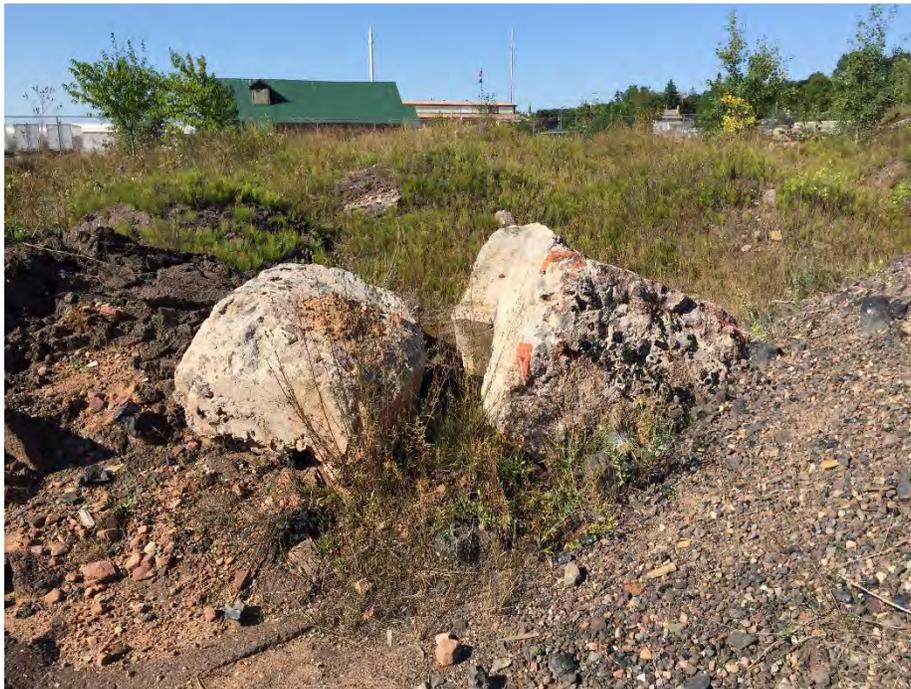
Photograph 34: WP-46 containing concrete pieces. Photograph by J. Chrestensen, August 25, 2016.

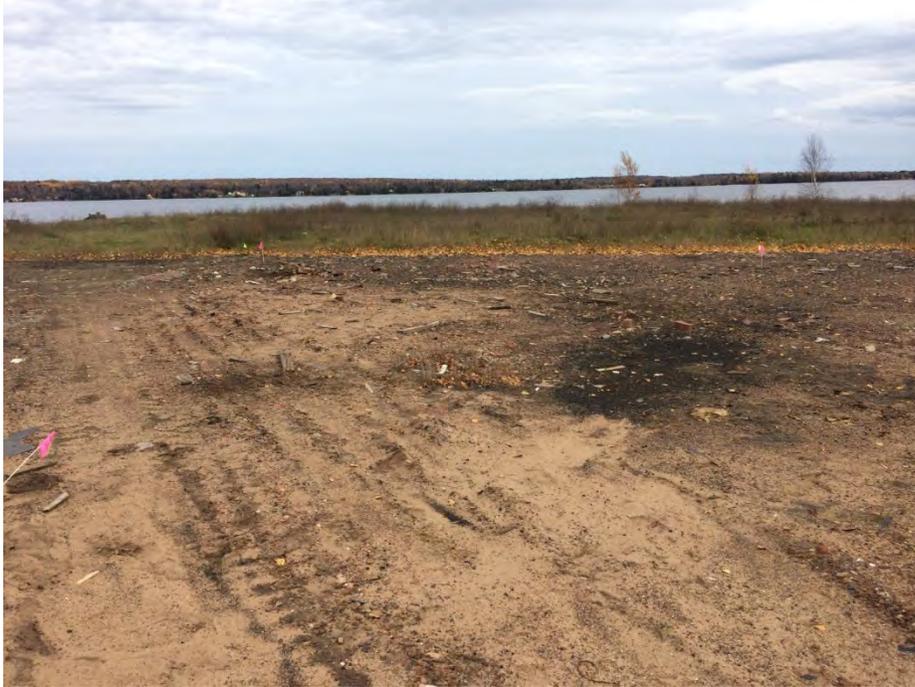
Photograph 35: WP-48 residual, primarily fine to medium grained sand with some wood and metal debris, and deteriorated corrugated cardboard. Photograph by MDEQ, October 23, 2017.
