Re: Removal Action Report for the Bonanza Mine 2014 Removal Action, Sutherlin, Oregon
Contract Number EP-S7-13-07, TDD Number 14-06-0006

REMOVAL ACTION REPORT

**Bonanza Mine Site
Nonpareil, Oregon
TDD: 14-06-0006**

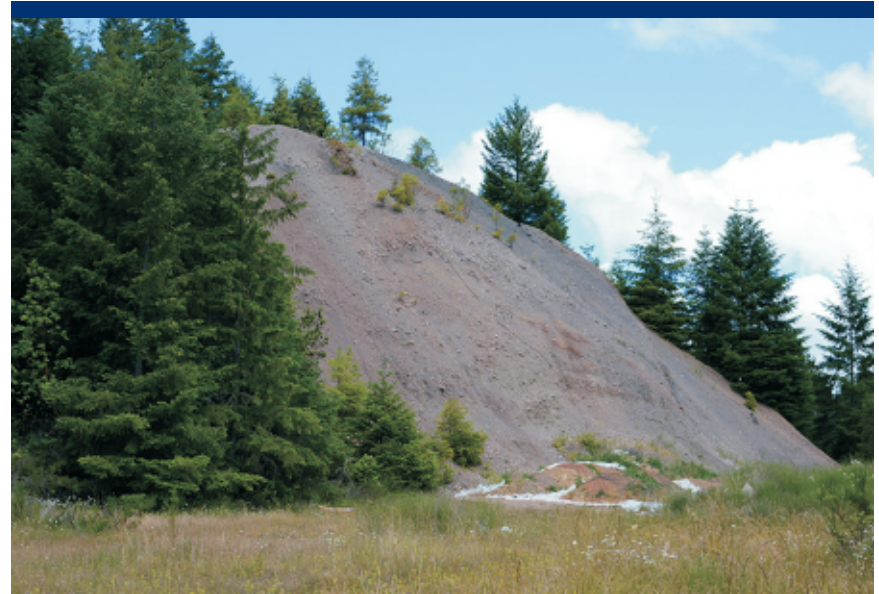
Photo 6 Pile of waste rock. The plastic tarp covers soil removed by ODEQ.

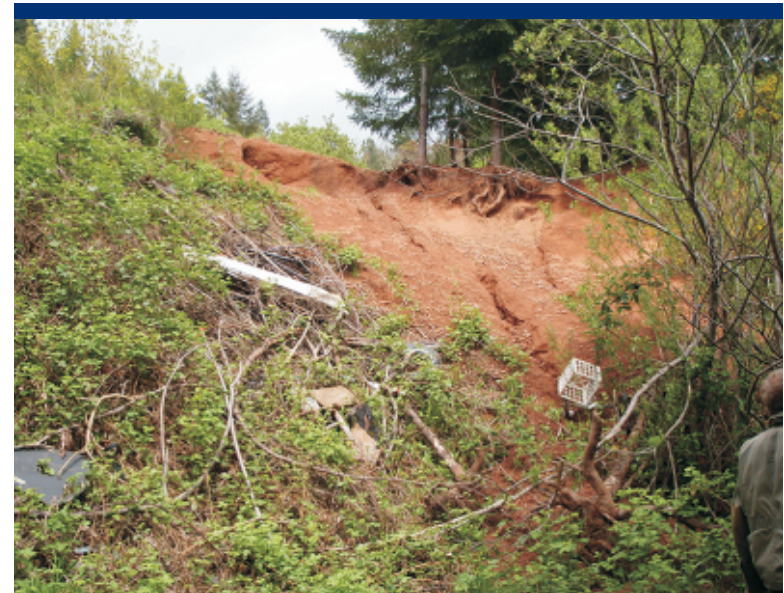
Photo 8 Calcine pile.

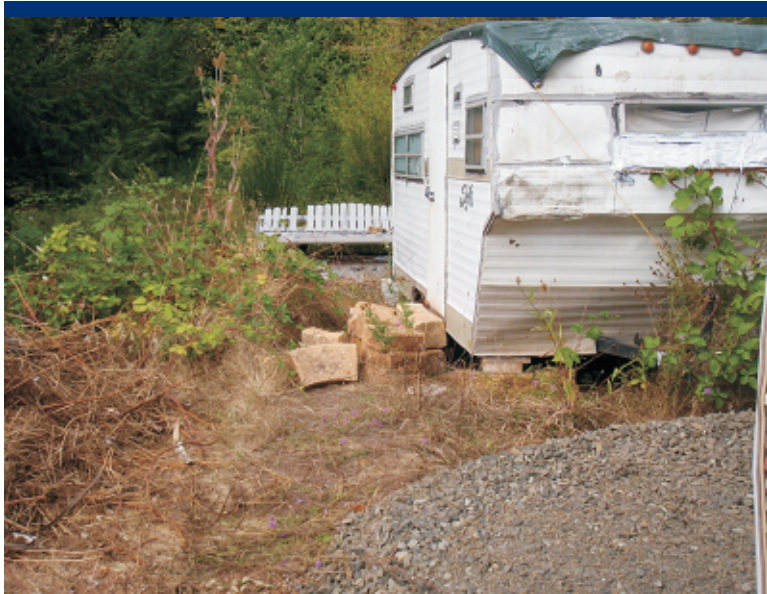
Photo 17 Dilapidated travel trailer supported by fire bricks from the former Mill Site at Residence 6.

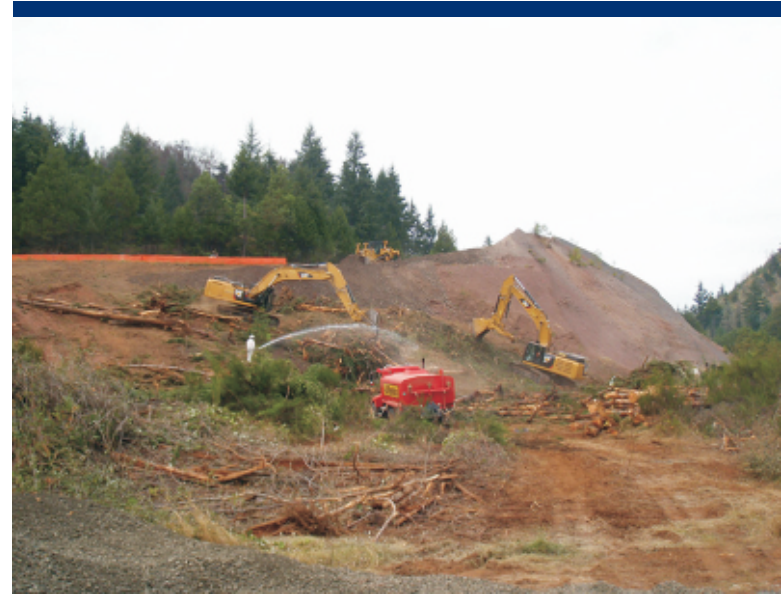
Photo 18 Shaping the waste rock pile; clearing and grubbing Area 1.

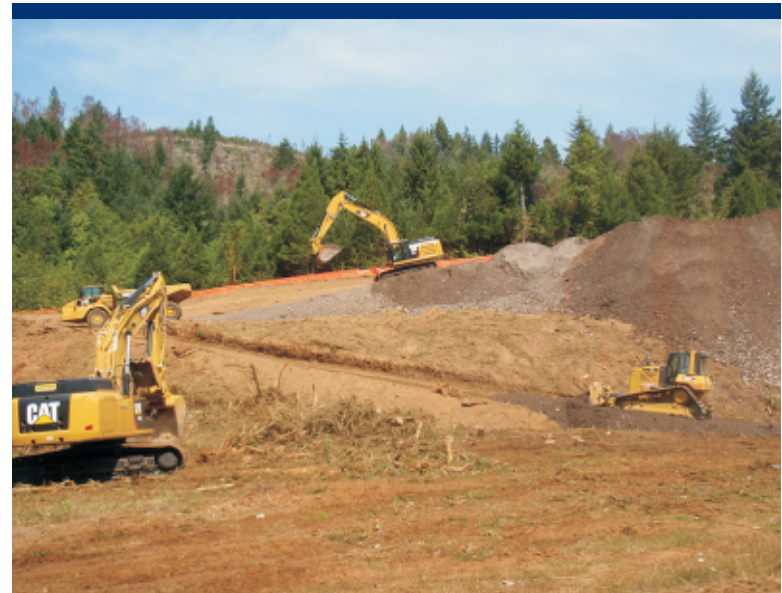
Photo 20 Shaping the calcine pile into the base for the on-Site repository.

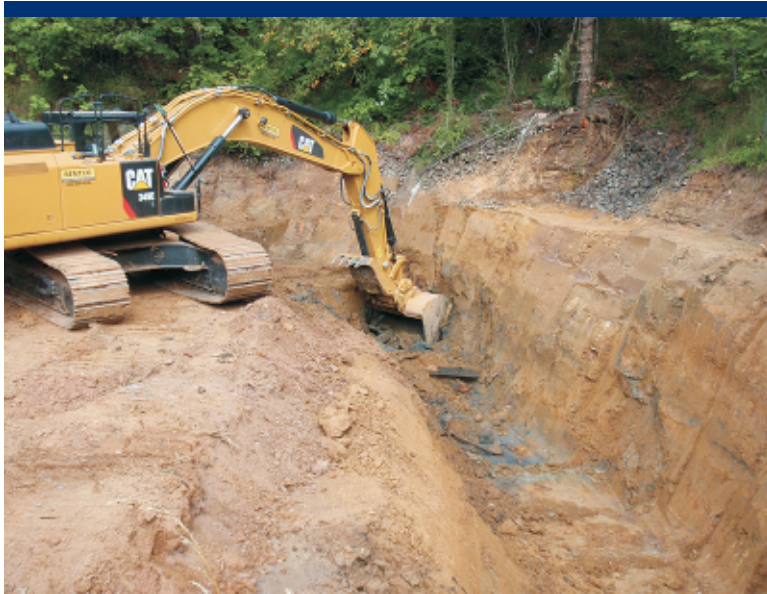
Photo 21 Excavation of the former Mill Site.

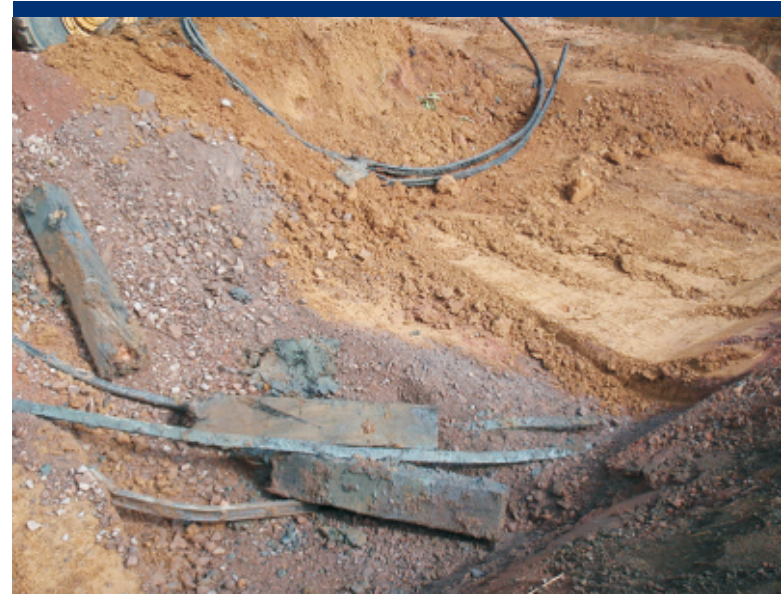
Photo 22 Exposed timbers and narrow gauge rail in the former Mill Site.

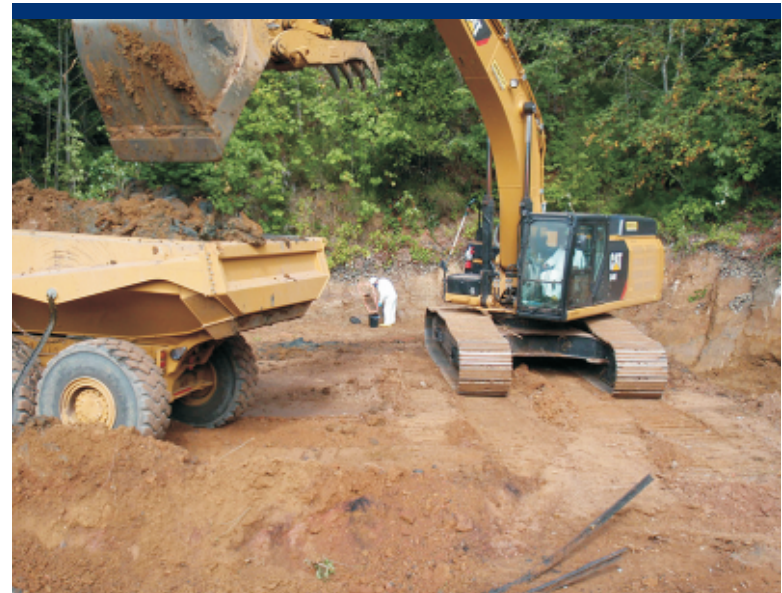
Photo 24 Excavation of the former Mill Site; a section containing free mercury was marked with orange spray paint.

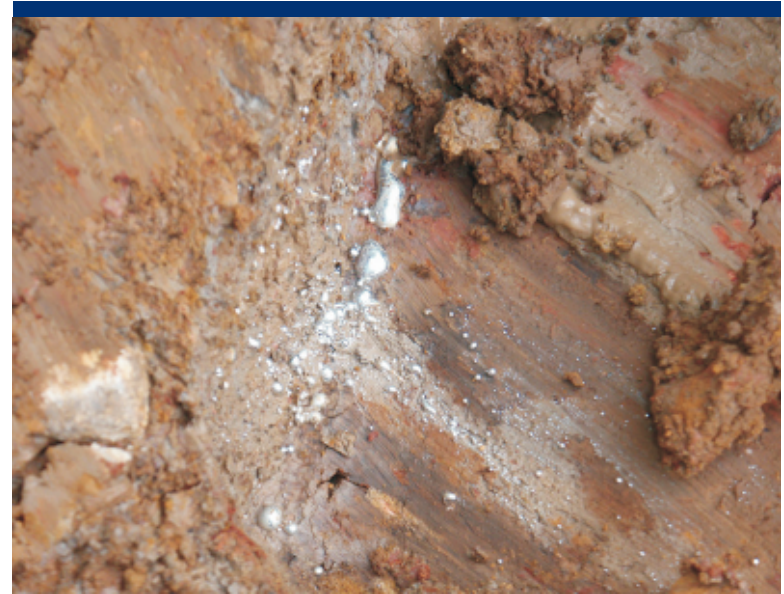
Photo 26 Free mercury at the former Mill Site.

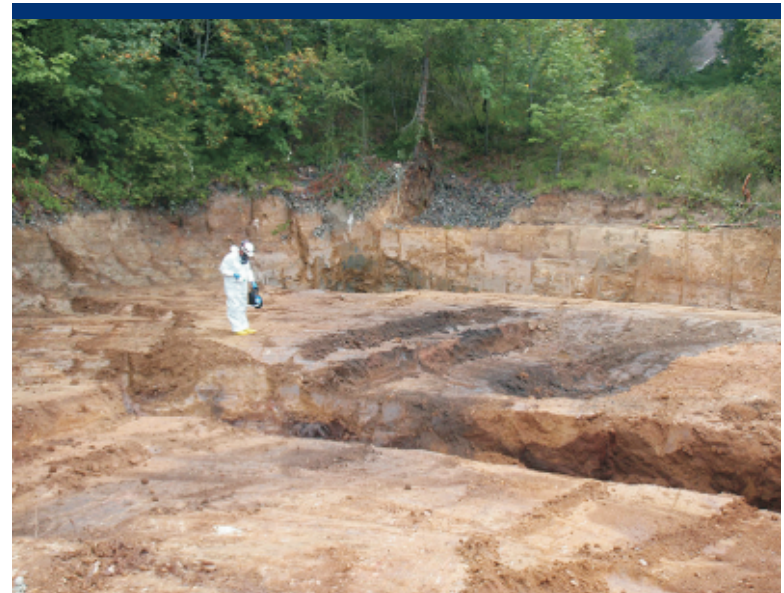
Photo 28 Field screening for mercury vapors at the former Mill Site.

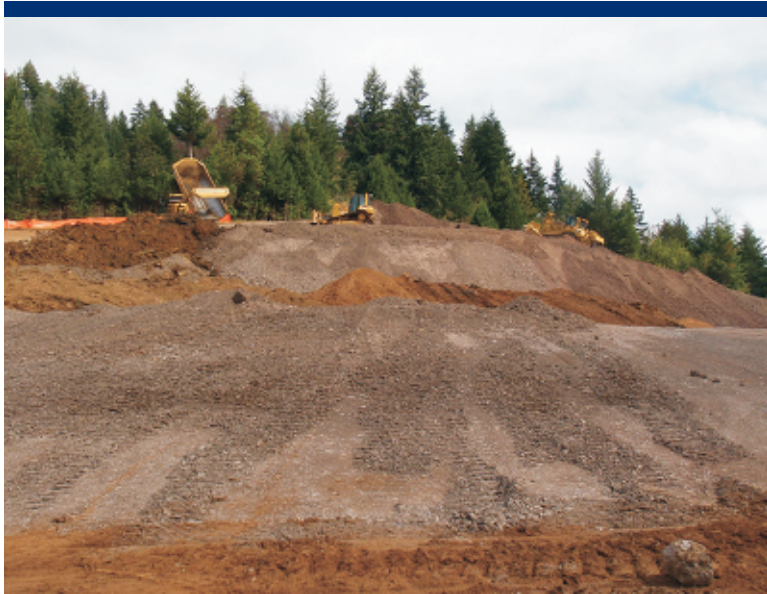
Photo 29 Construction of the repository with excavated mine waste material from the former Mill Site.

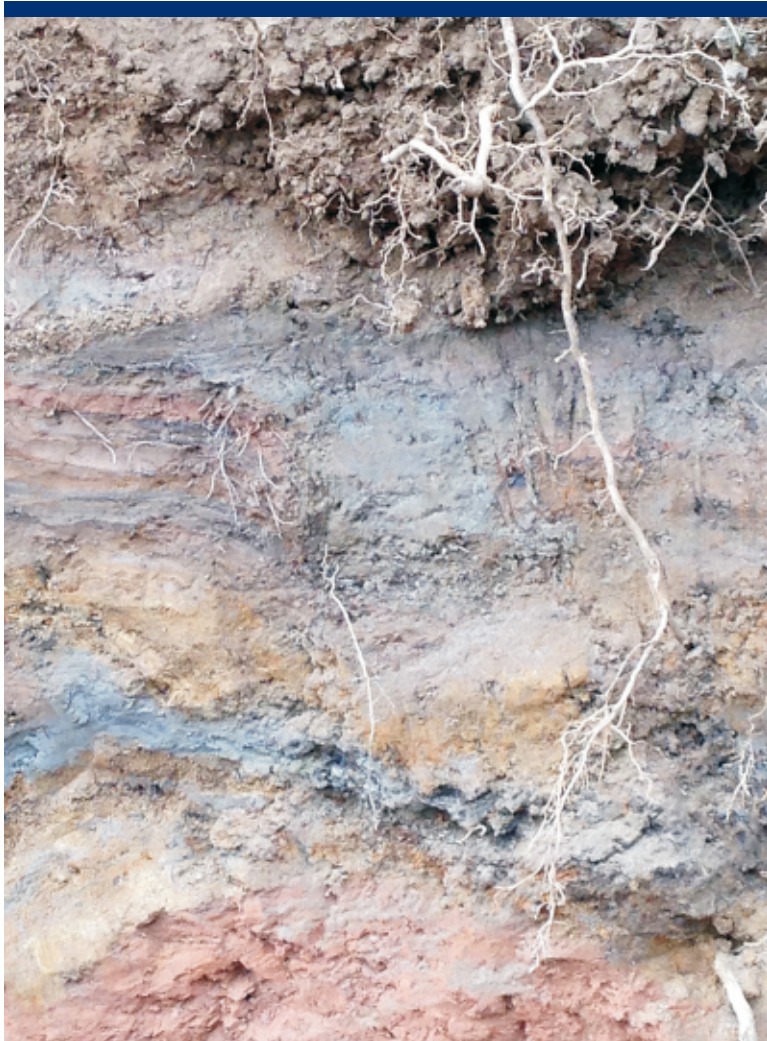
Photo 33 Sidewall in Area 2 containing visible layers of discolored soil.

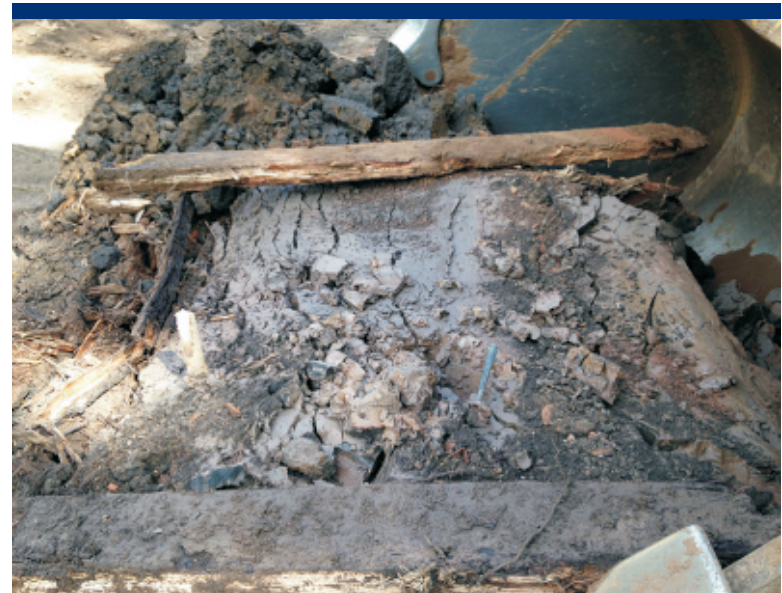
Photo 35 Gelatinous grey material from the mine feature in Area 2.

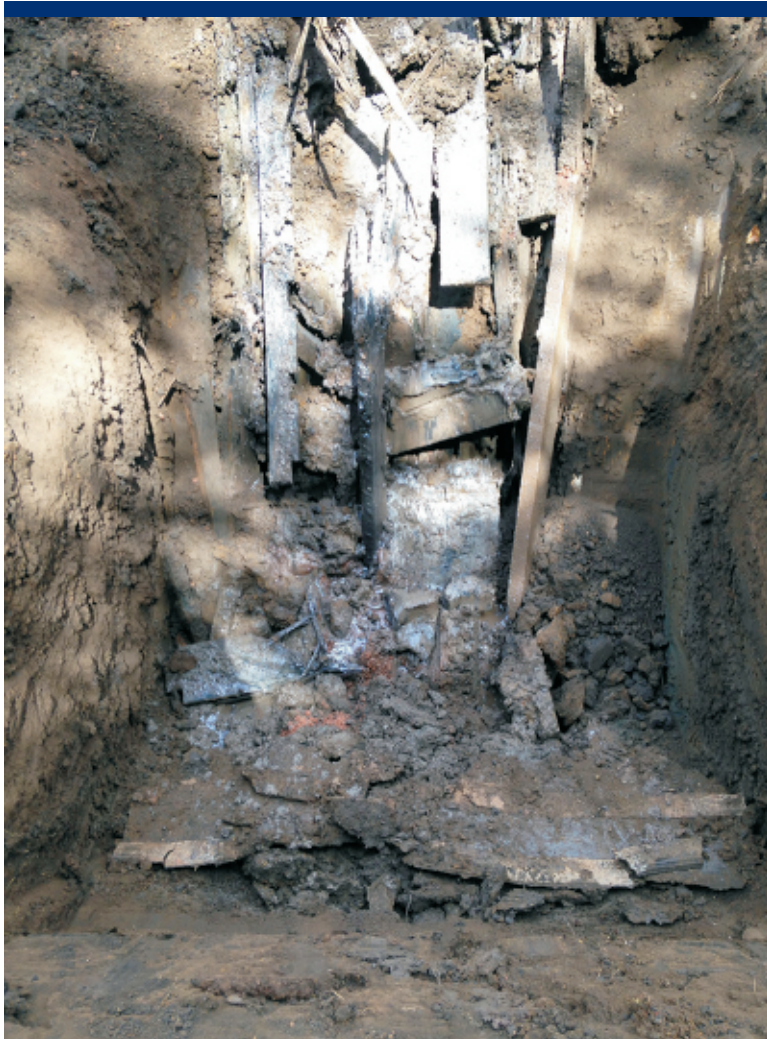
Photo 36 Excavated mine feature in Area 2 to a depth of 8 feet bgs.

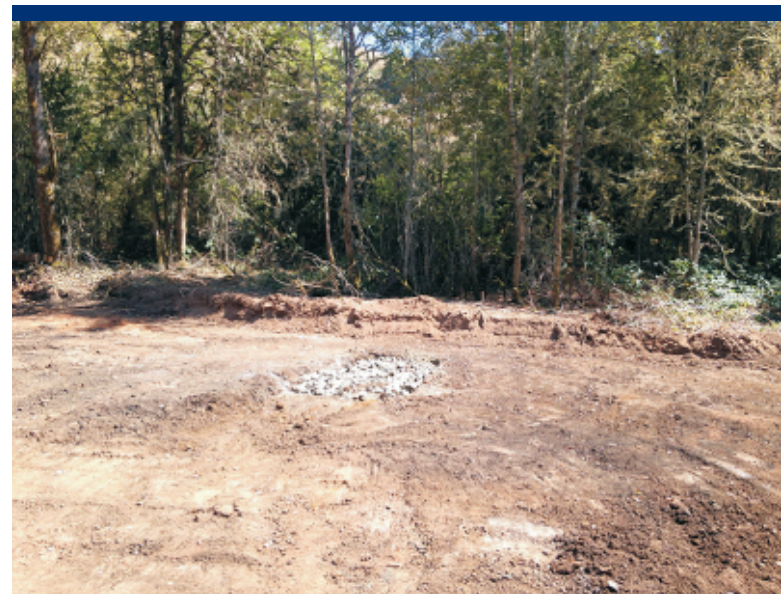
Photo 38 Mine feature backfilled with 4- to 8-inch rock.

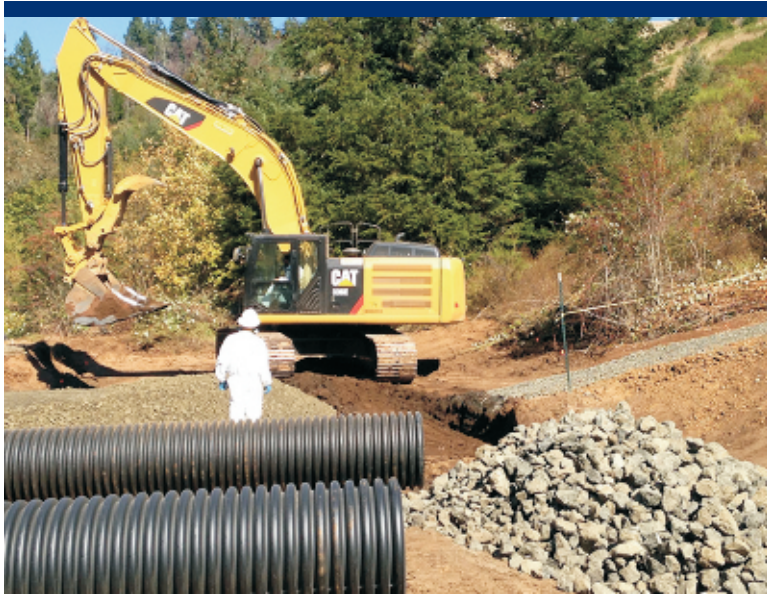
Photo 39 Replacing a culvert leading to Residence 3 from Area 2.

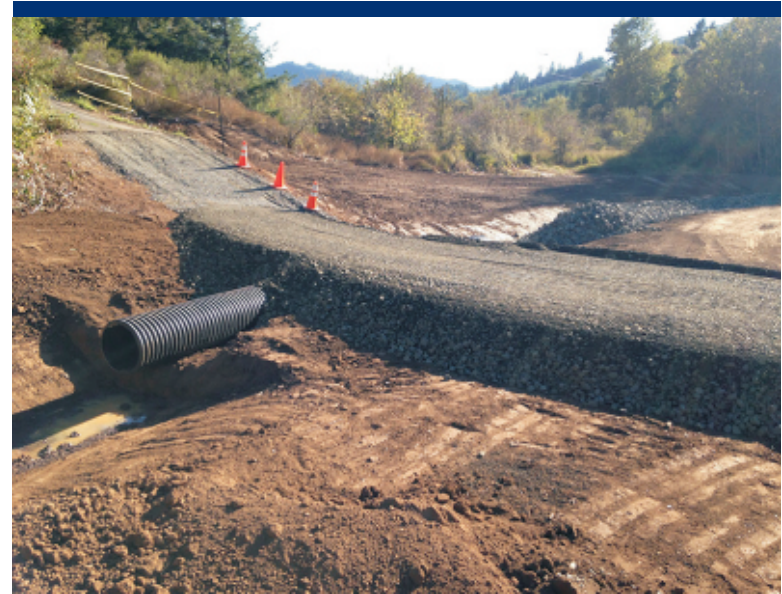
Photo 40 New 24 inch culvert installed between Area 1 and Area 2 leading to Residence 3.

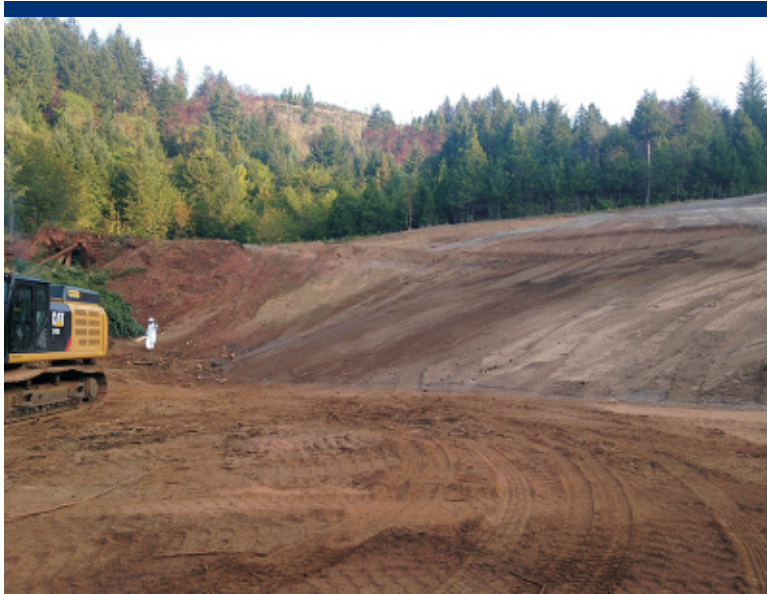
Photo 44 Expanding the repository to the west to accommodate increased volume of excavated material.

During the course of the removal action, an increased volume of excavated soil and concomitant soil and geomembrane cover necessitated adjustments to the design and slope calculations of the on-Site repository. Specific factors included the increased depth of excavation at the former mill site due to presence of highly-contaminated soil and free mercury, and the increased depth of excavation at nearly all areas based on field screening values (EPA 2014a). Additional information regarding the repository can be found in Section 4.2.4.

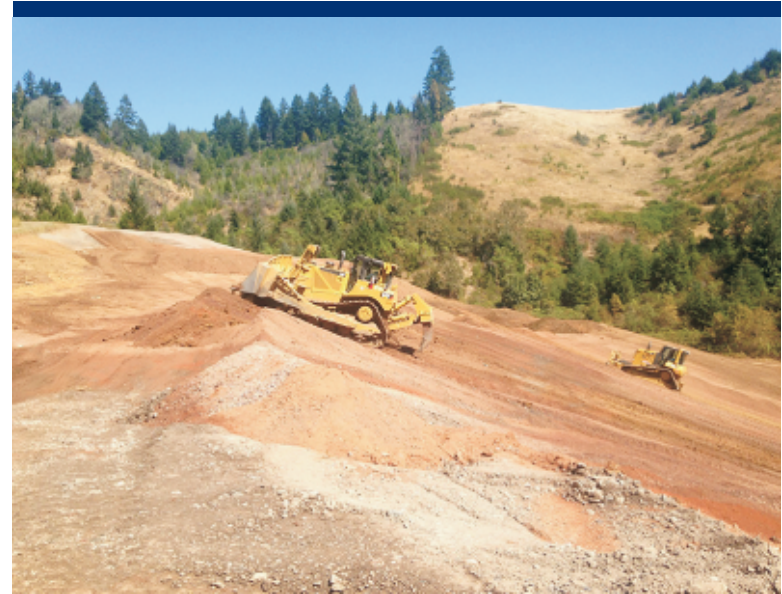
Photo 45 Grading and shaping the repository with heavy equipment.

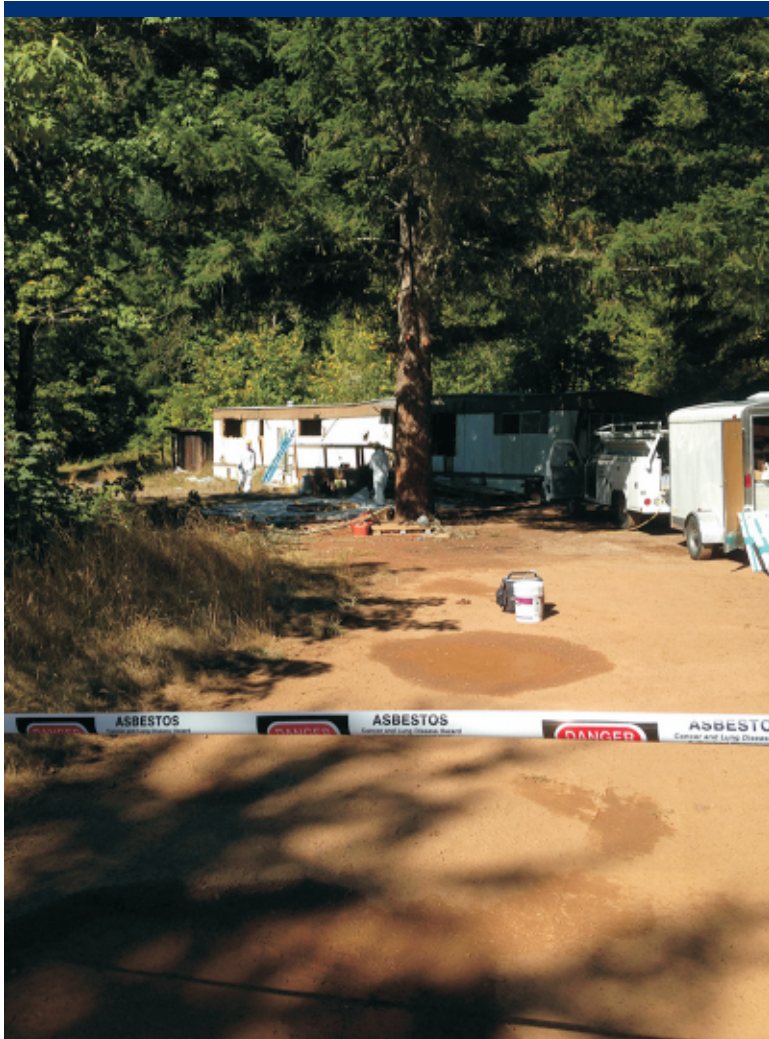
Photo 47 Asbestos abatement of Residence 1.

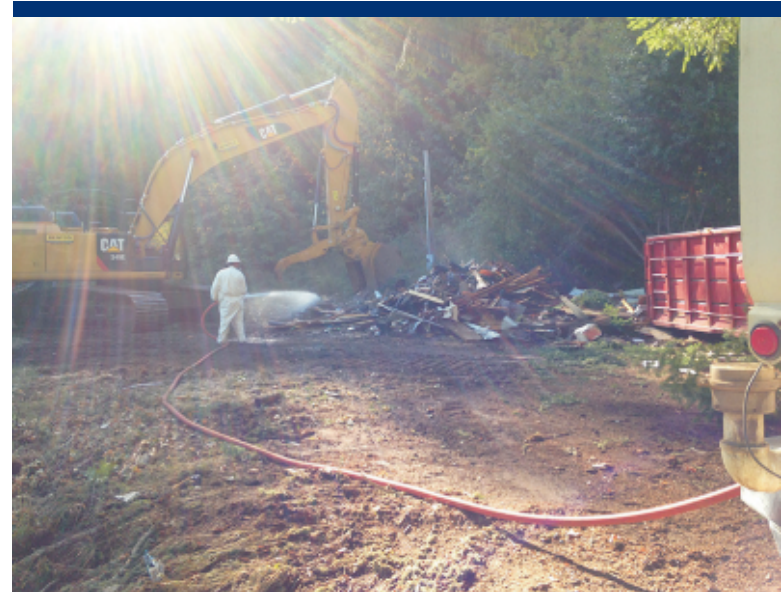
Photo 48 Demolition of Residence 1.

Upon completion of the asbestos abatement the homes were demolished using an excavator. The debris was placed into roll off containers and transported to the Douglas County landfill for disposal as non-hazardous construction and demolition debris.

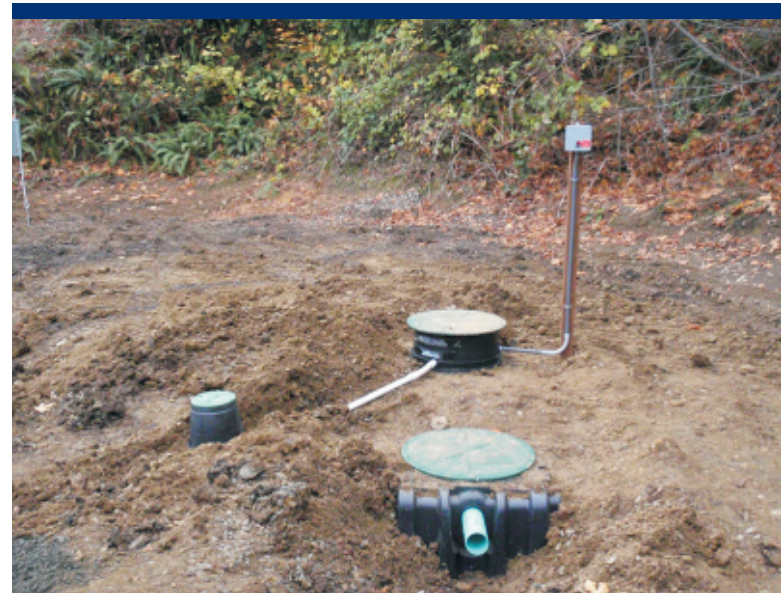
Photo 61 Installed septic tank at Residence 1.

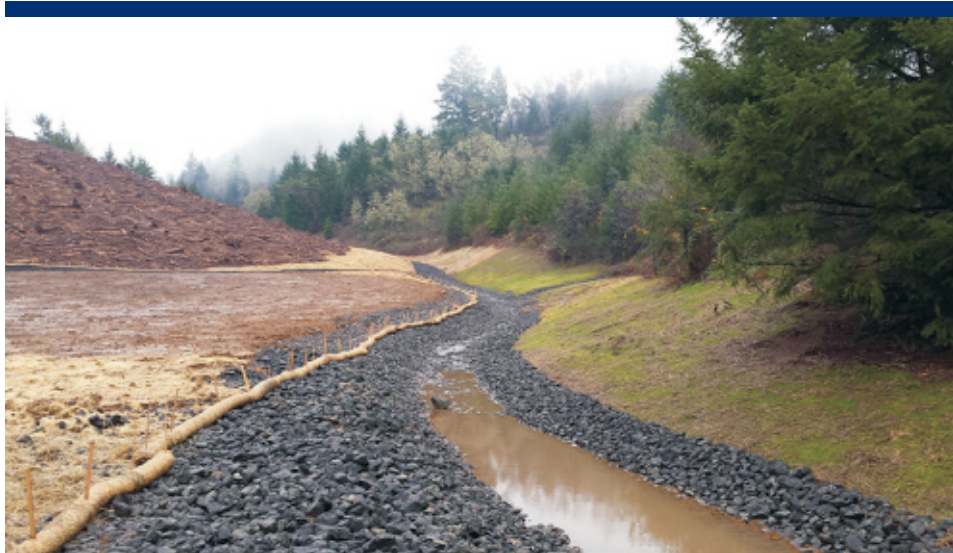
Photo 70 Armored channel leading past Area 1 and the repository.

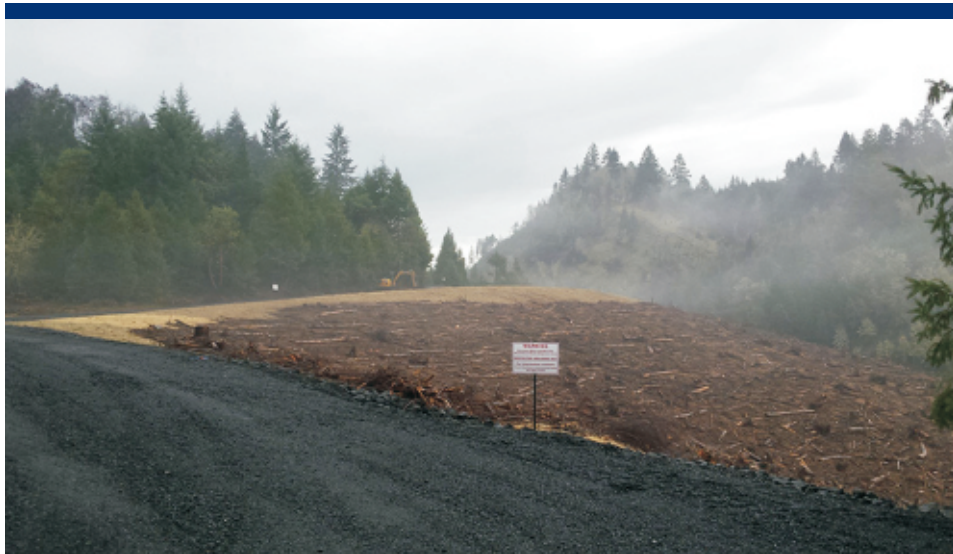
Photo 72 View of the finished repository face and warning sign.

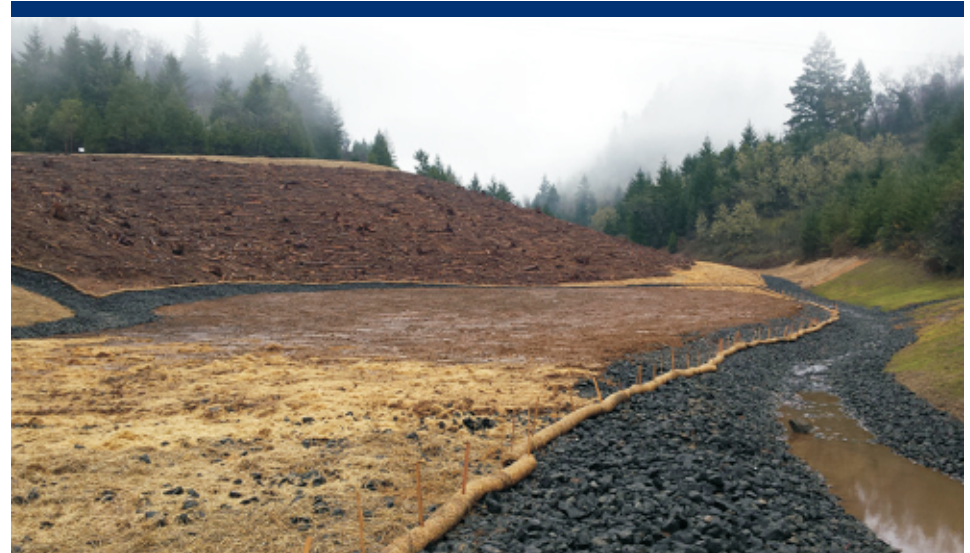
Photo 71 View of Area 1 with the finished repository in the background and multiple armored drainage channels.
