STATE OF MICHIGAN  
DEPARTMENT OF HEALTH AND HUMAN SERVICES  
LANSING

April 4, 2018

This letter is in response to your request for a public health evaluation of the asbestos in the area surrounding the C&H Mineral Building, located at 52986 Highway M-26 in Hubbell, Houghton County, Michigan.

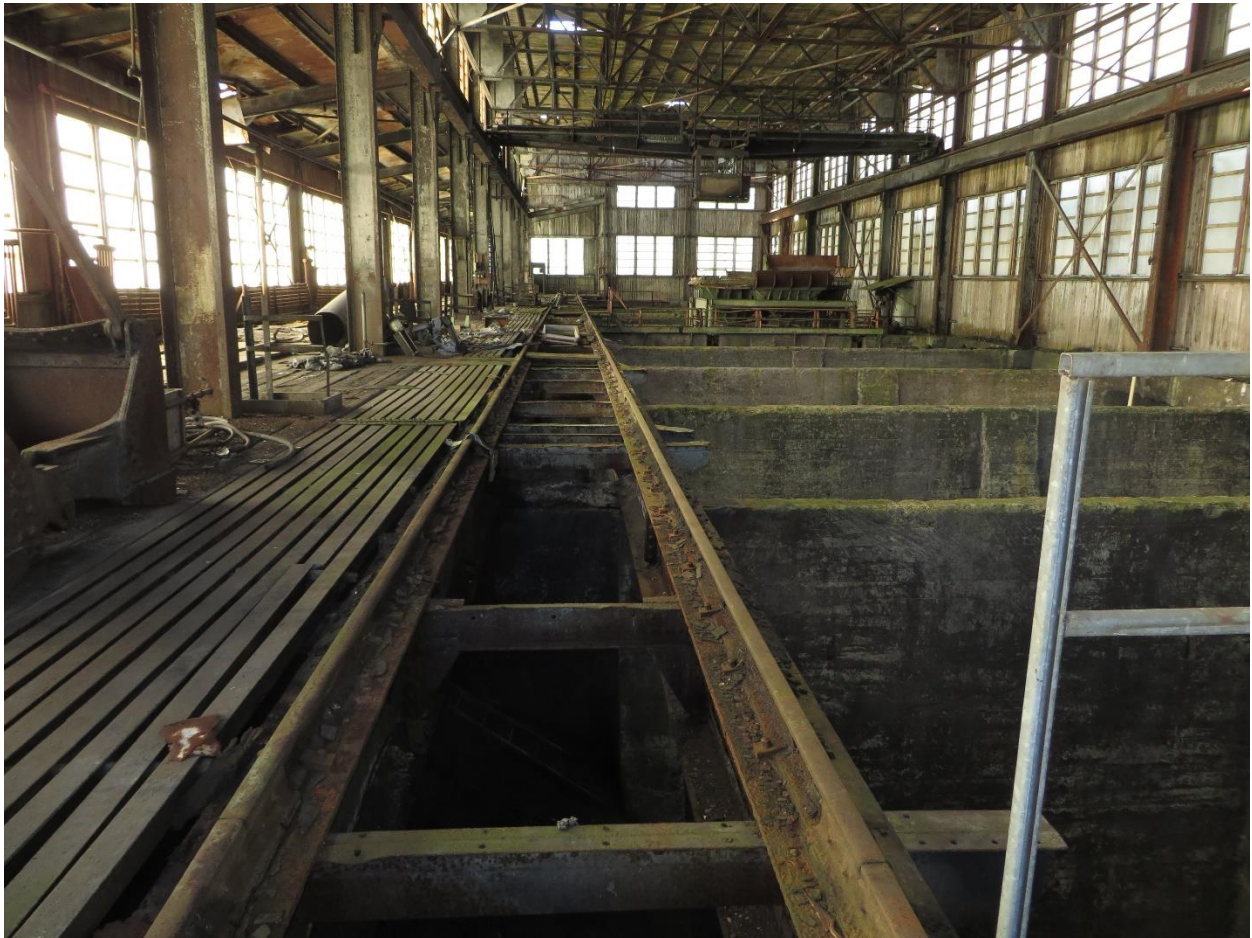
- The Mineral Building itself has pits (former mineral storage bins) that are 20 feet below the floor. The floor also appears uneven and has debris and material from former uses. See photo 1 and 2.

Photo 1: Mineral Building interior, looking southwest, with the bins (pits) on the right (MDEQ 2014)

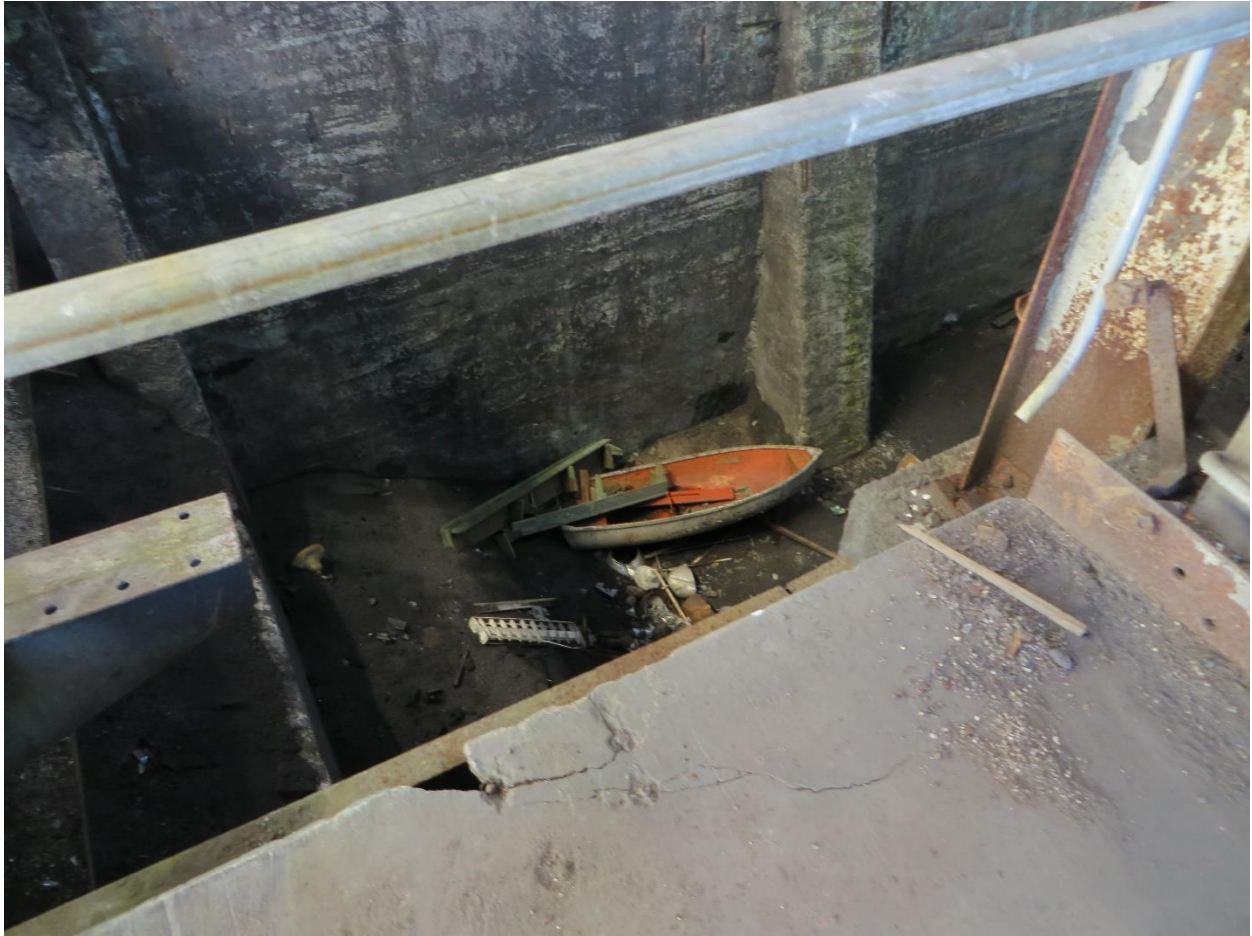
Photo 2: Mineral Building interior, boat in bin (pit) (MDEQ 2014)
