**Subject: Trip Report and Data Summary for Removal Site Evaluation Activities
Community Laundromat Site, Ava, Missouri
U.S. EPA Region 7 START 3, Contract No. EP-S7-06-01
Task Order No. 0068.000
Task Monitor: Eric Nold, EPA On-Scene Coordinator**

**TRIP REPORT AND DATA SUMMARY
FOR REMOVAL SITE EVALUATION ACTIVITIES**

COMMUNITY LAUNDROMAT SITE – AVA, MISSOURI

**Superfund Technical Assessment and Response Team (START) 3
Contract No. EP-S7-06-01, Task Order 0068.000**

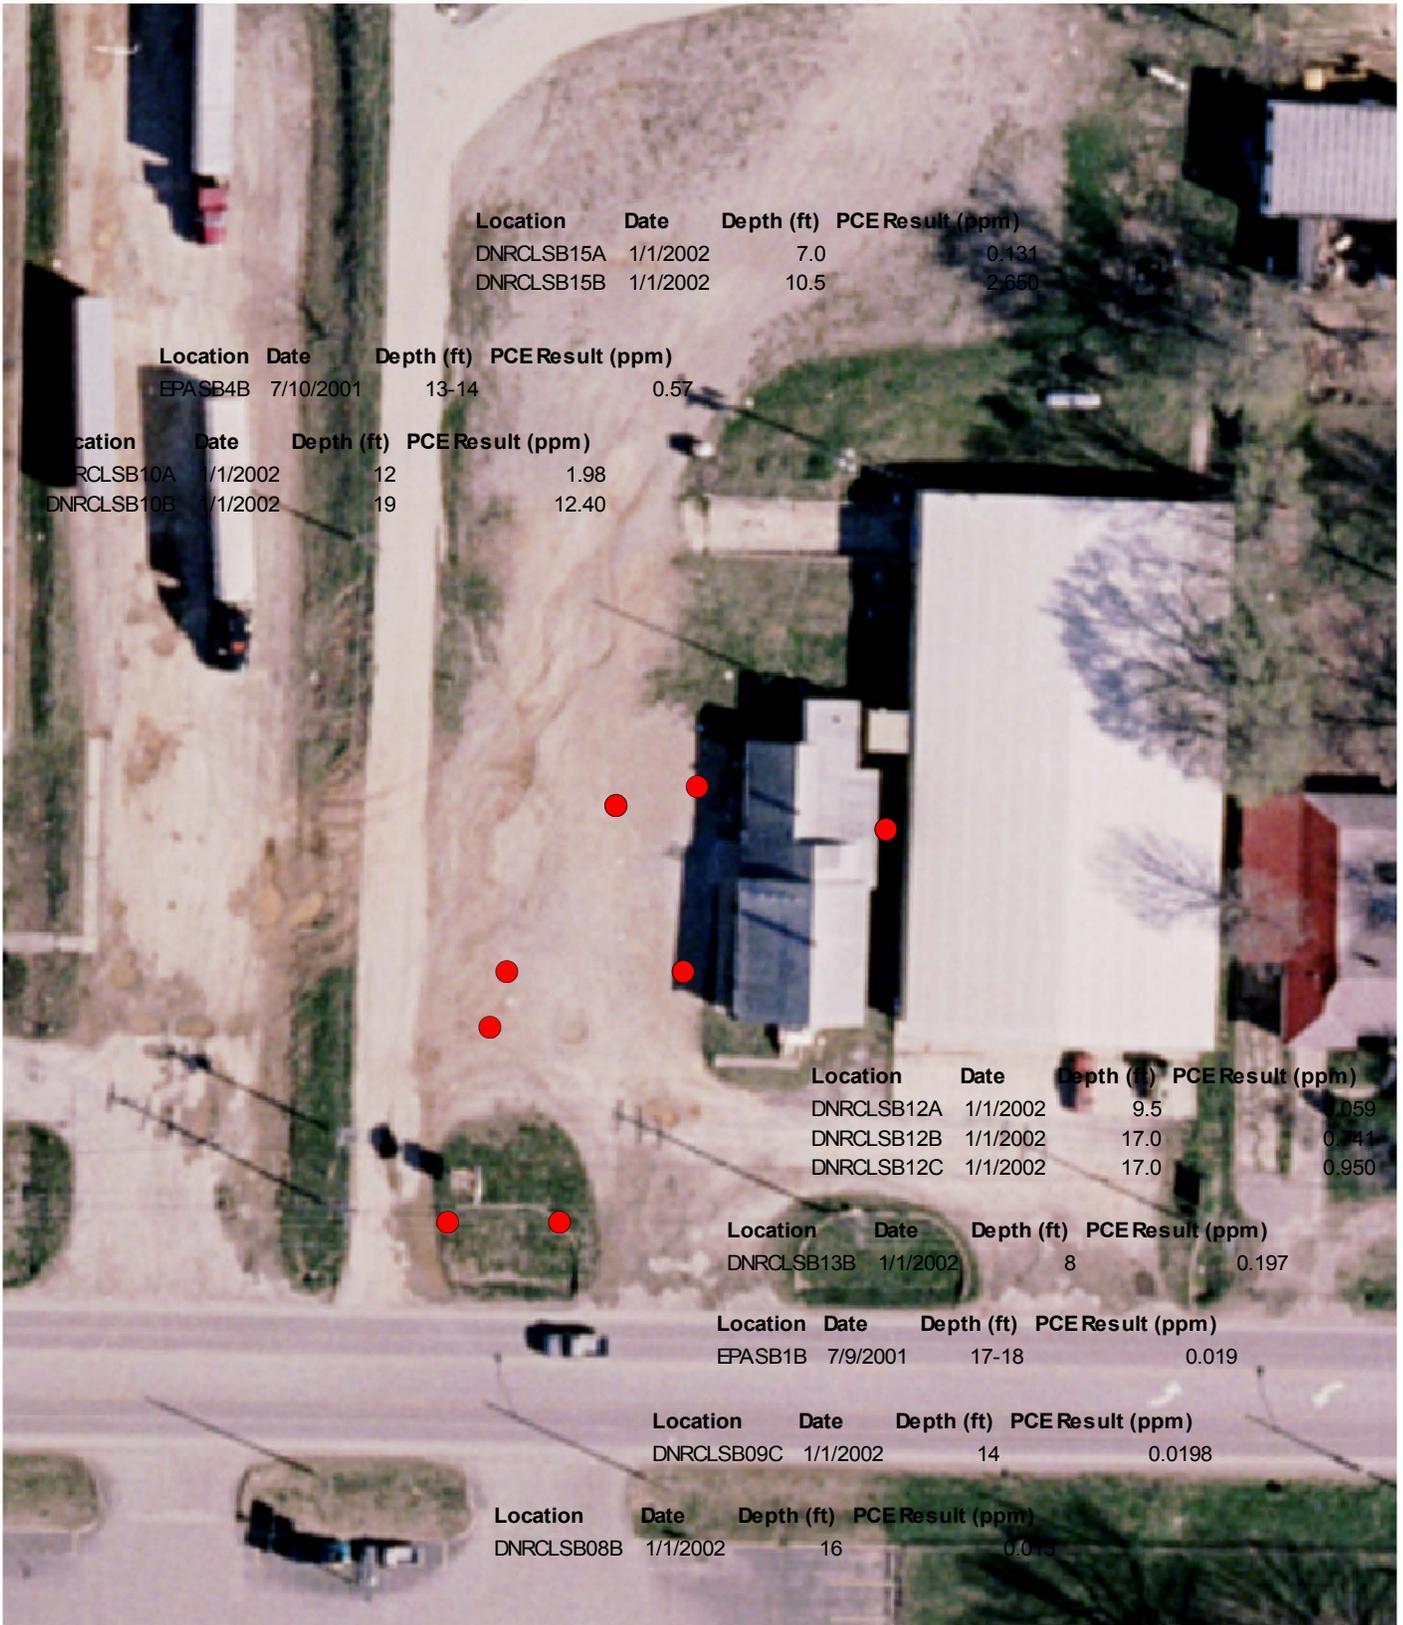
Figure 2
Previous Investigations
PCE Detections in Soil

Significant PCE detections reported during the various investigations are summarized in Table 1. Corresponding sample locations are shown on Figures 2 and 3 in Appendix A.

PCE was found at a concentration of 0.019 parts per million (ppm) in the soil sample collected from SB-1 at a depth of 17 to 18 feet bgs. This sample was collected very near the water table. PCE was also found at a concentration of 0.57 ppm in a soil sample collected from SB-4 at a depth of 13 to 14 feet bgs.

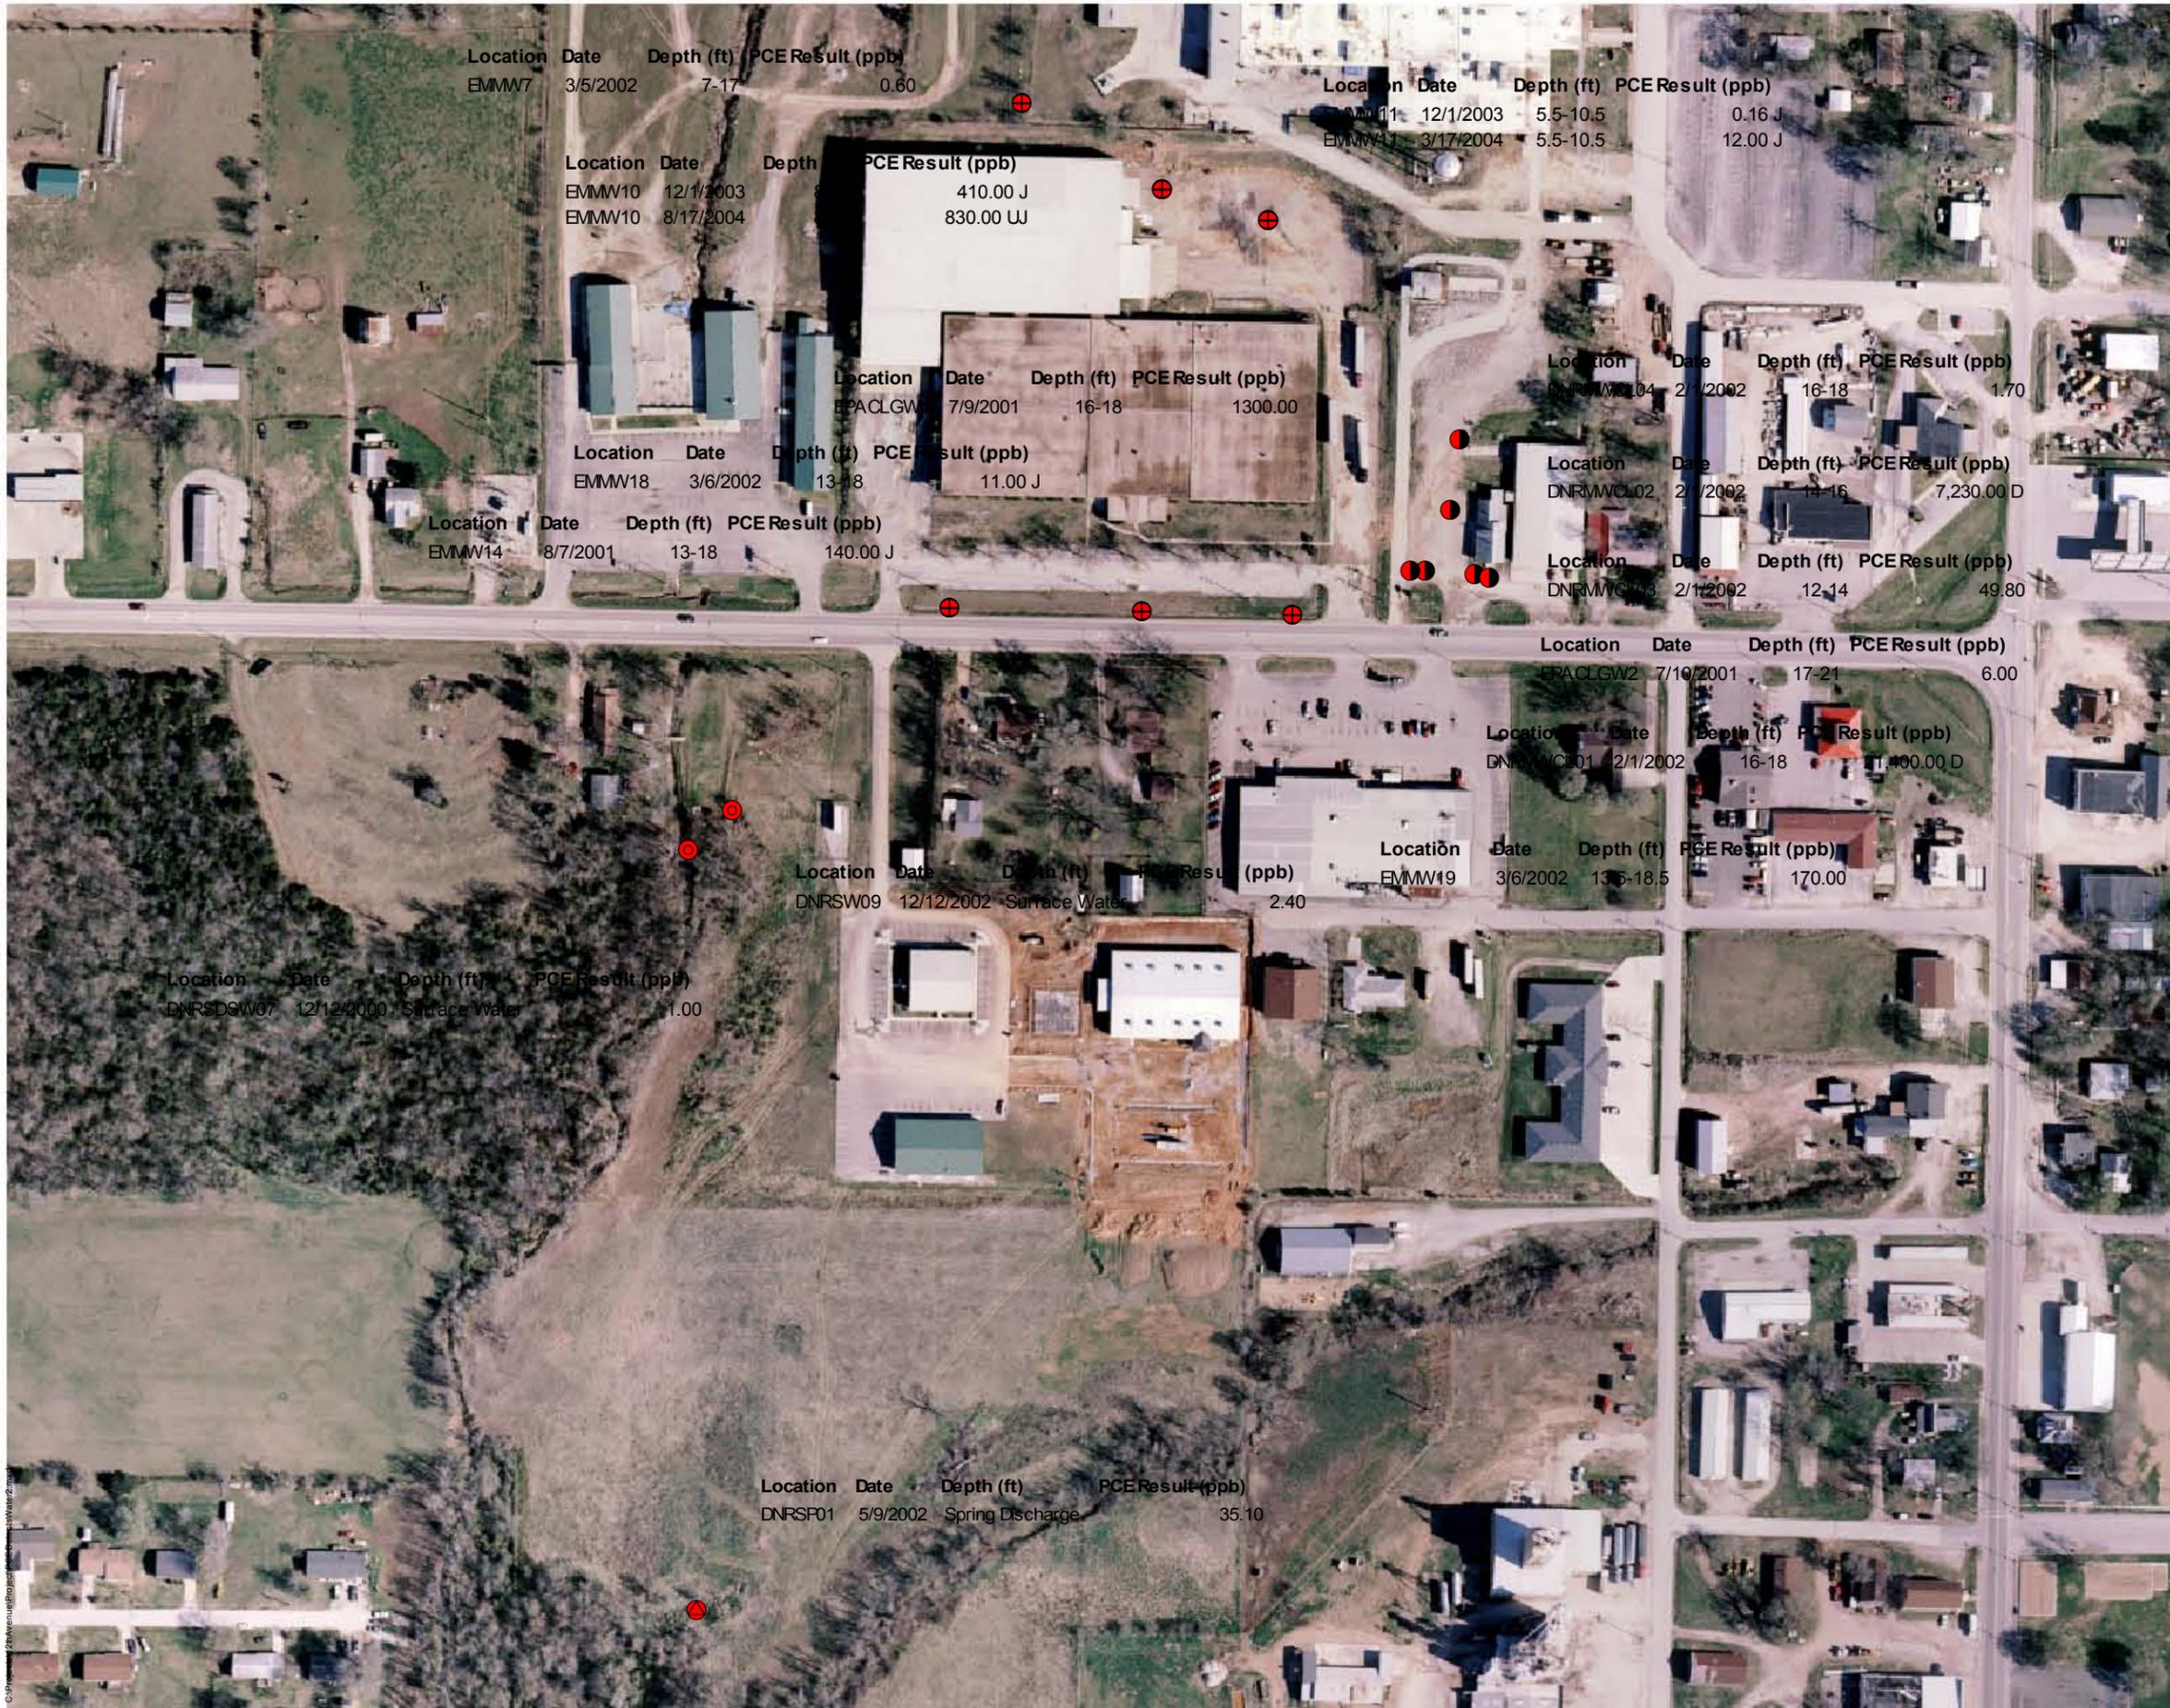
Figure 3
 Previous Investigations
 PCE Detections in Water

PCE was found at a concentration of 1,300 ppb in the groundwater sample collected from SB-1 at a depth of 16 to 18 feet bgs. This sample also contained 1,1,1-trichloroethane (TCA) at a concentration of 12 ppb.

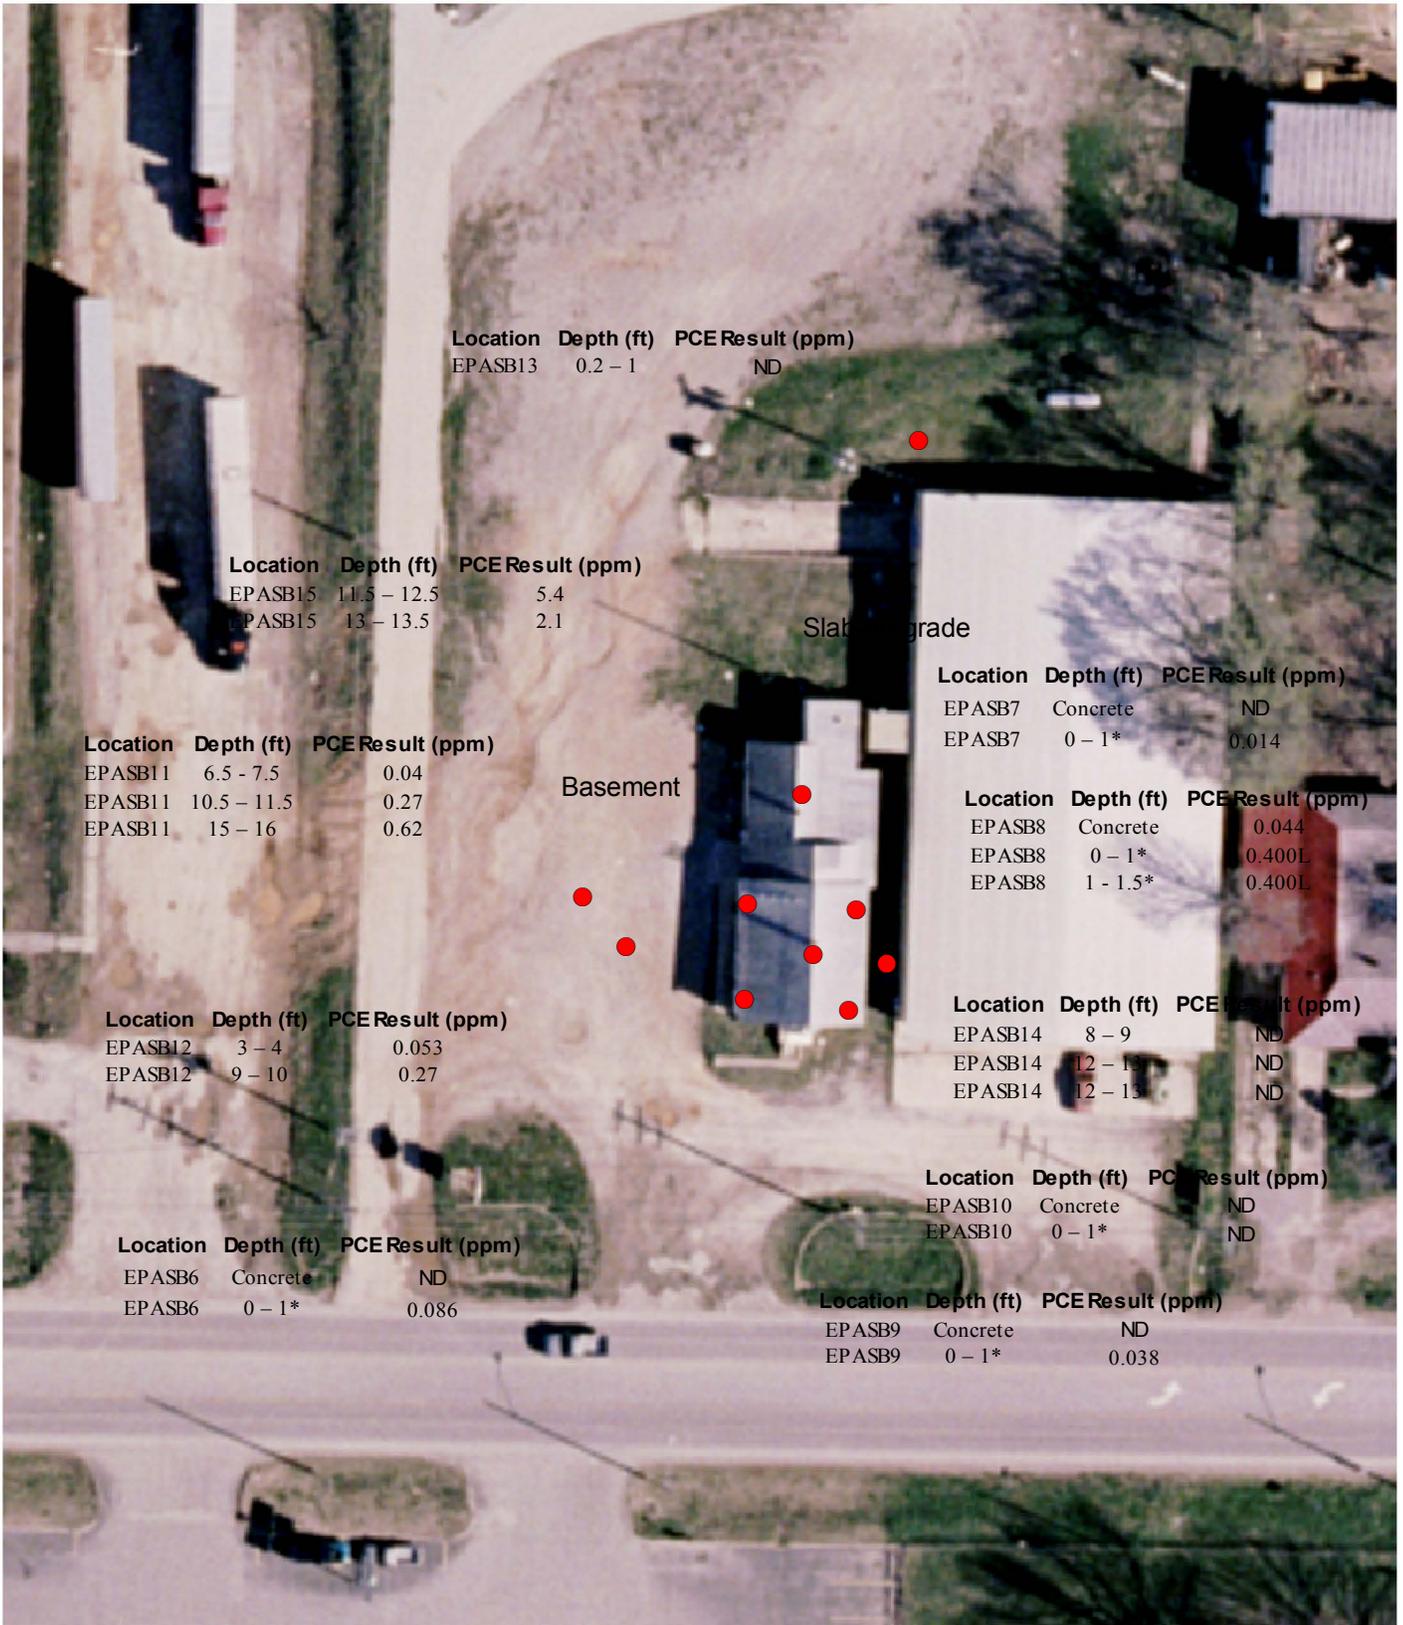
Figure 4
PCE Current Investigation
Sample Results

background sample, were collected from six hand-augered borings. Figure 4 depicts the soil boring locations for this RSE activity.

PCE was detected in one concrete sample, collected from SB8 located near the center of the basement floor, at a concentration of 0.044 ppm. Two soil samples collected from directly beneath the concrete at the SB8 location also contained PCE. A concentration of 0.400L ppm was reported for both soil samples—one collected at 0 to 0.5 feet bgs (i.e., beneath the concrete), and the other collected at 1.0 to 1.5 feet bgs.

Relatively high levels of PCE were also reported in soil samples collected from SB15, located near the center of the slab-on-grade floor north of the basement. Samples collected from 11.5 to 12.5 feet bgs and 13.0 to 13.5 feet bgs contained PCE at levels of 5.4 ppm and 2.1 ppm, respectively. These data, along with

PCE levels above the MRBCA soil threshold were also reported in samples collected from SB11 and SB12, located west of the former dry cleaner building. The PCE levels detected in these samples were consistent with levels detected in other samples collected from this area during previous investigations, thereby confirming the currently proposed “removal boundaries” west of the building.

The determination that PCE levels below the basement floor and the slab-on-grade north of the basement exceed the MRBCA soil threshold of 0.141 ppm impacts the removal scenarios currently described in *Evaluation of Removal Action Alternatives, Community Laundromat Site, Ava, Missouri*, dated August 11, 2006. As requested by EPA, START will revise this document to reflect the new soil data and associated impacts on the various removal action alternatives described therein.

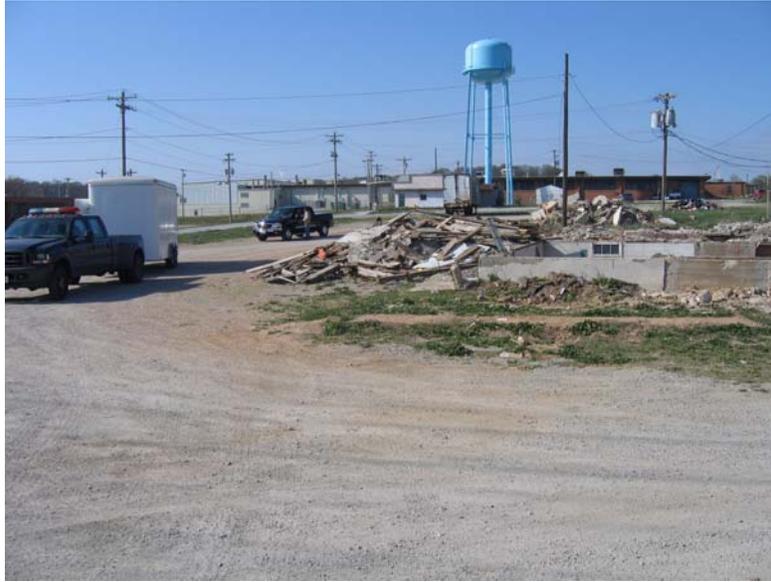
TETRA TECH PROJECT NO. X9004.07.0068.000 Direction: North	DESCRIPTION	This photograph shows remaining debris and basement foundation at the former dry cleaning facility. Municipal Well No. 4 is located next to water tower.	1
	CLIENT	U.S. Environmental Protection Agency Region 7	Date
	PHOTOGRAPHER	Laura Moore	04/09/2007

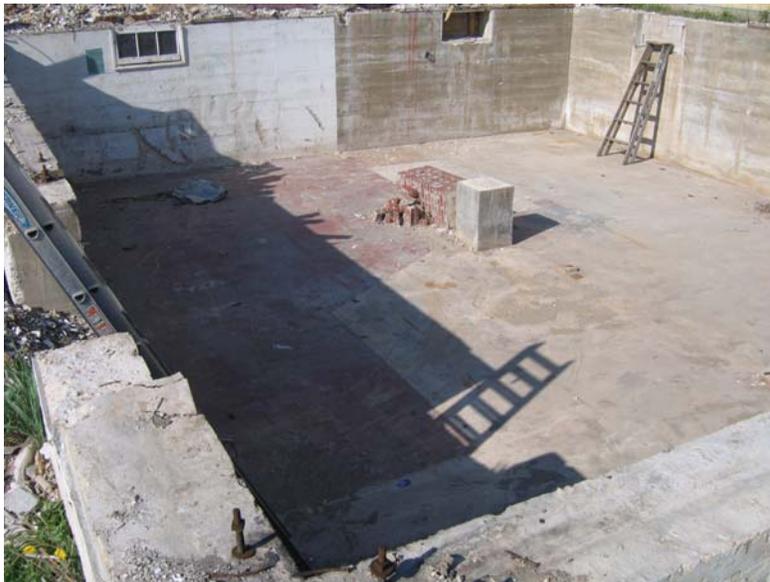
TETRA TECH PROJECT NO. X9004.07.0068.000 Direction: Northeast	DESCRIPTION	This photograph shows the basement of the former dry cleaning facility where SB6, SB7, SB8, SB9, and SB10 were located.	2
	CLIENT	U.S. Environmental Protection Agency Region 7	Date
	PHOTOGRAPHER	Laura Moore	04/09/2007

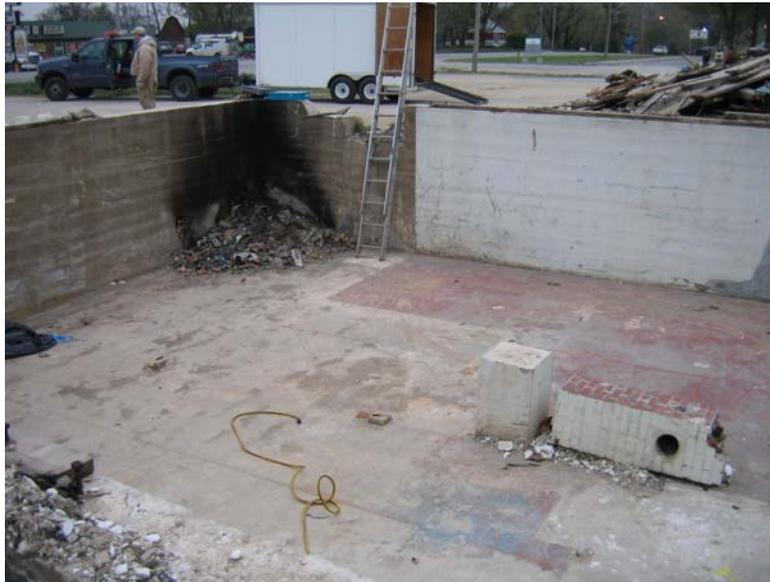
TETRA TECH PROJECT NO. X9004.07.0068.000 Direction: Southwest	DESCRIPTION	This photograph shows the basement of the former dry cleaning facility. Debris burn area is southwest corner.	3
	CLIENT	U.S. Environmental Protection Agency Region 7	Date
	PHOTOGRAPHER	Laura Moore	04/09/2007

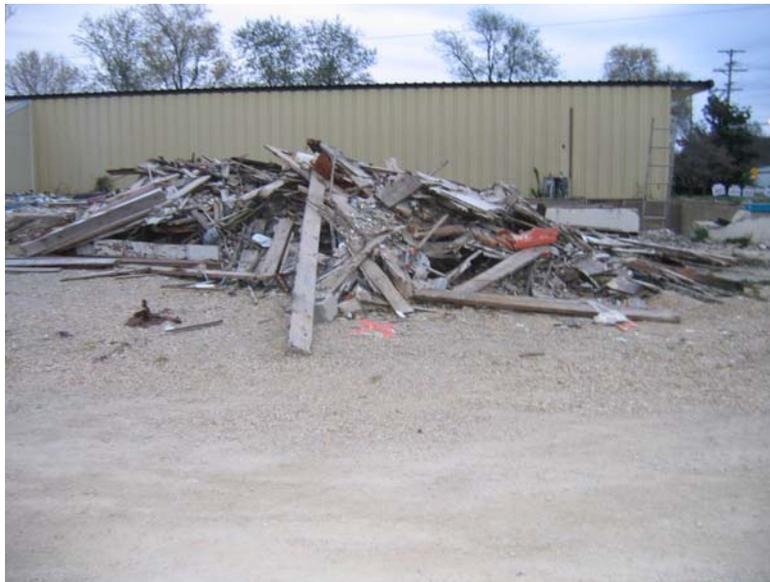
TETRA TECH PROJECT NO. X9004.07.0068.000 Direction: East	DESCRIPTION	This photograph shows the location of SB11 ("X"), west of the former building.	4
	CLIENT	U.S. Environmental Protection Agency Region 7	Date
	PHOTOGRAPHER	Laura Moore	04/09/2007

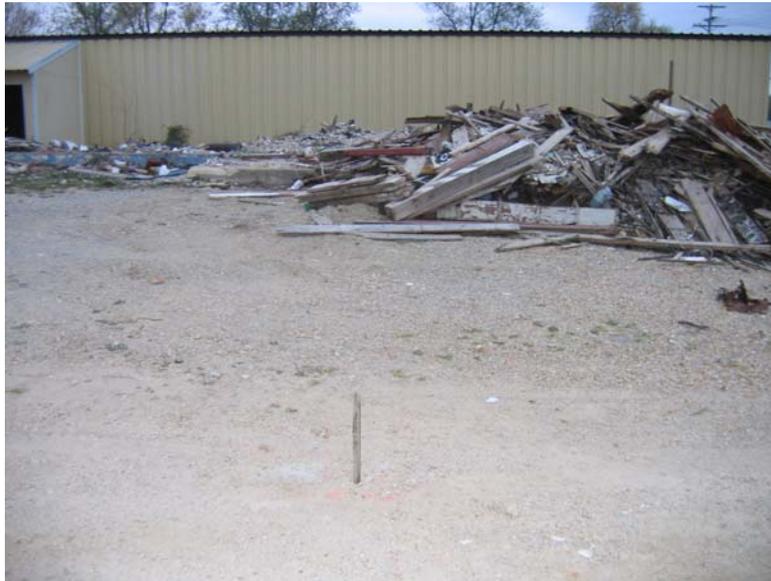
TETRA TECH PROJECT NO. X9004.07.0068.000 Direction: East	DESCRIPTION	This photograph shows the location of SB12 (wooden stake), west of the former building.	5
	CLIENT	U.S. Environmental Protection Agency Region 7	Date
	PHOTOGRAPHER	Laura Moore	04/09/2007

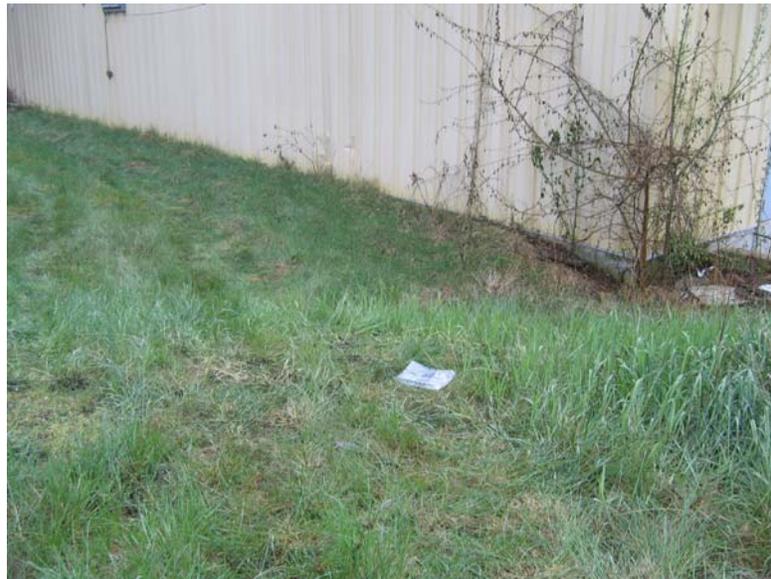
TETRA TECH PROJECT NO. X9004.07.0068.000 Direction: Southeast	DESCRIPTION	This photograph shows the location of SB13 (plastic bag), off northwest corner of Action Realty building.	6
	CLIENT	U.S. Environmental Protection Agency Region 7	Date
	PHOTOGRAPHER	Laura Moore	04/10/2007

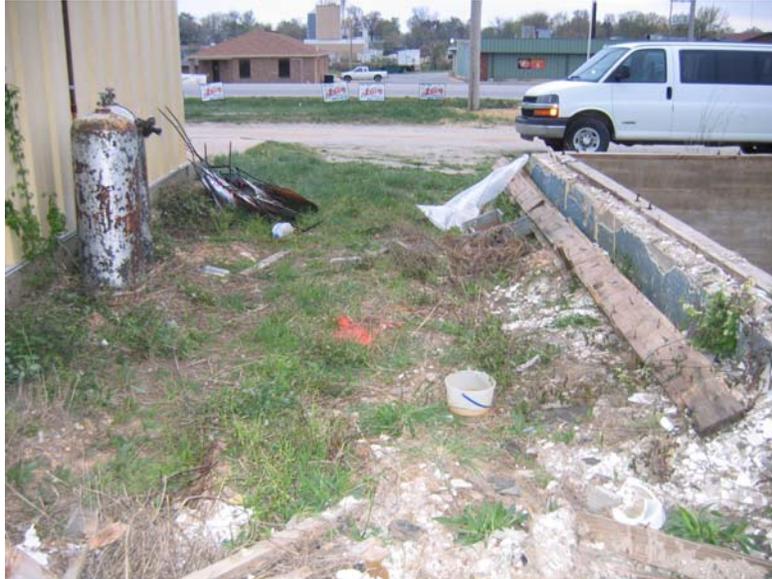
TETRA TECH PROJECT NO. X9004.07.0068.000 Direction: South	DESCRIPTION	This photograph shows the location of SB14 (orange paint), between the basement of the former dry cleaner building and the Action Realty building.	7
	CLIENT	U.S. Environmental Protection Agency Region 7	Date
	PHOTOGRAPHER	Laura Moore	04/09/2007

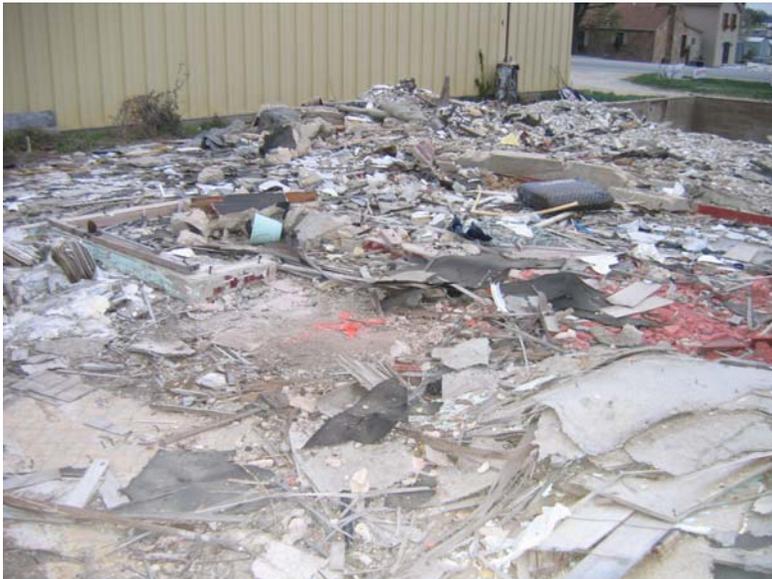
TETRA TECH PROJECT NO. X9004.07.0068.000 Direction: Southeast	DESCRIPTION	This photograph shows the location of SB15 (orange paint), near the center of the remaining slab-on-grade north of the basement.	8
	CLIENT	U.S. Environmental Protection Agency Region 7	Date
	PHOTOGRAPHER	Laura Moore	04/09/2007

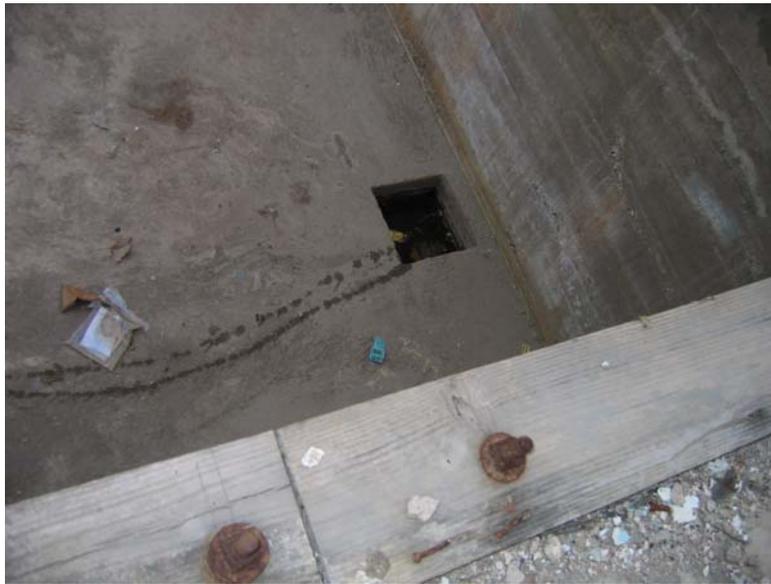
During the RSE activities, a sump containing water was identified in the southeast corner of the basement. Because the building had been demolished, the sump was exposed to the elements and probably contained rainwater. However, START collected a sample of this water to ensure it did not pose an obvious pathway threat, since the demolition site was essentially unsecured. The sample was preserved on ice at or below 4 °C and submitted to the EPA Region 7 laboratory for VOC analysis.

TETRA TECH PROJECT NO. X9004.07.0068.000 Direction: NA	DESCRIPTION	This photograph shows the sump located in the southeast corner of the basement.	9
	CLIENT	U.S. Environmental Protection Agency Region 7	Date
	PHOTOGRAPHER	Laura Moore	04/10/2007

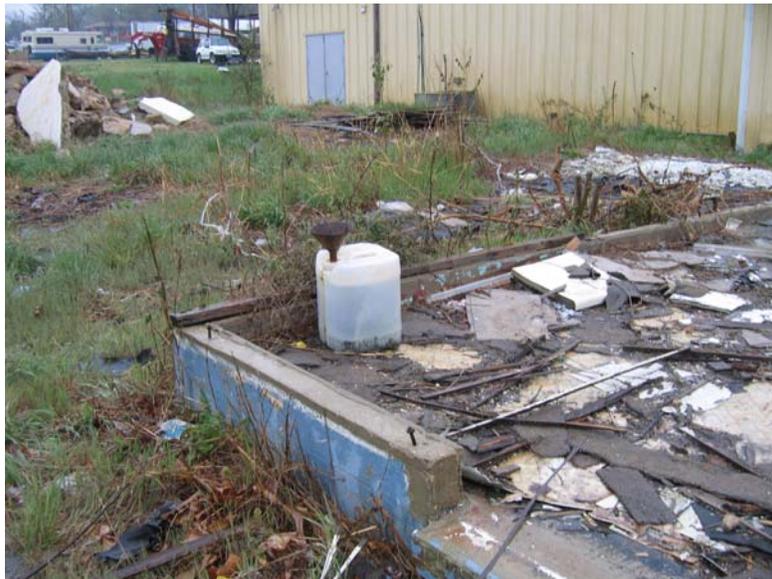
No detectable levels of VOCs were reported in the unknown liquid sample collected from the open plastic container on site. The liquid resembled hydraulic fluid (see Appendix B).

TETRA TECH PROJECT NO. X9004.07.0068.000 Direction: Northeast	DESCRIPTION	This photograph shows the container of unknown liquid located amid debris at the north end of the former dry cleaner building.	10
	CLIENT	U.S. Environmental Protection Agency Region 7	Date
	PHOTOGRAPHER	Laura Moore	04/10/2007

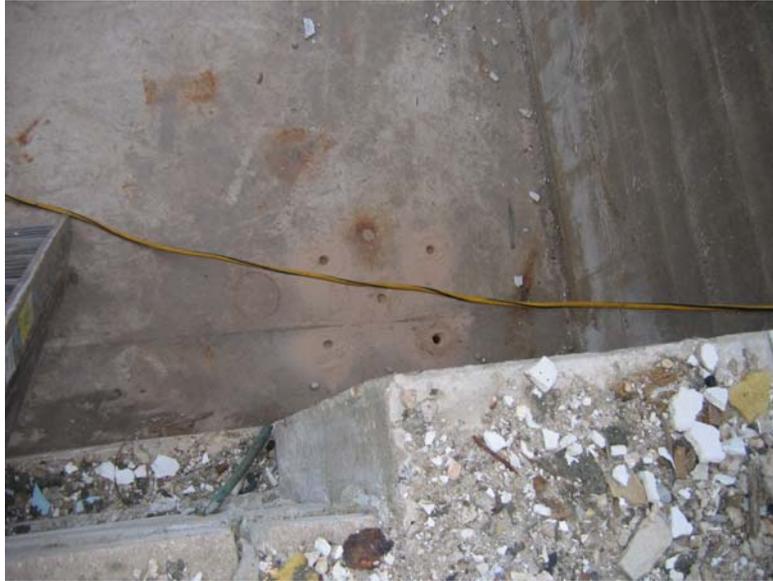
Five of the six hand-augered borings were completed beneath the basement floor of the former dry cleaner building. Penetrating this floor required the use of a pneumatic hammer. Samples of the concrete chips/dust derived from the hammering process were collected for VOC analysis to determine whether the concrete may have become contaminated by PCE releases on the basement floor, potentially serving as a source of PCE contamination to the subsurface. Five concrete chip/dust samples were collected as per Region 7 EPA Standard Operating Procedure (SOP) 4231.2011: *Chip, Wipe, and Sweep Sampling*, placed into 40-milliliter vials, and stored in coolers maintained at or below 4°C pending submittal to the EPA Region 7 laboratory. Similar to the soil samples, the EPA laboratory was scheduled to perform TCLP analysis on those samples found to contain PCE (or any degradation product of PCE) at or above its TCLP threshold value in the regular VOC sample.

TETRA TECH PROJECT NO. X9004.07.0068.000 Direction: NA	DESCRIPTION	This photograph shows an example of concrete coring through the basement floor. This photograph shows SB9 located in the southwest corner of the basement.	11
	CLIENT	U.S. Environmental Protection Agency Region 7	Date
	PHOTOGRAPHER	Laura Moore	04/10/2007
