Re: Contract Number EP-S7-06-02, Technical Direction Document Number 10-09-0008  
2010 Removal Action Report, Orofino Asbestos Site, Orofino, Clearwater County, Idaho

## 2010 REMOVAL ACTION REPORT

**Orofino Asbestos Site**  
**Orofino, Clearwater County, Idaho**  
**TDD: 10-09-0008**

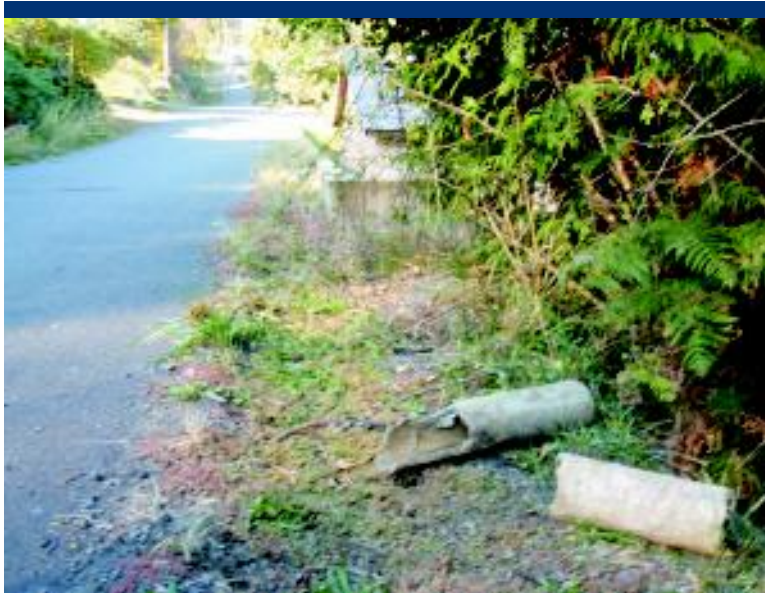
Photo 1 Asbestos-containing pipe (ACP) along Hartford Avenue (right of way).

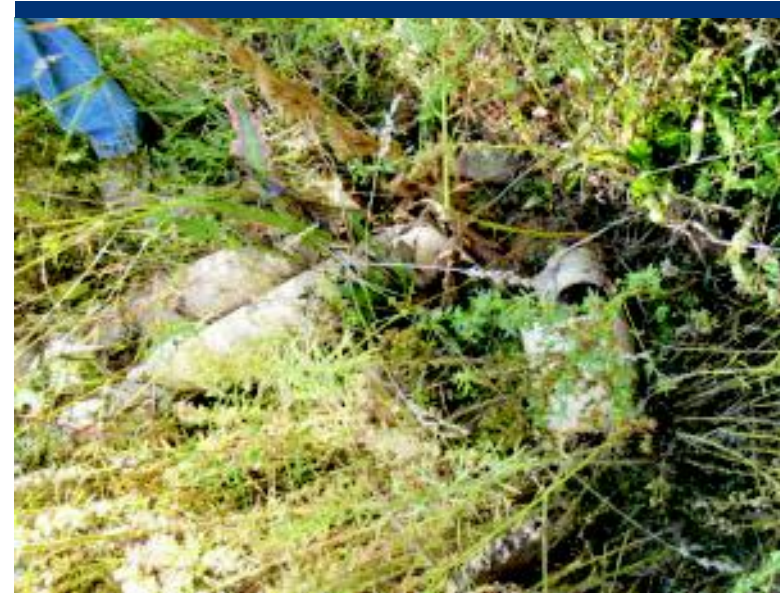
Photo 2 ACP in vegetation near fill pile.

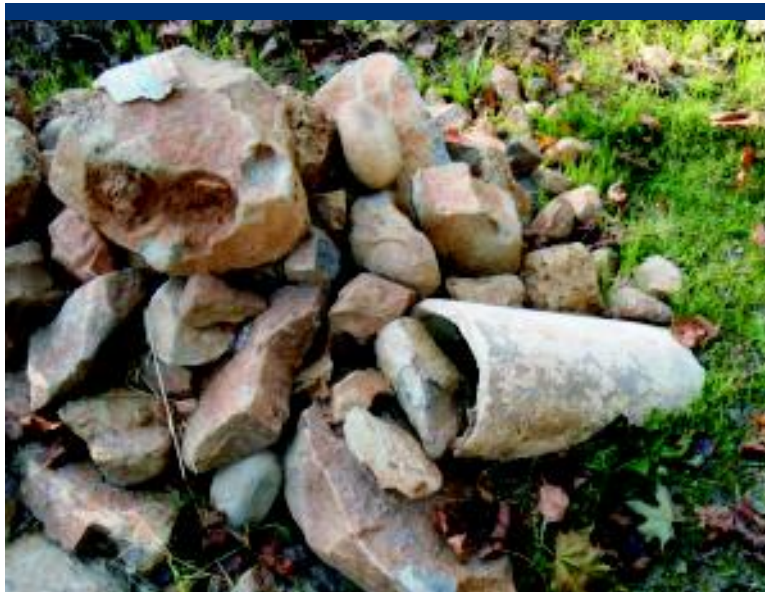
Photo 3 ACP and rocks recovered by property owner from fill pile.

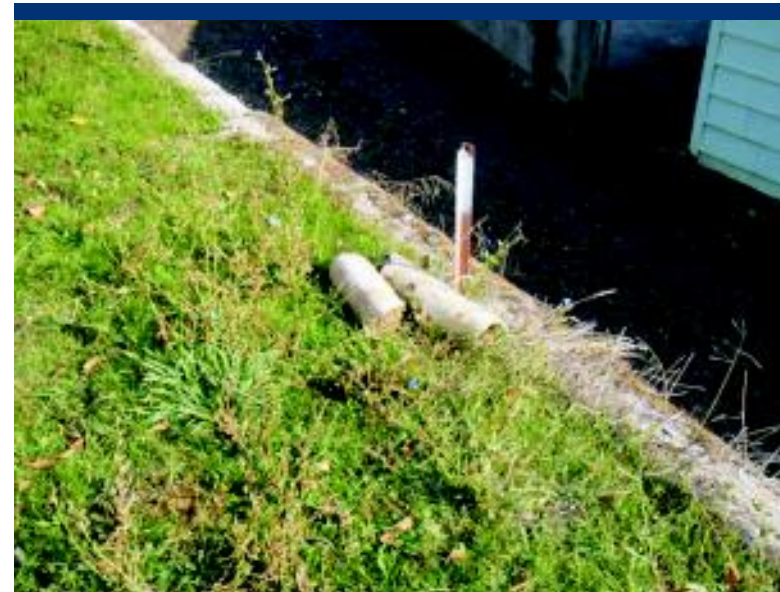
Photo 4 Two pieces of ACP on ground at 12252 Indio Avenue.

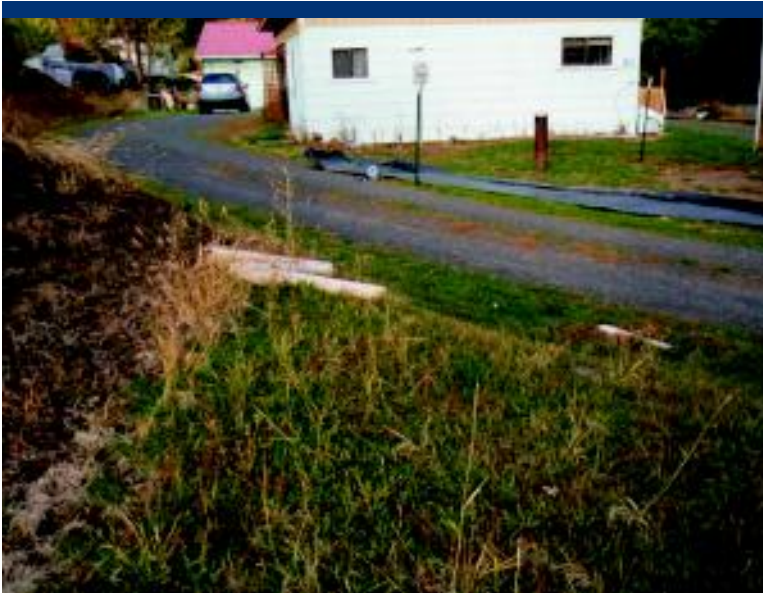
Photo 5 ACP on ground at 131 122nd Street.

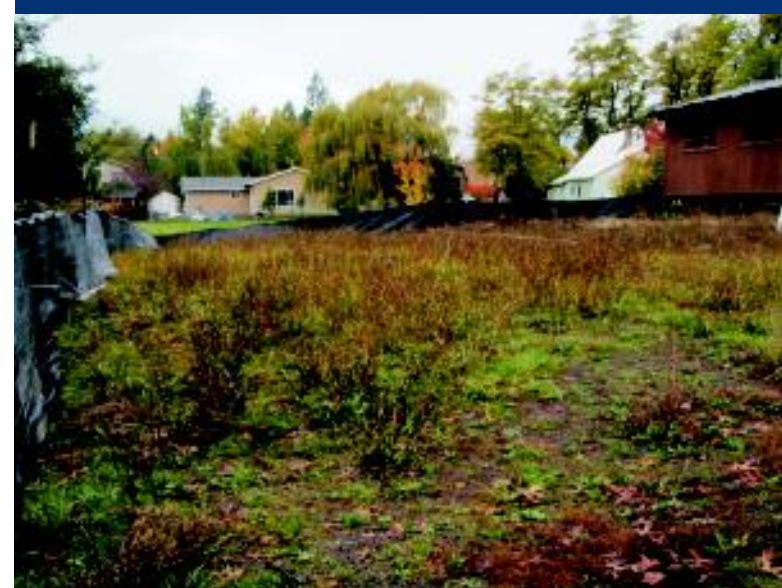
Photo 6 Preparation of work zone around contaminated fill area at 129 119th Avenue.

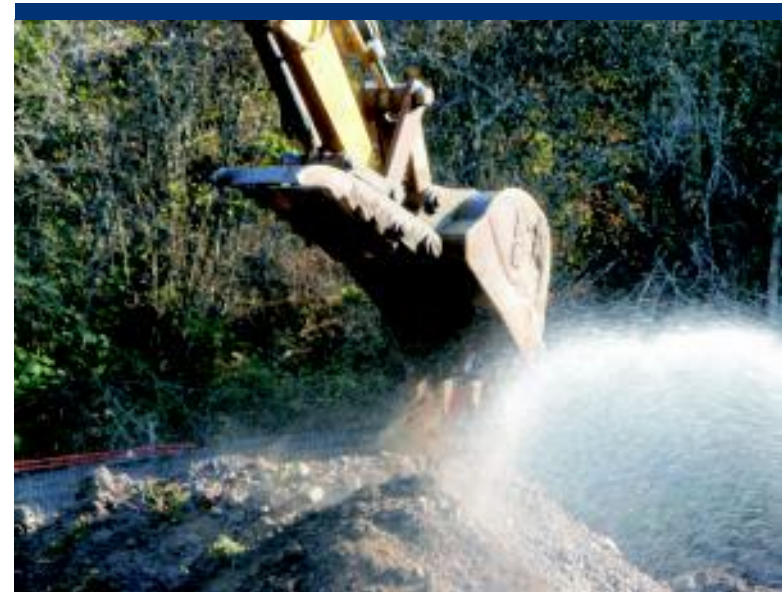
Photo 8 Dust suppression during excavation of contaminated fill.

During excavation, ERRS used best management practices (BMPs) for dust suppression and to minimize other impacts to the community. ERRS operated a water truck to constantly spray water on the soil as it was excavated, overturned, and stockpiled. Other BMPs used during the RA included wetting the excavated soil in the trucks, tarping the beds of the trucks, and inspecting the trucks for any loose material before leaving each property. Any loose material observed on the trucks was washed off before the trucks left the property. These BMPs were performed to prevent dust and asbestos fibers from becoming airborne and potentially migrating off Site.

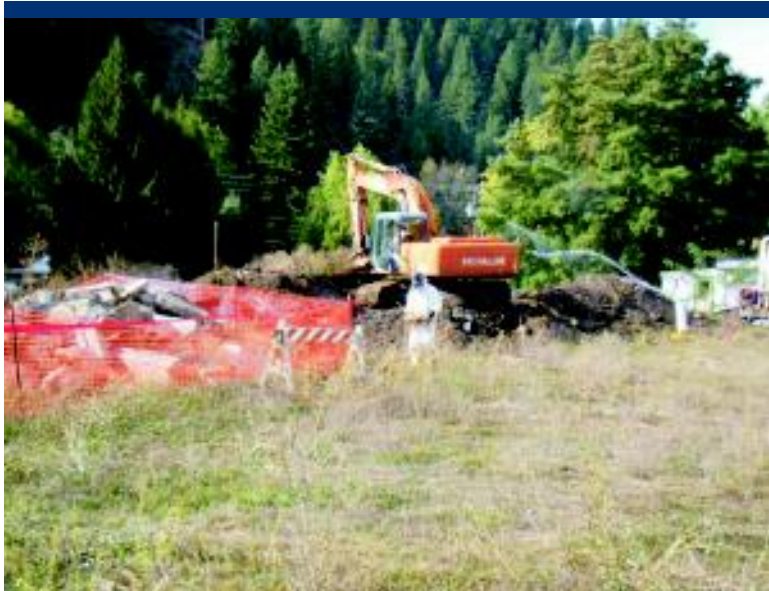
Photo 9 ERRS prepares contaminated fill stockpile at 14228 Highway 12 and recovers ACP.

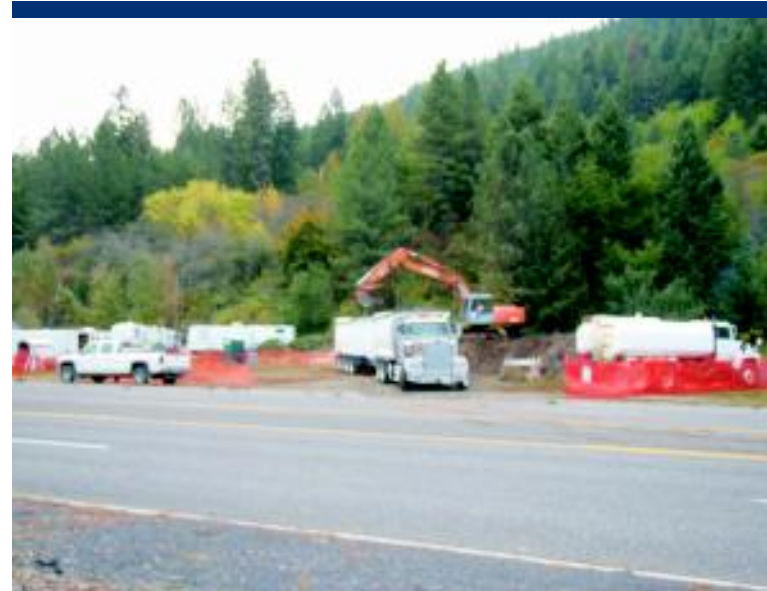
Photo 10 Overview of 14228 Highway 12 staging location; ERRS loads contaminated material into truck and pup.

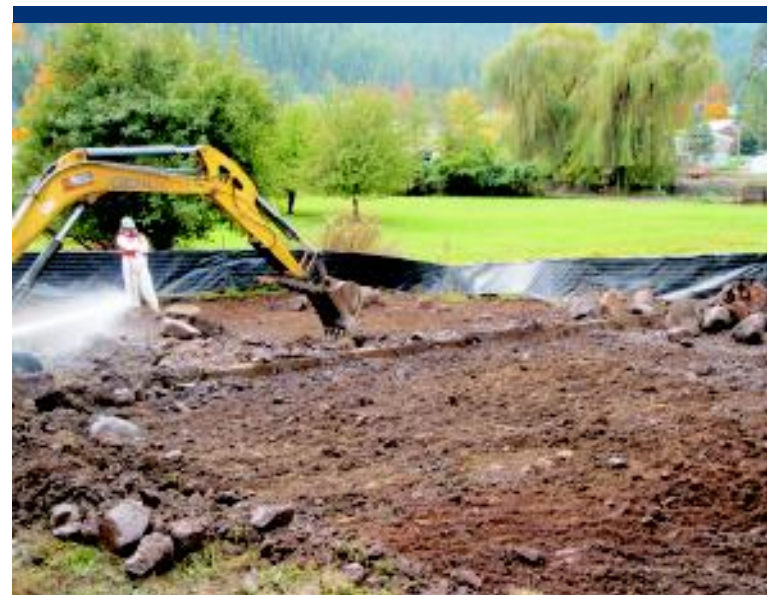
Photo 12 Dust suppression.

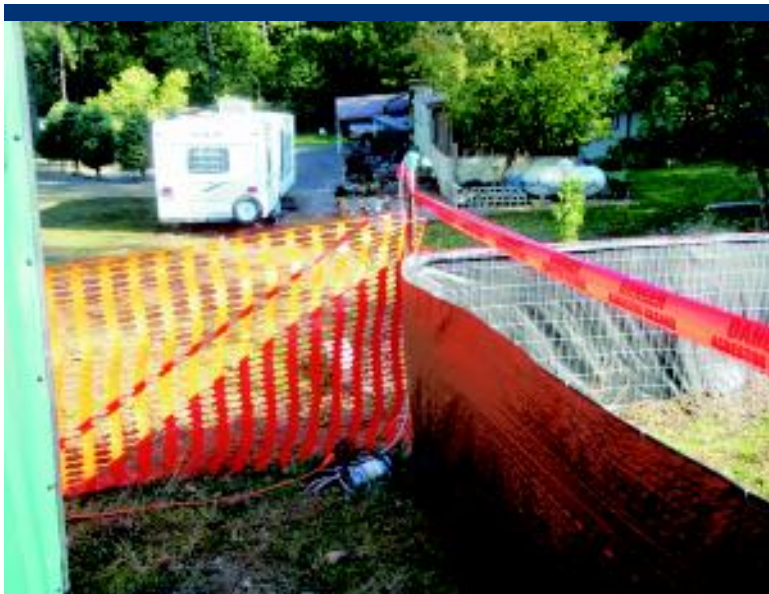
Photo 13 Air sampling location (WA-02) at 12586 Hartford Avenue.

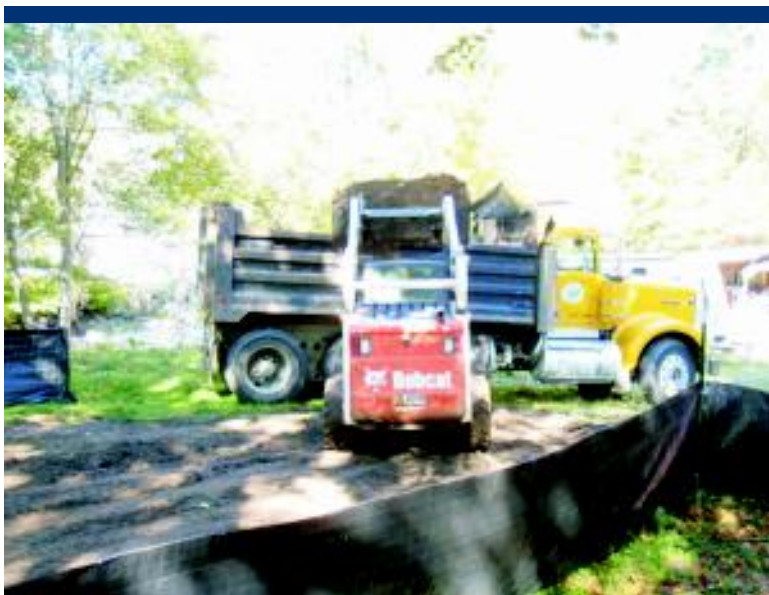
Photo 15 Loading truck with contaminated fill at 256 2nd Street.

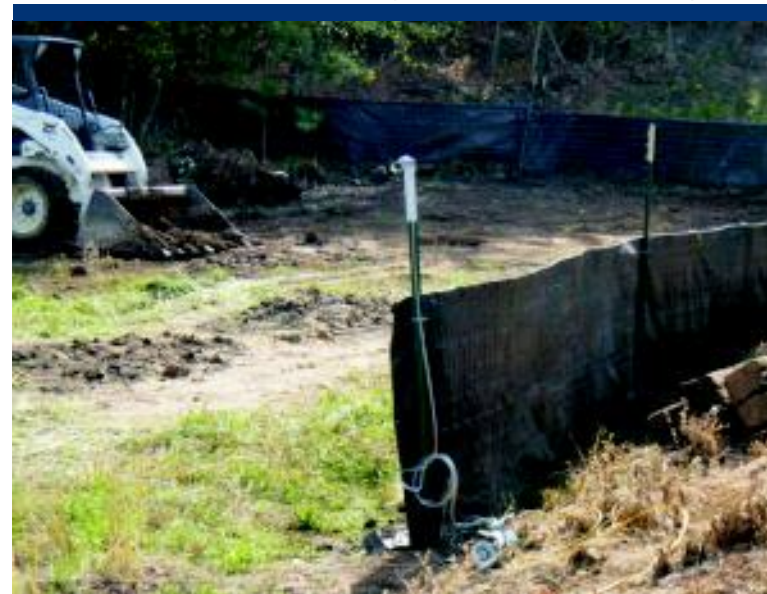
Photo 14 Air sampling location (WA01) at 12586 Hartford Avenue.

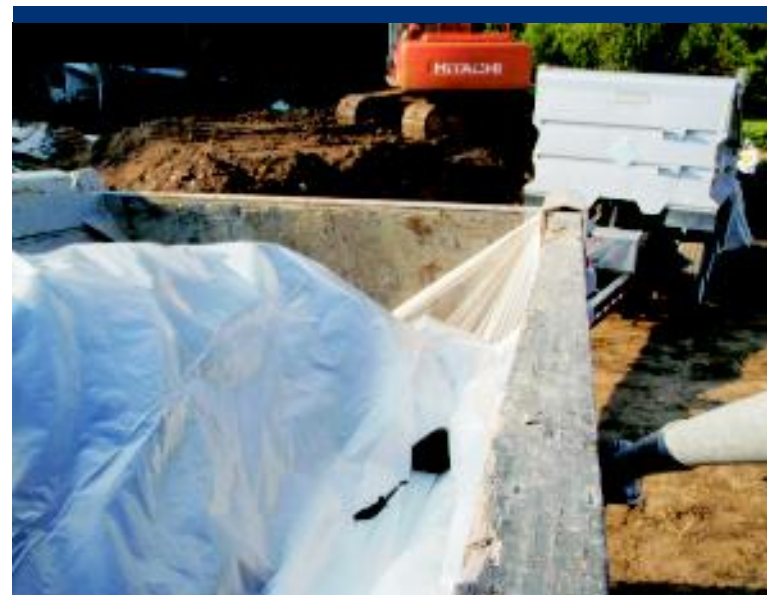
Photo 16 Contaminated material is covered with plastic in truck and pup beds.

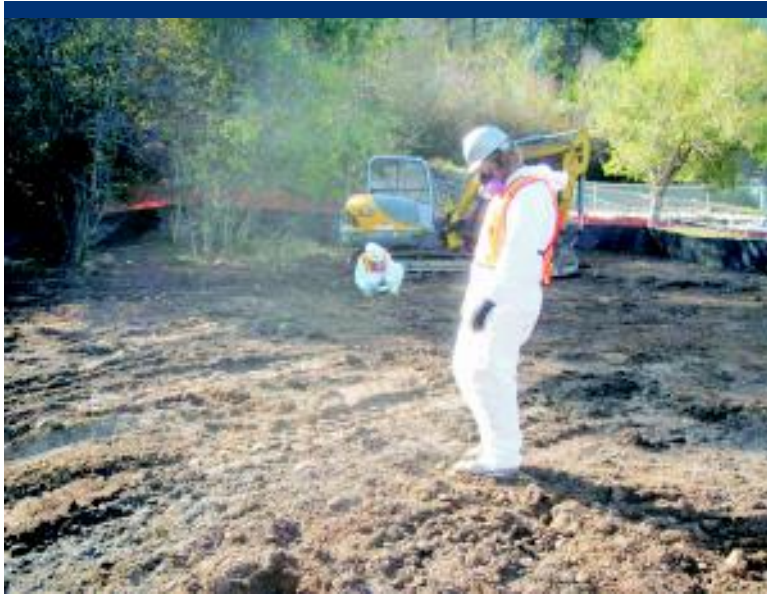
Photo 17 START collects soil composite sample following excavation of contaminated fill at 12586 Hartford Avenue.

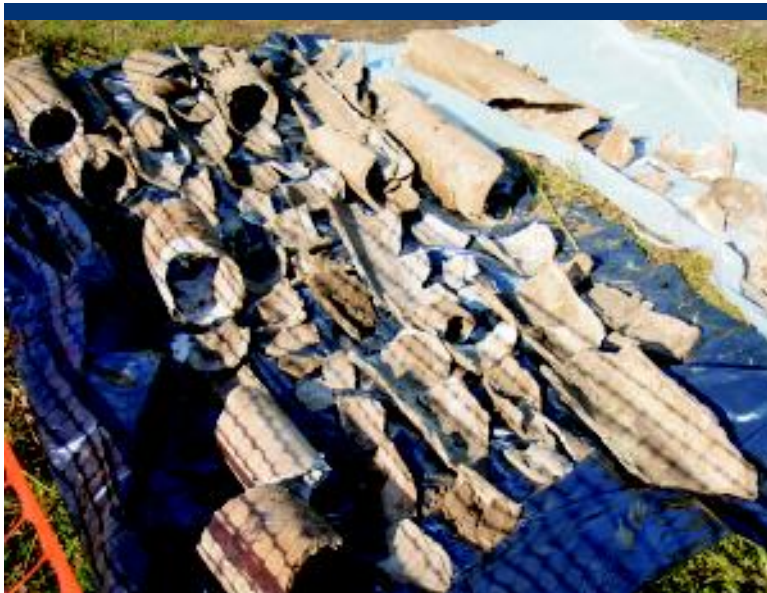
Photo 19 Sections of ACP recovered from 14228 Highway 12 on October 19, 21, and 22 (137 ln ft).

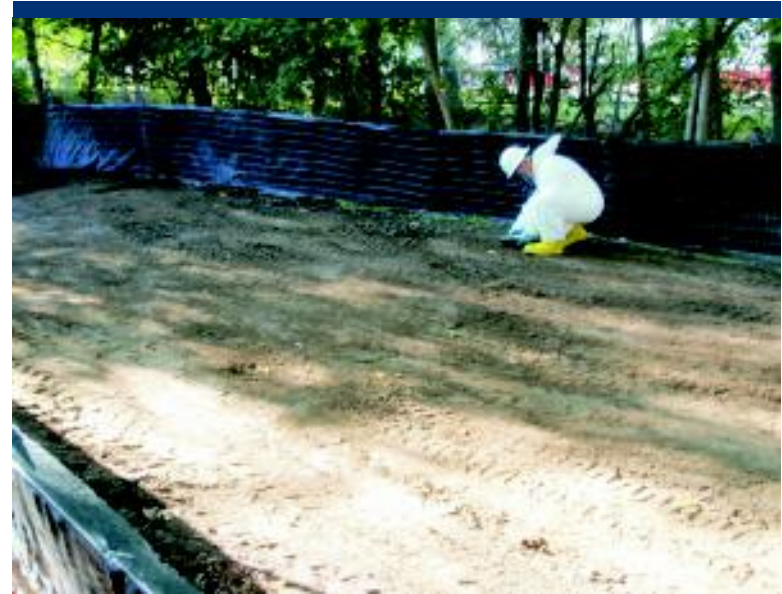
Photo 18 START collects soil composite sample following excavation of contaminated fill at 256 2nd Street.

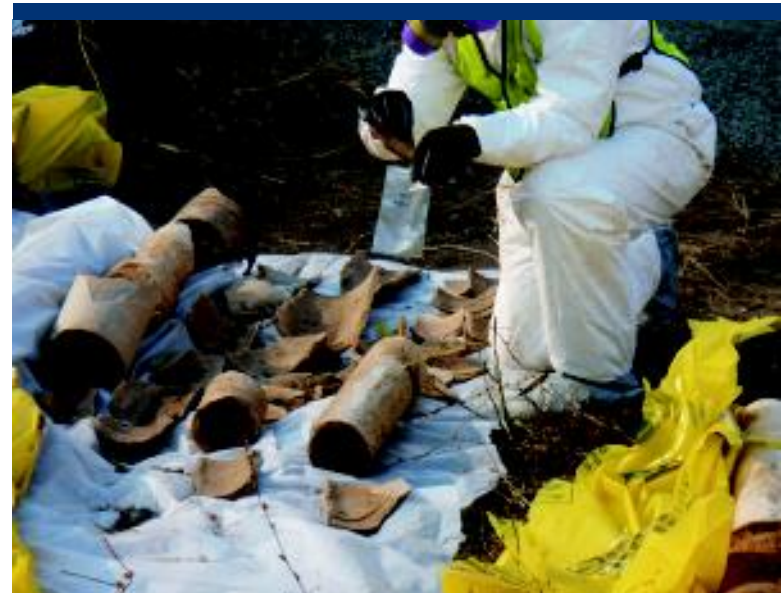
Photo 20 ERRS collects a bulk sample from recovered section of ACP.

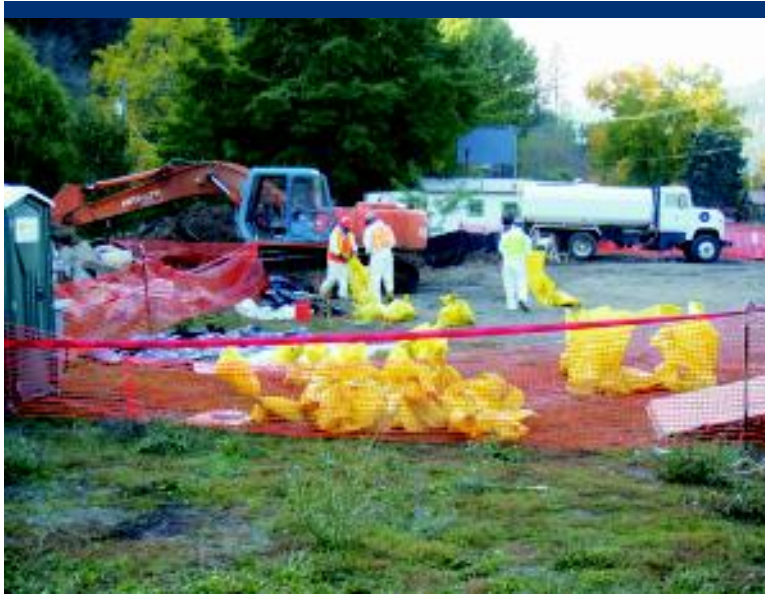
Photo 21 ERRS places recovered ACP into asbestos waste disposal bags.

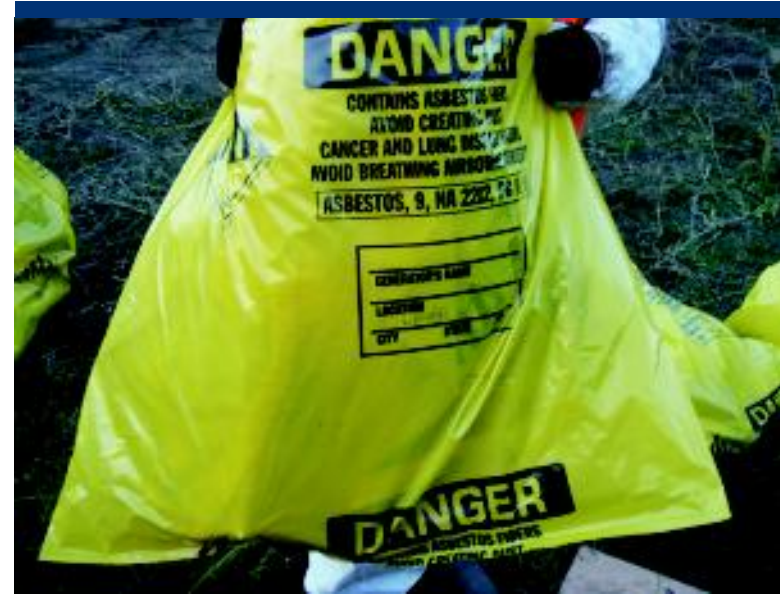
Photo 22 ACP in asbestos waste disposal bags for off-site disposal.

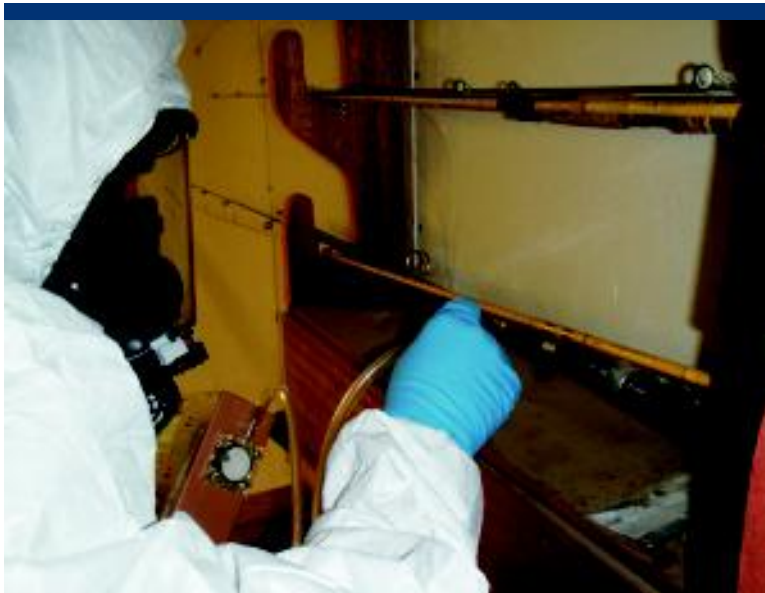
Photo 23 START collects MicroVac dust sample BK-01-MV.

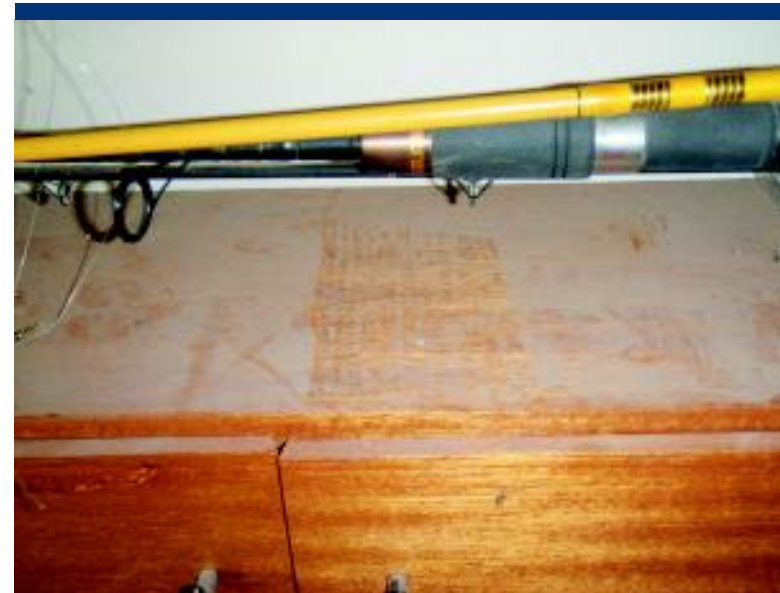
Photo 24 MicroVac dust sample location BK-01-MV after sampling.

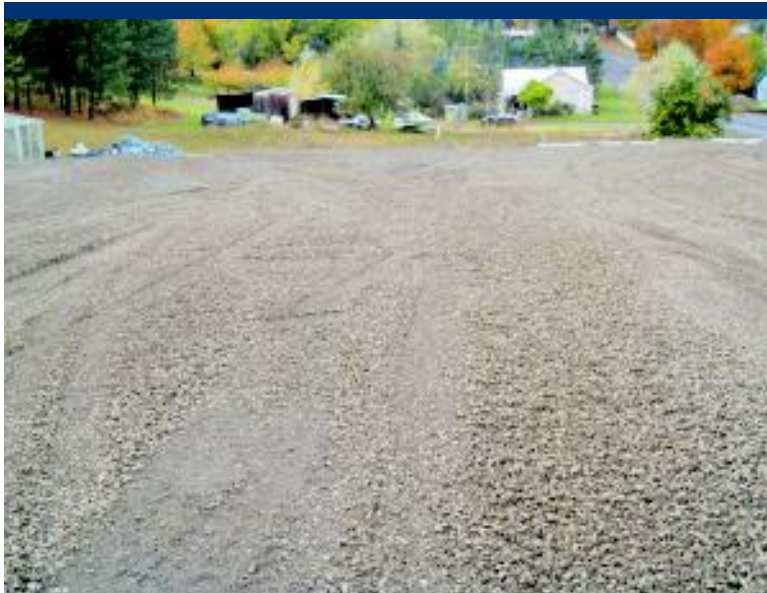
Photo 25 Interim gravel cover at 291 118th Street.

EPA assessed the condition of each asbestos-contaminated soil location that could not be completed during the 2010 RA and provided interim protective measures as needed. For properties with visible ACP at the ground surface, EPA generally provided a 4-inch layer of gravel as a temporary cap. For some of these properties no gravel cap was provided, either because there was no visible ACP or the property owner otherwise indicated that a temporary cap was not wanted. Additional property-specific details are provided in Section 5.2.

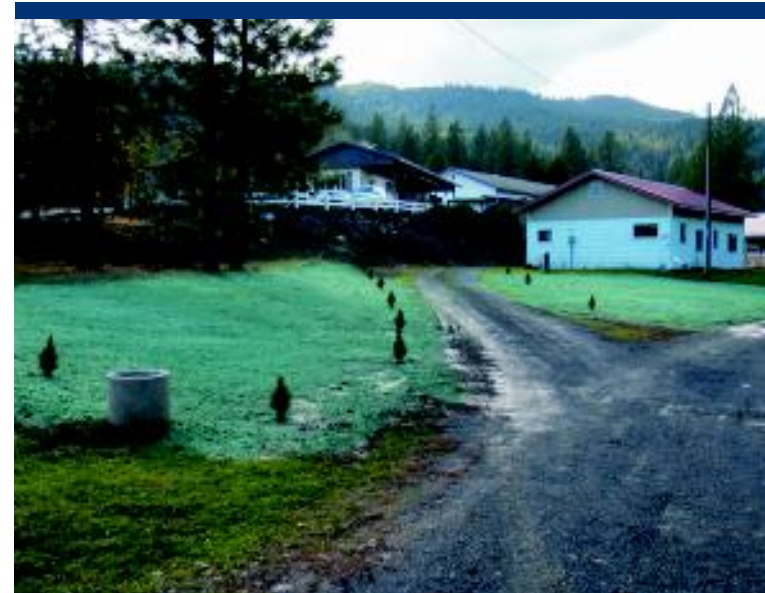
Photo 26 Hydroseed over top soil backfill at 131 122nd Street.

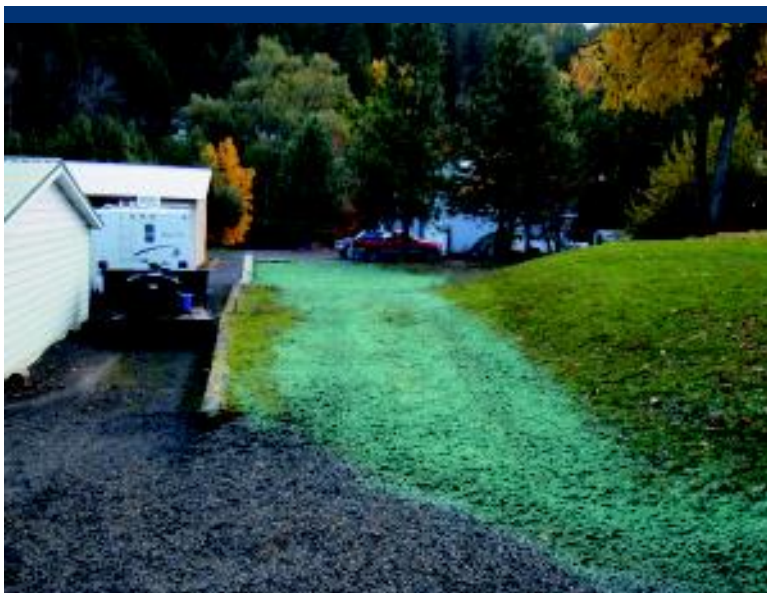
Photo 27 Hydroseed over top soil backfill at 12252 Indio Avenue.

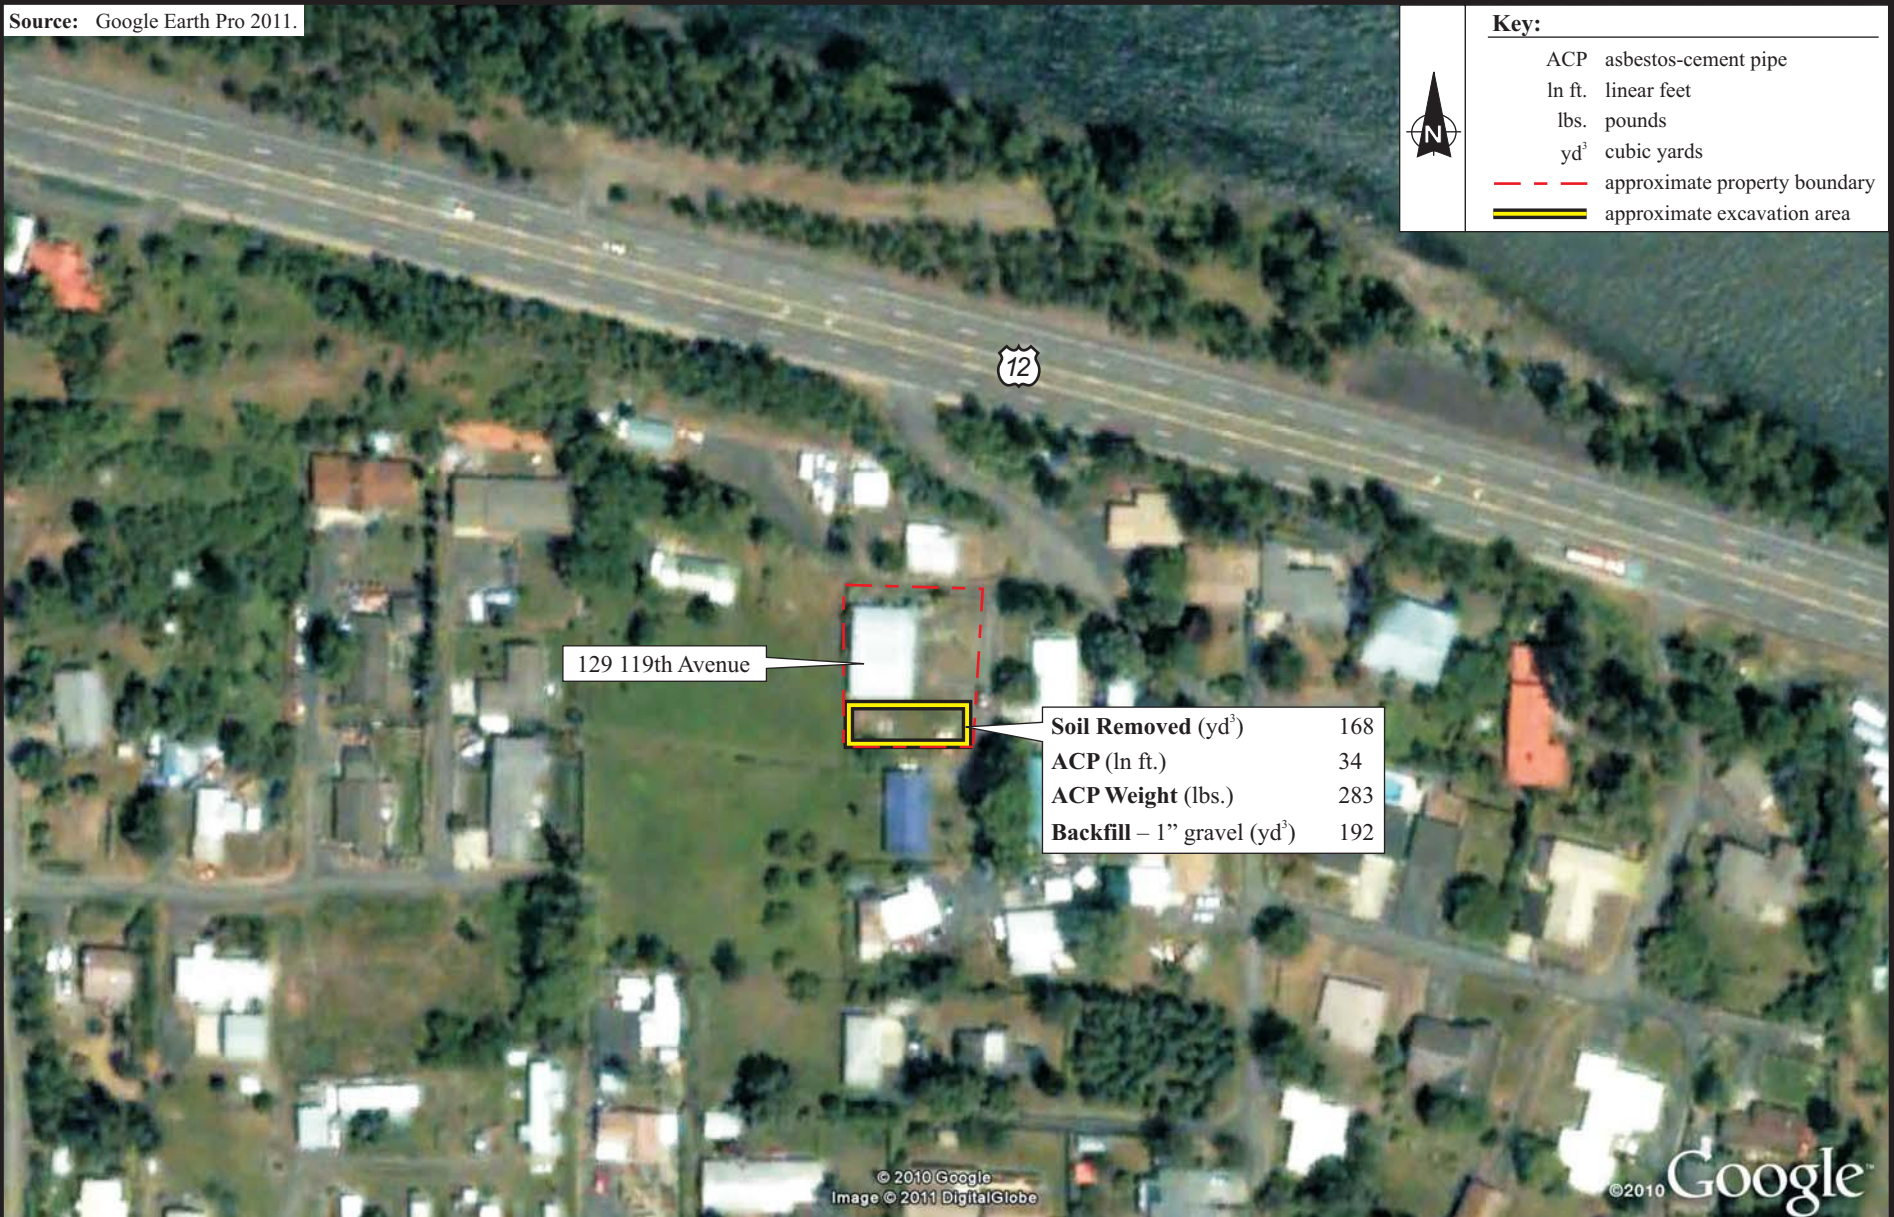
Soil Removed (yd³)	168
ACP (ln ft.)	34
ACP Weight (lbs.)	283
Backfill - 1" gravel (yd³)	192

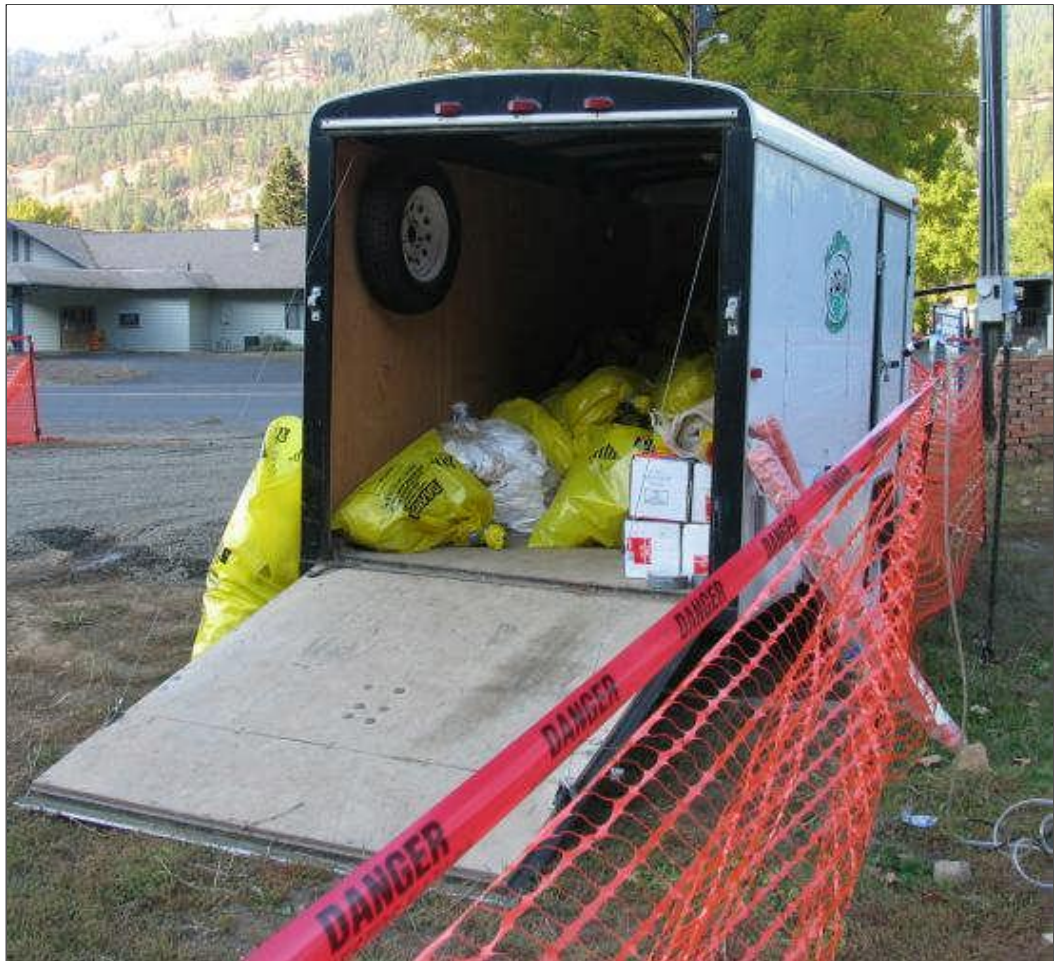
**This trailer contains bagged asbestos cement pipe from the clean up. The pipe is weighed and laid out to determine linear feet of the pipe that has been found to better document the work.**

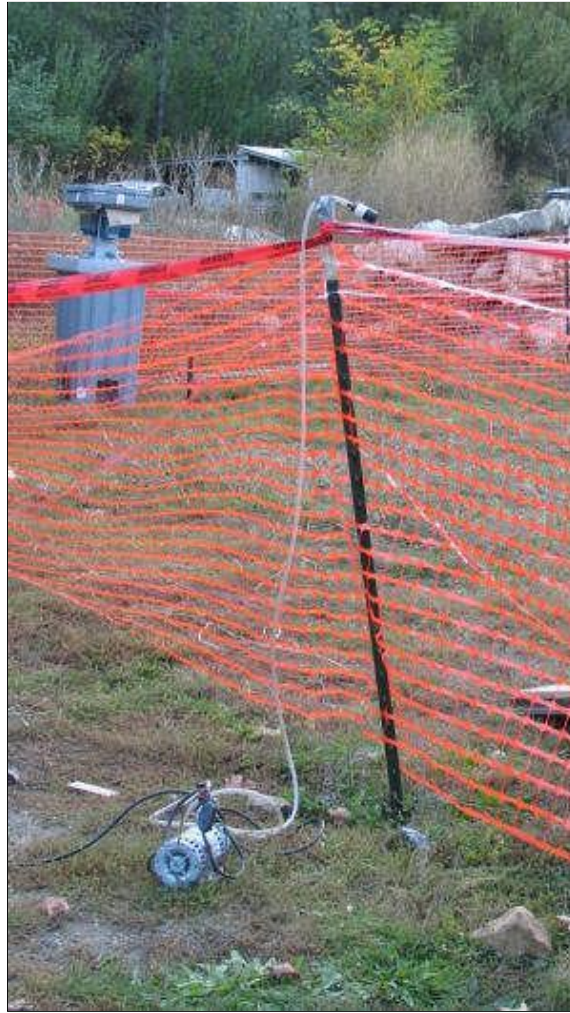
**Air monitors on the excavation sites record whether asbestos fibers are being found in the air. The monitor pulls air through it with the pump seen in the bottom of the photo.**

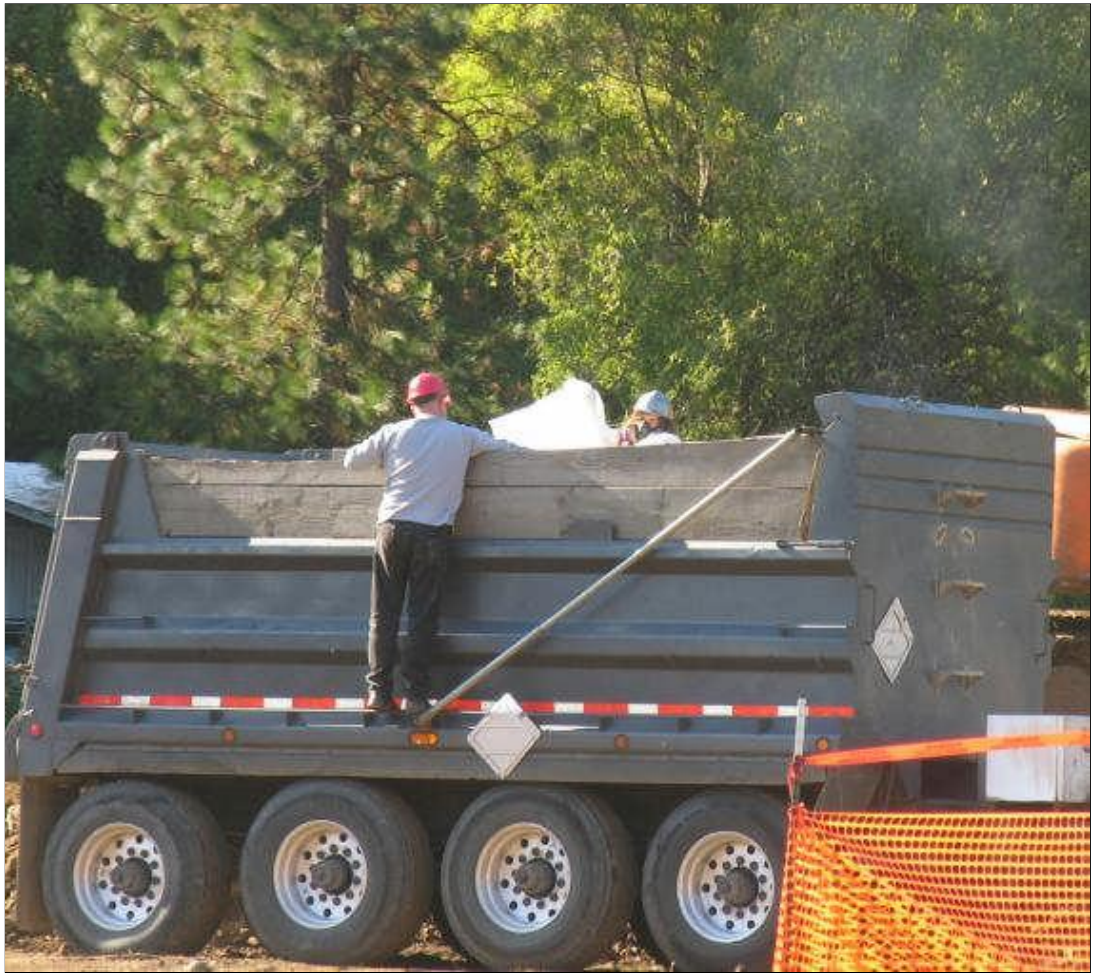
A truck driver and excavation site worker double cover the semi trailer before it heads out to deliver the load to a landfill between Medical Lake and Spokane, WA.
