**Subject: Phase I Targeted Brownfields Assessment
Former AutoZone, 9901 and 9947 West Florissant Avenue
Dellwood, St. Louis County, Missouri
U.S. EPA Region 7, START 4, Contract No. EP S7 13 06, Task Order No. 0002.055
Task Monitor: Randy Brown, On-Scene Coordinator**

PHASE I TARGETED BROWNFIELDS ASSESSMENT

**FORMER AUTOZONE
9901 AND 9947 WEST FLORISSANT AVENUE
DELLWOOD, MISSOURI**

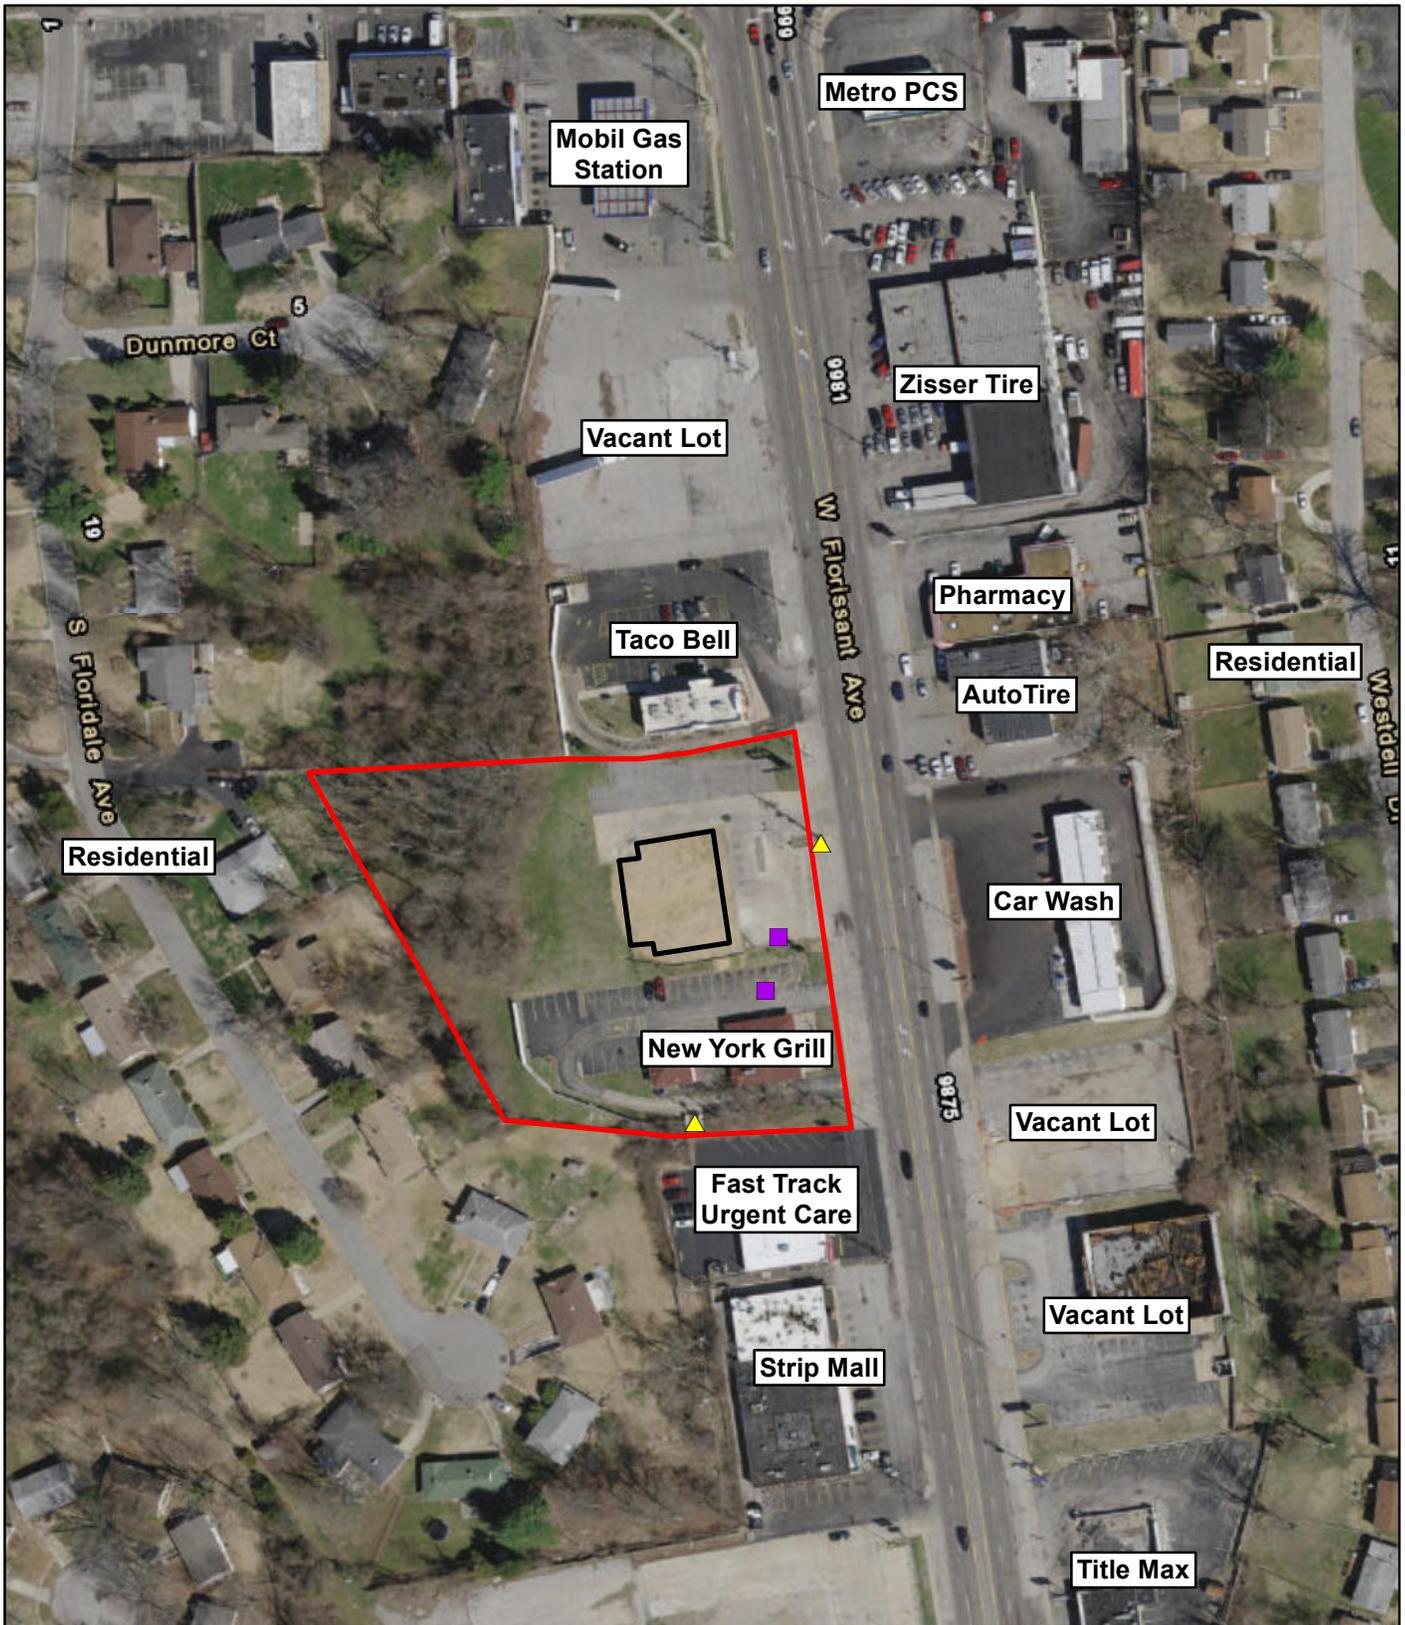
Former AutoZone
 9947 West Florissant Ave
 Dellwood, Missouri

- Stormwater drain
- ▲ Transformer (pole mounted)
- Former AutoZone building boundary
- Subject property boundary

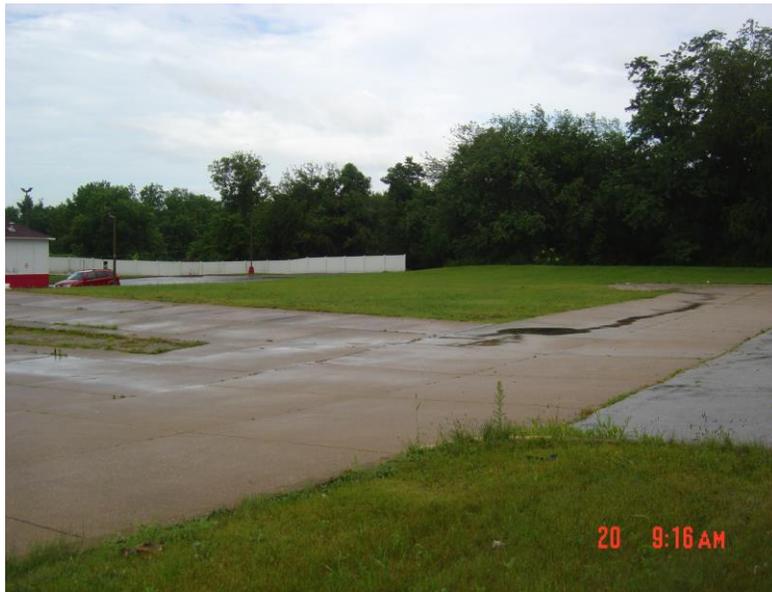
TETRA TECH PROJECT NO. X9025.14.0002.055 DIRECTION: Southwest	DESCRIPTION	This photograph shows the former AutoZone property on the northern portion of the subject property.	6
	CLIENT	Environmental Protection Agency - Region 7	DATE 6/20/18
	PHOTOGRAPHER	Ann Marie Pohlman

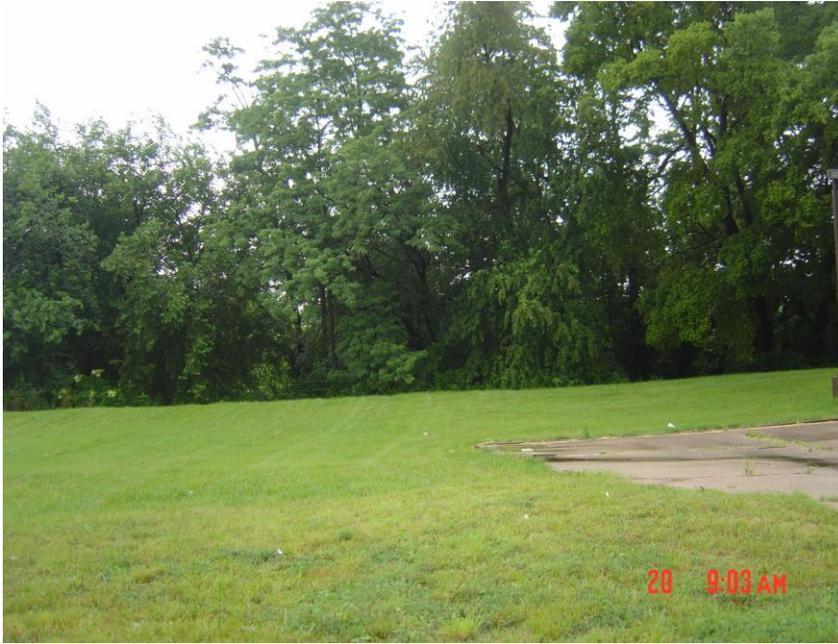
TETRA TECH PROJECT NO. X9025.14.0002.055 DIRECTION: West	DESCRIPTION	This photograph shows the western portion of the former AutoZone property, with residential properties beyond.	7
	CLIENT	Environmental Protection Agency - Region 7	DATE 6/20/18
	PHOTOGRAPHER	Ann Marie Pohlman

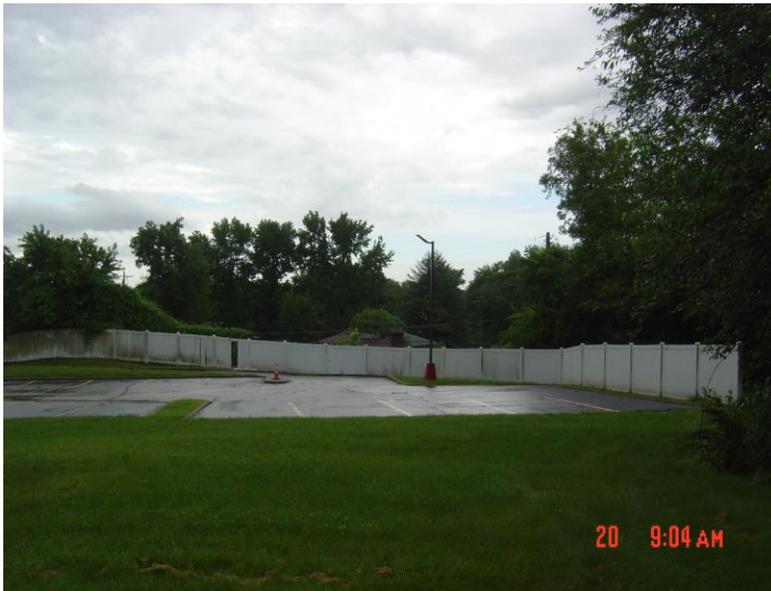
TETRA TECH PROJECT NO. X9025.14.0002.055 DIRECTION: South	DESCRIPTION	This photograph shows the southwestern portion of the subject property consisting of a parking area for the New York Grill, with residential properties beyond.	8
	CLIENT	Environmental Protection Agency - Region 7	DATE 6/20/18
	PHOTOGRAPHER	Ann Marie Pohlman

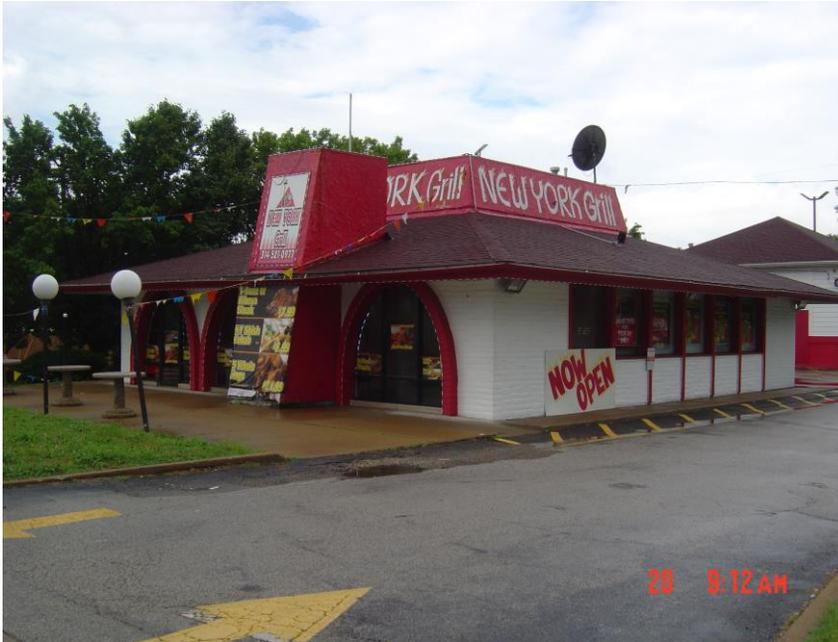
TETRA TECH PROJECT NO. X9025.14.0002.055 DIRECTION: Southwest	DESCRIPTION	This photograph shows the New York Grill on the southern portion of the subject property.	9
	CLIENT	Environmental Protection Agency - Region 7	DATE 6/20/18
	PHOTOGRAPHER	Ann Marie Pohlman

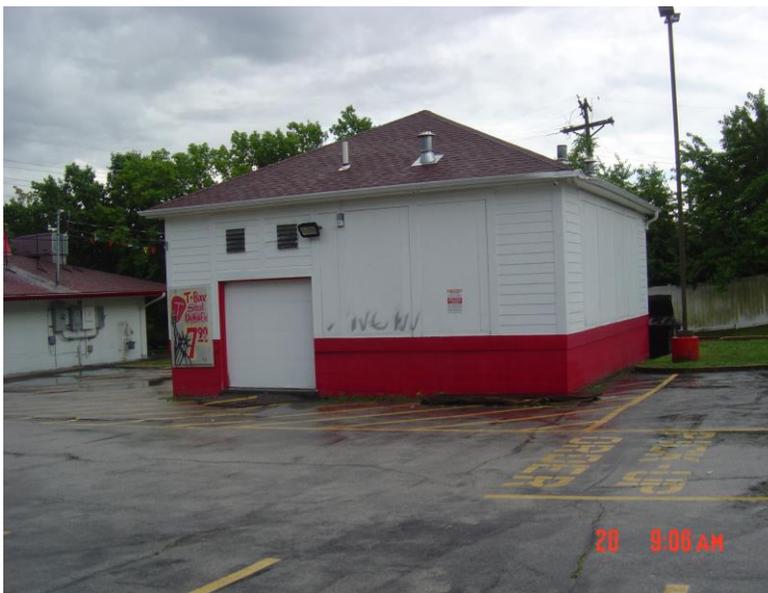
TETRA TECH PROJECT NO. X9025.14.0002.055 DIRECTION: Southeast	DESCRIPTION	This photograph shows the storage outbuilding west of the New York Grill restaurant. Access to this building was not available.	10
	CLIENT	Environmental Protection Agency - Region 7	DATE 6/20/18
	PHOTOGRAPHER	Ann Marie Pohlman

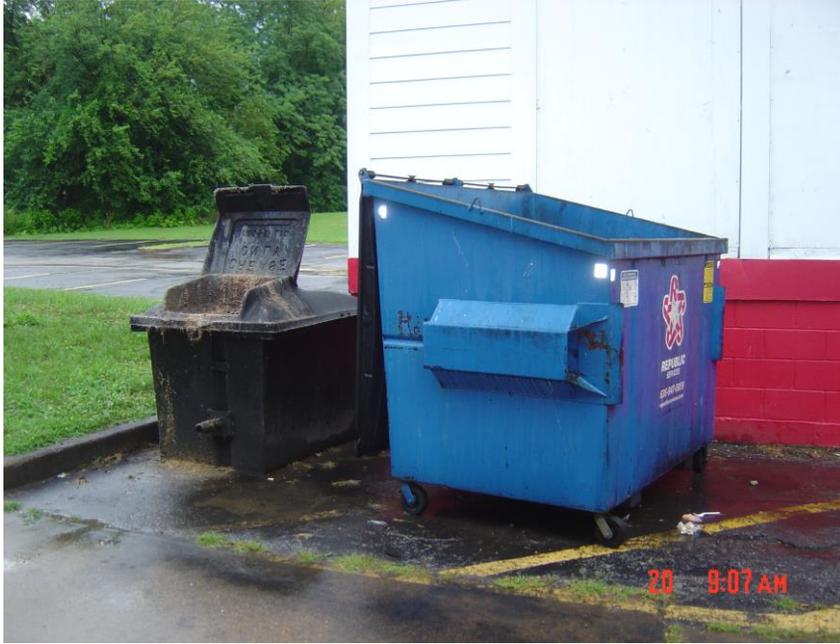
TETRA TECH PROJECT NO. X9025.14.0002.055 DIRECTION: Northwest	DESCRIPTION	This photograph shows the trash and grease dumpsters south of the storage outbuilding associated with the New York Grill.	11
	CLIENT	Environmental Protection Agency - Region 7	DATE
	PHOTOGRAPHER	Ann Marie Pohlman	6/20/18

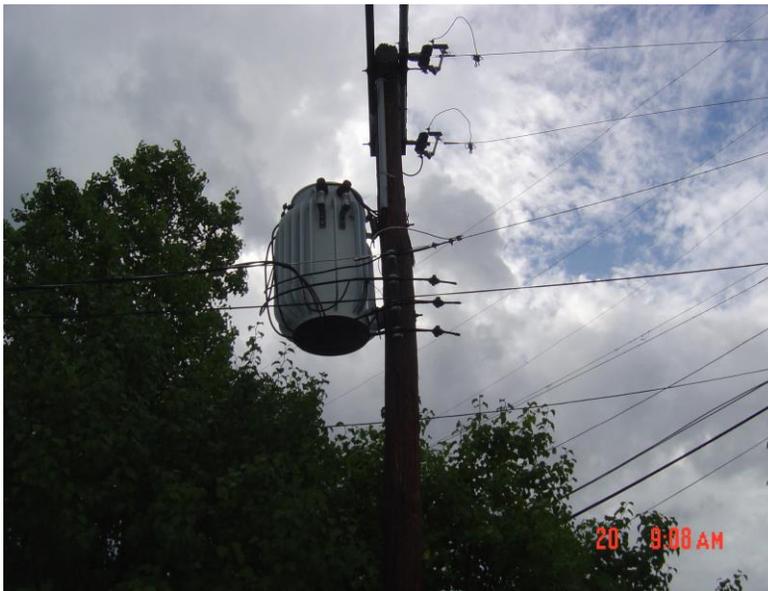
TETRA TECH PROJECT NO. X9025.14.0002.055 DIRECTION: None	DESCRIPTION	This photograph shows a pole-mounted transformer along the southern portion of the subject property.	12
	CLIENT	Environmental Protection Agency - Region 7	DATE
	PHOTOGRAPHER	Ann Marie Pohlman	6/20/18

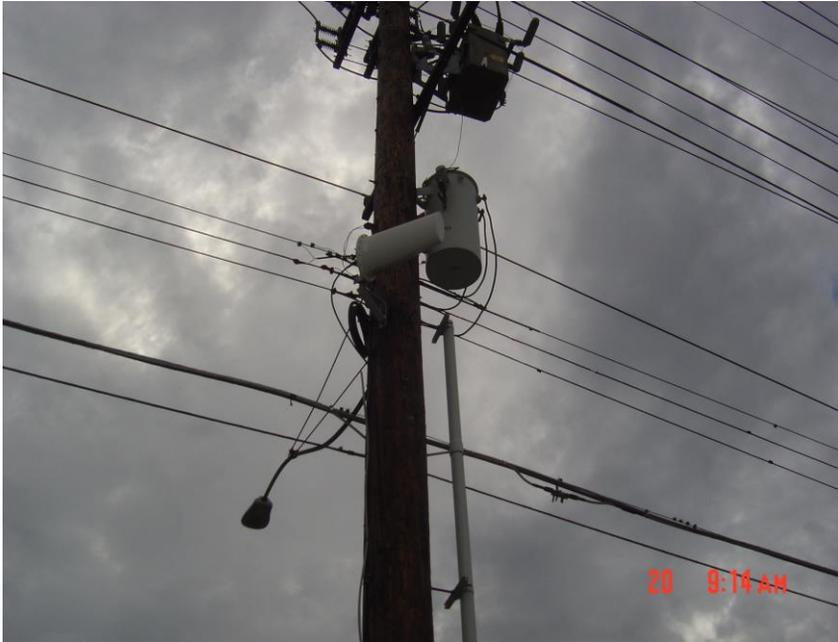
TETRA TECH PROJECT NO. X9025.14.0002.055 DIRECTION: None	DESCRIPTION	This photograph shows a pole-mounted transformer along the northeastern portion of the subject property.	13
	CLIENT	Environmental Protection Agency - Region 7	DATE 6/20/18
	PHOTOGRAPHER	Ann Marie Pohlman

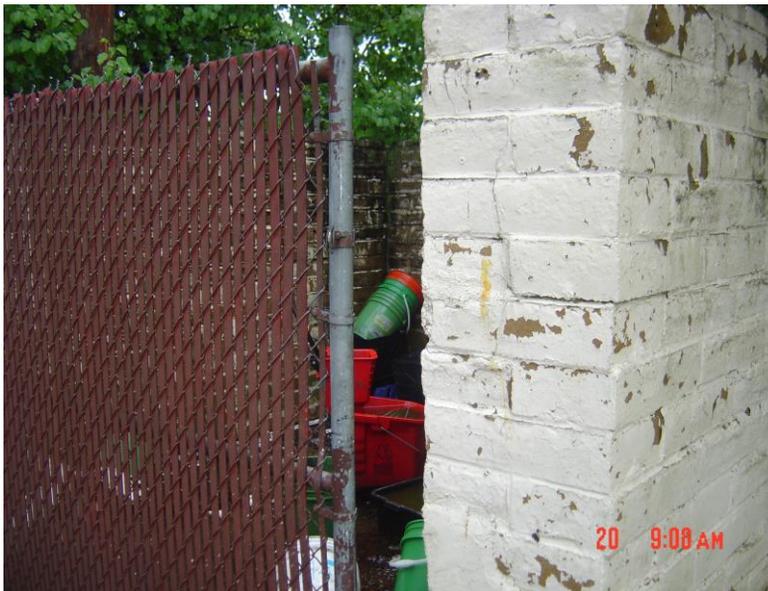
TETRA TECH PROJECT NO. X9025.14.0002.055 DIRECTION: Southeast	DESCRIPTION	This photograph shows a fenced area consisting of empty 5-gallon buckets and other miscellaneous items along the southern portion of the subject property.	14
	CLIENT	Environmental Protection Agency - Region 7	DATE 6/20/18
	PHOTOGRAPHER	Ann Marie Pohlman

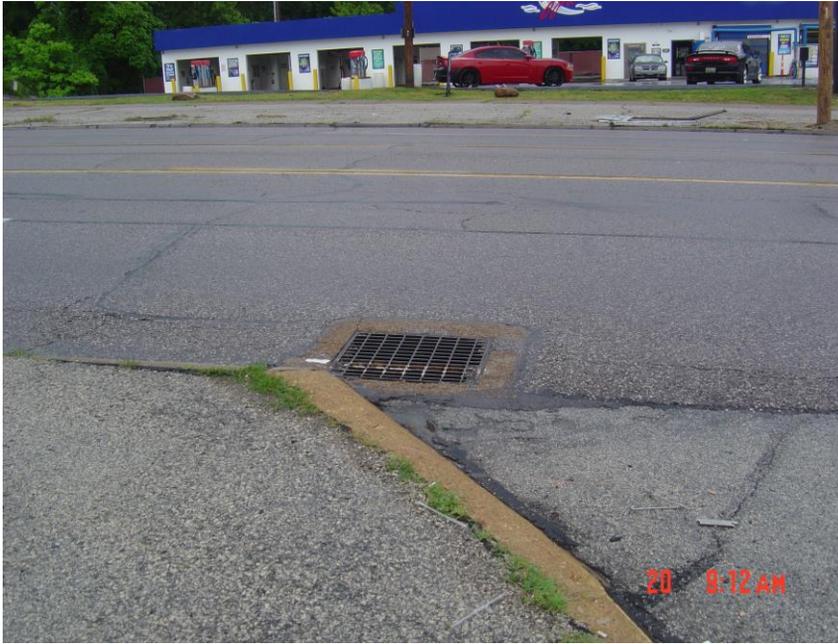
TETRA TECH PROJECT NO. X9025.14.0002.055 DIRECTION: East	DESCRIPTION	This photograph shows a storm sewer drain along West Florissant Avenue.	15
	CLIENT	Environmental Protection Agency - Region 7	DATE 6/20/18
	PHOTOGRAPHER	Ann Marie Pohlman

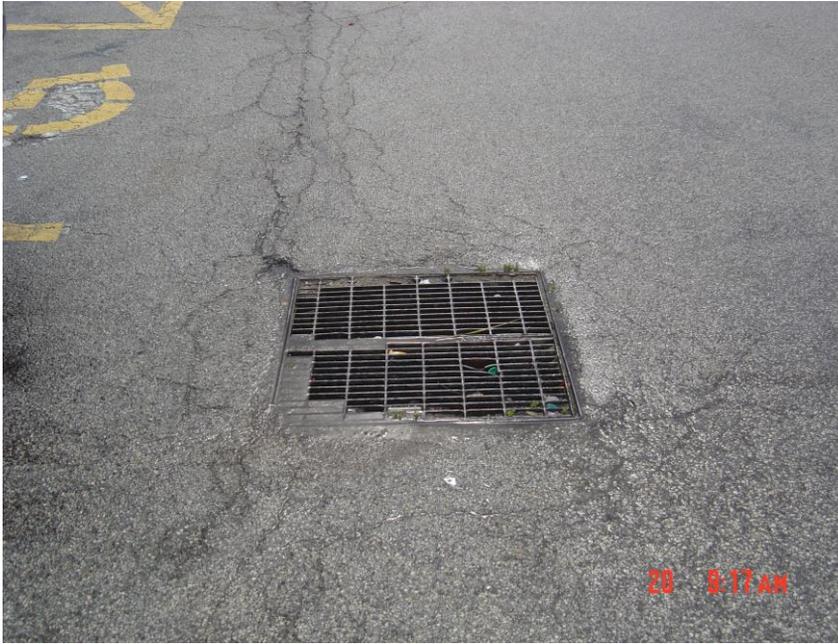
TETRA TECH PROJECT NO. X9025.14.0002.055 DIRECTION: None	DESCRIPTION	This photograph shows a storm sewer drain on the northern portion of the New York Grill property.	17
	CLIENT	Environmental Protection Agency - Region 7	DATE 6/20/18
	PHOTOGRAPHER	Ann Marie Pohlman

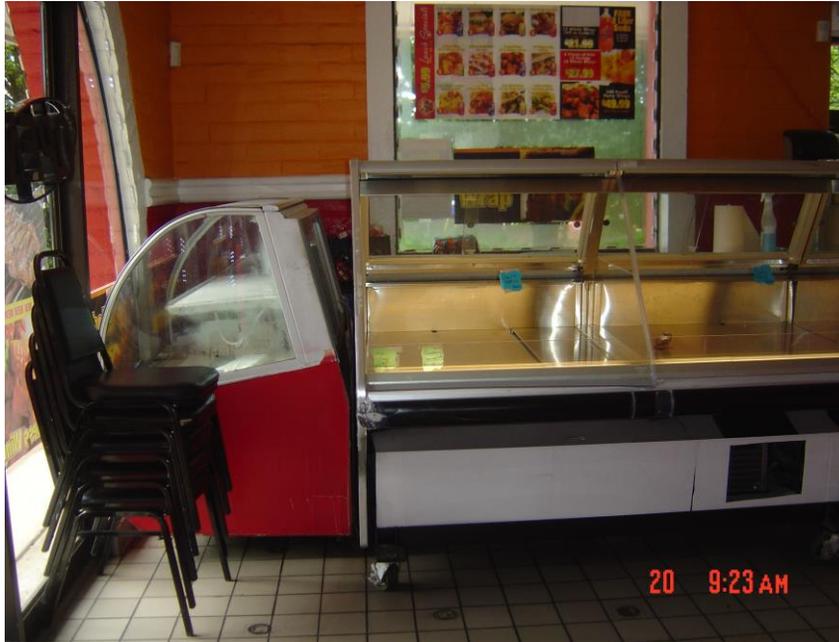
TETRA TECH PROJECT NO. X9025.14.0002.055 DIRECTION: South	DESCRIPTION	This photograph shows coolers and floor tile in the front part of the New York Grill.	19
	CLIENT	Environmental Protection Agency - Region 7	DATE 6/20/18
	PHOTOGRAPHER	Ann Marie Pohlman

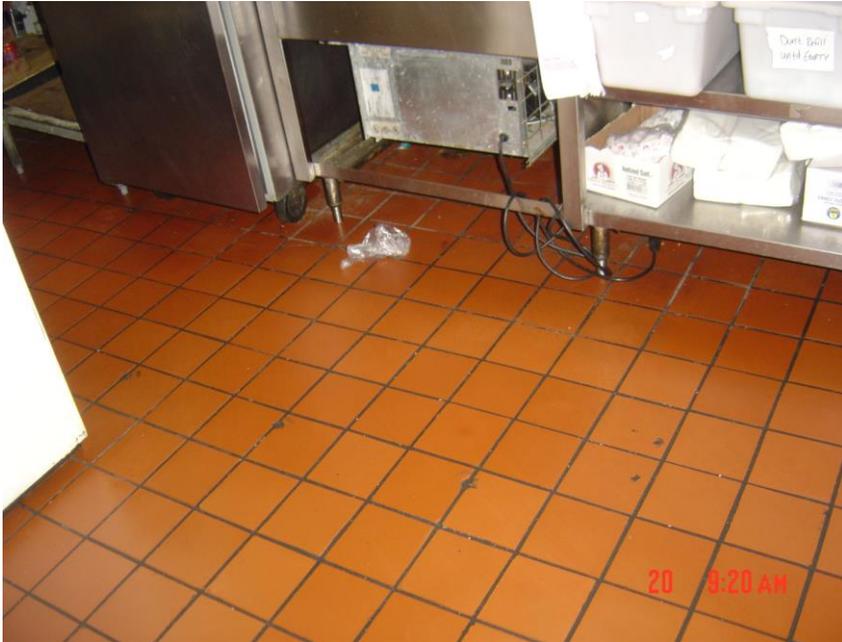
TETRA TECH PROJECT NO. X9025.14.0002.055 DIRECTION: None	DESCRIPTION	This photograph shows floor tile in the kitchen area of the New York Grill.	21
	CLIENT	Environmental Protection Agency - Region 7	DATE 6/20/18
	PHOTOGRAPHER	Ann Marie Pohlman

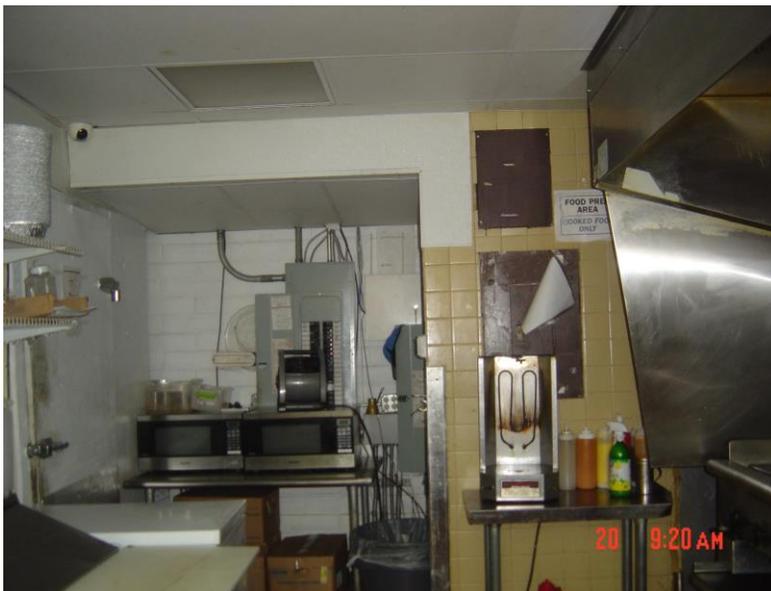
TETRA TECH PROJECT NO. X9025.14.0002.055 DIRECTION: West	DESCRIPTION	This photograph shows the kitchen area of the New York Grill.	22
	CLIENT	Environmental Protection Agency - Region 7	DATE 6/20/18
	PHOTOGRAPHER	Ann Marie Pohlman

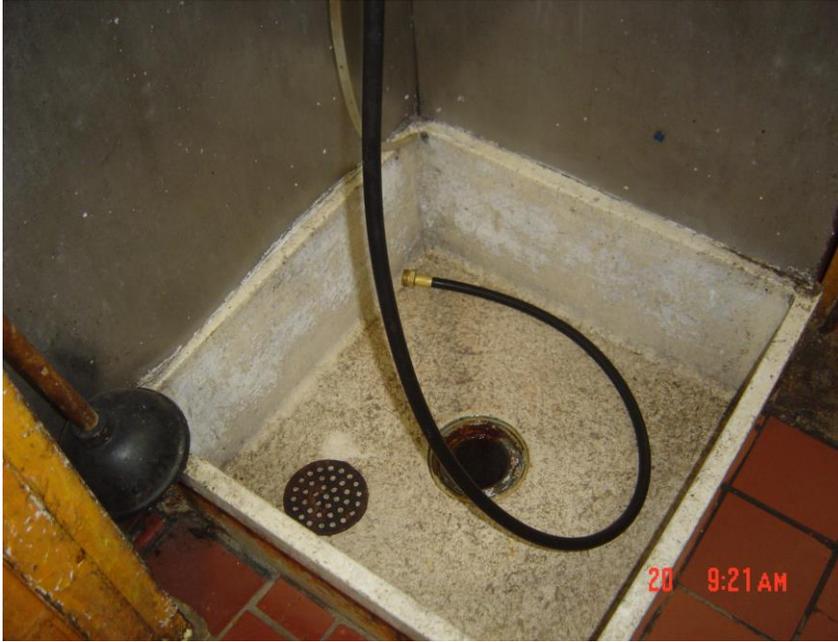
TETRA TECH PROJECT NO. X9025.14.0002.055 DIRECTION: None	DESCRIPTION	This photograph shows a drain in the back area of the New York Grill.	23
	CLIENT	Environmental Protection Agency - Region 7	DATE 6/20/18
	PHOTOGRAPHER	Ann Marie Pohlman

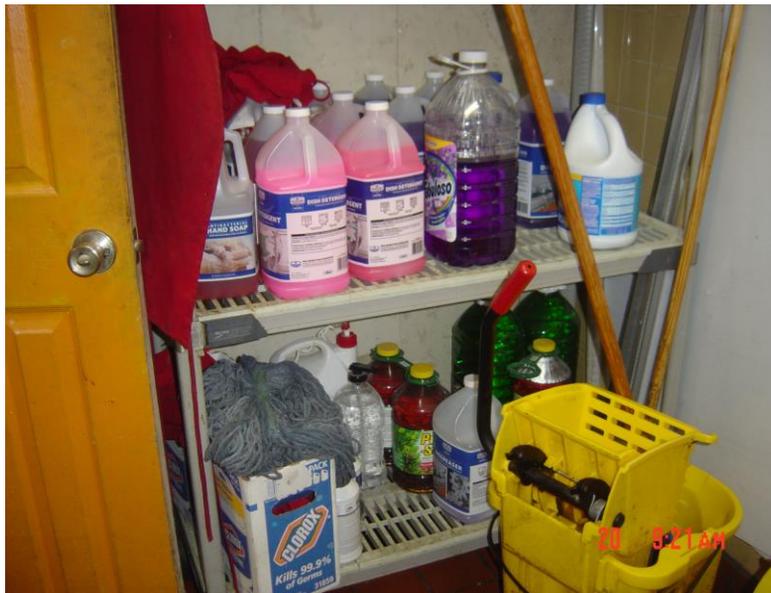
TETRA TECH PROJECT NO. X9025.14.0002.055 DIRECTION: Southwest	DESCRIPTION	This photograph shows chemical storage in the back area of the New York Grill.	24
	CLIENT	Environmental Protection Agency - Region 7	DATE 6/20/18
	PHOTOGRAPHER	Ann Marie Pohlman

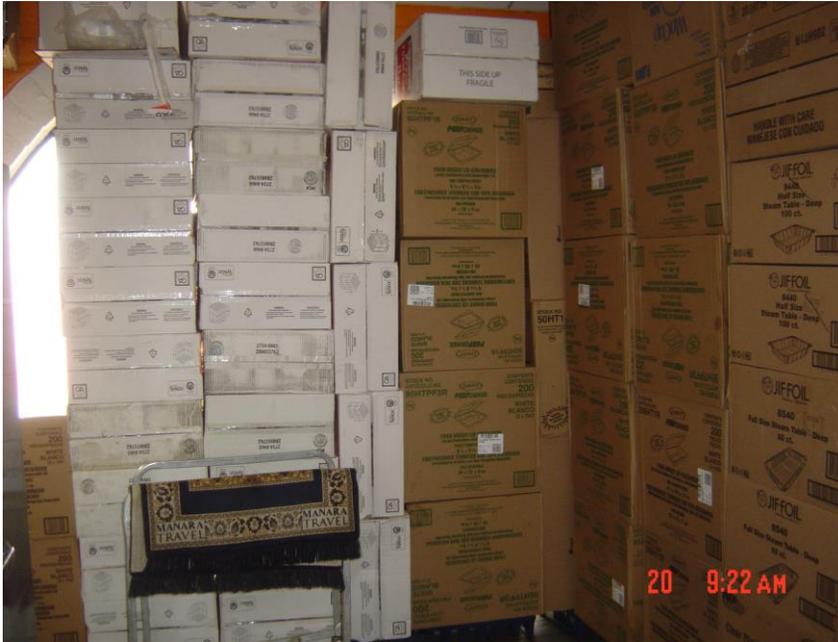
TETRA TECH PROJECT NO. X9025.14.0002.055 DIRECTION: North	DESCRIPTION	This photograph shows supplies storage in the back area of the New York Grill.	25
	CLIENT	Environmental Protection Agency - Region 7	DATE 6/20/18
	PHOTOGRAPHER	Ann Marie Pohlman

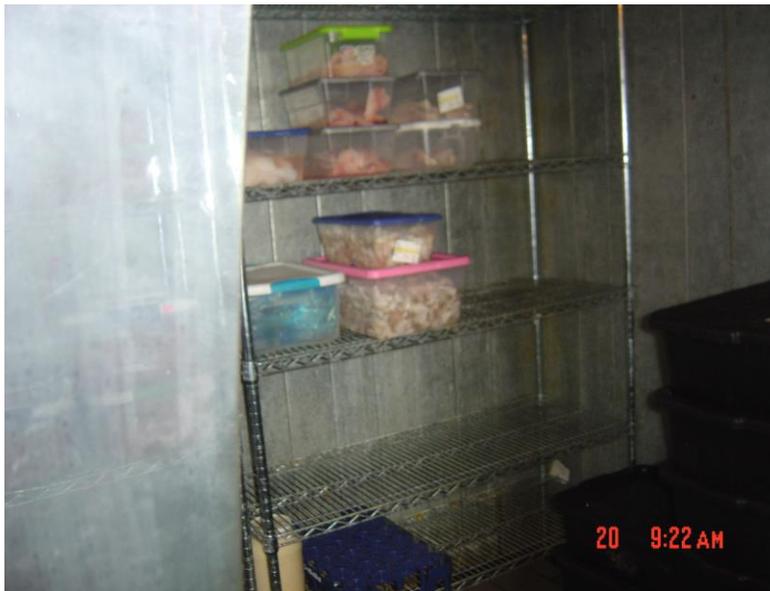
TETRA TECH PROJECT NO. X9025.14.0002.055 DIRECTION: Northeast	DESCRIPTION	This photograph shows a walk-in cooler in the back area of the New York Grill.	26
	CLIENT	Environmental Protection Agency - Region 7	DATE 6/20/18
	PHOTOGRAPHER	Ann Marie Pohlman
