Subject: Emergency Response Action Letter Report
Adair County Drum
Columbia, Adair County, Kentucky
Contract Number: EP-S4-14-03
TDD Number: TT-01-092

The Tetra Tech Superfund Technical Assessment and Response Team (START) submits this report to summarize the emergency response activities conducted on May 17 through May 18, 2018, and offsite waste disposal activities on July 16, 2018 at the Adair County Drum site in Columbia, Adair County, Kentucky. This report includes four enclosures. Enclosure 1 contains figures illustrating the site location and site layout. Enclosure 2 contains a sampling summary table. Enclosure 3 contains a photographic log of the response activities. Enclosure 4 contains a copy of the Tetra Tech START logbook notes. Attachment 1 contains the laboratory data packages.

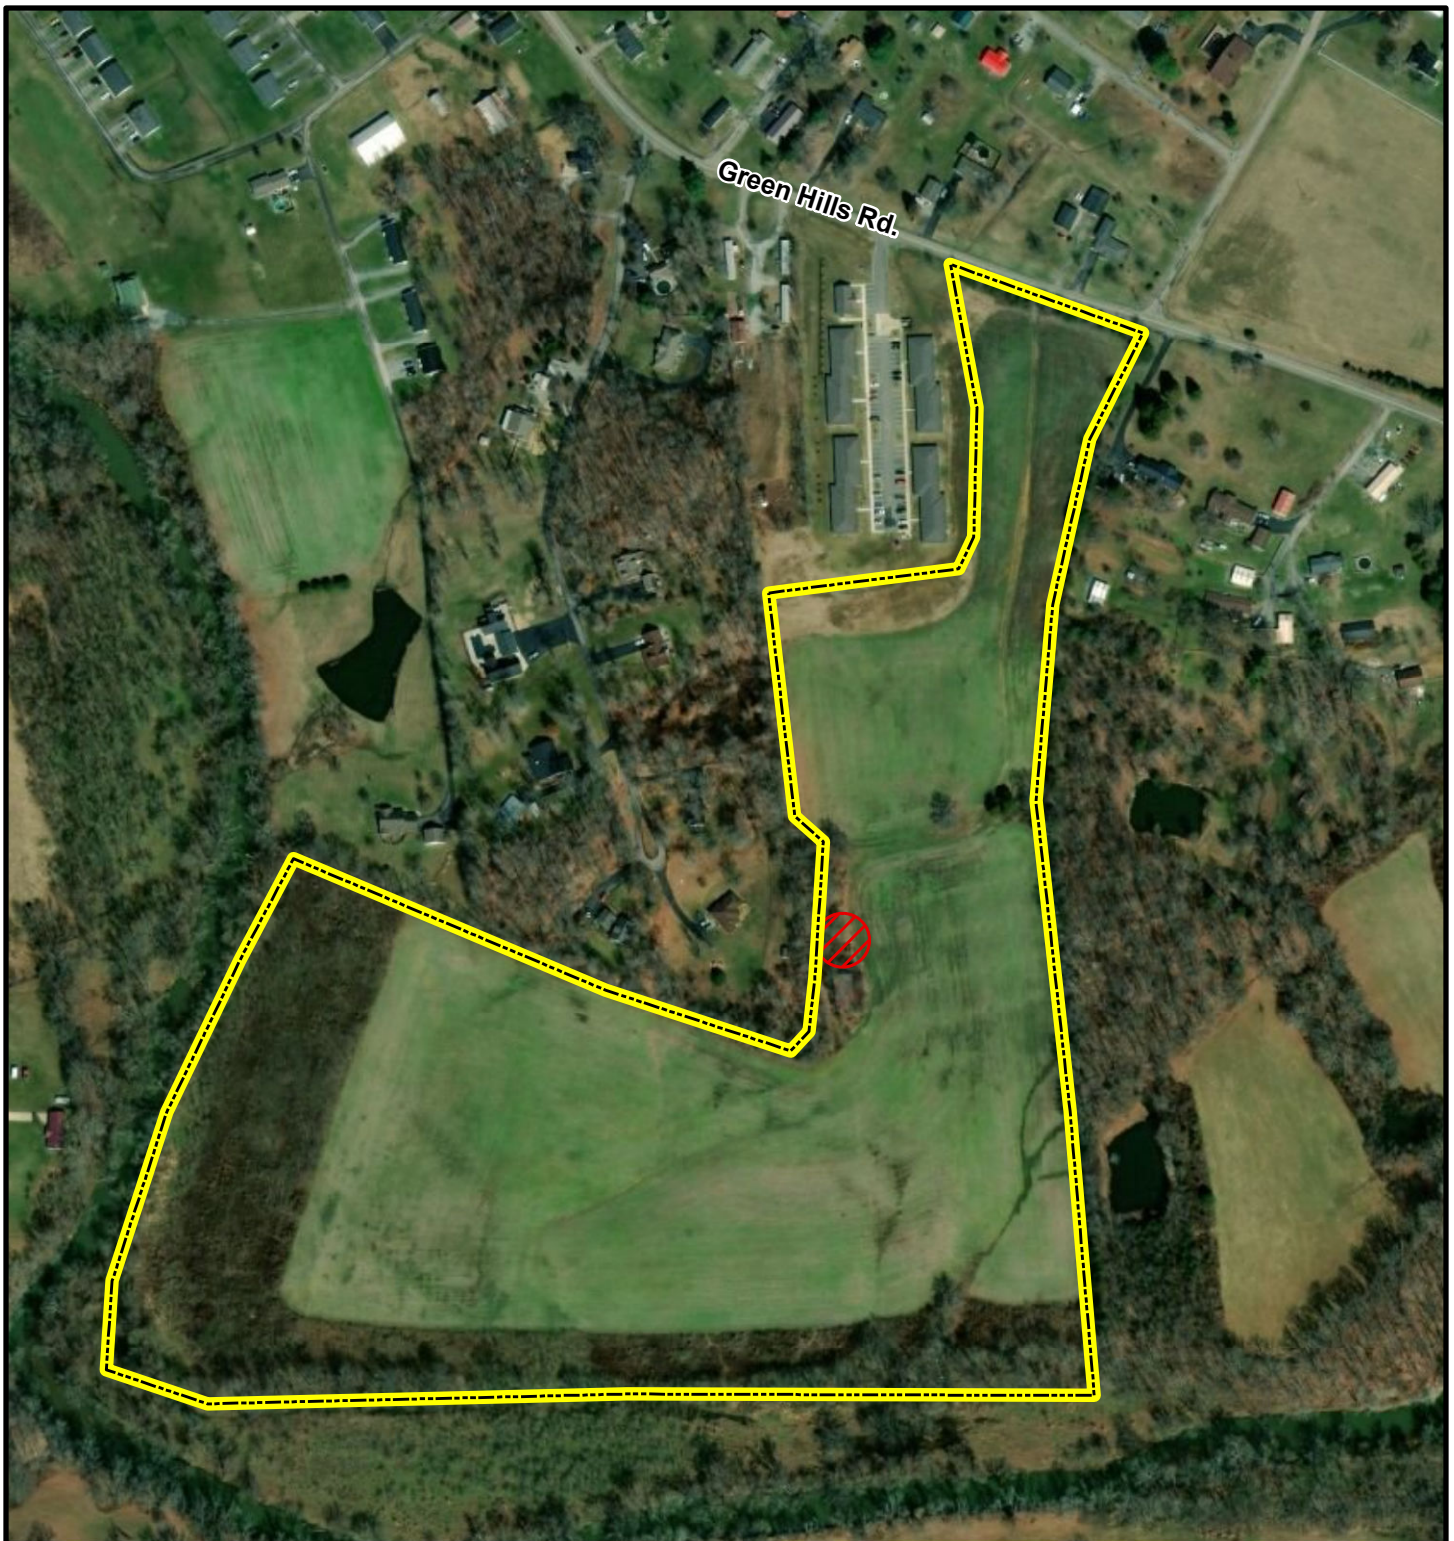
FIGURE 2

Drum and sampling area
-

Site Layout

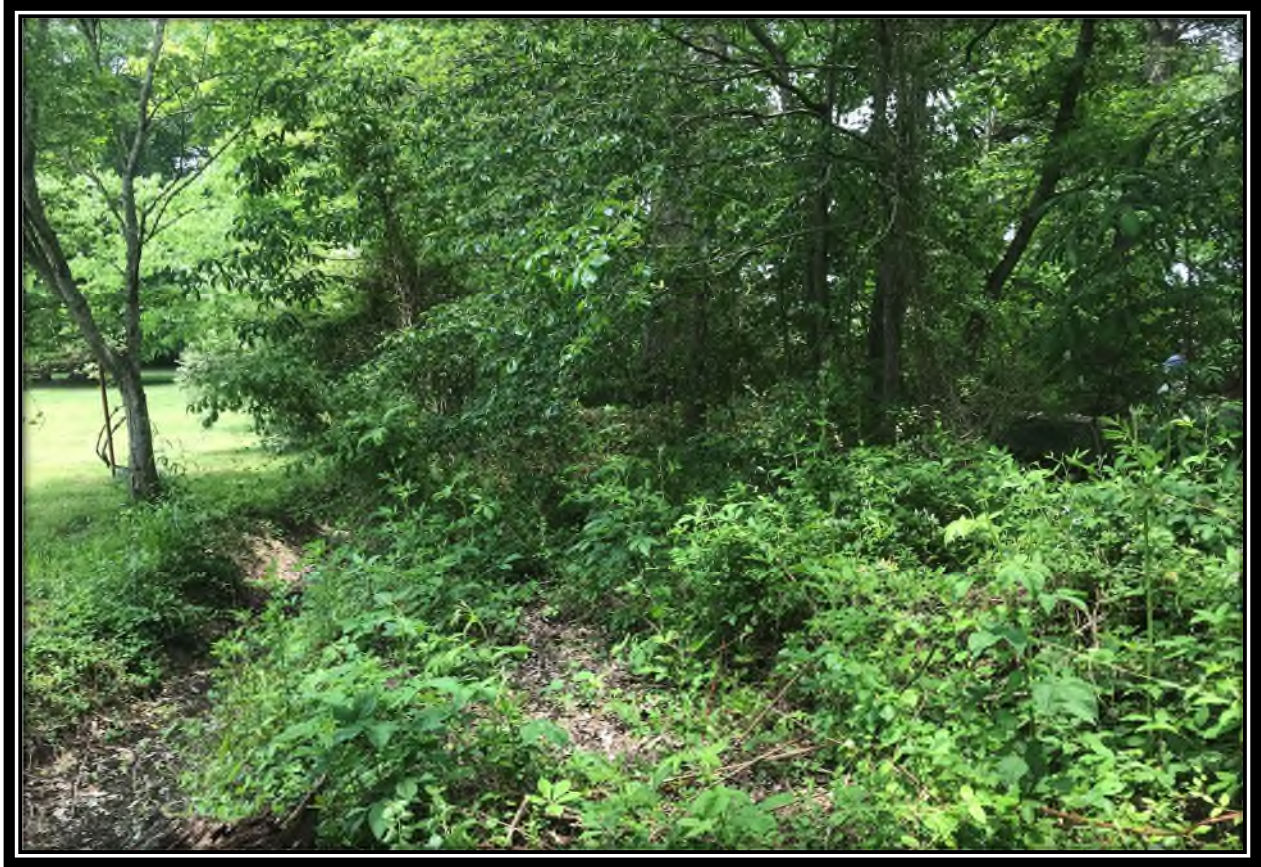
OFFICIAL PHOTOGRAPH NO. 1
U.S. ENVIRONMENTAL PROTECTION AGENCY

Subject: On Thursday, May 17, 2018, personnel from EPA and Tetra Tech START mobilized to the Adair Co. Drum Site, located at 285 Woodland Acre Columbia, Adair County, Kentucky to collect waste characterization grab and composite samples from drums and soil. Many of the drums were weathered and some were leaking.

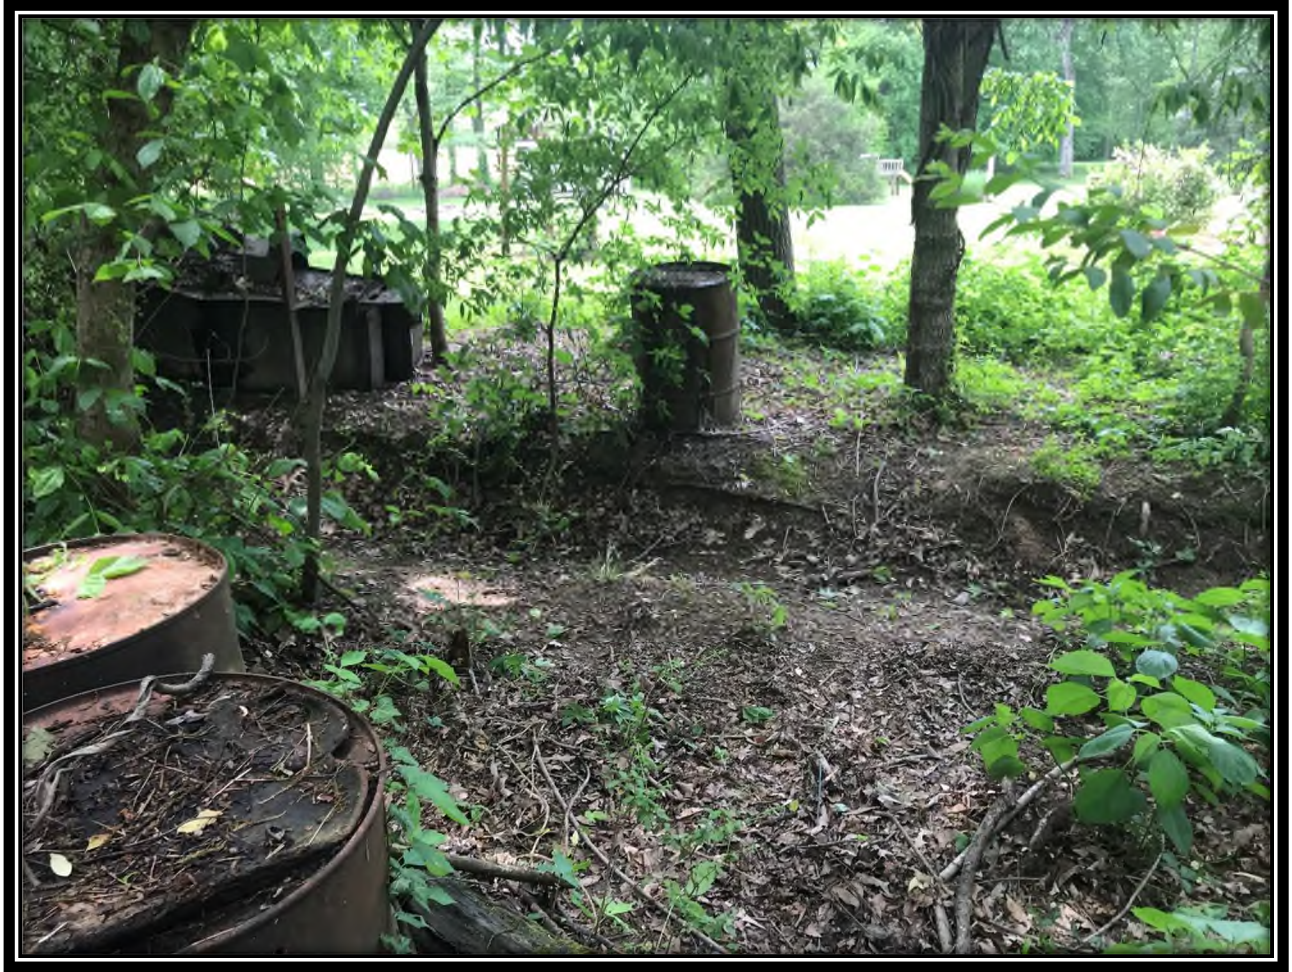
OFFICIAL PHOTOGRAPH NO. 2
U.S. ENVIRONMENTAL PROTECTION AGENCY

Subject: Abandoned drums along ditch line behind 285 Woodland Acre Columbia, Adair County, Kentucky.

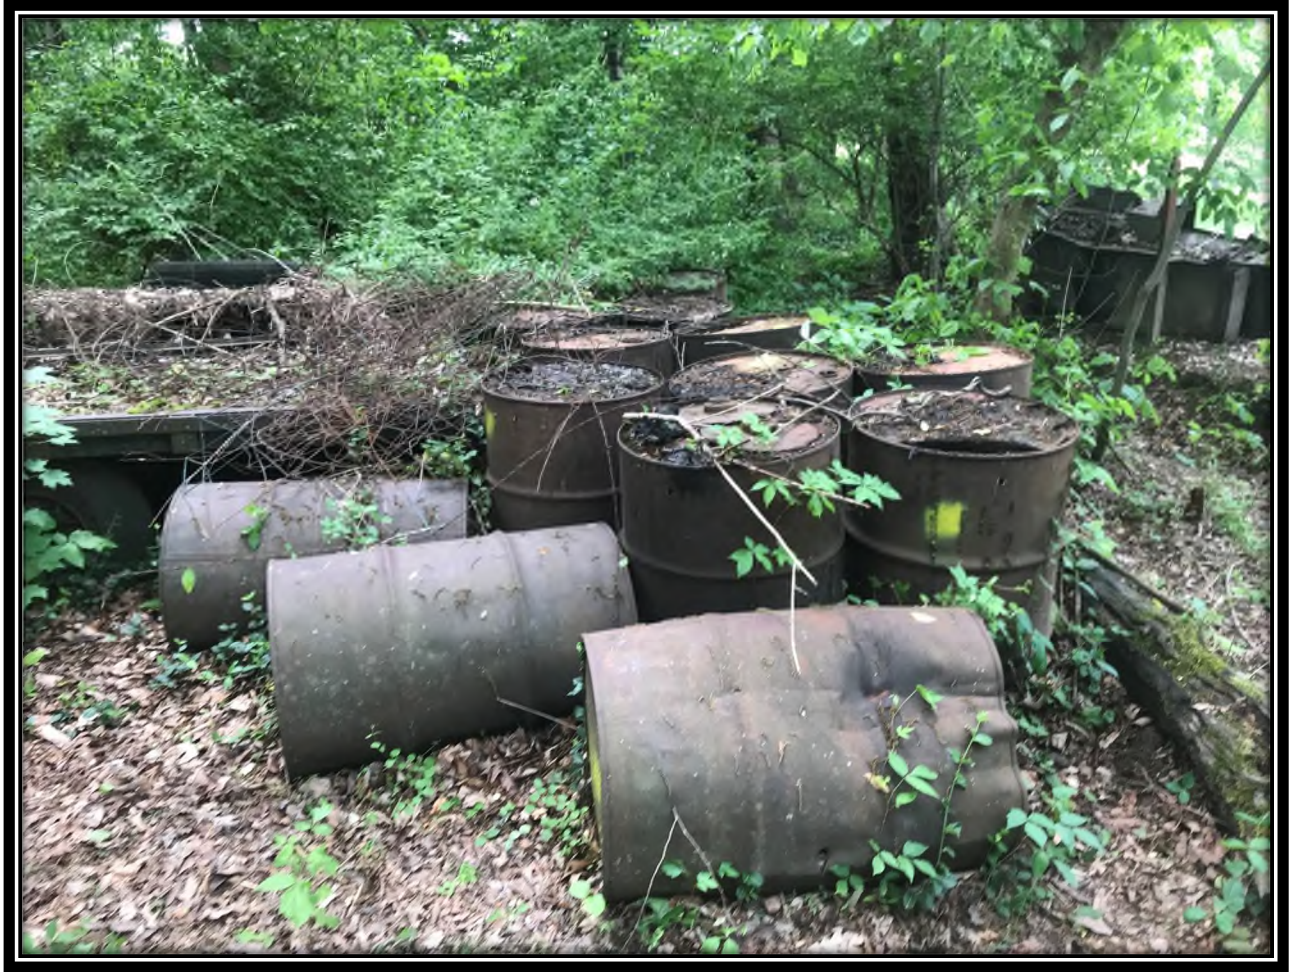
OFFICIAL PHOTOGRAPH NO. 3
U.S. ENVIRONMENTAL PROTECTION AGENCY

Subject: Tetra Tech START marked leaking drums that required overpacking.

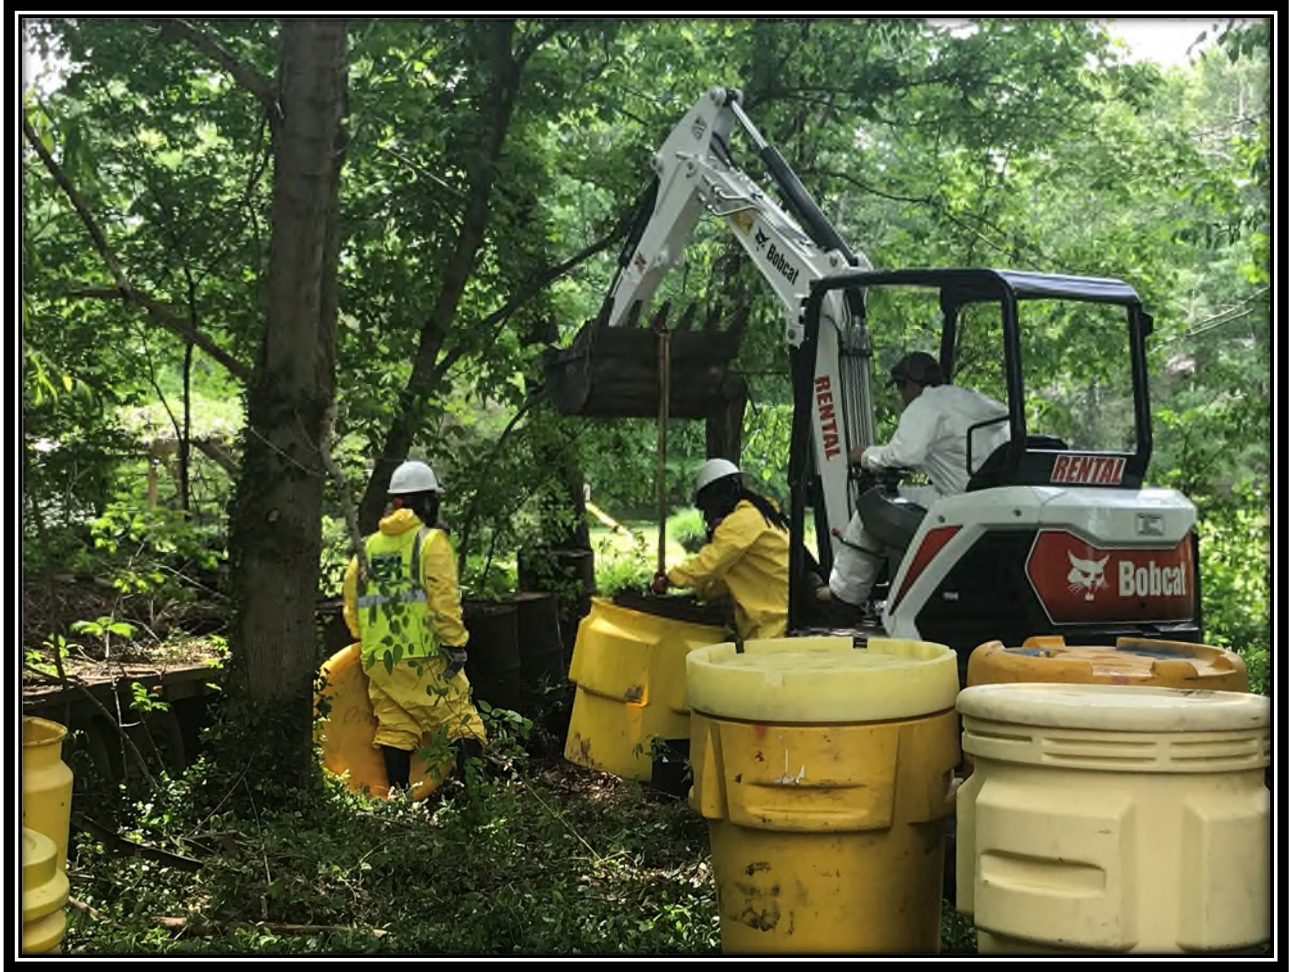
OFFICIAL PHOTOGRAPH NO. 4
U.S. ENVIRONMENTAL PROTECTION AGENCY

Subject: EPA's Emergency and Rapid Response Services (ERRS) contractor, Environmental Restoration LLC, provided site stabilization and overpacked leaking drums.

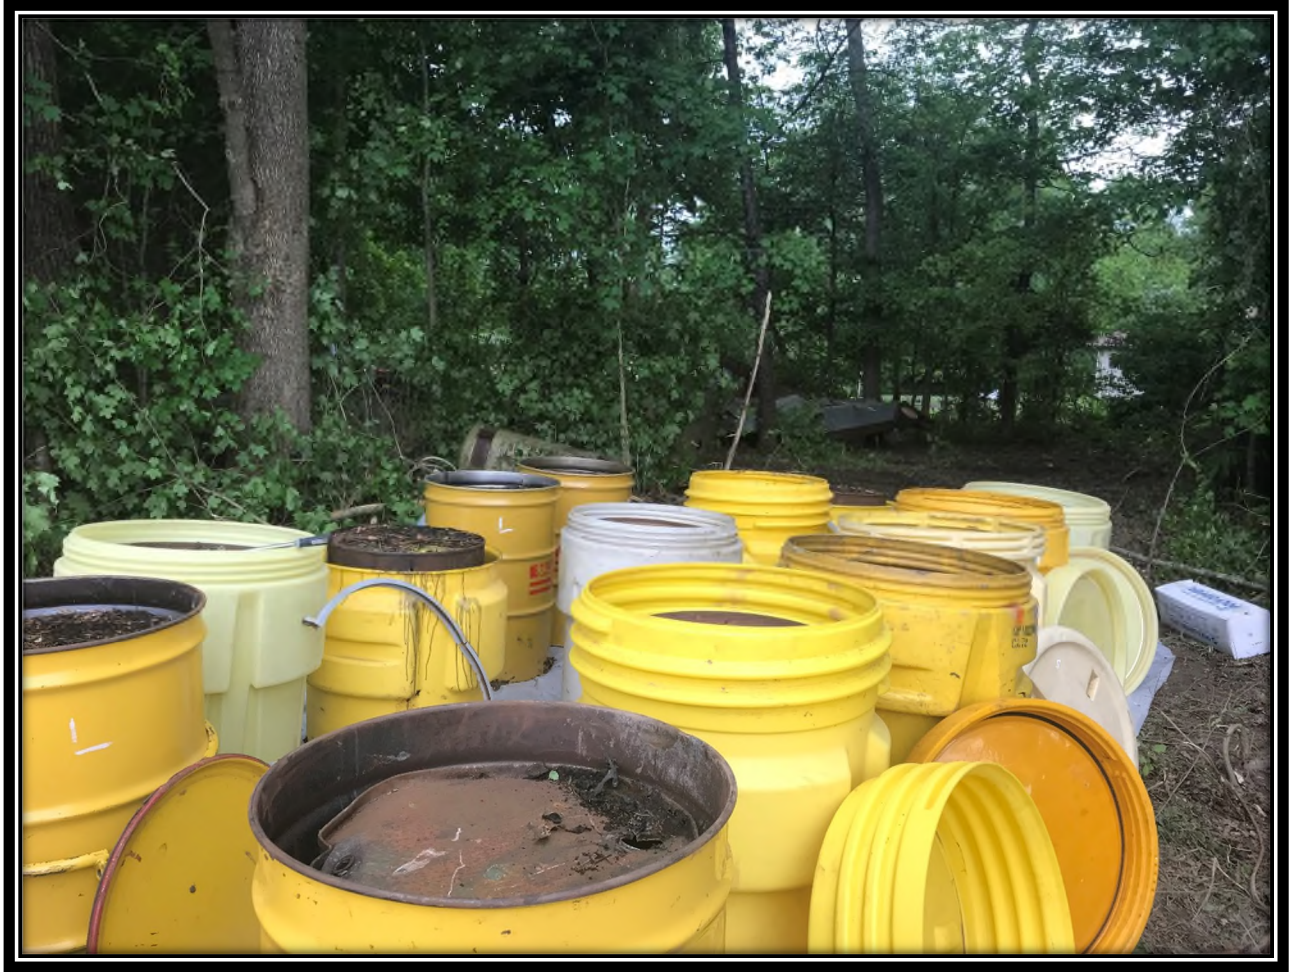
OFFICIAL PHOTOGRAPH NO. 5
U.S. ENVIRONMENTAL PROTECTION AGENCY

TDD Number:	TT-01-092	Location:	Adair Co. Drum Site
Orientation:	Northwest	Date:	May 17, 2018
Photographer:	Todd Taylor, Tetra Tech START	Witness:	None
Subject:	ERRS staged 22 overpacked drums for Tetra Tech START to conduct waste characterization using HAZCAT field testing.

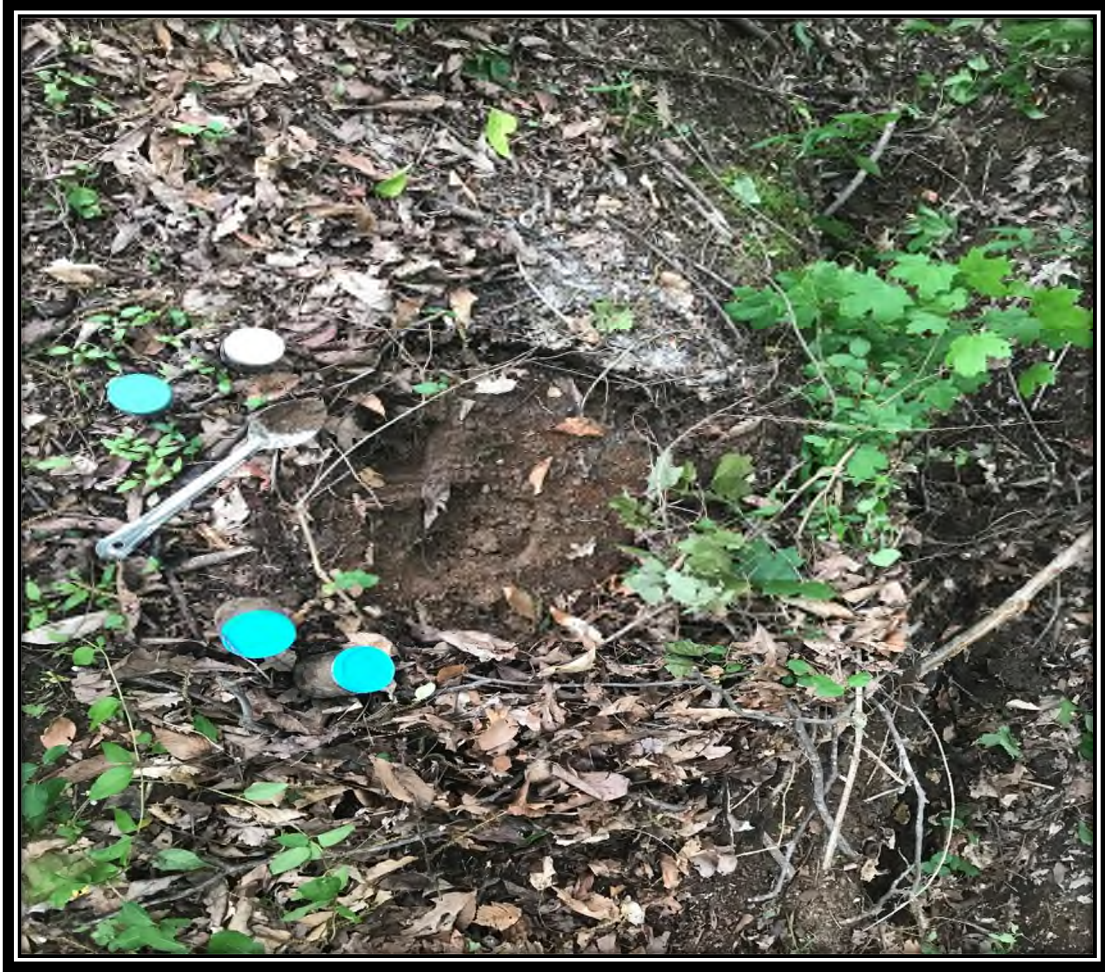
OFFICIAL PHOTOGRAPH NO. 6
U.S. ENVIRONMENTAL PROTECTION AGENCY

Subject: Tetra Tech START and EPA OSC Berry collected a soil sample from under a potentially leaking drum.

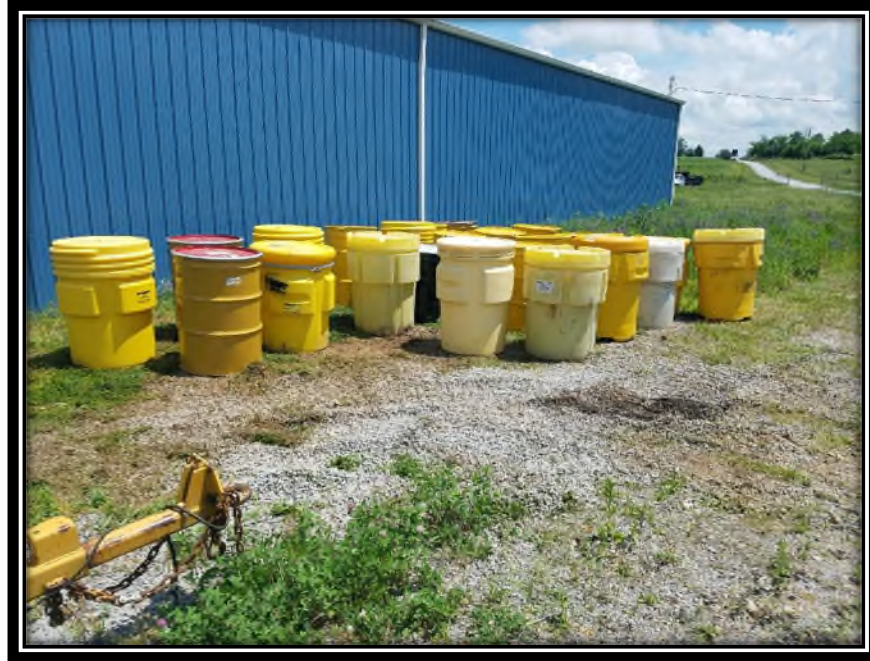
OFFICIAL PHOTOGRAPH NO. 7
U.S. ENVIRONMENTAL PROTECTION AGENCY

TDD Number:	TT-01-092	Location:	Adair Co. Drum Site
Orientation:	South	Date:	May 18, 2018
Photographer:	Todd Taylor, Tetra Tech START	Witness:	None
Subject:	The ERRS contractor placed overpack drums at a secure location awaiting transport and disposal.

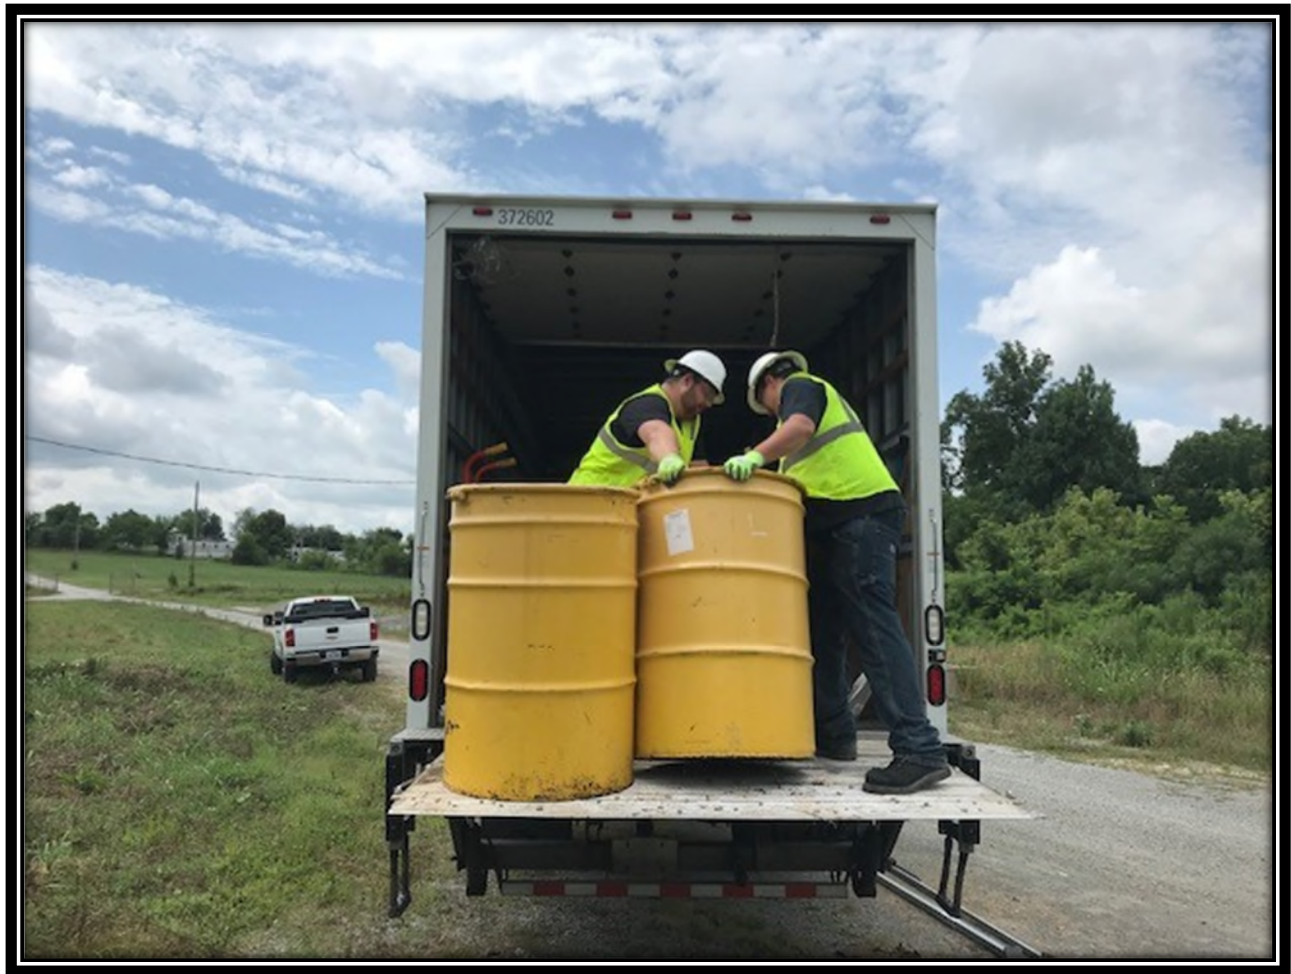
OFFICIAL PHOTOGRAPH NO. 8
U.S. ENVIRONMENTAL PROTECTION AGENCY

Subject: Tetra Tech START provided oversight of the load out of the 24 drums. Tradebe Treatment and Recycling of TN transported the drums to their disposal facility in Millington, TN.

EPA evaluated the waste characterization sample results and developed waste profiles for disposal. Based on the data, EPA determined all the drums contained non-hazardous waste. On July 16, 2018 Tetra Tech START met with ER and KDEP and provided oversight of the load out of the 24 drums for transport and offsite disposal to Tradebe Treatment and Recycling of TN, Millington, TN.
