PRELIMINARY CULTURAL ASSESSMENT OF THE UMPQUA MINE, DOUGLAS COUNTY, OREGON

Preliminary Cultural Assessment of the Umpqua Mine,
Douglas County, Oregon

Heritage Research Associates Report No. 224

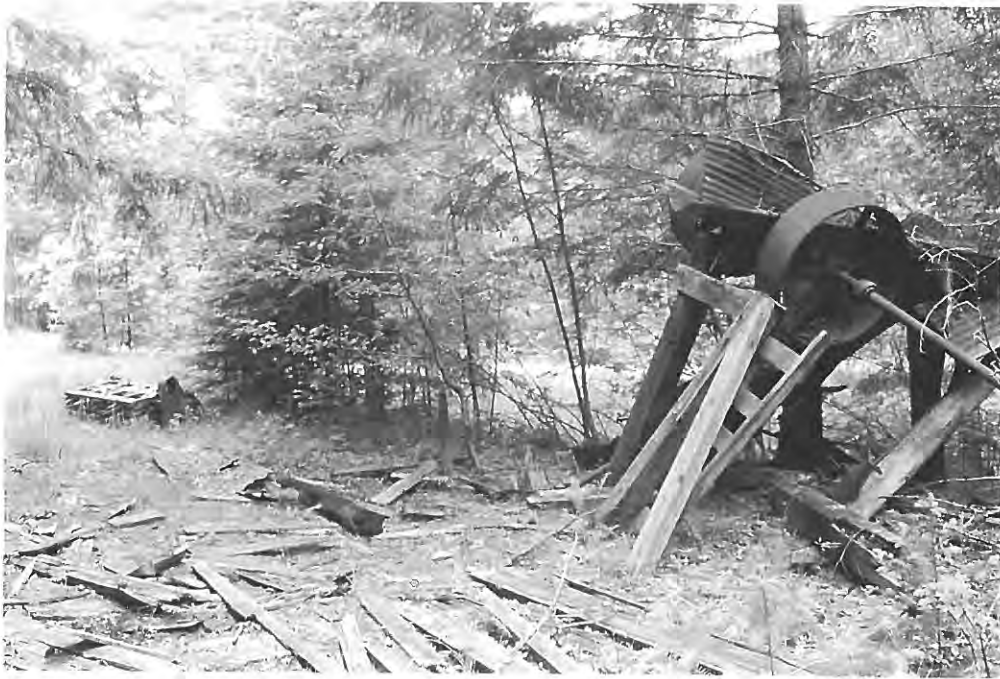
F.1 COLLAPSED STRUCTURE; Powerhouse and associated debris; probably location of a blacksmith shop, men's bathhouse (Hartley 1997:17-18). A wood-frame structure only partially standing, this feature includes a series of large (24" diameter) steel pulleys set on an arbor and pillow blocks. Nearby lies the partially dismantled diesel engine that powered the generator. "...[in front of the main tunnel] was another building containing the engine that ran an air compressor for starting the big Atlas Imperial Diesel engine that ran the 55,000 watt generator which supplied electricity for the plant and the entire camp" (Hartley 1997:17-18).

Figure 5. Collapsed structure, probable powerhouse [Feature F.1], Umpqua Mine, looking east (note diesel engine at left), June 1999.

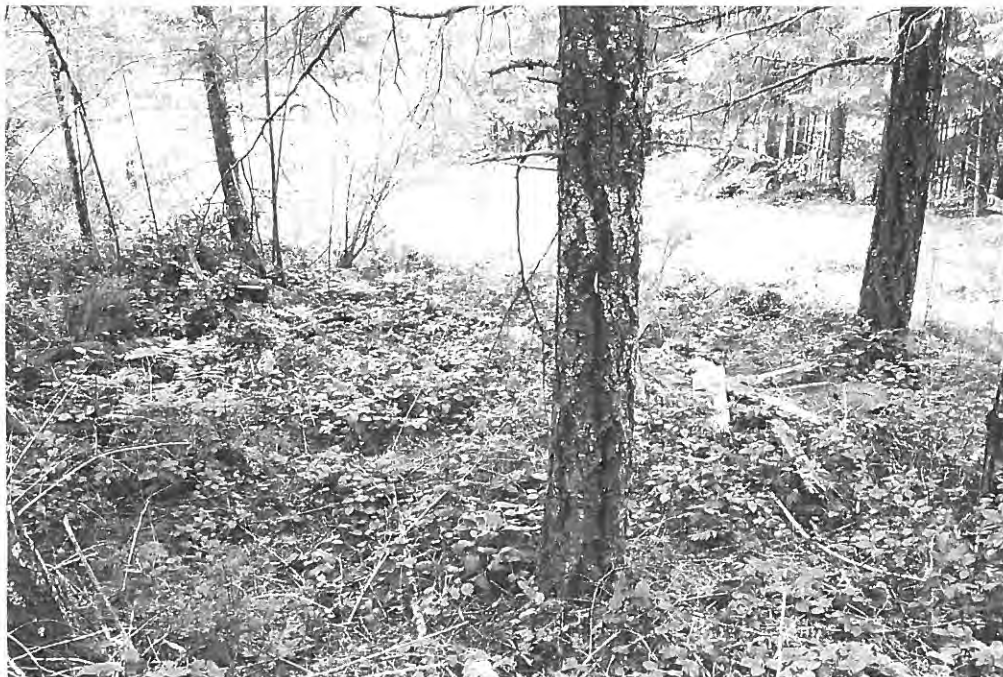
F.3 COLLAPSED STRUCTURE; probable location of men's bunkhouse (Hartley 1997:17-18).

Figure 6. Collapsed structure, probable location of Men's' Bunkhouse [Feature F.3], Umpqua Mine, looking NE, June 1999.

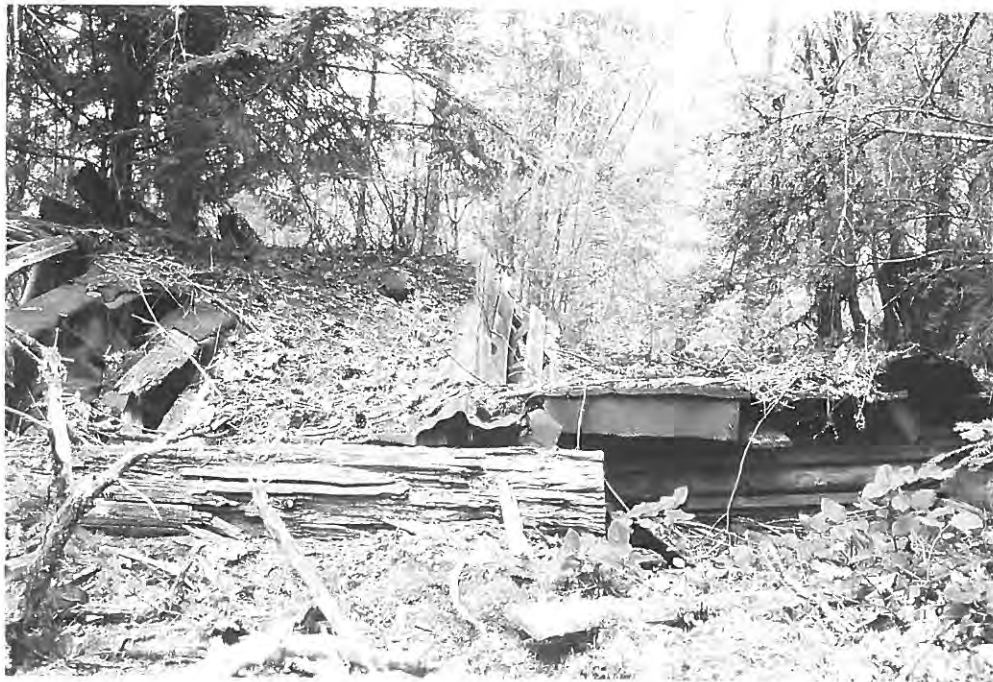
F.6 COLLAPSED STRUCTURE, log cabin approximately 22' x 15' (Hartley 1997:16, 21). There are two additional 4" flanged steel pipe sections located to the south. Photos of this feature taken in 1998 indicate that it was partially standing and of small notched log construction. Further decay, as evident in June 1999, leave the cabin with little standing elements and the entire debris pile is less than 36" above grade at any point. Roofing was originally green asphalt shingle with a steel ridge at the gable peak. *"From the back porch a narrow steep little trail wound its way up the hillside to a one-room log cabin. Sturdily built of peeled logs, a steep roof, 1 window that looked down on the cook shack and small front porch where you entered the front door. No one lived there"* (Hartley 1997:15).

Figure 7. Collapsed “one room log cabin,” [Feature F.6], Umpqua Mine, looking east, June 1999.

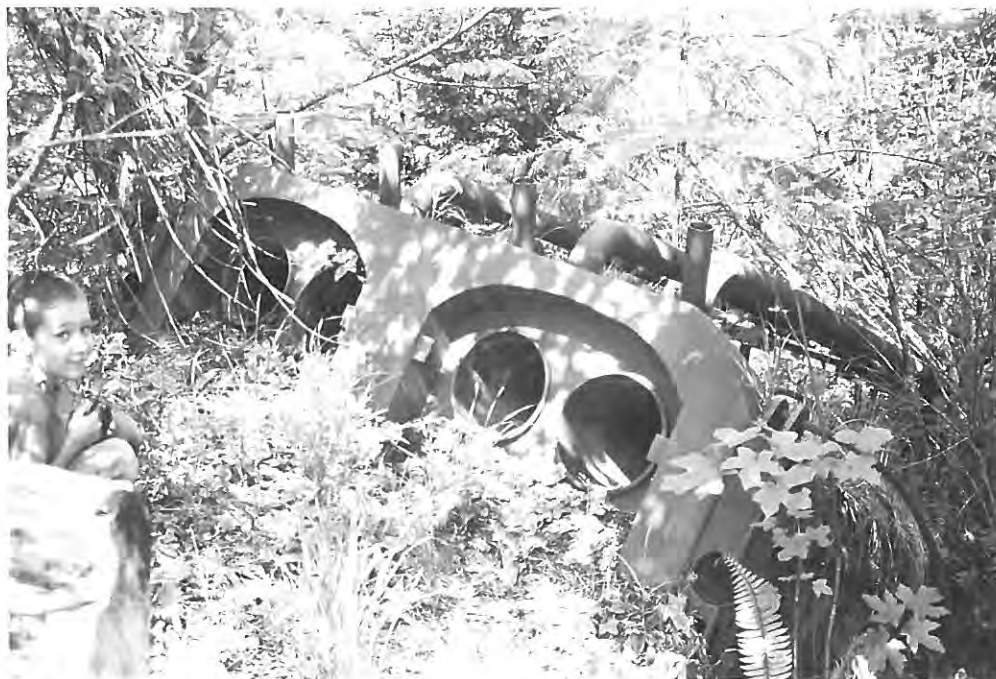
F.7 RETORT, This large steel feature is sited on the sloped grade immediately north of the road bed. Approximately 3' tall and 5' wide with four 13" diameter chambers running the full 14' length. A 36" diameter welded steel furnace, with surviving smoke stack, is located at the bottom of the retort with connecting overhead piping of approximately 6" diameter steel remaining. An earlier report states that this retort is a "converted dump truck bed with furnace and stack." However the construction of the retort supports the historic description which states, *"Sitting right out here is a Johnson-McKay Retort with 500lb capacity..."* (Hartley 1997:107).

Figure 8. Johnson-Kay Retort [Feature F.7]], Umpqua Mine, looking north, June 1999.

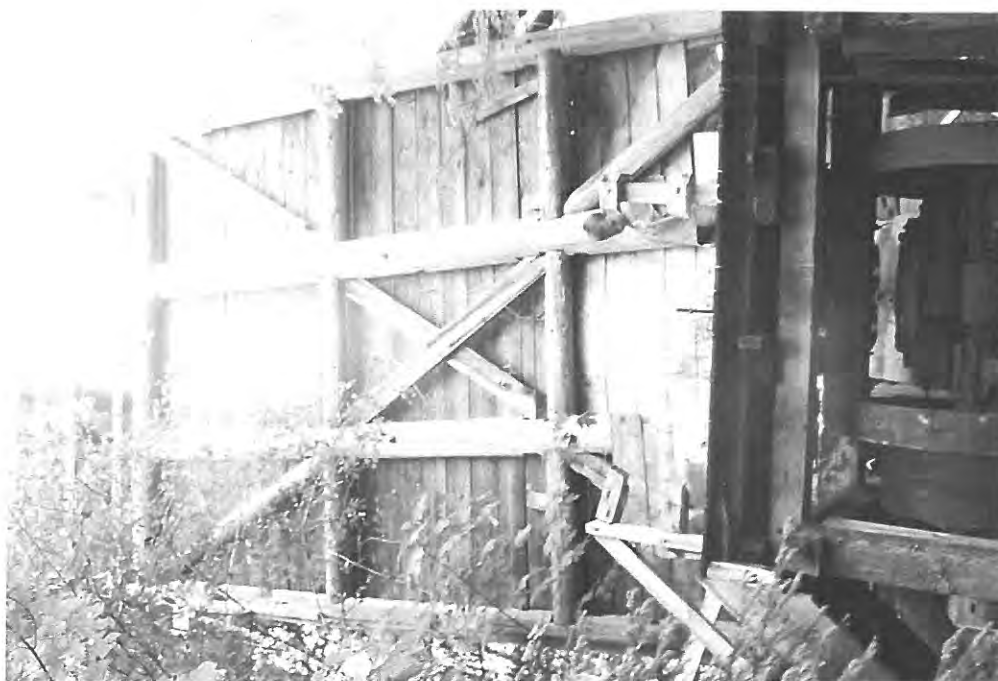
F.8.2 *Main Ore bin,* partially collapsed: A large, multi-story gable roofed structure built of 14" diameter log pole vertical members, rough-sawn (RS) lumber and pole horizontals and 2.5" x 10" RS (rough-sawn) interior cribbing. A corrugated metal roof is partially missing and the NE corner of the structure is collapsed under the weight of ore that remained inside. Severe compression to the 12" x 12" RS sills, especially at the SE corner, indicate that this structure will soon collapse even further.

Figure 10. Main Ore Processing Plant [Feature F.8.2] Umpqua Mine, looking west, June 1999.

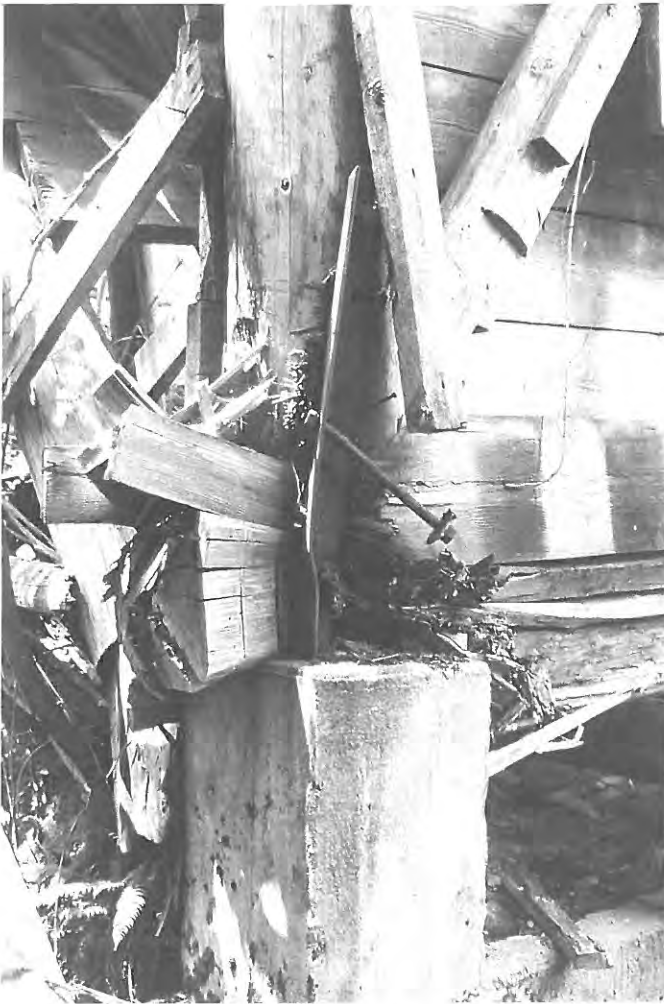
Figure 11. Main Ore Processing Plant detail [Feature F.8.2; note structural compression], Umpqua Mine, looking SW, June 1999.

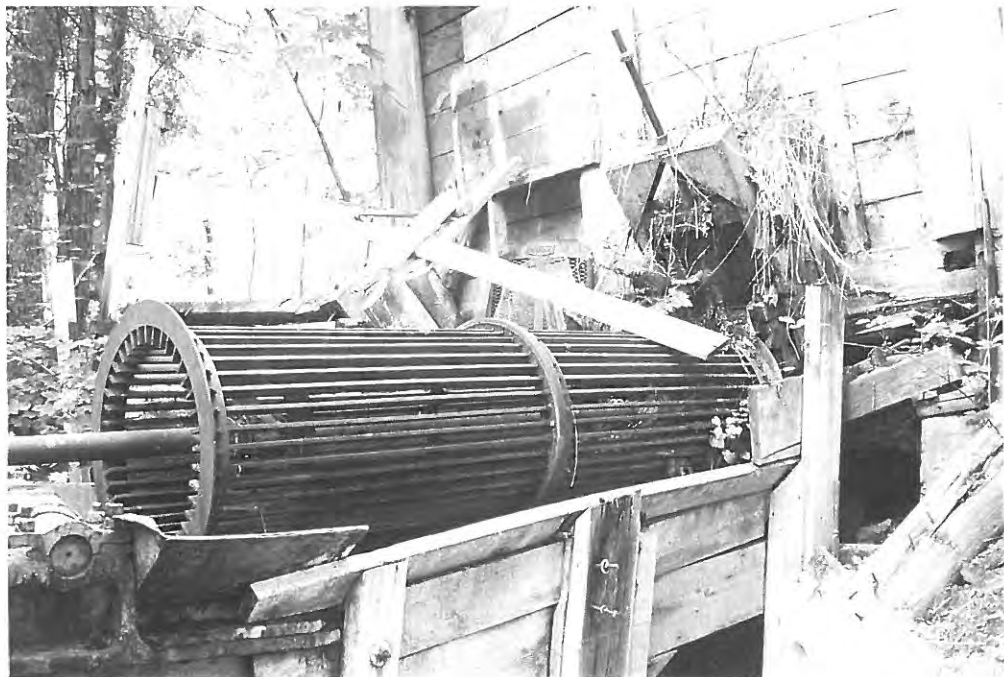
- F.8.3 *Rotary Grizzly*: A cast and welded manufactured steel piece of equipment with a 30" diameter cage comprised of forty ½" x 2" bars approximately 10-12' in length. A 3" diameter steel drive shaft was apparently powered by the diesel motor (F.8.5). The Grizzly, manufactured by the Acme Road Machinery Company of Frankfort, New York ("Patent Applied For") is generally intact. The grizzly rests on a poured concrete foundation.

Figure 12. Rotary Grizzly [Feature F.8.3.], Umpqua Mine, looking SW, June 1999.

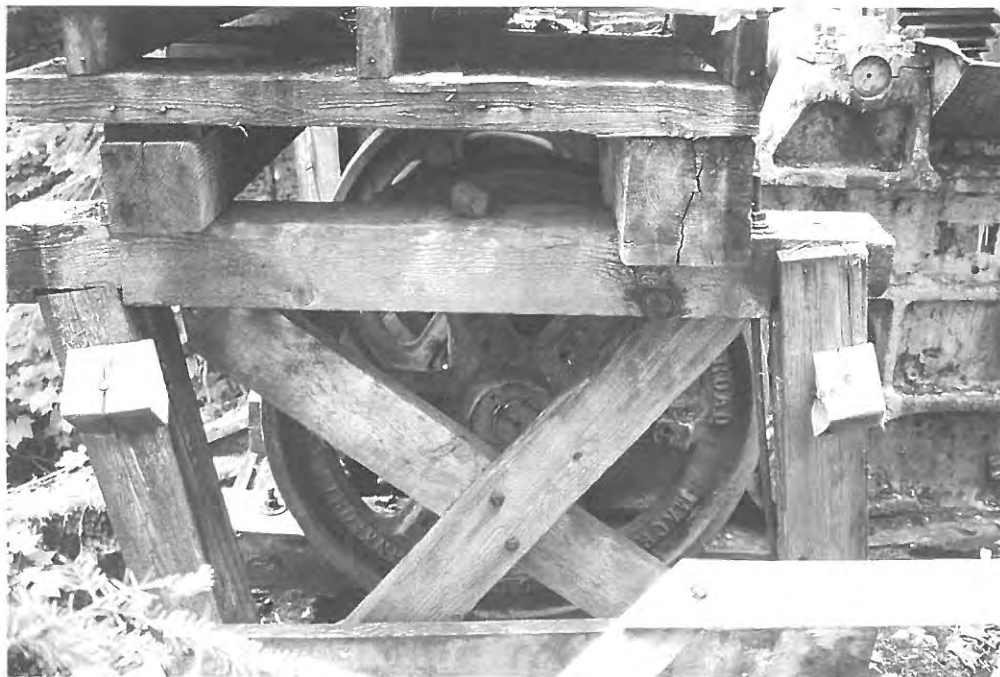
Figure 13. Detail of Rotary Grizzly [Feature F.8.3], Umpqua Mine, looking south, June 1999.

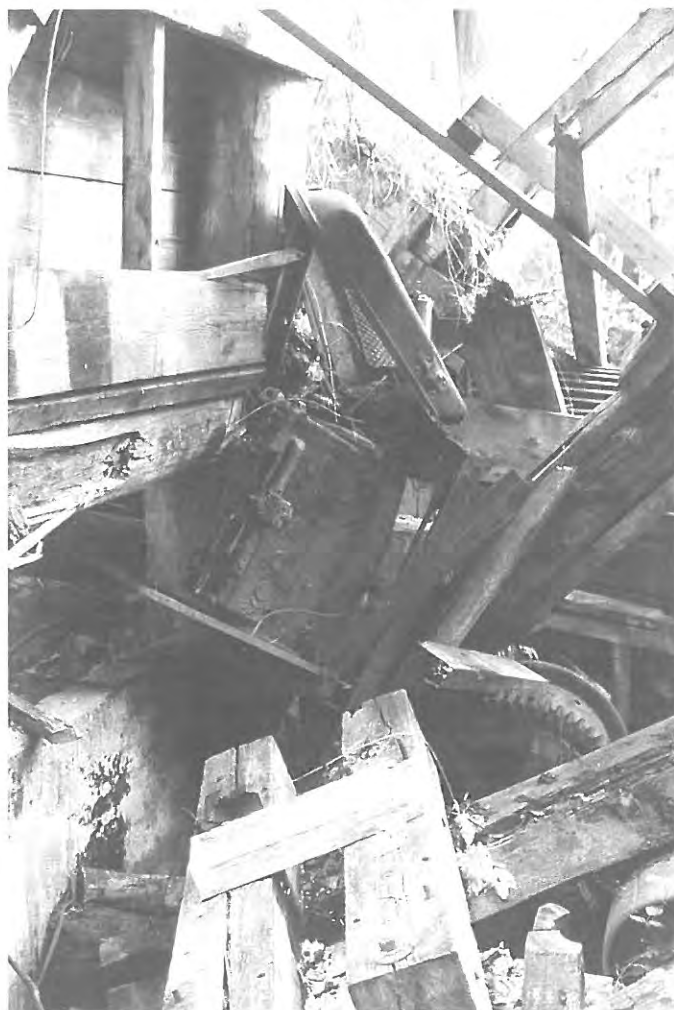
- F.8.5 *Diesel Motor*: partially disassembled, this power source for the grizzly is located at the SE corner of the ore bin. A surviving radiator cover is marked "Buda," presumably the manufacturer.

Figure 14. Diesel Motor [Feature F.8.5], Umpqua Mine, looking north, June 1999.

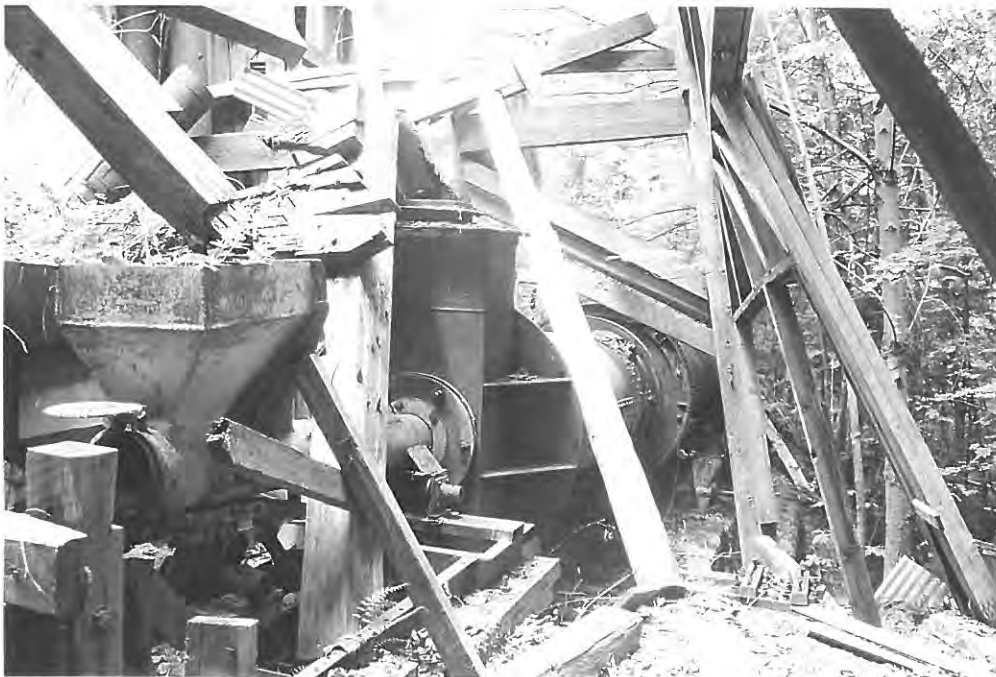
- F.8.8 *Rotary Furnace*: Described as a "Gould-type Furnace" by Hartley (1997:140), this feature is built of heavy riveted steel plates formed into a tube approximately 36" in diameter and 30' long. Two end boxes provide support and access for ore loading and removal. A series of steel trunnions are located along the length to support the spinning furnace during operation. Heavy machined gears and other features indicate this was a specially built piece of equipment but no manufacturer's label or other identification was noted. The interior of the furnace is lined with fire-brick. "*Then Shorty heard him [Roy Hickman] ordering all new special made fire brick for the big 36" Gould-type tube about 60' long (sic)... The bricks were shipped into Riddle [and] Bill Cox picked them with his truck and hauled them up to Salt Creek where the mine crew transferred them to Carl Hill's trailer and Carl brought them into the mine*" (Hartley 1997:140).

Figure 15. Rotary Furnace, "hopper," [Feature F.8.8], Umpqua Mine, looking north, June 1999.

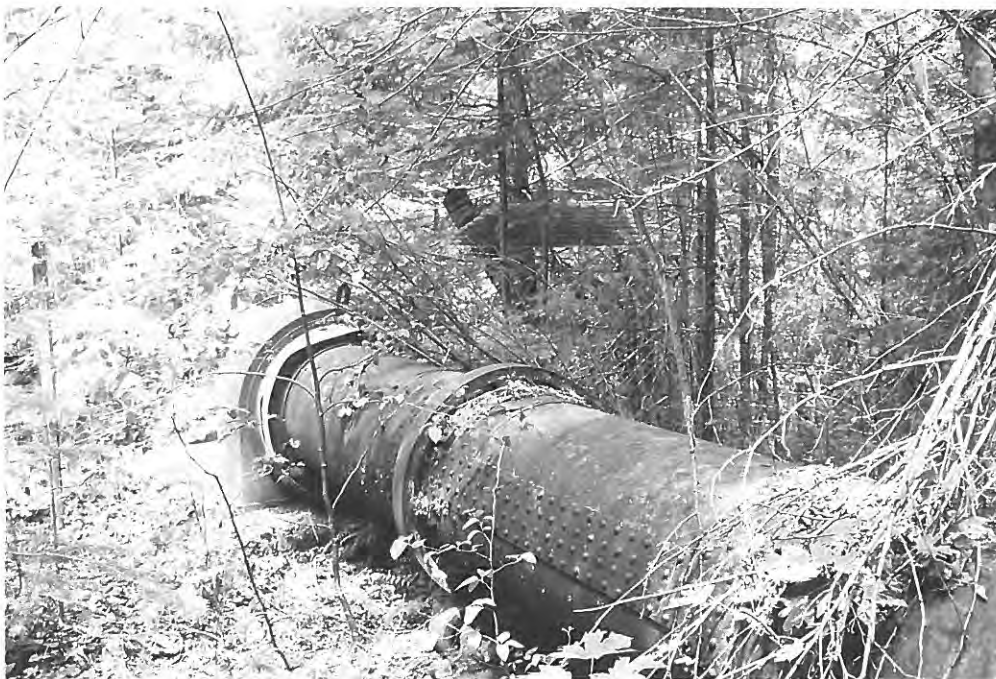
Figure 16. Rotary Furnace, [Feature F.8.8], Umpqua Mine, looking north, June 1999.

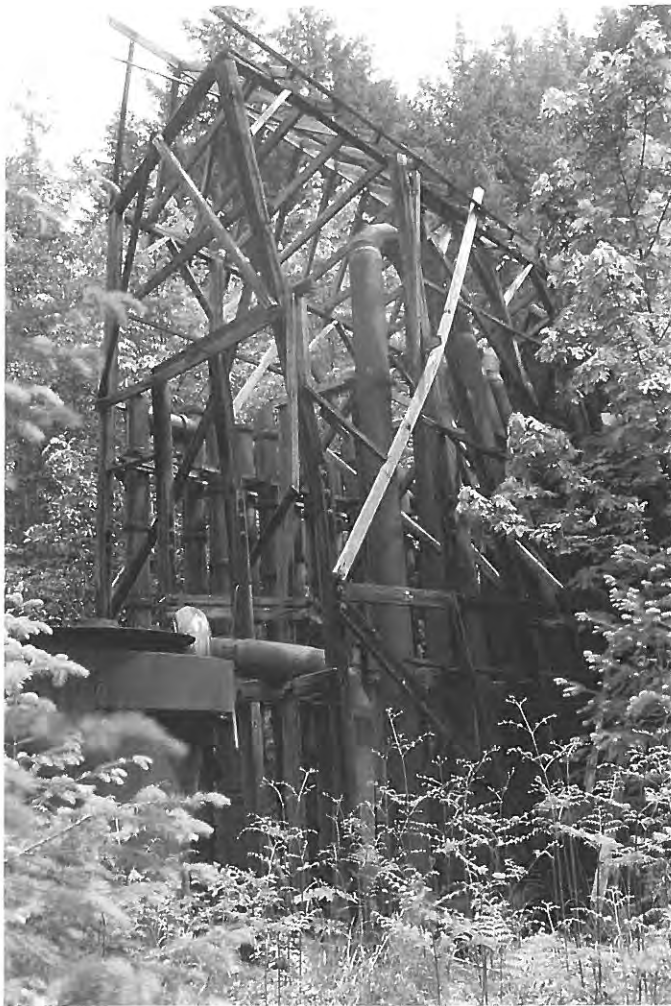
- F.8.9 *Condenser Shed*: A fairly large, approximately 12' x 25' open structure, the condenser shed is built of heavy 4" x 6" and larger RS timbers with cross-bracing of smaller stock. Essentially a gable-roofed volume, there is no roof sheathing present and it is uncertain whether or not there ever was. On the west side of the structure a series of eight and a half undulating 12" diameter steel tubes are connected to a similar series of nine chimney-type features built of sections of glazed terra cotta piping, also approximately 12" in diameter. The terra cotta pipes are marked, from south-to-north, with hand-painted numbers. Elements of the Condenser Shed are identified as the product of the "Independent Foundry, Portland, Ore." Some of the terra cotta elements are broken but the condenser shed is generally intact. According to Hartley, the condenser pre-dates 1938 (Hartley 1997:137).

Figure 17. Condenser Shed [Feature F.8.9], Umpqua Mine, looking SE, June 1999.

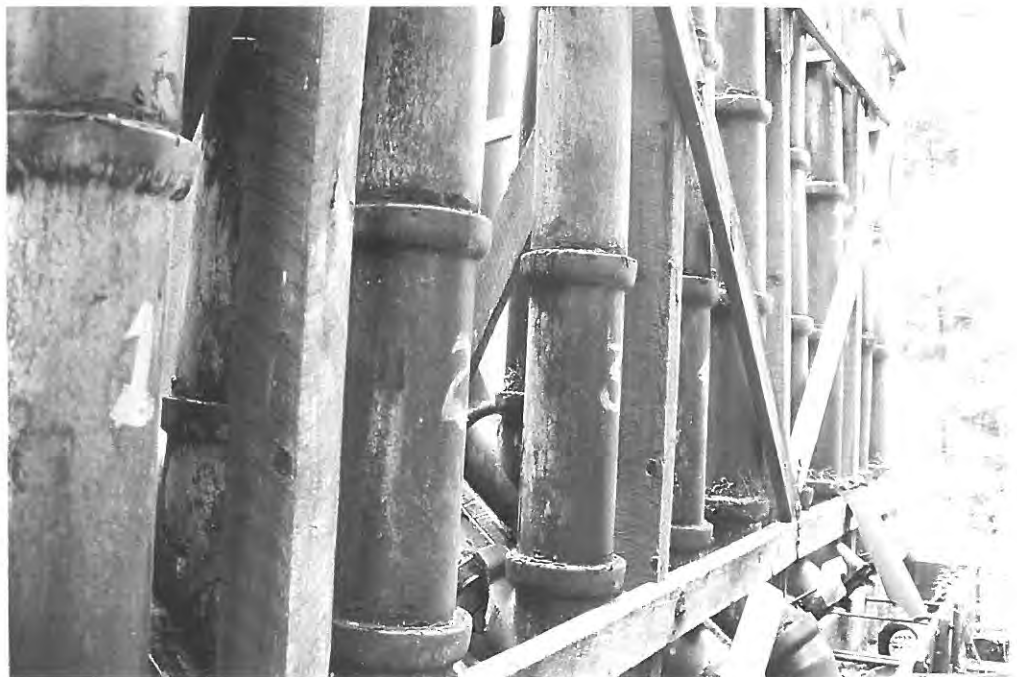
Figure 18. Condenser Shed, Terra Cotta detail, [Feature F.8.9], Umpqua Mine, looking west, June 1999.

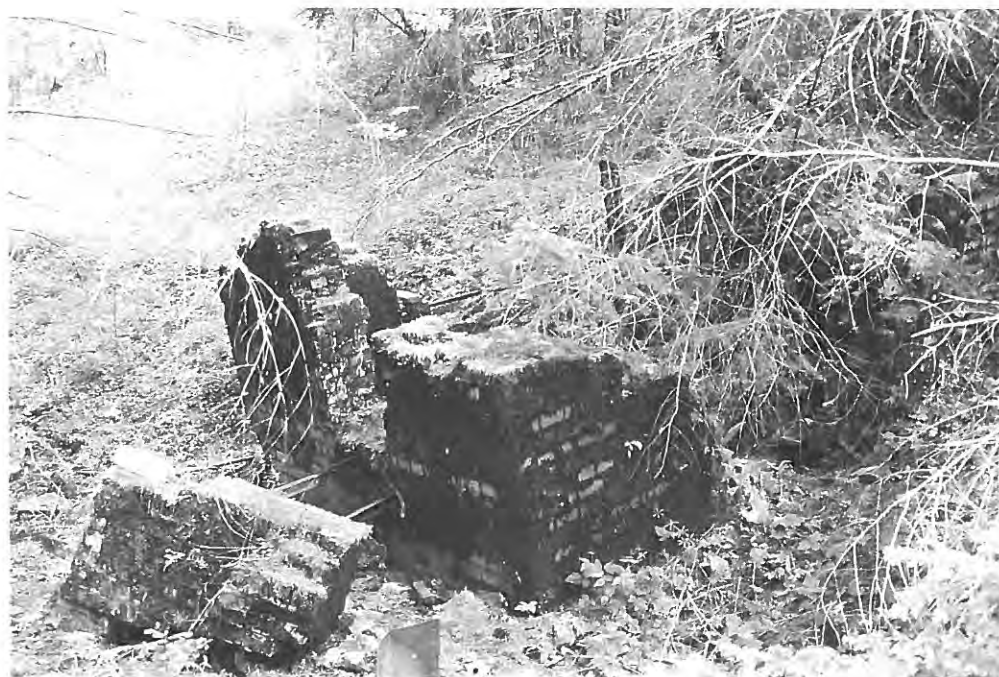
- F.10 **BRICK FURNACE**, partially collapsed: Stoutly constructed of multi-wythe mortared brick, the exact nature and date of this 10' x 10' [+/-] structure is uncertain. (A wythe is a brick unit referring to one layer of brick.)

Figure 19. Brick Furnace, portion [Feature F.10], Umpqua Mine, looking NE, June 1999.

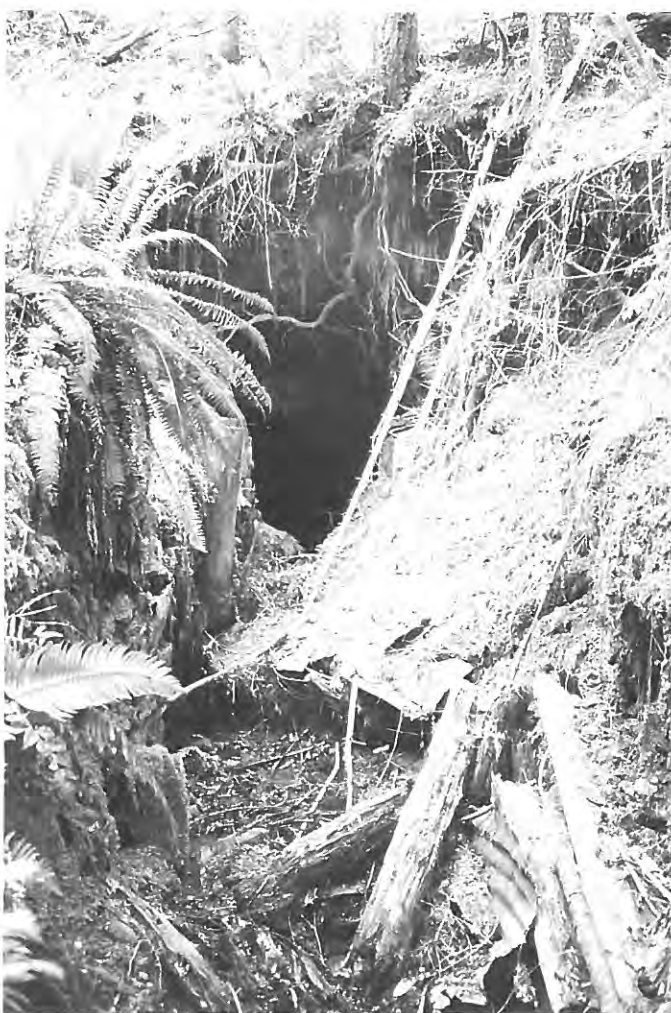
- F.11 **SLIGHT DEPRESSION**: reportedly remains of older processing, ties, bolts, possible narrow gauge track.
- F.12 **ADIT**, collapsed at entrance: This adit and tunnel of unknown depth are entirely collapsed, remaining as a depression in the slope just east of F.10.

Figure 20. Main Adit [Feature F.12], Umpqua Mine, looking north, June 1999.
