**LIMITED PHASE II ENVIRONMENTAL SITE ASSESSMENT  
FOR  
SWIFT BUILDING  
390 WEST EXCHANGE ROAD  
OGDEN, UT 84401**

Date Prepared	December 2018
TDD No.	0003/1807-05
Document Control No.	W0620.1A.01842
Contract No.	EP-S8-13-01
U.S. EPA Work Assignment Manager	Christina Wilson

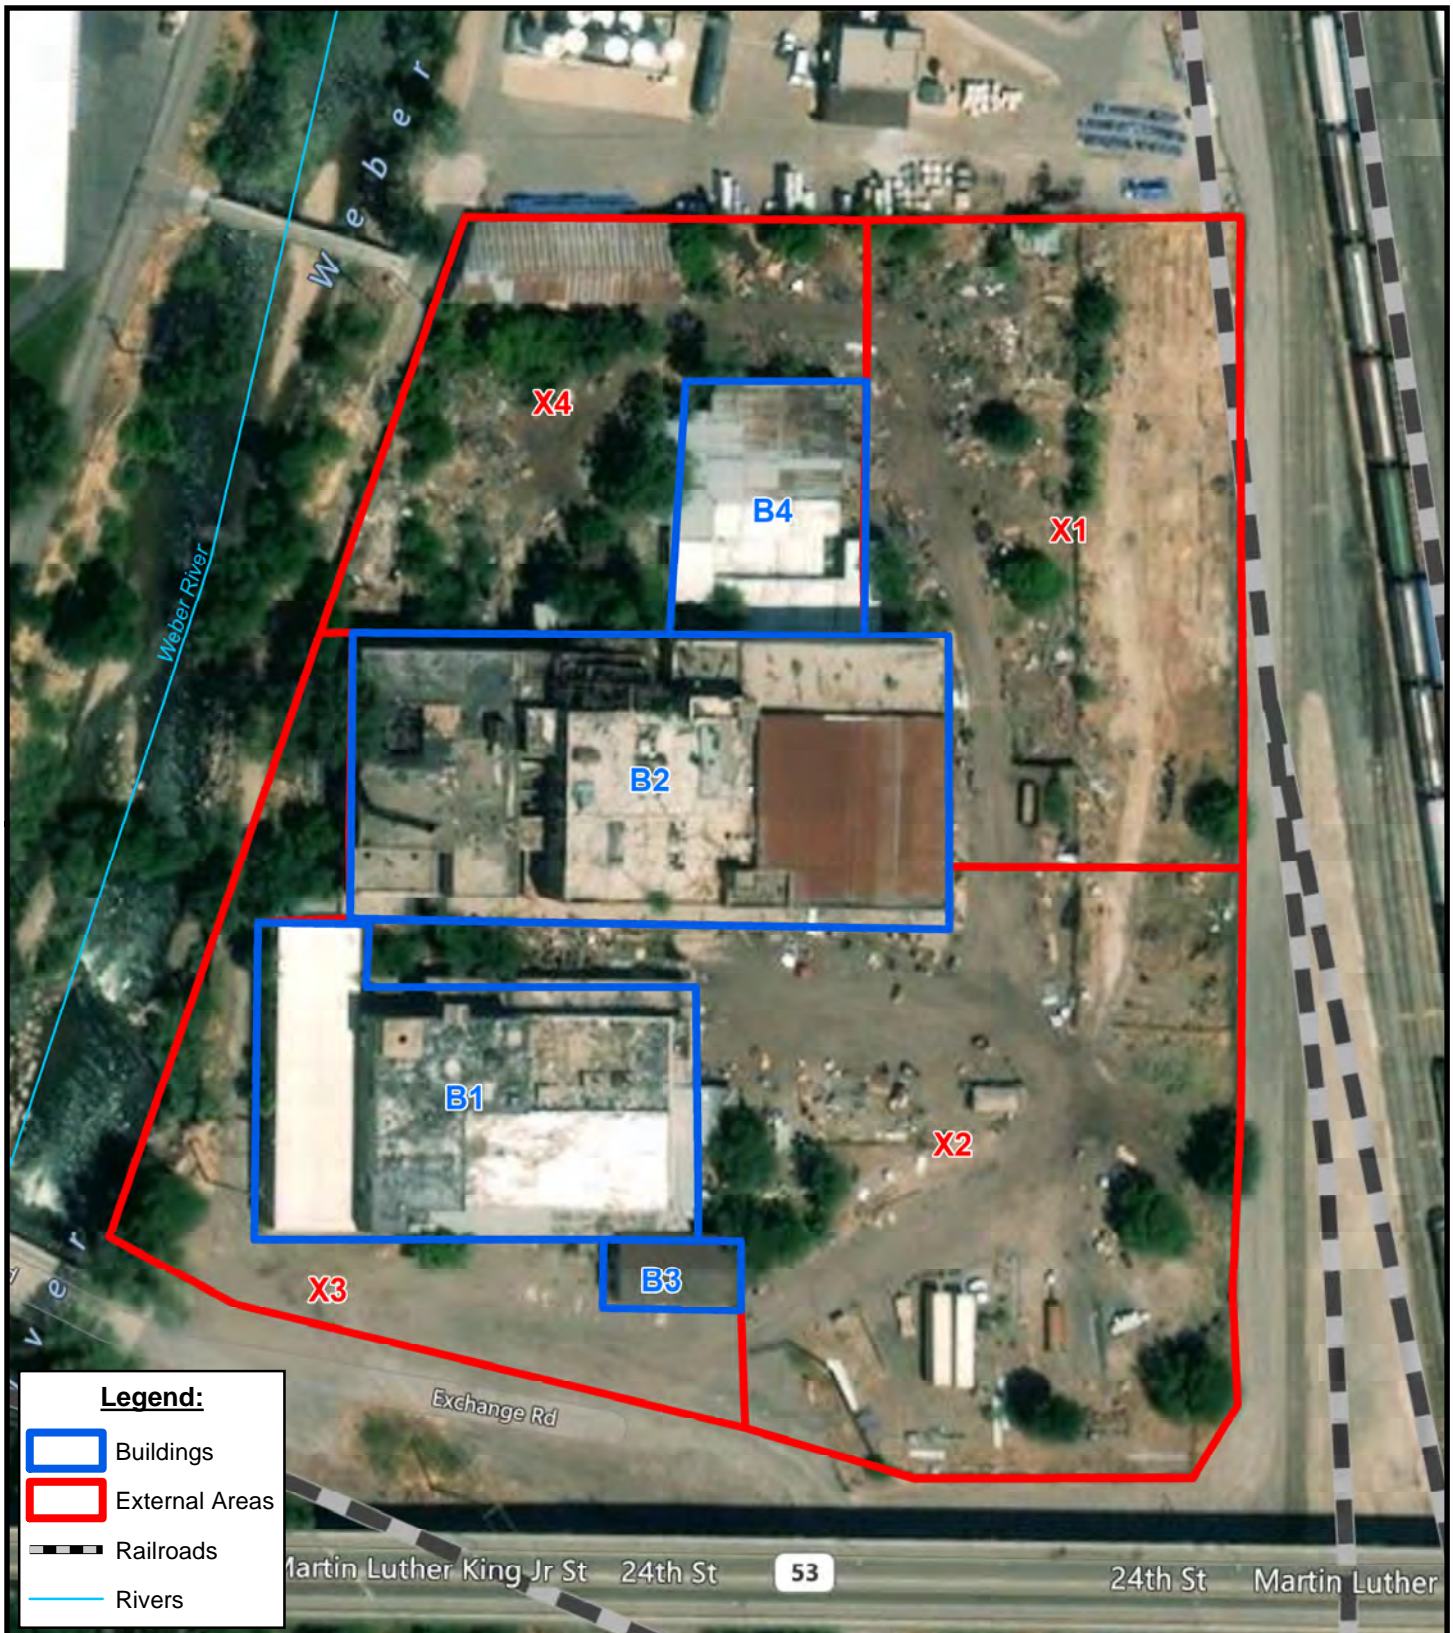
**FIGURE 3**  
**SWIFT BUILDING INVENTORY ZONES**  
**390 EXCHANGE RD, OGDEN**  
**WEBER COUNTY, UTAH**

Due to the ongoing evaluation and refinement of the SOO, changes can occur to the approved SAP based upon site conditions encountered. The only deviation from the approved SAP was the changing of the inventory zones based upon field conditions. The new inventory zones employed at the site are shown in Figure 3.

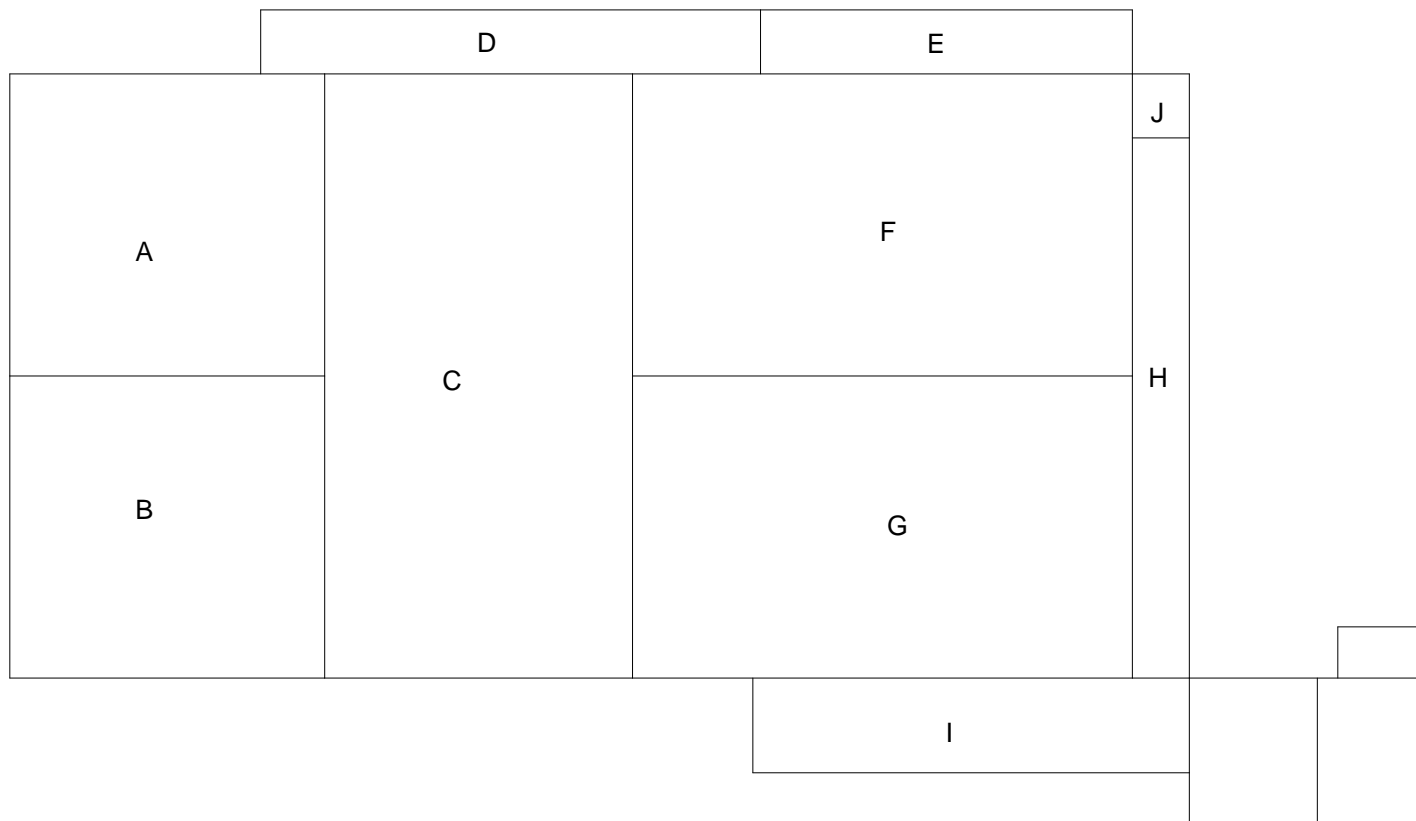
Figure  
4

Note: Rooms in which chemical containers were not observed or could not be accessed, were not assigned room identifiers.

**SWIFT BUILDING SITE FLOOR PLANS  
BUILDING 1, BASEMENT  
HAZARDOUS BUILDING MATERIAL SURVEY**

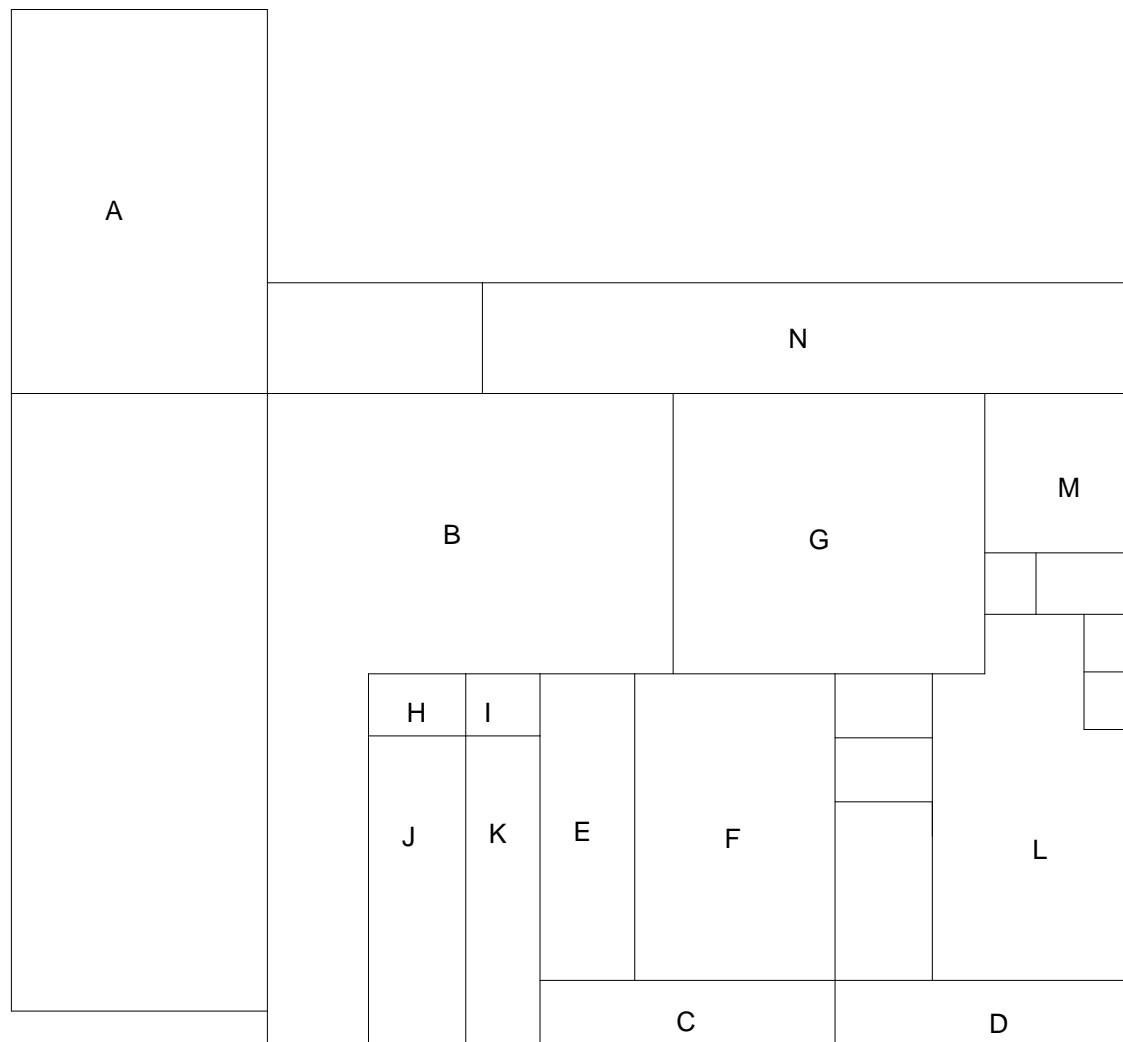
Figure  
5

Note: Rooms in which chemical containers were not observed or could not be accessed, were not assigned room identifiers.

**SWIFT BUILDING SITE FLOOR PLANS  
BUILDING 1, FLOOR 1  
HAZARDOUS BUILDING MATERIAL SURVEY**

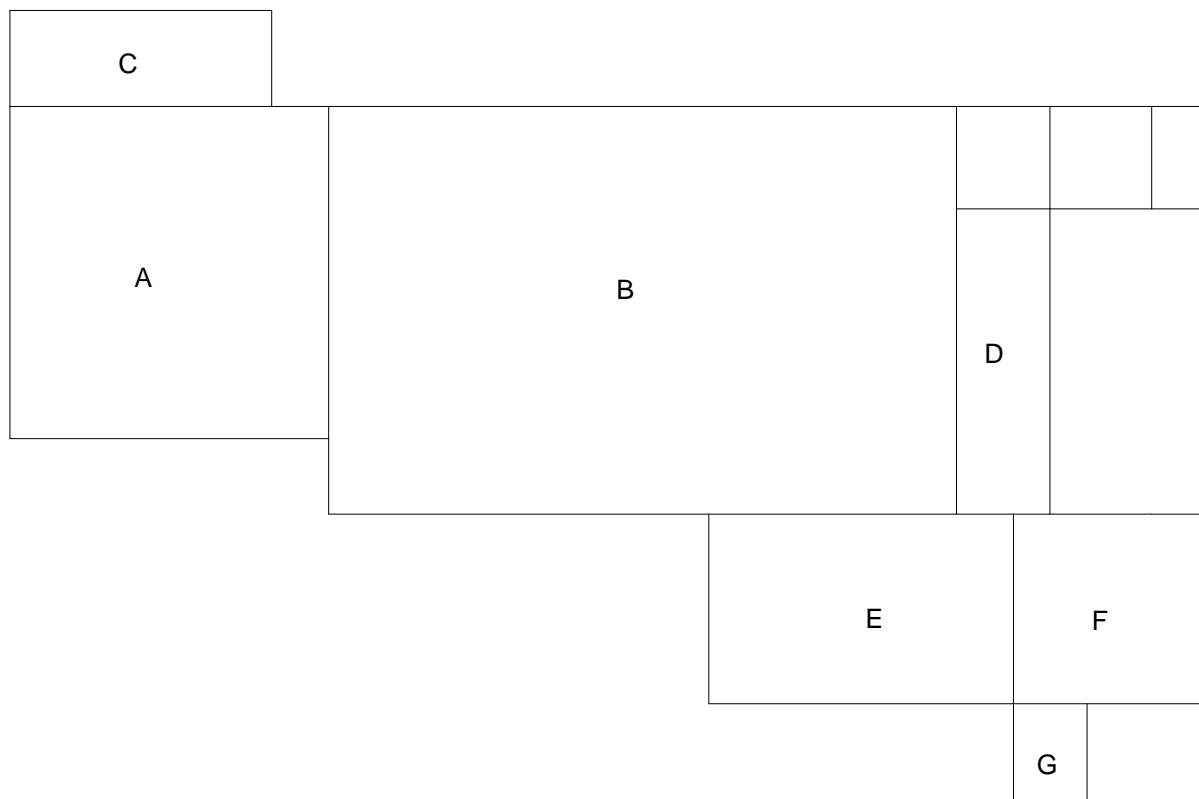
Figure  
6

Note: Rooms in which chemical containers were not observed or could not be accessed, were not assigned room identifiers.

**SWIFT BUILDING SITE FLOOR PLANS  
BUILDING 1, FLOOR 2  
HAZARDOUS BUILDING MATERIAL SURVEY**

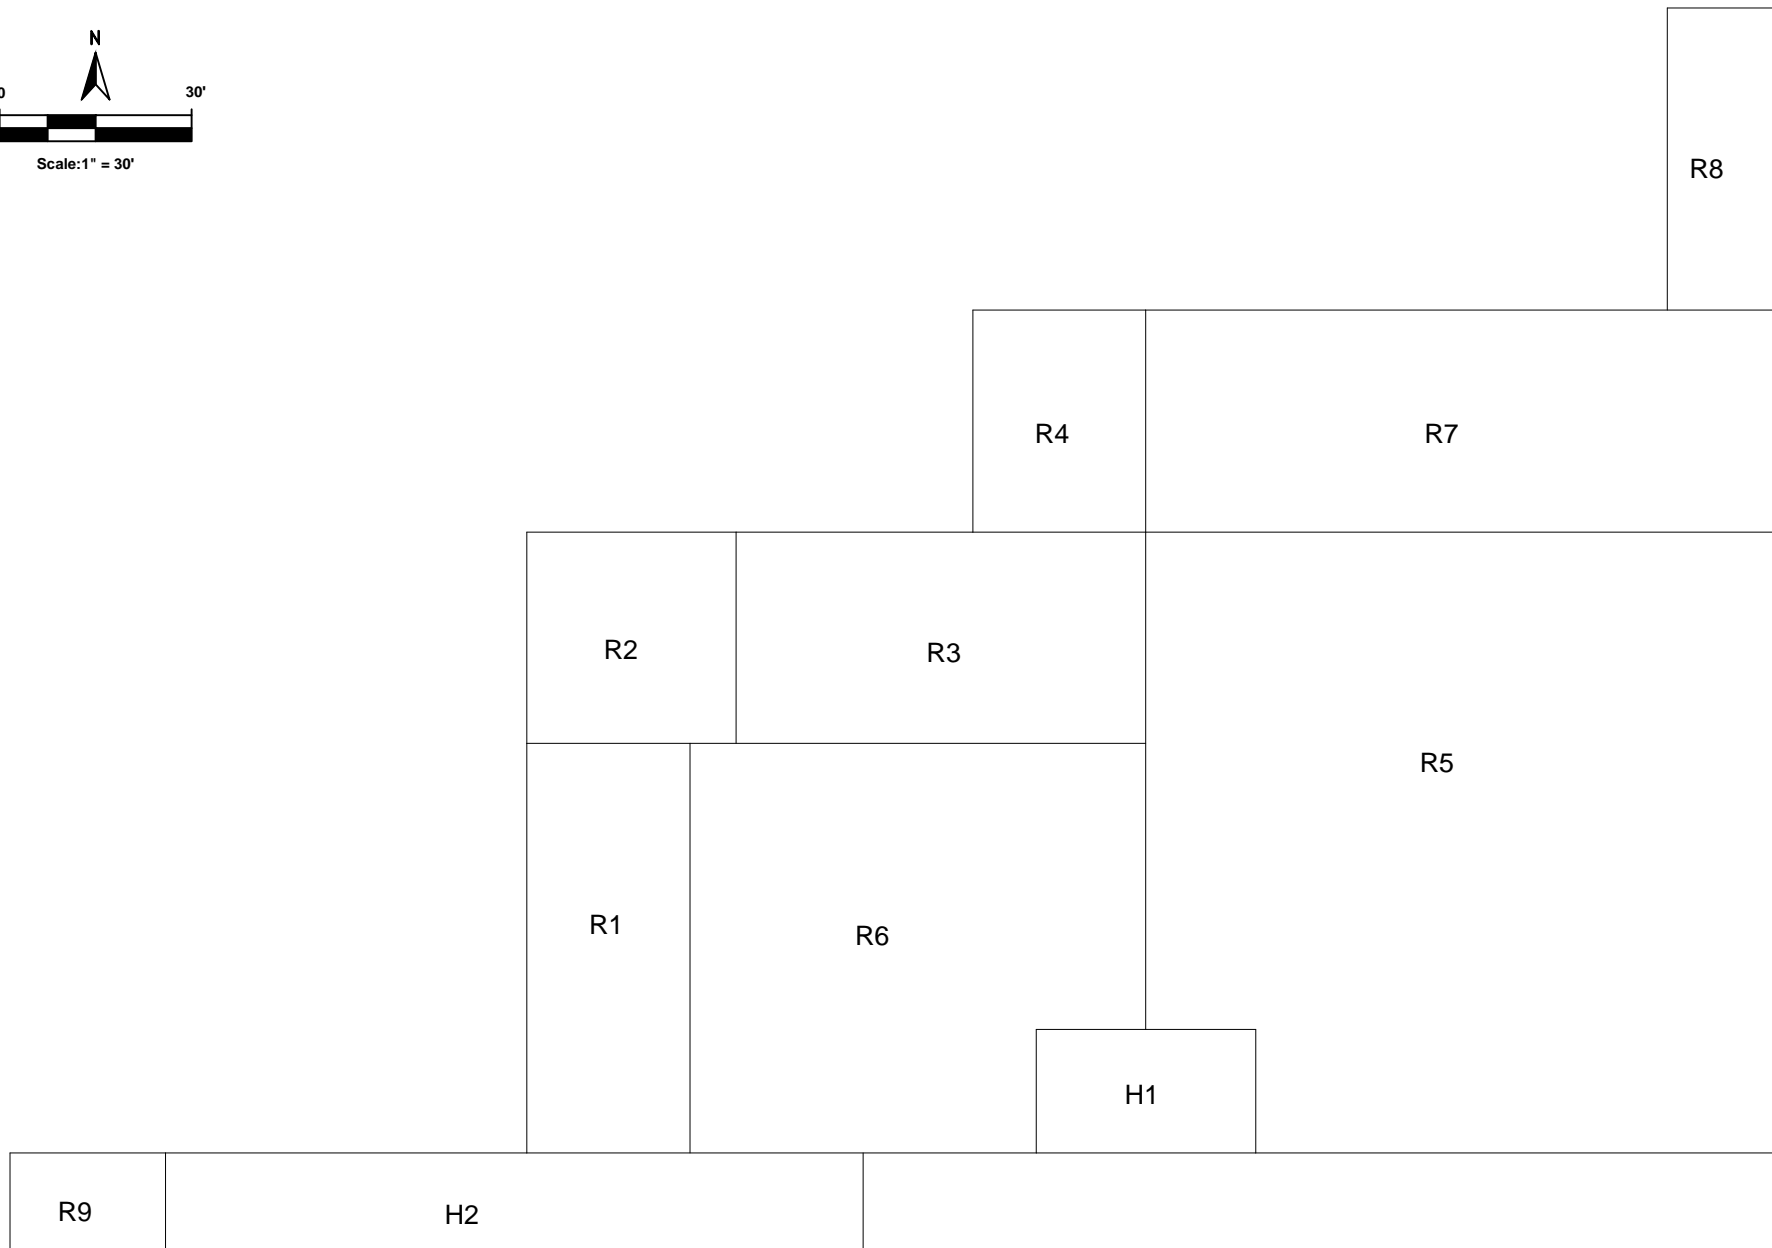
Figure  
8

**SWIFT BUILDING SITE FLOOR PLANS  
BUILDING 2, BASEMENT  
HAZARDOUS BUILDING MATERIAL SURVEY**

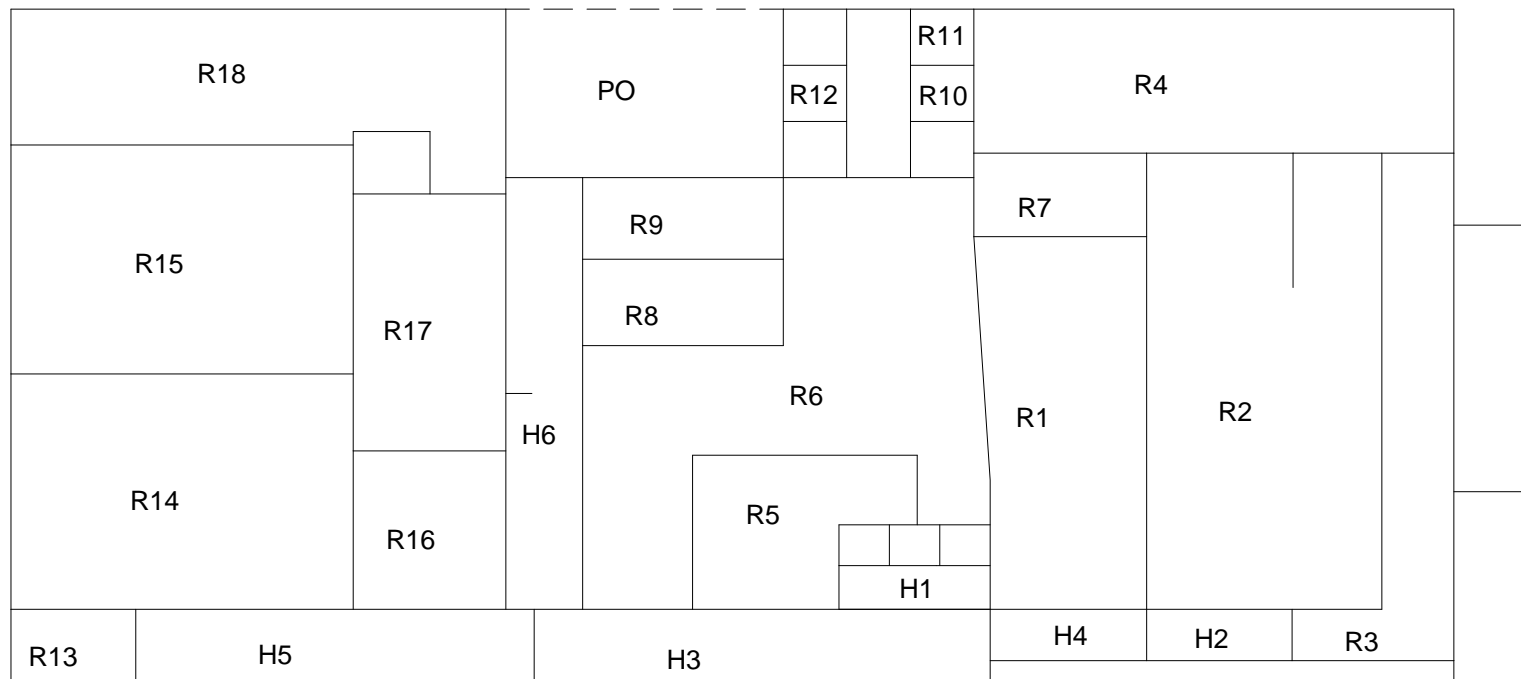
Figure  
9

Note: Rooms in which chemical containers were not observed or could not be accessed, were not assigned room identifiers.

**SWIFT BUILDING SITE FLOOR PLANS  
BUILDING 2, FLOOR 1  
HAZARDOUS BUILDING MATERIAL SURVEY**

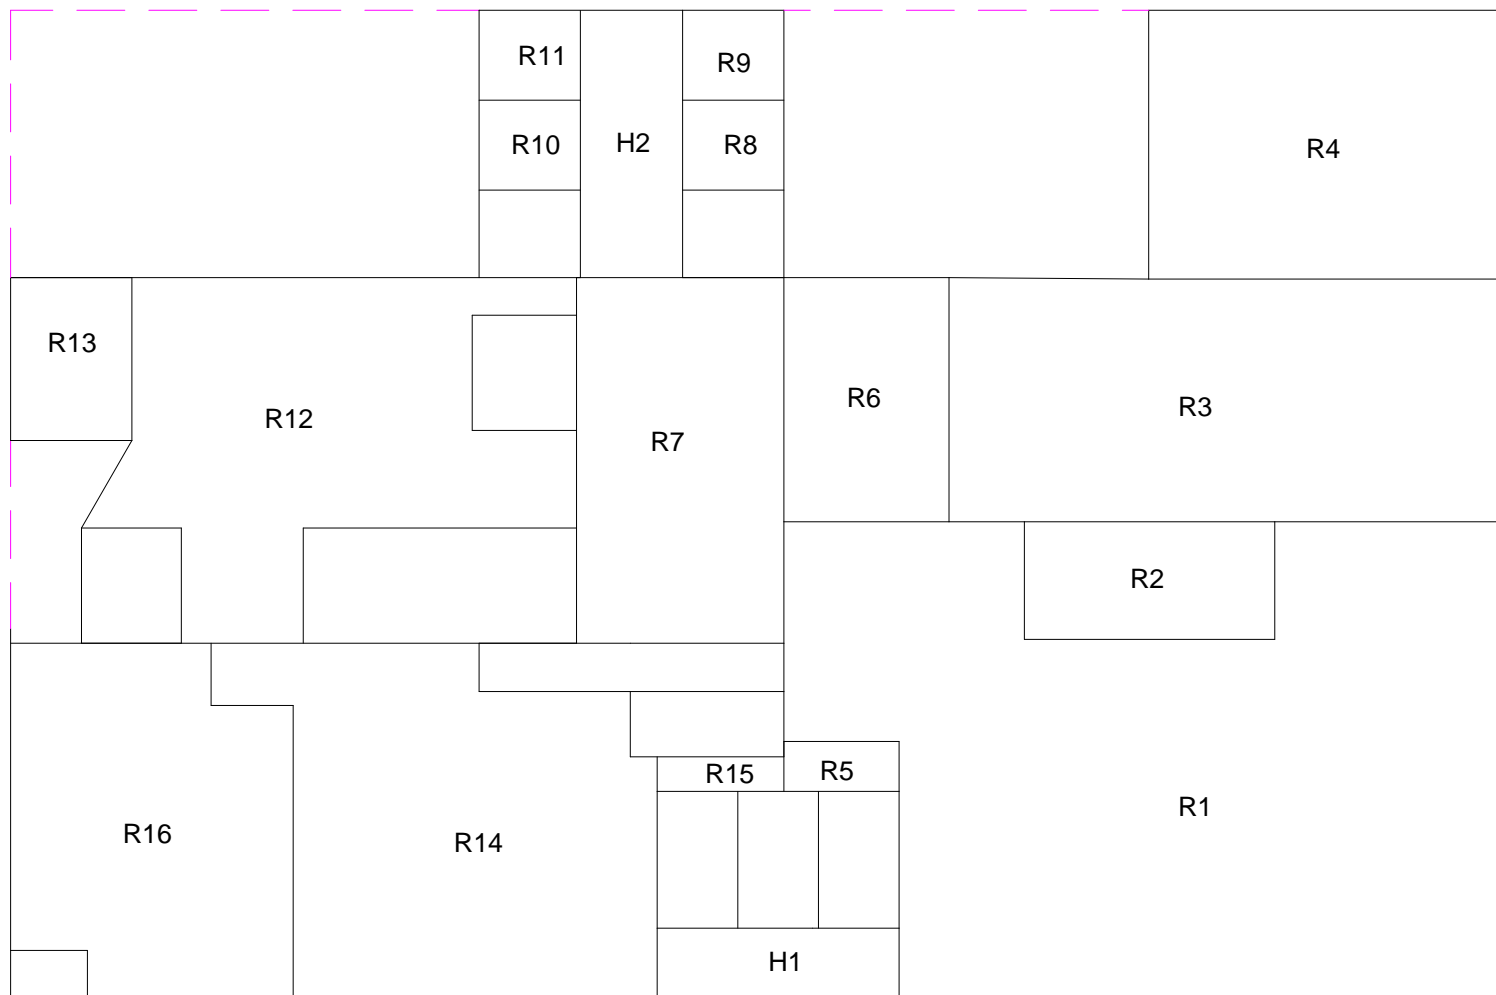
Figure  
10

Note: Rooms in which chemical containers were not observed or could not be accessed, were not assigned room identifiers.

**SWIFT BUILDING SITE FLOOR PLANS  
BUILDING 2, FLOOR 2  
HAZARDOUS BUILDING MATERIAL SURVEY**

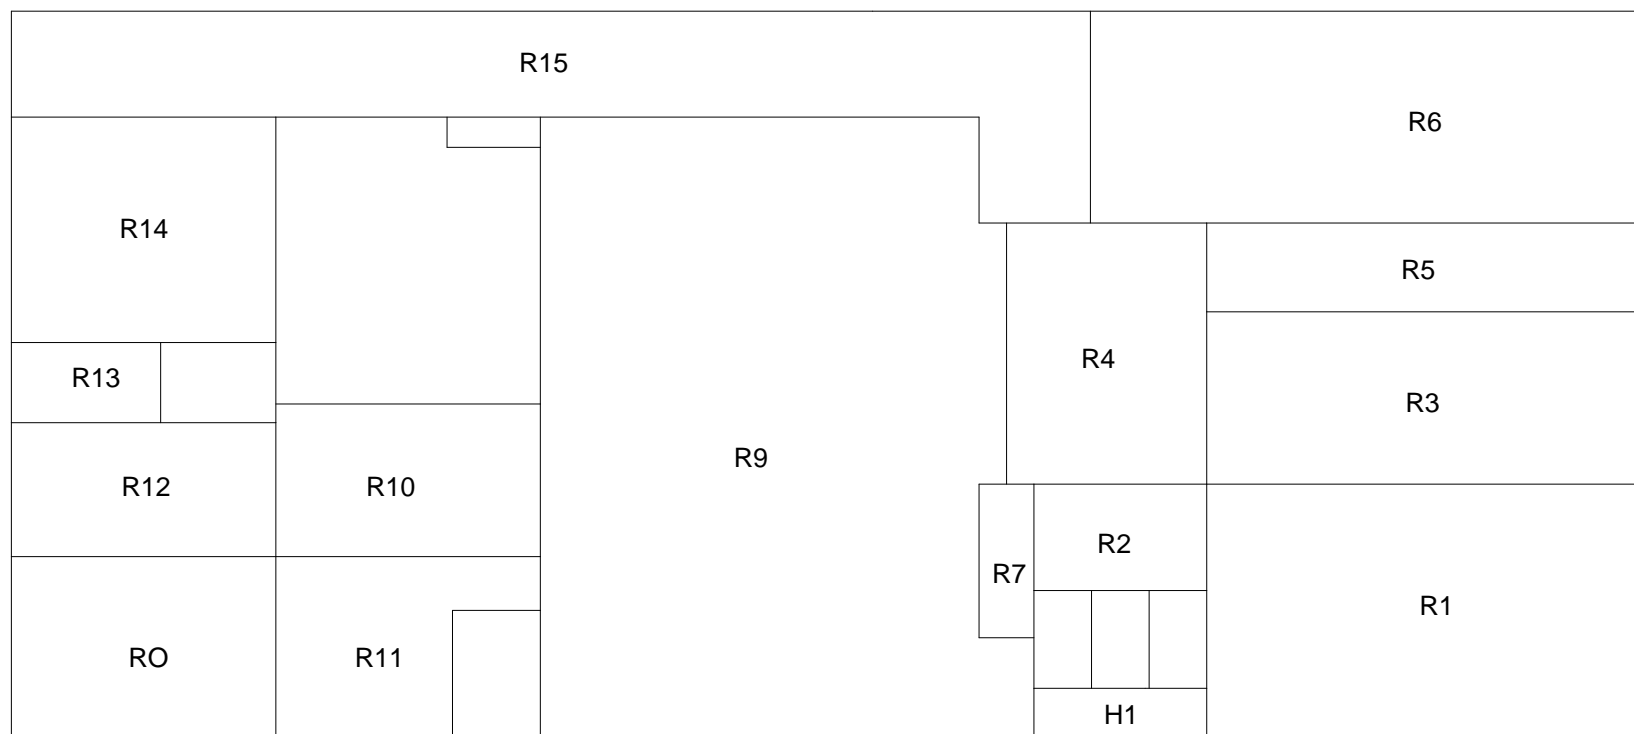
Figure  
11

Note: Rooms in which chemical containers were not observed or could not be accessed, were not assigned room identifiers.

**SWIFT BUILDING SITE FLOOR PLANS  
BUILDING 2, FLOOR 3  
HAZARDOUS BUILDING MATERIAL SURVEY**

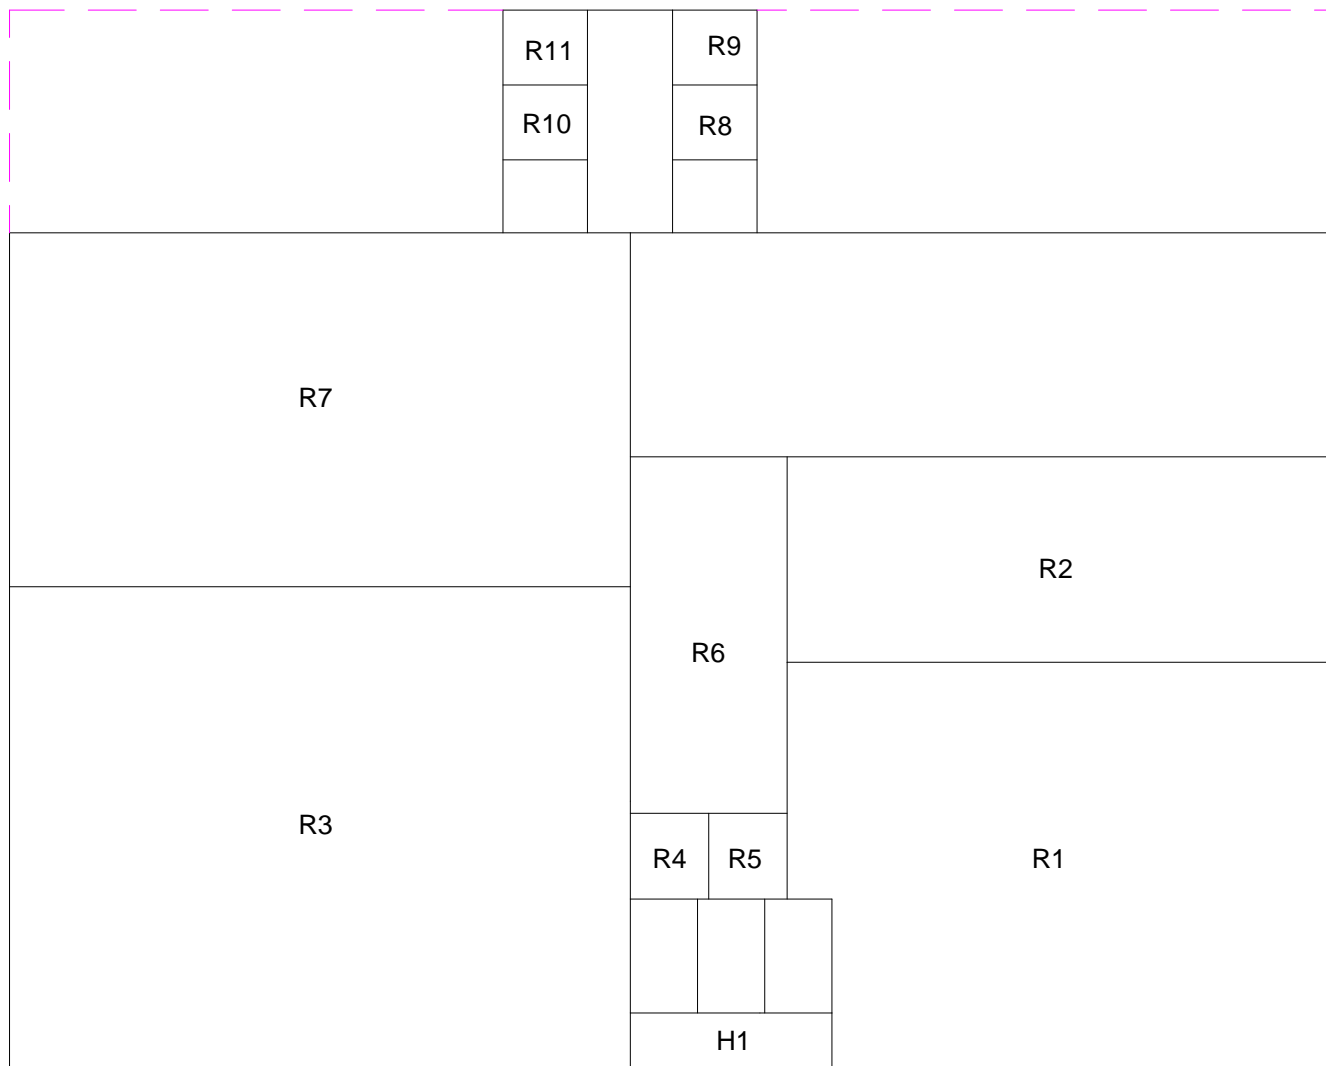
Figure  
12

Note: Rooms in which chemical containers were not observed or could not be accessed, were not assigned room identifiers.

**SWIFT BUILDING SITE FLOOR PLANS  
BUILDING 2, FLOOR 4  
HAZARDOUS BUILDING MATERIAL SURVEY**

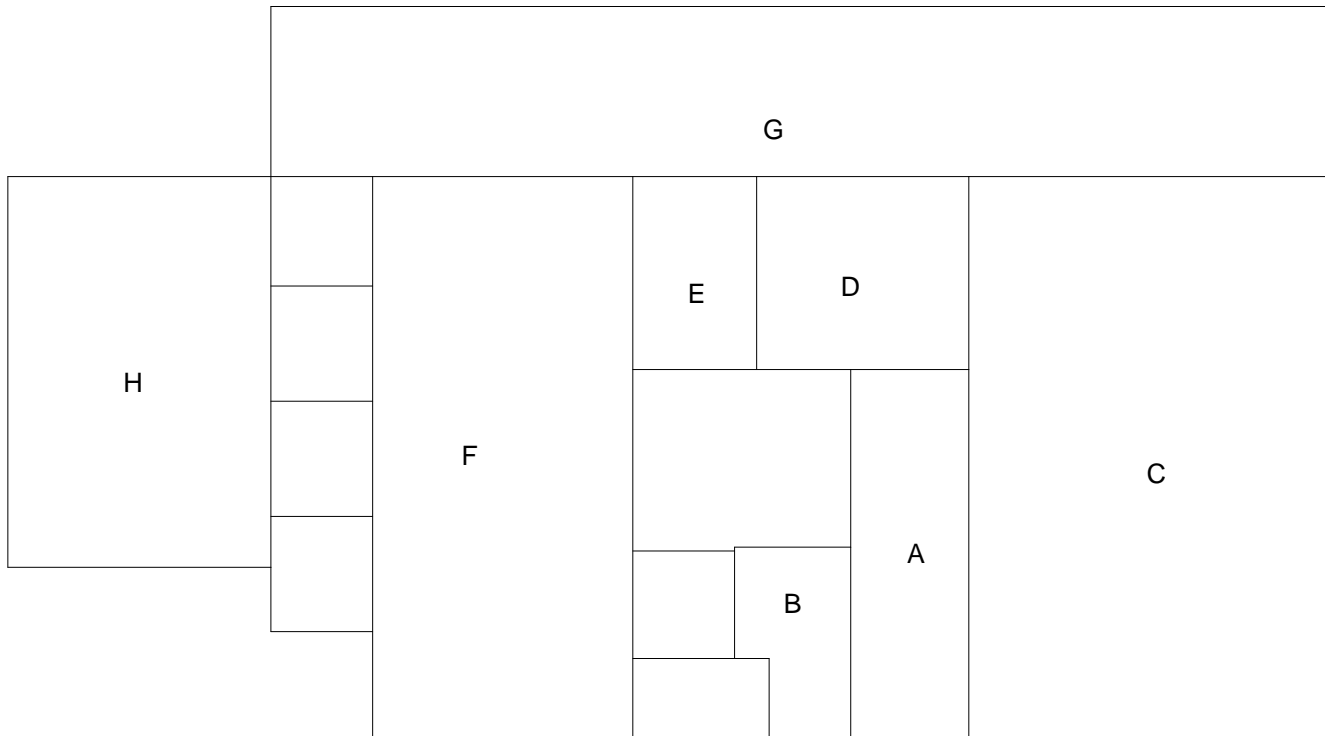
Figure  
15

Note: Rooms in which chemical containers were not observed or could not be accessed, were not assigned room identifiers.

**SWIFT BUILDING SITE FLOOR PLANS  
BUILDING 4  
HAZARDOUS BUILDING MATERIAL SURVEY**

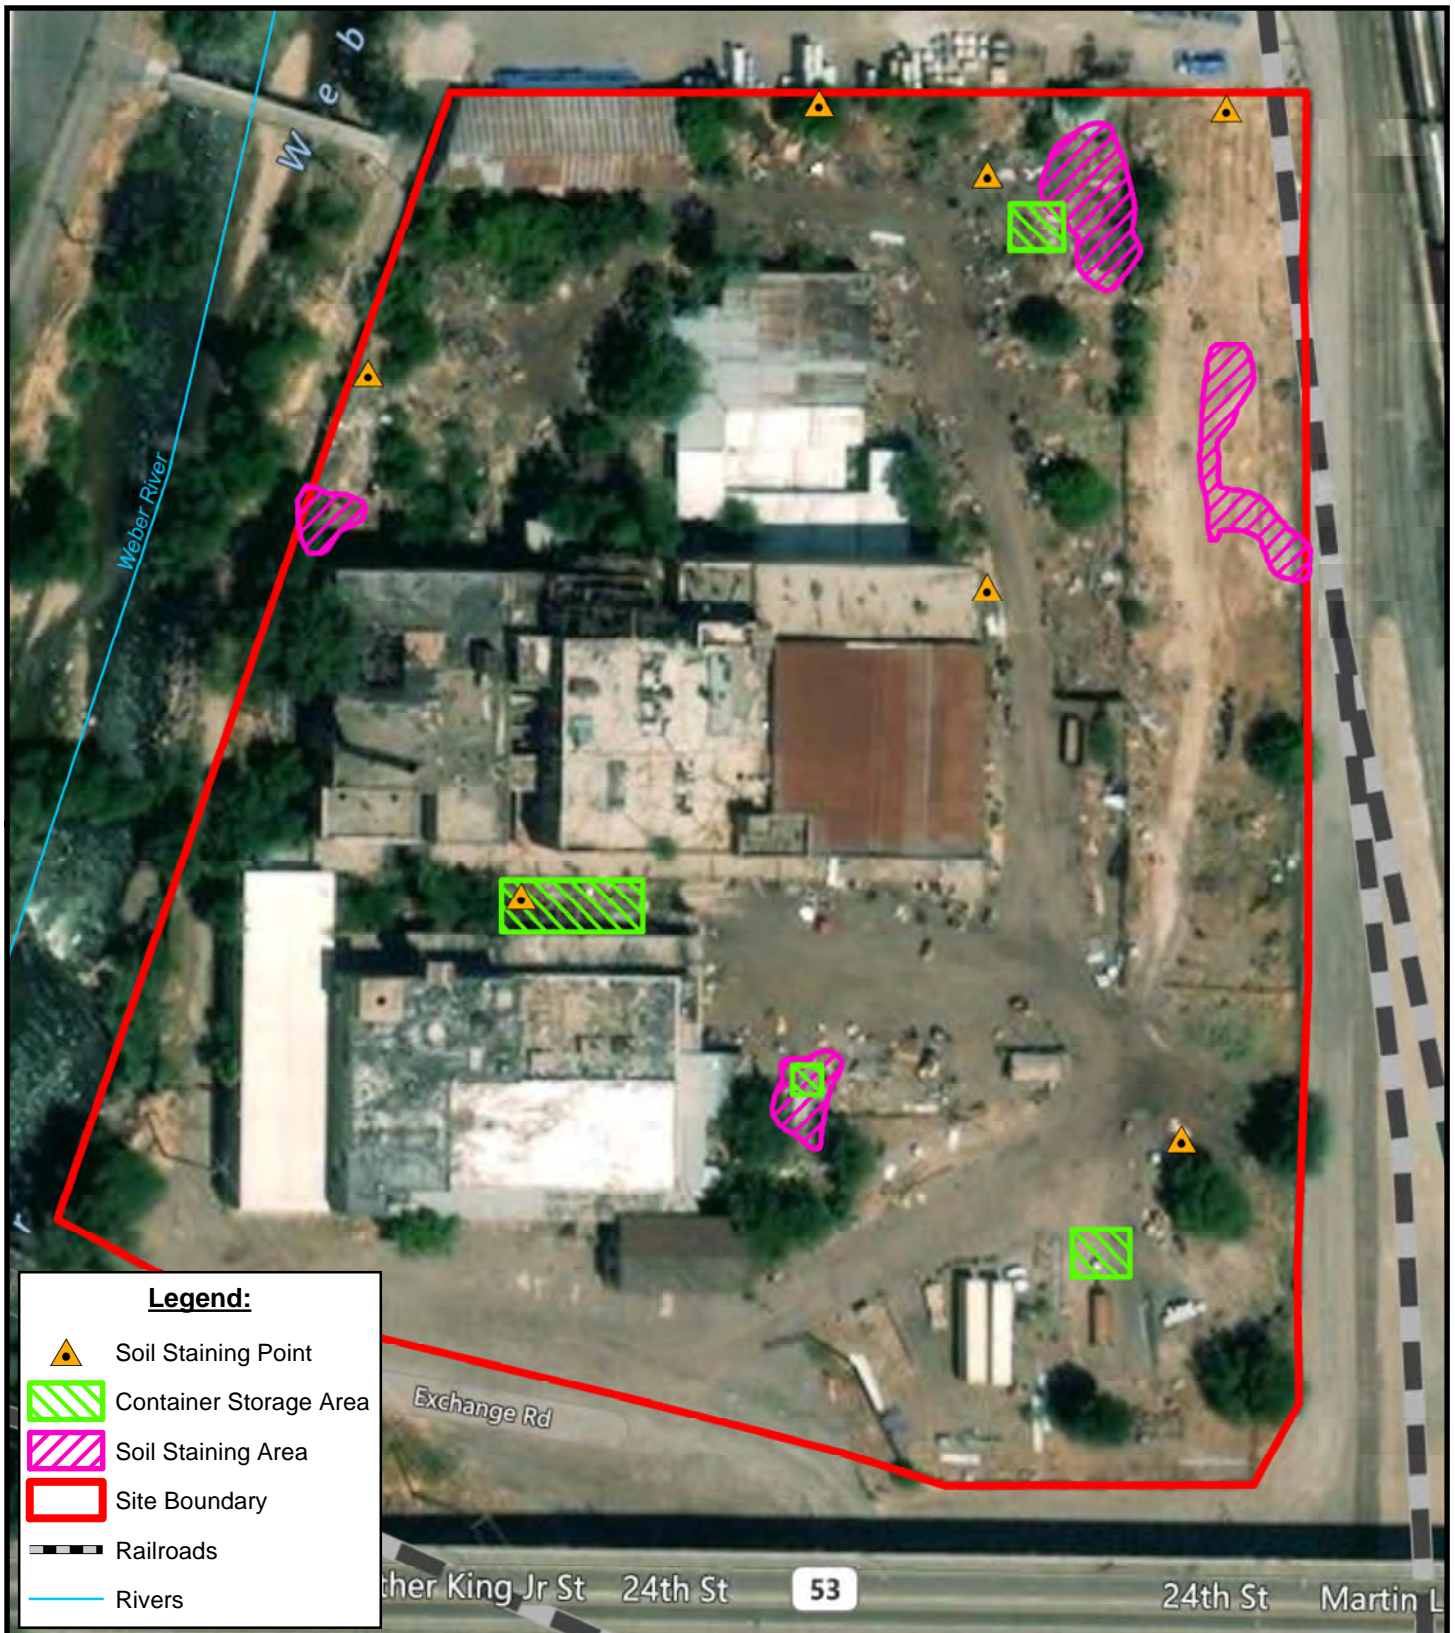
**FIGURE 16**  
**SOIL STAINING AND CONTAINER LOCATIONS**  
**SWIFT BUILDING**  
**390 EXCHANGE RD, OGDEN**  
**WEBER COUNTY, UTAH**

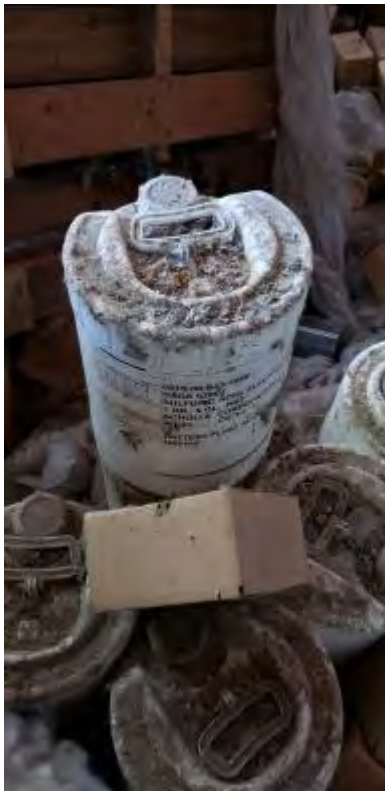
<b>Photo No.</b> <b>1</b>	<b>Date:</b> 10/17/2018												
<b>Photo Coordinates</b>													
<b>Lat</b>	41.223885												
<b>Long</b>	-111.987609												
<b>Direction Photo Taken:</b>													
<b>Description:</b>  Sulfuric Acid 5-gal containers in Building 1

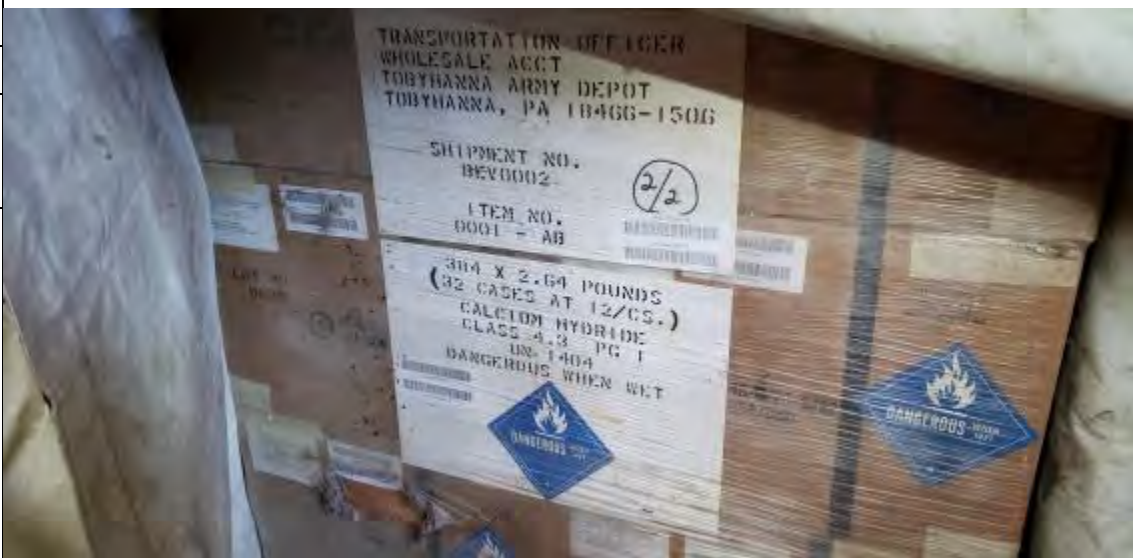
<b>Photo No.</b> <b>2</b>	<b>Date:</b> 10/17/2018												
<b>Photo Coordinates</b>													
<b>Lat</b>	41.223937												
<b>Long</b>	-111.987736												
<b>Direction Photo Taken:</b>													
<b>Description:</b>  Calcium Hydride (Dangerous When Wet) storage in Building 1.

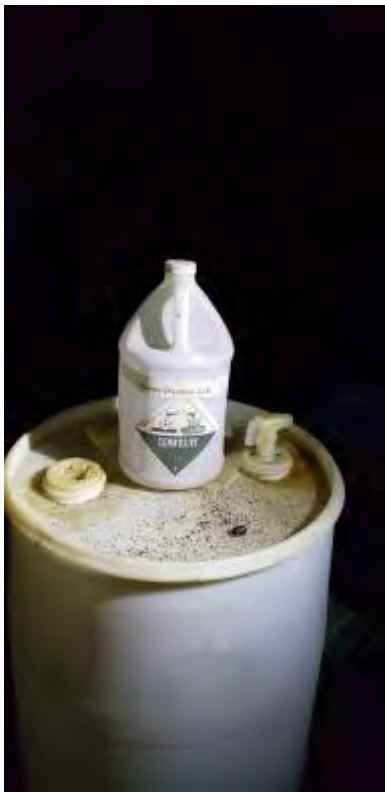
<b>Photo No.</b> <b>5</b>	<b>Date:</b> 10/17/2018												
<b>Photo Coordinates</b>													
<b>Lat</b>	41.225377												
<b>Long</b>	-111.971811												
<b>Direction Photo Taken:</b>													
<b>Description:</b>  Hydroflouric Acid container in Building 1

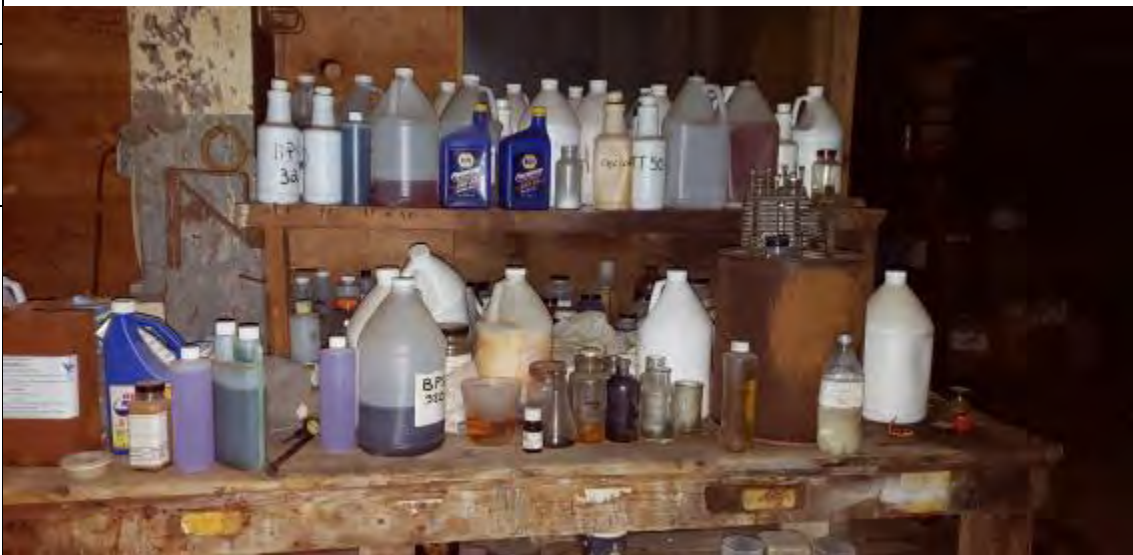
<b>Photo No.</b> <b>6</b>	<b>Date:</b> 10/17/2018												
<b>Photo Coordinates</b>													
<b>Lat</b>	41.225377												
<b>Long</b>	-111.971811												
<b>Direction Photo Taken:</b>													
<b>Description:</b>  Chemical storage with hand-written labels in Building 1.

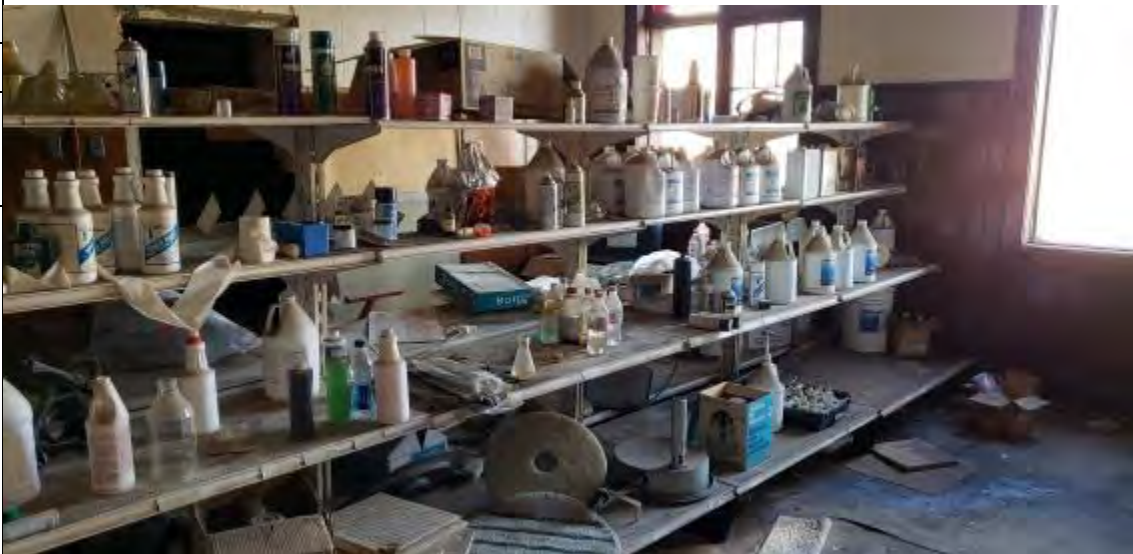
<table border="1"> <tr> <td><b>Photo No.</b> <b>9</b></td><td><b>Date:</b> 10/17/2018</td></tr> <tr> <td colspan="2"><b>Photo Coordinates</b></td></tr> <tr> <td><b>Lat</b></td><td>41.22354</td></tr> <tr> <td><b>Long</b></td><td>-111.986829</td></tr> <tr> <td colspan="2"><b>Direction Photo Taken:</b></td></tr> <tr> <td colspan="2"><b>Description:</b>  Chemical storage in Building 3.</td></tr> </table>	<b>Photo No.</b> <b>9</b>	<b>Date:</b> 10/17/2018	<b>Photo Coordinates</b>		<b>Lat</b>	41.22354	<b>Long</b>	-111.986829	<b>Direction Photo Taken:</b>		<b>Description:</b>  Chemical storage in Building 3.

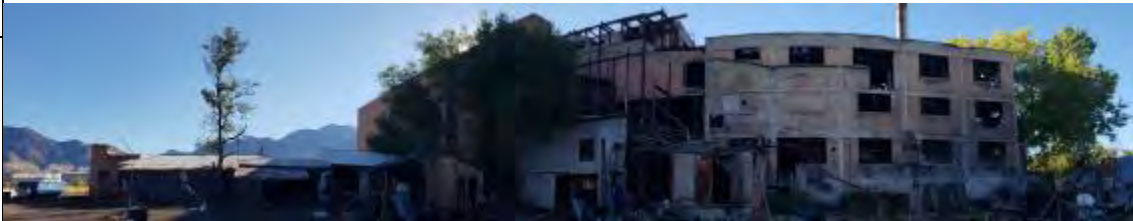
<b>Photo No.</b> <b>10</b>	<b>Date:</b> 10/18/2018												
<b>Photo Coordinates</b>													
<b>Lat</b>	41.224444												
<b>Long</b>	-111.987222												
<b>Direction Photo Taken:</b>  South													
<b>Description:</b>  North side of Building 2. Fire damage on right (West) side of building.

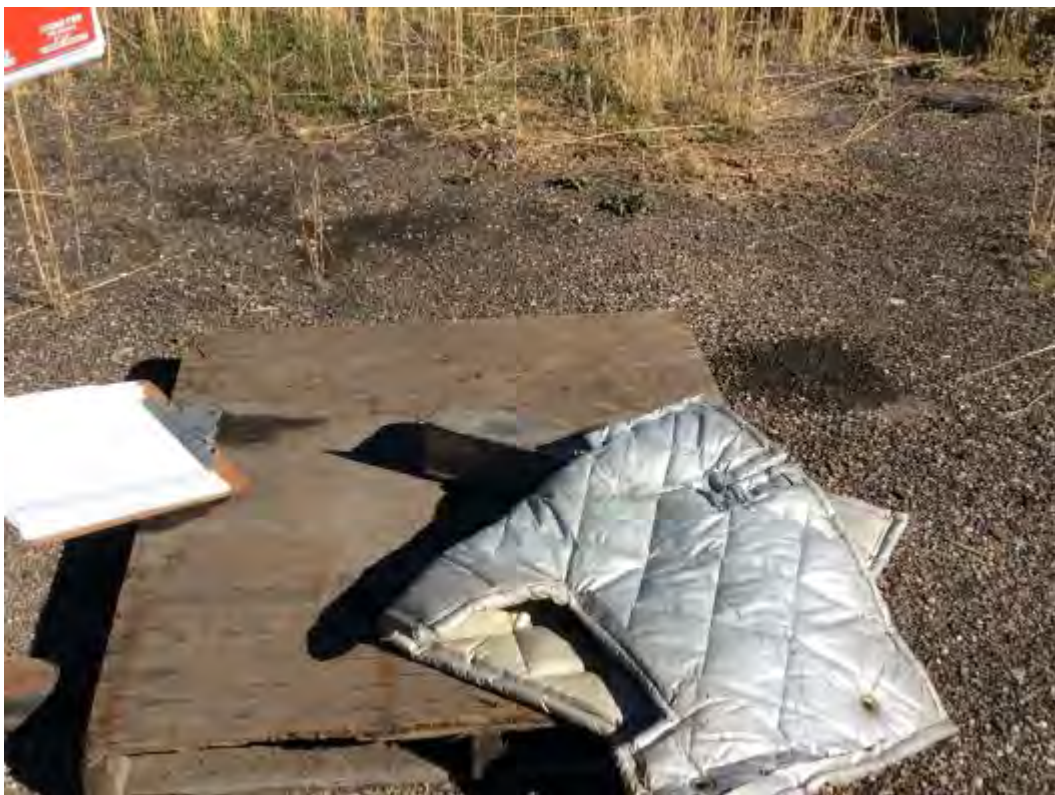
Photo Coordinates			
Lat	41.224728		
Long	-111.986389		
Direction Photo Taken:			
Description:  Cesium-137 source.

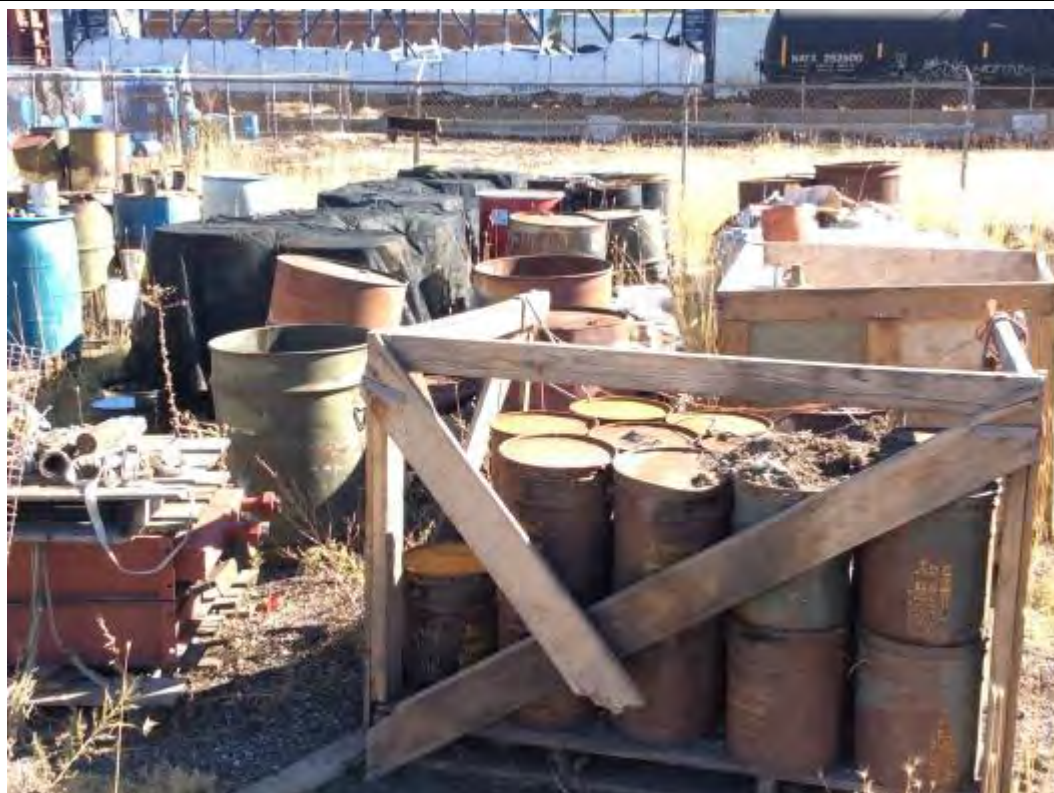
<b>Photo No.</b> <b>17</b>	<b>Date:</b> 10/16/2018
<b>Photo Coordinates</b>	
<b>Lat</b>	41.224781
<b>Long</b>	-111.986267
<b>Direction Photo Taken:</b>	
<b>Description:</b>  Drum storage in zone SB-X1.

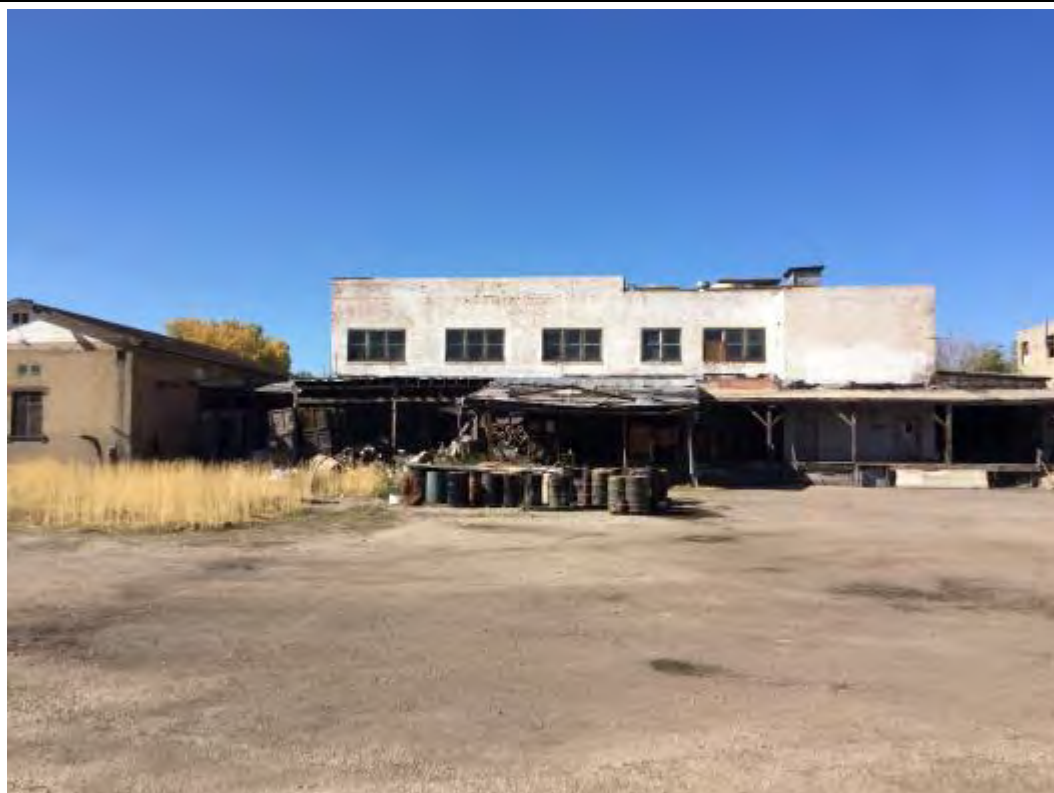
<b>Photo No.</b> <b>20</b>	<b>Date:</b> 10/16/2018
<b>Photo Coordinates</b>	
<b>Lat</b>	41.223647
<b>Long</b>	-111.986717
<b>Direction Photo Taken:</b>	
<b>Description:</b>  Drum storage and surface soil stain in zone SB-X2.
