**LIMITED PHASE II ENVIRONMENTAL SITE ASSESSMENT  
FOR  
SWIFT BUILDING  
390 WEST EXCHANGE ROAD  
OGDEN, UT 84401**

Date Prepared	December 2018
TDD No.	0003/1807-05
Document Control No.	W0620.1A.01842
Contract No.	EP-S8-13-01
U.S. EPA Work Assignment Manager	Christina Wilson

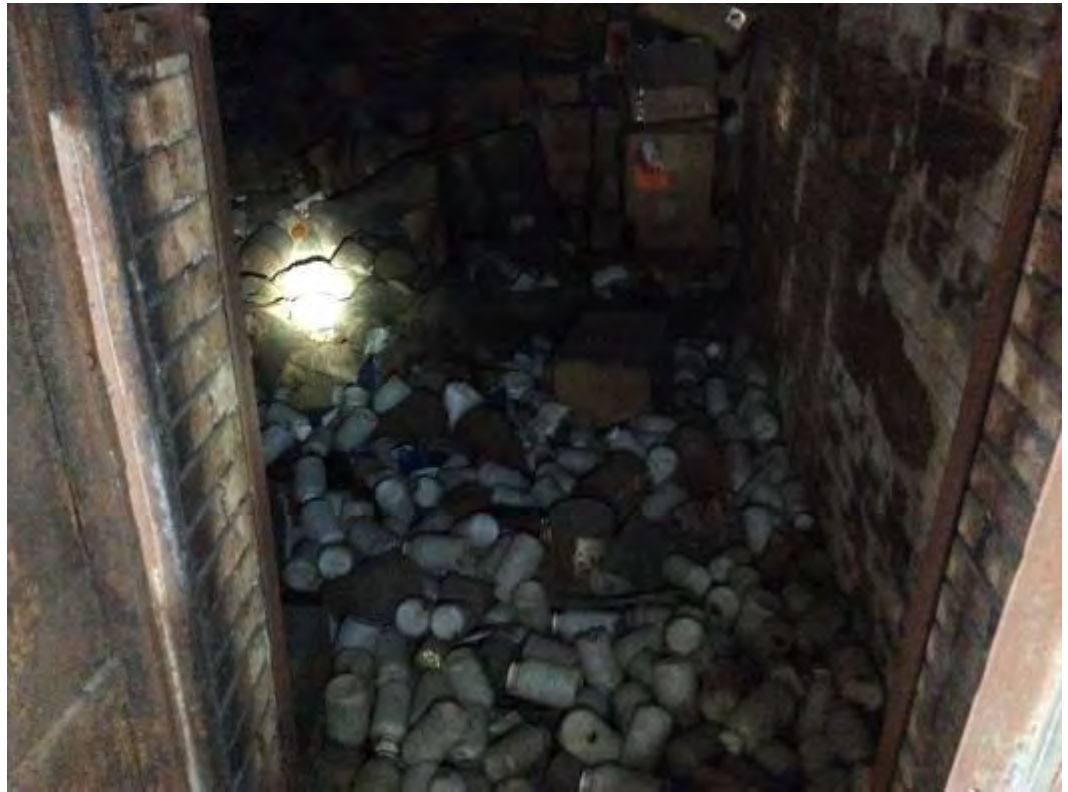
<b>Photo No.</b> <b>24</b>	<b>Date:</b> 10/17/2018
<b>Photo Coordinates</b>	
<b>Lat</b>	41.225114
<b>Long</b>	-111.986756
<b>Direction Photo Taken:</b>	
<b>Description:</b>  Cases of (assumed) ammonium hydroxide.

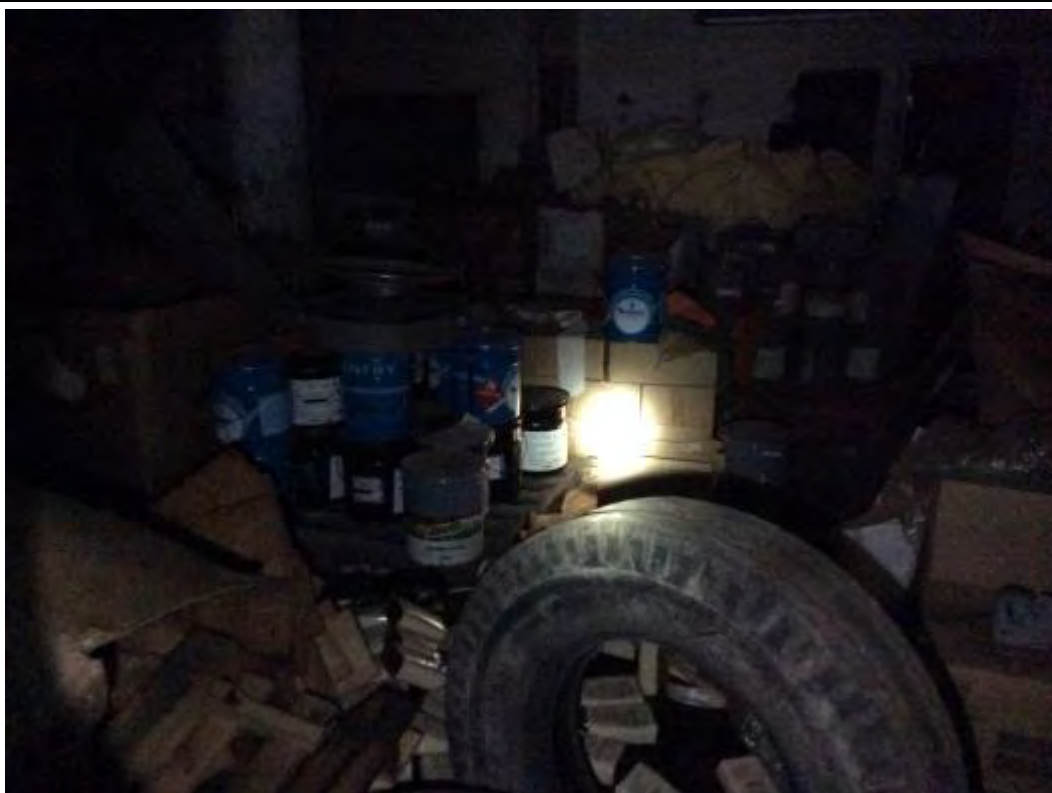
<b>Photo No.</b> <b>26</b>	<b>Date:</b> 10/18/2018
<b>Photo Coordinates</b>	
<b>Lat</b>	41.223156
<b>Long</b>	-111.985786
<b>Direction Photo Taken:</b>	
<b>Description:</b>  "Explosives" crate observed in Building 2 (SB-B2-F1-R2).

- Based on the chemical container inventory identified at the Site, START recommends contracting an environmental remediation contractor to facilitate the re-packaging, transportation, shipment and disposal of all hazardous materials following all local, state, and federal regulations.

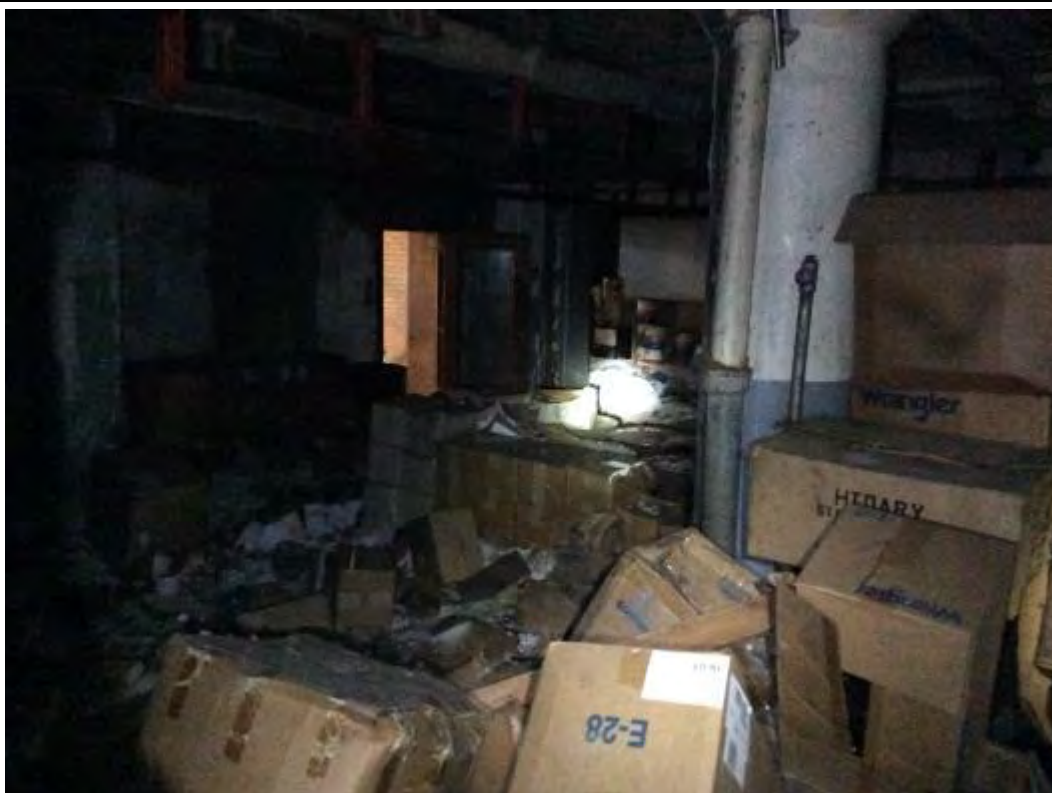
<b>Photo No.</b> <b>28</b>	<b>Date:</b> 10/18/2018
<b>Photo Coordinates</b>	
<b>Lat</b>	41.224364
<b>Long</b>	-111.987672
<b>Direction Photo Taken:</b>	
<b>Description:</b>  Drum storage in SB-B2-F1-R16.

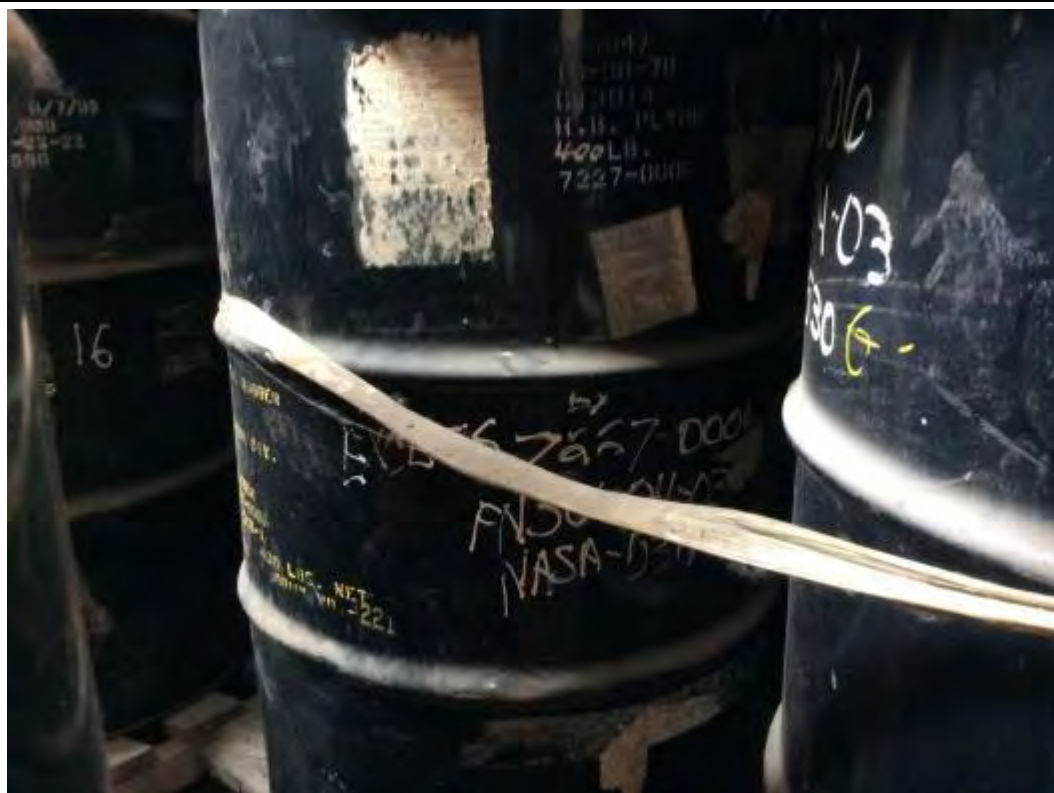
<b>Photo No.</b> <b>33</b>	<b>Date:</b> 10/18/2018
<b>Photo Coordinates</b>	
<b>Lat</b>	41.223889
<b>Long</b>	-111.987464
<b>Direction Photo Taken:</b>	
<b>Description:</b>  Drum storage in SB-B2-F1-R16.

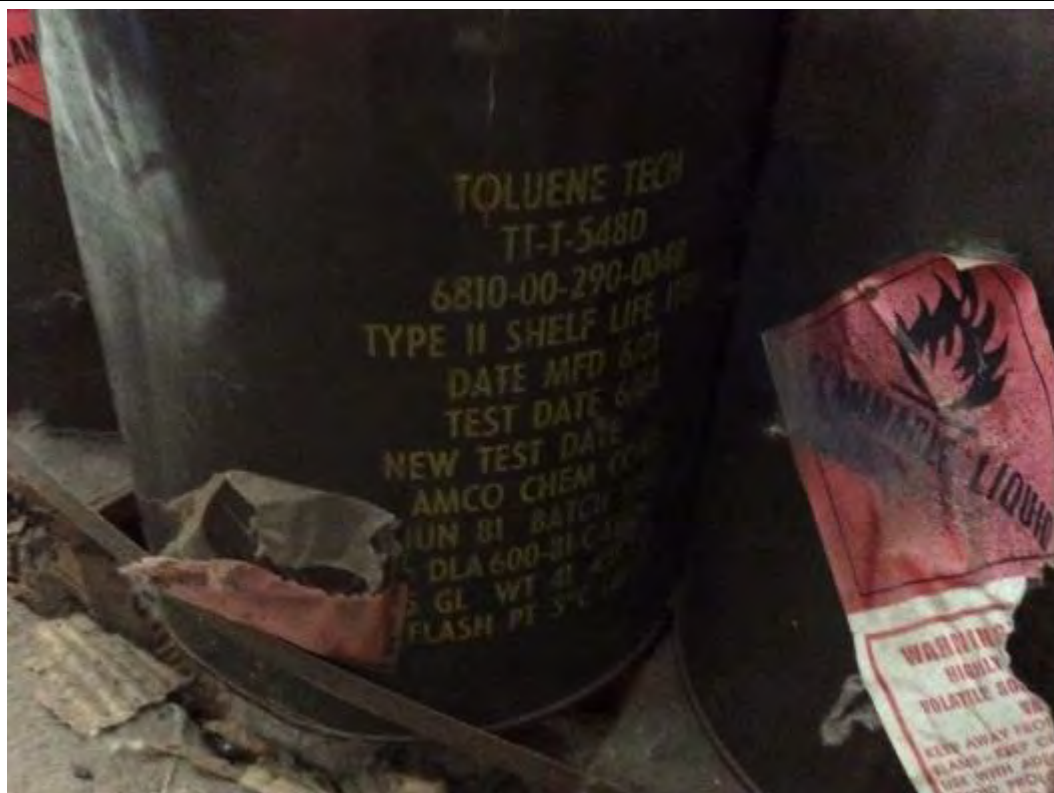
<b>Photo No.</b> <b>34</b>	<b>Date:</b> 10/18/2018
<b>Photo Coordinates</b>	
<b>Lat</b>	41.223881
<b>Long</b>	-111.987397
<b>Direction Photo Taken:</b>	
<b>Description:</b>  Flammable drum storage in SB-B2-F1-R16.

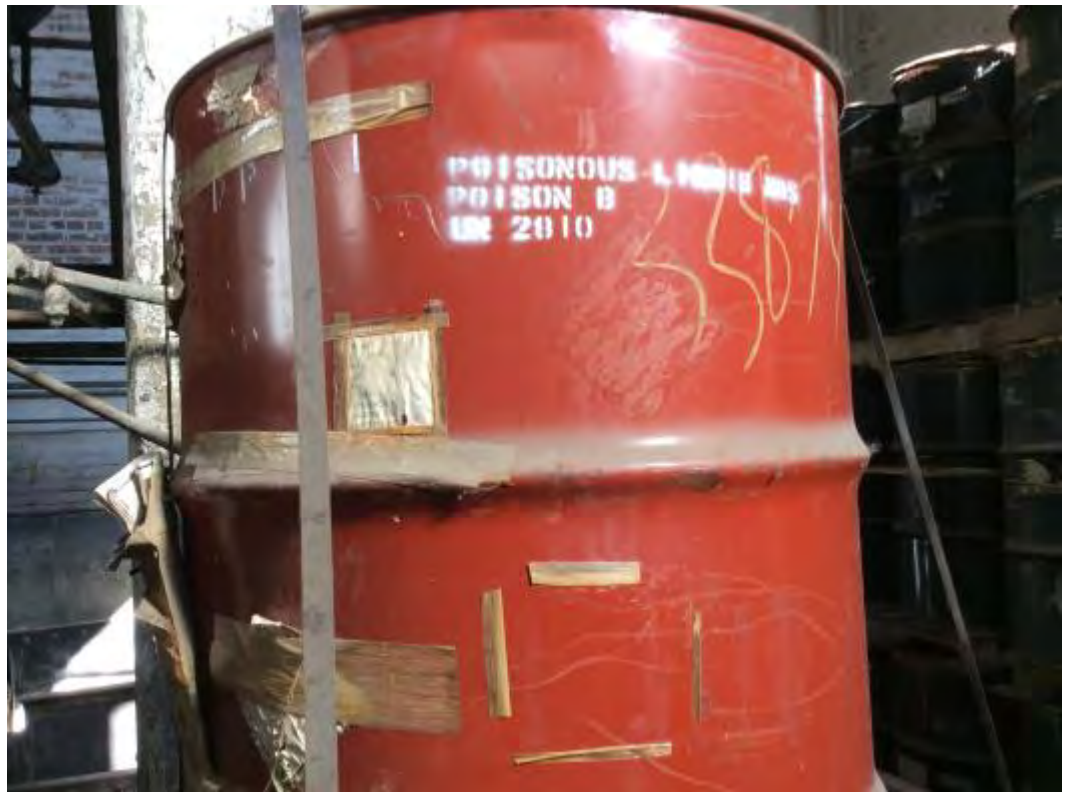
<b>Photo No.</b> <b>36</b>	<b>Date:</b> 10/18/2018
<b>Photo Coordinates</b>	
<b>Lat</b>	41.224389
<b>Long</b>	-111.987397
<b>Direction Photo Taken:</b> East	
<b>Description:</b>  Drum storage in fire damaged area SB-B2-F1-PO.

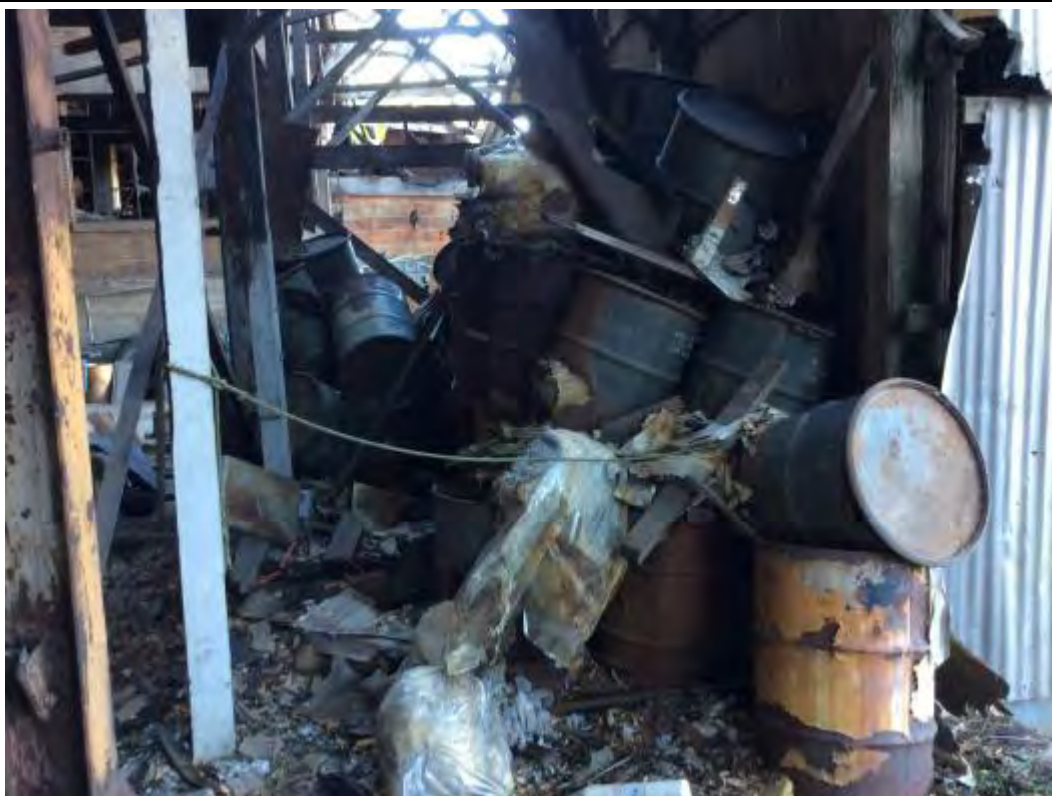
<b>Photo No.</b> <b>38</b>	<b>Date:</b> 10/18/2018
<b>Photo Coordinates</b>	
<b>Lat</b>	41.224381
<b>Long</b>	-111.987153
<b>Direction Photo Taken:</b> South	
<b>Description:</b>  Drum storage in fire damaged area SB-B2-F1-PO.

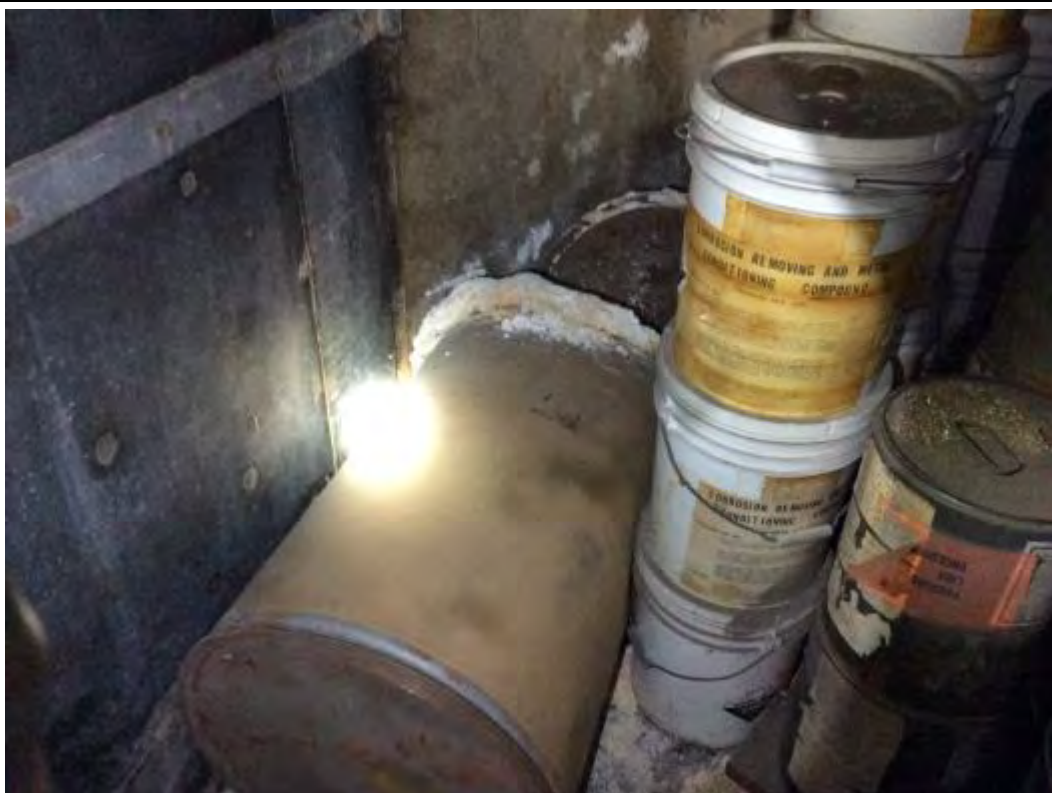
<b>Photo No.</b> <b>40</b>	<b>Date:</b> 10/18/2018
<b>Photo Coordinates</b>	
<b>Lat</b>	41.223094
<b>Long</b>	-111.985825
<b>Direction Photo Taken:</b>	
<b>Description:</b>  Green unknown spill in hazardous waste storage room SB-B2- FB-R1.

- Based on the chemical container inventory activities and air monitoring employed during the inventory activities, a Mercury spill is known in room SB-B2-FB-R1 and other spills may be discovered as removal activities are conducted. Mercury was identified in the basement of Building 2 at 0.036 milligrams per cubic meter ( $\text{mg}/\text{m}^3$ ), which is above the EPA Response Worker Protective Equipment Upgrade action level of  $0.025 \text{ mg}/\text{m}^3$ . Any future site work should address air monitoring and appropriate health and safety requirements. START recommends contracting an environmental remediation contractor to remediate all mercury and other hazardous material spills within the buildings.

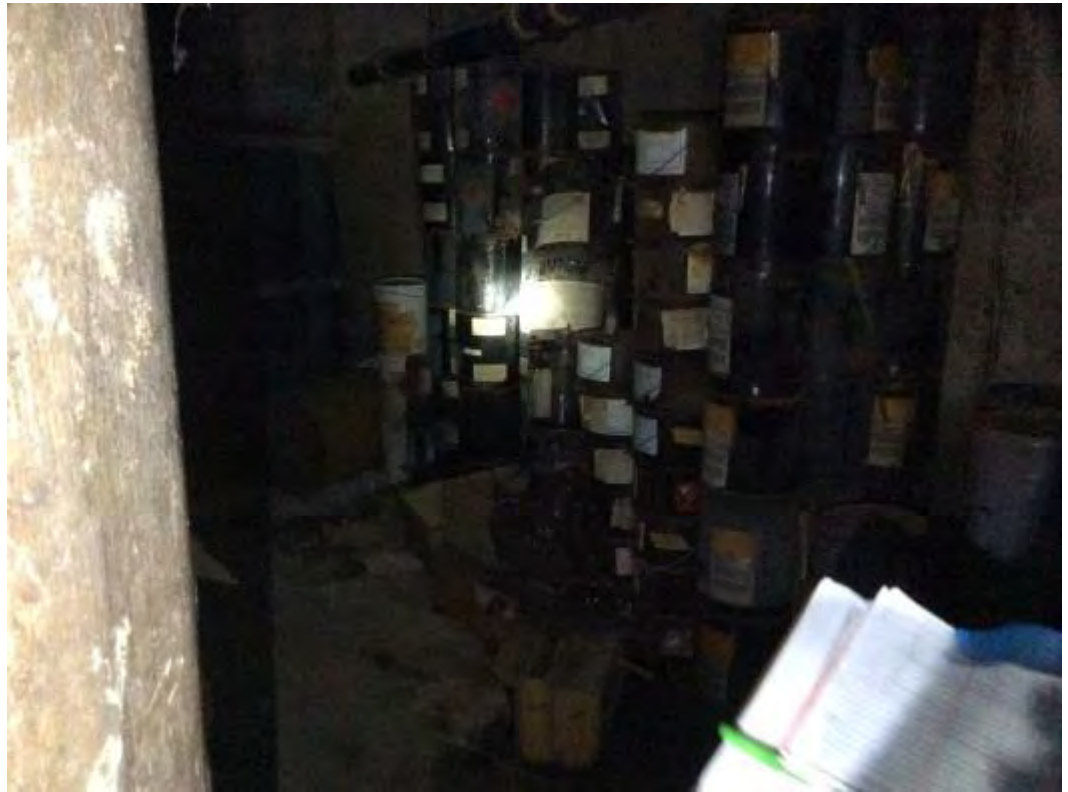
<b>Photo No.</b> <b>42</b>	<b>Date:</b> 10/18/2018
<b>Photo Coordinates</b>	
<b>Lat</b>	41.223094
<b>Long</b>	-111.985825
<b>Direction Photo Taken:</b>	
<b>Description:</b>  Chemical storage in hazardous waste storage room SB-B2-FB-R1.

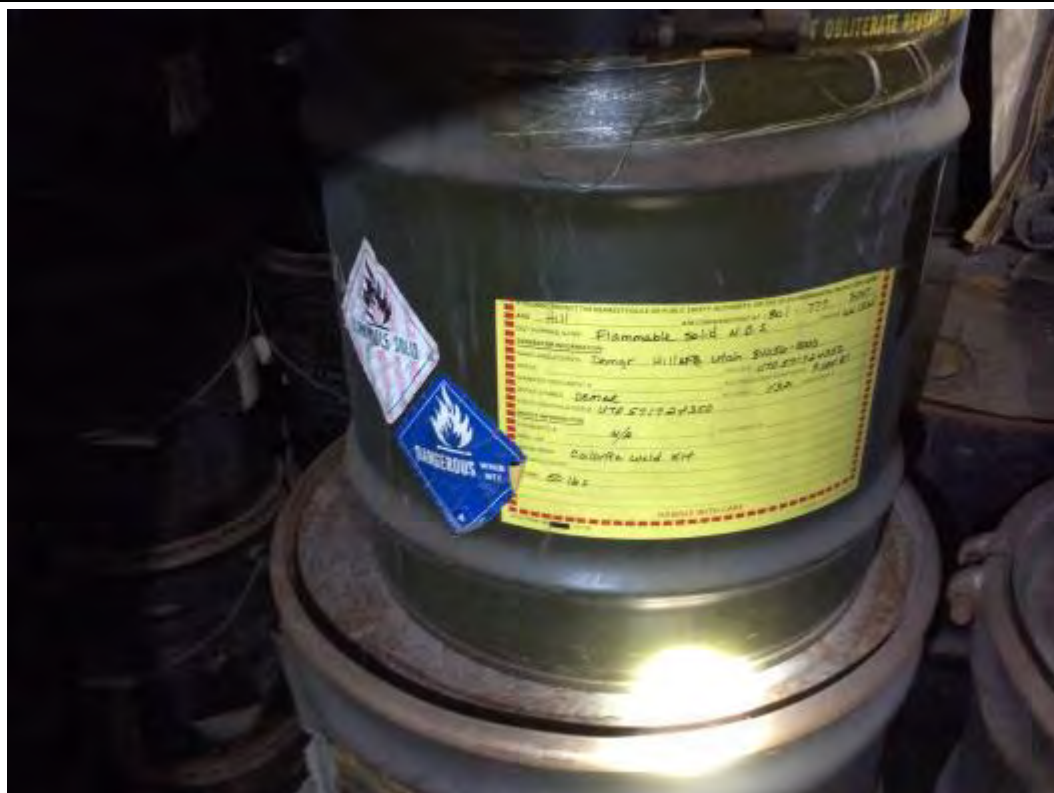
<b>Photo No.</b> <b>44</b>	<b>Date:</b> 10/18/2018
<b>Photo Coordinates</b>	
<b>Lat</b>	41.223094
<b>Long</b>	-111.985825
<b>Direction Photo Taken:</b>	
<b>Description:</b>  Metallic Mercury crate in hazardous waste storage room SB-B2- FB-R1.

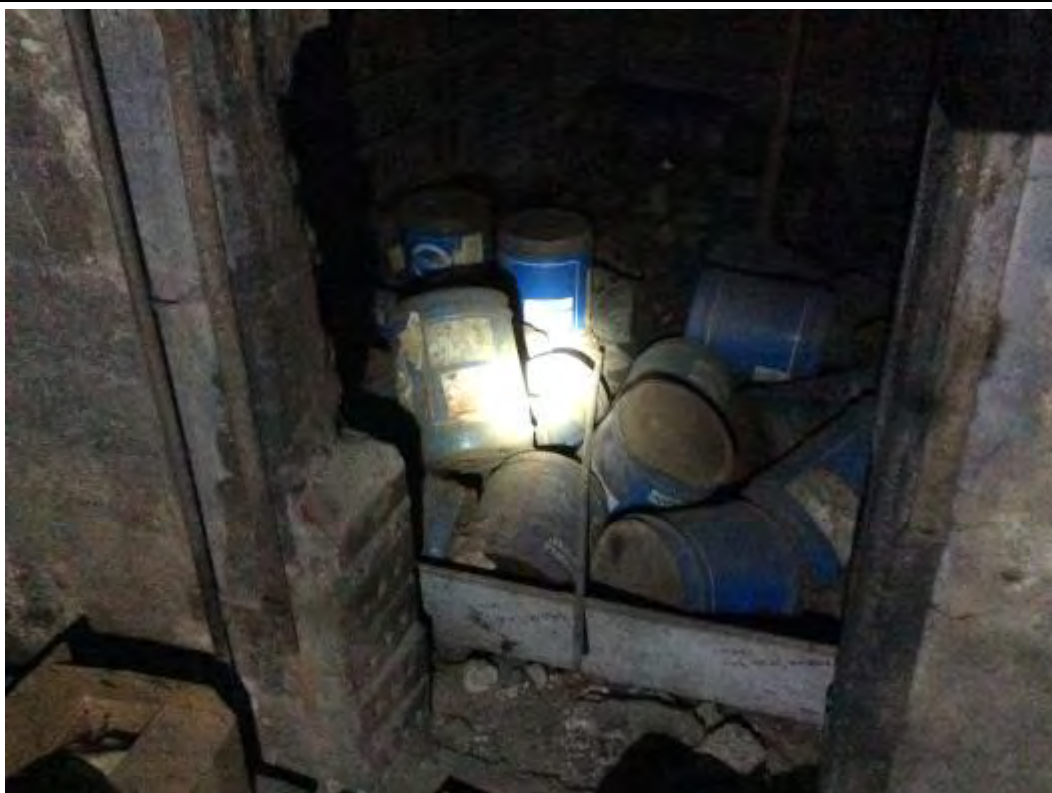
<b>Photo No.</b> <b>45</b>	<b>Date:</b> 10/18/2018
<b>Photo Coordinates</b>	
<b>Lat</b>	41.223094
<b>Long</b>	-111.985825
<b>Direction Photo Taken:</b>	
<b>Description:</b>  5-gal buckets of Benzene in SB-B2-FB-R4.

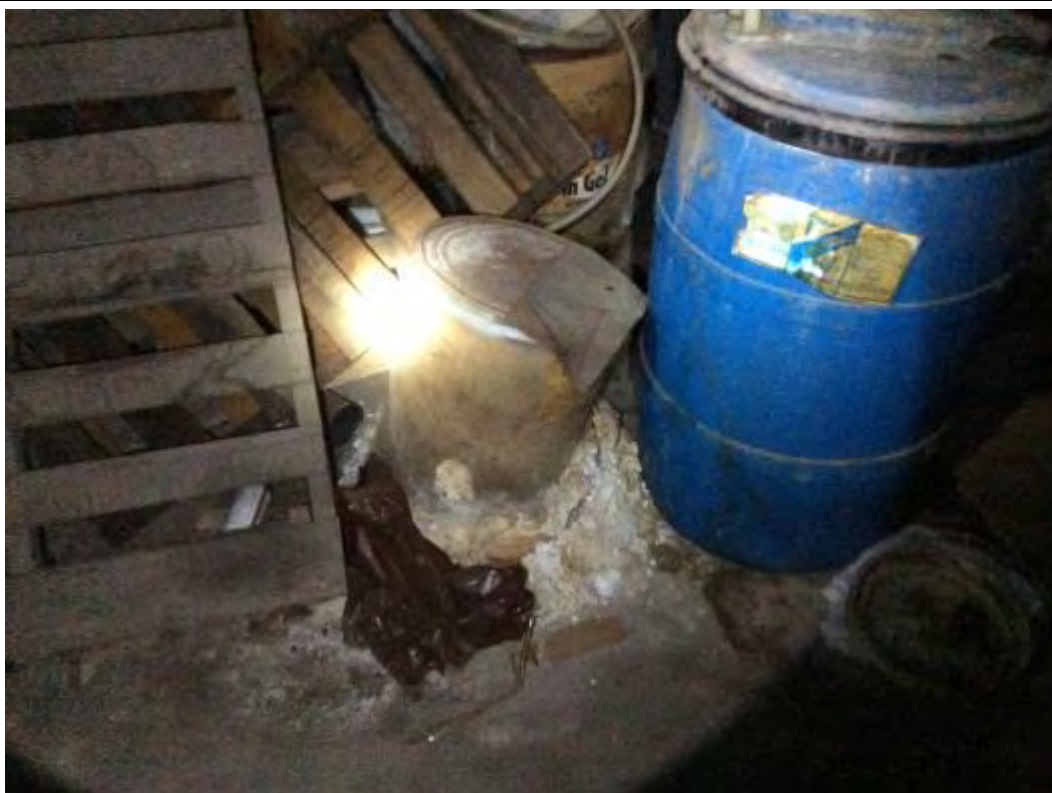
<b>Photo No.</b> <b>46</b>	<b>Date:</b> 10/18/2018
<b>Photo Coordinates</b>	
<b>Lat</b>	41.223919
<b>Long</b>	-111.987114
<b>Direction Photo Taken:</b>	
<b>Description:</b>  Container having reacted/released its contents in SB-B2-FB.

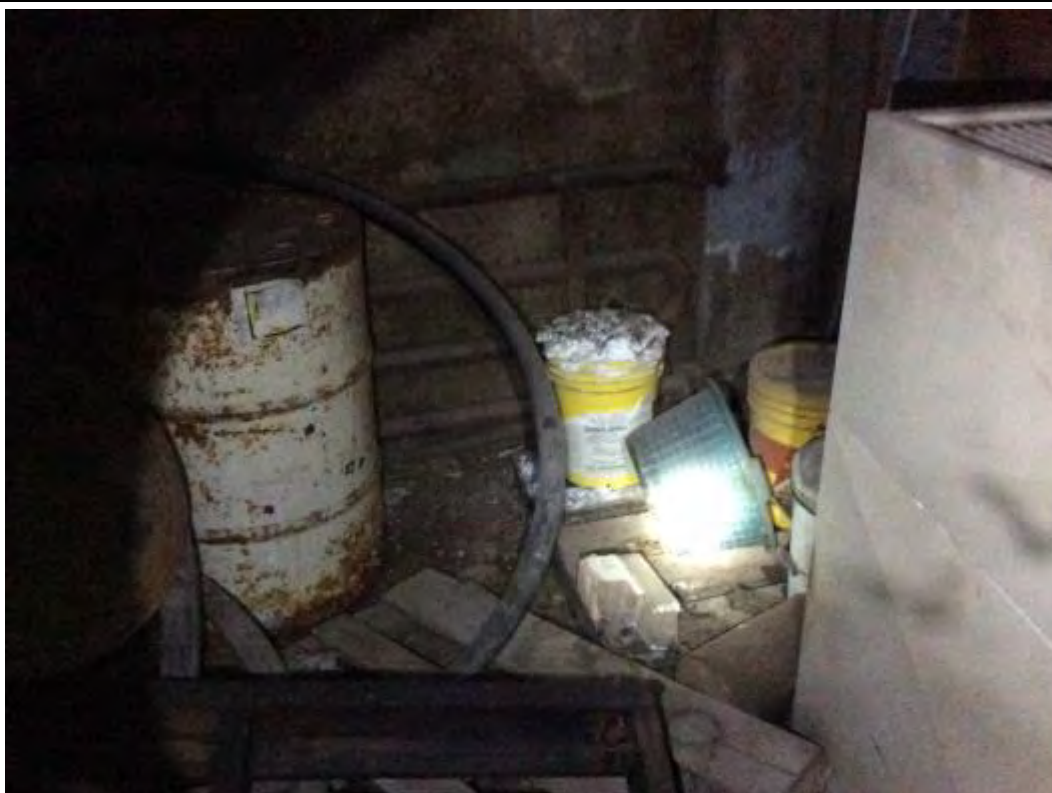
<b>Photo No.</b> <b>47</b>	<b>Date:</b> 10/18/2018
<b>Photo Coordinates</b>	
<b>Lat</b>	41.223919
<b>Long</b>	-111.987114
<b>Direction Photo Taken:</b>	
<b>Description:</b>  Crystallized bucket in SB-B2-FB.

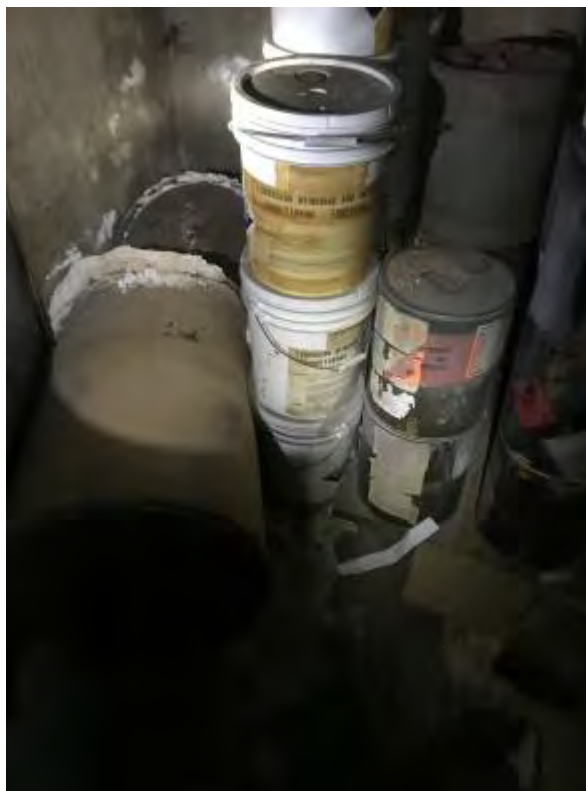
<b>Photo No.</b> <b>52</b>	<b>Date:</b> 10/16/2018
<b>Photo Coordinates</b>	
<b>Lat</b>	
<b>Long</b>	
<b>Direction Photo Taken:</b>	
<b>Description:</b>  5-gal bucket storage in hazardous waste storage room SB-B2- FB-R1.

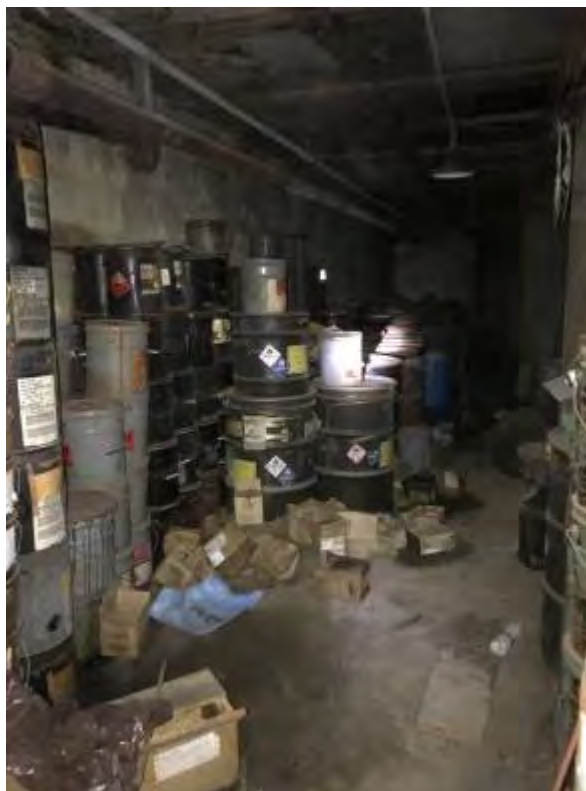
<b>Photo No.</b> <b>54</b>	<b>Date:</b> 10/16/2018
<b>Photo Coordinates</b>	
<b>Lat</b>	
<b>Long</b>	
<b>Direction Photo Taken:</b>	
<b>Description:</b>  Flammable solid; dangerous when wet hazardous waste storage in room SB-B2-FB-R1.

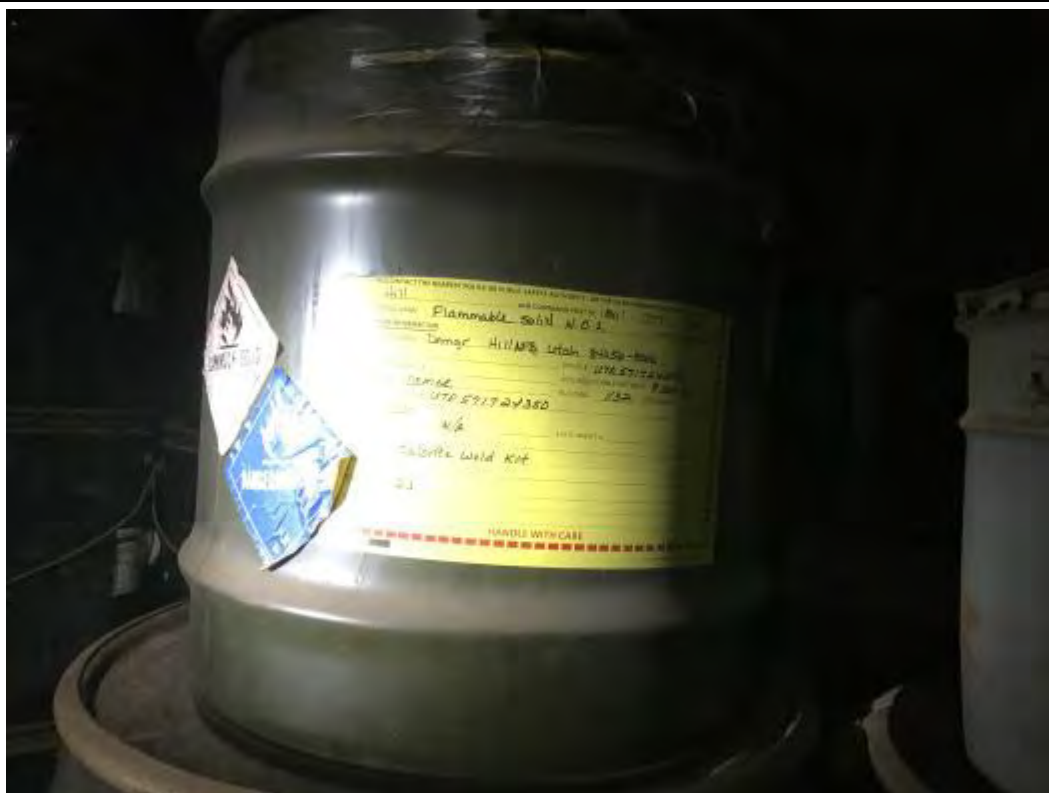
<b>Photo No.</b> <b>56</b>	<b>Date:</b> 10/16/2018
<b>Photo Coordinates</b>	
<b>Lat</b>	
<b>Long</b>	
<b>Direction Photo Taken:</b>	
<b>Description:</b>  Containers which appear to have reacted/released their contents in room SB- B2-FB-R1.

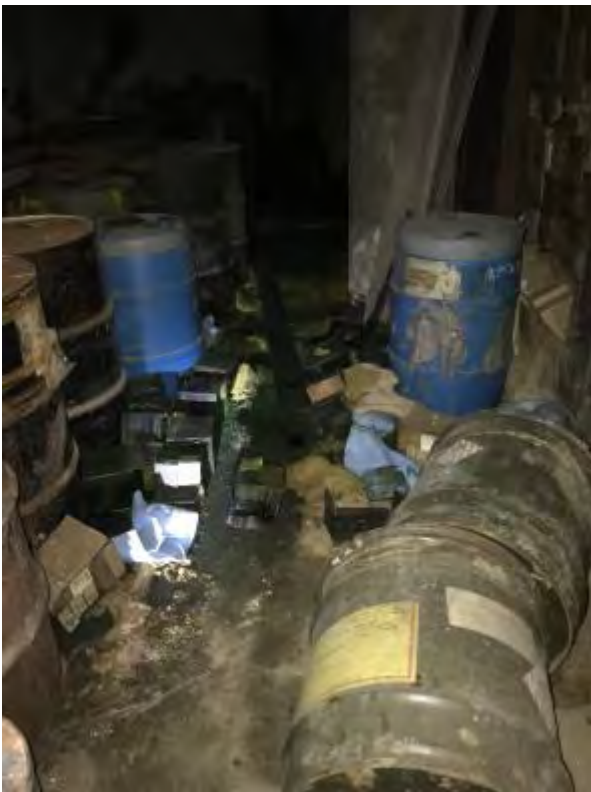
<b>Photo No.</b> <b>57</b>	<b>Date:</b> 10/16/2018												
<b>Photo Coordinates</b>													
<b>Lat</b>													
<b>Long</b>													
<b>Direction Photo Taken:</b>													
<b>Description:</b>  Green unknown spill and container storage in hazardous waste storage room SB-B2-FB-R1.

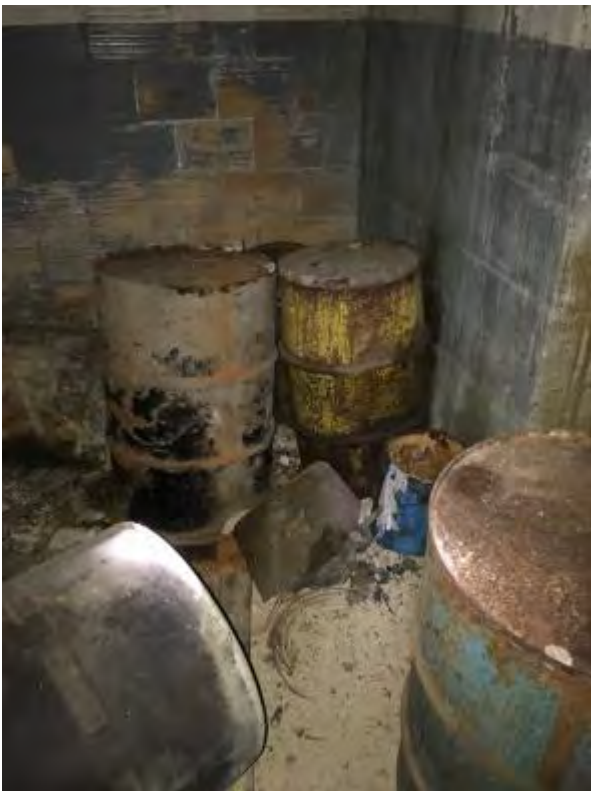
<b>Photo No.</b> <b>58</b>	<b>Date:</b> 10/16/2018												
<b>Photo Coordinates</b>													
<b>Lat</b>													
<b>Long</b>													
<b>Direction Photo Taken:</b>													
<b>Description:</b>  Drum storage in SB-B2-FB.

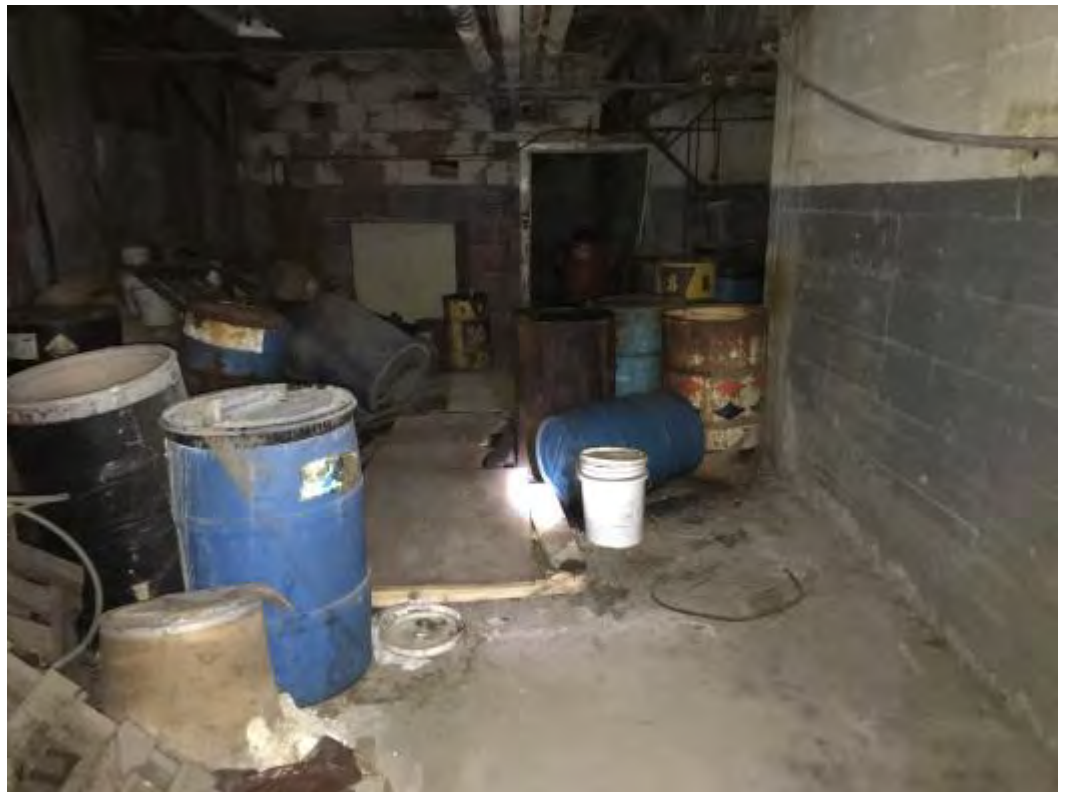
<b>Photo No.</b> <b>59</b>	<b>Date:</b> 10/16/2018
<b>Photo Coordinates</b>	
<b>Lat</b>	
<b>Long</b>	
<b>Direction Photo Taken:</b>	
<b>Description:</b>  Drum storage in SB-B2-FB.
