**Subject: Time Critical Removal Action Letter Report – Allied Paper Inc./Portage  
Creek/Kalamazoo River Site OU5 – Area 3 RV - Revision 2  
EPA Contract No. EP-S5-13-01  
Technical Direction Document No. S05-0001-1506-003  
Document Tracking No. 2391**

**OTSEGO TOWNSHIP DAM AREA TIME CRITICAL REMOVAL ACTION  
LETTER REPORT**

**ALLIED PAPER INC./PORTAGE CREEK/KALAMAZOO RIVER SITE OU5 – AREA 3 RV  
OTSEGO, ALLEGAN COUNTY, MICHIGAN**

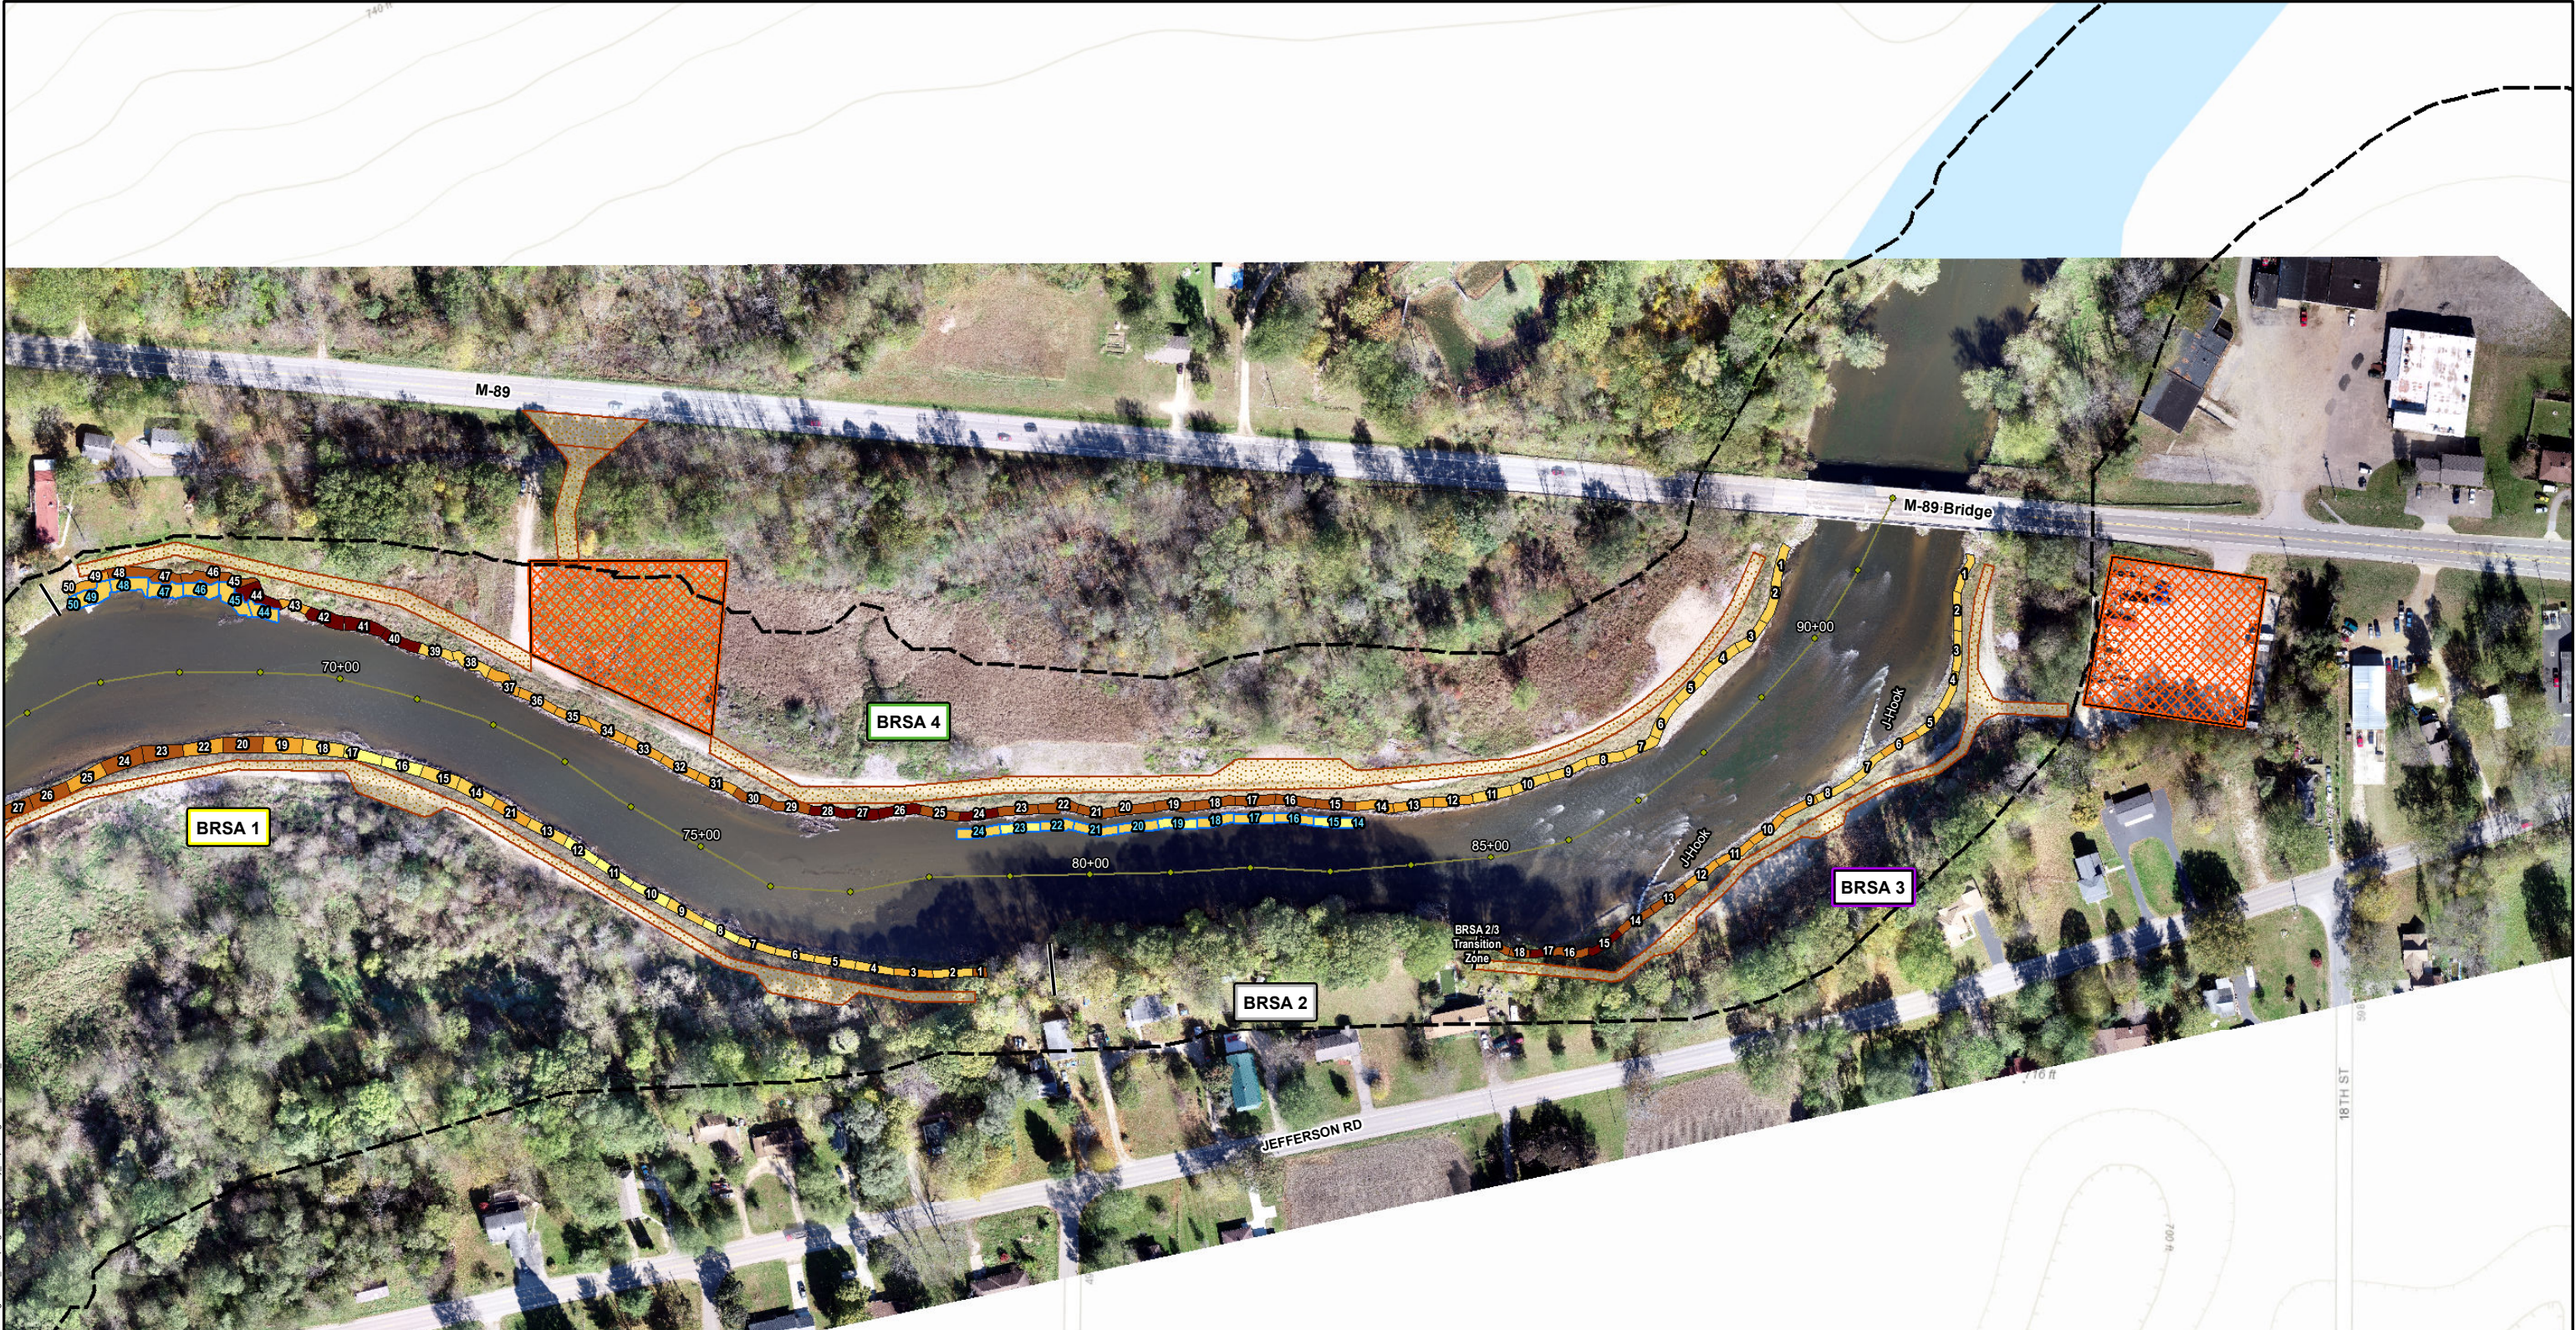
**Figure 3**  
**BRSA 1 (Partial), BRSA 2,**  
**BRSA 3 and BRSA 4**

BRSA 4 was comprised of 51 riverbank grids and 17 stream tube grids (Figure 3, Appendix A). A total of 7,803 tons of non-TSCA soil was removed from BRSA 4. The volume of contact water treated in the on-Site WWTP from BRSA 4 was 633,922 gallons. Specific details regarding removal and restoration in BRSA 4 can be found in *Otsego Township Dam Area TCRA Technical Memorandum Riverbank Removal Stabilization Areas 4, 5, 6, and 9* (AMEC, 2017).

BRSA 1 was comprised of 58 riverbank grids (50-foot lengths) and no stream tube grids (Figures 3 & 4, Appendix A). A total of 6,022 tons of non-TSCA (< 50 ppm total PCBs, not subject to Toxic Substances Control Act requirements) soil and 113.02 tons of TSCA (> 50ppm total PCBs, subject to Toxic Substances Control Act requirements) soil was removed and disposed of off-Site during the BRSA 1 TCRA activities. The volume of contact water treated in the on-Site WWTP from BRSA 1 was 303,075 gallons. Specific details regarding removal and restoration activities in BRSA 1 can be found in *Otsego Township Dam Area TCRA Technical Memorandum No. 1* (AMEC, 2016).

part of the riverbank restoration on the right descending bank in BRSA 4. As part of the BRSA 3 restoration, two ‘J-hooks’ were installed as engineering controls to protect the left descending riverbank. A total of 3,543 tons of non-TSCA soil was removed and disposed of off-Site from BRSA 3. The volume of contact water treated in the on-Site WWTP from BRSA 3 was 68,300 gallons. Specific details regarding removal and restoration in BRSA 3 can be found in *Otsego Township Dam Area TCRA Technical Memorandum Riverbank Removal Stabilization Areas 2 & 3* (AMEC, 2016).

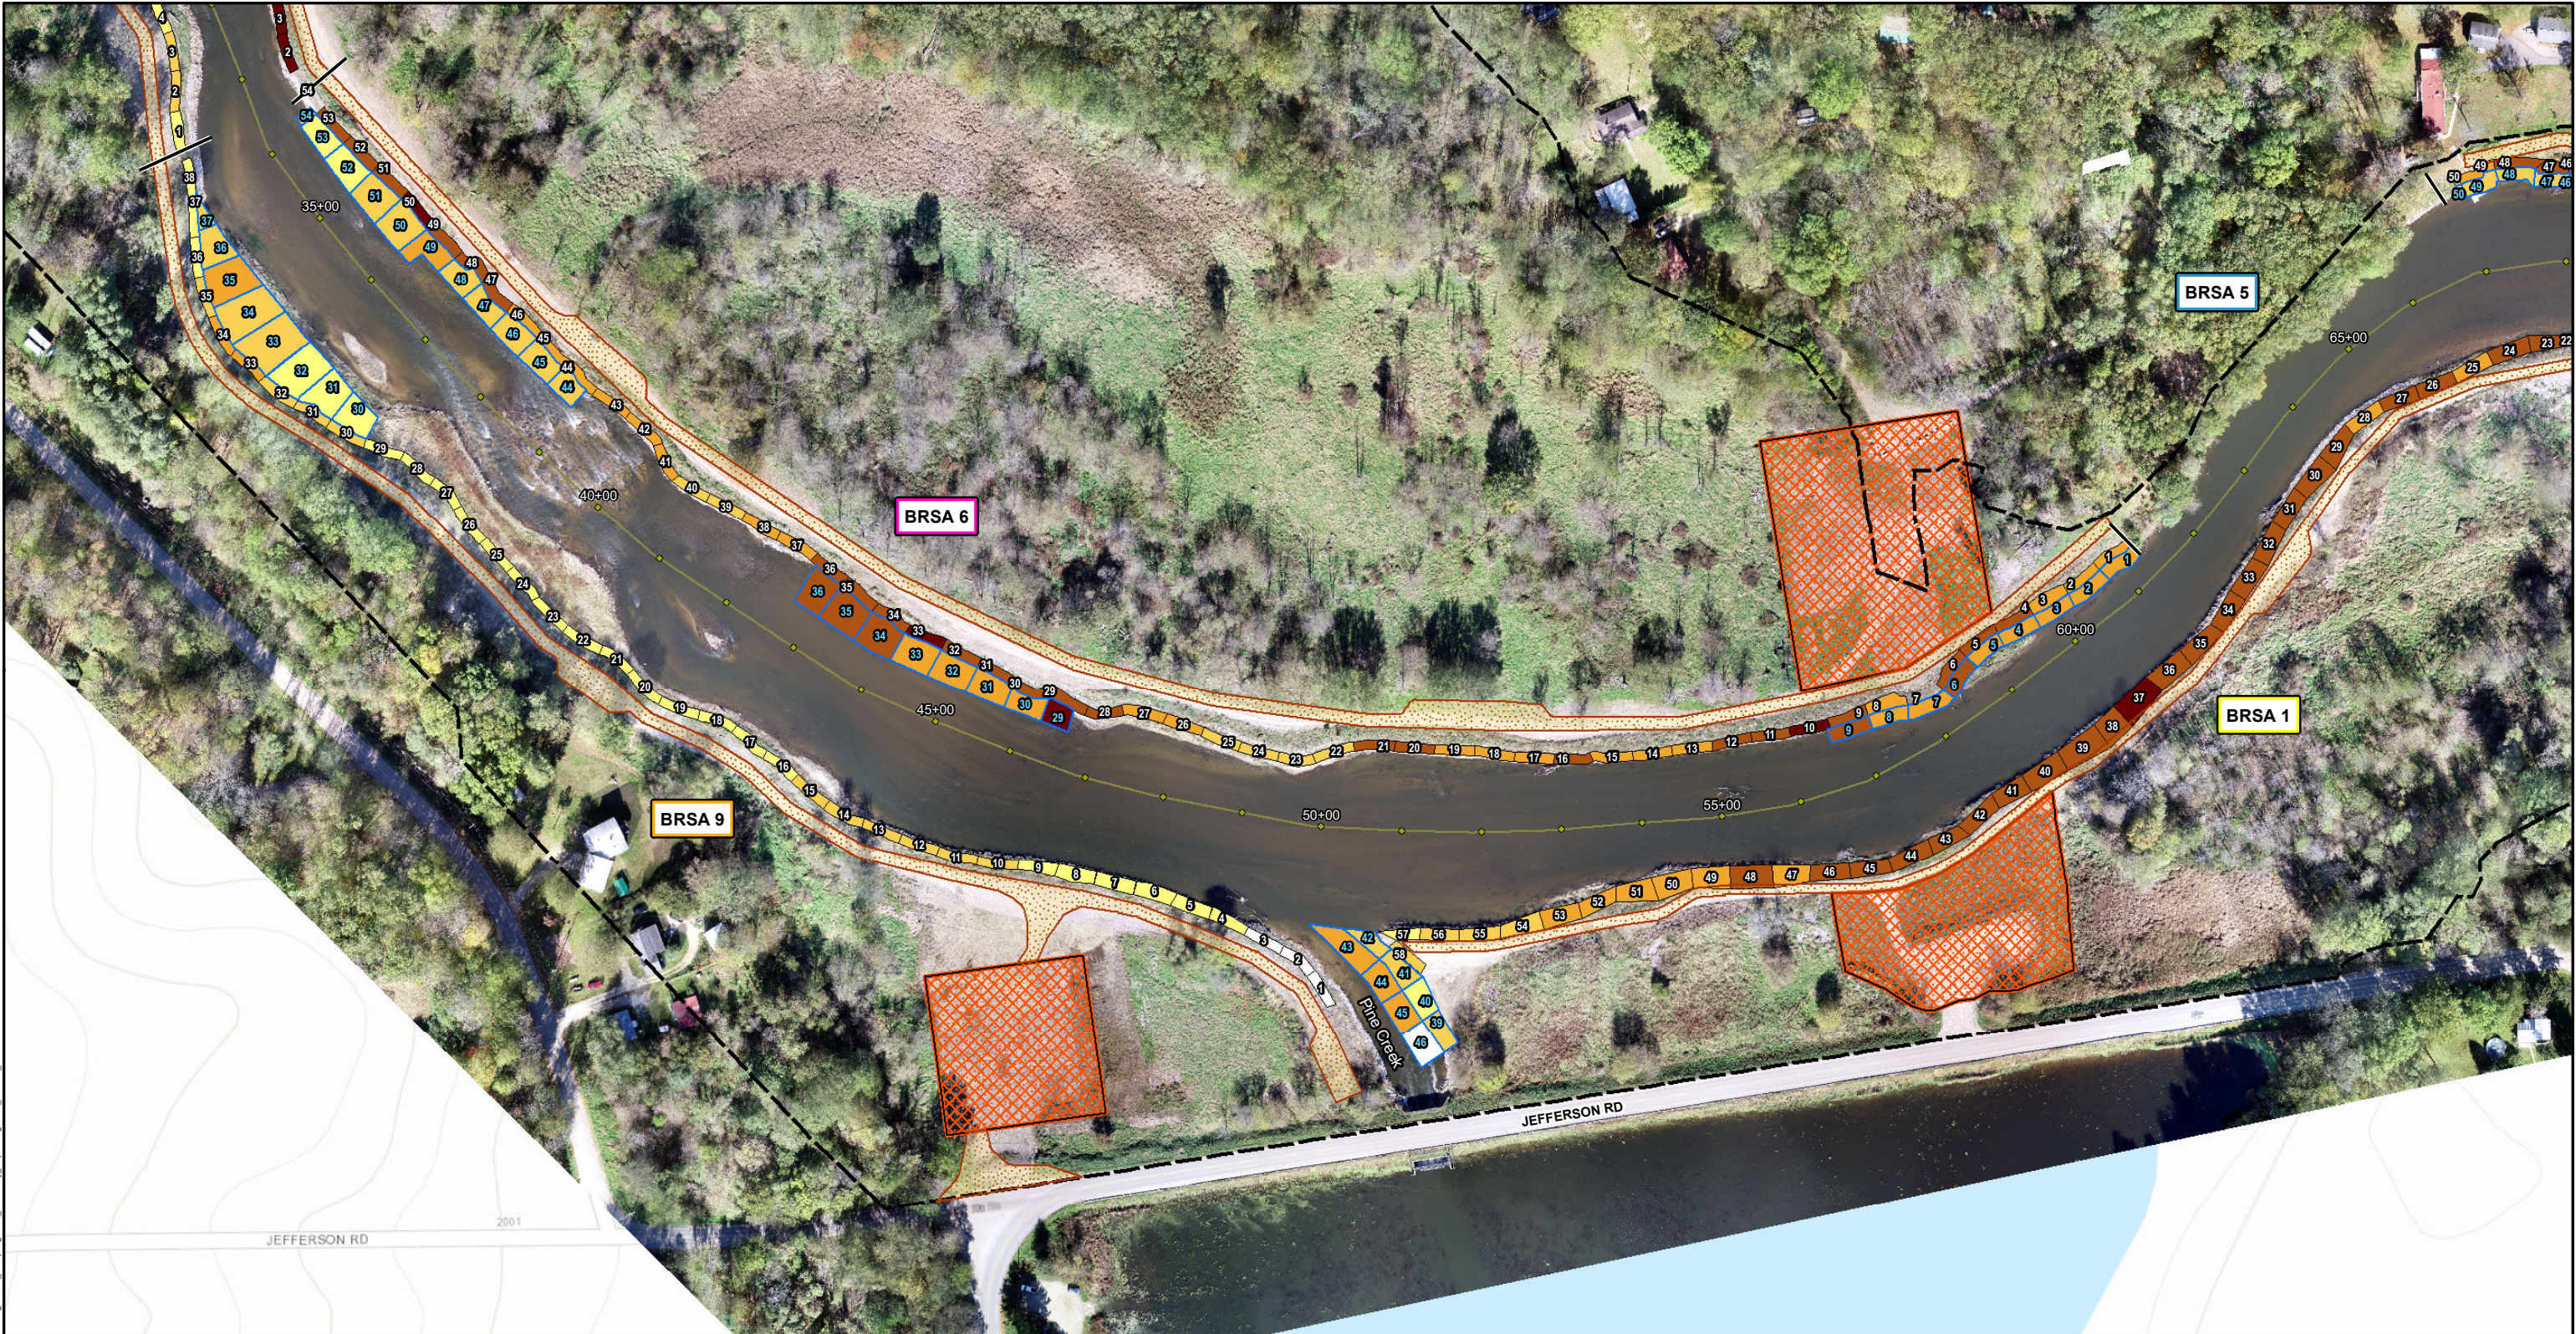
**Figure 4**  
**BRSA 1 (Partial), BRSA 5, BRSA 6 and BRSA 9**

BRSA 6 was comprised of 54 riverbank grids and 28 stream tube grids (Figure 4, Appendix A). A total of 10,750 tons of non-TSCA soil was removed and disposed of off-Site from BRSA 6. The volume of contact water treated in the on-Site WWTP from BRSA 6 was 363,100 gallons. Specific details regarding removal and restoration in BRSA 6 can be found in *Otsego Township Dam Area TCRA Technical Memorandum Riverbank Removal Stabilization Areas 4, 5, 6, and 9* (AMEC, 2017).

BRSA 9 was comprised of 38 riverbank grids and 15 stream tube grids (Figure 4, Appendix A). A total of 8,312 tons of non-TSCA soil was removed and disposed of off-Site from BRSA 9. The volume of contact water treated in the on-Site WWTP from BRSA 9 was 371,978 gallons. Specific details regarding removal and restoration in BRSA 9 can be found in the *Otsego Township Dam Area TCRA Technical Memorandum Riverbank Removal Stabilization Areas 4, 5, 6, and 9* (AMEC, 2017).
