INDOOR AIR SOIL VAPOR INTRUSION STUDY REPORT

**12 Wright Avenue
Merrimack, NH
New Hampshire Plating Company
Superfund Site**

**U.S. ENVIRONMENTAL PROTECTION AGENCY
NEW ENGLAND REGIONAL LABORATORY
OFFICE OF ENVIRONMENTAL MEASUREMENT & EVALUATION
11 TECHNOLOGY DRIVE
NORTH CHELMSFORD, MASSACHUSETTS 01863**

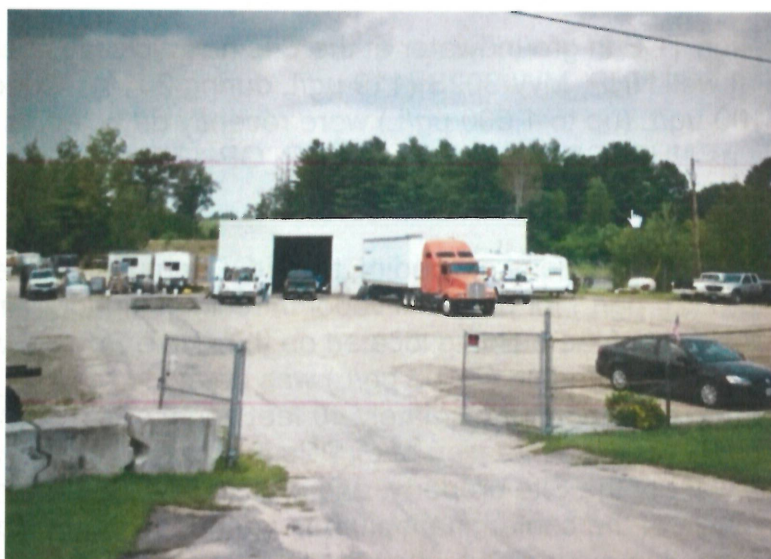
Approx. location of 1.5 ppm TCE in groundwater

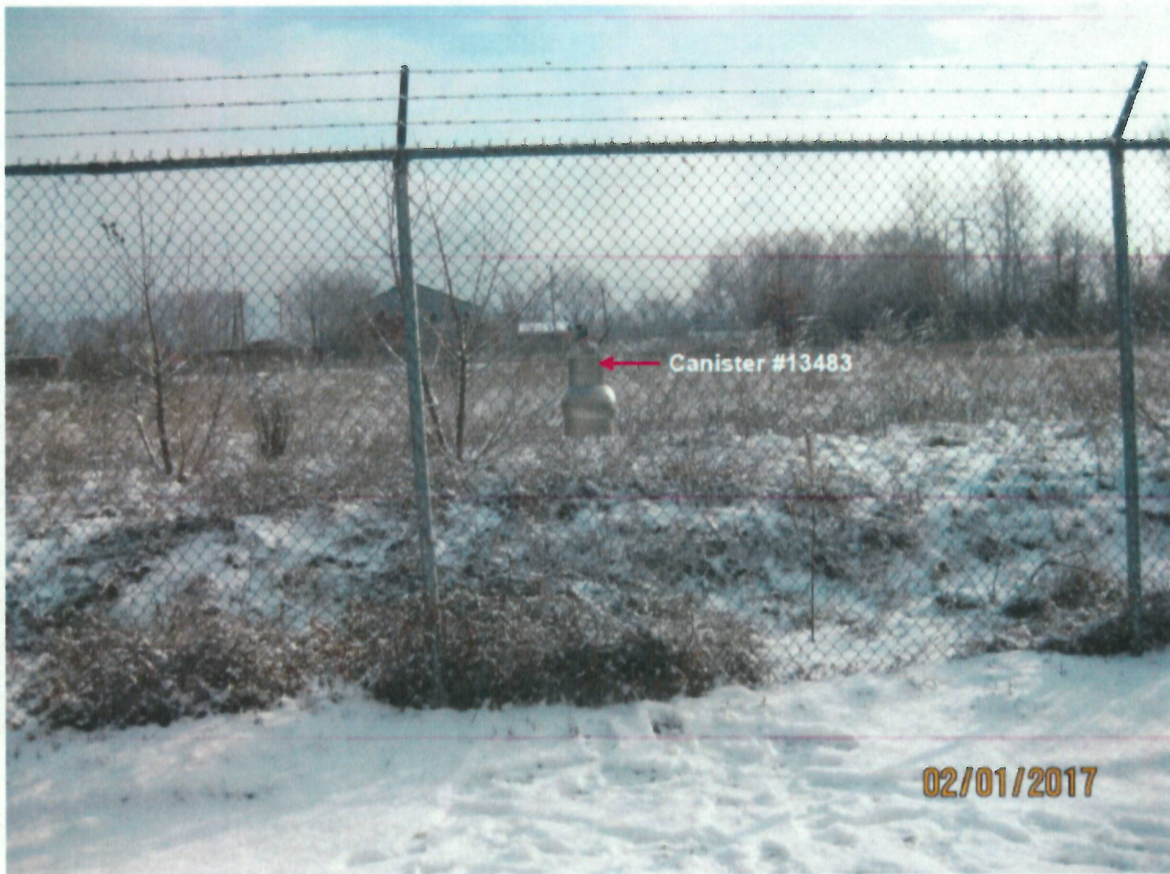
Canister #13483 was collected on February 1, 2017 from 8:13 to 16:13, 5 feet 4 inches above the ground and 17 feet 6 inches 122 feet from the northeast corner of the building, on the fence separating the 12 Wright Avenue property line the NHPC site boundary.

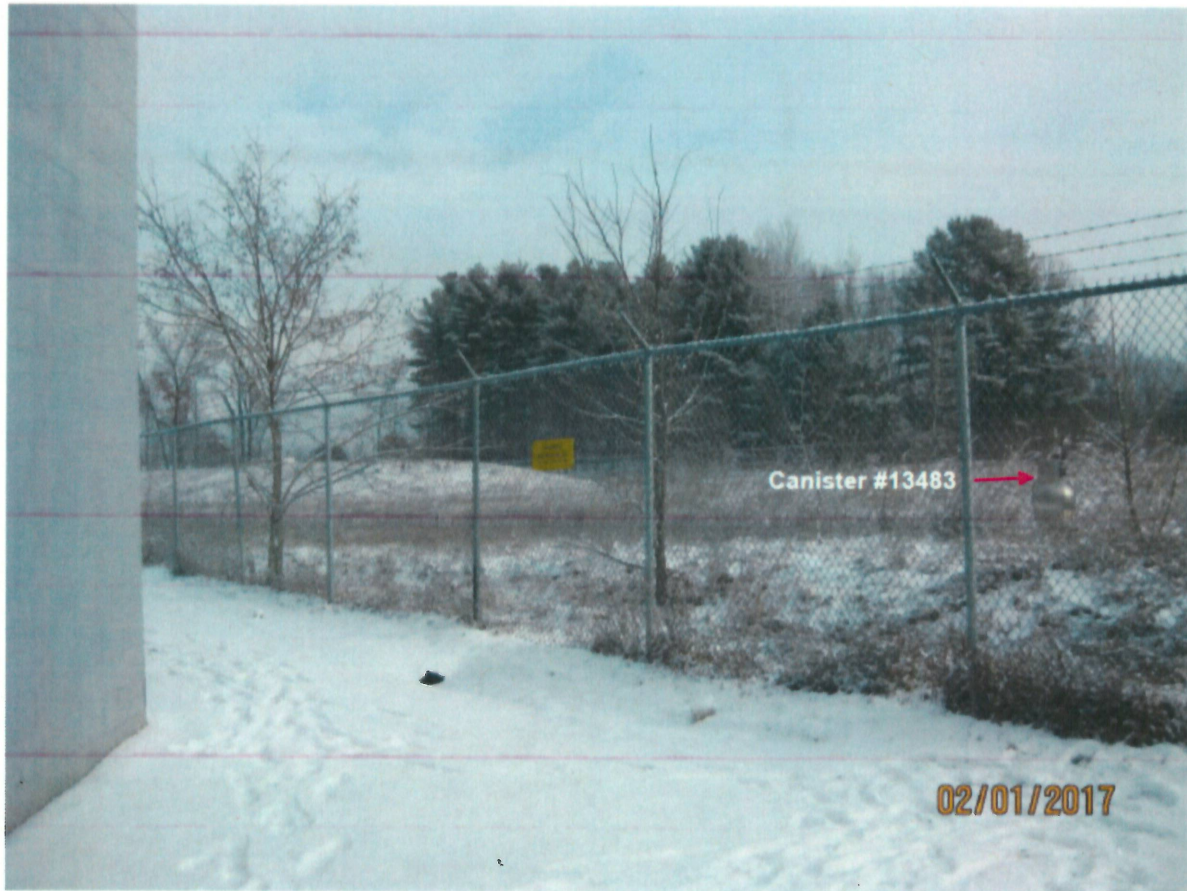
EPA observed the building from the west side of the building to be relatively no visible signs of open smoke or penetration. There were two areas on the east side of the building where the concrete slab had been cut away exposing gravel. One area on the south side adjacent to where the water line enters the building and in the northwest corner of the area where the 6 inch indoor air samples were collected. These two areas are potential vapor intrusion points of entry. The west side of the building where the truck loading dock is located is all open. The east side of the building where Agnes Power Washing has its shop, which is mostly open except for a small office located in the northeast corner and a bath room next to that.

There were numerous heavy cans of paint, cans of lubricants, and car detailing products stored in cabinets and on benches in both areas. In the truck repair shop there is a waste oil tank not all full with two tanks to supply fuel for the furnace which was not on during the sampling event. A 55-gallon drum of waste oil and a

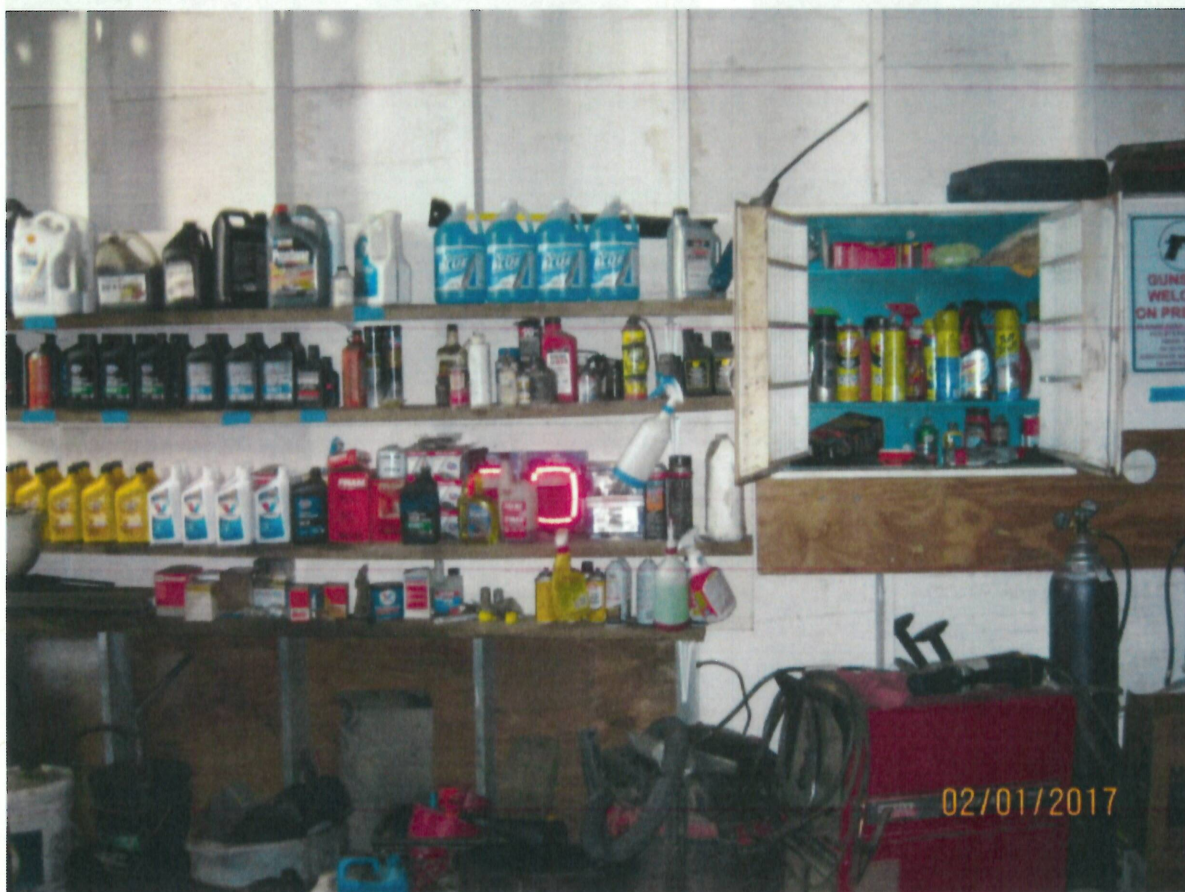
EPA observed the building slab on the west side of the building to be solid with no visible signs of open cracks or penetrations. There were two areas on the east side of the building where the concrete slab has been cut away exposing gravel; one area on the south end adjacent to where the water line enters the building and in the northwest corner of the area where the 8-hour indoor are samples were collected. These two areas are potential vapor intrusion points of entry. The west side of the building, where the truck repair shop is located is all open. The east side of the building is where Acme Power Washing has its shop, which is mostly open except for a small office located in the southeast corner and a bath room next to that.

There were numerous spray cans of brake cleaner, oil lubricants, and car detailing products stored in cabinets and on benches in both areas. In the truck repair shop there is a waste oil fired hot air furnace with two tanks to supply fuel for the furnace, which was not on during the sampling event. A 55-gallon drum of waste oil and a 5-

gallon open container of waste oil/diesel fuel mixture were present. Also in this area, two trucks were in various states of repair. No one was working in this area during the sampling event. There were noticeable oil and or fuel spills on the concrete floor. Two ceiling fans were present, one of which was on. The entire area had a very strong odor of oil/petroleum.

The east side of the building is heated with a natural gas fired hot air furnace, which was not on during the sampling event. A motorcycle and leaf blower with fuel in their tanks were being stored in the area for the winter. Work clothes and cleaning cloths are sent out for cleaning by UniFirst. Early on in the sampling event a clean bag of cloths and clothing were brought into the building. No one was working in this area during the sampling event. To obtain additional information about the building, an indoor air assessment survey was completed, which is provided in Appendix C.

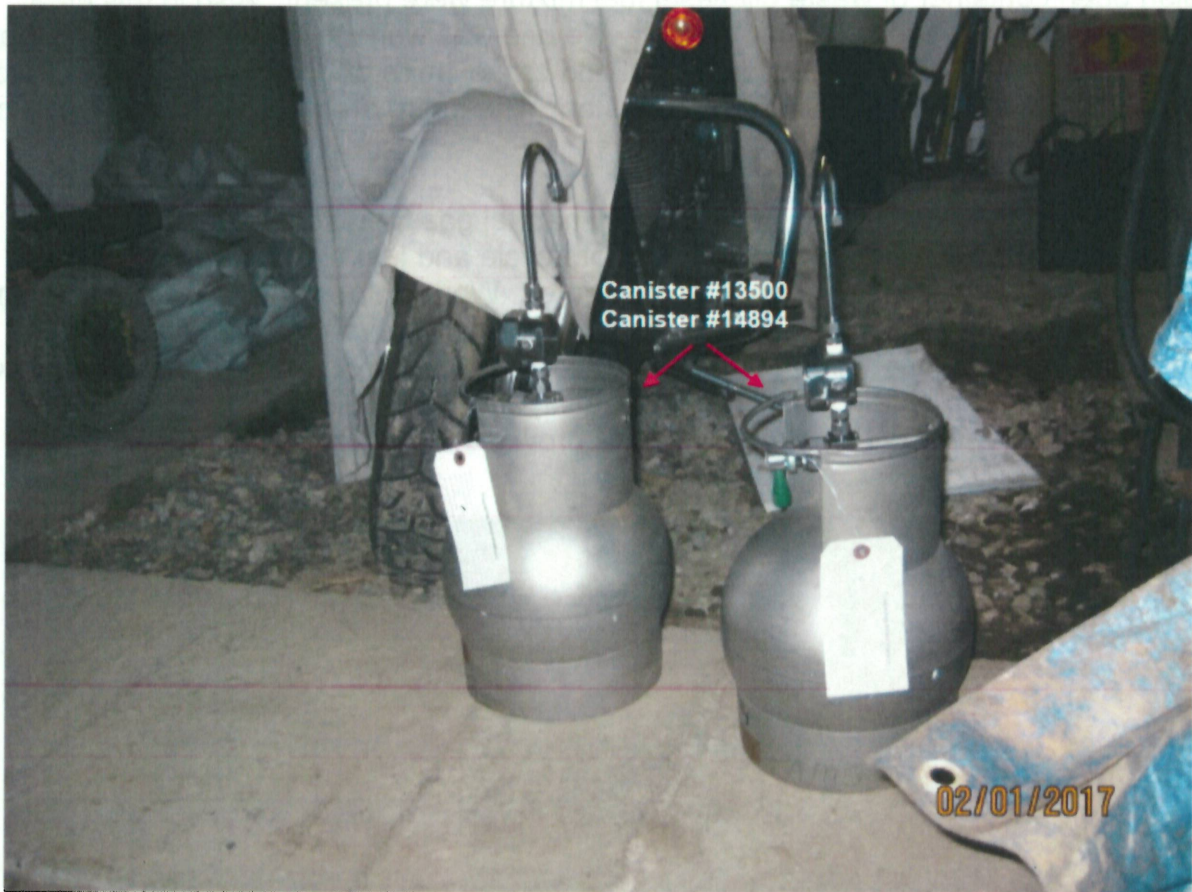
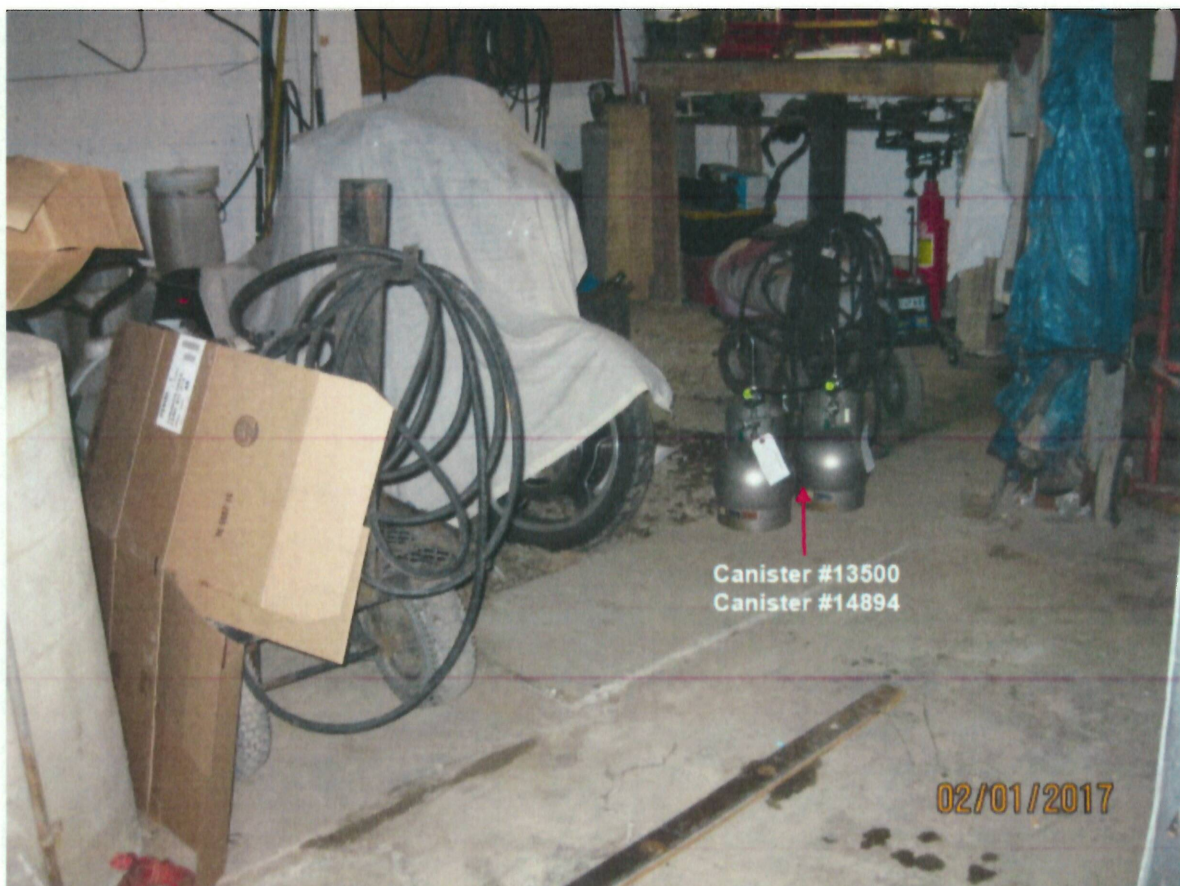
Canister #13500 and Canister #14894 were collected on the east side of the building where Acme Power Washing has its shop from 08:14 to 16:14 on February 1, 2017, 18 feet from the north exterior wall, 18 feet from the west interior wall, 21 feet from the east exterior wall and 18 inches above the floor. These were located next to where the concrete slab was cut away exposing gravel. Canister #14894 was a duplicate sample collocated with canister #13500.

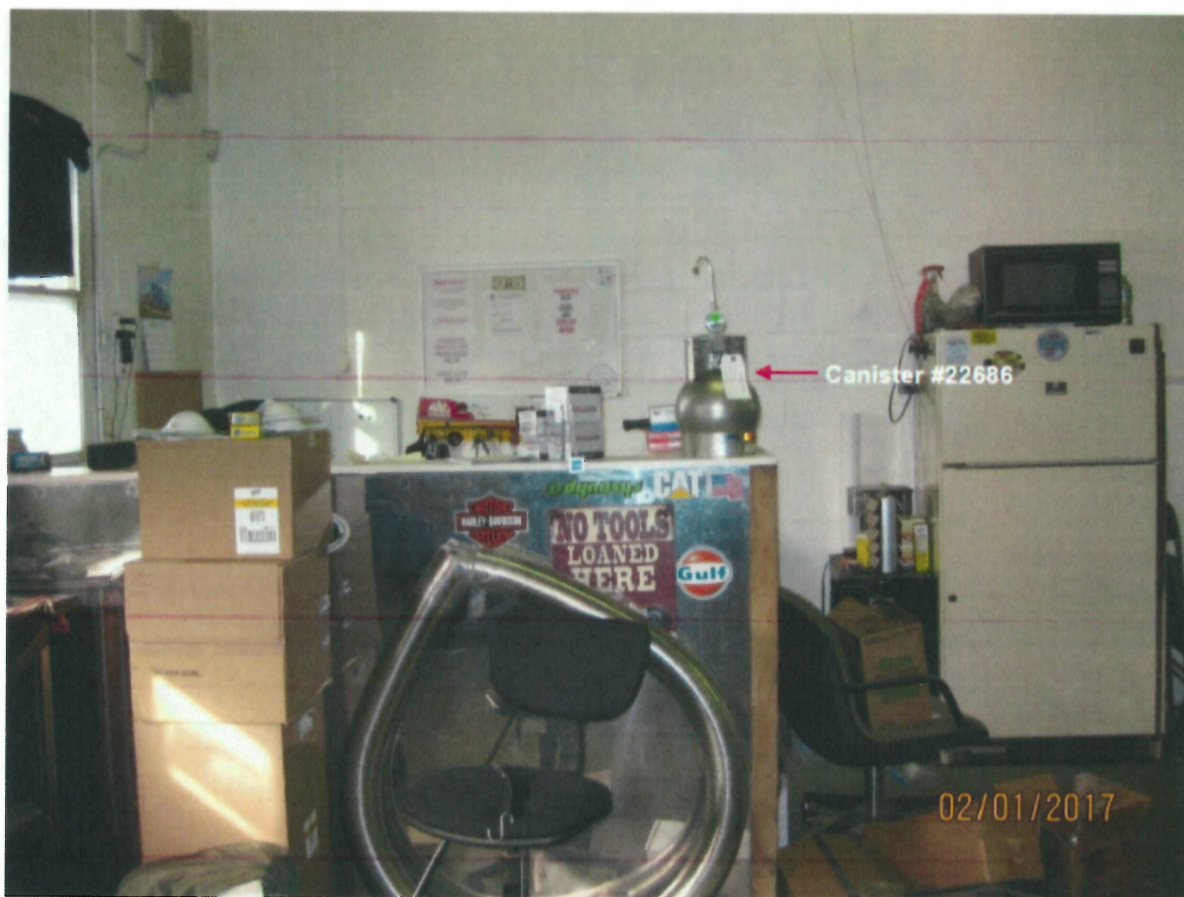
Canister #22686 was collected on the west side of the building where the truck repair shop is located from 08:15 to 16:15 on February 1, 2017, 7 feet from the west exterior wall, 8 feet from the south exterior wall, 30 feet 8 inches from the east interior wall and 6 feet above the floor.

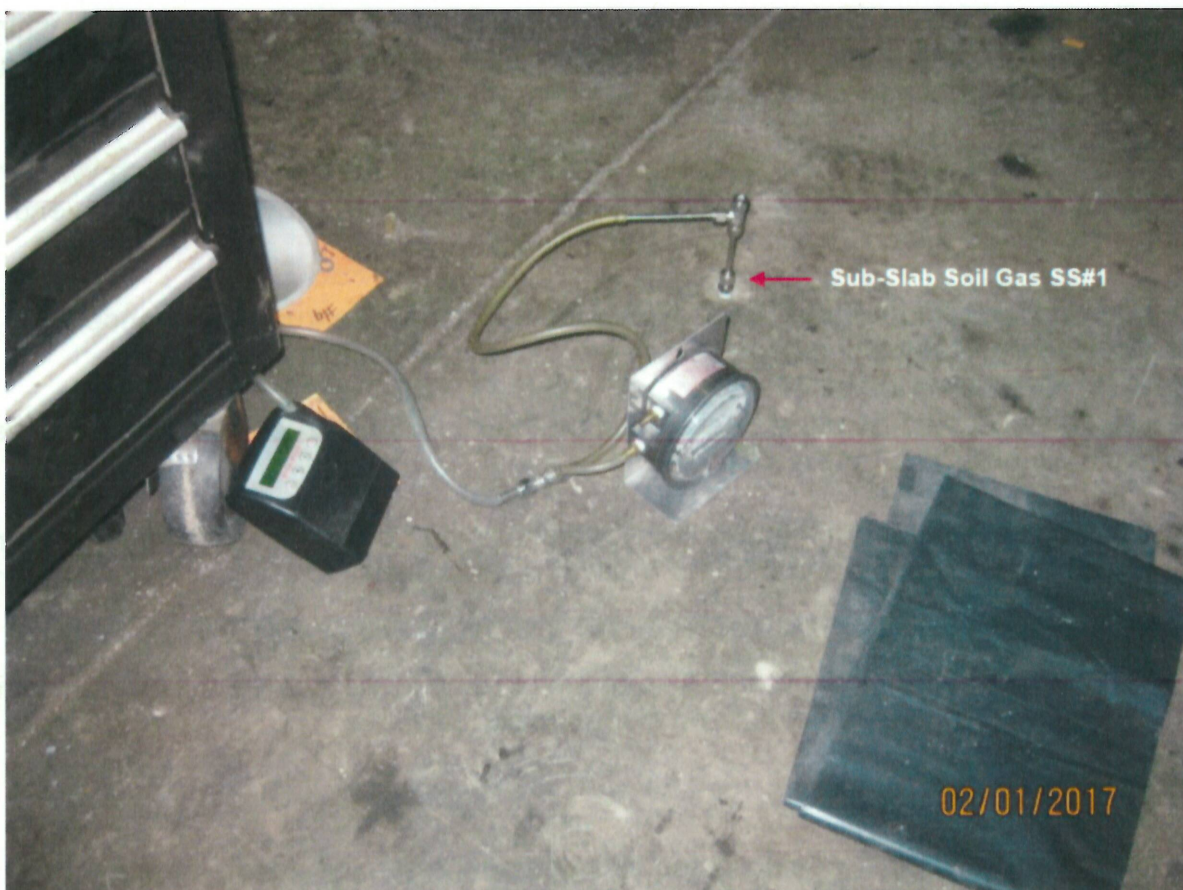
SS-1 was collected from the sub-slab soil gas sampling probe inserted through the 4-inch concrete slab on the west side of the building. The probe inlet was 4 inches below the floor surface. On 2/1/17 sub-slab soil gas samples were collected below the concrete slab 21 feet 6 inches from the north exterior wall, 19 feet from the west exterior wall and 4 inches below the slab. A canister grab sample (Canister #15046) was collected as a confirmation sample and then analyzed at the EPA New England Regional laboratory (NERL).

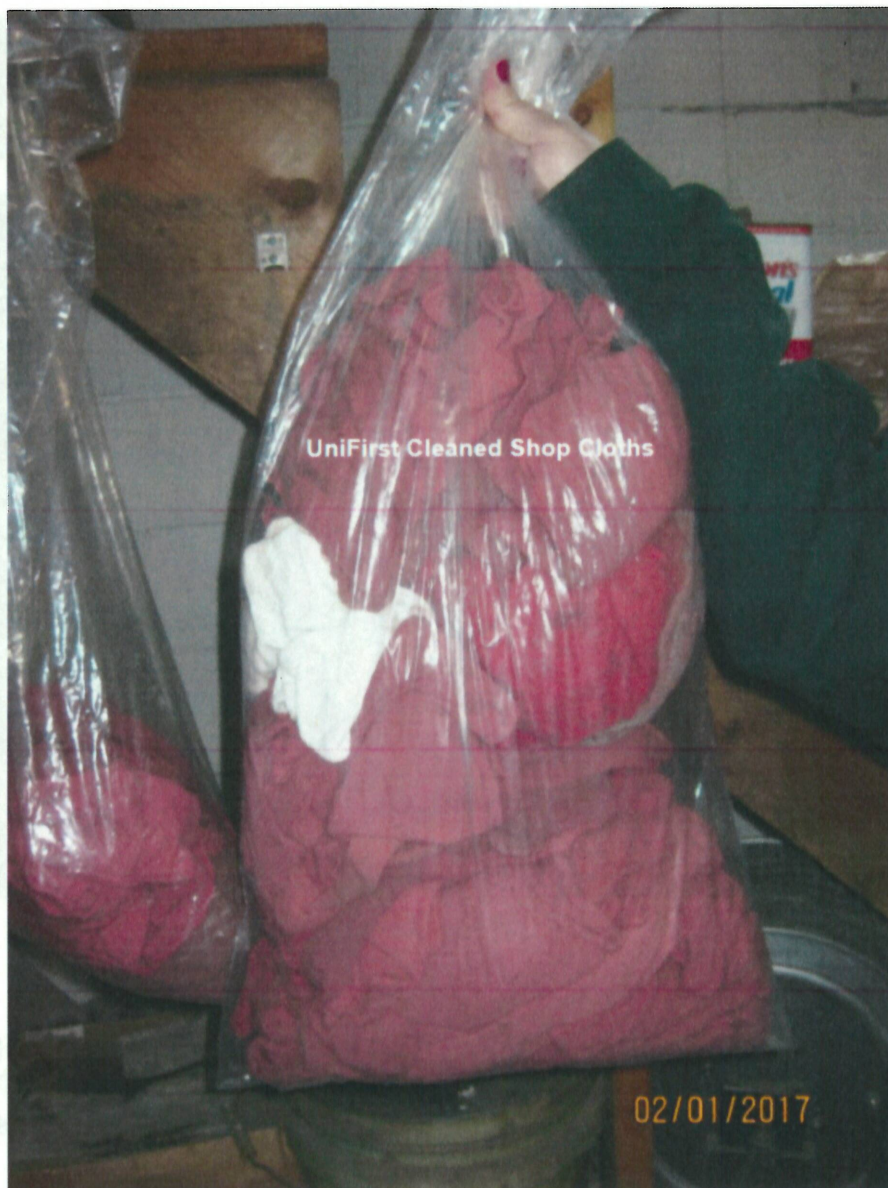
A syringe grab air sample was collected by inserting the syringe needle through the plastic bag to determine if cleaning cloths were off gassing PCE. The bag contained clean shop cloths that were brought into the building by UniFirst the morning of the sampling event.

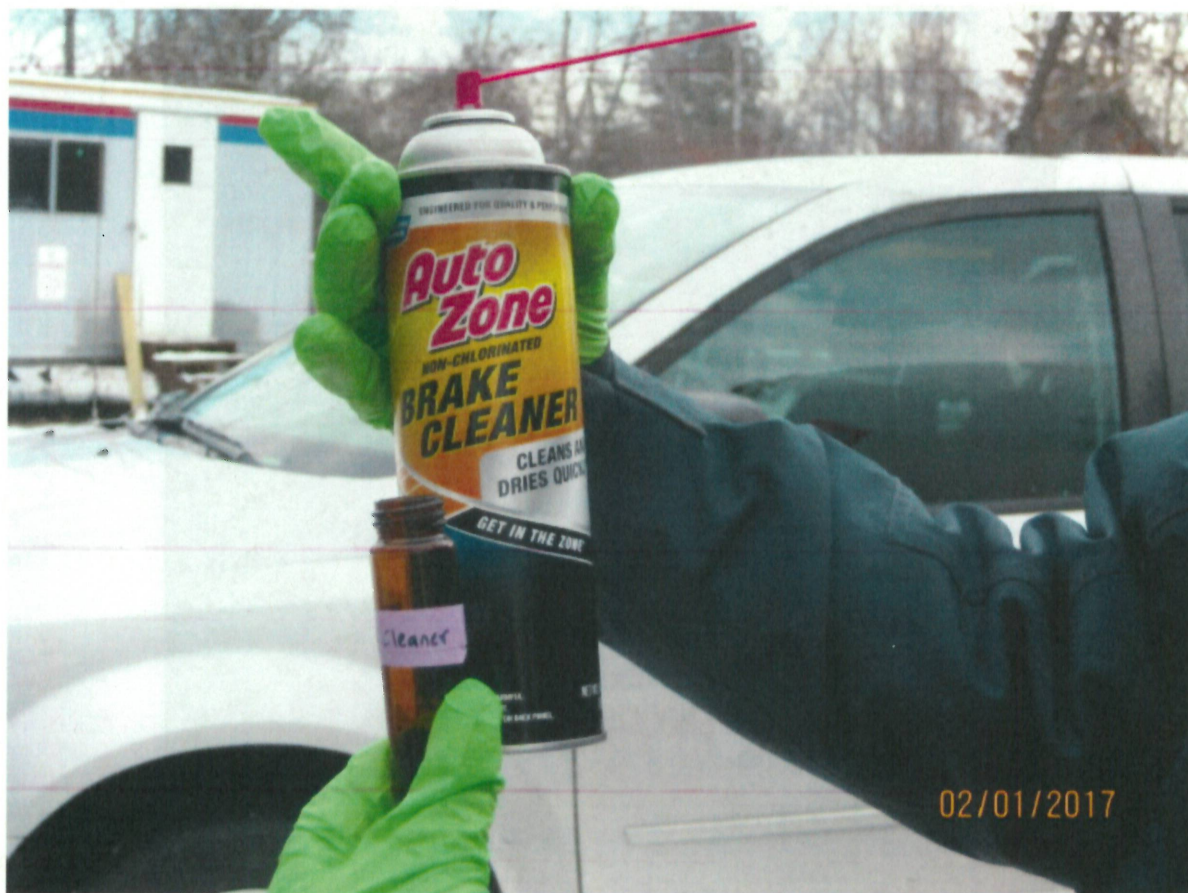
Brake Cleaner VOA Vile Head Space

A small amount of brake cleaner was sprayed into a VOA vile. A grab headspace air sample was collected from the vile using a syringe.
