**Subject: Final Letter Report for the Joseph Street Asbestos Removal Site**  
**EPA Contract No. EP-S5-13-01**  
**Technical Direction Document No. 0001/S05-0001-1407-003**  
**Document Tracking No. 0150**

**FINAL LETTER REPORT  
FOR THE  
JOSEPH STREET ASBESTOS REMOVAL SITE  
MARION, MARION COUNTY, OHIO**

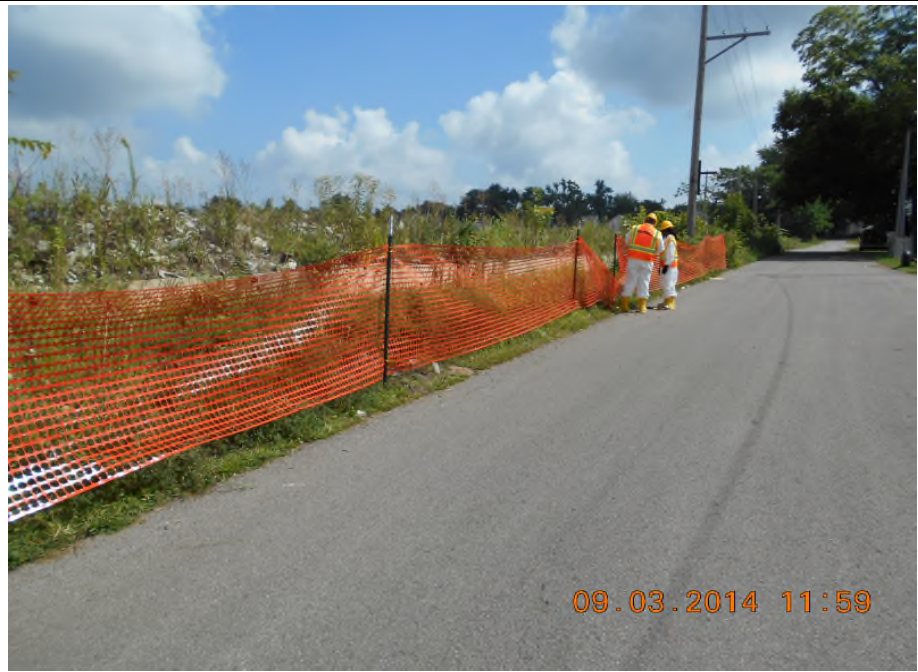
**Description:**  
Installation of orange snow fencing along the southern perimeter of the site.

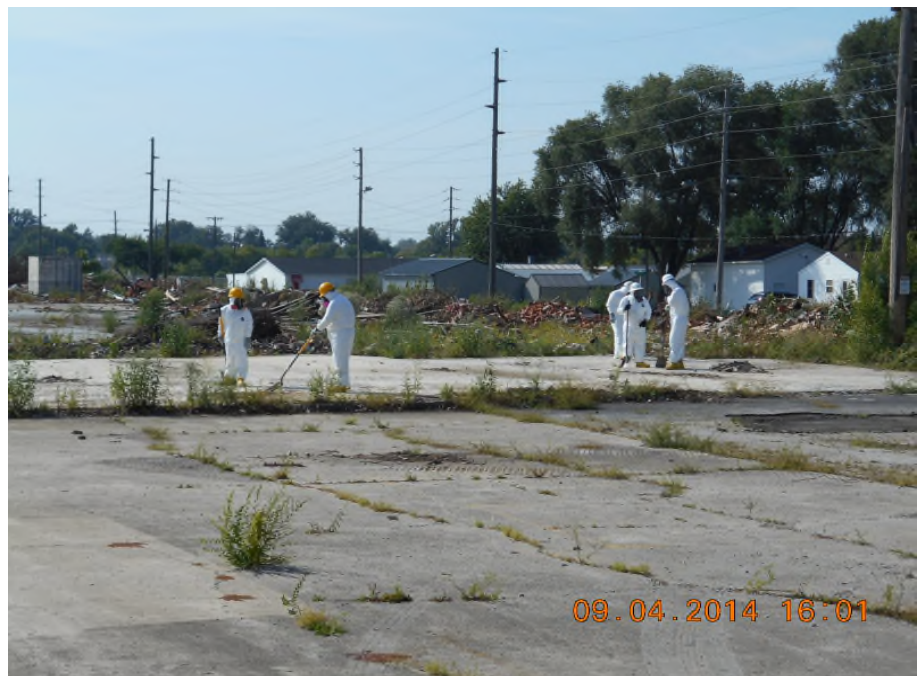
**Photograph:** 2

**Description:**  
Workers removing tiles from the concrete located near the northeast corner of the site.

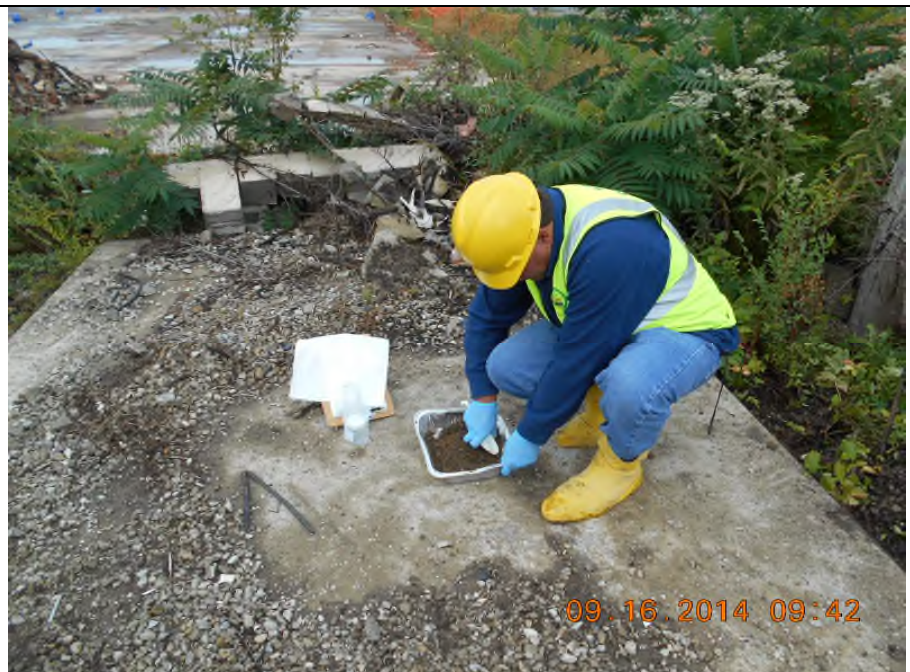
**Photograph:** 4

**Description:**  
Collection of Sample JS-PCB-001-091614 near a concrete pad that previously contained an electrical transformer.

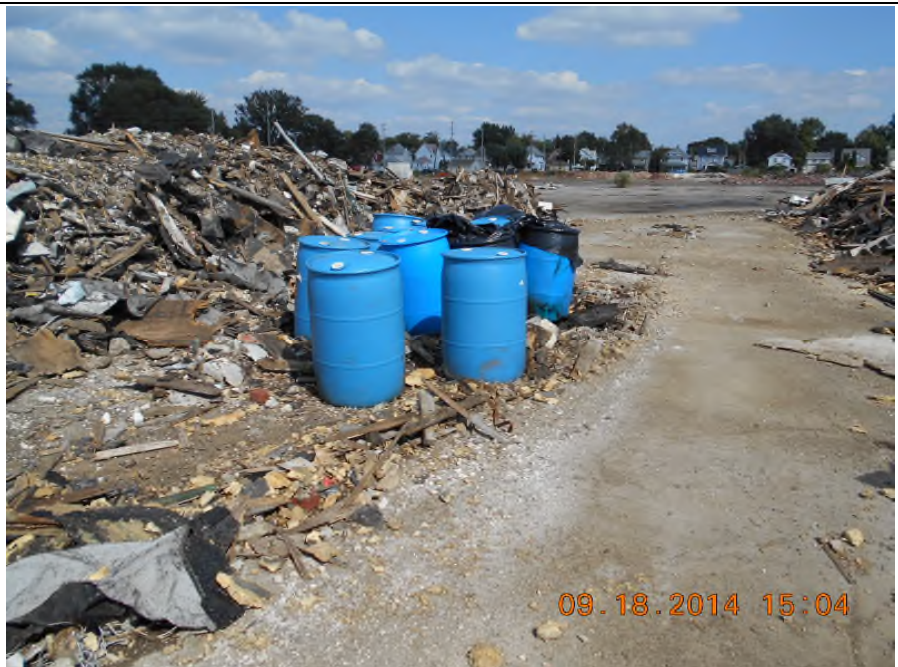
**Photograph:** 8

**Description:**  
Poly 55-gallon drums staged on the site's concrete pad.

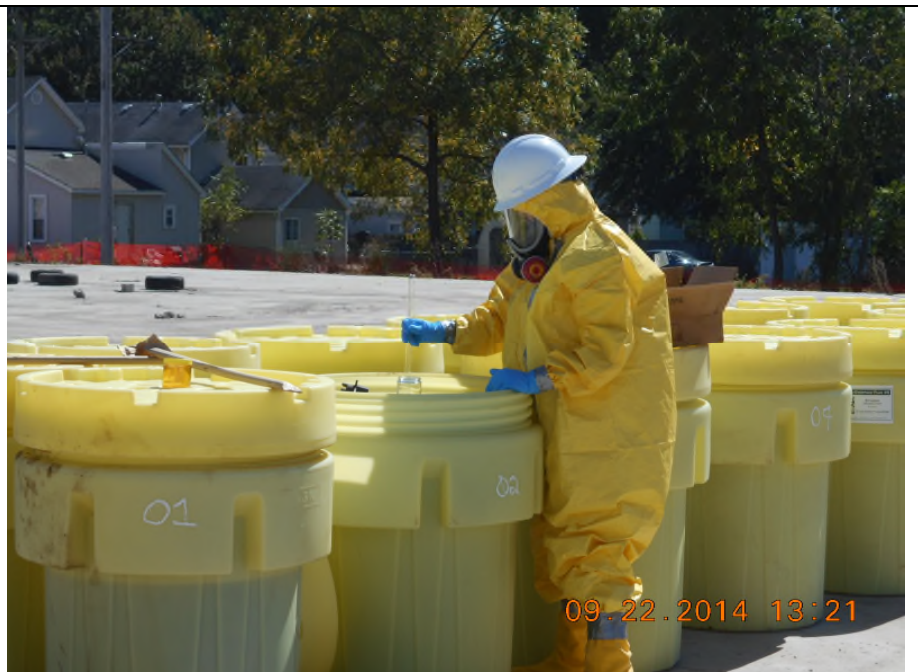
**Photograph:** 14

**Description:**  
Collection of a waste characterization sample from one of the poly 55-gallon drums that was staged on the site's concrete pad.

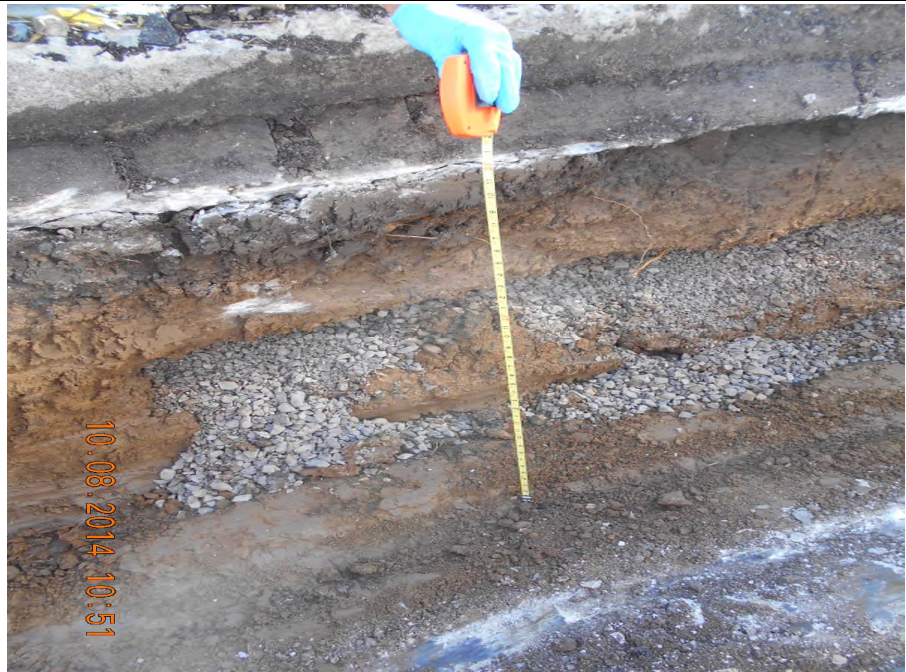
**Description:**  
Depth of the soil prior to the collection of soil samples from the side of the concrete pad that is located near the northeast corner of the site.

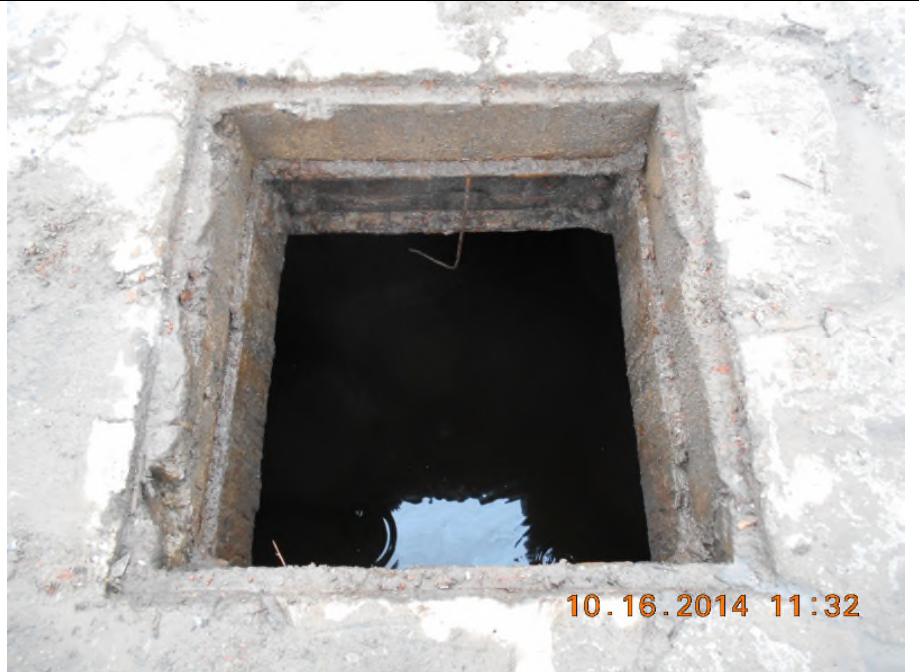
**Description:**  
View of the water  
located in the cistern  
located near the southern  
edge of the site.

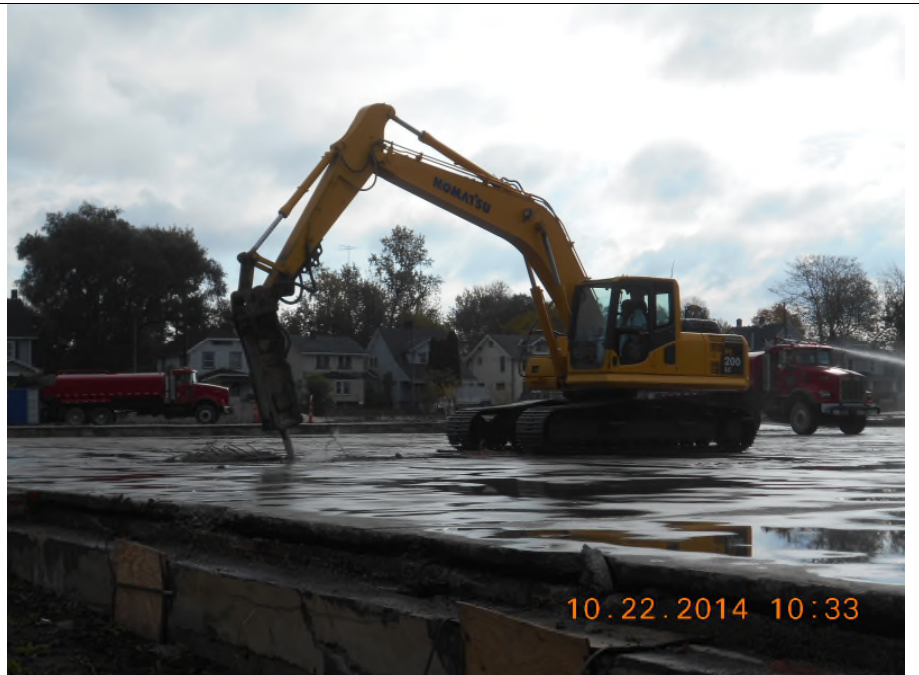
**Description:**  
ERRS operator using a  
hoe ram to open a tunnel  
located near the  
northeastern corner of  
the site.

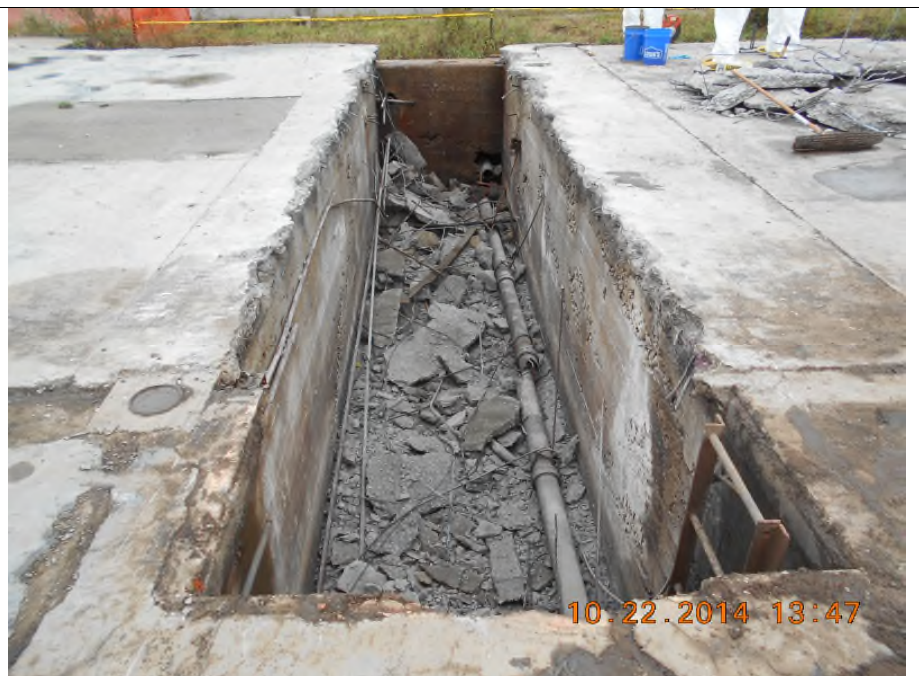
**Photograph:** 40

**Description:**  
View of the tunnel  
located near the  
northeastern corner of  
the site.

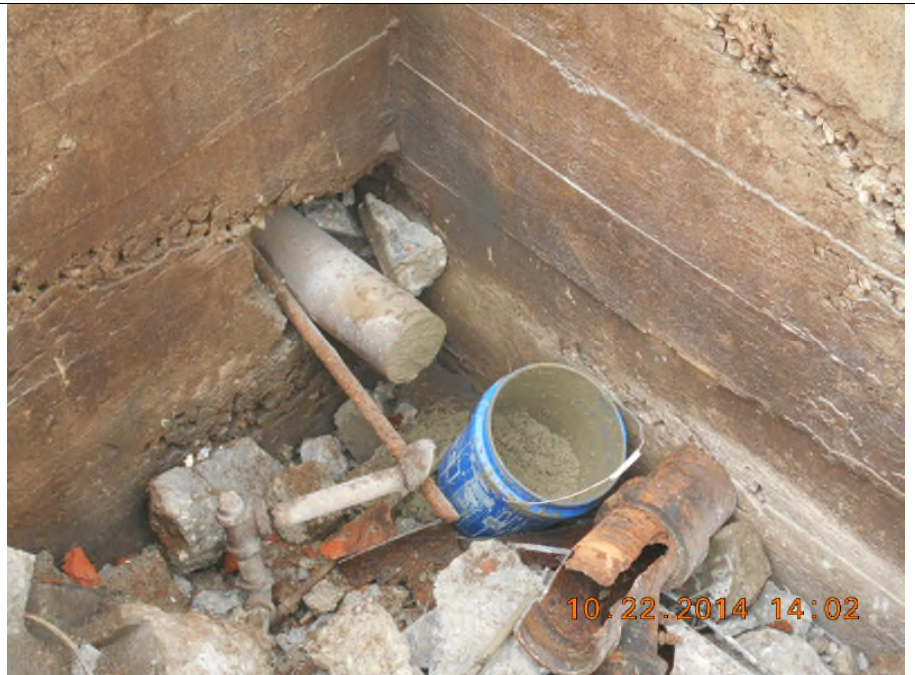
**Description:**  
Pipe, filled with concrete, located at the northern end of the tunnel.

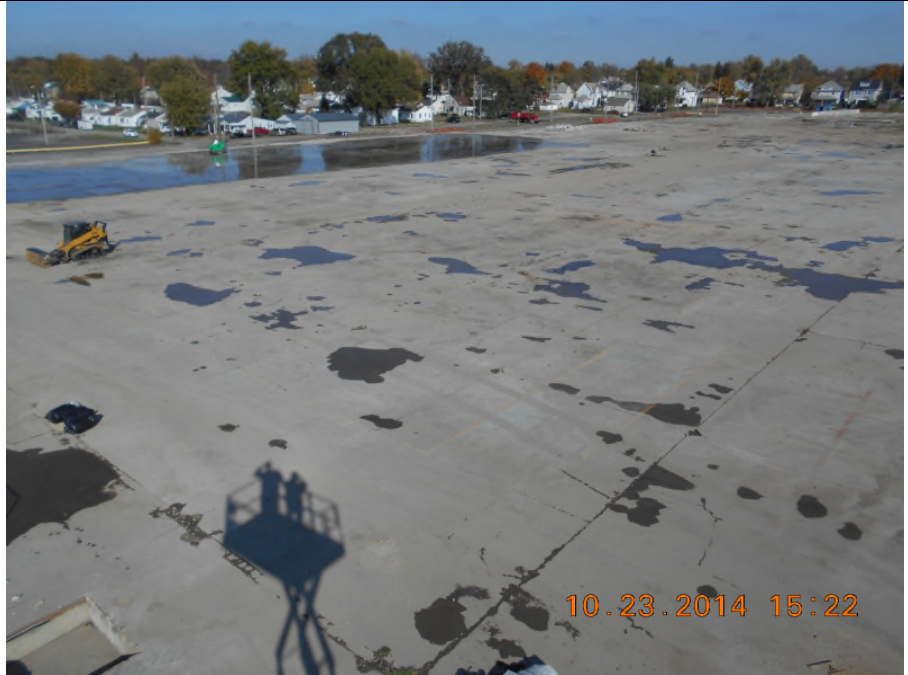
**Description:**  
Status of the concrete pad following the removal of the demolition debris.

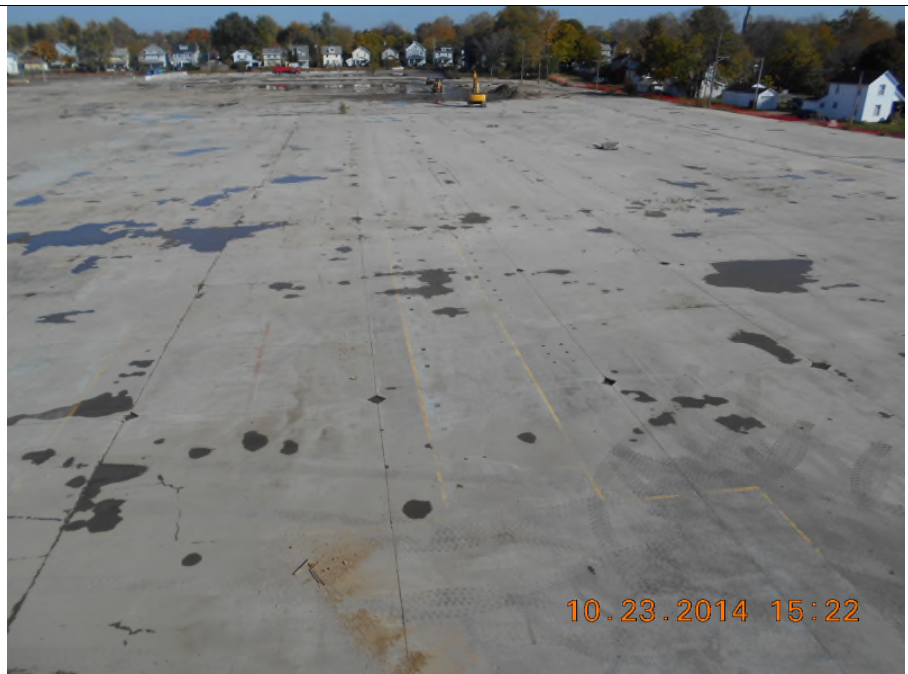
**Photograph:** 48

**Description:**  
Status of the concrete pad following the removal of the demolition debris.

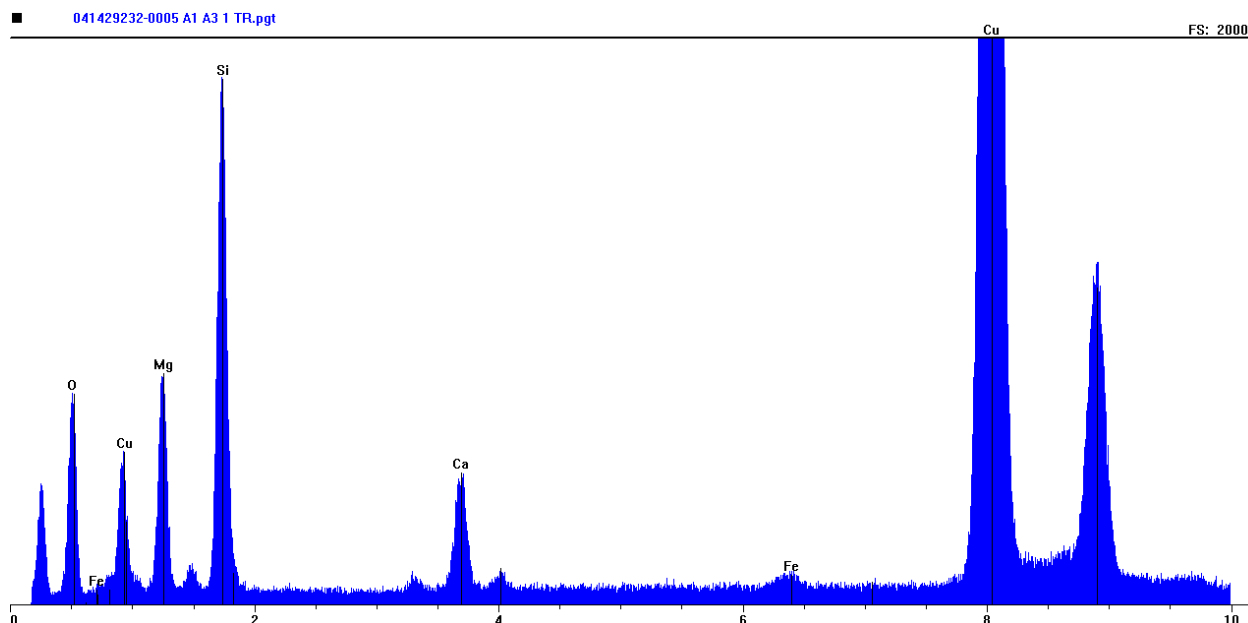
Element	Line	keV	CL Ratio	Wt%	At%	At Prop	Compound	Cmpd Wt%
Mg	KA1	1.254	1.4000	18.73	17.07	7.9	MgO	31.05
Si	KA1	1.740	1.0000	34.21	26.99	12.4	SiO	53.69
Ca	KA1	3.691	1.1000	10.22	5.65	2.6	CaO	14.30
Fe	KA1	6.403	1.3900	0.74	0.29	0.1	FeO	0.95
Cu	KA1	8.046	0.0000	0.00	0.00	0.0		
O	KA1	0.523	0.0000	36.10	50.00	23.0		
Total			0.0000	100.00	100.00	46.0	Total	100.00

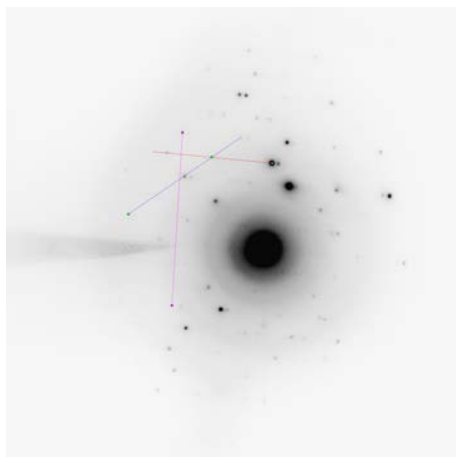
From SAED Reference Book, "unknown" diffraction pattern was found to be that of: **TREMOLITE**

With a Zone Axis of: [ **9-14** ]

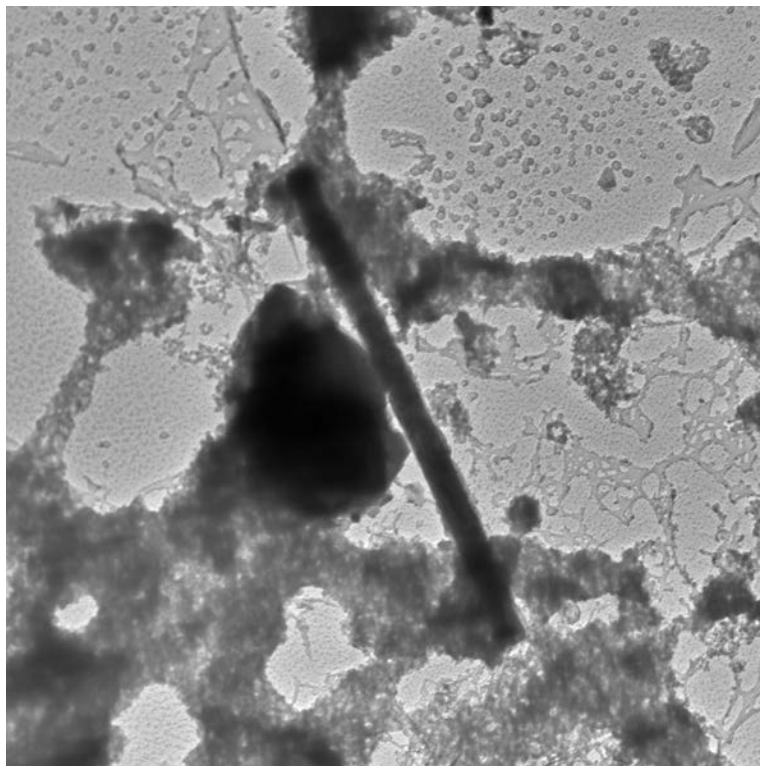
<b>Sample ID:</b>	0005
<b>Order ID:</b>	041429232
<b>Image Number:</b>	04541
<b>Mineral Type:</b>	TREMOLITE
<b>Date:</b>	10/7/2014
<b>Magnification:</b>	20000
<b>Microscope:</b>	3
