SITE VISIT REPORT
NAVAJO ABANDONED MINE LANDS RECLAMATION PROGRAM

DATE (S) OF VISIT:	04 February 2019
MINE/PROJECT NAME:	Cove Mesa V Haul Shaft Closure Project
DURATION OF VISIT:	1:00 pm – 2:00 pm
PURPOSE OF VISIT:	Construction Monitoring

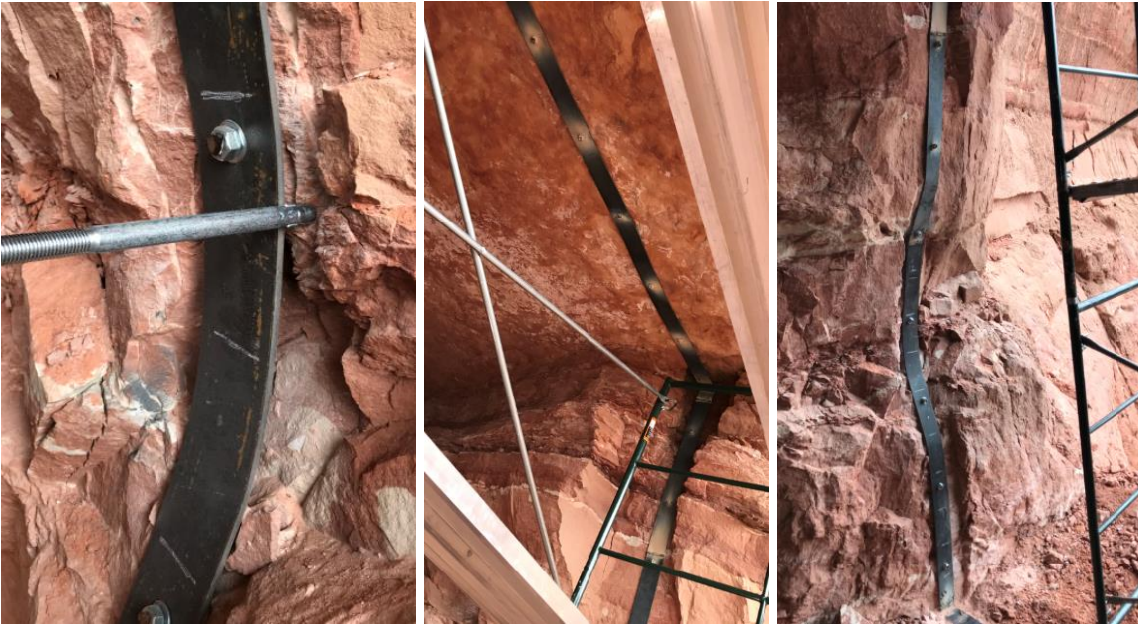
NAMLRD arrived to the site, a contractor was welding anchors to the frame plate, 80% completed at this point. Earlier, the outer framework had been completed. A 12inch ultrawdge anchor steel bolt (5/8-11x12) was anchored into the bed rock and welded on to the frame plate. The superintendent contractor, stated that they had a bit of a challenge with the rock bed above the haul shaft. The Civil Engineer and contractor discussed options for a robust support; it was agreed to install 3 support beams (2" pipe material, 4 foot on center) for vertical support. The field order, for this additional work will be issued. This should give the framework the support it needs to withstand the wire cables (1/4" 7x7 galv aircraft cable) tension force on the frame plates. Other contractors were staging the construction materials (see picture) for installation, thought out the day, while welding continued.

Anchor bolts (size: 5/8 – 11 x 12) installed into bed rock.

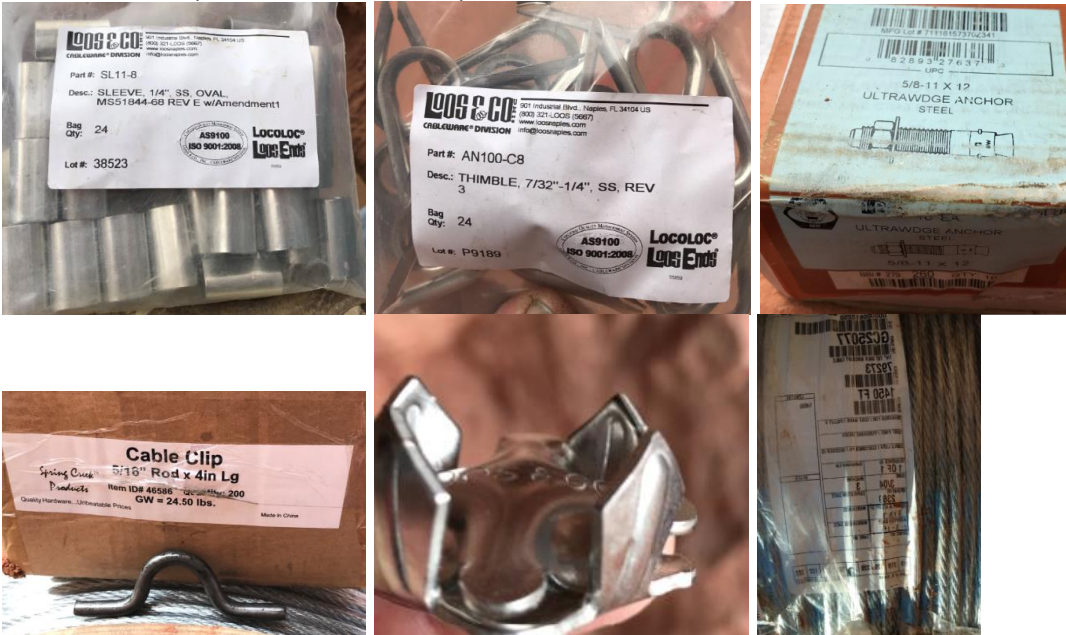
Materials staged for fabricating designed structure.
