SITE VISIT REPORT
NAVAJO ABANDONED MINE LANDS RECLAMATION PROGRAM

DATE (S) OF VISIT:	05 February 2019
MINE/PROJECT NAME:	USEPA Region 9, Cove Mesa V Haul Shaft Closure Project
DURATION OF VISIT:	2:00 pm – 5:00 pm
PURPOSE OF VISIT:	Construction Progress Inspection

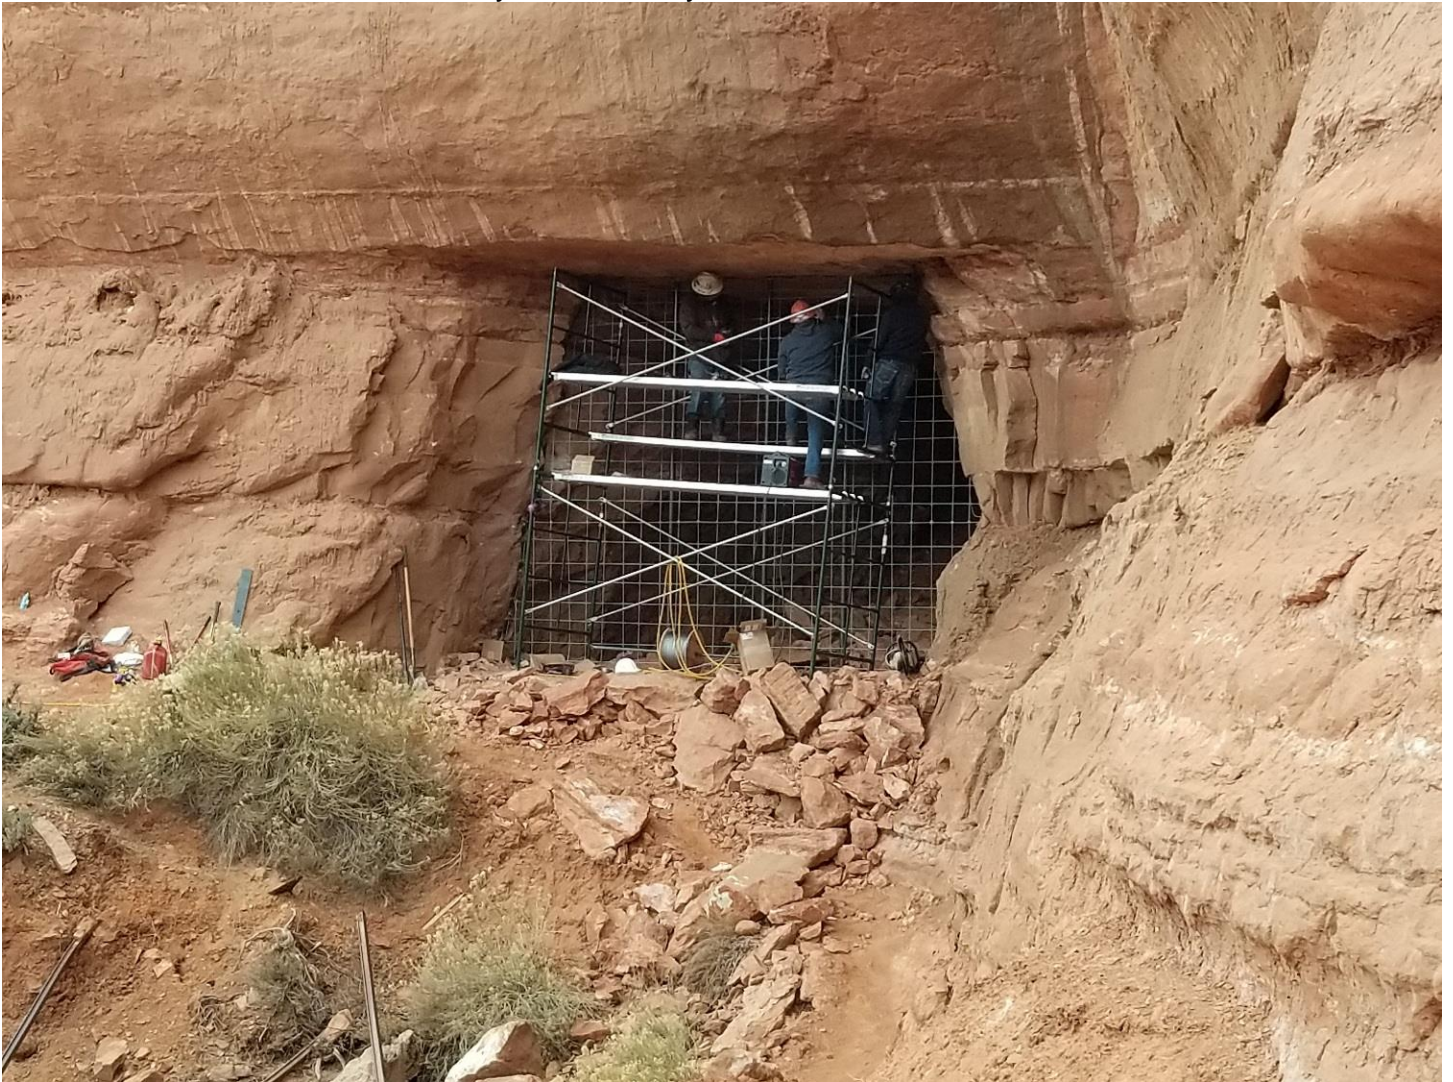
The contractor installed the three vertical support columns as discussed on the previous day. Upon inspecting the bottom plate and the vertical support columns, we decided that one more support was need to permanently stabilize the both the bottom and top plates to withstand the tension forces applied by the cables. All vertical and horizontal wire ropes were installed. The contractor's crew was installing the wire rope net clips (CP3-2) with a specific compression tool (#1-N). The clips were supplement with steel epoxy for permanent clamping. The closure was successfully coming together expect for the bottom plate slightly lifting of the floor.

Three vertical supports installed.

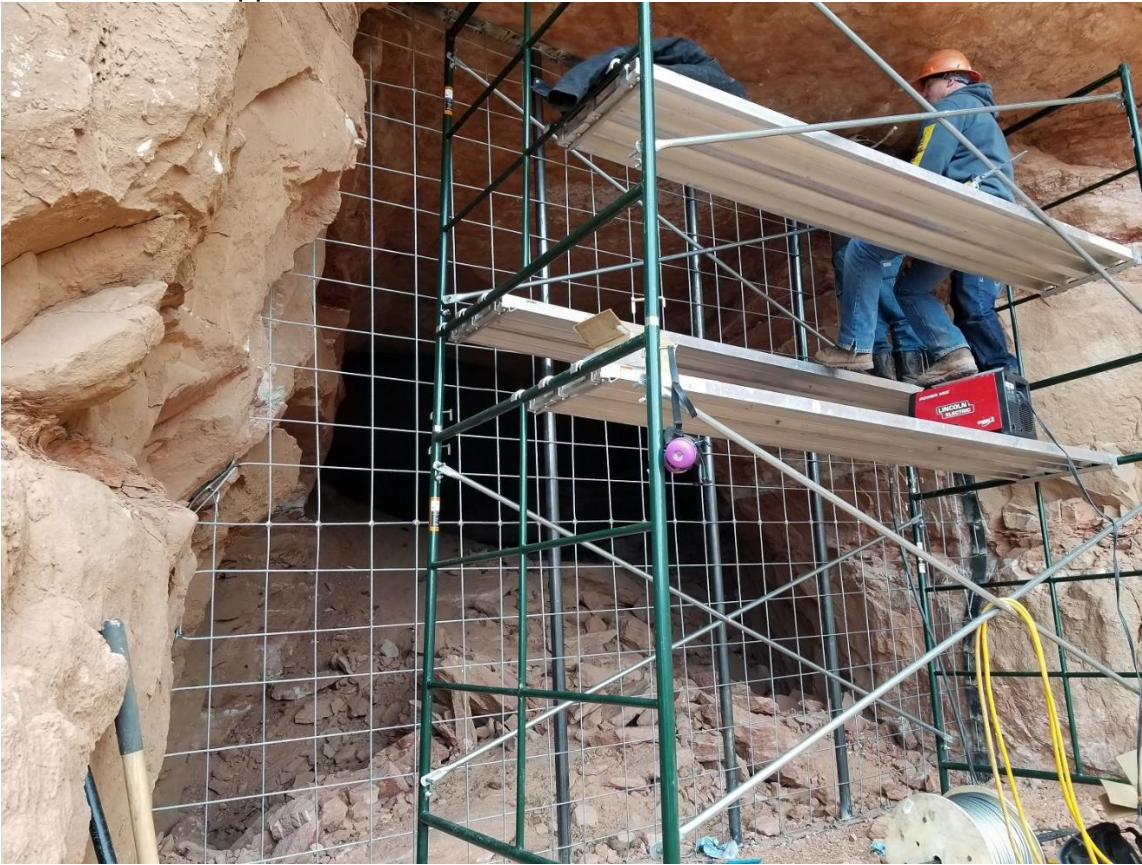
Three vertical support failed to secure bottom plate completely.
