Subject: Removal Action Report
Good Hope Road Drum Site, Berger, Missouri
U.S. EPA Region 7 START 5, [REDACTED]
Task Order No. 19F0058
Task Monitor: Kirk Mammoliti, On-Scene Coordinator

REMOVAL ACTION REPORT
GOOD HOPE ROAD DRUM SITE
BERGER, MISSOURI

Superfund Technical Assessment and Response Team (START) 5
[REDACTED]

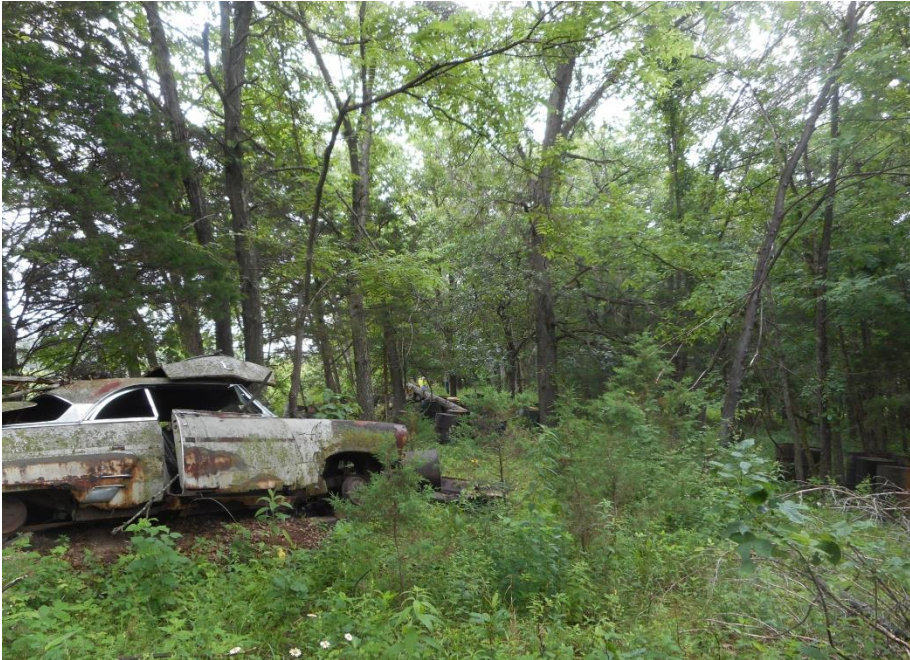
TETRA TECH PROJECT NO. <div style="background-color: black; width: 100px; height: 15px; margin: 5px 0;"></div> Direction: North	PHOTO DESCRIPTION	This photograph shows the wooded area where the drums had been abandoned.	1
	CLIENT	U. S. Environmental Protection Agency Region 7	Date
	PHOTOGRAPHER	<div style="background-color: black; width: 100px; height: 15px;"></div>	6/17/19

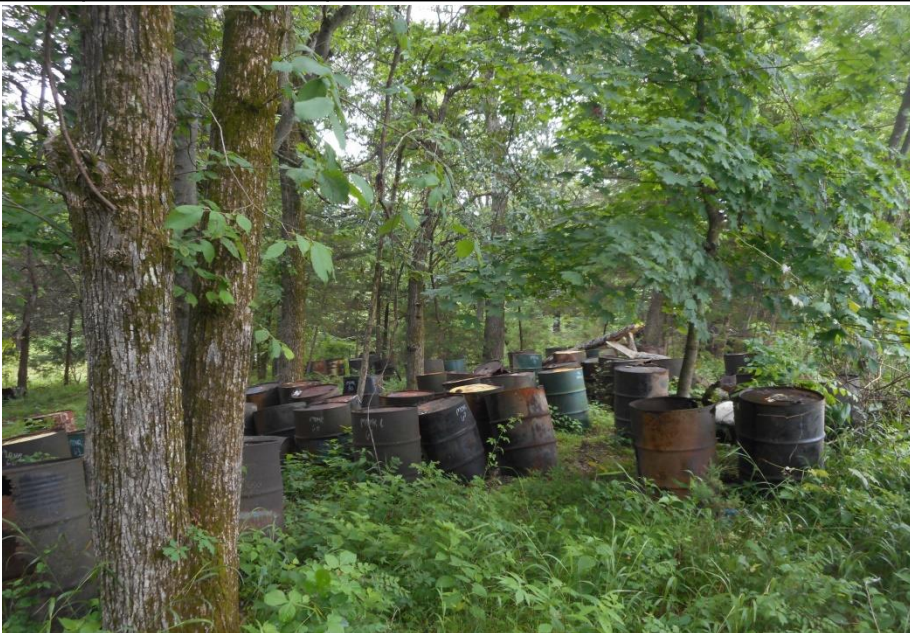
TETRA TECH PROJECT NO. <div style="background-color: black; width: 100px; height: 15px; margin: 5px 0;"></div> Direction: South	PHOTO DESCRIPTION	This photograph shows drums at the north side of the abandoned drum area.	2
	CLIENT	U. S. Environmental Protection Agency Region 7	Date
	PHOTOGRAPHER	<div style="background-color: black; width: 100px; height: 15px;"></div>	6/17/19

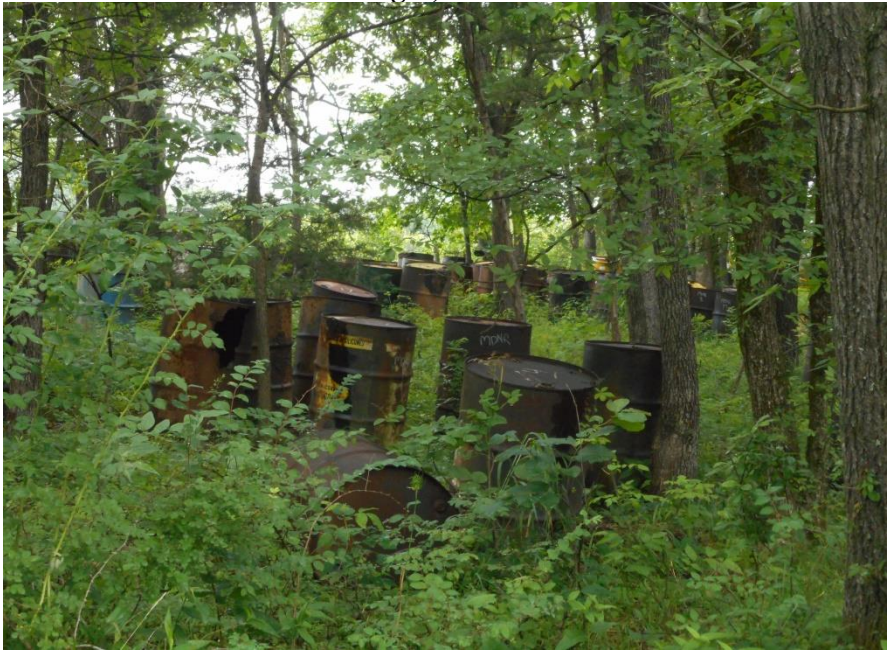
TETRA TECH PROJECT NO. <div style="background-color: black; width: 100px; height: 15px; margin: 5px 0;"></div> Direction: North	PHOTO DESCRIPTION	This photograph shows some of the abandoned drums.	3
	CLIENT	U. S. Environmental Protection Agency Region 7	Date
	PHOTOGRAPHER	<div style="background-color: black; width: 100px; height: 15px;"></div>	6/17/19

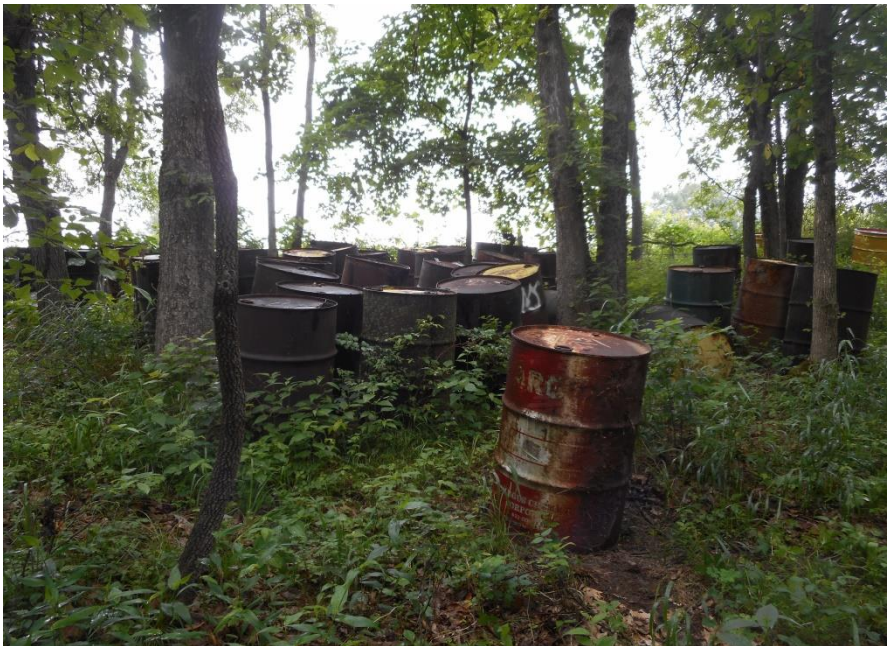
TETRA TECH PROJECT NO. <div style="background-color: black; width: 100px; height: 15px; margin: 5px 0;"></div> Direction: Northwest	PHOTO DESCRIPTION	This photograph shows a group of drums at the northeastern portion of the abandoned drum area.	4
	CLIENT	U. S. Environmental Protection Agency Region 7	Date
	PHOTOGRAPHER	<div style="background-color: black; width: 100px; height: 15px;"></div>	6/17/19

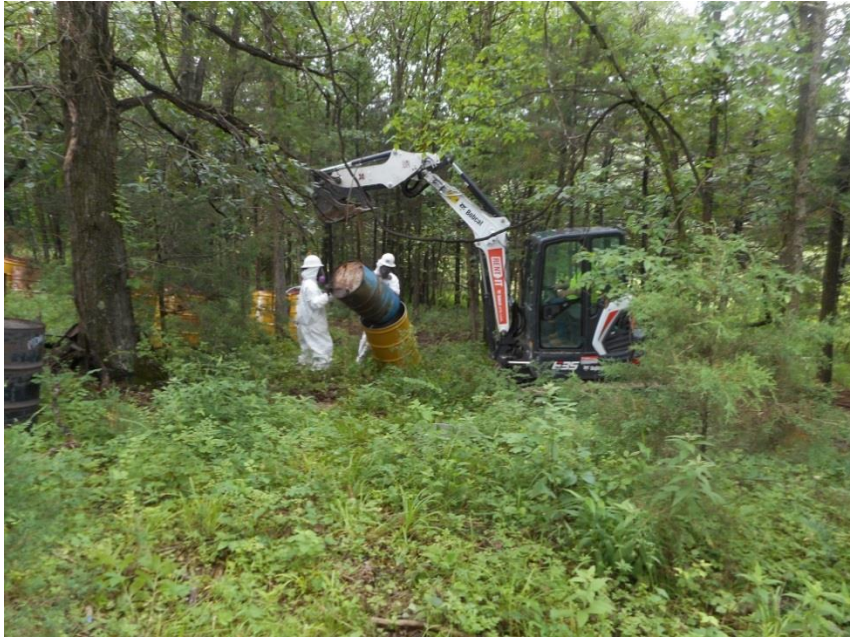
TETRA TECH PROJECT NO. <div style="background-color: black; width: 100px; height: 15px; margin: 5px 0;"></div> Direction: North	PHOTO DESCRIPTION	This photograph shows placement of an abandoned drum into an 85-gallon overpack drum.	5
	CLIENT	U. S. Environmental Protection Agency Region 7	Date
	PHOTOGRAPHER	<div style="background-color: black; width: 100px; height: 15px; margin: 5px 0;"></div>	6/18/19

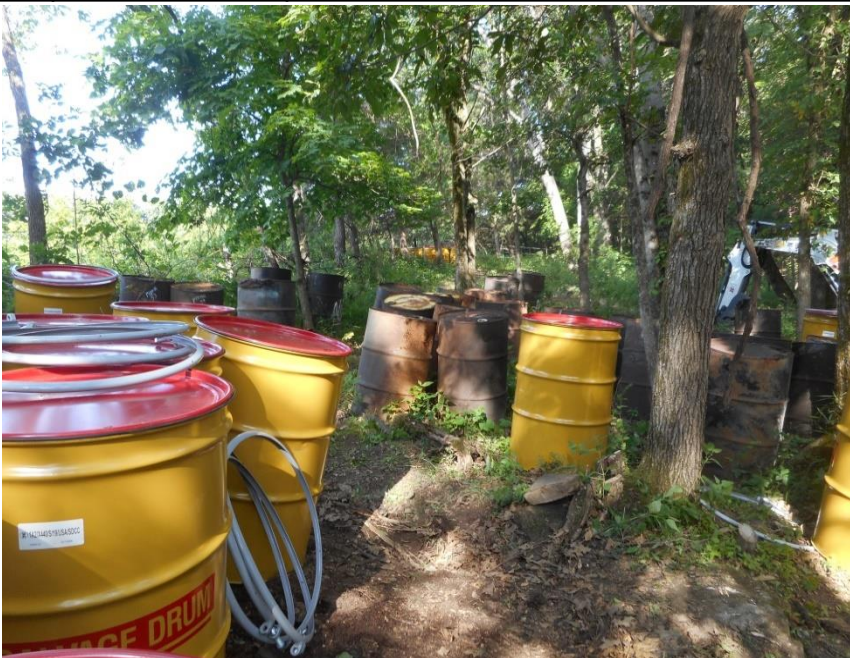
TETRA TECH PROJECT NO. <div style="background-color: black; width: 100px; height: 15px; margin: 5px 0;"></div> Direction: North	PHOTO DESCRIPTION	This photograph shows some abandoned drums and 85-gallon overpack drums.	6
	CLIENT	U. S. Environmental Protection Agency Region 7	Date
	PHOTOGRAPHER	<div style="background-color: black; width: 100px; height: 15px; margin: 5px 0;"></div>	6/18/19

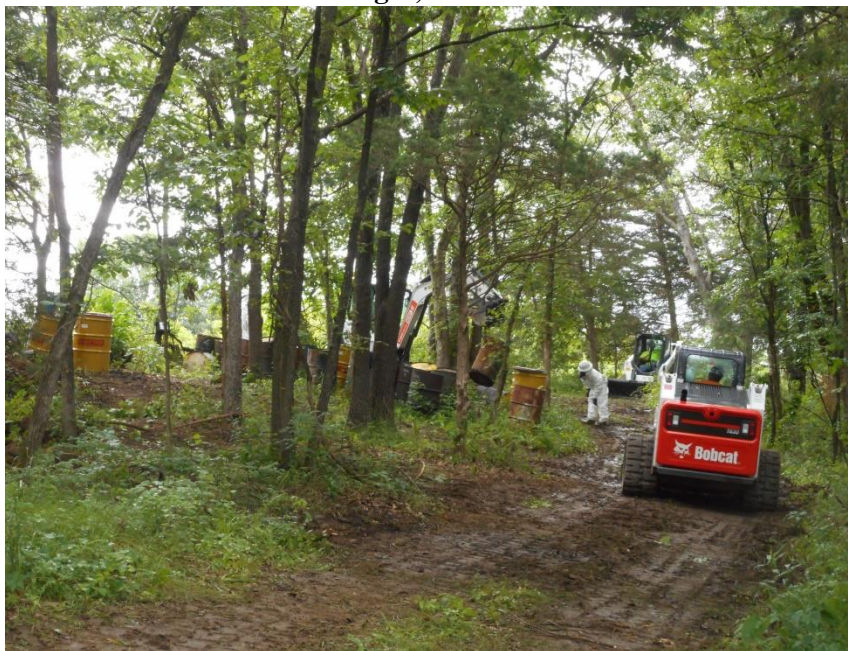
TETRA TECH PROJECT NO. <div style="background-color: black; width: 100px; height: 15px; margin-top: 5px;"></div>	PHOTO DESCRIPTION	This photograph shows an abandoned drum being lifted into an overpack drum.	7
	CLIENT	U. S. Environmental Protection Agency Region 7	Date
	PHOTOGRAPHER	<div style="background-color: black; width: 100px; height: 15px;"></div>	6/19/19

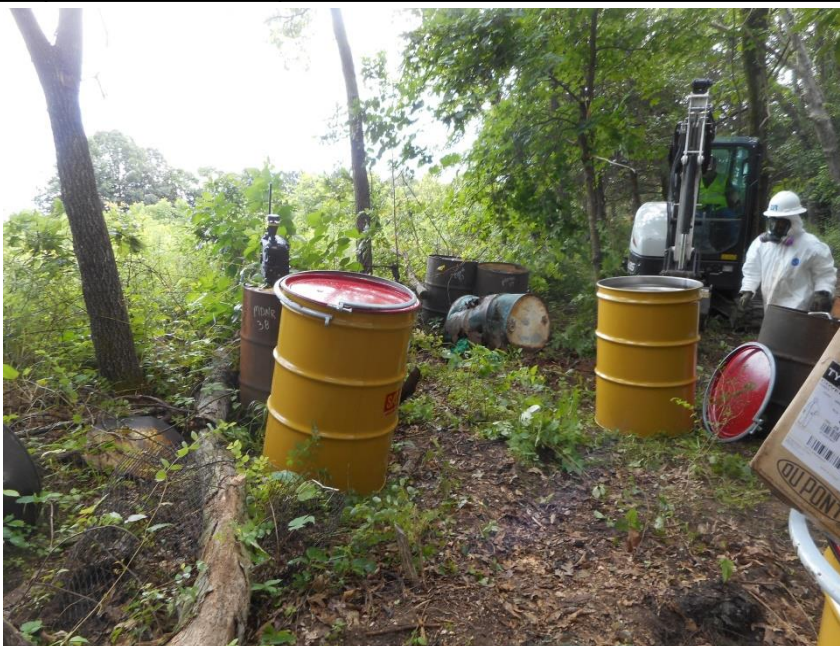
TETRA TECH PROJECT NO. <div style="background-color: black; width: 100px; height: 15px; margin-top: 5px;"></div>	PHOTO DESCRIPTION	This photograph shows overpacking activities in the northwest portion of the abandoned drum area.	8
	CLIENT	U. S. Environmental Protection Agency Region 7	Date
	PHOTOGRAPHER	<div style="background-color: black; width: 100px; height: 15px;"></div>	6/19/19

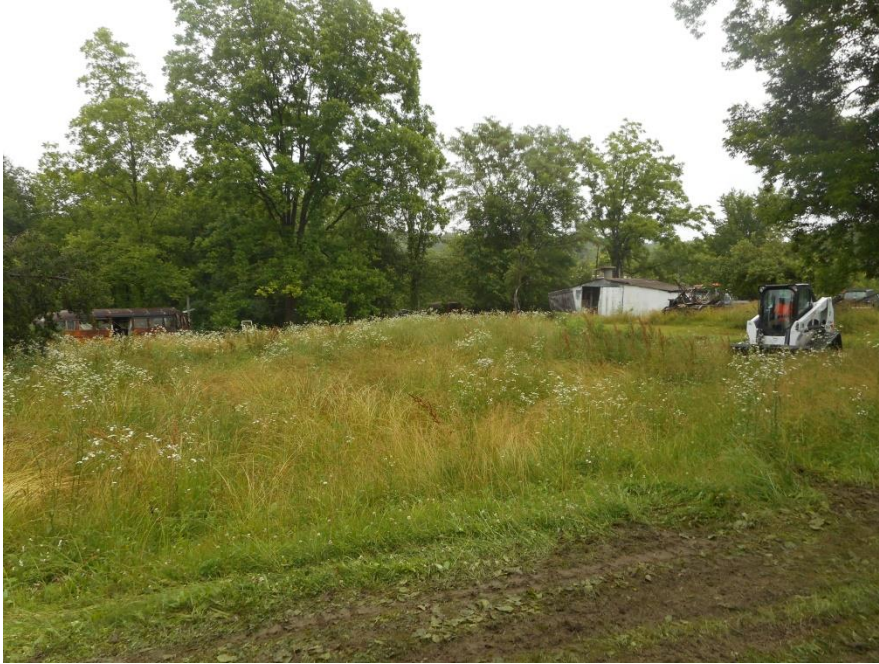
TETRA TECH PROJECT NO. <div style="background-color: black; width: 100px; height: 15px; margin: 5px 0;"></div> Direction: West	PHOTO DESCRIPTION	This photograph shows the area near Good Hope Road where the overpacked drums were staged.	9
	CLIENT	U. S. Environmental Protection Agency Region 7	Date
	PHOTOGRAPHER	<div style="background-color: black; width: 100px; height: 15px;"></div>	6/17/19

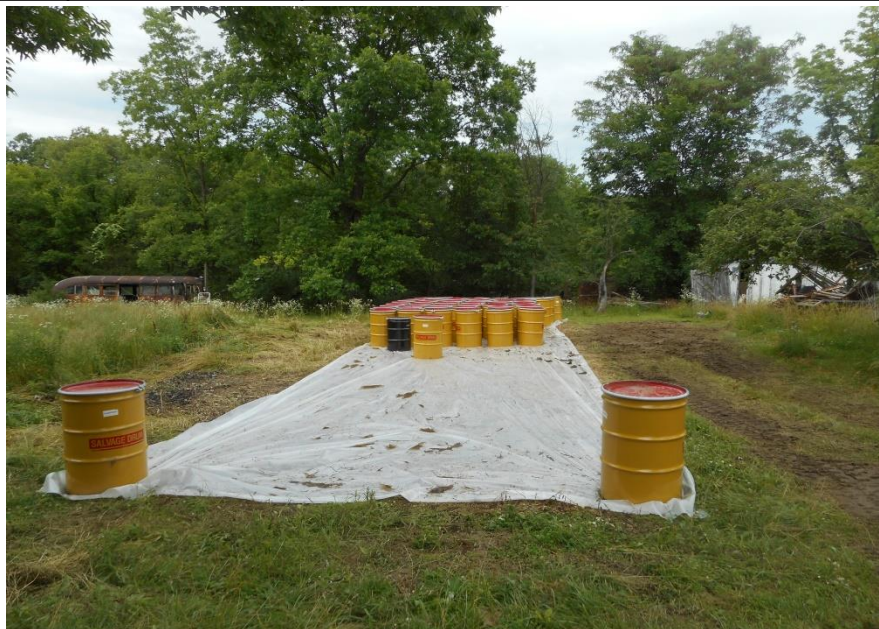
TETRA TECH PROJECT NO. <div style="background-color: black; width: 100px; height: 15px; margin: 5px 0;"></div> Direction: West	PHOTO DESCRIPTION	This photograph shows the staging area with overpacked drums sitting on plastic sheeting.	10
	CLIENT	U. S. Environmental Protection Agency Region 7	Date
	PHOTOGRAPHER	<div style="background-color: black; width: 100px; height: 15px;"></div>	6/19/19

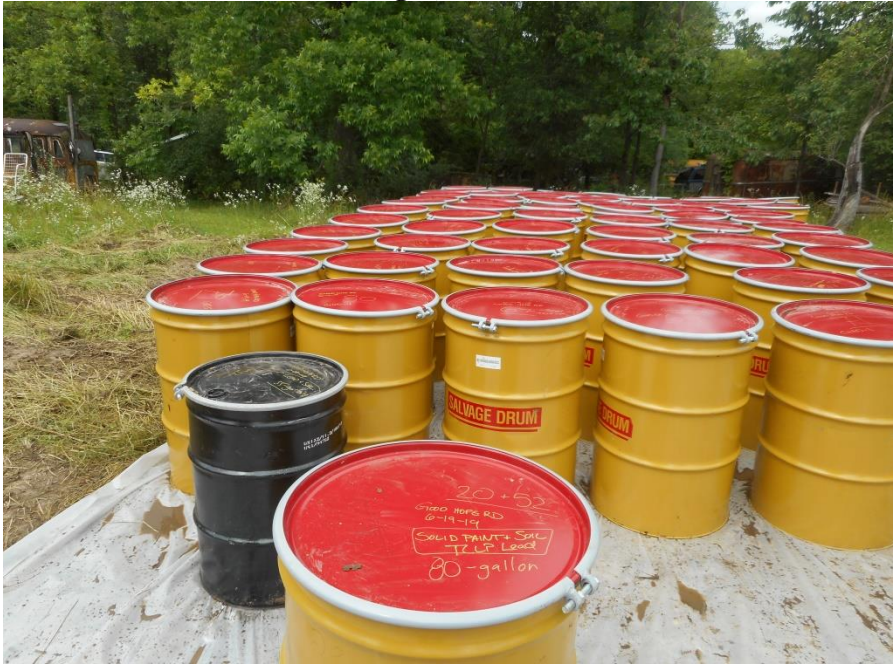
TETRA TECH PROJECT NO. <div style="background-color: black; width: 100px; height: 15px; margin: 5px 0;"></div> Direction: West	PHOTO DESCRIPTION	This photograph shows the staged overpacked drums.	11
	CLIENT	U. S. Environmental Protection Agency Region 7	Date
	PHOTOGRAPHER	<div style="background-color: black; width: 100px; height: 15px;"></div>	6/19/19

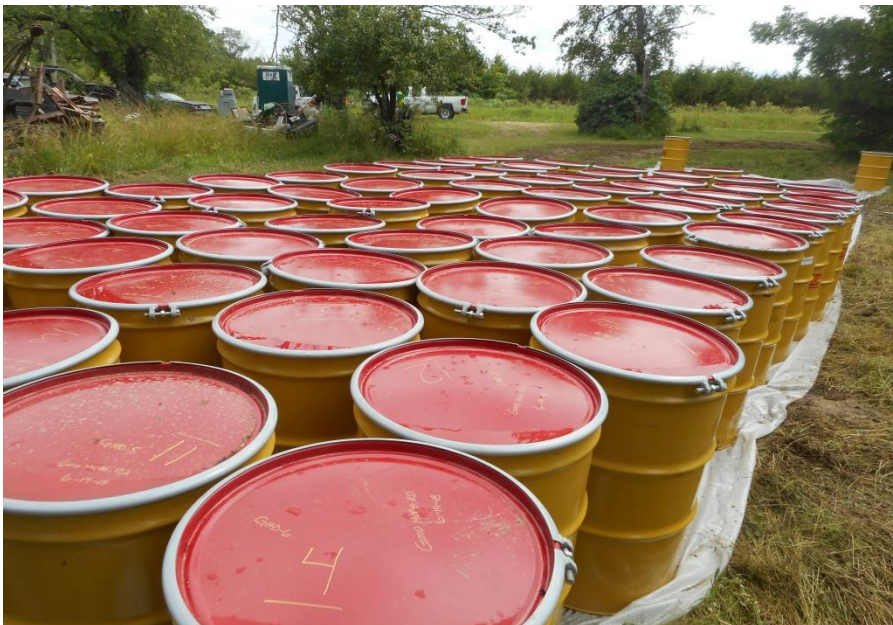
TETRA TECH PROJECT NO. <div style="background-color: black; width: 100px; height: 15px; margin: 5px 0;"></div> Direction: East	PHOTO DESCRIPTION	This photograph shows the staged overpacked drums, looking toward Good Hope Road.	12
	CLIENT	U. S. Environmental Protection Agency Region 7	Date
	PHOTOGRAPHER	<div style="background-color: black; width: 100px; height: 15px;"></div>	6/19/19

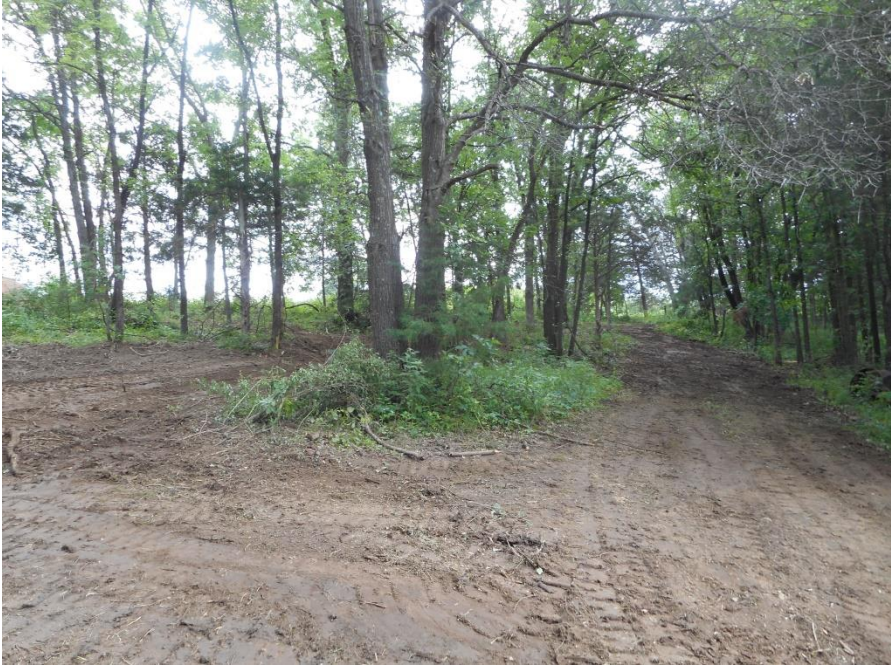
TETRA TECH PROJECT NO. <div style="background-color: black; width: 100px; height: 15px; margin-top: 5px;"></div> Direction: North	PHOTO DESCRIPTION	This photograph shows the abandoned drum area after all drums had been removed.	13
	CLIENT	U. S. Environmental Protection Agency Region 7	Date
	PHOTOGRAPHER	<div style="background-color: black; width: 100px; height: 15px;"></div>	6/19/19

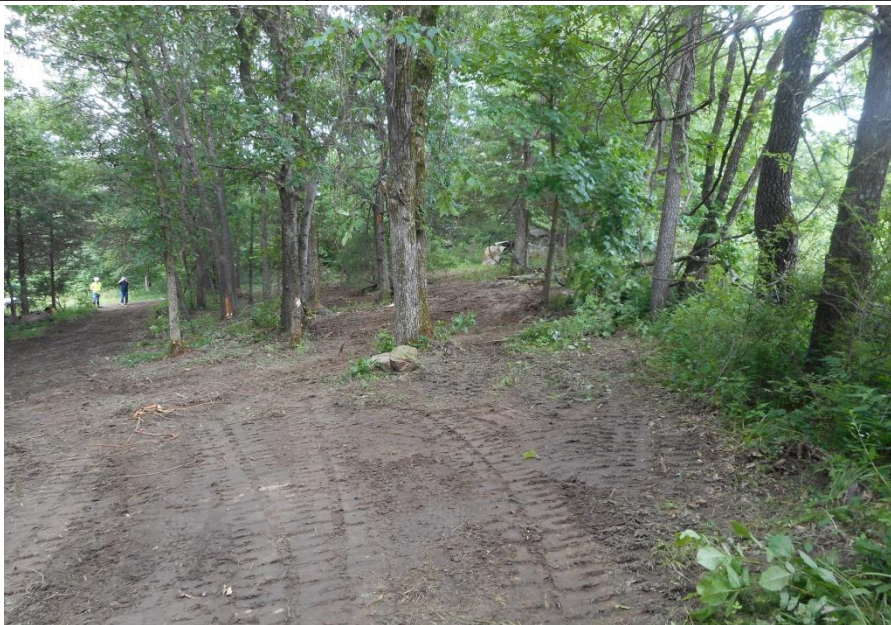
TETRA TECH PROJECT NO. <div style="background-color: black; width: 100px; height: 15px; margin-top: 5px;"></div> Direction: South	PHOTO DESCRIPTION	This photograph shows the abandoned drum area after all drums had been removed.	14
	CLIENT	U. S. Environmental Protection Agency Region 7	Date
	PHOTOGRAPHER	<div style="background-color: black; width: 100px; height: 15px;"></div>	6/19/19
