**REMOVAL ASSESSMENT REPORT  
ELECTRO PLATING SERVICES SITE - RS  
MADISON HEIGHTS, OAKLAND COUNTY, MICHIGAN**

**FINAL Report**

TDD No.:	S05-0001-16-12-002
Date Prepared:	January 17, 2017
Contract No.:	EP-S5-16-01
Prepared by:	SRS
START Project Manager:	Cheryl Kondreck
Telephone No.:	(312) 220-7171 x2227
U.S. EPA On-Scene Coordinator:	Jeffrey Lippert
Telephone No.:	(734) 692-7682

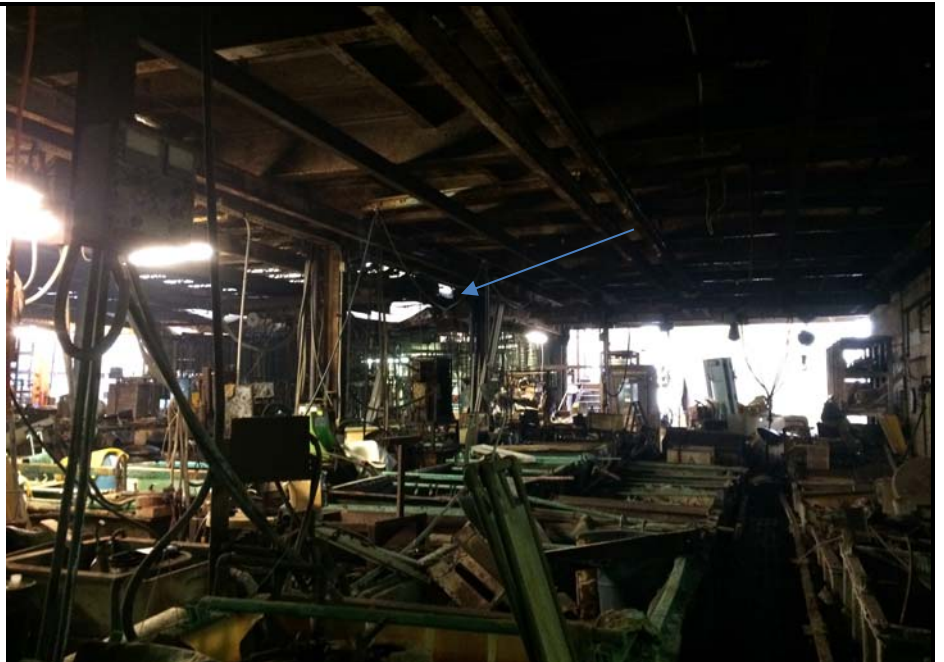
**Official Photograph No.1:** Second  
 level general layout of facility.  
 Ceiling caving is depicted in this  
 photograph

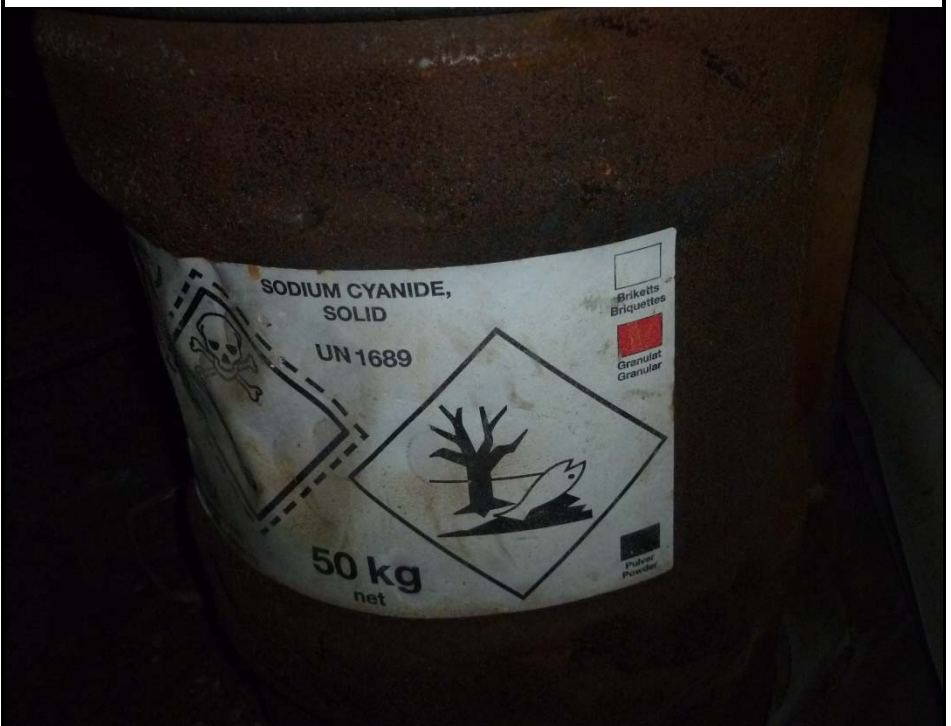
**Official Photograph No.2:** Rusty  
 metal drum with sodium cyanide  
 label.

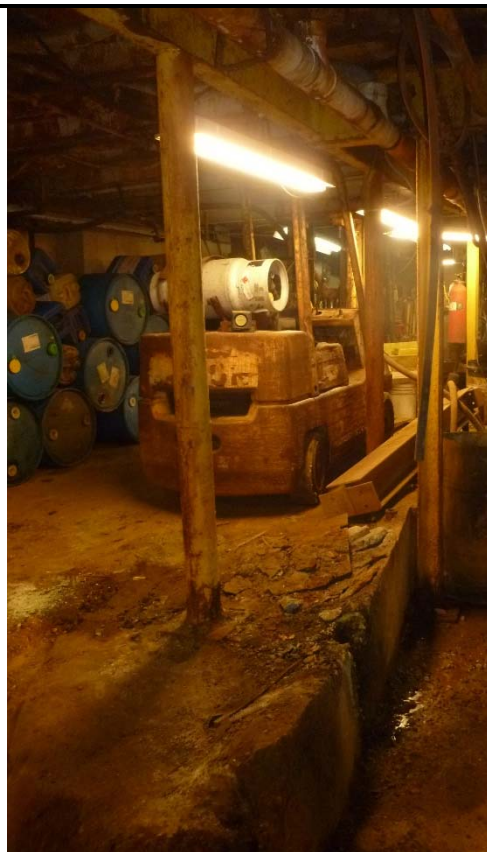
**Official Photograph No.7:** Corroded basement floor from waste dripping from the ceiling

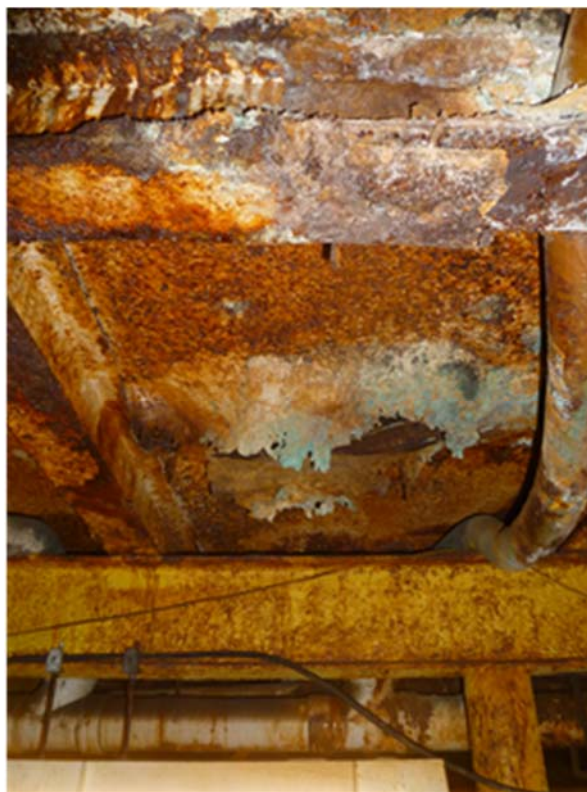
**Official Photograph No.8:** Corroded ceiling of the basement

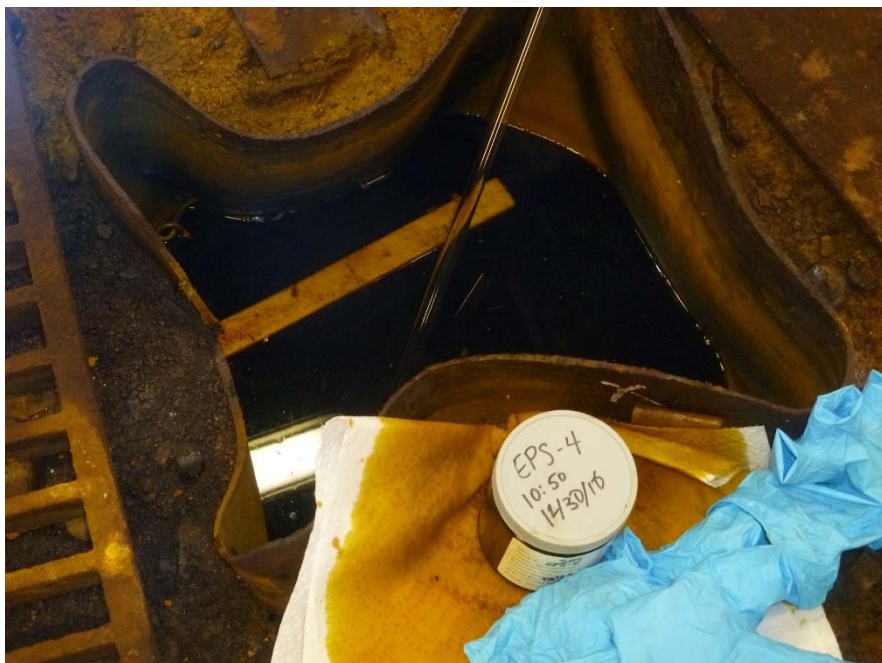
**Official Photograph No.12:** Makeshift  
 container buried in the floor of the  
 basement holding liquid waste.  
 Sample ID: EPS-4  
 Sample description: Brownish/orange  
 liquid.
