COMPREHENSIVE ASBESTOS CONTAINING BUILDING MATERIALS SURVEY

Project Name:
Asbestos Sequence and Removal
National Forest Products Industry Site
Navajo, New Mexico

EES Project Number: 18-958

Envision Environmental Solutions, LLC has prepared the following potential “Sequence of Removal operations for the decommissioned Drying Kiln Building located upon the former National Forest Industry Site near Red Lake, Arizona.

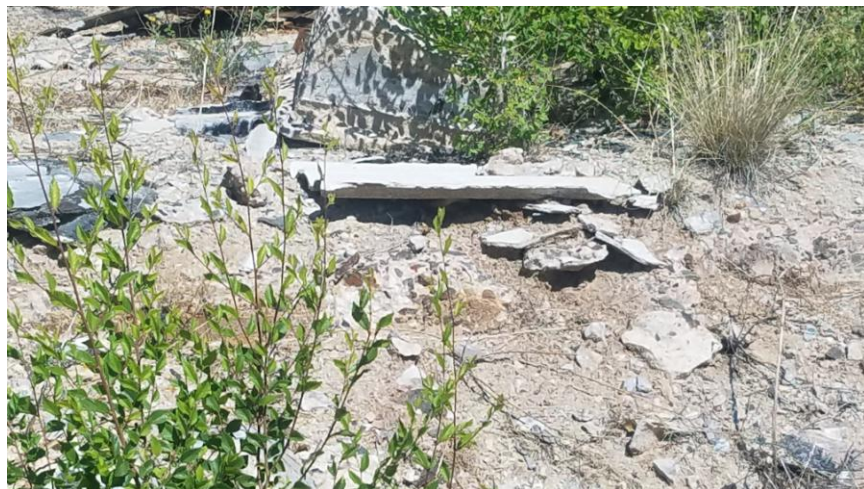
The first step in the removal process should be the clean-up of the soils along the perimeter of the building, possibly to a distance of up to 50 feet. As mentioned, the sealant material originally applied to wall surfaces has delaminated in places and has been scattered by the elements to beyond the building footprint.

Photo 1 – Example of potential contamination on soil beyond the building’s footprint

The distance from the buildings perimeter walls, as well as a determination of how much and to what depth the soils should be removed could be determined by additional bulk sample collection and analysis of the soil. Prior to soils clean-up, penetrations and doorways in the building should be sealed to ensure that ACM within the structure cannot re-contaminate the soil.

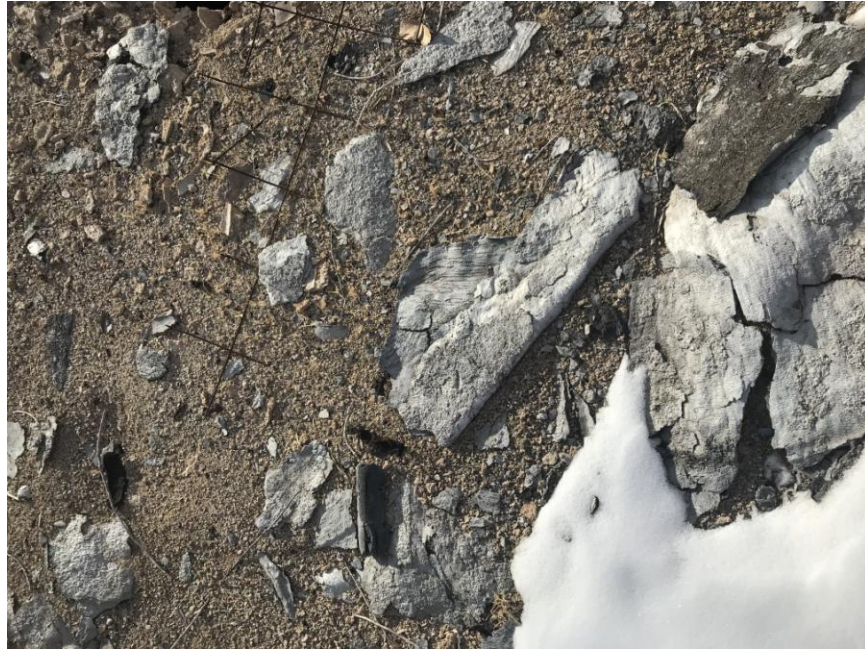
Photo 2 – Example of potential contamination on soil beyond the building's footprint

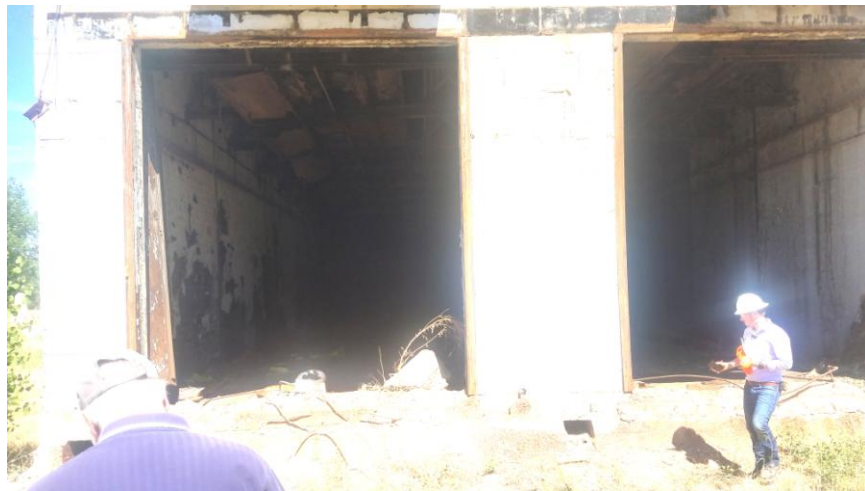
A likely second step in the clean-up process would most likely be the clean-up and disposal of debris on floor surfaces within the building. Presently, floors are littered with debris, “blown-in” soils and dead vegetation.

Photo 3 – Example of potential contamination on floor surfaces within the structure.

Clean-up must be accomplished within a “negative pressure enclosure” complete with three compartment personnel decontamination enclosure located at each entrance.

Once floors within the structure are clean and HEPA vacuumed, they should be protected from likely future contamination with a minimum of two layers of 6 mil polyethylene sheeting, held in place by duct tape.

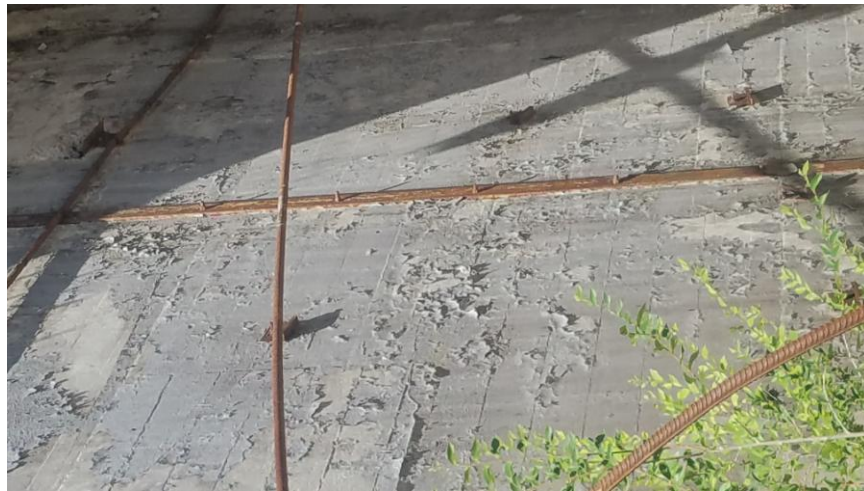
Asbestos materials were identified in the tar-like material applied to all interior walls which has delaminated in many areas and has fallen into the debris on the floors. The delaminated material has been able to migrate to the soils along the building’s exterior. Asbestos content has also been confirmed in the corrugated concrete material used as underlayment on the roof. Additionally, asbestos content is also assumed in roofing sealants applied to seams and penetrations located on the roof.

Photo 4 – Example of delaminating “Tar like” material on wall surfaces within the structure.

Once clean-up and surface protection is in place, removal of the tar-like material on interior concrete wall surfaces could be accomplished. The use of any type of abrasive power tools is prohibited by the Occupational Safety and Health Administration (OSHA). Some contractors have had success using a “Hydo-Jet” high pressure spray inside an enclosed vessel that is placed against the wall. The system is totally enclosed and all water from the system is captured, filtered and re-used. Resulting solid wastes are double bagged and land-filled as asbestos containing waste material (ACWM).

Once removal of tar-like materials from wall surfaces is complete, “final clearance samples” should be obtained in each work area. This needs to be accomplished prior to the removal of critical barriers over doors and other penetrations into the work areas.

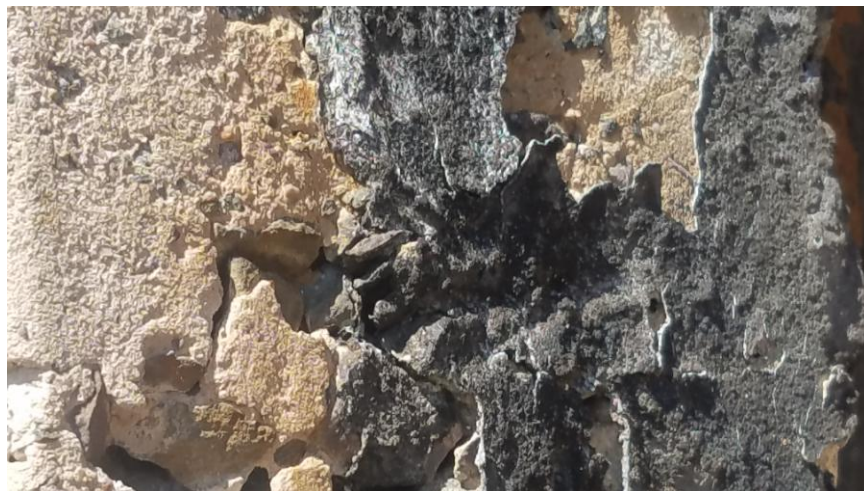
Photo 5 – Close-up of delaminating “tar like” material on wall surfaces within the structure.

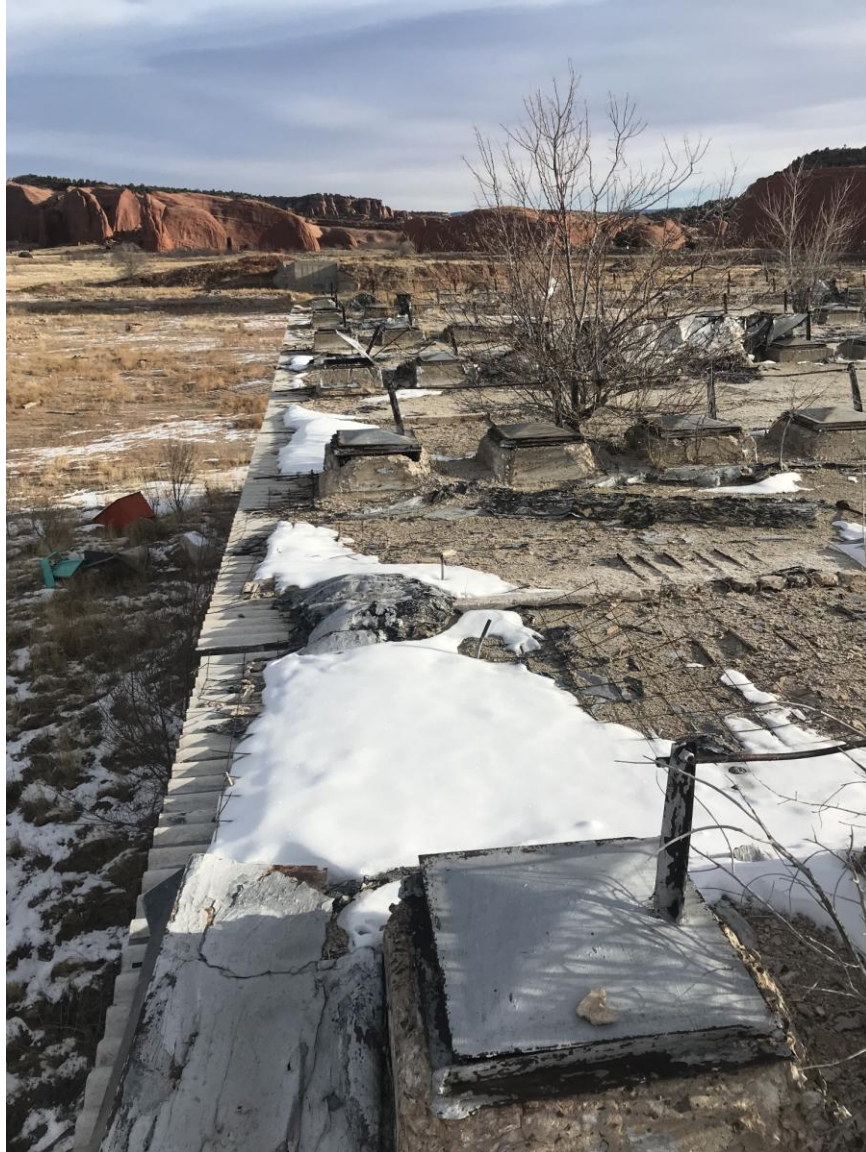
Roof sealants are commonly found to contain ACM. This particular roof has numerous small structures that are likely coated with asbestos containing sealants. This material, if confirmed to contain asbestos must be removed to expose the corrugated cement asbestos board. The removed material must be disposed of as ACWM.

Once the “built-up” roofing material is removed the exposed corrugated concrete panels could then be removed immediately after being exposed, as the fastening system holding the panels in place is most likely deteriorated, and the panels could likely blow off in the wind, or become dislodged and fall. All removed panels must be wrapped in two layers of six mil polyethylene sheeting and disposed as asbestos contaminated waste material.
