M/V St. Clair Fire Case Study

USCG MSU Toledo

- M/V ST CLAIR (U.S.)
- 770' Bulk Carrier
- O/O: American Steamship Company
- Year Built: 1976
- Twin conveyor system below cargo holds to transport cargo to inclined conveyor belt to deck-mounted boom conveyor.
- Long-haul transport of iron ore pellets, coal, & limestone.

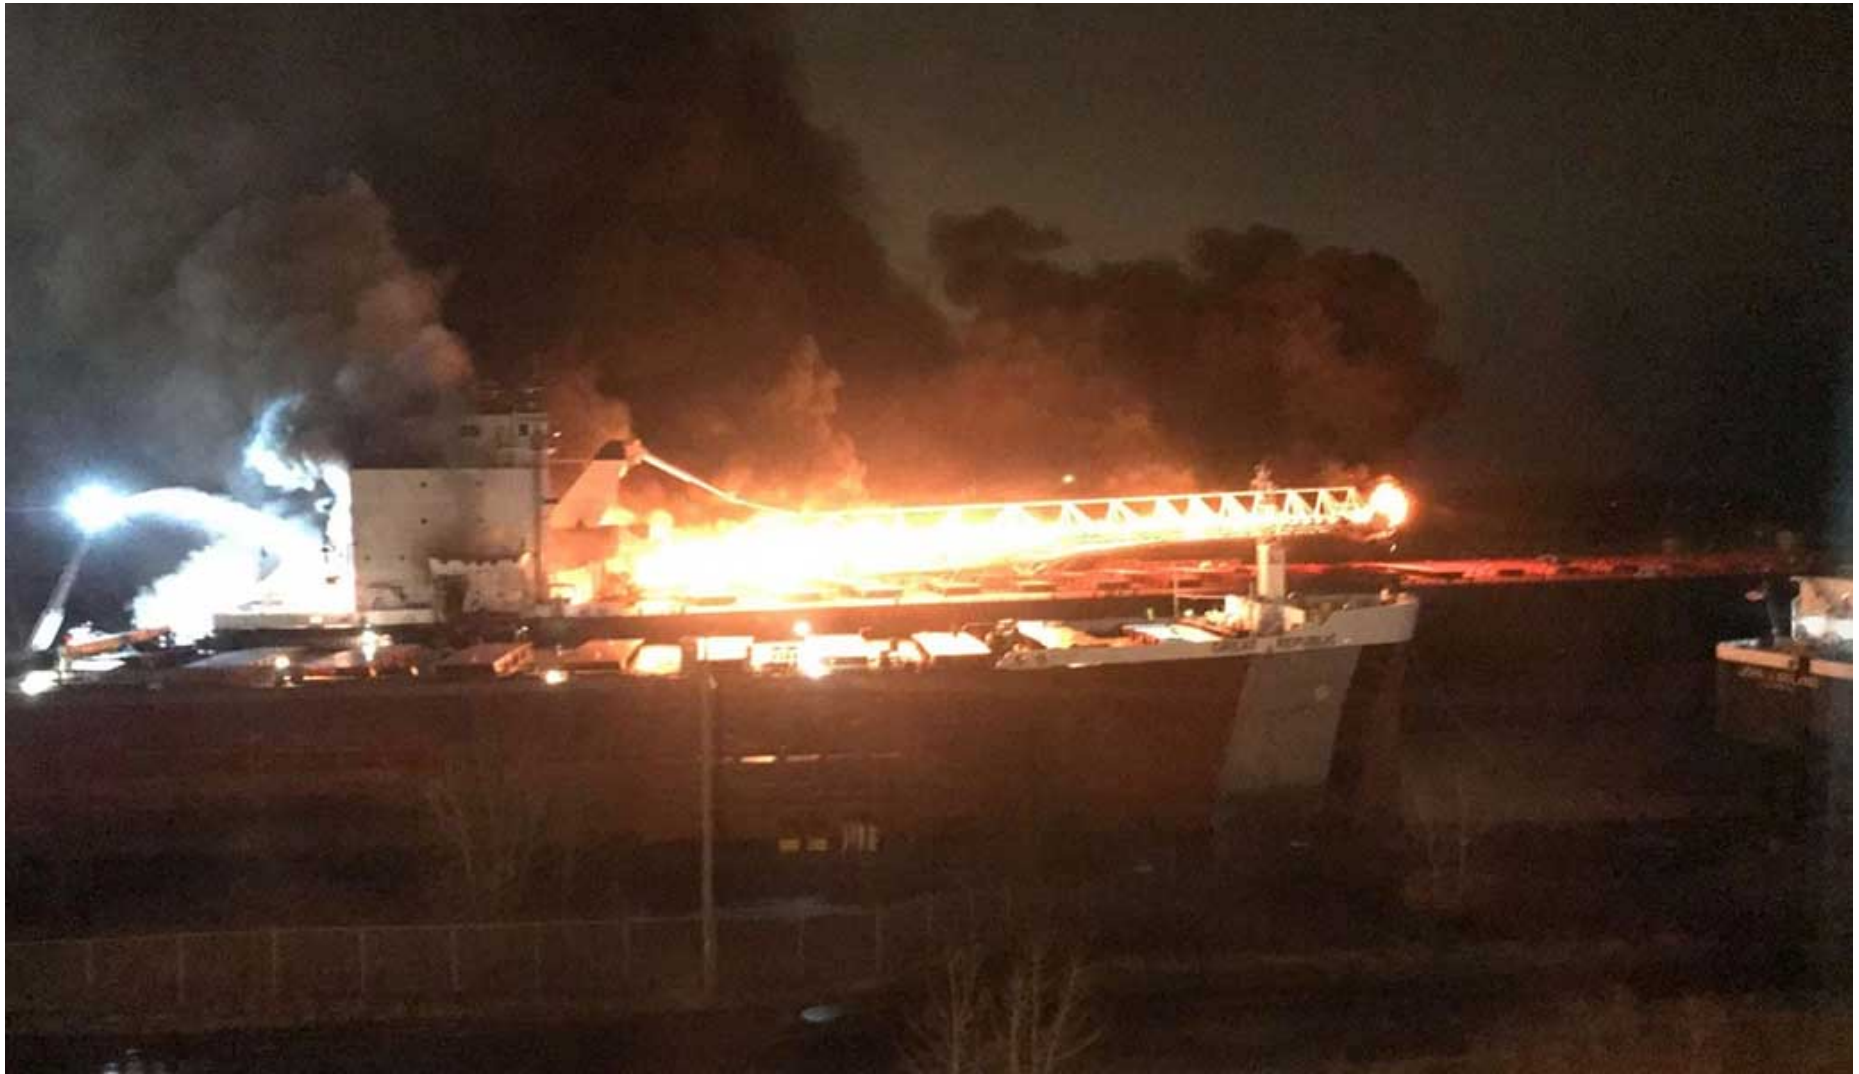
2300 – 16 February 2019

- Fire broke out on vessel at approximately **2015 (local) on 16Feb19.**
- Vessel moored at the CSX Torco Iron Ore Terminal.
- Vessel in caretaker status during winter layup – no personnel on board/no cargo with the exception of 69,000 gallons residual fuel oil onboard.
- Oregon OH Fire Department – first responders (assumed Incident Commander).
- Incident Command Post established on site.
- Eight other local fire departments assisted through mutual aid request.
- **0800 18Feb19** - Unified Command formally established (CG MSU Toledo, Oregon FD, Ohio EPA, RP American Steamship)
- Fire continued to burn for over 36 hours and smoldered for 8 days.
- **27Feb19** – Unified Command stood down

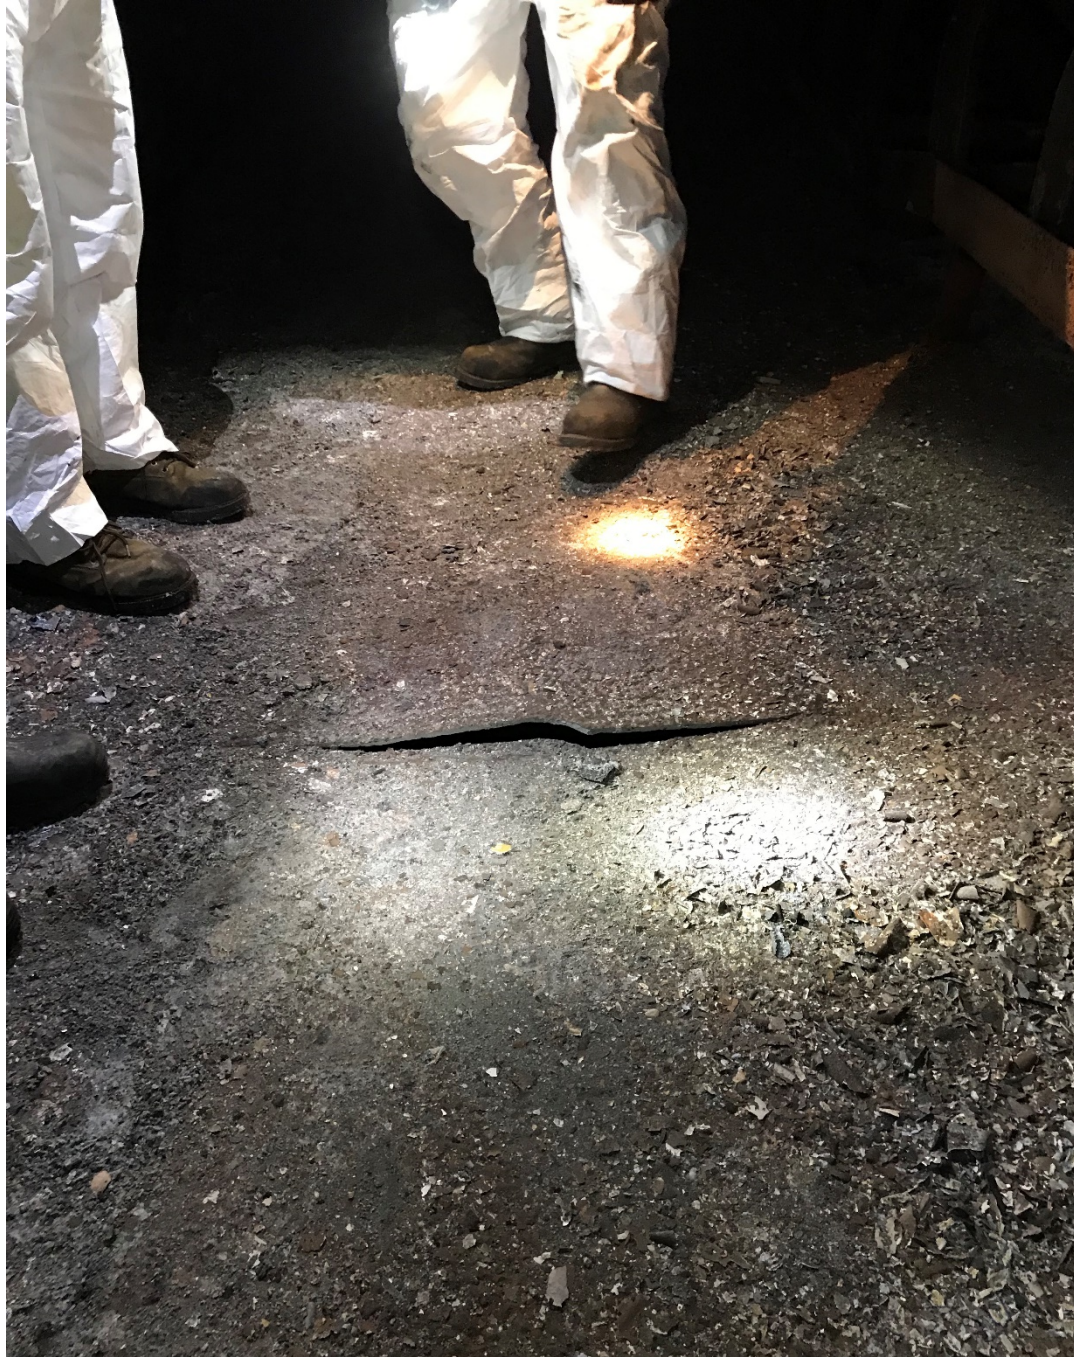
Starboard Conveyor Tunnel Deck Fracture - amidship

- Oil Spill Liability Trust Fund (opened to augment ICS positions)
- OH EPA “After-the-fact” direct overboard discharge permit – 1.5 million gallons of water to preserve stability of vessel at 0300 on 19Feb19.
- Sampling of direct overboard discharge water from #5 center ballast tank
- Air Quality Monitoring
