Airborne Spectral Photometric Environmental Collection Technology

ASPECT Hurricane Laura Assessment Beaumont, Orange and Port Arthur, TX 28-30 August 2020

ASPECT Hurricane Laura Assessment Beaumont and Port Arthur, TX 30 August 2020

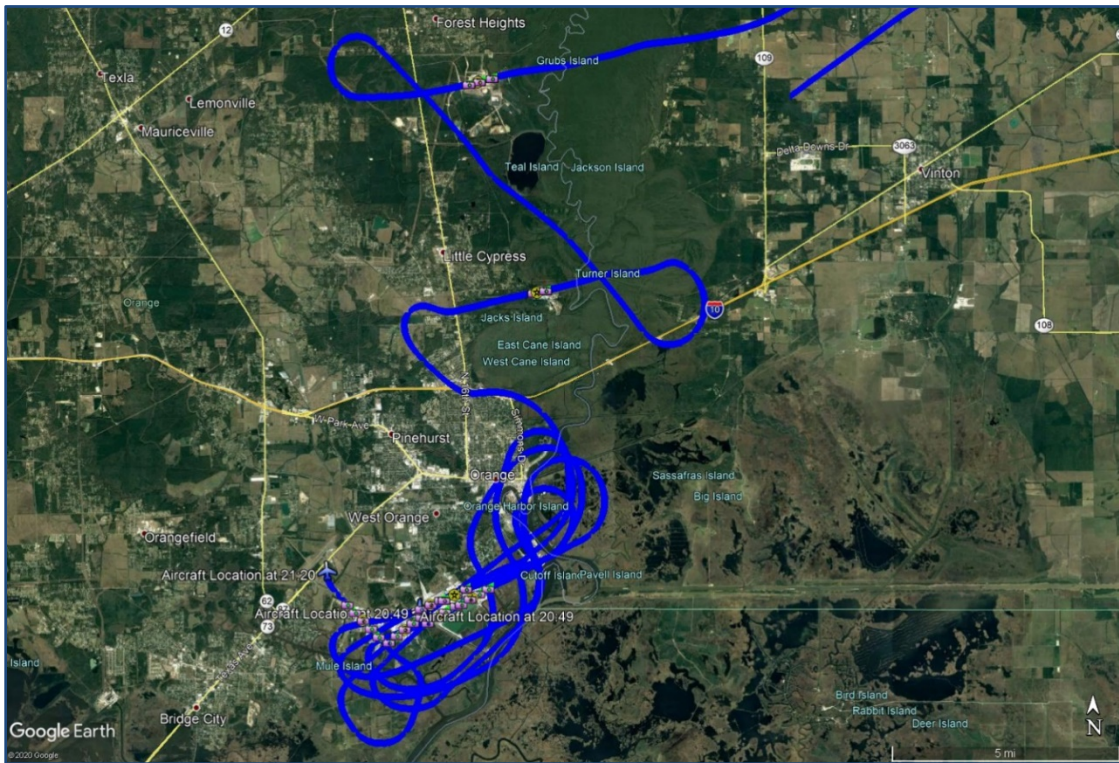
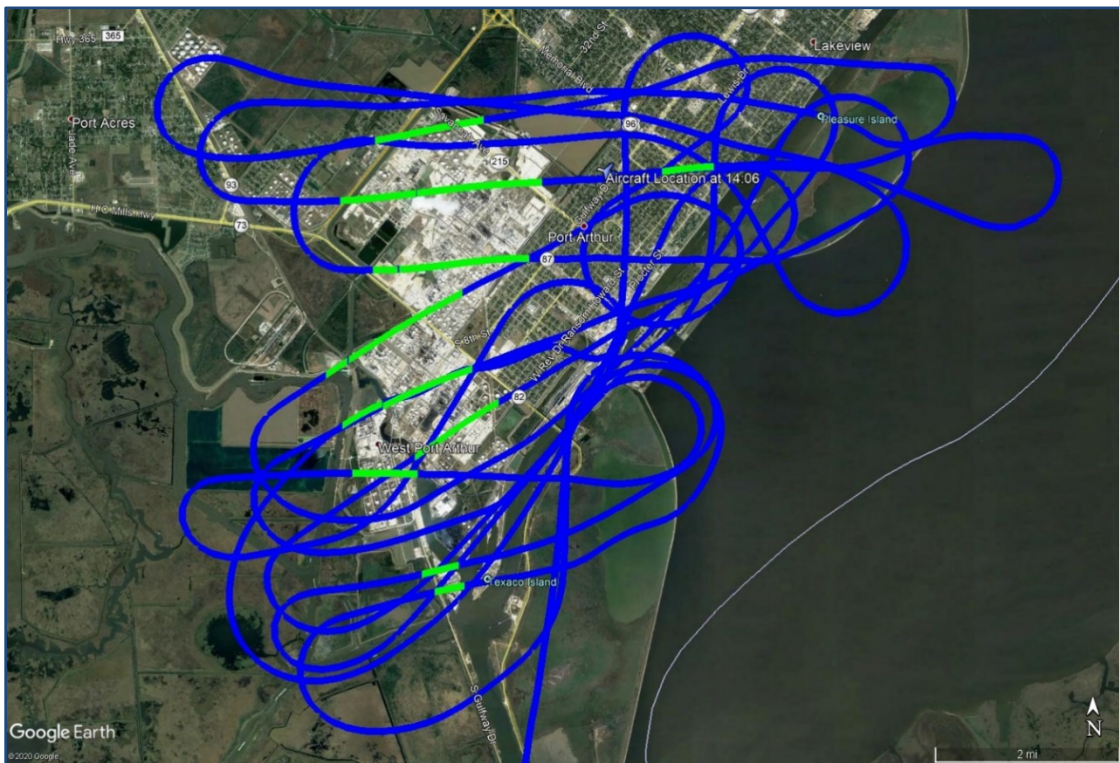
Wide, slow turns are required to be made in between runs in order to keep the instruments stable. Figures 4a, 4b, 5, and 6 show the path of each completed flight. The blue lines indicate the flight path while the green lines indicate the specific sections of the flight where chemical data was collected and processed.

Figure 4a. 28 August 2020, Flight 1.1, data collection runs in Port Arthur, Beaumont, and Orange, TX

Figure 4b. 28 August 2020, Flight 1.2, data collection runs in Port Arthur, Beaumont, and Orange, TX

Figure 5. 29 August 2020, Flight 2.1, data collection runs in Port Arthur, Beaumont, and Orange, TX

Figure 6. 30 August 2020, Flight 3.1, data collection runs in Beaumont and Port Neches, TX

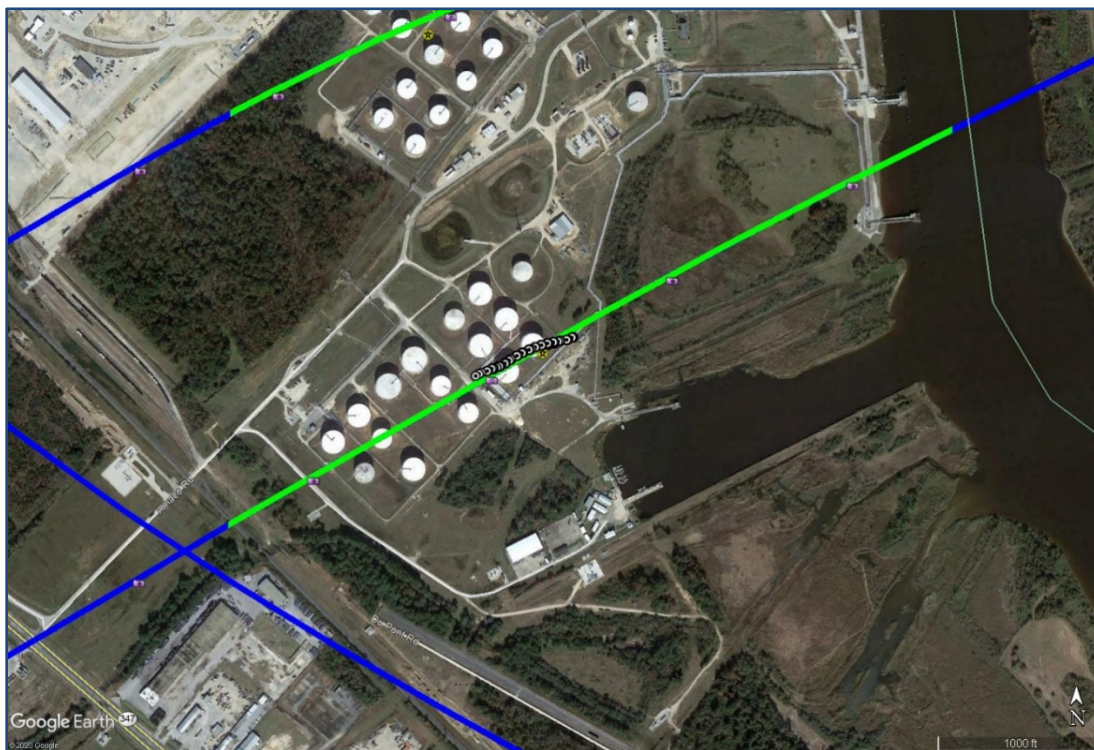
Figure 8. 28 August 2020 Ammonia detection location, Flight 1.1

28 August 2020. Ammonia was observed during the first flight (CAS 7664-41-7) on runs 7 and 8 at maximum concentrations of 1.08 and 0.69 ppm, respectively. The location of these detections are shown in Figure 8.

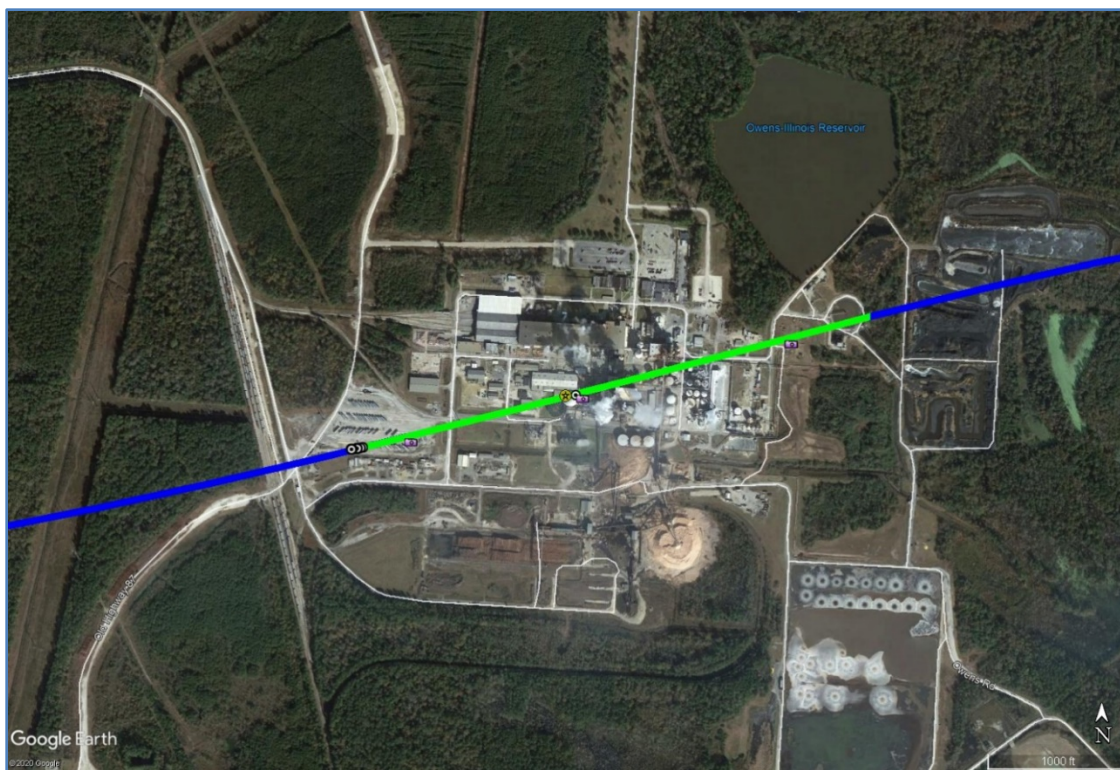
Figure 9. 28 August 2020 1-Butene, 1,3-Butadiene and Isoprene detection locations, Flight 1.2

Three compounds were detected on the second flight including 1-butene, 1,3-butadiene and isoprene at maximum concentrations of 1.41 ppm, 0.53 ppm, and 0.79 ppm respectively (see Appendix A). Figure 10a illustrates a low concentration 1,3-butadiene spectrum with Figure 10b showing an associated library spectrum. Locations of detections made during Flight #1.2 are shown in Figure 9. Of note is the peak located near 910 cm^{-1} . In addition to the listed compounds, ozone was detected in most collected data with a representative spectrum given in Figure 11 as evident by the large broad peak centered on 1050 cm^{-1} .

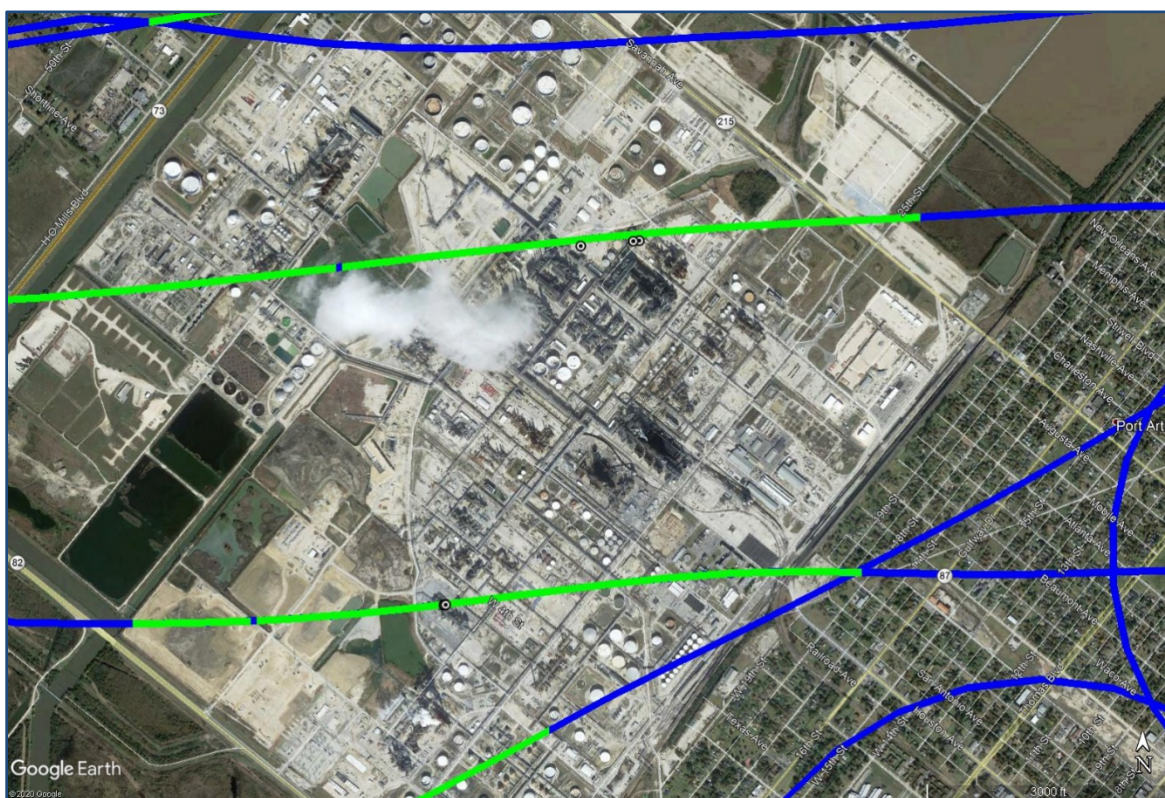
Figure 12. 29 August 2020 isoprene detection locations, Runs 11 and 12

29 August 2020. Isoprene (CAS 78-79-5) was the only compound detected on this mission. Maximum concentrations of 1.55 and 0.75 ppm were made on runs 11 and 12, respectively. The locations of these detections are shown in Figure 12.

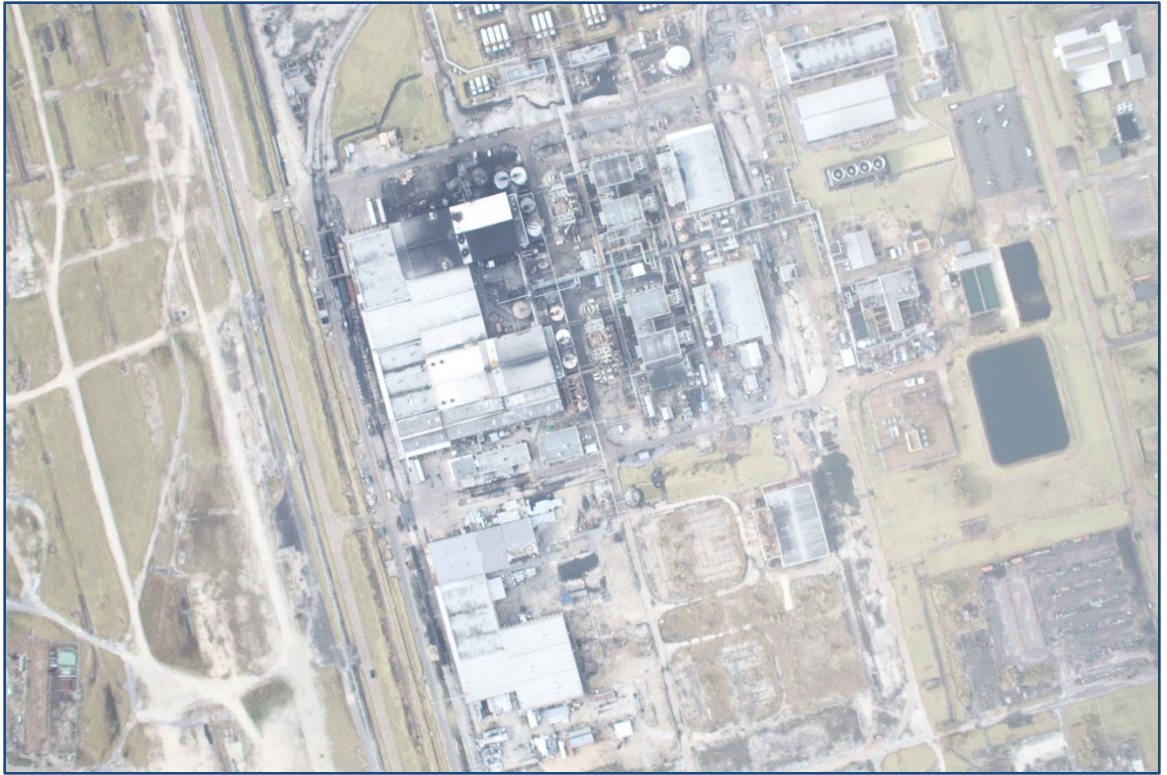
Figure 14. MSIC Aerial Image, Run 8

A full set of high-resolution aerial digital photographs were collected as part of each flight. Figure 14 shows a representative image collected using the MSIC camera on 30 August 2020. Analysis of the image shows that a sizable amount of standing water is present at this particular site. Figure 15 shows an oblique image of a facility in the survey area taken on 28 August 2020 with visible storm damage.

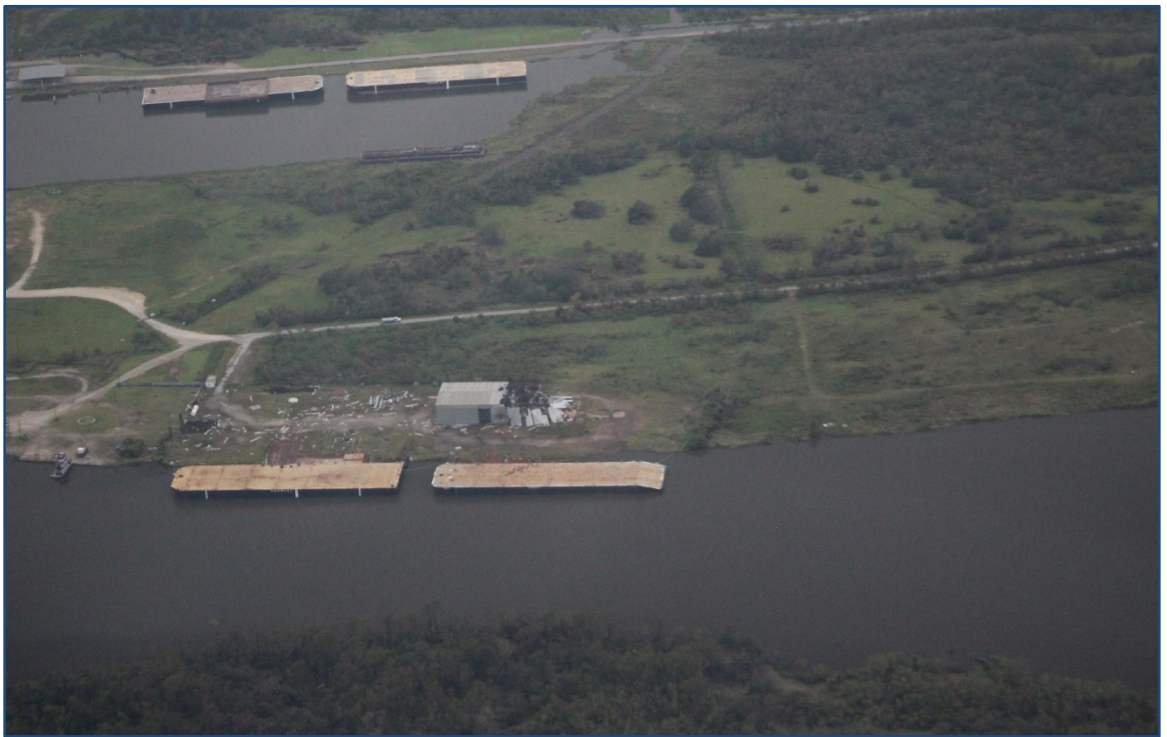
Figure 15. Oblique image of a facility in the survey area with visible storm damage
