Phase I Field Investigation Report

Morrow Dam
700 East Michigan Avenue Consumers Power Drive
Comstock Township, Michigan

STS Hydropower, LLC

February 9, 2021

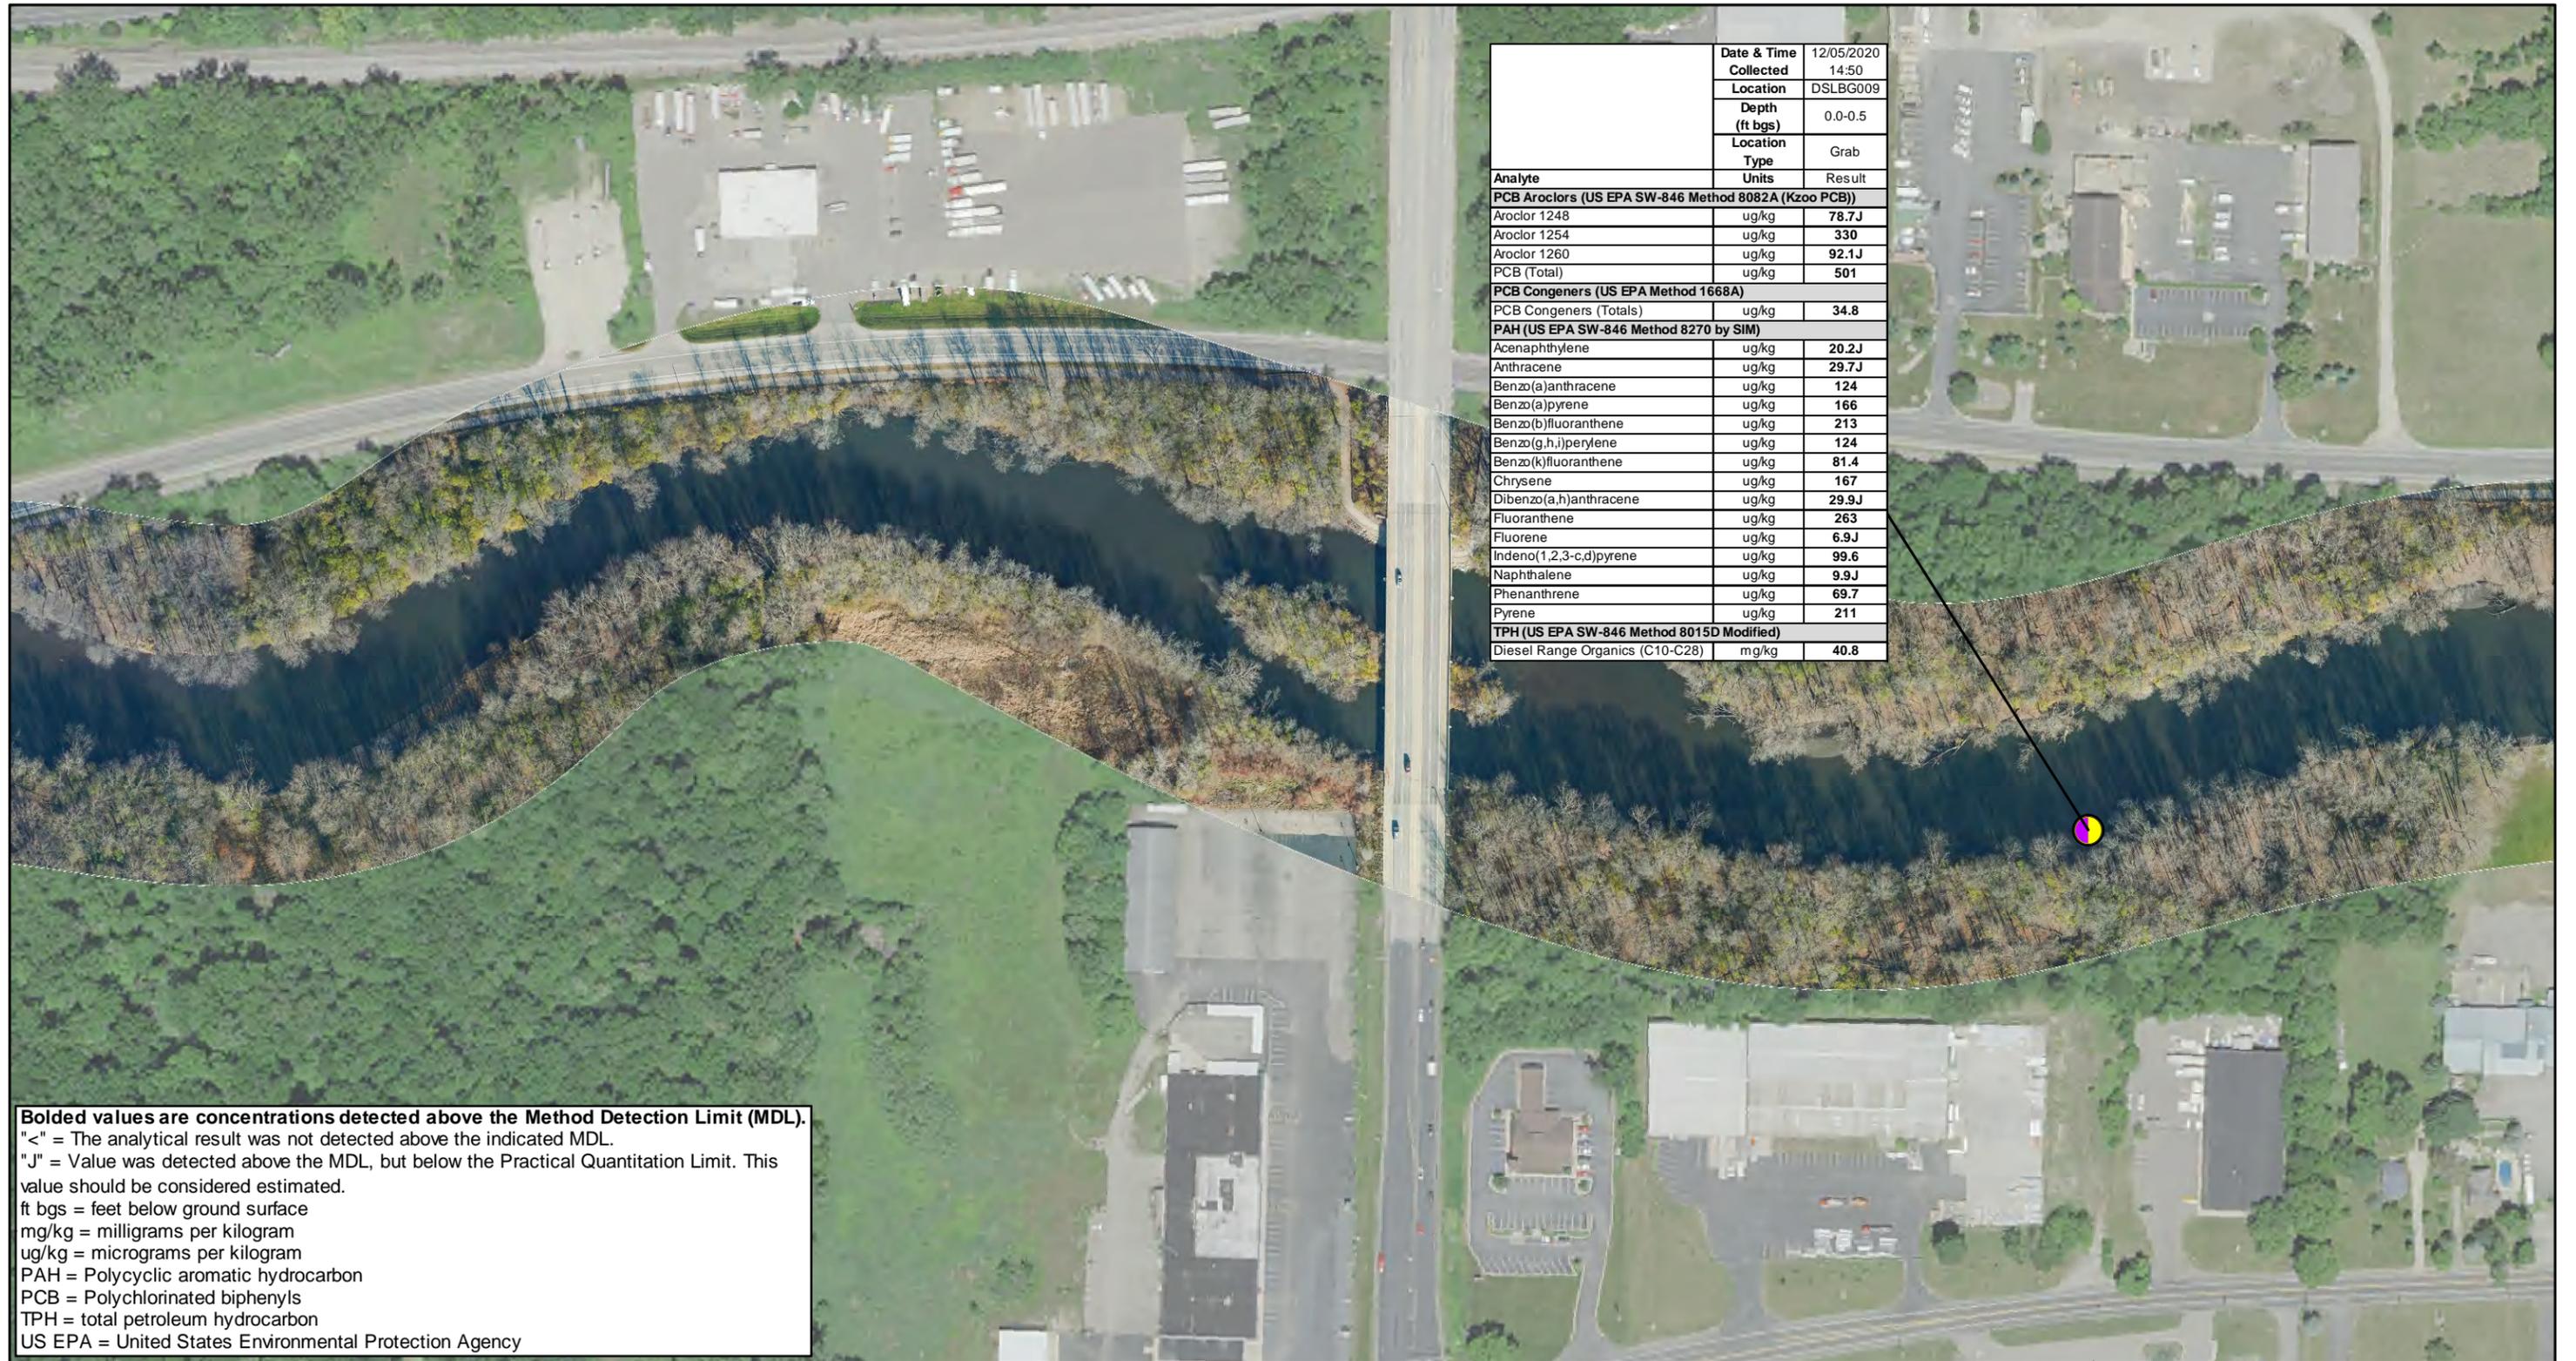
**FIGURE 2
 SEDIMENT SAMPLE LOCATIONS &
 ANALYTICAL DETECTIONS
 SHEET 6 OF 7**

Date & Time		12/05/2020
Collected		14:50
Location		DSLBG009
Depth (ft bgs)		0.0-0.5
Location Type		Grab
Analyte	Units	Result
PCB Aroclors (US EPA SW-846 Method 8082A (Kzoo PCB))		
Aroclor 1248	ug/kg	78.7J
Aroclor 1254	ug/kg	330
Aroclor 1260	ug/kg	92.1J
PCB (Total)	ug/kg	501
PCB Congeners (US EPA Method 1668A)		
PCB Congeners (Totals)	ug/kg	34.8
PAH (US EPA SW-846 Method 8270 by SIM)		
Acenaphthylene	ug/kg	20.2J
Anthracene	ug/kg	29.7J
Benzo(a)anthracene	ug/kg	124
Benzo(a)pyrene	ug/kg	166
Benzo(b)fluoranthene	ug/kg	213
Benzo(g,h,i)perylene	ug/kg	124
Benzo(k)fluoranthene	ug/kg	81.4
Chrysene	ug/kg	167
Dibenzo(a,h)anthracene	ug/kg	29.9J
Fluoranthene	ug/kg	263
Fluorene	ug/kg	6.9J
Indeno(1,2,3-c,d)pyrene	ug/kg	99.6
Naphthalene	ug/kg	9.9J
Phenanthrene	ug/kg	69.7
Pyrene	ug/kg	211
TPH (US EPA SW-846 Method 8015D Modified)		
Diesel Range Organics (C10-C28)	mg/kg	40.8

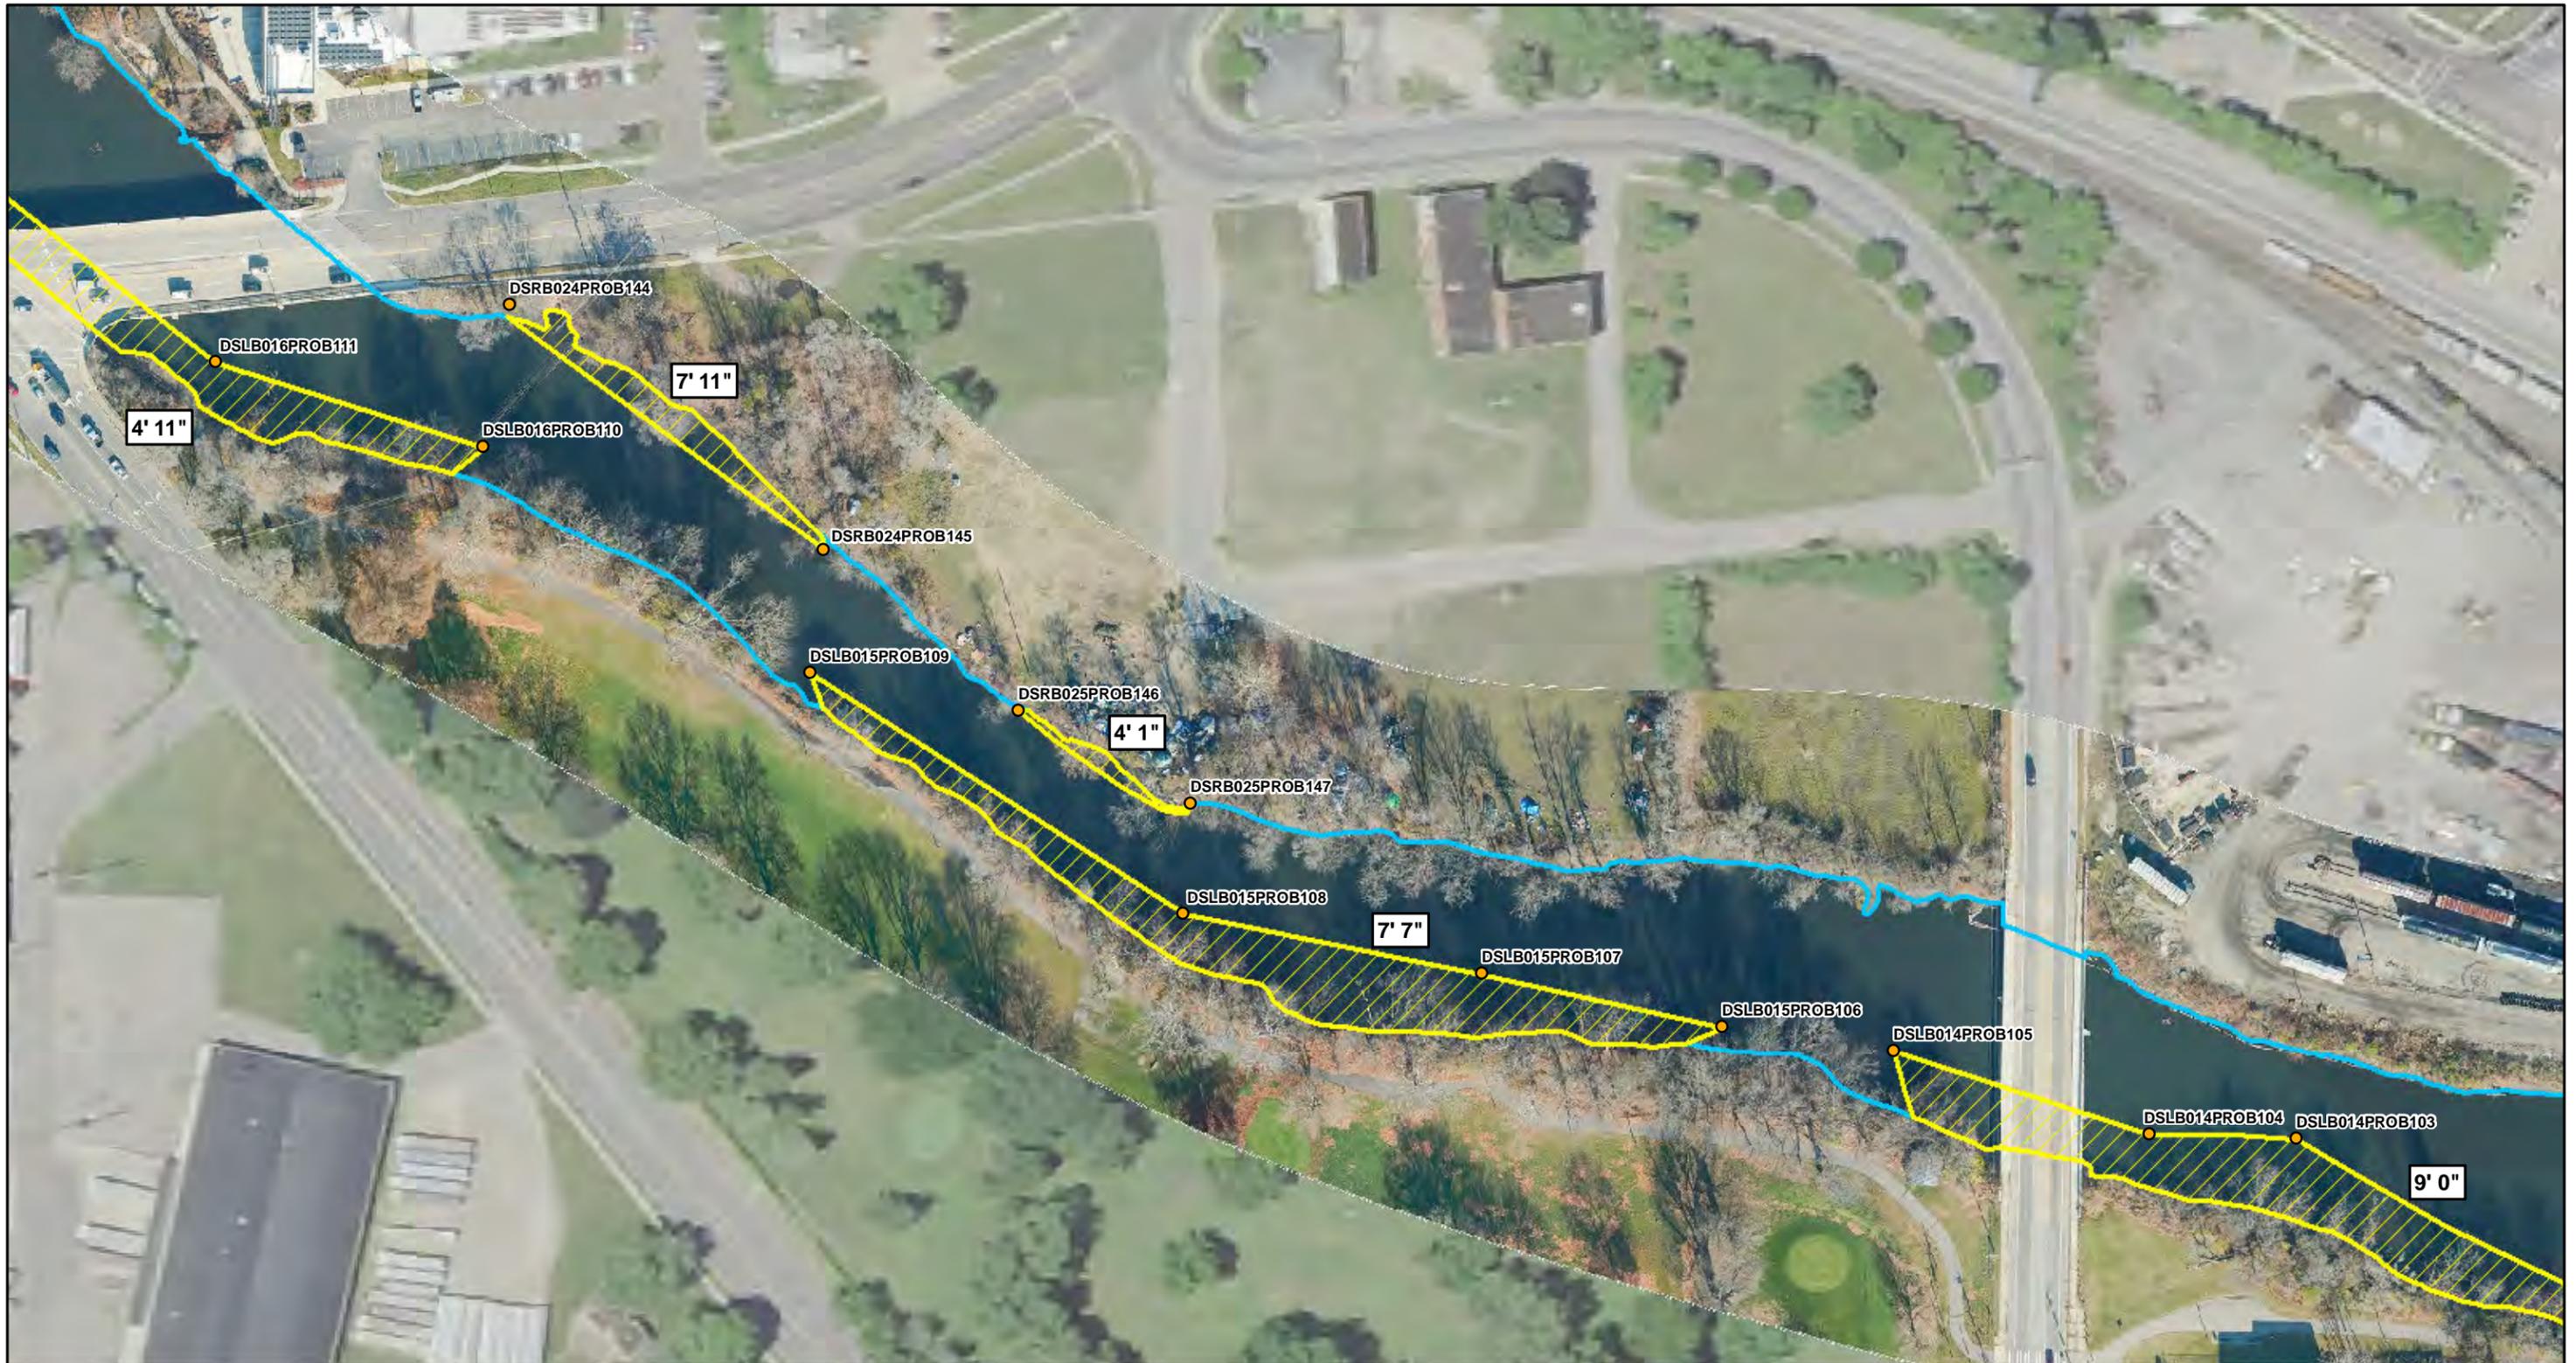
FIGURE 3
FIELD DELINEATED SEDIMENT AREAS
SHEET 9 OF 23

Note: Sediment depositional areas downstream of Area A-10 are not given an area number as those deposits were too variable to delineate.

Within the 4-mile reach from RM 72.5 to RM 68.5 variability in sediment thickness and extent was observed. Twenty-seven depositional areas were identified, probed and mapped. Each area was generally confined to the margin of the riverbanks (**Figure 3**). A portion of the survey areas was only observed from a distance via boat as the braided channels near RM 72.5 caused navigational and access challenges. The sediment delineation effort extended approximately 2/3 of a mile downstream of the 2020 Seaworks bathymetric survey (**Appendix A**), limiting delineation of the edge of water boundary in this reach of the river. Based on the observations from this area, it was identified that depositional sediments exist, but it is not known to what extent and thickness as noted in **Figure 3**.

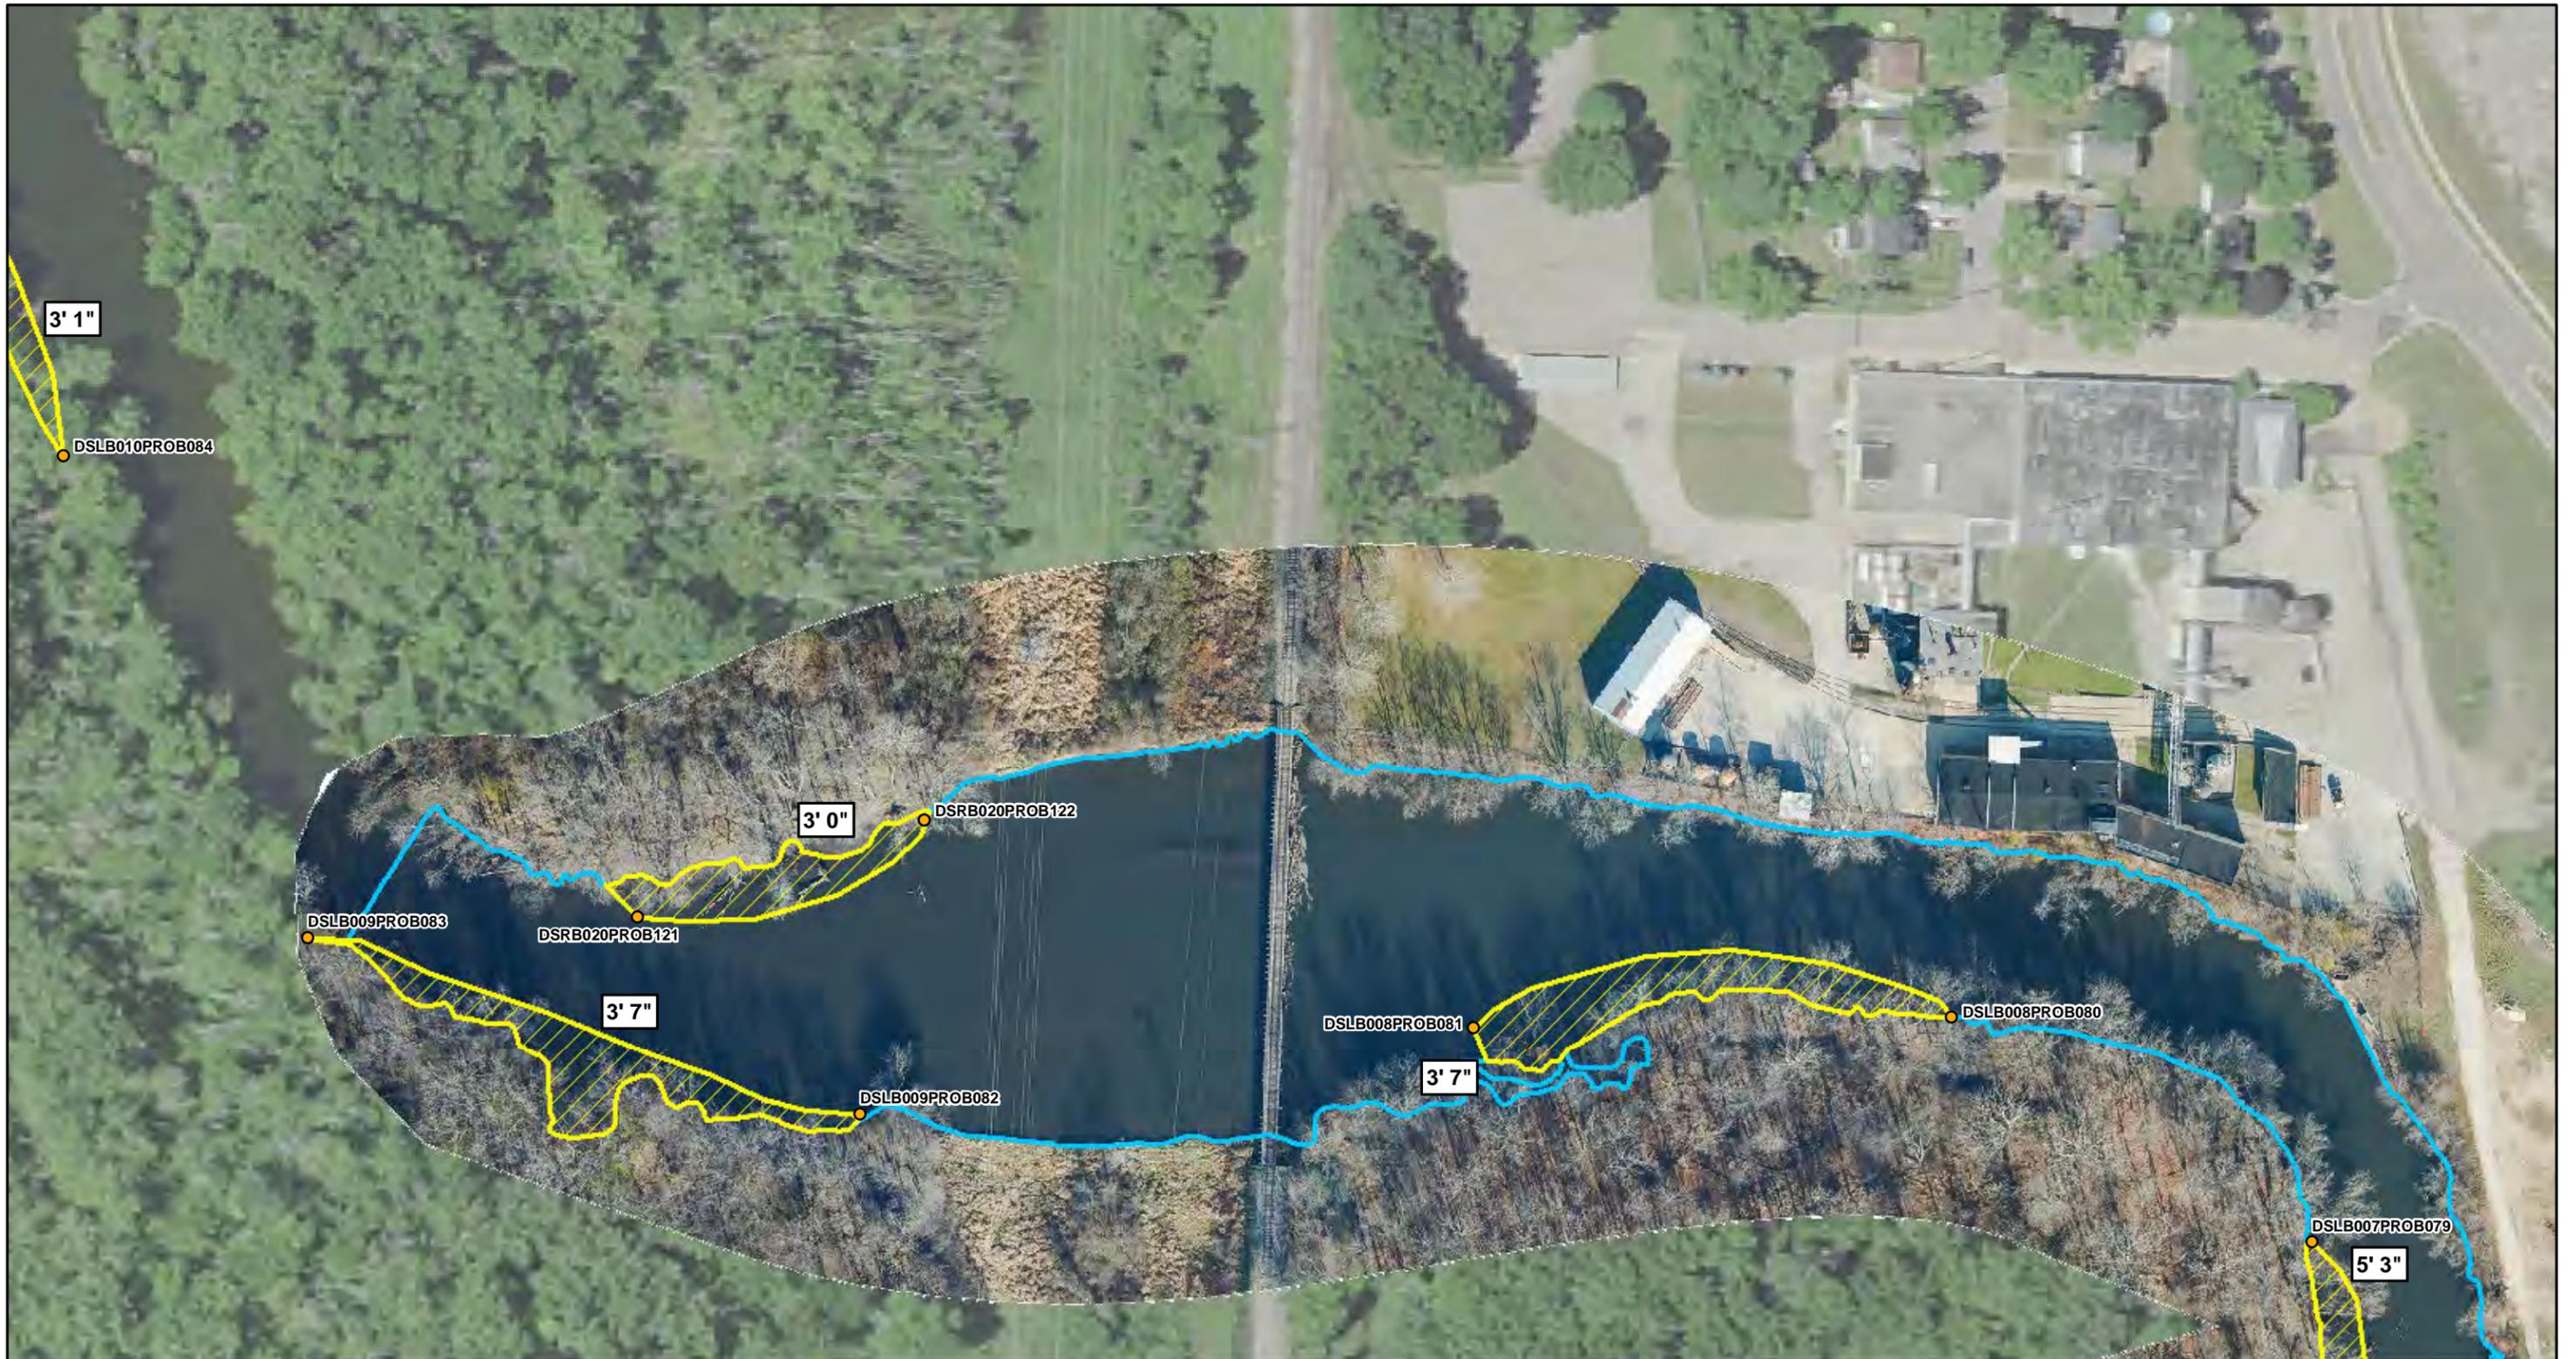
FIGURE 3
FIELD DELINEATED SEDIMENT AREAS
SHEET 19 OF 23

Maximum Sediment Thickness Measured (feet/inches)
 Note: Sediment depositional areas downstream of Area A-10 are not given an area number as those deposits were too variable to delineate.
