Airborne Spectral Photometric Environmental Collection Technology

ASPECT Texas Air Quality Survey Beaumont and Corpus Christi, TX 11 March 2021

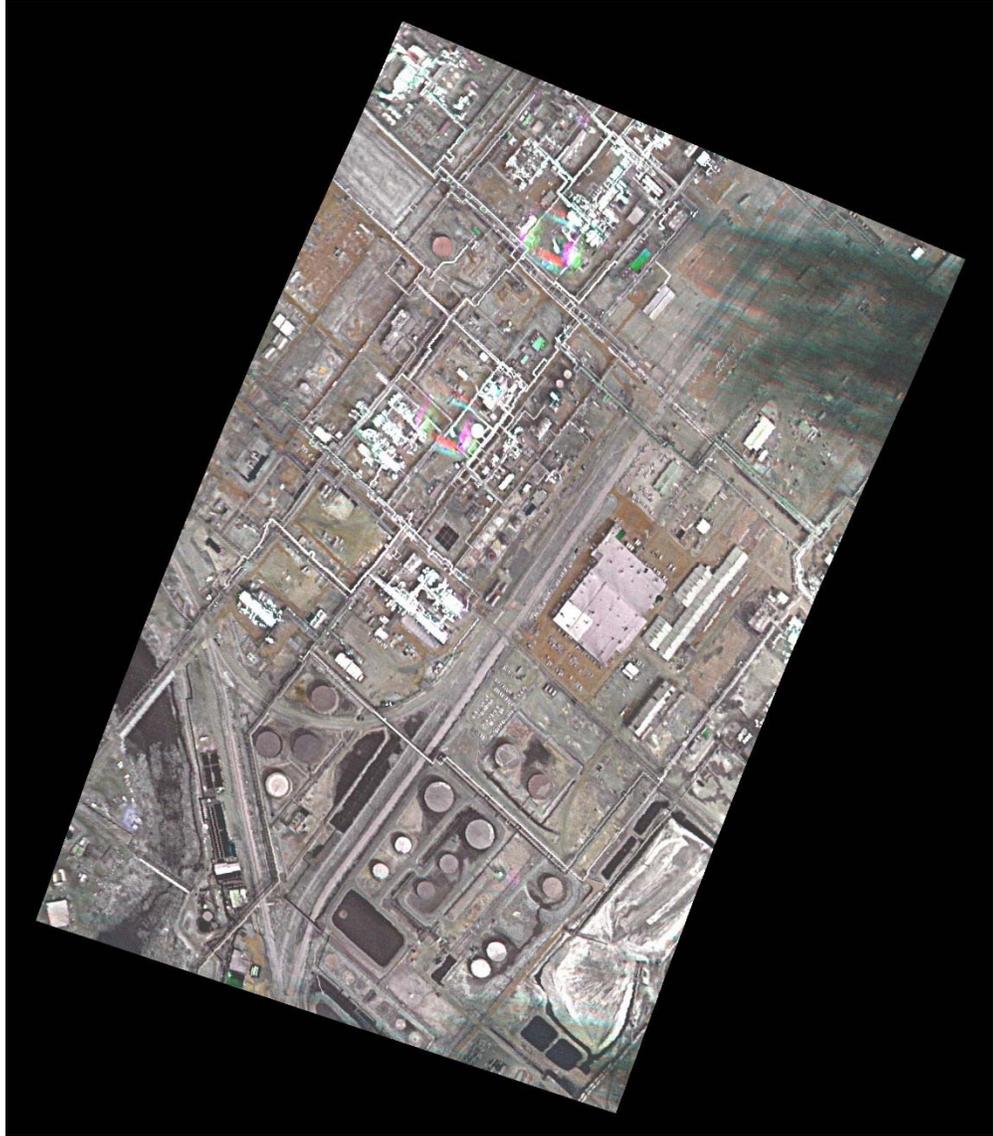
A total of 11 data collection runs were made over the Port Arthur and Beaumont area and during each collection run an infrared line scanner image was generated. Figure 8 shows a 3-band infrared image collected over the Port Arthur area. Examination of the image shows two small flares and hot process/piping throughout the upper portion of the image. Also, the dark feature in the upper right of the image is a cloud. No chemical plumes can be observed being emitted from the facility.

Figure 8. Three band IR image, Port Arthur Area, Run 6, Flight 22, 11 March 2021

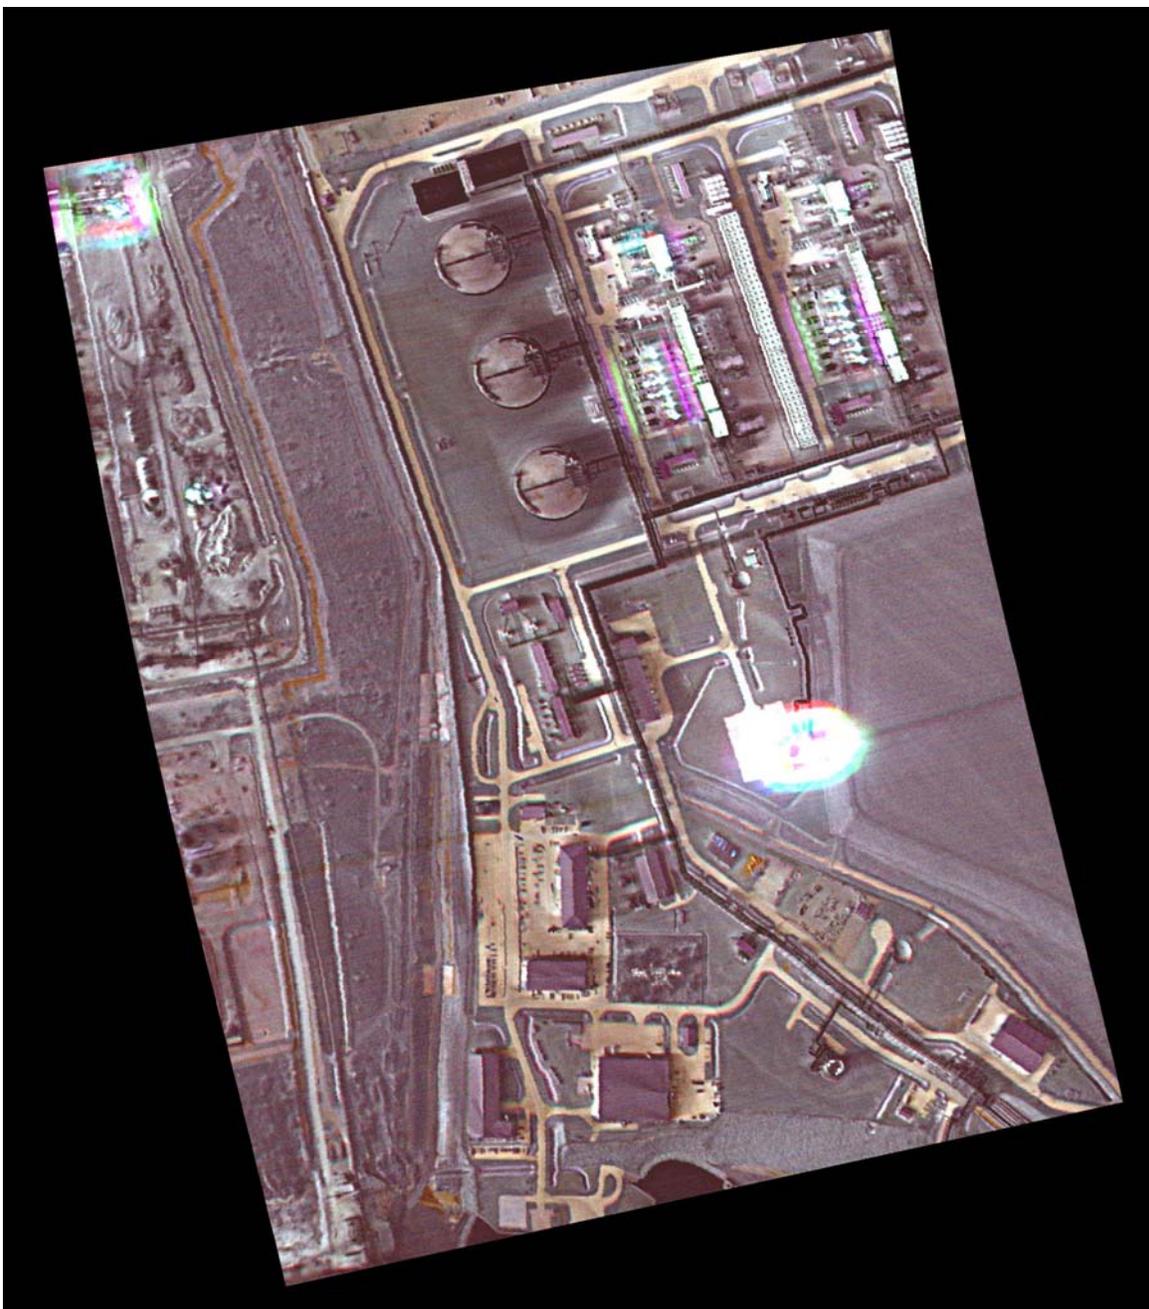
On the afternoon of 11 March 2021, ASPECT collected 12 IR images over selected sites over the Point Comfort and Corpus Christi areas. Figure 9 shows an image collected in the Corpus Christi areas showing a hot flare and several hot process units. No chemical plumes can be seen being emitted from the facility.

Figure 9. Three band IR image, Corpus Christi Area, Run 11, Flight 23, 11 March 2021

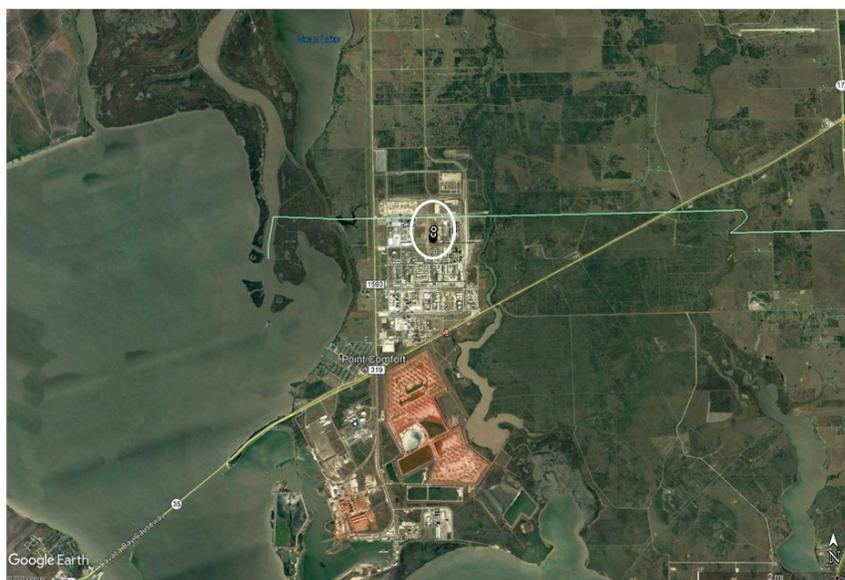
On Flight 23 ASPECT detected 1-butene (2.071 ppm) over a facility in the Point Comfort area. The location for this detection is given in Figure 10. Compounds detected over the Corpus Christi area included 1-butene (1.543 ppm) and 1,3-butadiene (0.696 ppm). Figures 11A and 11B show the respective locations for these detections. Figure 12 shows a representative spectrum of 1,3-butadiene. Detection details for the entire mission can be found in Table 4.

Figure 10. 1-Butene Detection Location, Point Comfort area, Flight 23, 11 March 2021

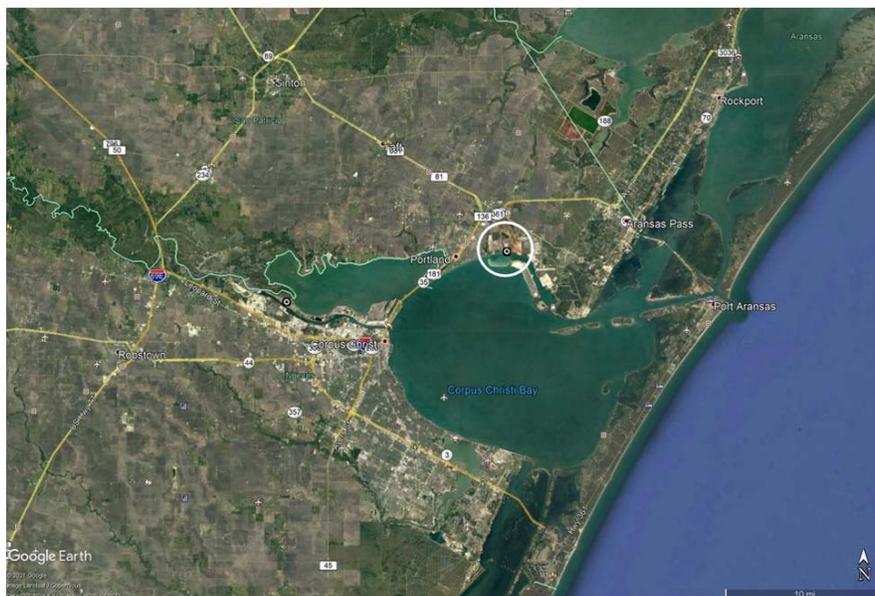
Figure 11A. 1-Butene Detection Locations, Corpus Christi, Flight 23, 11 March 2021

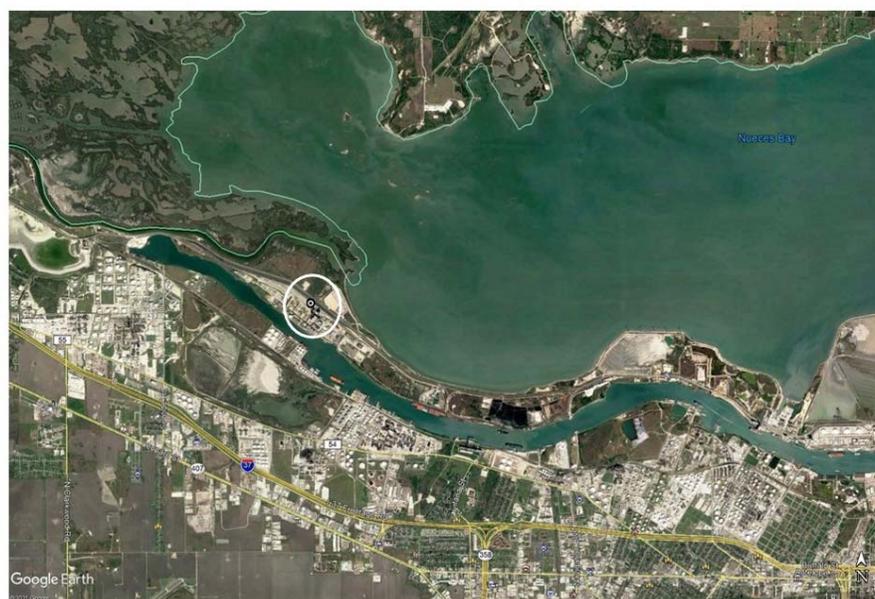
Figure 11B. 1,3-Butadiene Detection Location, Corpus Christi, Flight 23, 11 March 2021

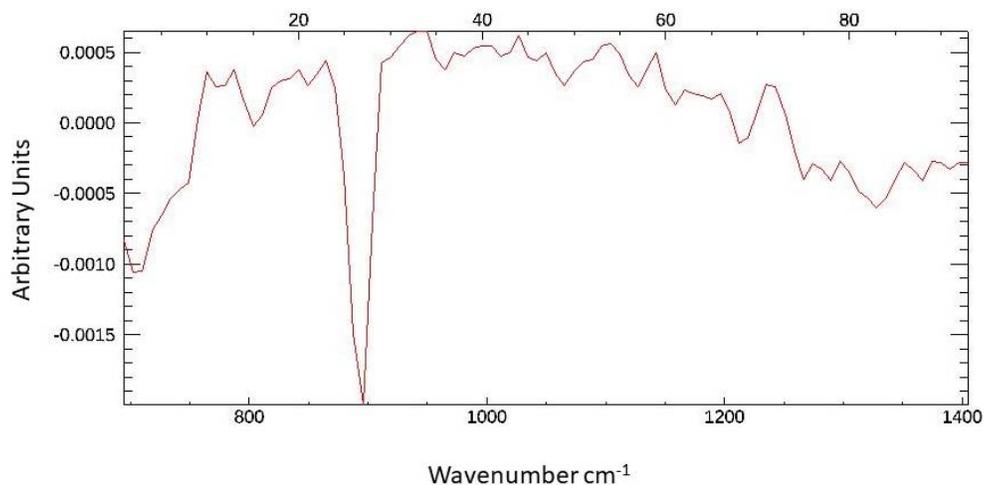
Figure 12. 1,3-Butadiene Spectrum, Corpus Christi Area, Flight 23, 11 March 2021

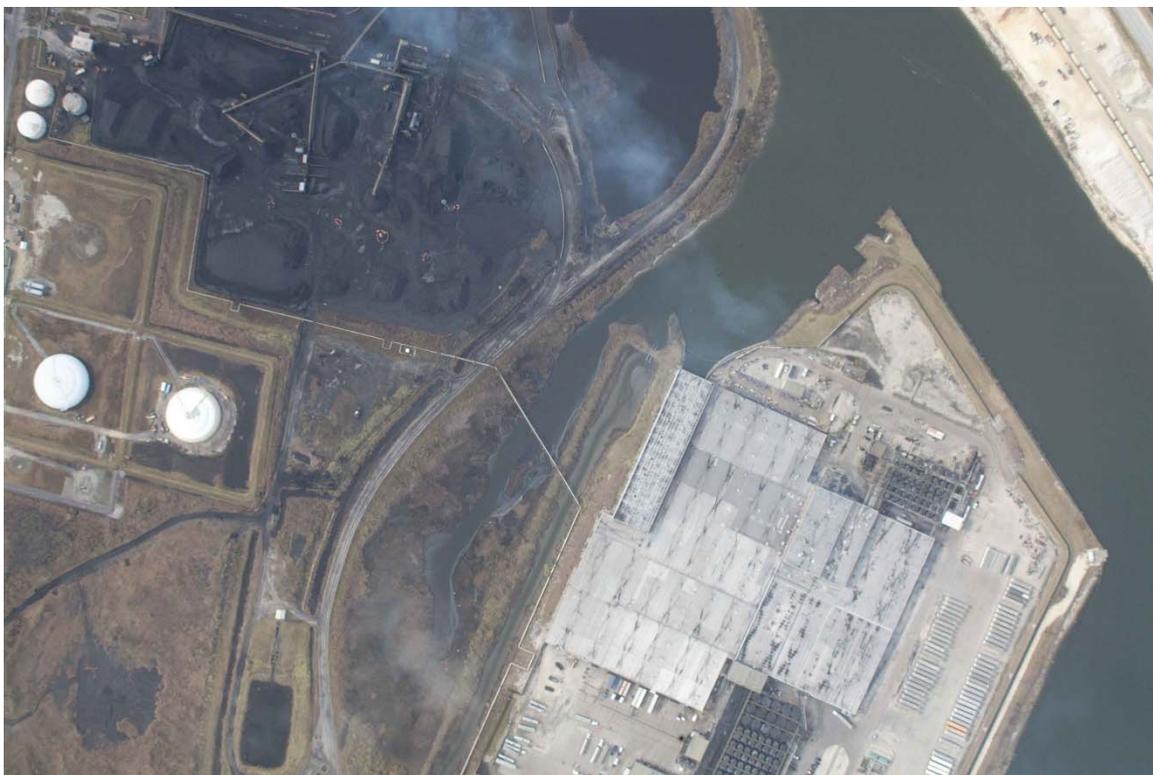
A full set of high-resolution aerial digital photography were collected as part of each data collection pass. Weather conditions over the Beaumont/Port Arthur areas was poor to marginal and resulted in several photos with cloud content. Figure 13 shows an example of light cloud content in the frame. In addition to cloud content there appears to be some emissions from the process unit, but differentiation is difficult due to the similar texture and color as low level clouds.

Figure 13. MSIC Aerial Image, Port Arthur Area, Flight 22
