# Telluride Valley Floor

A U.S. EPA Region 8 Story Map

August 9, 2021

## Overview

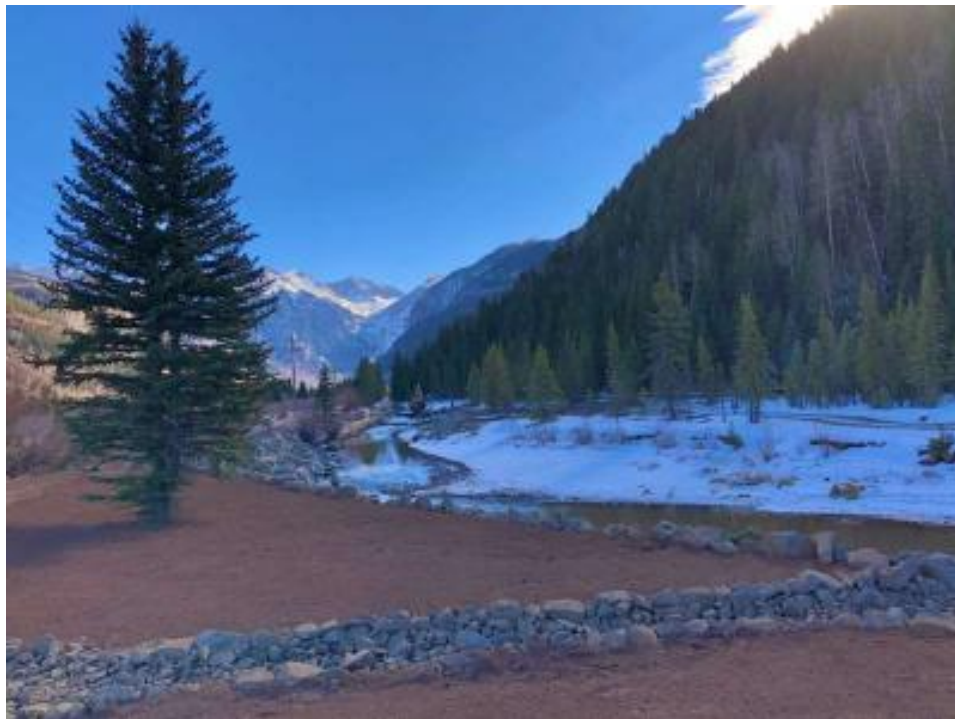
Completed North Riverbank Lining and Arm

- Removed up to 3,000 cubic yards of tailing and stabilized/armored bank area.
- Installed a low water crossing for moving equipment and material.
- Stabilized hike/bike area by placing a thin cap of gravel over the tailings.
- Placed barriers around contaminated areas, until mitigated or cleaned up.
- Hauled excavated contaminated material to state-designated, responsible party-owned on-site repository.

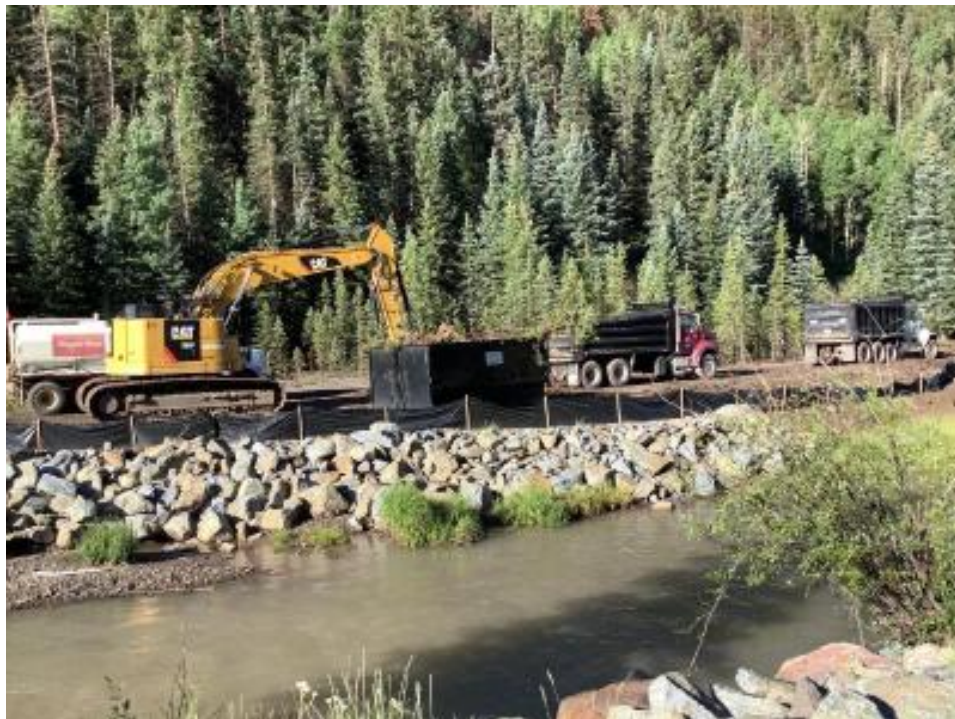
Excavation of tailings within the ST1 tailing boundary near the San Miguel River.

- Continued site setup, building up roads/turn around points, trail reroutes, and creating truck cleaning areas.
- Placed clean rock/road base that were dropped at the site and repository to create truck cleaning areas and safer roads for waste haulage.
- Met with stakeholders on site updates.
- Started excavation/hauling on Thursday, July 29, 2021 in location ST1(a total of approximately 230 cubic yards or 23 truck loads were removed from the site).
- Deployed air sampling and monitoring locations along the trucking route to capture background levels and assess any potential impacts associated with EPA trucking operations for dust and air borne contamination. Sample results and real time data can found on the Telluride Valley Floor Site Updates page.

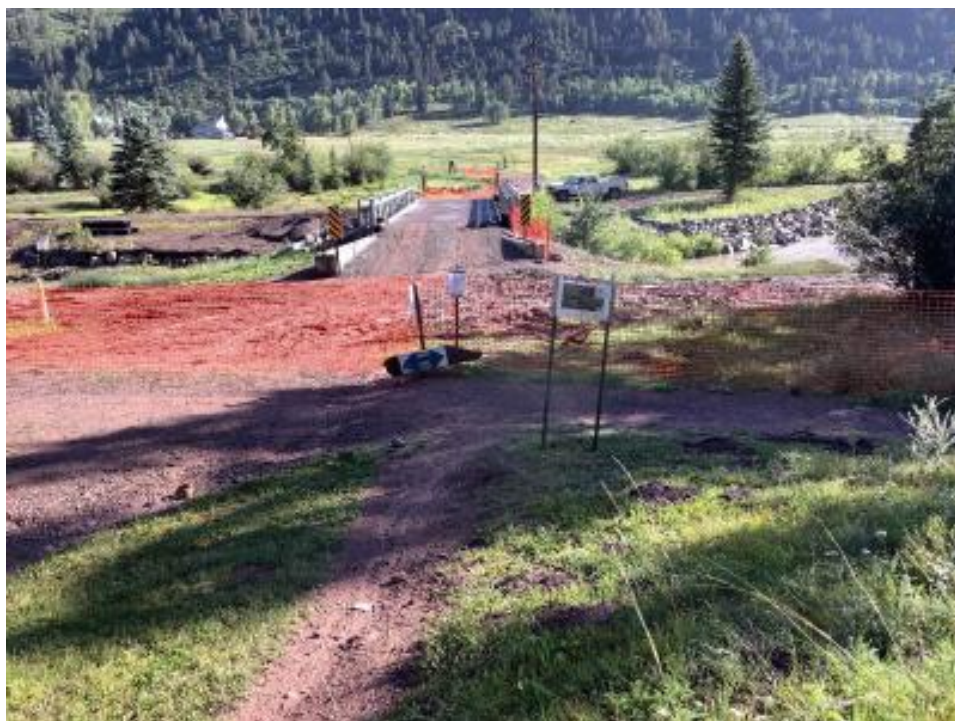
Trail closure with map depicting direction of rerouted trail running east to west.

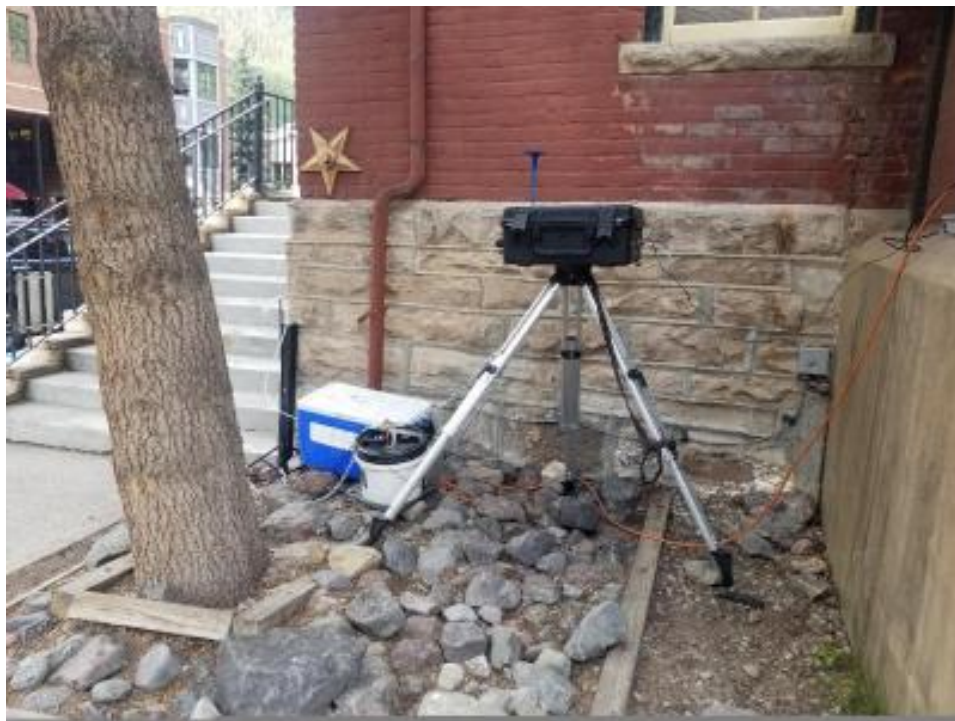
Air Monitoring station near Court House with continuous dust particulate monitoring during transportation of excavated tailings to the repository.

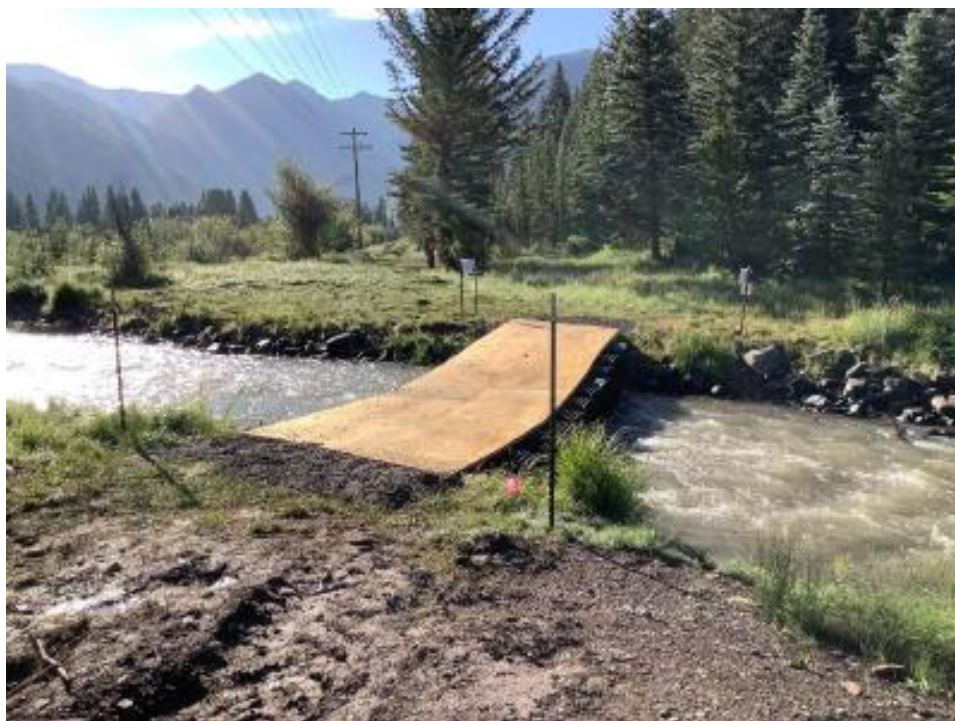
Newly installed bridge connecting the eastern and western sides of rerouted recreational trail.
