**Subject: Contract No. 68HERH19D0018; Task Order (TO) No. 68E0719F0190
Pine Lawn, 6261 Natural Bridge Road, Pine Lawn, Missouri;
Analysis of Brownfields Cleanup Alternatives Report (ABCA)**

ANALYSIS OF BRONFIELDS CLEANUP ALTERNATIVES REPORT

**PINE LAWN
6261 NATURAL BRIDGE ROAD, PINE LAWN, MISSOURI**

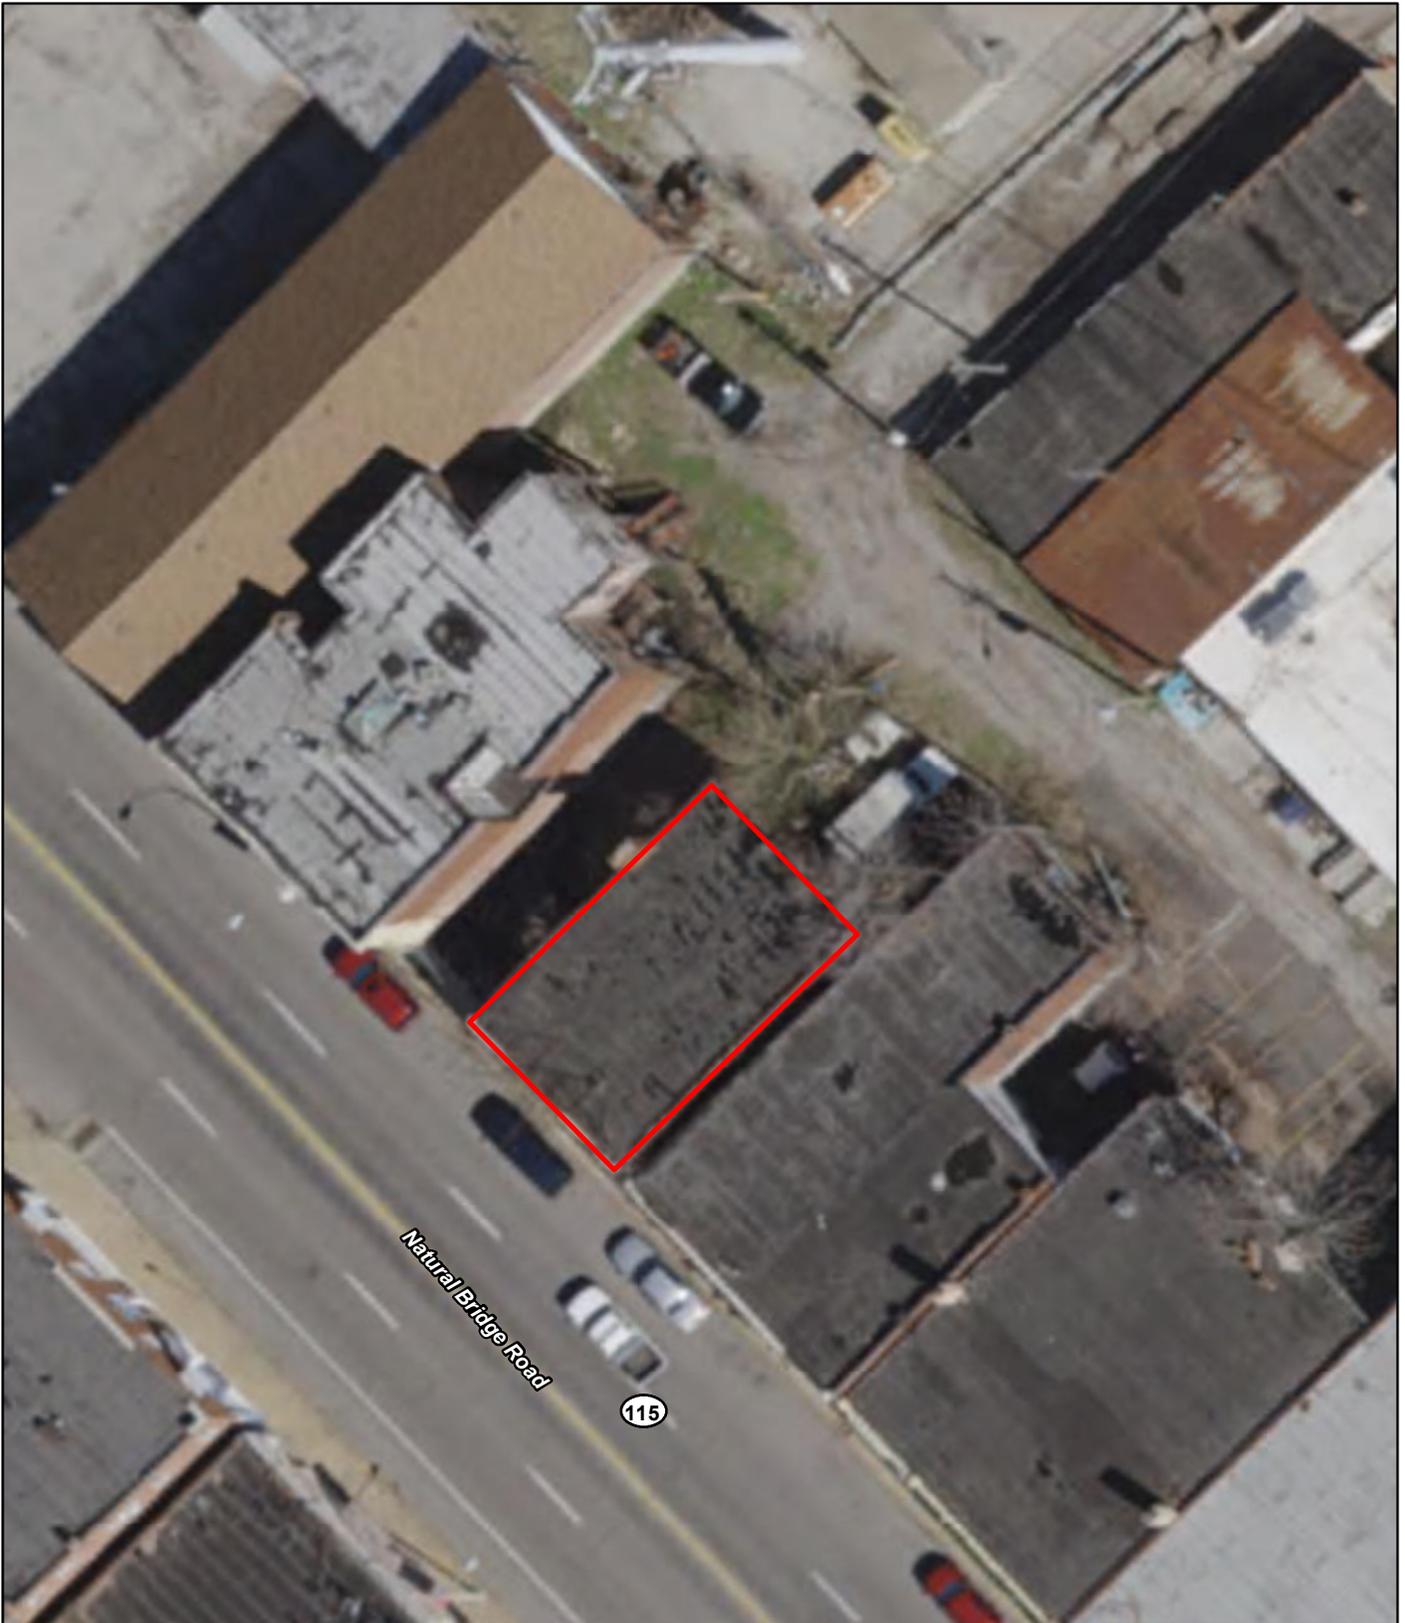
During the ACM survey, the Toeroek Team collected 32 bulk samples of suspect ACM. Figure 3 in Appendix A shows ACM sample locations. Collections of samples of building materials accorded with National Emissions Standards for Hazardous Air Pollutants (NESHAP) as adopted by EPA and Asbestos Hazard and Emergency Response Act of 1986 (AHERA) protocols. Upon completion of sampling activities, the bulk samples were sent to Eurofins EMLab P&K Laboratories (Eurofins). Suspect ACM samples were analyzed per EPA Method 600/R-93/116 via Polarized Light Microscopy (PLM) analysis. AHERA defines ACM as any material or product that contains more than 1% asbestos. The ACM survey yielded the following significant findings:

ACM was identified in black roofing tar around the chimney (approximately 20 square feet [SF]) and on the east, south, and west roof perimeters (approximately 210 linear feet [LF]).

During the LBP survey, the Toeroek Team tested 18 surfaces in the subject property buildings. Figure 3 in Appendix A shows locations of LBP detections. The LBP survey accorded with protocols similar to the single-family housing inspection procedures in Department of Housing and Urban Development (HUD) *Guidelines for the Evaluation and Control of LBP in Housing* (HUD Guidelines) (HUD 1997). The Toeroek Team utilized an Innov-X 6000 Alpha Series analyzer to perform the LBP screening. The Innov-X 6000 Alpha Series is an x-ray fluorescence (XRF) spectrum analyzing system for quantitative measurement of lead in paint on various substrates. HUD guidelines suggest that paint applied before 1978 may contain lead. HUD considers LBP as paint with lead levels above 1.0 milligram per square centimeter (mg/cm²).

Approximately 300 SF of various colors of LBP on multiple substrates was identified on the exterior of the building.

Alternative 3—abatement of ACM—is the recommended cleanup alternative for ACM. Future plans at the subject property include either rehabilitation/renovation or demolition; therefore, removal of the identified ACM would be required prior to initiation of those activities.

Alternative 2—LBP removal by demolition—is the recommended cleanup alternative for LBP identified at the subject property. Building materials containing LBP would be demolished and sent for disposal as demolition waste. General construction/demolition workers could implement this alternative. Based on presence of lead, construction/demolition work must accord with OSHA guidelines for protection of workers.
