Airborne Spectral Photometric Environmental Collection Technology

ASPECT Air Quality Survey for Hurricane Ida Baton Rouge, LA. September 02 2021

ASPECT Air Quality Survey

Hurricane IDA

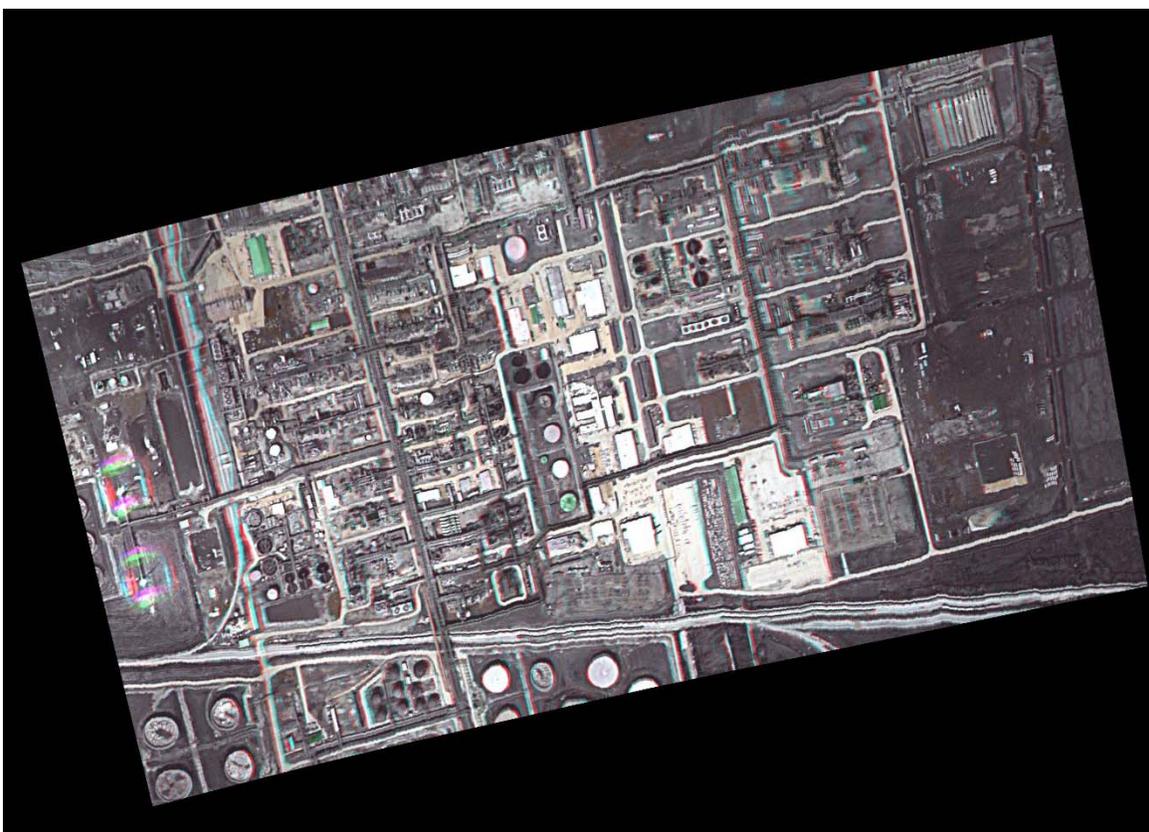
A total of 11 data collection runs were made over the Baton Rouge area and during each collection run an infrared line scanner image was generated. Figure 2 shows a 3-band infrared image collected over a facility within the survey area. Examination of the image shows two small flares on the western side of the facility. Process piping throughout the facility shows ambient temperatures. No chemical plumes can be observed being emitted from the facility.

Figure 2. Three band IR image, Baton Rouge Area, Run 5, Flight 2, September 2 2021

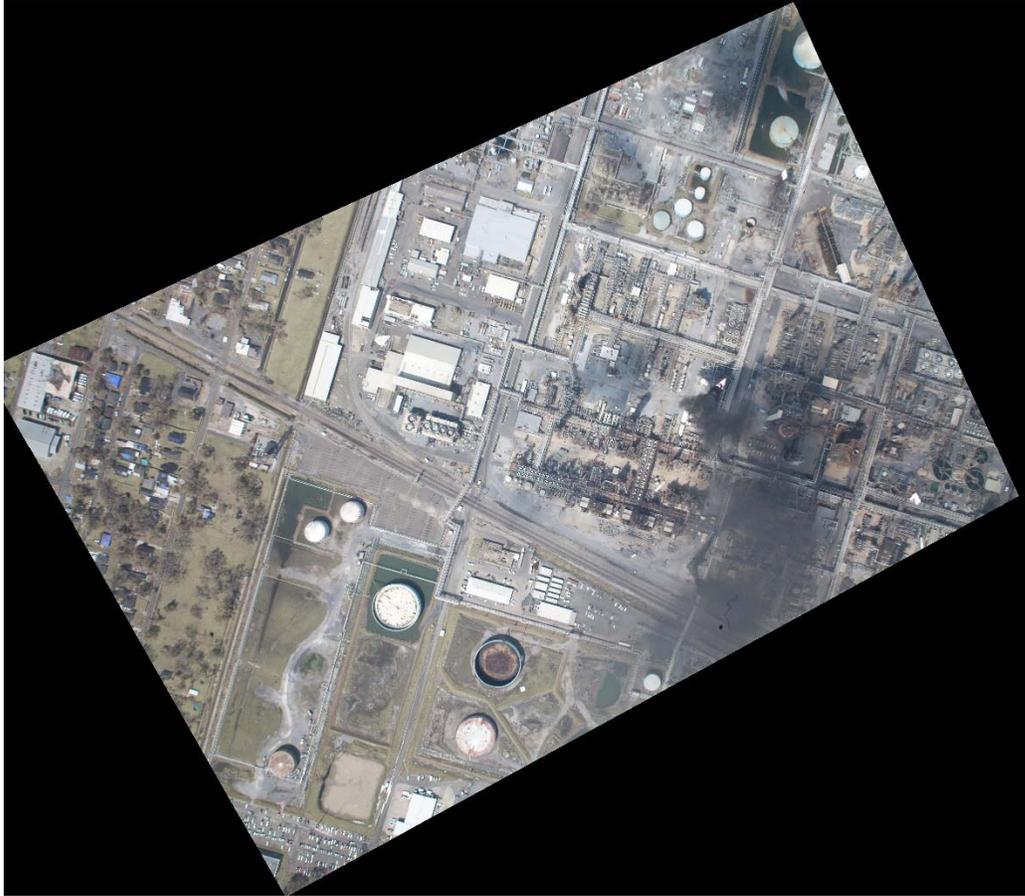
A full set of high-resolution aerial digital photography were collected as part of each data collection pass. Weather conditions over the New Orleans area allowed high quality aerial images to be collected. Figures 3 and 4 show representative overhead and oblique images of the Shell Norco Plant East Site imaged on Flight 2.

Figure 1. MSIC photo taken over the Shell Norco Plant East Site in Garyville, LA on September 2, 2021

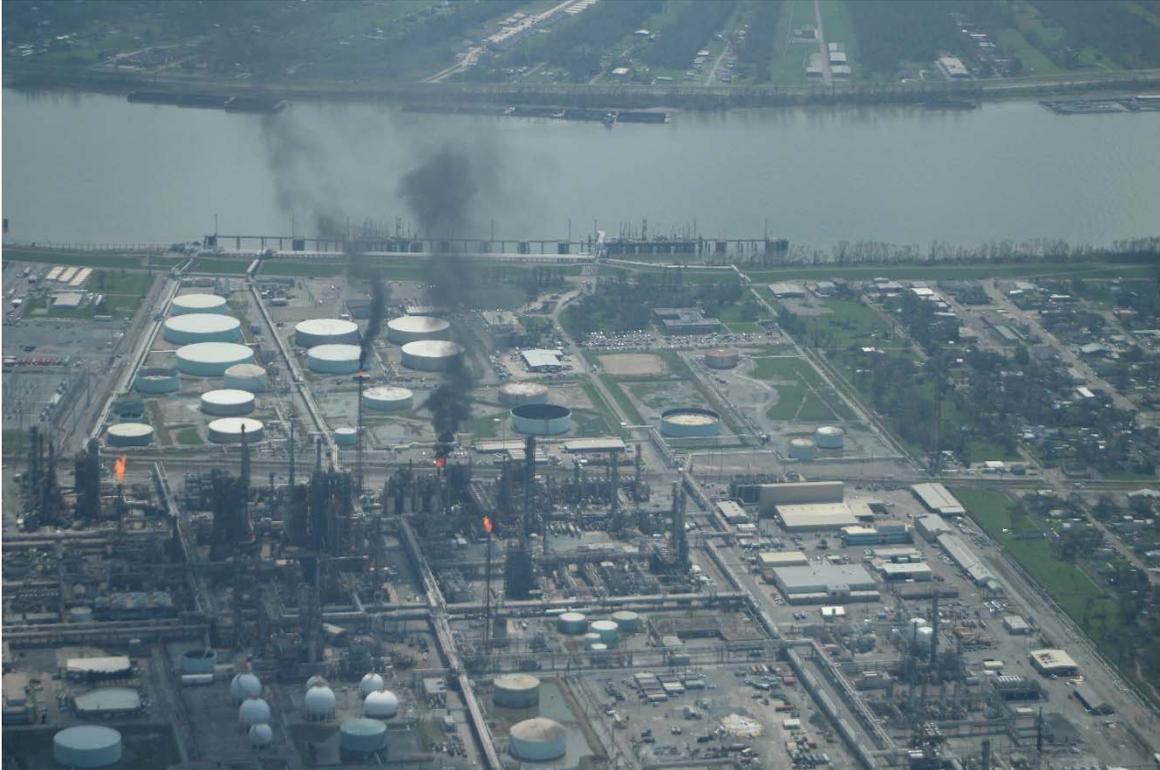
Figure 2. Oblique photo taken over the Shell Norco Plant East Site in Garyville, LA on September 2, 2021
