Airborne Spectral Photometric Environmental Collection Technology

ASPECT Air Quality Survey after Hurricane Ida Baton Rouge, LA September 3, 2021

ASPECT Air Quality Survey Hurricane IDA Baton Rouge, LA September <u>33</u>, 2021

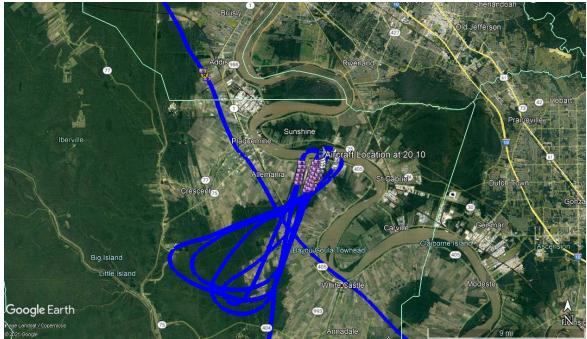
Wide, slow turns are required to be made in between runs to keep the instruments stable. The blue lines indicate the flight path while the green lines indicate the specific sections of the flight where chemical data was collected and processed. On Flight 3 the Allemania area was surveyed, and on Flight 4 the Baton Rouge area was surveyed. The flight paths are shown in Figures 1 and 2, respectively.

Figure 1. Data Collection Flight Path over the Baton Rouge Area Flight 3, September 3, 2021

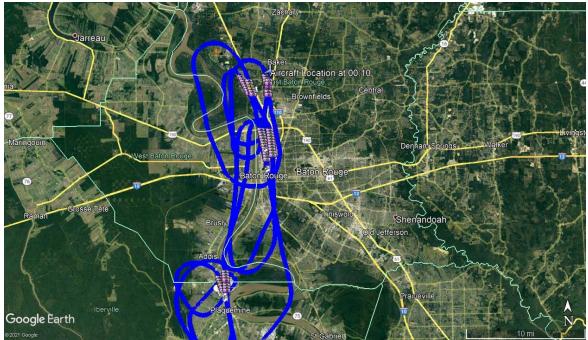
Figure 2. Data Collection Flight Path over the Baton Rouge Area Flight 4, September 3, 2021

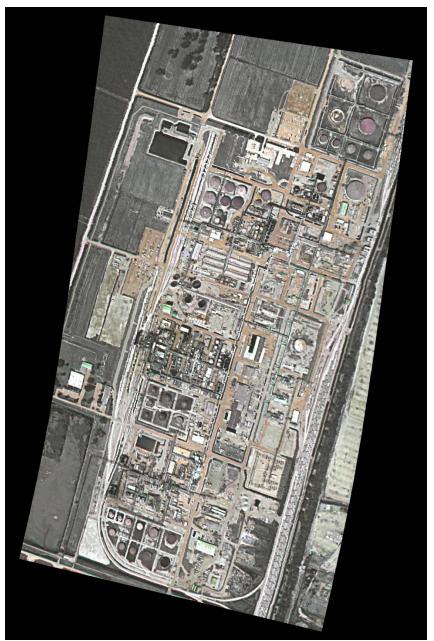
A total of 14 data collection runs (2 system checks and 12 data runs) were made over the Baton Rouge area and during each collection run an infrared line scanner image was generated. Figure 3 shows a 3-band infrared image collected over a facility collected as part of Flight 3. Minimum elevated thermal information is present in the image indicating little activity at the facility. Figure 4 shows a similar image collected on Flight 4 with flare signatures present on the northern portion of the facility. No chemical plumes can be observed being emitted from the facility.

Figure 3. Three band IR image, Baton Rouge Area, Run 2, Flight 3, September 3, 2021

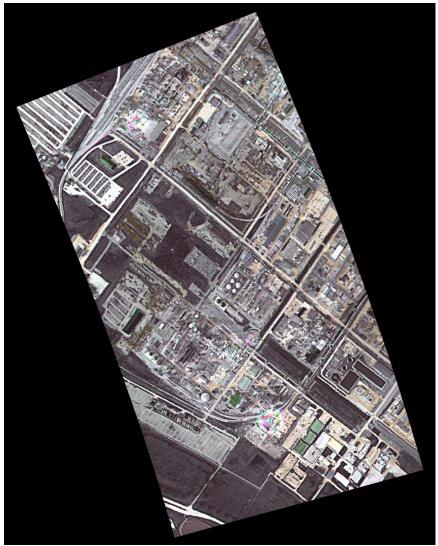
Figure 4. Three band IR image, Baton Rouge Area, Run 2, Flight 4, September 3, 2021

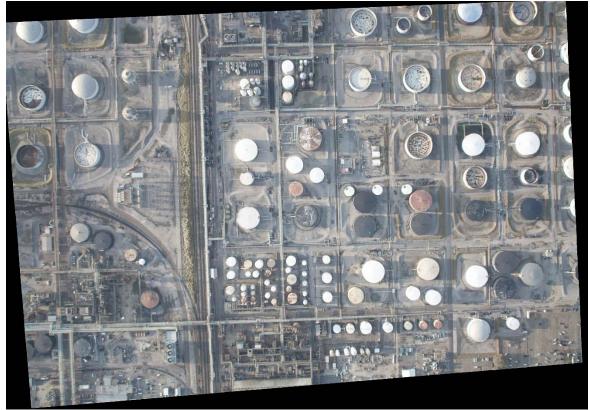
A full set of high-resolution aerial digital photography were collected as part of each data collection pass. Weather conditions over the Baton Rouge allowed high quality aerial images to be collected. Figure 4 shows an aerial image of part of the tank farm over the Exxon Chemical facility near Baton Rouge. It is noted that little water is present in the secondary containment structures. Figure 5 shows representative oblique image of the Westlake Plaquemine facility collected during Flight 3. Some activity is present at the facility as evident by the steam plume being released from a process unit.

Figure 5. MSIC photo taken over the Exxon Chemical Facility in Baton Rouge, LA on September 3, 2021

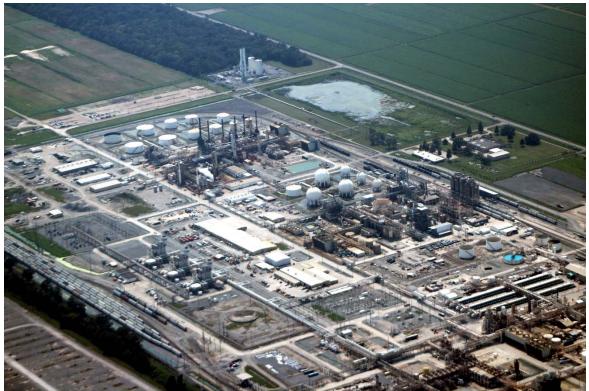
Figure 6. Oblique photo taken over the Shintech Plaquemine Facility as part of Flight 3, September 3, 2021
