Airborne Spectral Photometric Environmental Collection Technology

ASPECT Air Quality Survey after Hurricane Ida Baton Rouge, LA September 7, 2021

ASPECT Air Quality Survey

Hurricane IDA

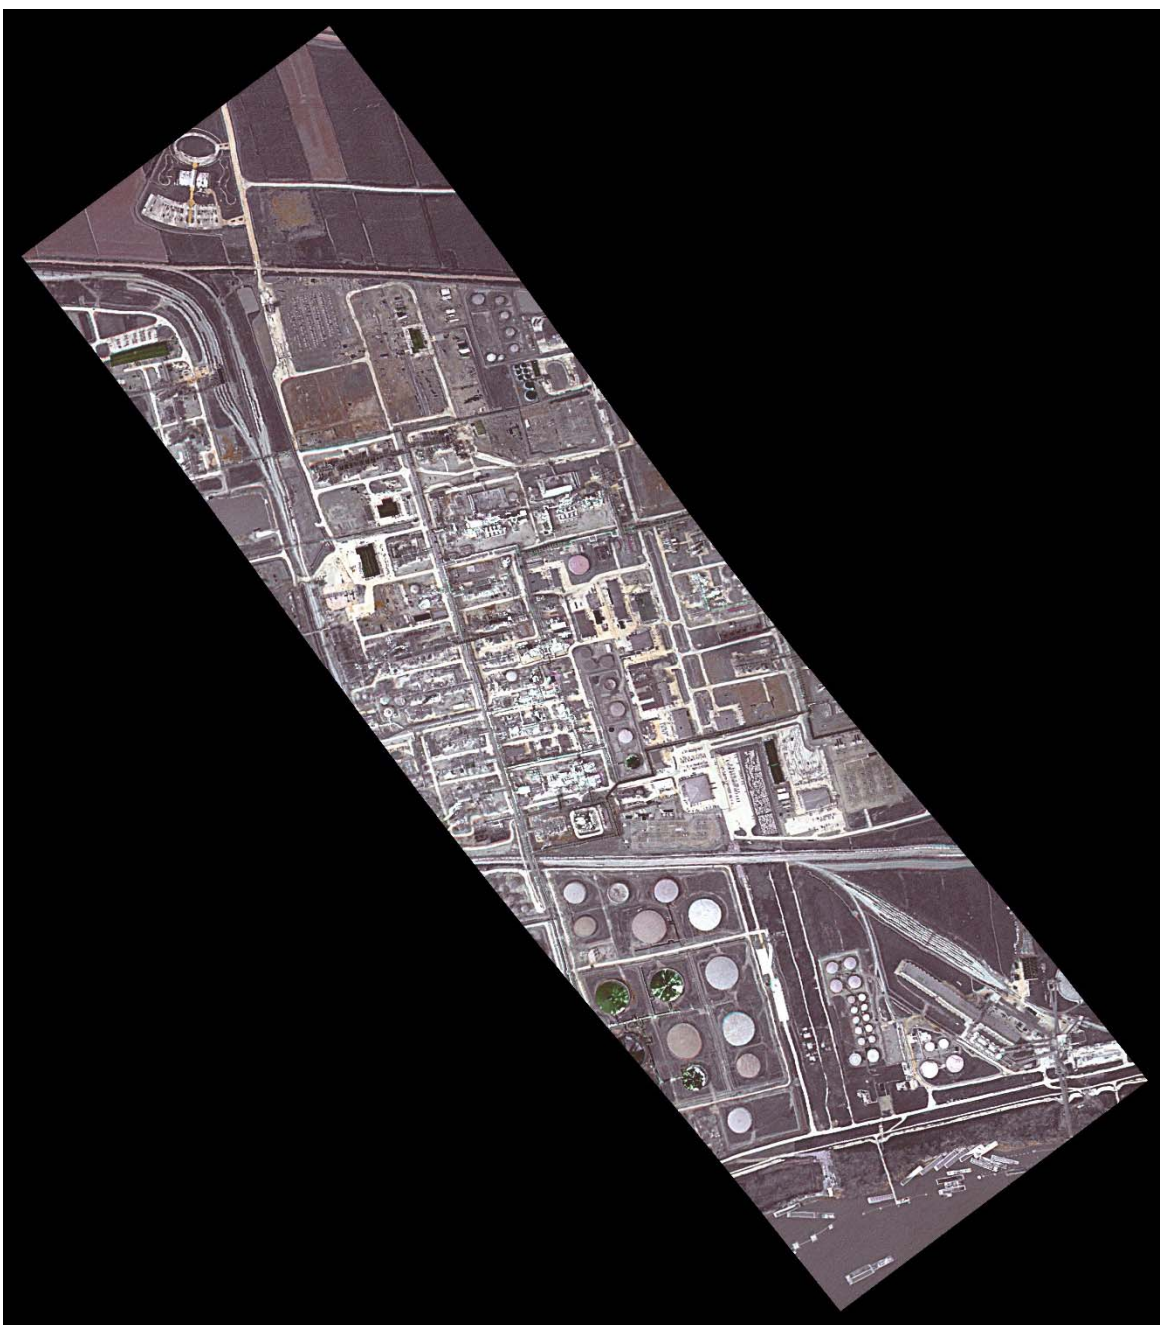
Figure 3. Three band IR image, Marathon Petroleum Company, Run 11, Flight 9, September 7, 2021

A total of 16 data collection runs (2 test and 14 active) were made over the target facilities and an infrared line scanner image was generated for each collection run. Figure 3 shows a 3-band infrared image collected over the Marathon Petroleum Company near Garyville. No significant features are evident in the image (such as flare or steam vents) and no discharges can be seen leaving the facility.

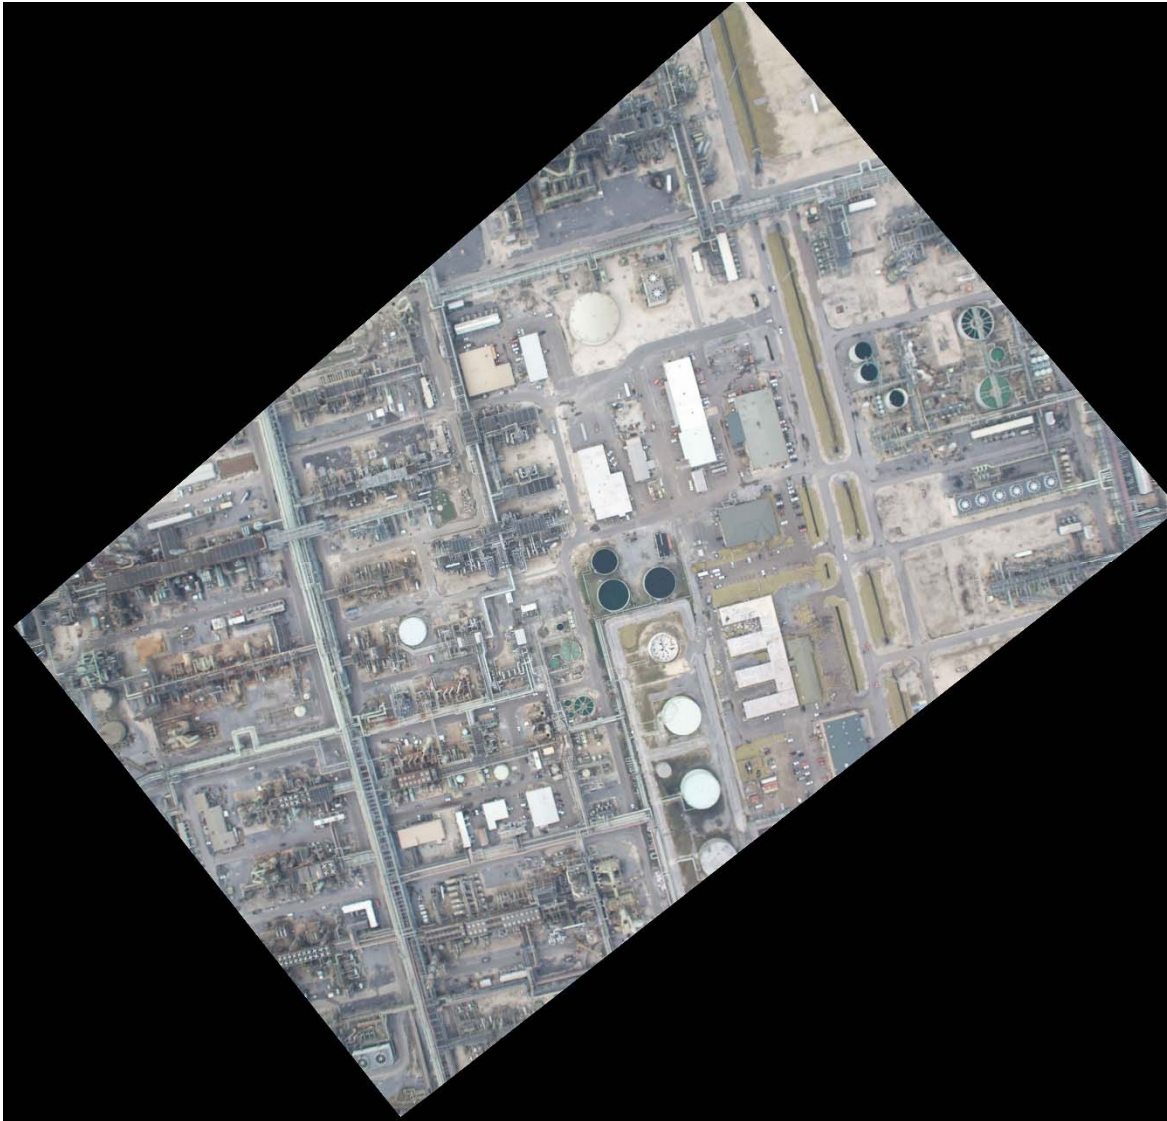
Figure 4. MSIC image of the Marathon Petroleum Company, Garyville, LA, Flight 10, September 7, 2021

A full set of high-resolution aerial digital photography were collected as part of each data collection pass. Weather conditions over the survey were challenging with both low ceiling and convective activity within the survey areas. These conditions made some images marginal. Figure 4 shows a representative aerial image collected over the Marathon

Petroleum Company in the Garyville area. No significant damage or activity is evident in the image. Figure 5 shows an oblique image of a flooded tank battery near Port Fourchon. Although flooded, no product appears to be leaking from the facility.
