Airborne Spectral Photometric Environmental Collection Technology

ASPECT Air Quality Survey for Hurricane Ida Baton Rouge, LA September 8, 2021

ASPECT Air Quality Survey

Hurricane IDA

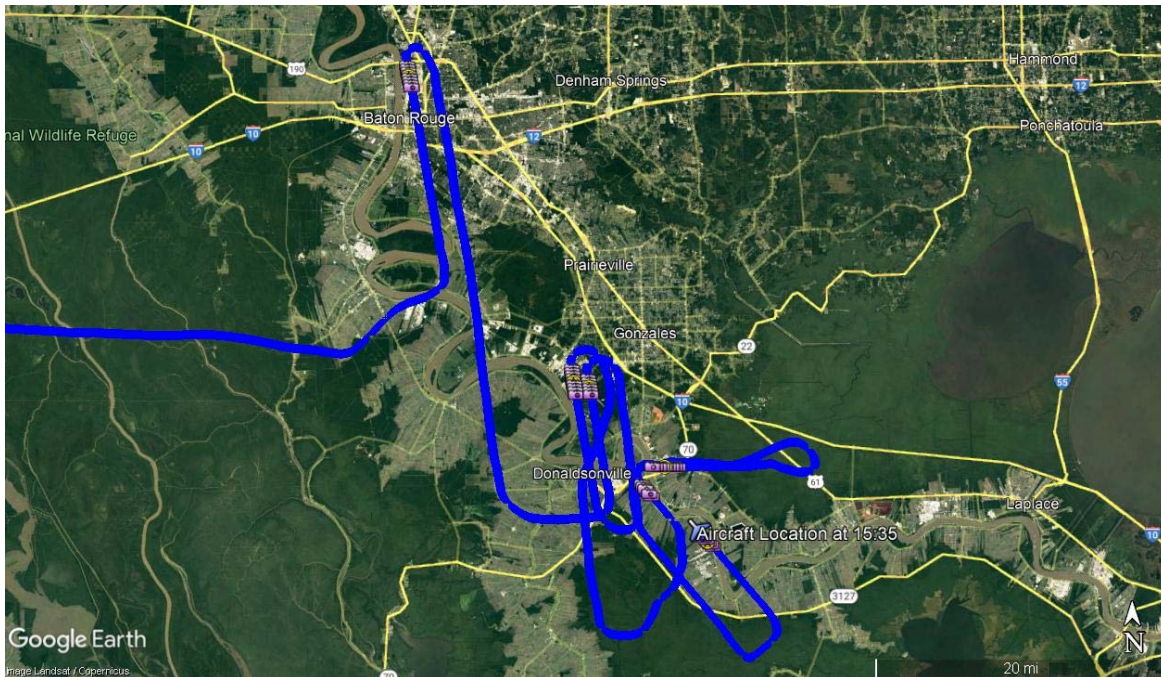
Figure 1. Data Collection Flight Path,
St. Bernard, Terrebonne, St. Charles, and St. James, Flight 11,
September 8, 2021

Wide, slow turns are required to be made in between runs to keep the instruments stable. The blue lines indicate the flight path while the green lines indicate the specific sections of the flight where chemical data was collected and processed. On Flight 11 and 12, the St. Bernard, Terrebonne, St. Charles, and St. James areas were surveyed, and the flight paths are shown in Figures 1 and 2.

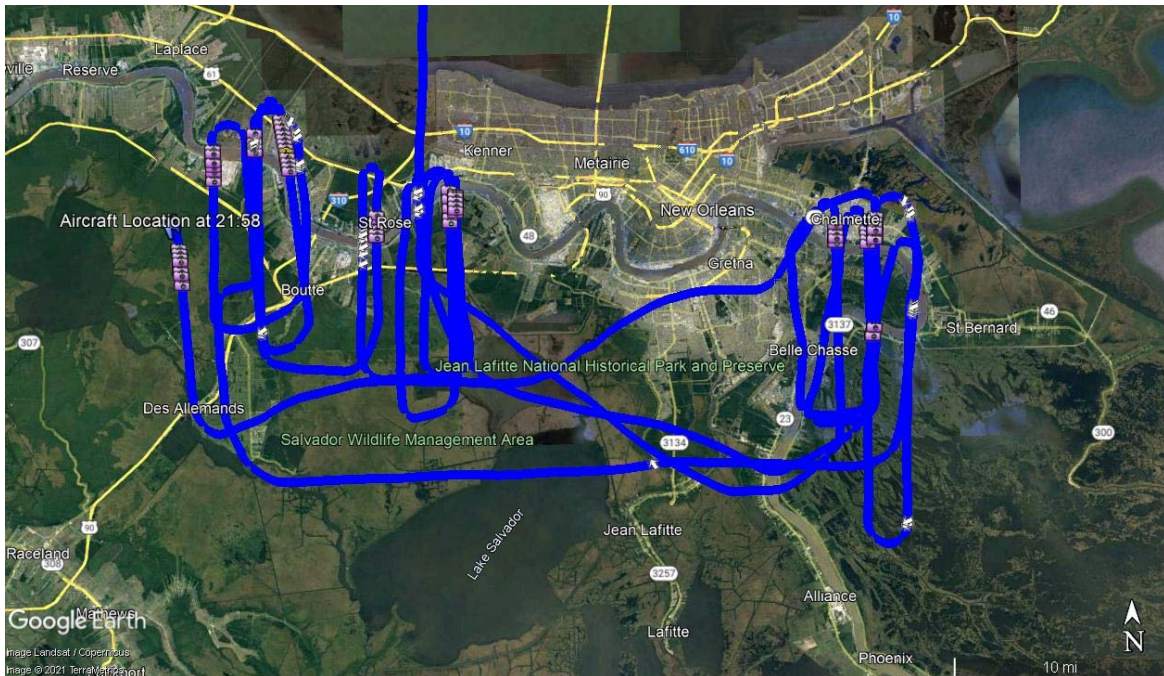
Figure 2. Data Collection Flight Path, St. Bernard, Terrebonne, St. Charles, and St. James, Flight 12, September 8, 2021

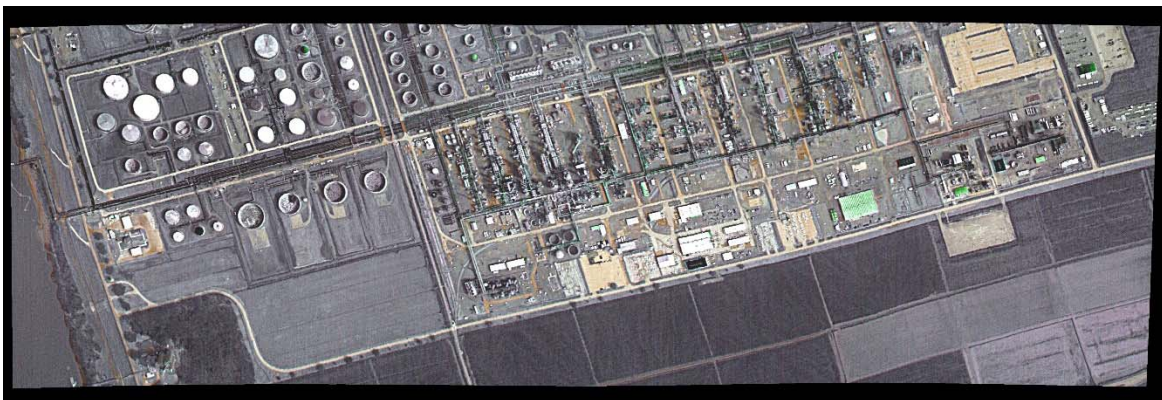
A total of 21 data collection runs (2 tests and 19 active) were made over the target facilities and an infrared line scanner image was generated for each collection run. Figure 3 shows a 3-band infrared image collected over the Shell Convent refinery. Analysis of the image shows elevated piping and hot units in the main process section of the facility. No discharges can be seen leaving the facility. Figure 4 shows a similar image collected over the Valero Refining Meraux Refinery. Hot flares in the lower portion of the image in addition to some hot process piping is evident.

Figure 3. Three band IR image, Equilon Enterprises LLC dba Shell Oil Products US - Convent Refinery, Flight 11, September 8, 2021

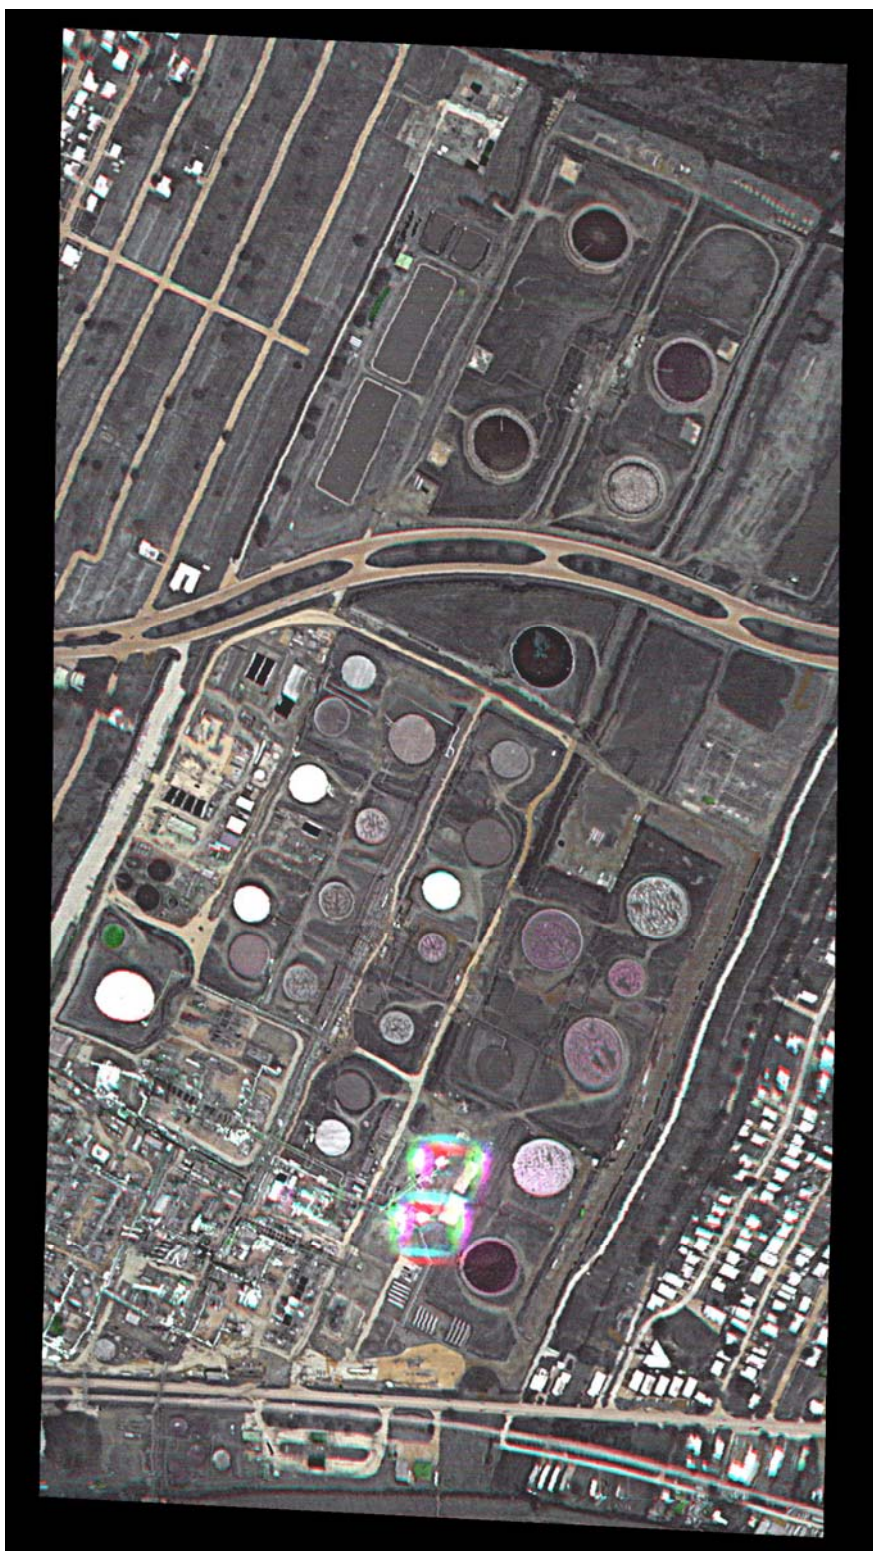
Figure 4. Three band IR image, Valero Refining - Meraux LLC - Meraux Refinery, Flight 12, September 8, 2021

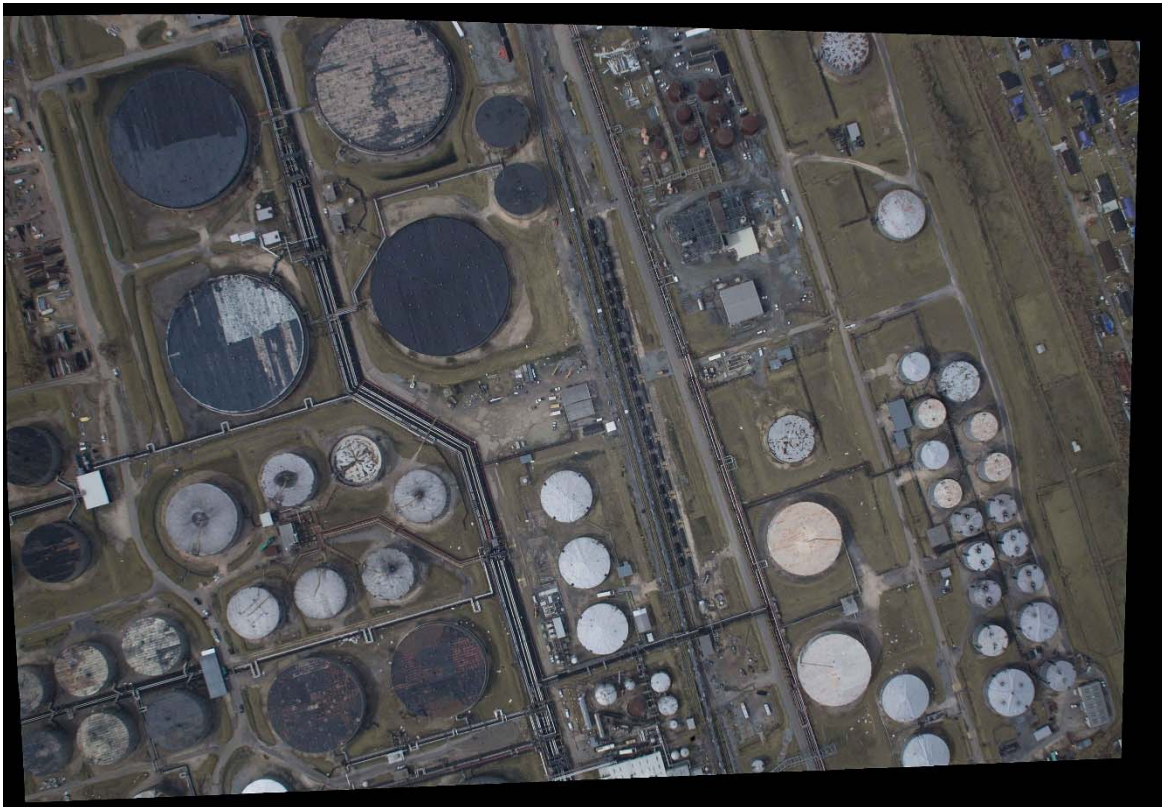
A full set of high-resolution aerial digital photography were collected as part of each data collection pass. As with the missions on September 7, flight conditions were complicated by low ceiling and convective activity. An aerial image of the St. Rose refinery is given in Figure 5. No significant damage or activity is evident in the image. An oblique image of the Valero Meraux Refinery is shown in Figure 6. As indicated in IR images of the same facility, two flares can be observed indicating some activity within the facility.

Figure 5. MSIC image of the St Rose Refinery LLC - St Rose, Flight 12, September 8, 2021

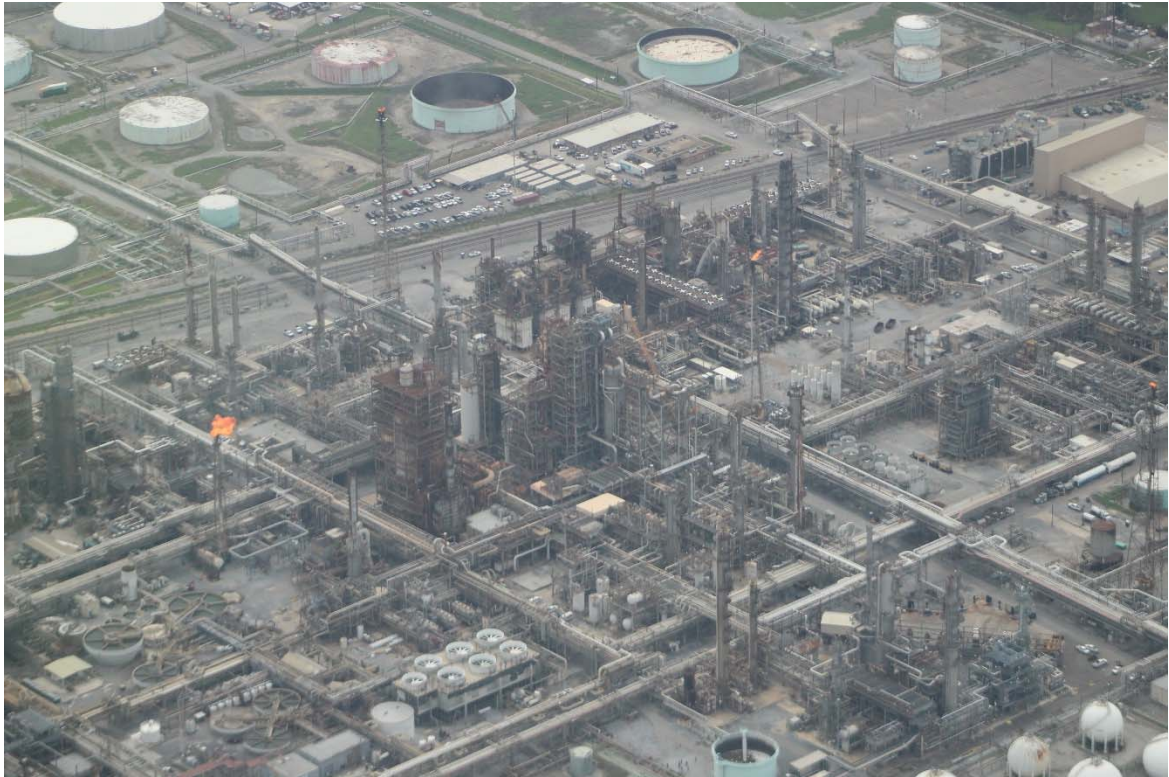
Figure 6. Oblique photo of the Valero Meraux Refinery, Flight 12, September 8, 2021
