EMERGENCY RESPONSE REPORT

GRETNA PLATING AND POLISHING
725 CARRICOX STREET
GRETNA, JEFFERSON PARISH, LOUISIANA

December 2015

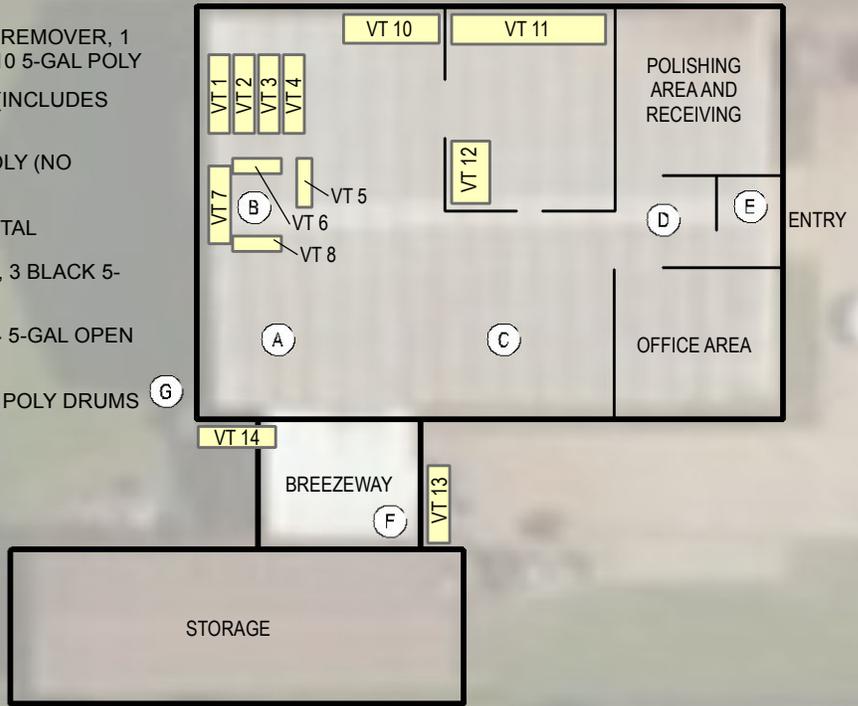
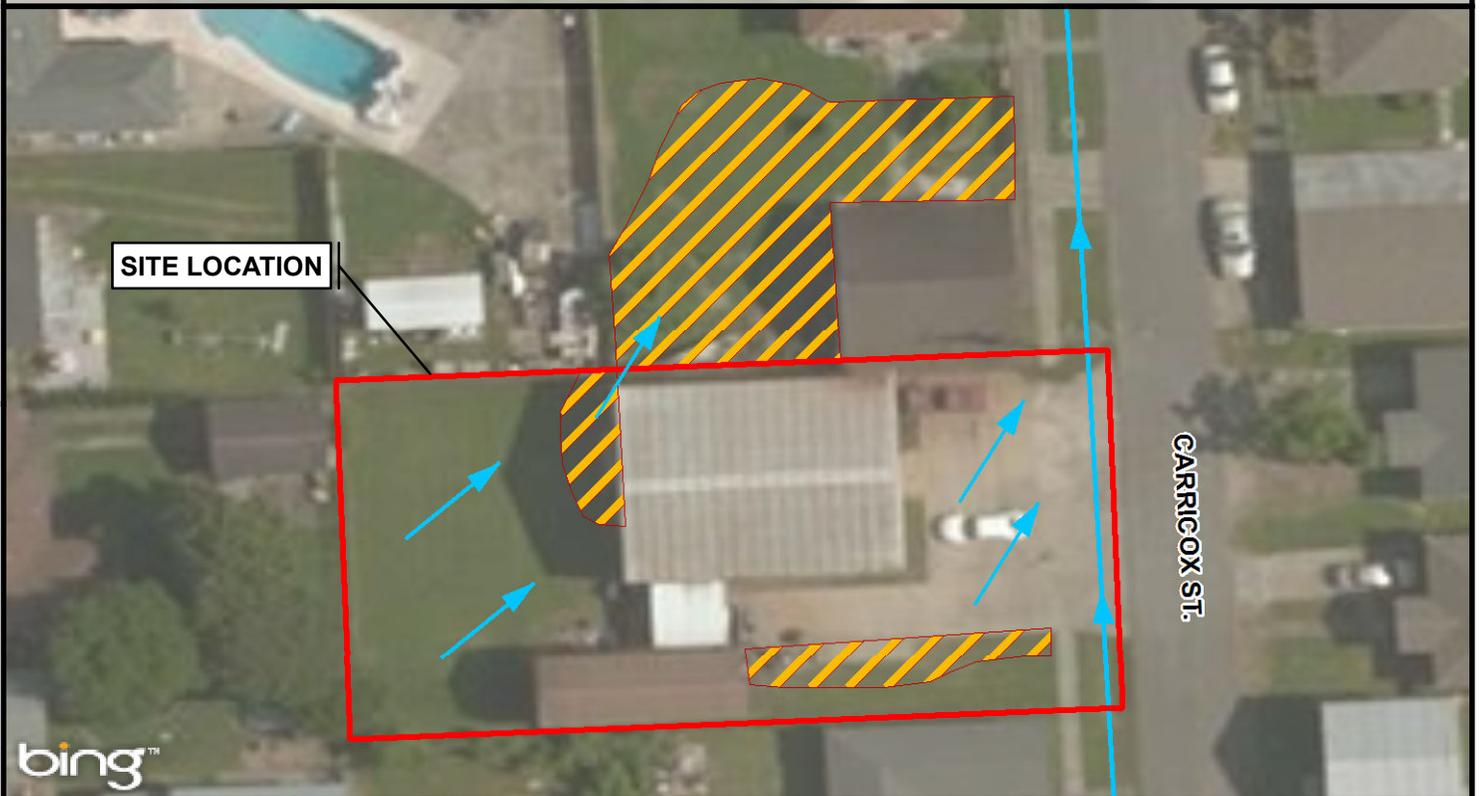
ATTACHMENT C
SITE SKETCH
 GREтна PLATING AND POLISHING
 725 CARRICOX STREET
 GREтна, JEFFERSON PARISH, LOUISIANA

- (A) 5 1-GAL METAL PAINT THINNER ADHESIVE REMOVER, 1 5-GAL METAL (HEXAVALENT CHROMIUM), 10 5-GAL POLY
- (B) 1 55-GAL POLY OPEN TOP, 10 5-GAL POLY (INCLUDES NIPLUS II AND MY T-WET COMPOUNDS)
- (C) 20 5-GAL POLY, 4 55-GAL POLY, 1 30GAL POLY (NO LABELS)
- (D) 4 5-GAL POLY, 1 35-GAL POLY, 2 35-GAL METAL
- (E) 3 BLACK 55-GAL POLY, 3 BLUE 5-GAL POLY, 3 BLACK 5-GAL, 4 BAGS SODAASH
- (F) 9 5-GAL BLUE POLY (FLUROBORIC ACID), 4 5-GAL OPEN TOP (NIBRITE AND NIPLUS II)
- (G) 7 5-GAL POLY (NICKEL SULFATE), 2 BLACK POLY DRUMS

- SITE LOCATION
- POTENTIAL IMPACT AREA
- ➔ STORMWATER FLOW

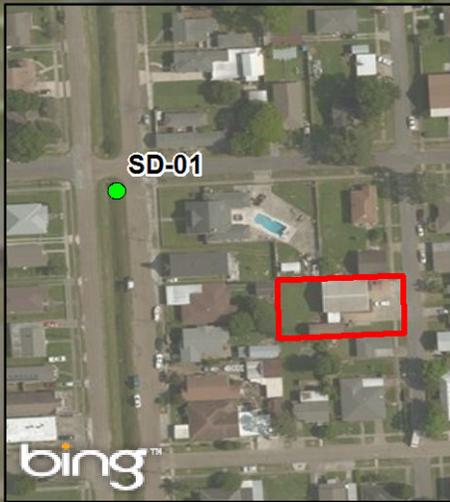
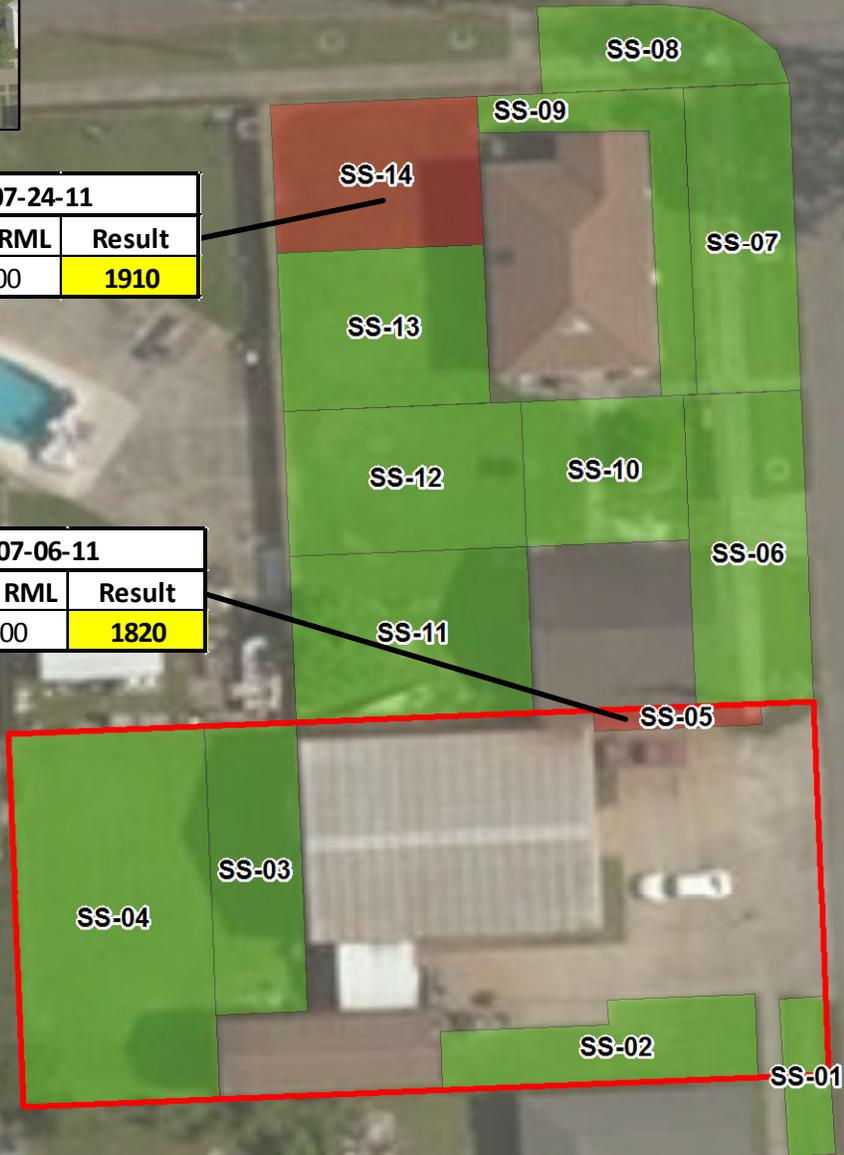
ATTACHMENT D
SAMPLE LOCATION MAP
GREटना PLATING AND POLISHING
725 CARRICOX STREET
GREटना, JEFFERSON PARISH, LOUISIANA

SS14-150807-24-11		
Analyte	2015 RML	Result
Manganese	1800	1910

SS05-150807-06-11		
Analyte	2015 RML	Result
Nickel	1500	1820

LEGEND

NO EXCEEDANCE OF 2015 RMLs

EXCEEDANCE OF 2015 RMLs

Final Level 4 analytical data packages were received from the GCAL Laboratory on 23 August 2015. Sample results were compared to LDEQ Risk Evaluation/Corrective Action Program (RECAP) Screening Option - Soil Screening Standard for non-industrial usage and EPA Regional Screening Levels (RSLs) for residential usage soil, using target hazard quotients (THQ) of 1.0 (June 2015). No sample results exceeded the corresponding EPA RSL for Total Chromium, Chromium III, or Nickel. Nineteen soil samples exceeded the Chromium IV EPA

RSL of 0.3 milligrams per kilogram (mg/kg). Chromium IV sample results ranged from 0.4 to 1.15 mg/kg. A summary of the soil sample analytical results is provided Attachment F.

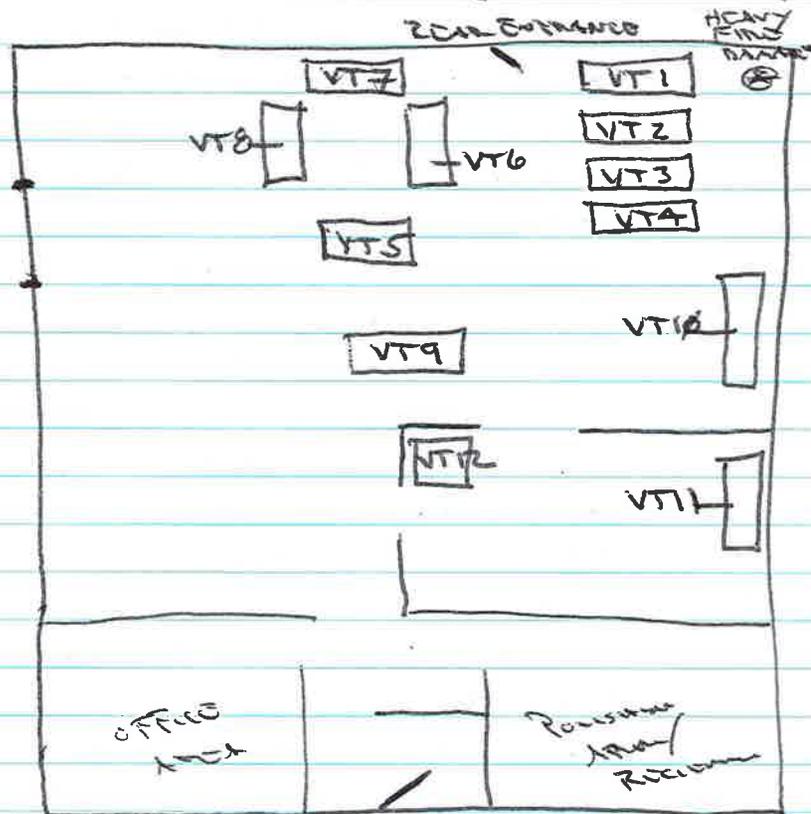
1535 START WITHOUT MARKING
LABELLING VATS. SEE SKETCH.

FRONT
ENTRANCE
