**Subject: Contract No. 68HERH19D0018; Task Order (TO) No. 68E0719F0190
Advanced Auto Parts and Former Fashions R Boutique
9844 and 9846 West Florissant Avenue, Dellwood, MO 63136
Analysis of Brownfields Cleanup Alternatives Report (ABCA)**

ANALYSIS OF BROWNFIELDS CLEANUP ALTERNATIVES REPORT

**ADVANCED AUTO PARTS AND FORMER FASHIONS R BOUTIQUE
9844-9846 WEST FLORISSANT AVENUE
DELLWOOD, ST. LOUIS COUNTY, MISSOURI**

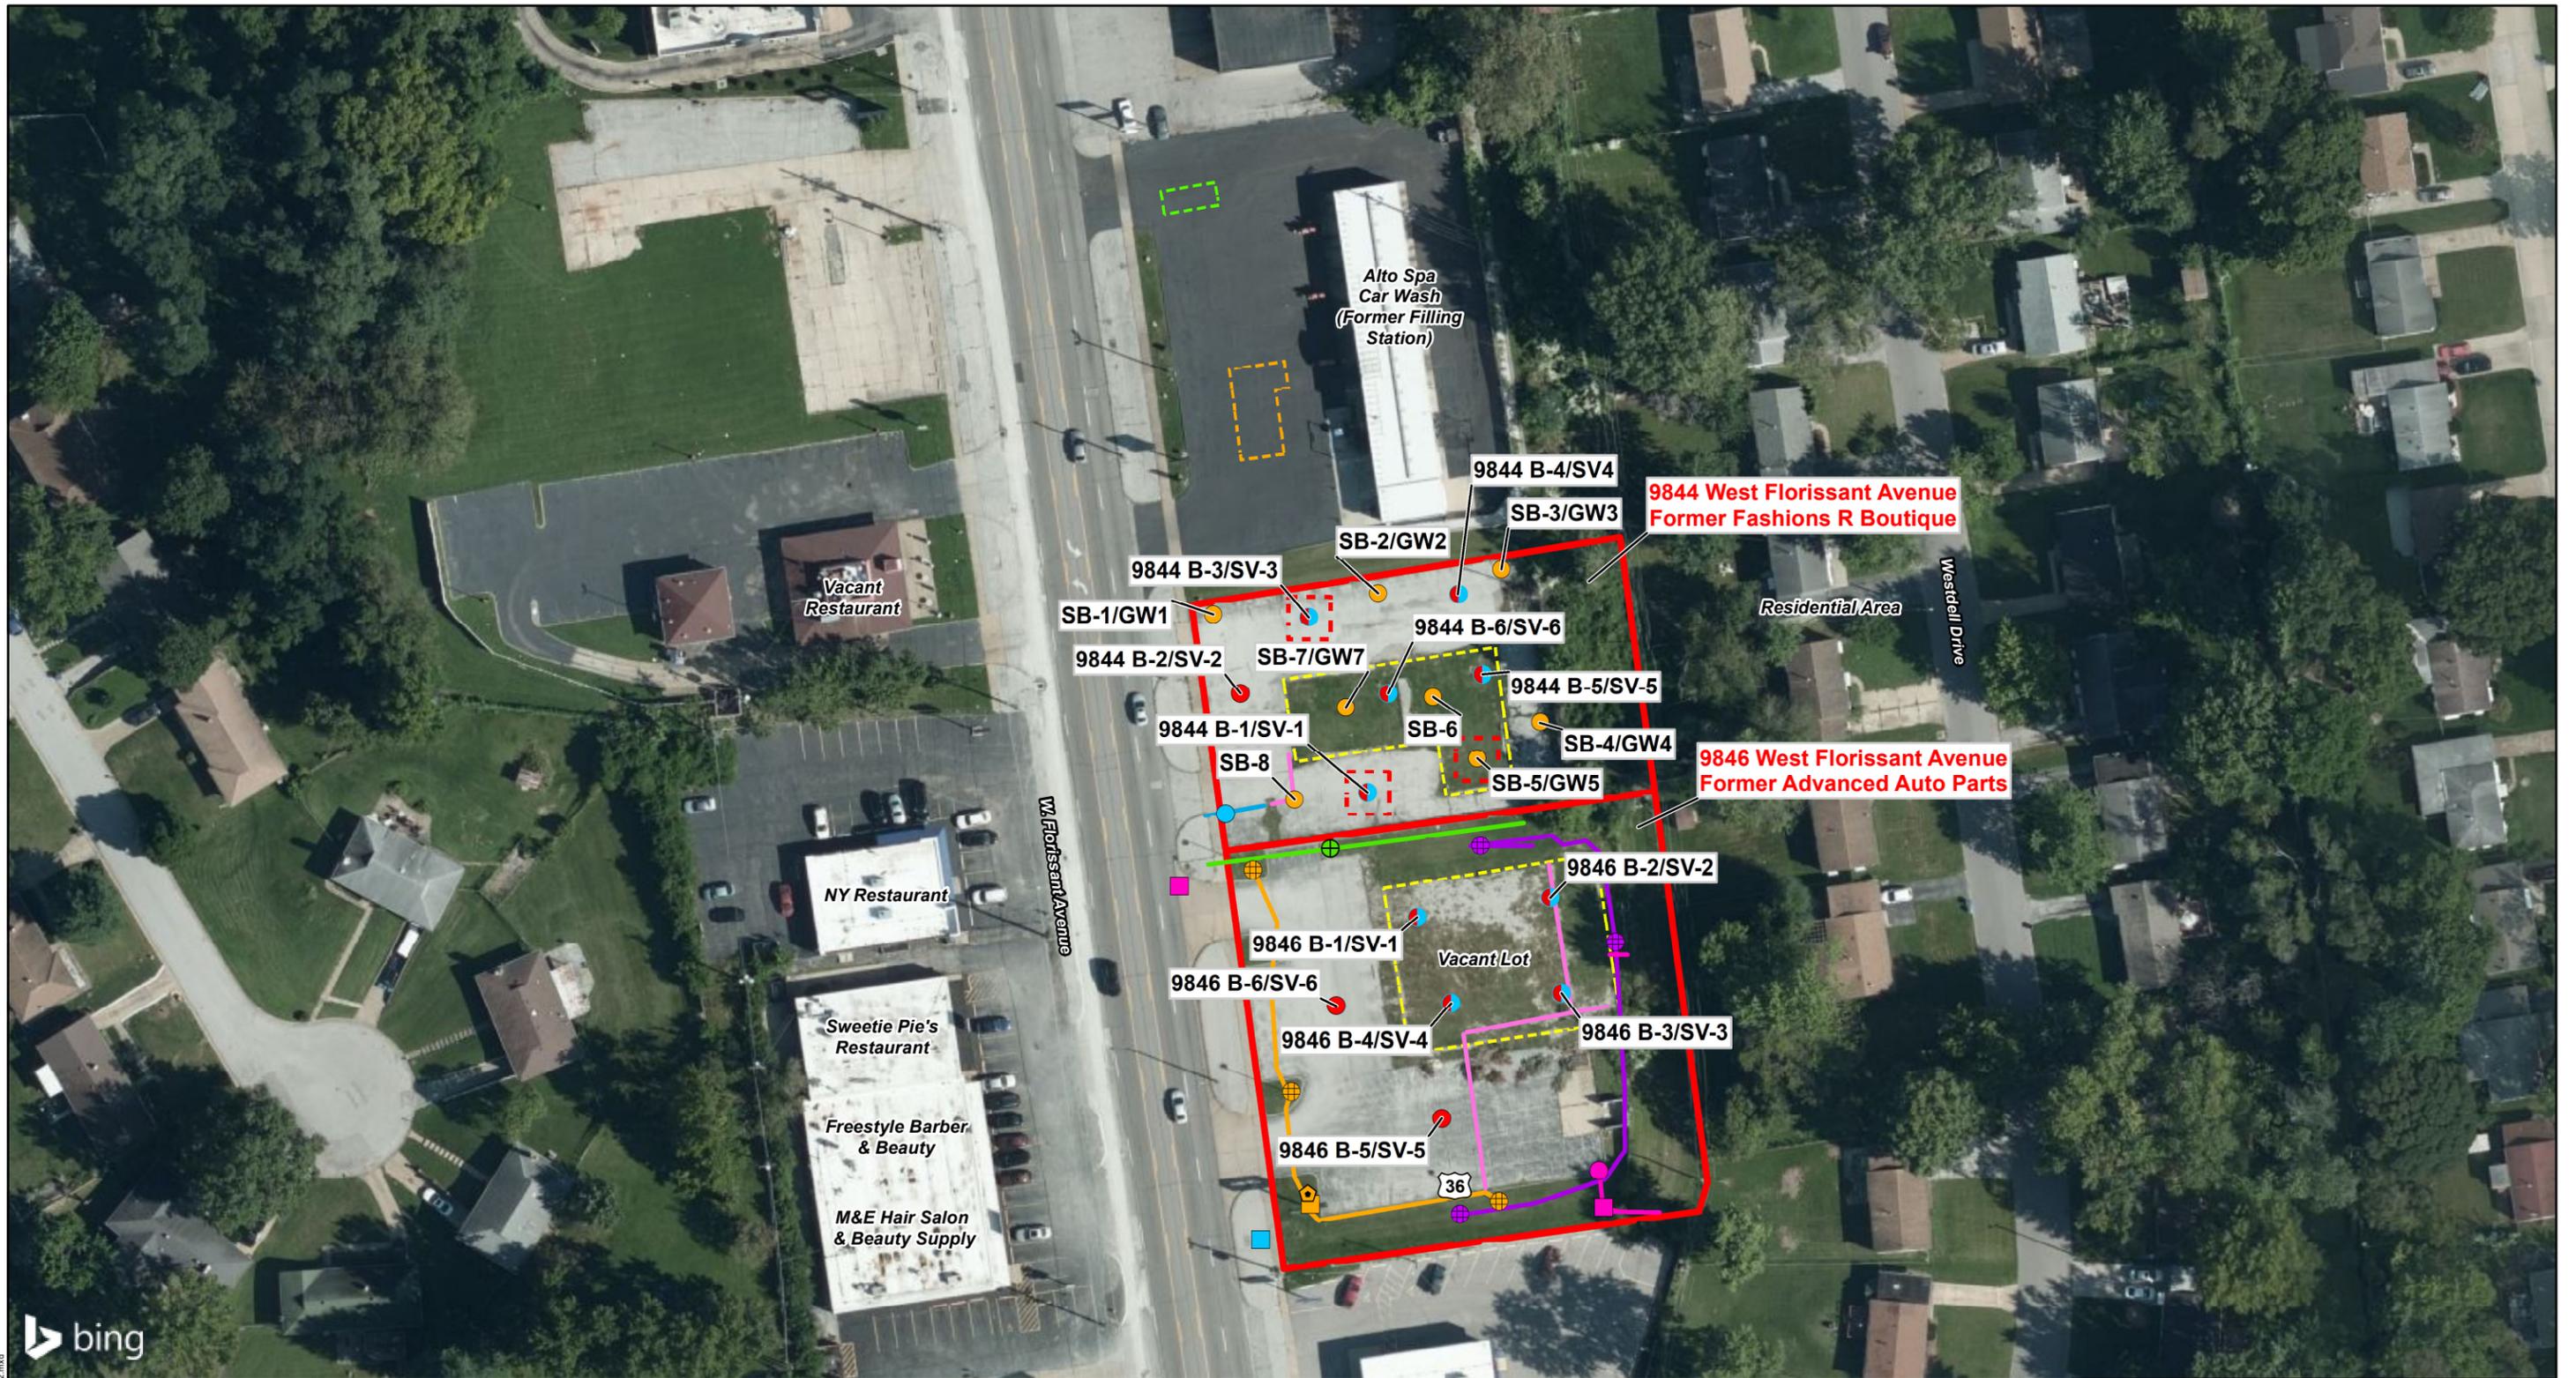
Tetra Tech’s 2018 Phase II ESA included collection of 17 subsurface soil samples (including one field duplicate) at eight locations (SB-1 through SB-8) across the 9844 West Florissant Avenue property (see Appendix A, Figure 2). Subsurface soil samples were collected within select intervals based on visual staining, detected odor, or elevated photoionization detector (PID) readings. If no staining/odor or elevated PID reading was noted, a sample was collected at a location determined by the field team, including intervals within the capillary fringe (if groundwater was encountered) or within the bottom portion of the boring (if refusal was encountered). Samples were analyzed for VOCs, polycyclic aromatic hydrocarbons (PAHs), TPH – gasoline range organics (GRO), TPH – diesel range organics (DRO), TPH – oil range organics (ORO), and RCRA metals, excluding mercury. Comparisons of analytical data to MRBCA Tier 1 RBTLs for Type 3 (clayey) subsurface soils, indoor inhalation of vapor emissions pathway (or MRBCA LDTLs if RBTLs were not available) and to USGS average background concentrations of metals in St. Louis County resulted in the following noteworthy findings:

As part of the Phase II ESA completed by the Toeroek Team in 2021, 14 subsurface soil samples were collected (including two field duplicates) at 12 locations (9844-B1 through -B6 and 9846-B1 through -B6) across the subject property (see Appendix A, Figure 2). Subsurface soil samples were collected within select intervals based on visual staining, detected odor, or elevated PID readings. If no staining/odor or elevated PID reading was noted, a sample was collected from the bottom two feet of the soil core. Samples were analyzed for VOCs, SVOCs, TPH-GRO, TPH-DRO, TPH-ORO, and RCRA metals, including mercury. Comparisons of analytical data to MRBCA Tier 1 RBTLs for Type 3 (clayey) subsurface soils, indoor inhalation of vapor emissions pathway (or MRBCA LDTLs if RBTLs are not available) and to USGS average background concentrations of metals in St. Louis County resulted in the following noteworthy findings:

Tetra Tech's 2018 Phase II ESA included collection of seven groundwater samples (including one field duplicate) at six locations (SB-1 through SB-5 and SB-7) across the 9844 West Florissant Avenue property (see Appendix A, Figure 2). Samples were analyzed for VOCs, PAHs, TPH-GRO, TPH-DRO, TPH-ORO, and total and dissolved RCRA metals (excluding mercury). Comparisons of analytical data to MRBCA Tier 1 RBTLs for Type 3 (clayey) groundwater dermal contact (or MRBCA LDTLs if RBTLs were not available) resulted in the following noteworthy findings:

As part of the 2021 Phase II ESA by the Toeroek Team, nine groundwater samples were collected at locations collocated with nine of the subsurface soil samples (see Appendix A, Figure 2). Groundwater was not encountered at depths above the planned maximum boring depth of 30 feet below ground surface (bgs) in soil borings 9844-B2, 9846-B5, and 9846-B6. Samples were analyzed for VOCs, SVOCs, TPH-GRO, TPH-DRO, TPH-ORO, and total and dissolved RCRA metals. Volumes of groundwater in samples collected at 9844-B6 and 9846-B1 through -B4 were not sufficient for total or dissolved metals analyses. Comparisons of analytical data to MRBCA Tier 1 RBTLs for Type 3 (clayey) groundwater dermal contact (or MRBCA LDTLs if RBTLs were not available) resulted in the following noteworthy findings:

- Soil Excavation around Sample Location SB-5 (16-18): The volume of soil to be excavated to cleanup levels is approximately 280 CY, assuming an area of 400 square feet and a depth of 19 feet bgs. Shoring would be needed because of the excavation depth. The approximate area for excavation is depicted on Figure 2.

- Soil Excavation around Sample Location 9844-B1 (24-26): The volume of soil to be excavated to cleanup levels is approximately 400 CY, assuming an area of 400 square feet and a depth of 27 feet bgs. Shoring would be needed because of the excavation depth. The approximate area for excavation is depicted on Figure 2.

- Soil Excavation around Sample Location 9844-B3 (24-26): The volume of soil to be excavated to cleanup levels is approximately 400 CY, assuming an area of 400 square feet and a depth of 27 feet bgs. Shoring would be needed because of the excavation depth. The approximate area for excavation is depicted on Figure 2.
