**Subject: Contract No. 68HERH19D0018; Task Order (TO) No. 68E0719F0190  
Red Earth Residential Buildings, 1619, 1629, 1653, and 1671 340<sup>th</sup> Street,  
Hiawatha, Kansas  
Targeted Brownfields Assessment Hazardous Materials Survey**

**TARGETED BROWNFIELDS ASSESSMENT  
HAZARDOUS MATERIALS SURVEY**

**RED EARTH RESIDENTIAL BUILDINGS  
1619, 1629, 1653, AND 1671 340<sup>TH</sup> STREET  
HIAWATHA, BROWN COUNTY, KANSAS**

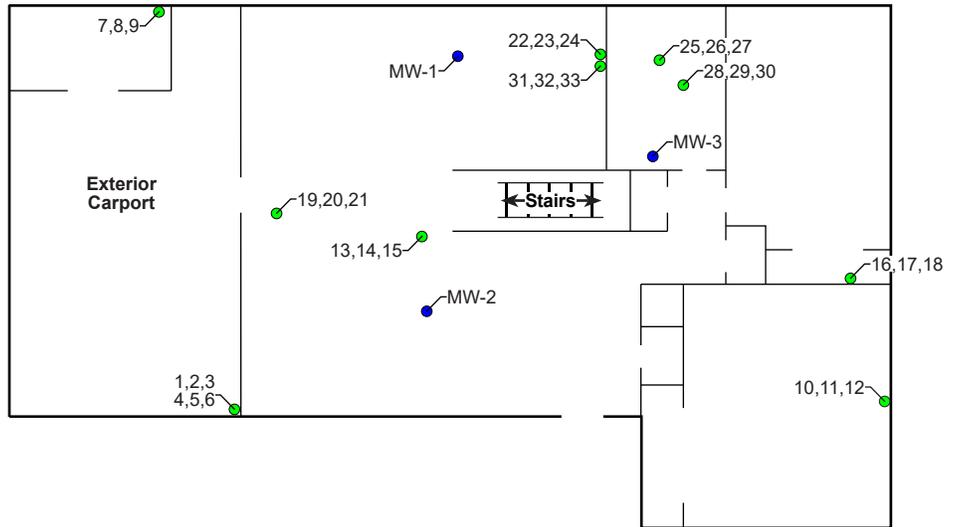
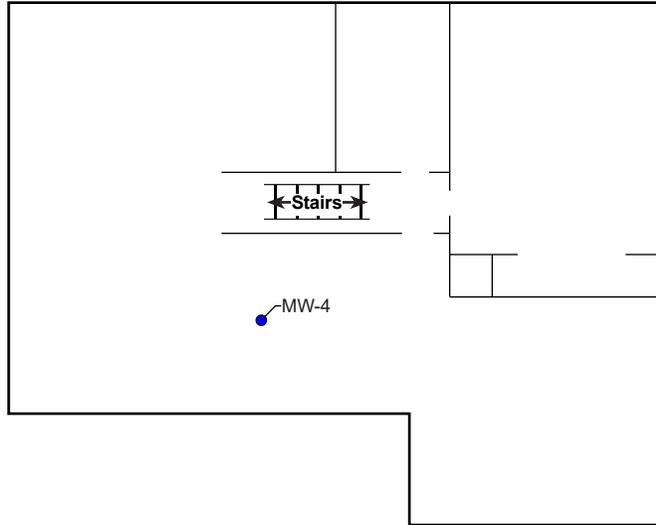
**1619 340th Street**

**First Floor**

**Basement**

- Meth Wipe Sample Location
- Non-asbestos Containing Material Sample Location

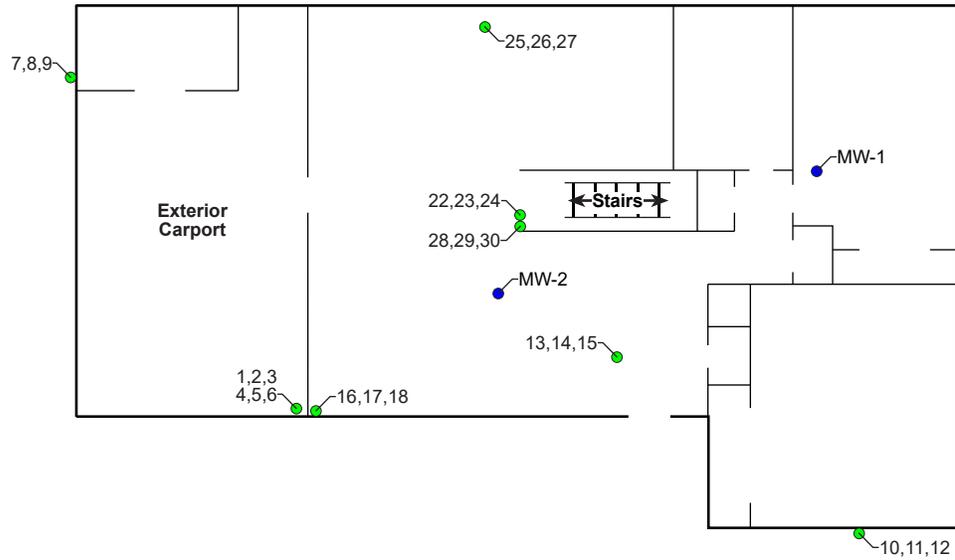
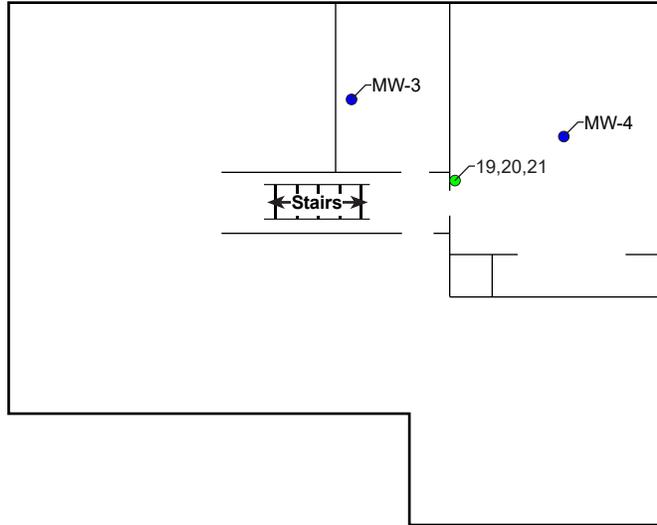
**1629 340th Street**

**First Floor**

**Basement**

- Meth Wipe Sample Location
- Non-asbestos Containing Material Sample Location

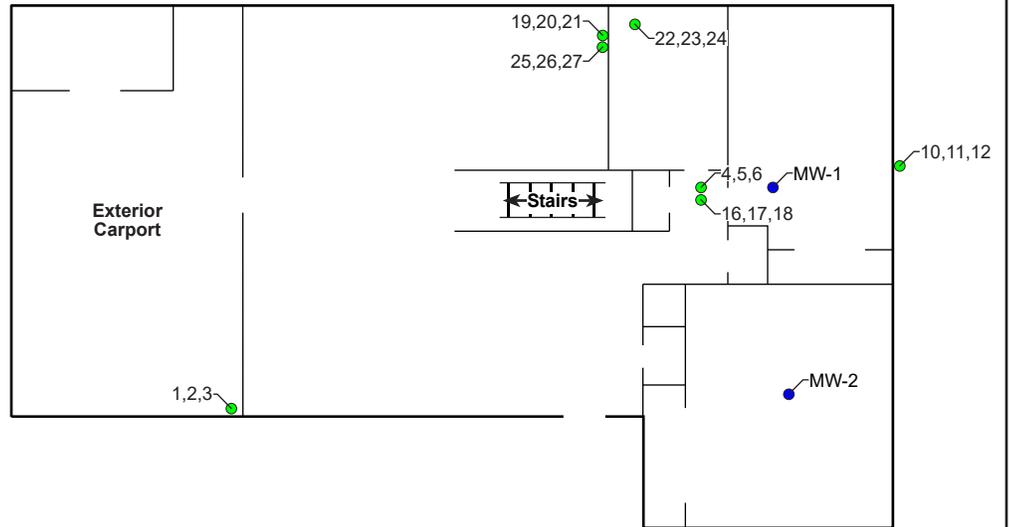
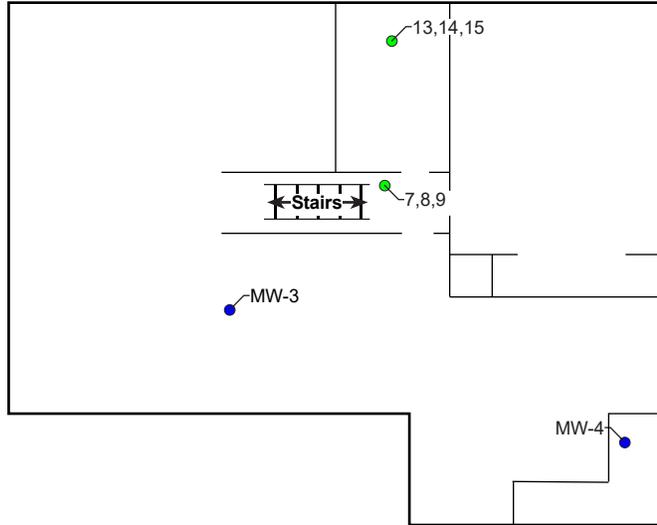
**1653 340th Street**

**First Floor**

**Basement**

- Meth Wipe Sample Location
- Non-asbestos Containing Material Sample Location

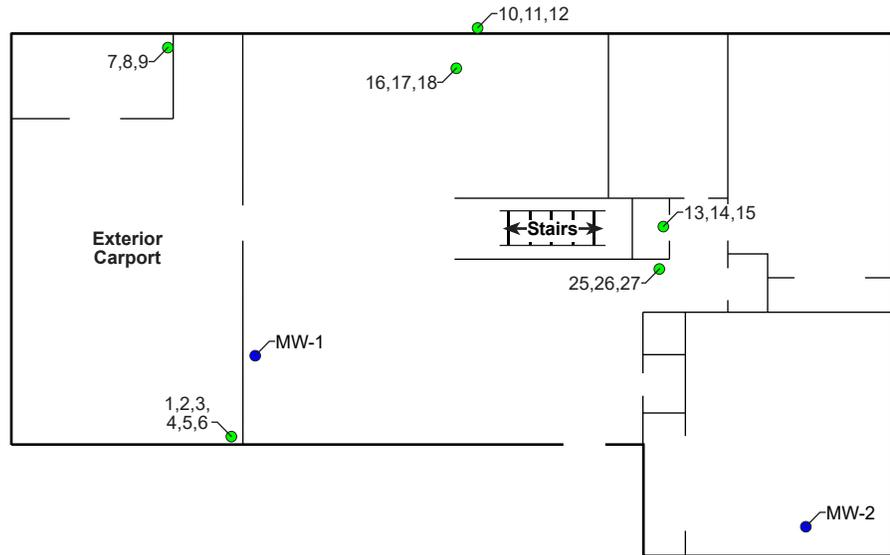
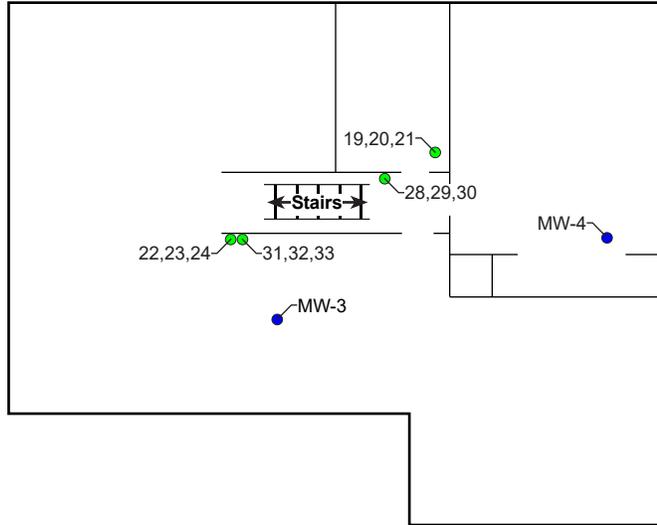
**1671 340th Street**

**First Floor**

**Basement**

- Meth Wipe Sample Location
- Non-asbestos Containing Material Sample Location

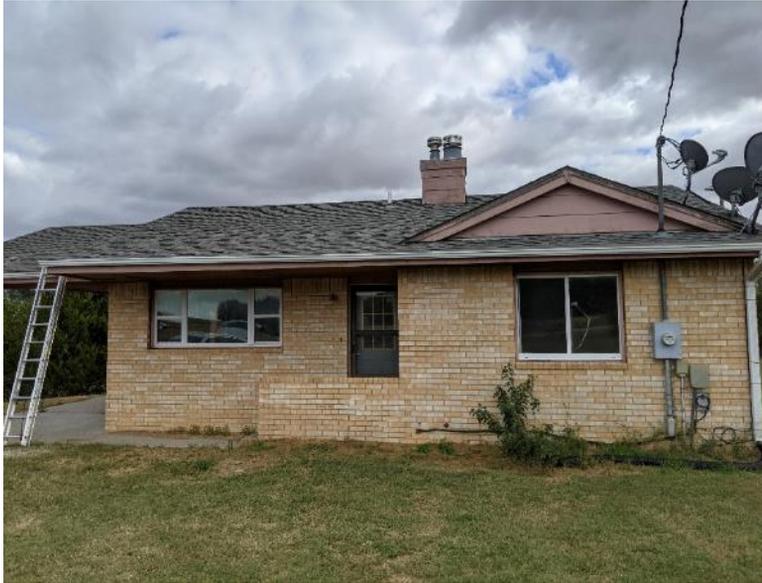
SUBTASK NO. 07.05  Direction: South	DESCRIPTION	This photograph shows the subject property at 1619 340 <sup>th</sup> Street.	1
	CLIENT	U.S. Environmental Protection Agency (EPA)	Date
	PHOTOGRAPHER	Ryan Slanczka	10/5/2021

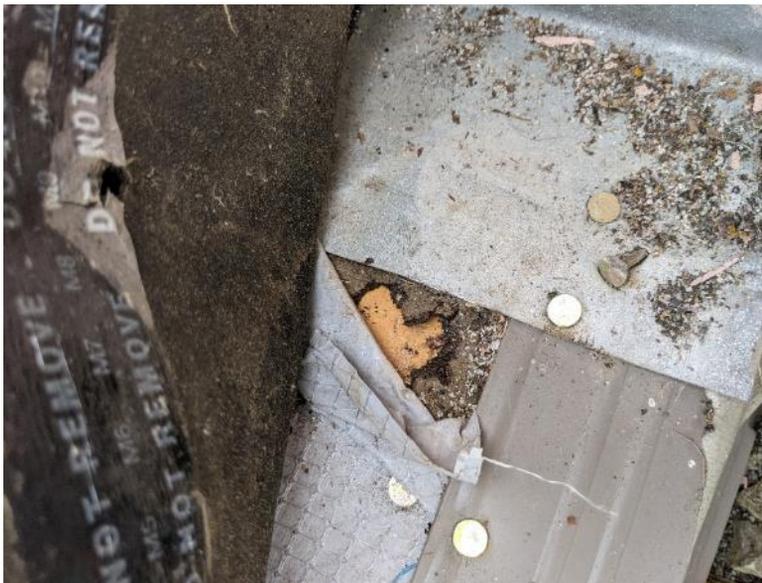
SUBTASK NO. 07.05  Direction: NA	DESCRIPTION	This photograph shows vapor barrier at 1619 340 <sup>th</sup> Street.	2
	CLIENT	EPA	Date
	PHOTOGRAPHER	Ryan Slanczka	10/5/2021

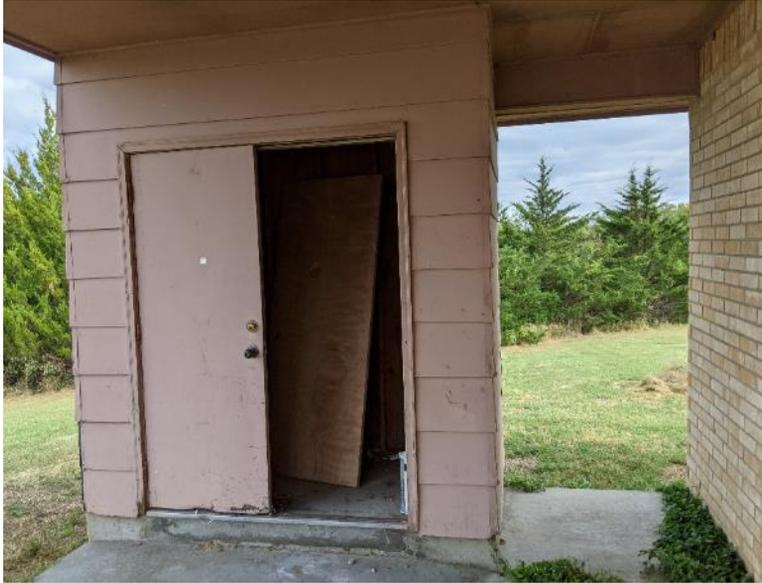
SUBTASK NO. 07.05  Direction: South	DESCRIPTION	This photograph shows pink panel siding at 1619 340 <sup>th</sup> Street.	3
	CLIENT	EPA	Date
	PHOTOGRAPHER	Ryan Slanczka	10/5/2021

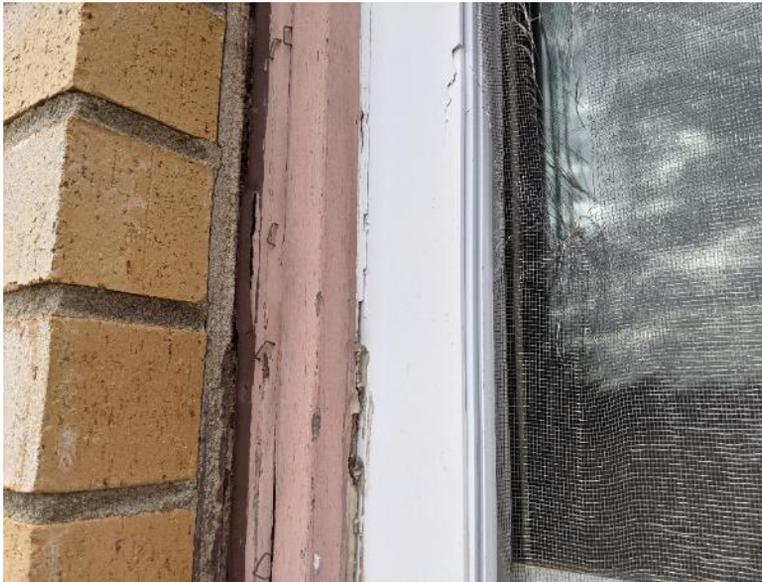
SUBTASK NO. 07.05  Direction: North	DESCRIPTION	This photograph shows window caulk at 1619 340 <sup>th</sup> Street.	4
	CLIENT	EPA	Date
	PHOTOGRAPHER	Ryan Slanczka	10/5/2021

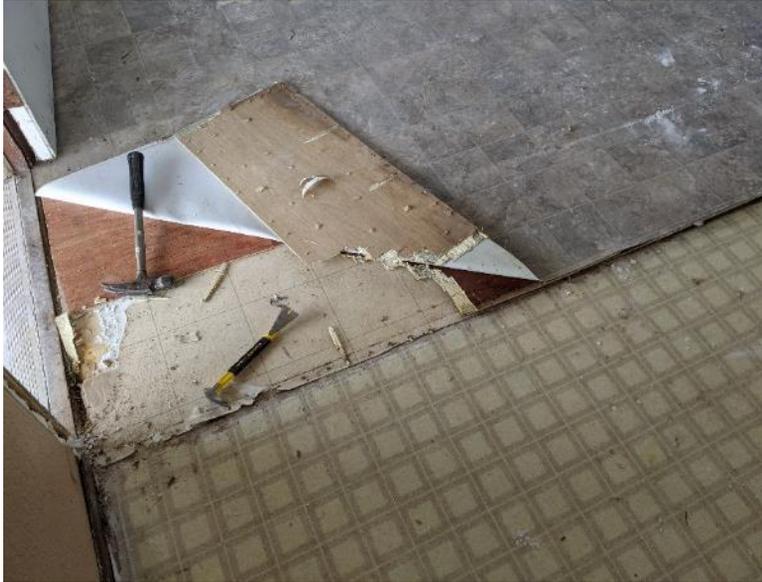
SUBTASK NO. 07.05  Direction: NA	DESCRIPTION	This photograph shows ceramic-façade, small square-patterned, and 6" tile-façade sheet flooring with associated mastic at 1619 340 <sup>th</sup> Street.	5
	CLIENT	EPA	Date
	PHOTOGRAPHER	Ryan Slanczka	10/5/2021

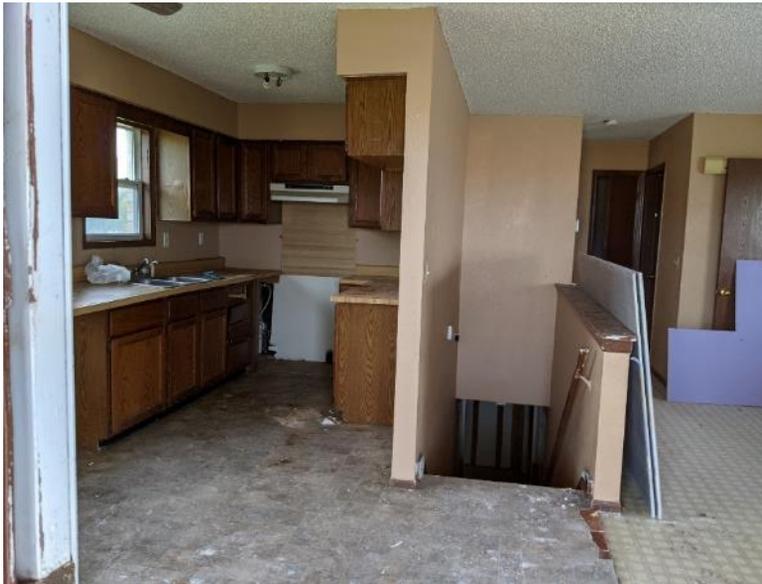
SUBTASK NO. 07.05  Direction: NA	DESCRIPTION	This photograph shows ceiling texture, wall texture, and drywall with joint compound at 1619 340 <sup>th</sup> Street.	6
	CLIENT	EPA	Date
	PHOTOGRAPHER	Ryan Slanczka	10/5/2021

The Toeroek Team identified suspect drywall with associated joint compound in each of the subject property buildings. Joint compound was not collected with samples of drywall from 1619 and 1629 340<sup>th</sup> Street. The Toeroek Team recommends that if suspect joint compound is to be disturbed during renovations at 1619 or 1629 340<sup>th</sup> Street, this material should be sampled to determine its asbestos content.

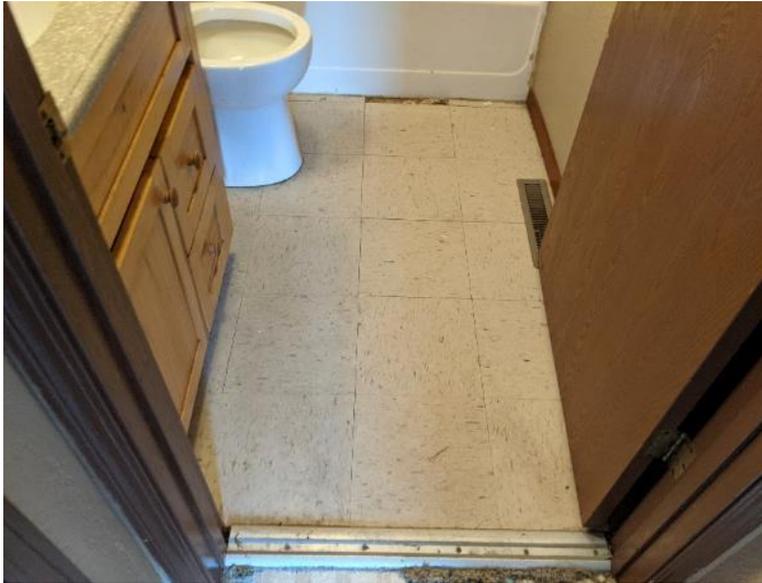
SUBTASK NO. 07.05  Direction: NA	DESCRIPTION	This photograph shows 12” vinyl floor tile with associated mastic at 1619 340 <sup>th</sup> Street.	7
	CLIENT	EPA	Date
	PHOTOGRAPHER	Ryan Slanczka	10/5/2021

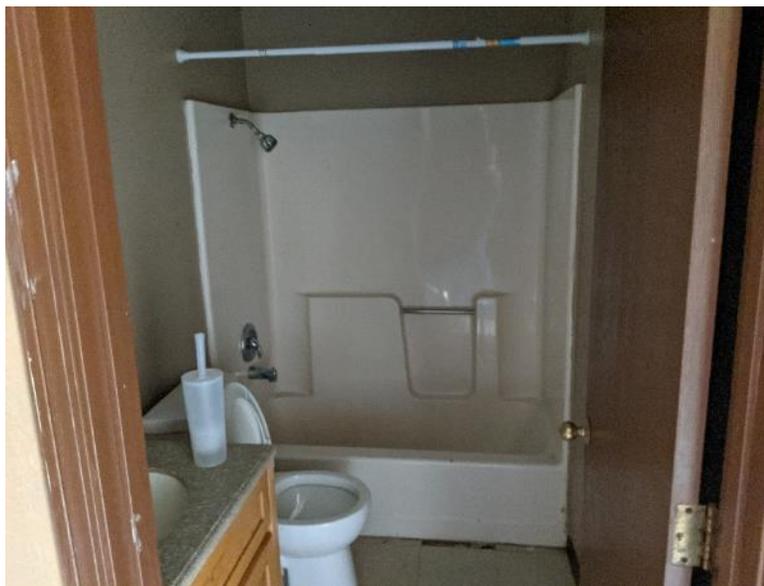
SUBTASK NO. 07.05  Direction: NA	DESCRIPTION	This photograph shows a bathtub with associated mastic at 1619 340 <sup>th</sup> Street.	8
	CLIENT	EPA	Date
	PHOTOGRAPHER	Ryan Slanczka	10/5/2021

The Toeroek Team identified suspect asbestos-containing sink undercoat and bathtub mastic in each of the subject property buildings. To maintain the integrity of this material, samples were not collected. The Toeroek Team recommends that if suspect bathtub mastic is to be disturbed during renovations, this material should be sampled to determine its asbestos content. All other areas of the subject property building were inspected.

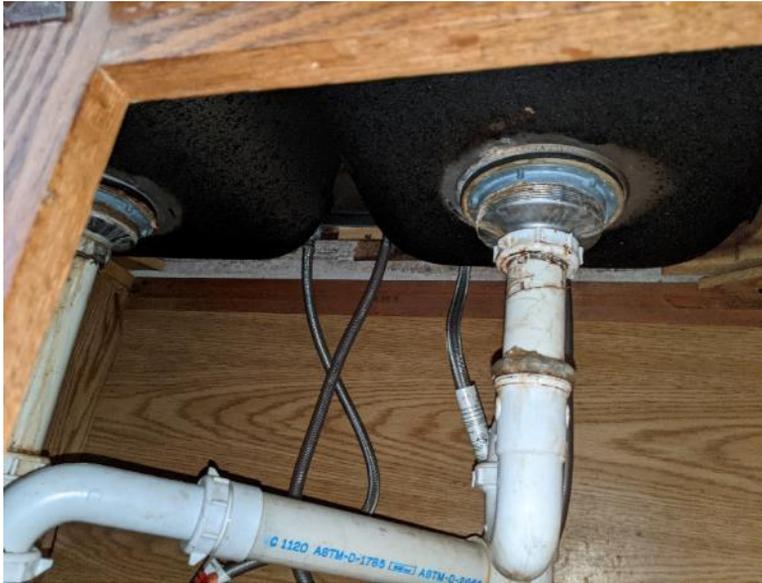
SUBTASK NO. 07.05  Direction: NA	DESCRIPTION	This photograph shows sink undercoating at 1619 340 <sup>th</sup> Street.	9
	CLIENT	EPA	Date
	PHOTOGRAPHER	Ryan Slanczka	10/5/2021

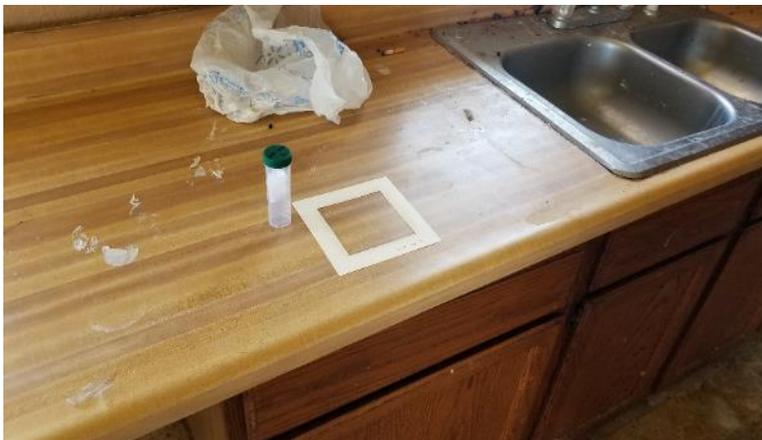
SUBTASK NO. 07.03  Direction: NA	DESCRIPTION	This photograph shows methamphetamine residue wipe sampling at the kitchen counter at 1619 340 <sup>th</sup> Street.	10
	CLIENT	EPA	Date
	PHOTOGRAPHER	Reed Niemack	10/4/2021

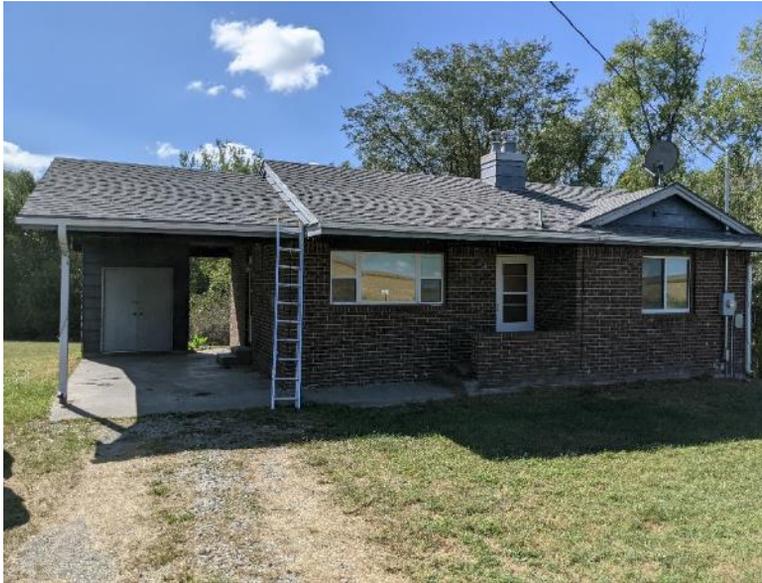
SUBTASK NO. 07.05  Direction: South	DESCRIPTION	This photograph shows the subject property at 1629 340 <sup>th</sup> Street.	11
	CLIENT	EPA	Date
	PHOTOGRAPHER	Ryan Slanczka	10/5/2021

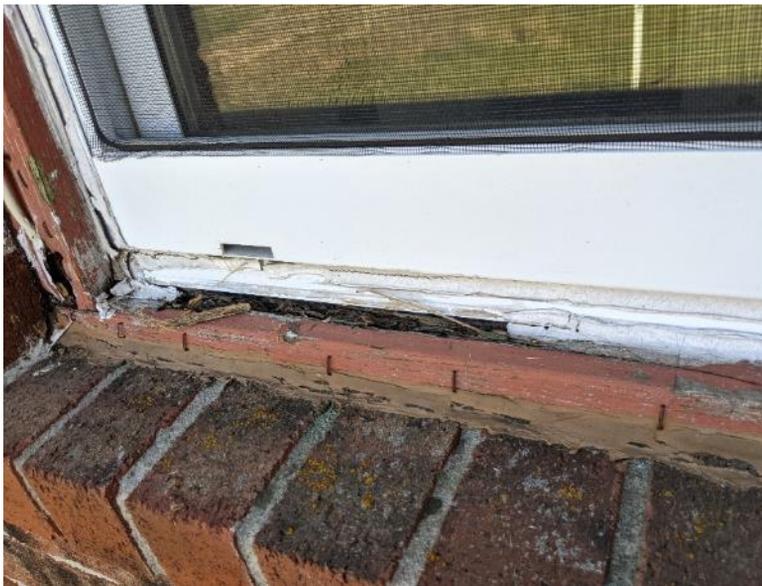
SUBTASK NO. 07.05  Direction: North	DESCRIPTION	This photograph shows window caulk at 1629 340 <sup>th</sup> Street.	12
	CLIENT	EPA	Date
	PHOTOGRAPHER	Ryan Slanczka	10/5/2021

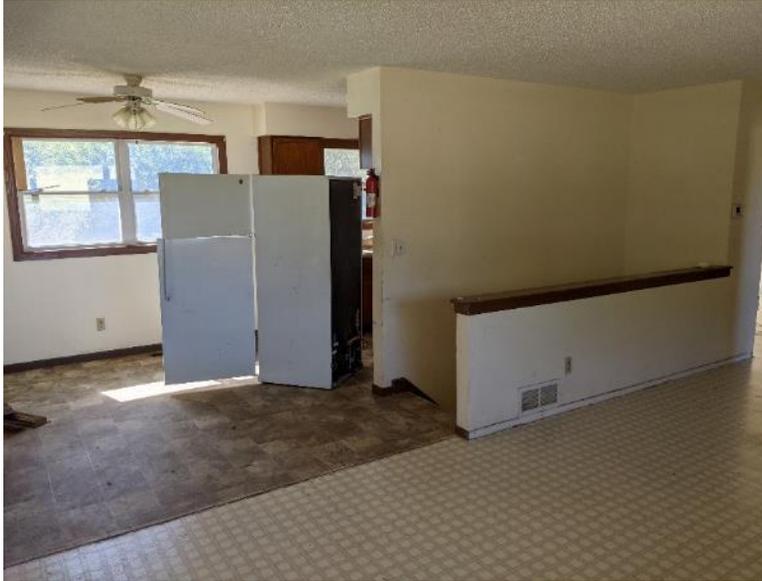
SUBTASK NO. 07.05  Direction: NA	DESCRIPTION	This photograph shows ceiling texture, wall texture, and drywall with joint compound at 1629 340 <sup>th</sup> Street.	13
	CLIENT	EPA	Date
	PHOTOGRAPHER	Ryan Slanczka	10/5/2021

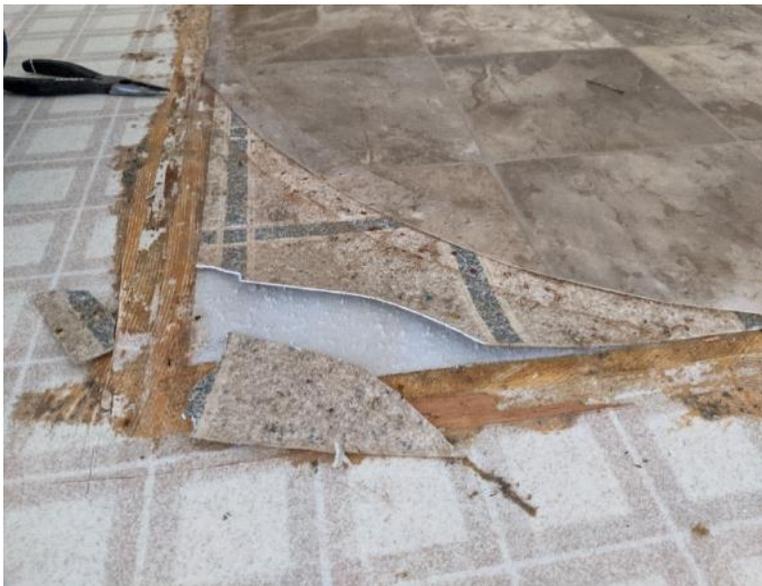
SUBTASK NO. 07.05  Direction: NA	DESCRIPTION	This photograph shows small and large square-patterned sheet flooring with mastic at 1629 340 <sup>th</sup> Street.	14
	CLIENT	EPA	Date
	PHOTOGRAPHER	Ryan Slanczka	10/5/2021

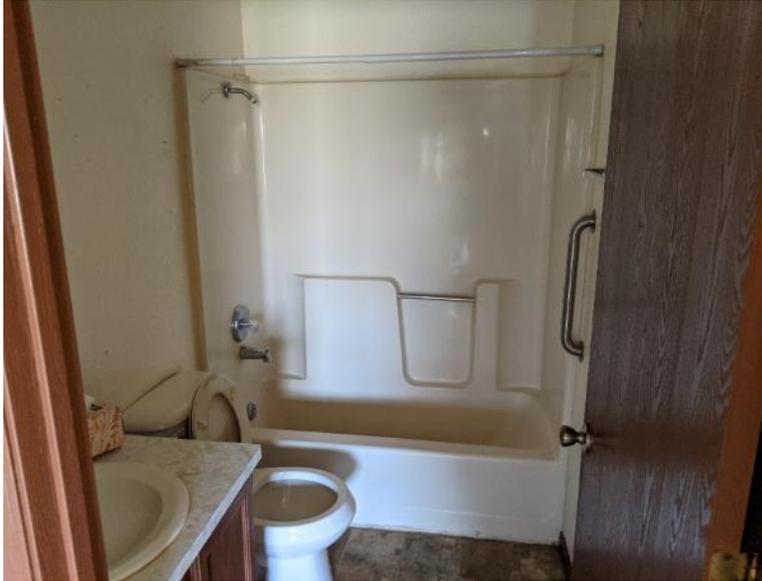
SUBTASK NO. 07.05  Direction: NA	DESCRIPTION	This photograph shows a bathtub with associated mastic at 1629 340 <sup>th</sup> Street.	15
	CLIENT	EPA	Date
	PHOTOGRAPHER	Ryan Slanczka	10/5/2021

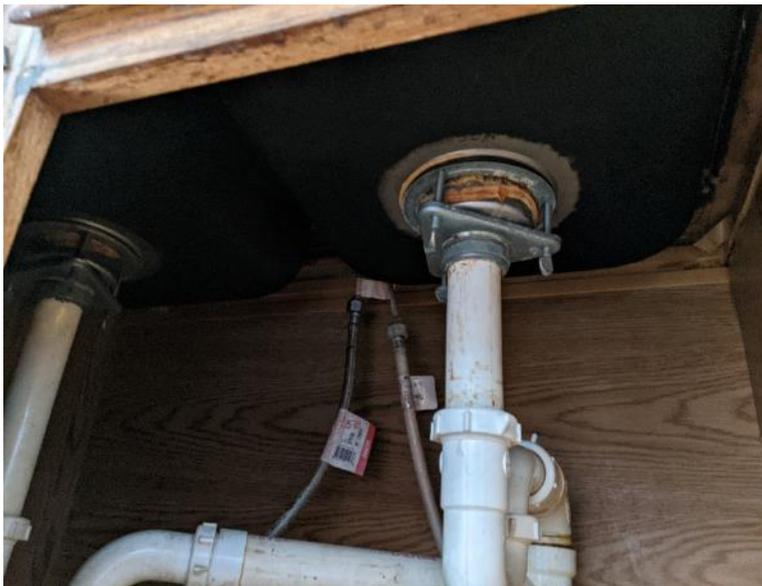
SUBTASK NO. 07.05  Direction: NA	DESCRIPTION	This photograph shows sink undercoating at 1629 340 <sup>th</sup> Street.	16
	CLIENT	EPA	Date
	PHOTOGRAPHER	Ryan Slanczka	10/5/2021

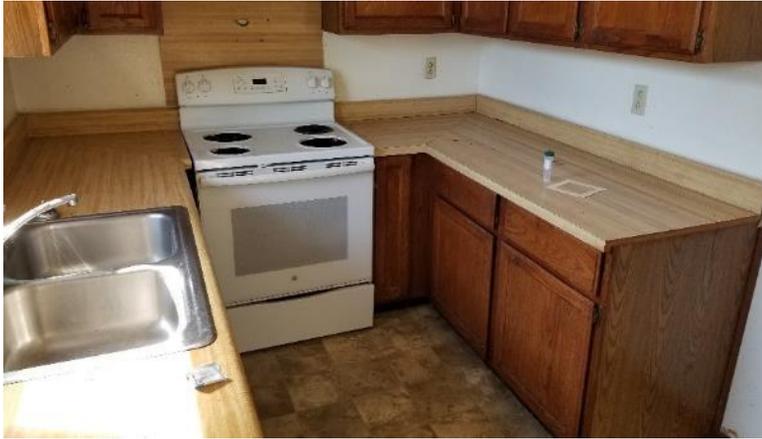
SUBTASK NO. 07.03  Direction: NA	DESCRIPTION	This photograph shows methamphetamine residue wipe sampling at the kitchen counter at 1629 340 <sup>th</sup> Street.	17
	CLIENT	EPA	Date
	PHOTOGRAPHER	Ryan Slanczka	10/4/2021

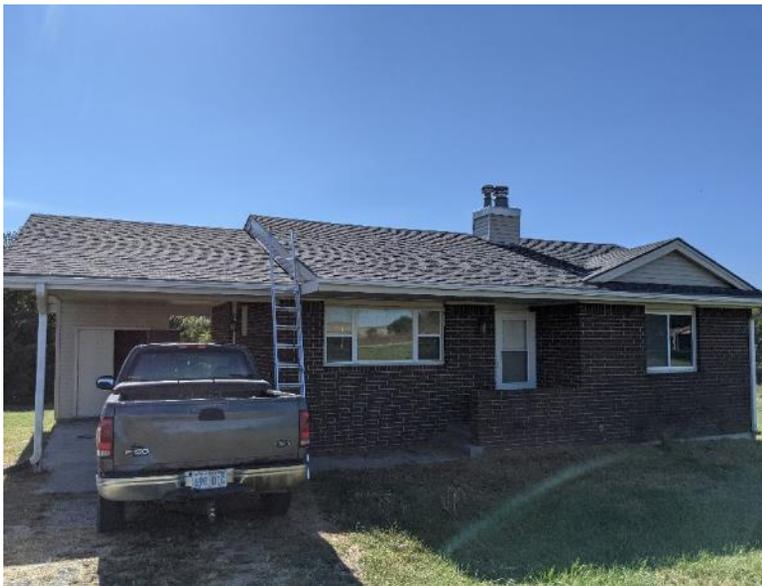
SUBTASK NO. 07.05  Direction: South	DESCRIPTION	This photograph shows the subject property at 1653 340 <sup>th</sup> Street.	18
	CLIENT	EPA	Date
	PHOTOGRAPHER	Ryan Slanczka	10/5/2021

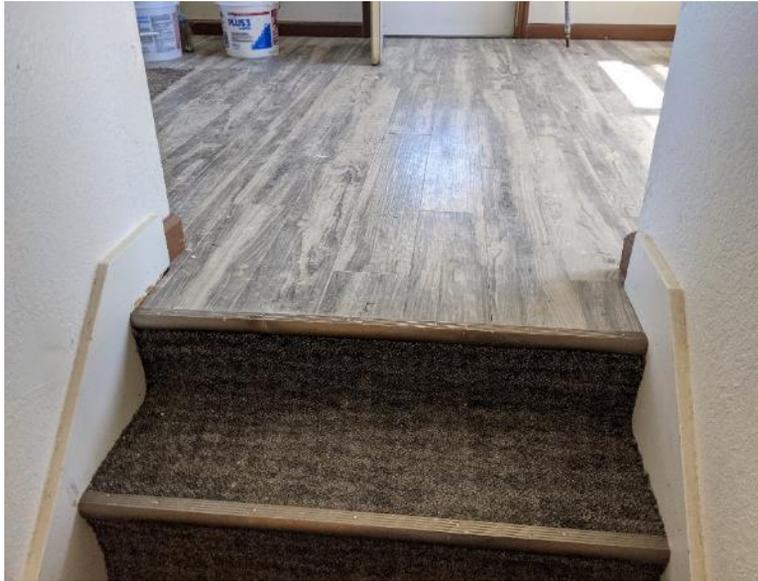
SUBTASK NO. 07.05  Direction: NA	DESCRIPTION	This photograph shows vinyl flooring with associated mastic and carpet with associated adhesive at 1653 340 <sup>th</sup> Street.	19
	CLIENT	EPA	Date
	PHOTOGRAPHER	Ryan Slanczka	10/5/2021

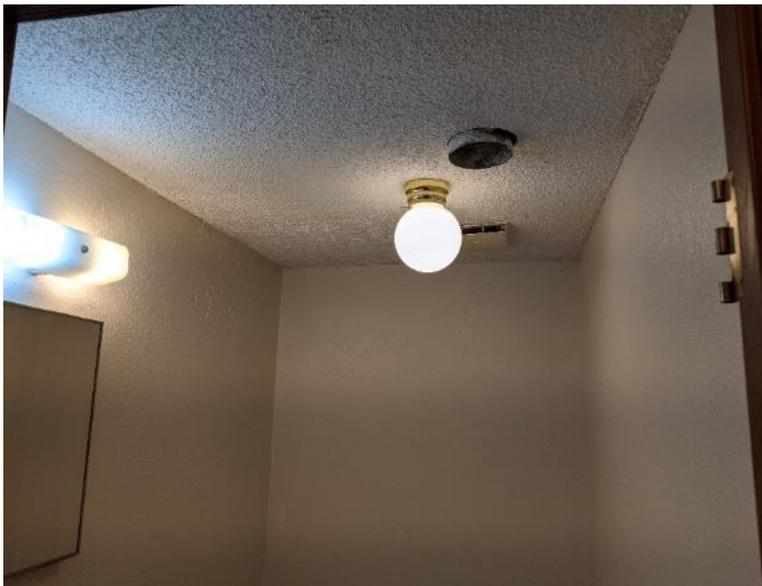
SUBTASK NO. 07.05  Direction: NA	DESCRIPTION	This photograph shows ceiling texture, wall texture, and drywall with joint compound at 1653 340 <sup>th</sup> Street.	20
	CLIENT	EPA	Date
	PHOTOGRAPHER	Ryan Slanczka	10/5/2021

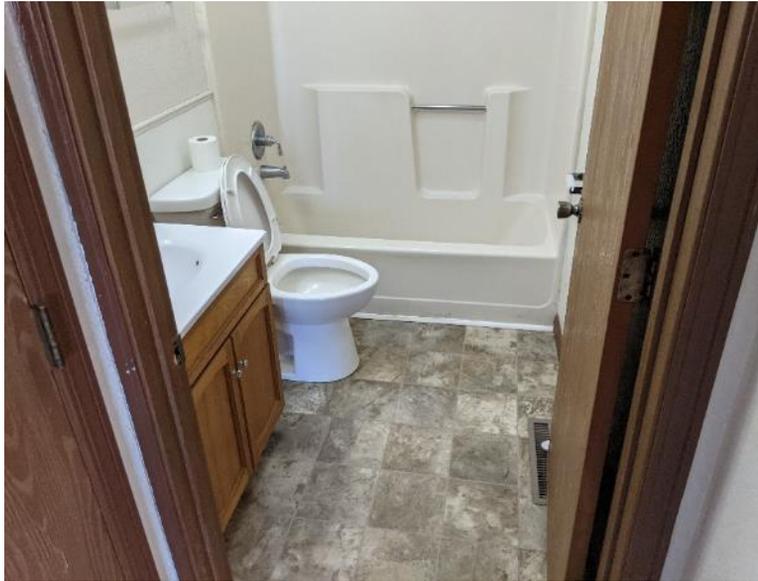
SUBTASK NO. 07.05  Direction: NA	DESCRIPTION	This photograph shows a bathtub with associated mastic at 1653 340 <sup>th</sup> Street.	21
	CLIENT	EPA	Date
	PHOTOGRAPHER	Ryan Slanczka	10/5/2021

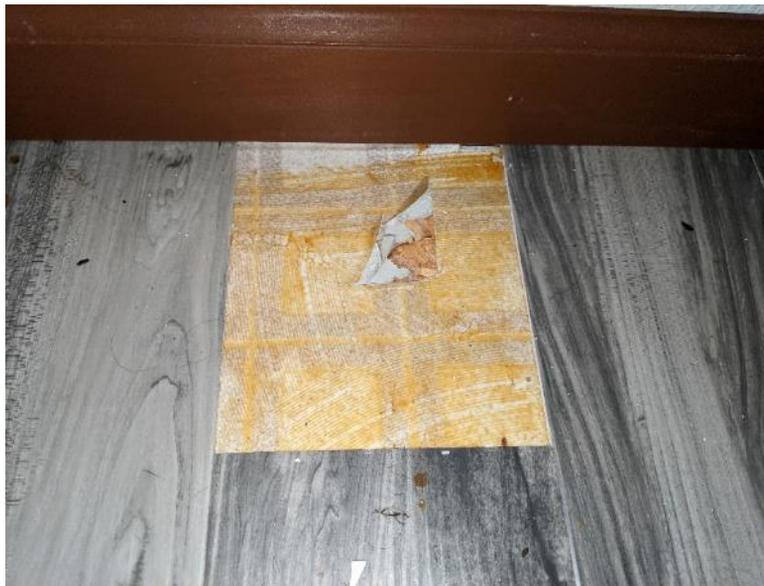
SUBTASK NO. 07.05  Direction: NA	DESCRIPTION	This photograph shows square-patterned sheet flooring with associated mastic under vinyl flooring at 1653 340 <sup>th</sup> Street.	22
	CLIENT	EPA	Date
	PHOTOGRAPHER	Ryan Slanczka	10/5/2021

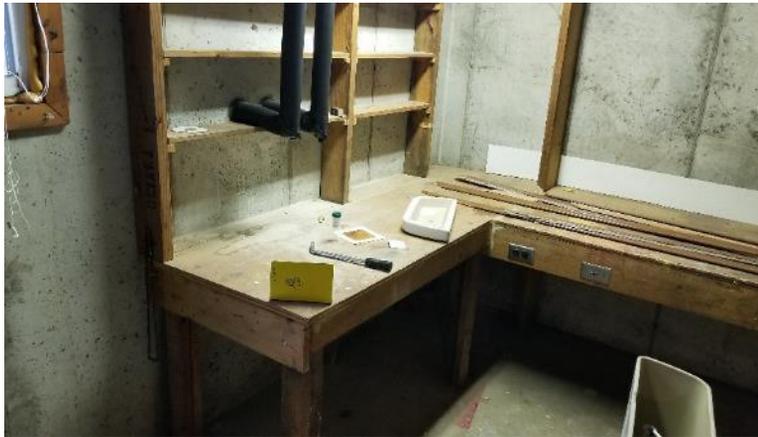
SUBTASK NO. 07.03  Direction: NA	DESCRIPTION	This photograph shows methamphetamine residue wipe sampling at the work bench at 1653 340 <sup>th</sup> Street.	23
	CLIENT	EPA	Date
	PHOTOGRAPHER	Reed Niemack	10/4/2021

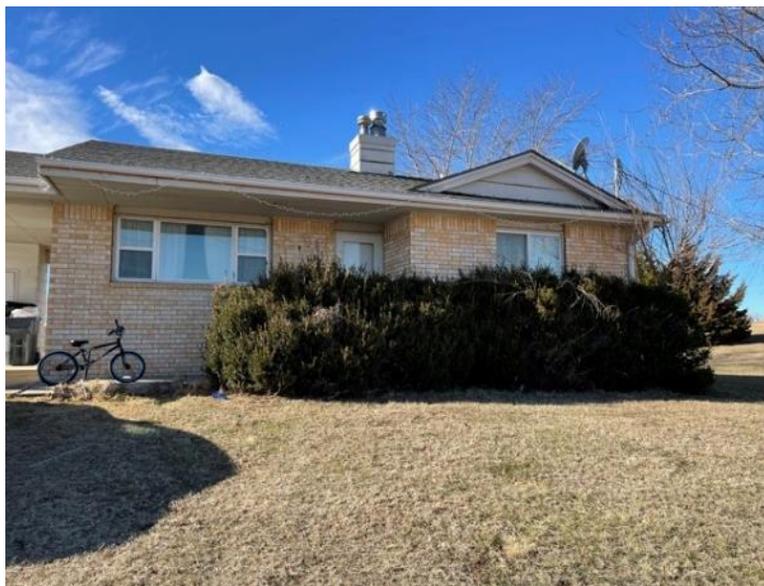
SUBTASK NO. 07.05  Direction: South	DESCRIPTION	This photograph shows the subject property at 1671 340 <sup>th</sup> Street.	24
	CLIENT	EPA	Date
	PHOTOGRAPHER	Ryan Slanczka	10/5/2021

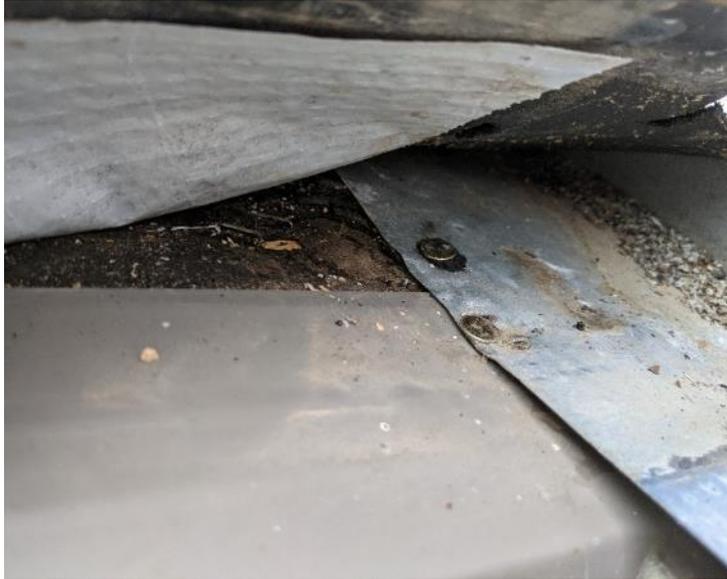
SUBTASK NO. 07.05  Direction: NA	DESCRIPTION	This photograph shows vapor barrier at 1671 340 <sup>th</sup> Street.	25
	CLIENT	EPA	Date
	PHOTOGRAPHER	Ryan Slanczka	10/6/2021

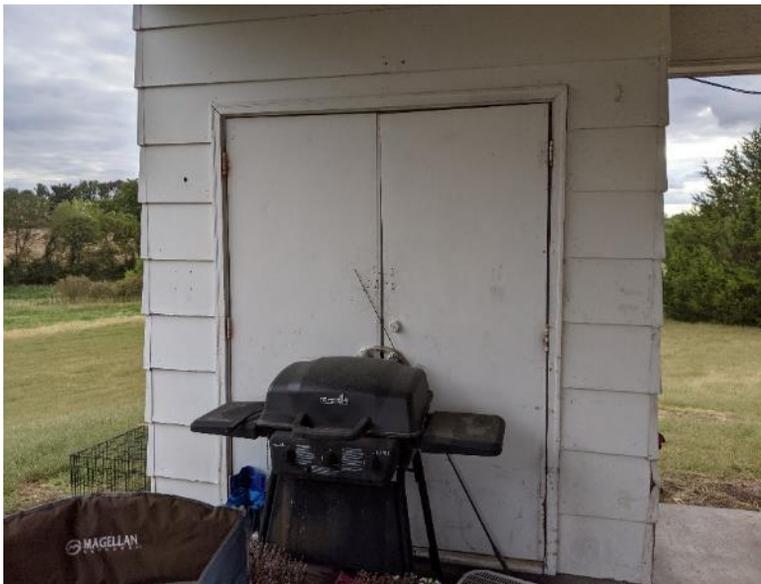
SUBTASK NO. 07.05  Direction: South	DESCRIPTION	This photograph shows white panel siding at 1671 340 <sup>th</sup> Street.	26
	CLIENT	EPA	Date
	PHOTOGRAPHER	Ryan Slanczka	10/5/2021

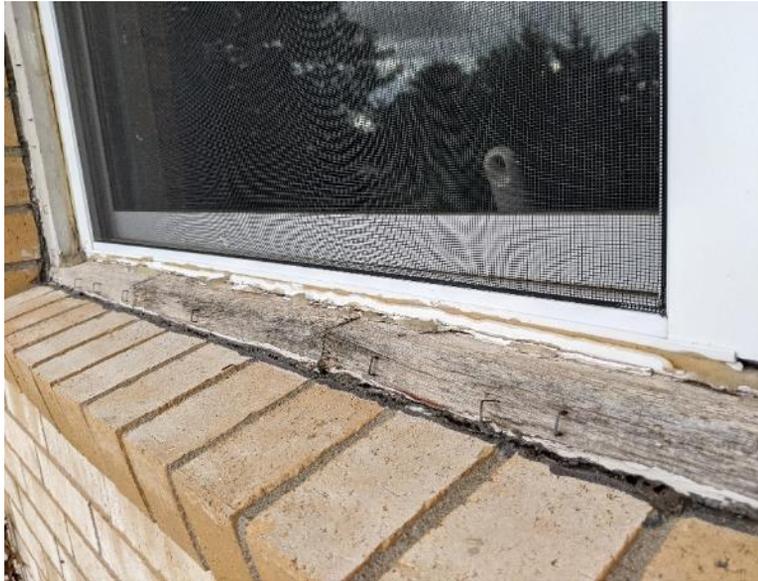
SUBTASK NO. 07.05  Direction: Northwest	DESCRIPTION	This photograph shows window caulk at 1671 340 <sup>th</sup> Street.	27
	CLIENT	EPA	Date
	PHOTOGRAPHER	Ryan Slanczka	10/5/2021

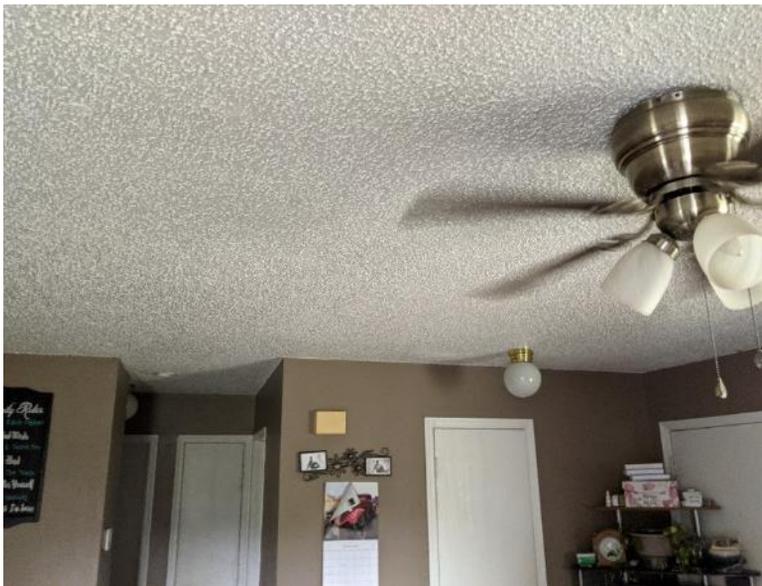
SUBTASK NO. 07.05  Direction: NA	DESCRIPTION	This photograph shows ceiling texture, wall texture, and drywall with joint compound at 1671 340 <sup>th</sup> Street.	28
	CLIENT	EPA	Date
	PHOTOGRAPHER	Ryan Slanczka	10/5/2021

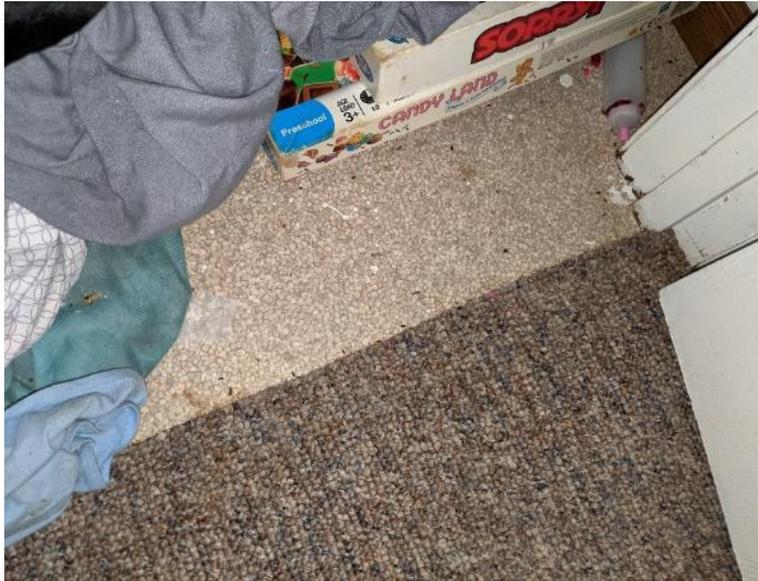
SUBTASK NO. 07.05  Direction: NA	DESCRIPTION	This photograph shows carpeting with associated adhesive and pebble-patterned sheet flooring with associated mastic at 1671 340 <sup>th</sup> Street.	29
	CLIENT	EPA	Date
	PHOTOGRAPHER	Ryan Slanczka	10/5/2021

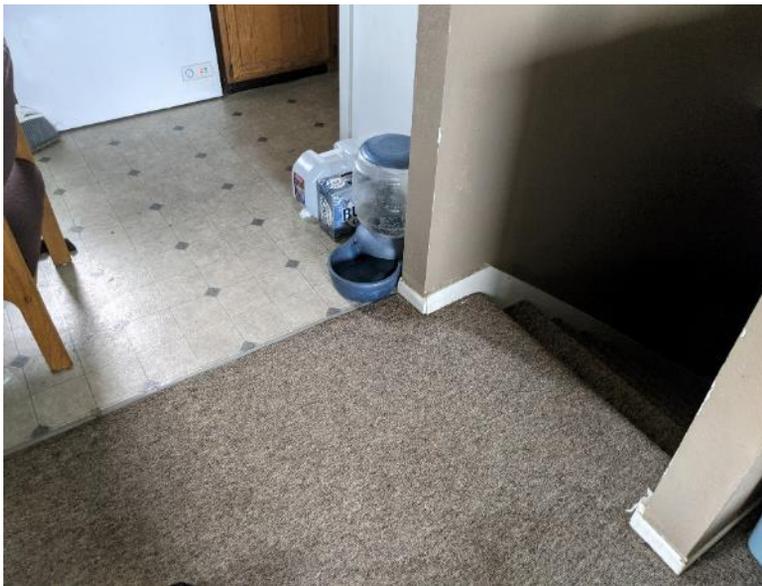
SUBTASK NO. 07.05  Direction: NA	DESCRIPTION	This photograph shows large square-patterned sheet flooring with associated mastic at 1671 340 <sup>th</sup> Street.	30
	CLIENT	EPA	Date
	PHOTOGRAPHER	Ryan Slanczka	10/5/2021

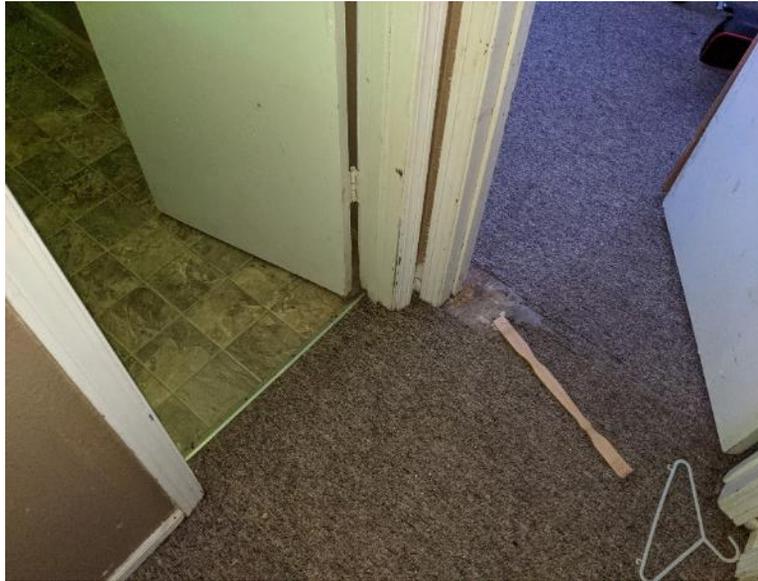
SUBTASK NO. 07.05  Direction: NA	DESCRIPTION	This photograph shows ceramic-façade sheet flooring with associated mastic at 1671 340 <sup>th</sup> Street.	31
	CLIENT	EPA	Date
	PHOTOGRAPHER	Ryan Slanczka	10/5/2021

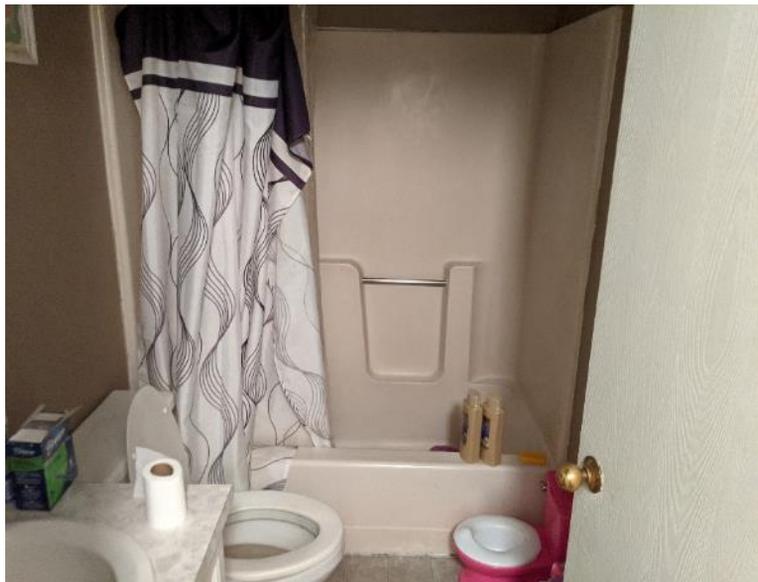
SUBTASK NO. 07.05  Direction: NA	DESCRIPTION	This photograph shows a bathtub with associated mastic at 1671 340 <sup>th</sup> Street.	32
	CLIENT	EPA	Date
	PHOTOGRAPHER	Ryan Slanczka	10/5/2021

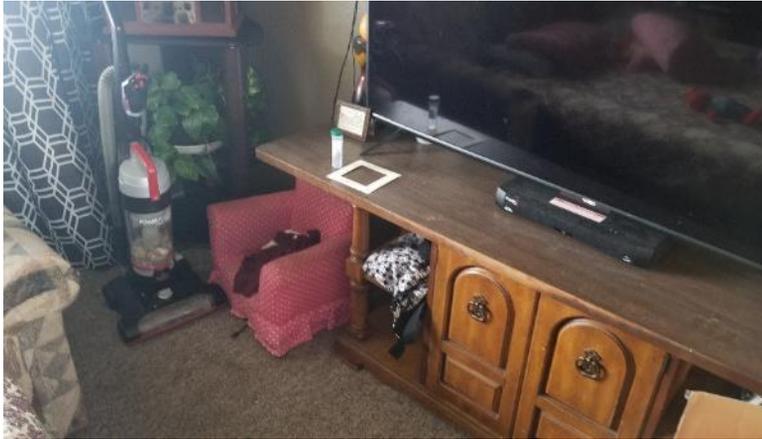
SUBTASK NO. 07.03  Direction: NA	DESCRIPTION	This photograph shows methamphetamine residue wipe sampling at a TV stand at 1671 340 <sup>th</sup> Street.	33
	CLIENT	EPA	Date
	PHOTOGRAPHER	Reed Niemack	10/5/2021
