REMOVAL ACTION REPORT

**Argonaut Mine Headframe Area
Jackson, Amador County, California**

Prepared for:
U.S. Environmental Protection Agency
Region 9, Emergency Response Section
EPA Contract Number: 68HE0919D0002
Document Control Number: 0081-08-AARH
Task Order Number: 68HE0920F0073

January 2022

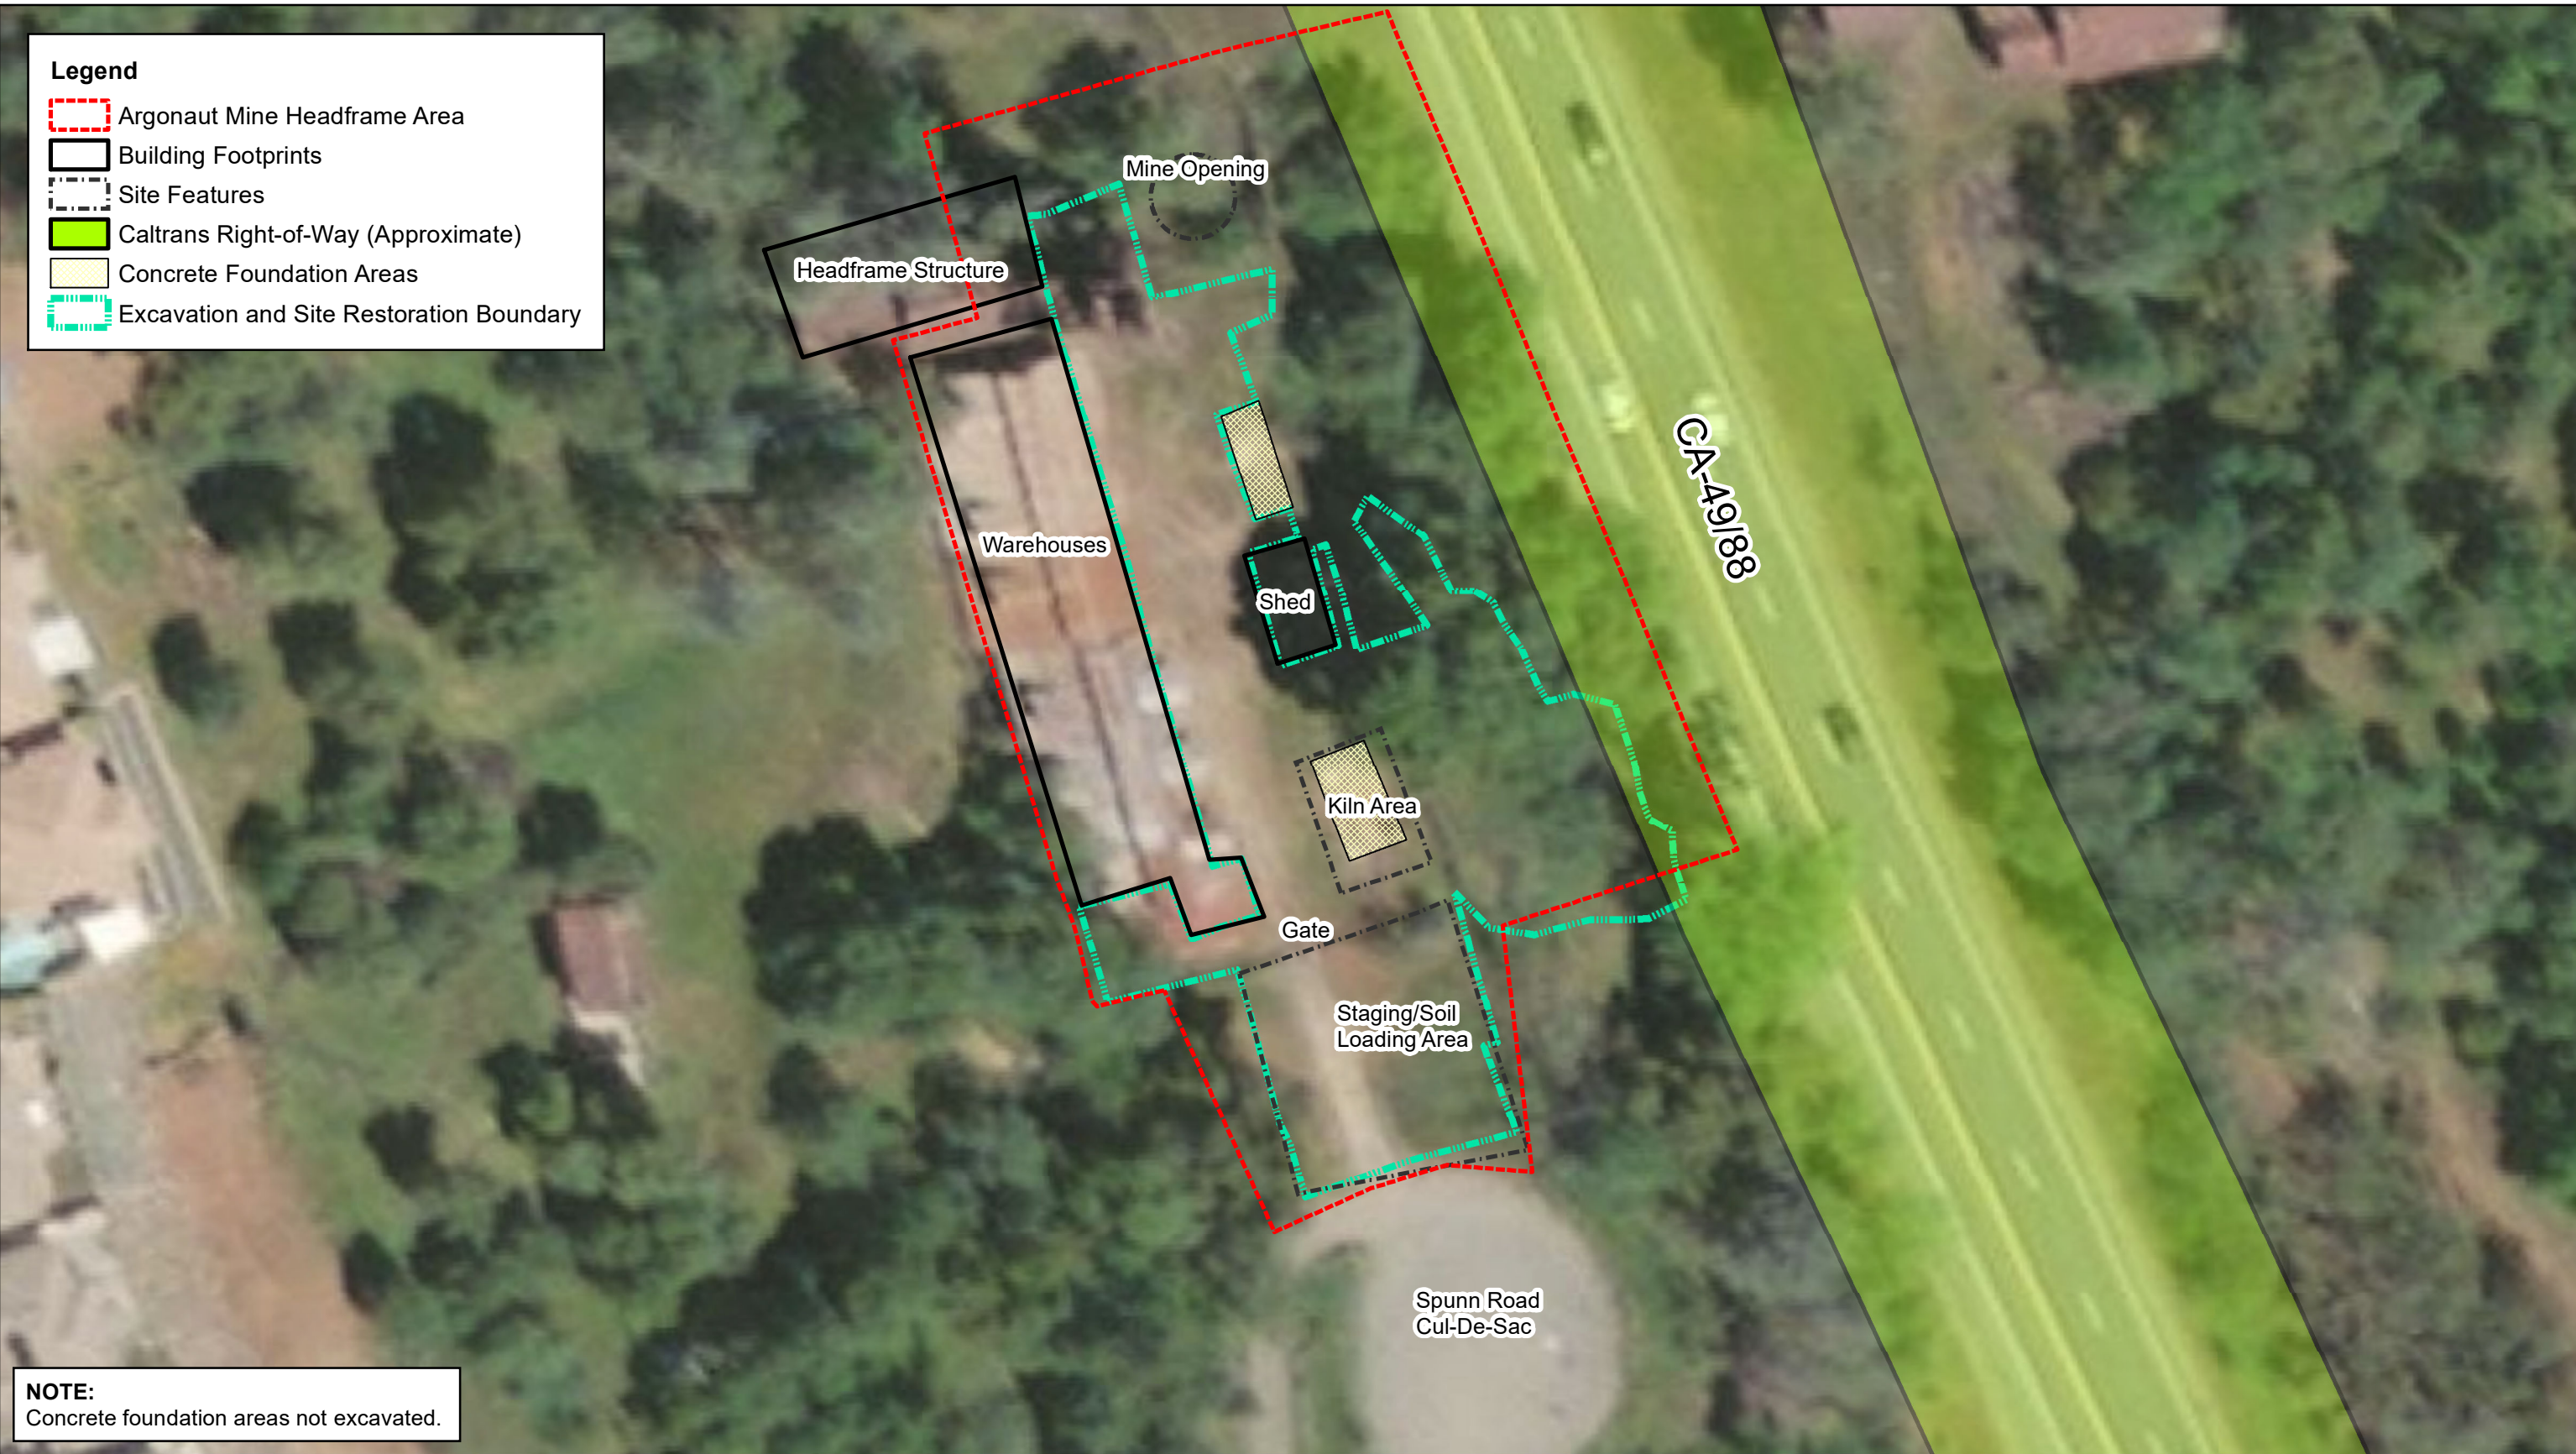
FIGURE ES-2
SITE LAYOUT MAP
Argonaut Mine Headframe Area Removal
Jackson, Amador County, California

NOTE:
Concrete foundation areas not excavated.

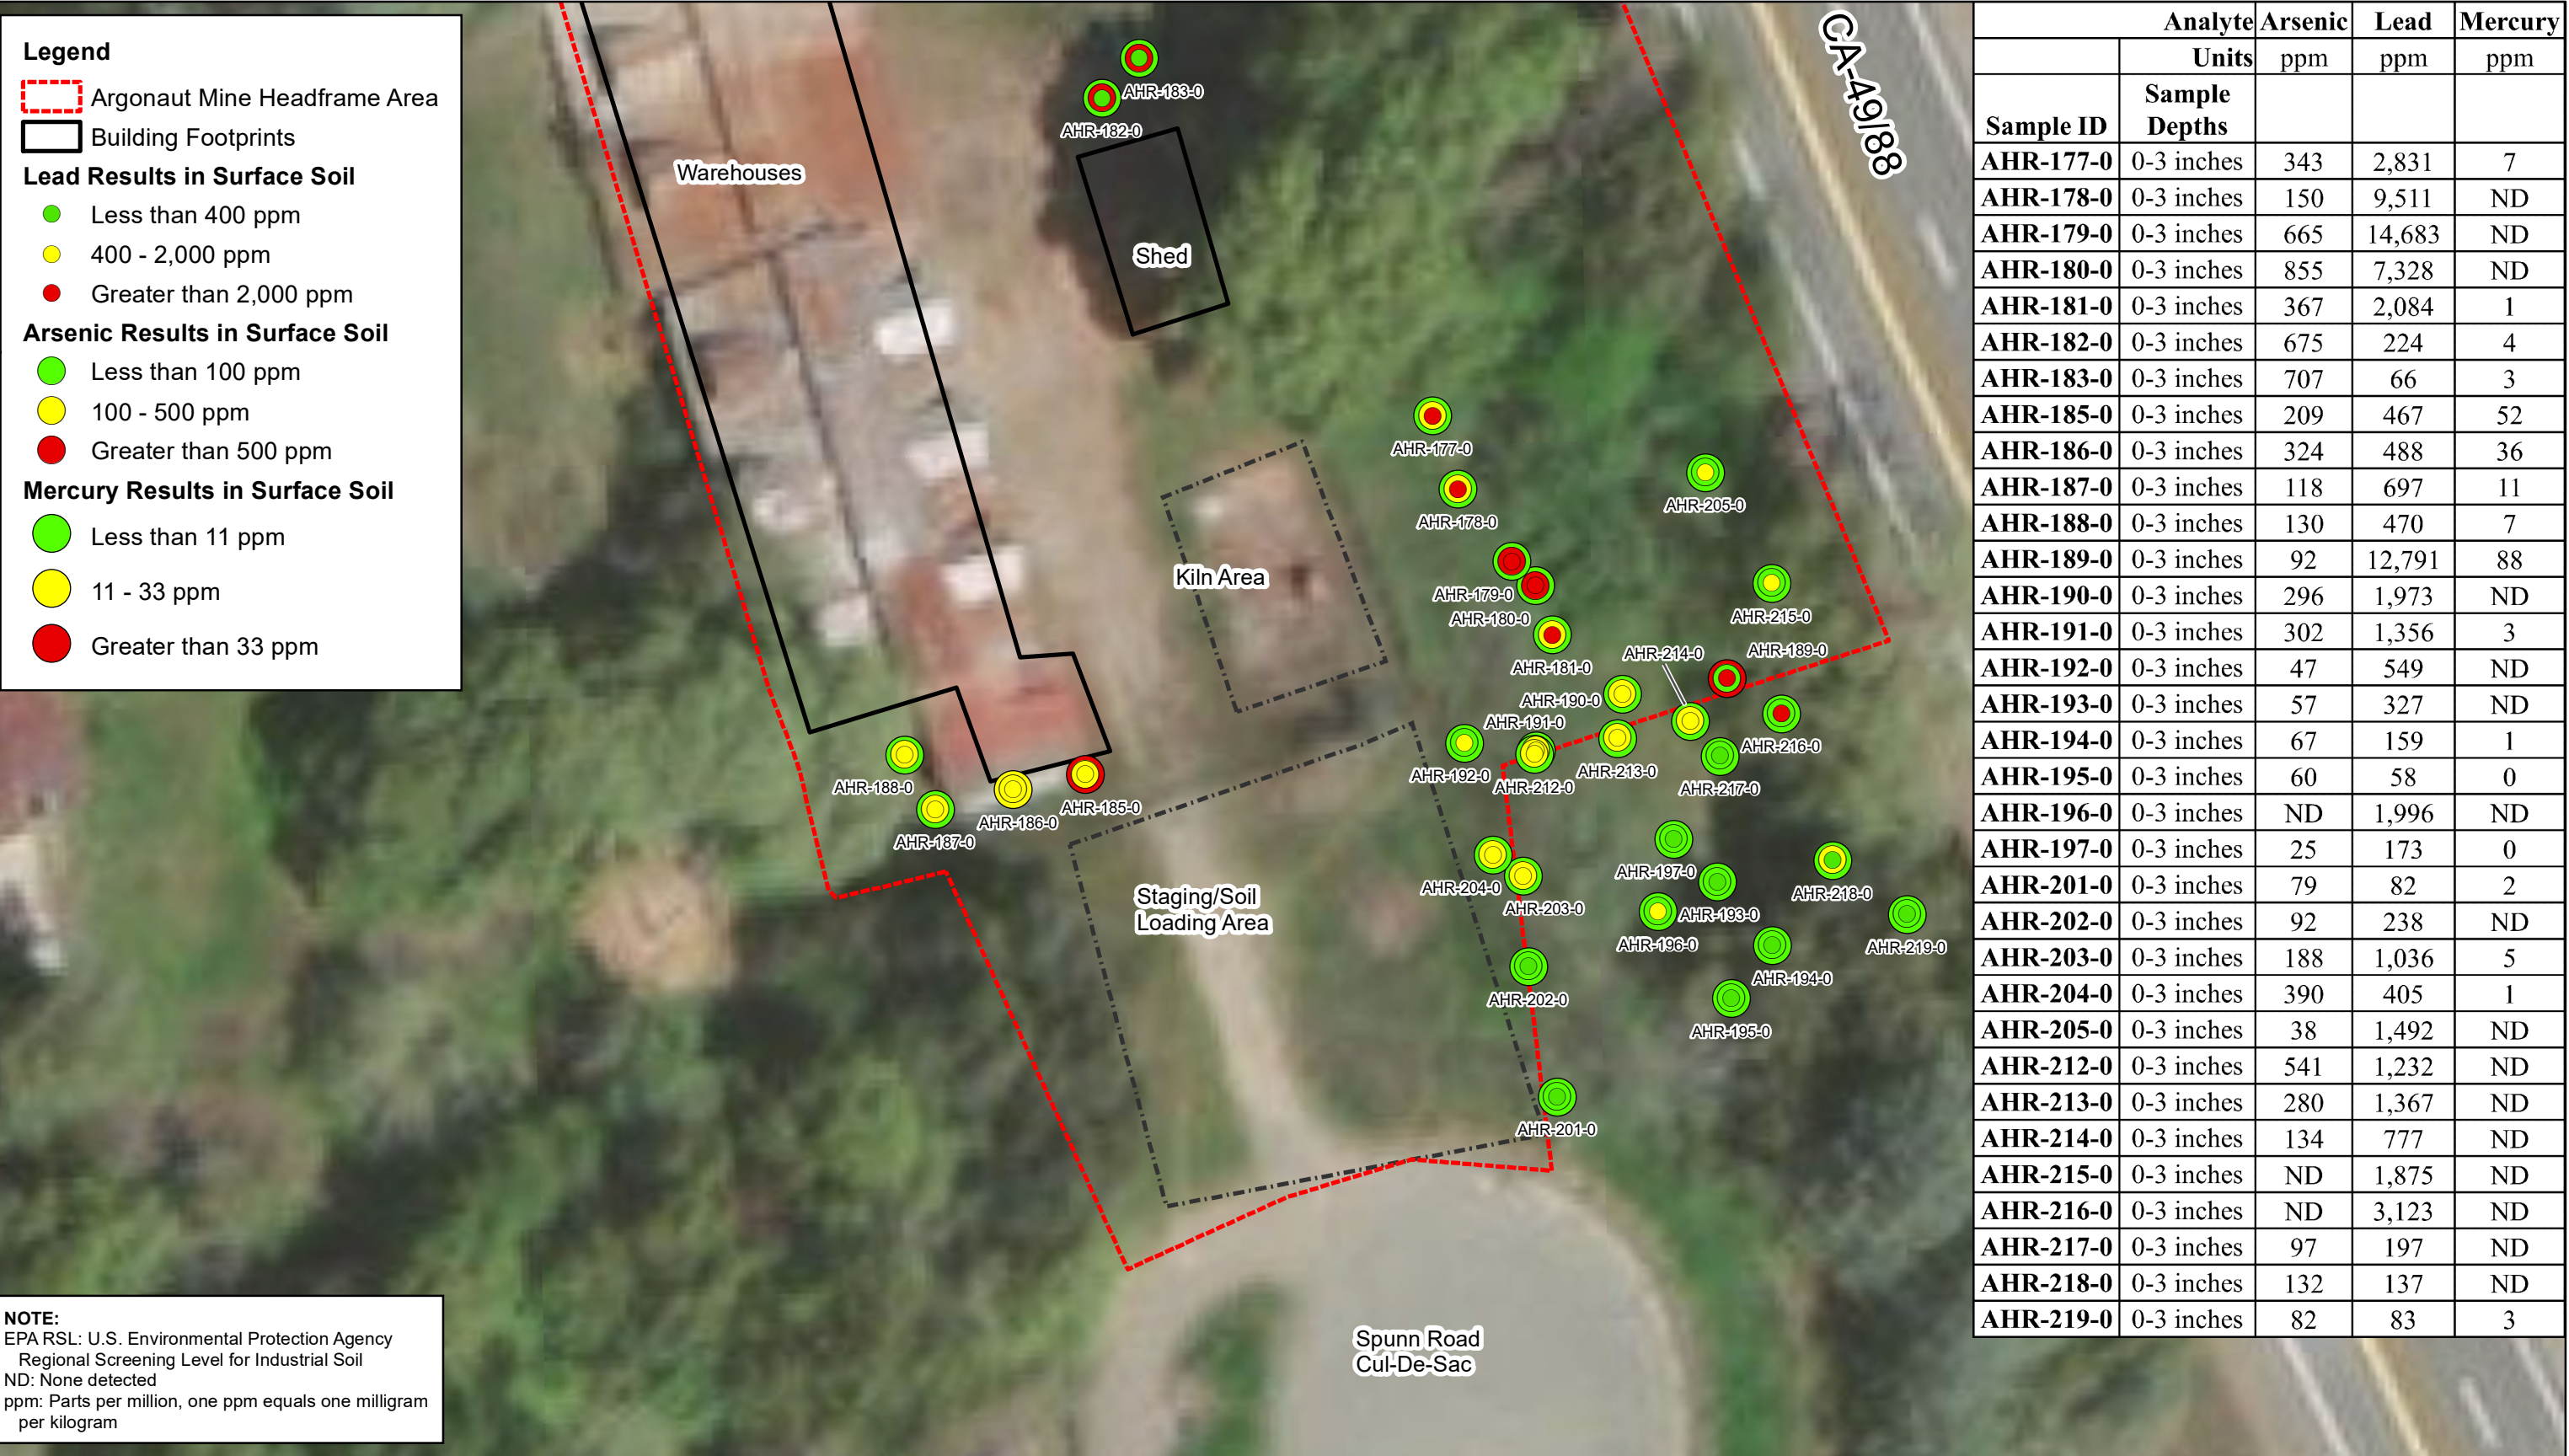
FIGURE ES-4
2020/2021 SITE ASSESSMENT SUBSURFACE SOIL SAMPLING RESULTS
Argonaut Mine Headframe Area Removal
Jackson, Amador County, California

NOTE:
mg/kg = milligrams per kilogram

concentrations ranging from 3.3 mg/kg to 1,600 mg/kg. Mercury exceeded the EPA RSL of 12 mg/kg in eight samples, with detected concentrations ranging from 0.12 mg/kg to 260 mg/kg. A ceramic crucible was sampled and was found to contain lead at a concentration of 67,000 mg/kg. Two of the samples of building materials collected were positive for asbestos at 35 percent (%) chrysotile. Assessment results are presented on Figure ES-3 and Figure ES-4.

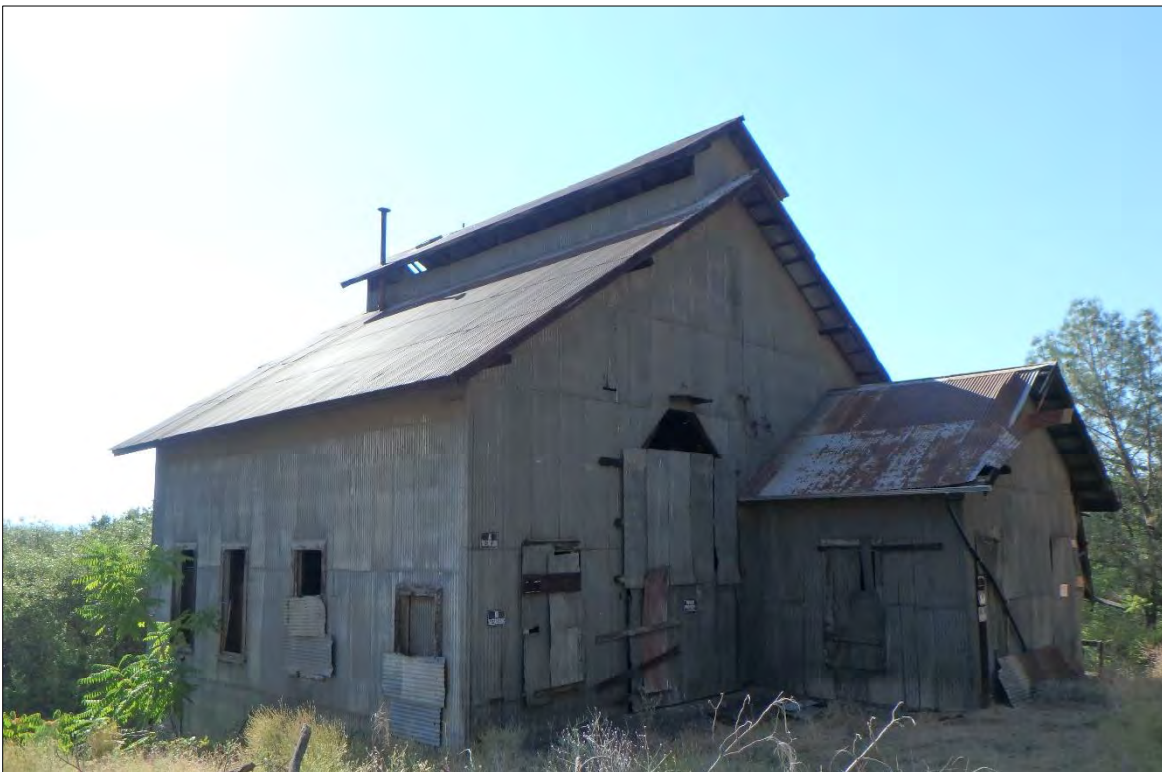
Figure 7.6: Building 08, main Hoist House (Photo: P7220224.jpg, 7/22/2020)

Building 08 is located in the Argonaut Mine Site, to the east of CA-49/CA-88. Building 08 is the hoist house for the Argonaut Mine, which is adjacent to the west. The original Hoist House was constructed c. 1893-1894 (Sanborn Map Company 1895). According to Sanborn Fire Insurance maps (1895, 1898, 1912) this building underwent multiple alterations and expansions as the mine grew during its period of operations. Between 1895 and 1898, a wood/steel wing was added to the north corner of the eastern wall. This wing supported a rope that was connected to the water wheel located northeast of the mining complex, part of the mine's hydroelectric system (Sanborn Map Company 1895, 1898). Between 1898 and 1912, two wood/steel wings were added to the southern half of the western wall and the southern half of the eastern wall, respectively. The western wall addition expanded the overall length and width of the original building's dimensions (Sanborn Map Company 1898, 1912). Between 1912 and 1920, both additions to the eastern wall of the building were removed, reverting back to the original extent of the eastern wall (Sanborn Map Company 1912; California State Library 1920a). This configuration remained until the closure of the mine in 1942 and remains intact to the present day.

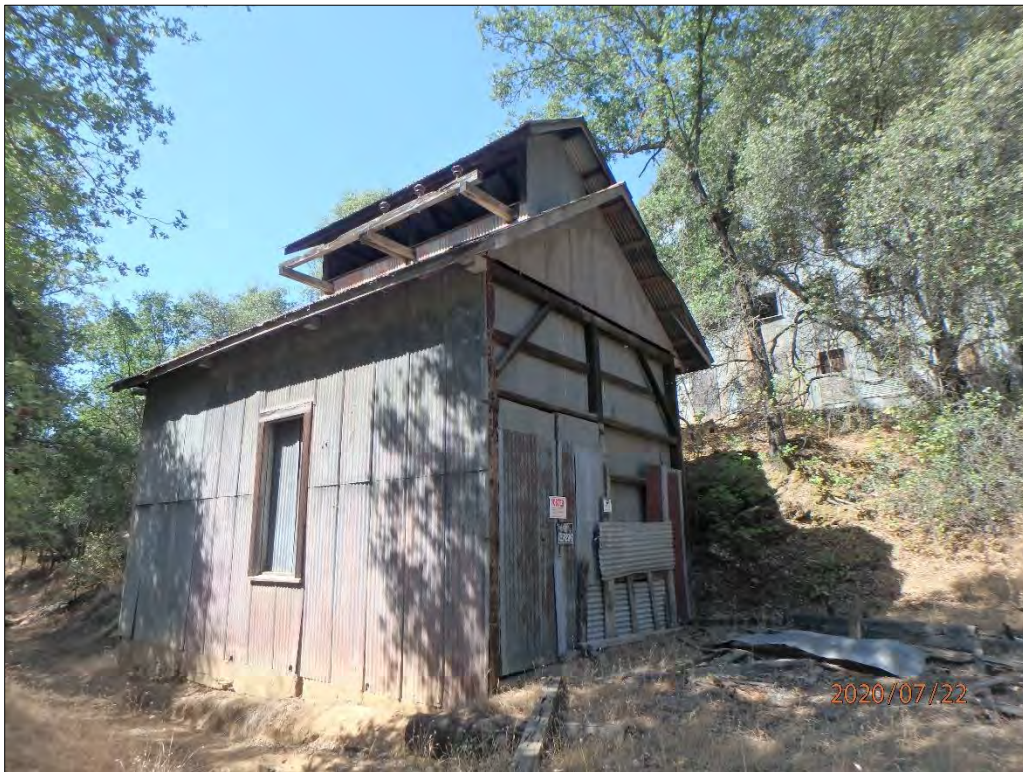
Figure 7.7: Building 09, Air Compressor/Power House (Photo: P7220248.jpg, 7/22/2020)

Building 09 is located in the Industrial Area of the Argonaut Mine Site downslope of Building 08. This building is surrounded by features related to the hydroelectric system. Its eastern side abuts a sluice ditch (Feature 17), and there are two utility poles adjacent to its south elevation (Features 23 and 24). Building 09 was constructed in between 1895 and 1898 (Sanborn Map Company 1895, 1898). In both the 1898 and 1912 Sanborn Fire Insurance maps, the building is listed as a compressor house, pulling electricity from a water wheel in 1898, then being decommissioned by 1912 (Sanborn Map Company 1898, 1912). It is likely that this building fell out of use as preparations were being made to construct a new mill west of Structure 01, the main headframe (Muratore 2013). There do not appear to have been any major alterations to the building since its creation.

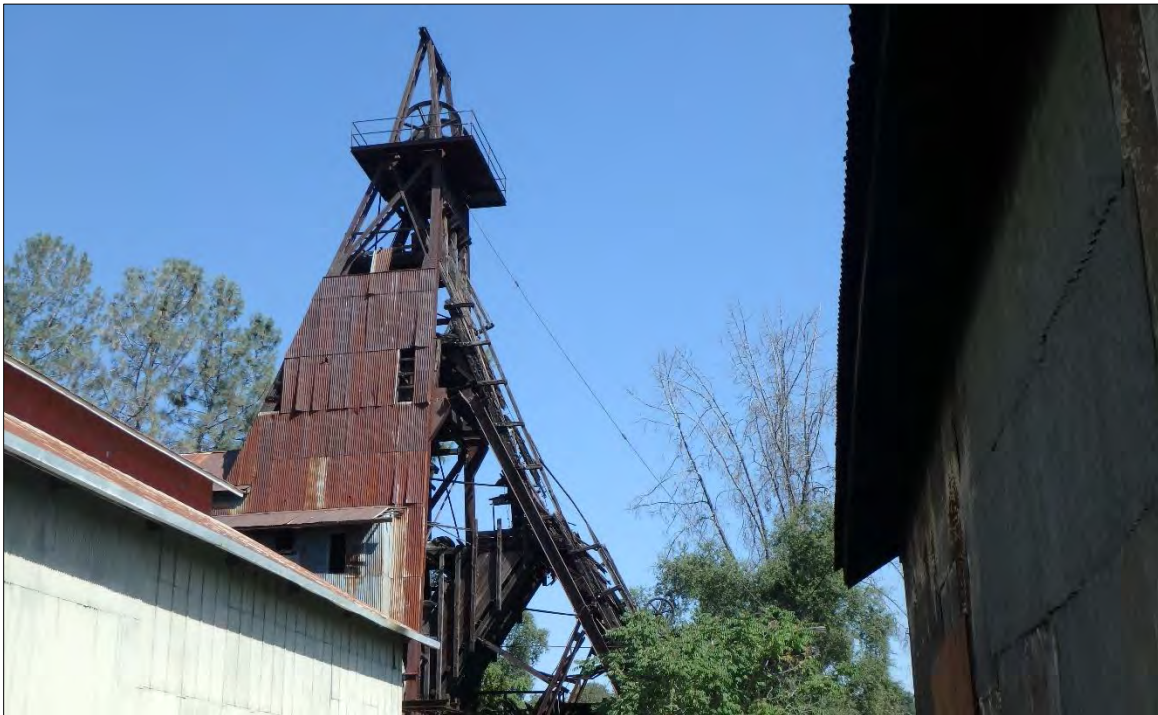
Figure 7.8: Structure 01, Headframe (Photo: P7210141.jpg, 7/21/2020)

This is the headframe for the Argonaut Mine. It is a gallows-style frame measuring approximately 55 feet in height, consisting of a steel and wood superstructure on a poured concrete foundation. It is set into the west-facing hill slope, north of Building 4. The foundations on the north and south sides are pylons spaced six to nine feet apart, joined by solid concrete walls. The concrete foundations are straddled by steel girders set into concrete footings at ground level on either side of the shaft. The hoistroom/winch house underneath the headframe is not secured, and it is possible to access the shaft. The headframe and hoist supports are also constructed with steel I-beams and the upper portions of the superstructures are enclosed with corrugated metal siding. On the south side of the frame, there is a narrow wing that extends out from the primary wall about 40 feet above the ground level, in line with the top of the concrete foundation. This extension is framed with corrugated metal siding and roofing with windows set along its length. It may have been accessed from upslope and used to access the hoist mechanism. The ore bin and tipple, both wood-framed, are set on the eastern elevation of the structure. The remaining rails from the tipple extend over a large pit located to the west of the frame that is currently enclosed by a chain-link fence. The downslope side of the pit is reinforced by Feature 10, a large concrete retaining wall.

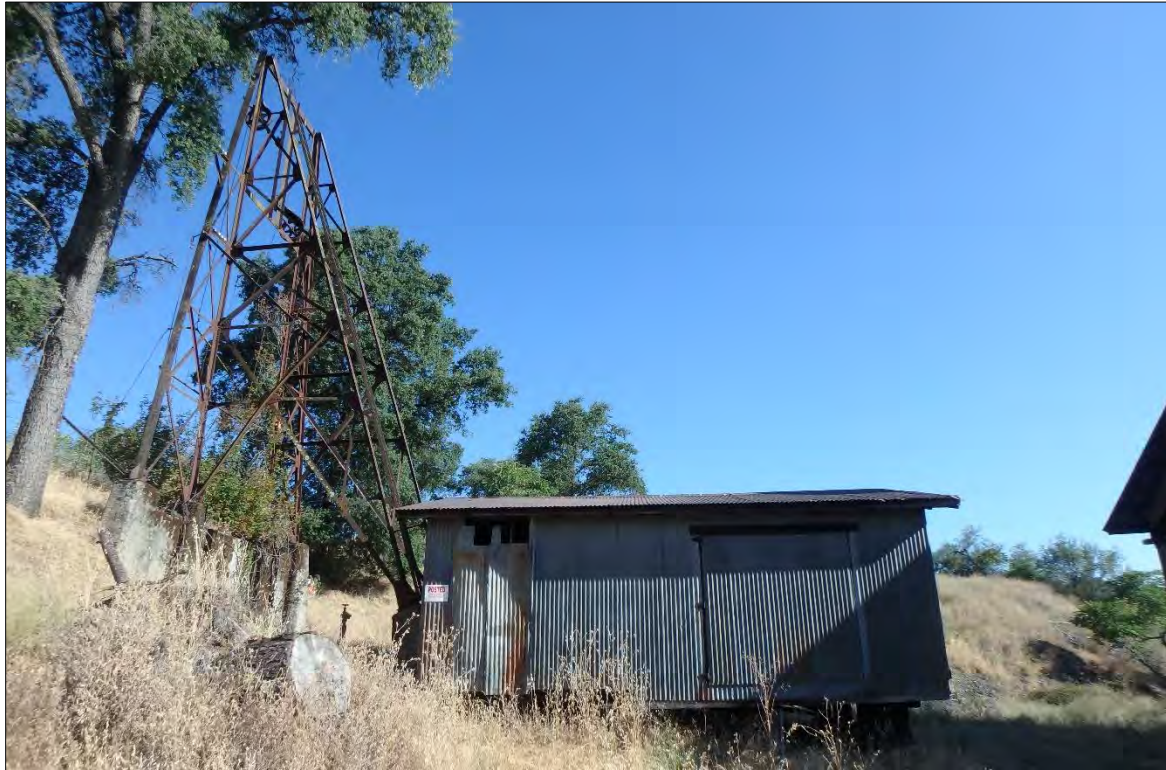
Figure 7.9: Structure 02, Hoist Frame, with associated shed (Photo: P7220215.jpg, 7/22/2020)

Structure 2 is comprised of a steel I-beam superstructure set atop poured concrete footings. The hoist cable tower frame stands approximately 30 feet above the ground surface and contains the remains of one pulley-wheel system with some cable still in situ.

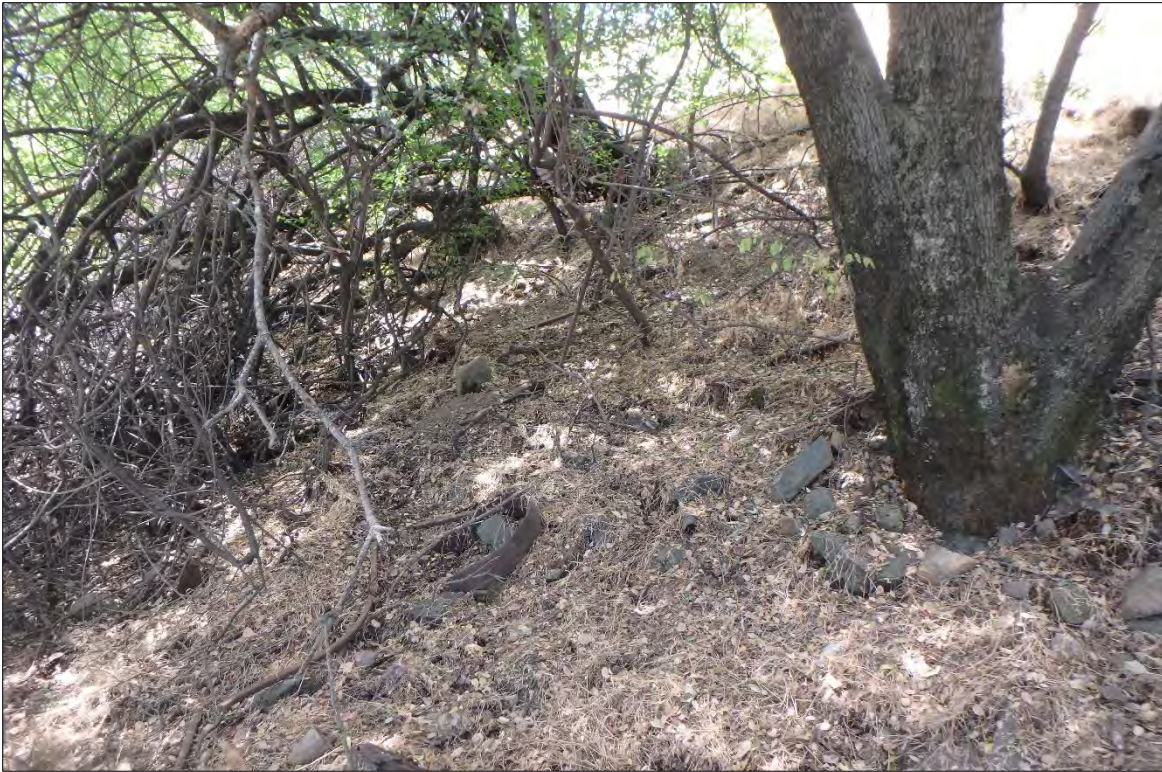
Figure 7.12: Concentration 01, Artifact Scatter (Photo: P7210171.jpg, 7/21/2020)

Concentration 01: Diffuse deposit of approximately 20 clay crucibles and mixed historic and modern refuse. It is located on a steep (42 degree) slope overlooking CA-49/CA-88, downslope of Feature 8, the Assay Office foundations. The scatter measures roughly 65 feet north-south by 50 feet east-west. Most of the crucibles are concentrated in the southern part of the scatter, under a large tree. Artifact 02 was recorded as an example of the crucibles, which were consistent in form and size. Other artifacts present within the scatter include five fragments of fire brick, a paint can with the remnants of blue paint, a bulk-size sanitary can, pieces of corrugated sheet metal, and machinery parts. Overall, approximately 50 artifacts are present with an average density of two artifacts per square meter. The scatter is in secondary context; while the crucibles were likely discarded from the assay office, the other materials have accumulated over time from multiple contexts. The area has also been disturbed by modern litter and the installation of a safety fence along the slope.

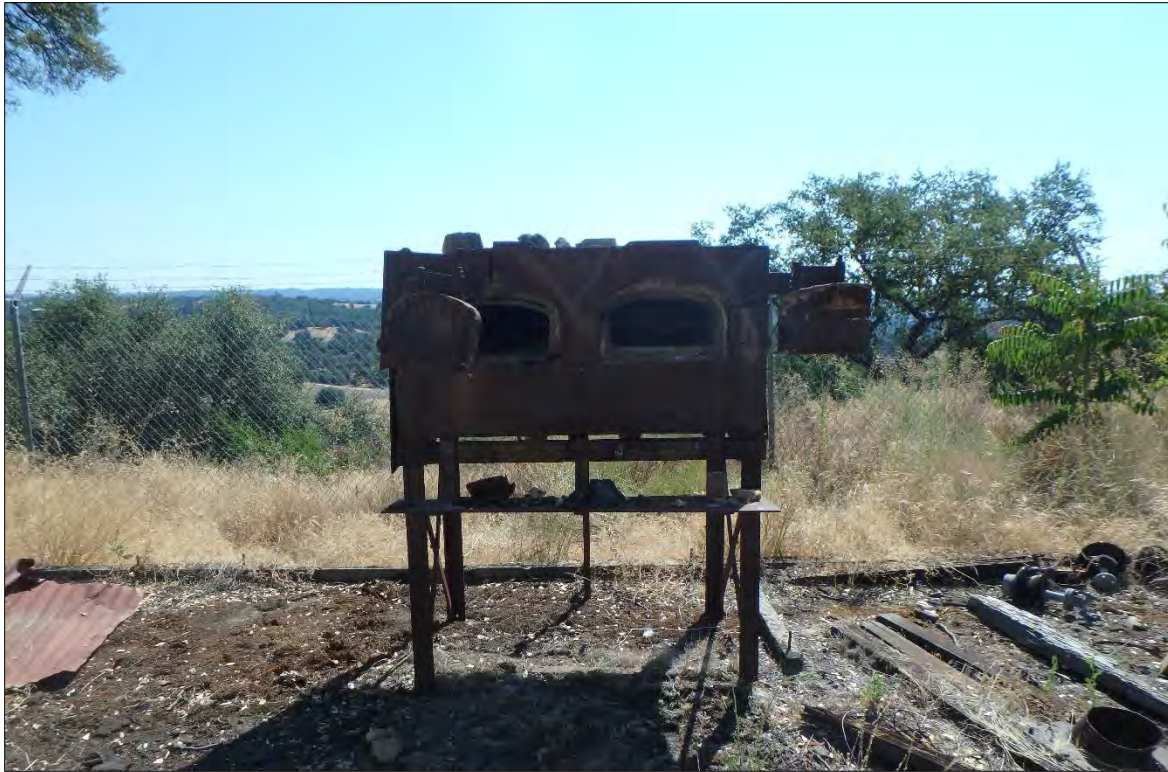
Figure 7.13: Artifact 01, Assay Furnace (Photo: P7210133.jpg, 7/21/2020)

Artifact 01: Free-standing steel assay furnace, located in the southeast corner of Feature 08. It includes two semi-circular clay-lined chambers, with an intact metal shelf beneath them. Two flues at the rear of the furnace align with a standing set of narrow gas pipes embedded in the concrete foundation of the building. The furnace is embossed “CASE OIL FURNACE DENVER COLO USA/ PAT SEPT 5 1905” over both chambers. The chamber doors are embossed “S1730.”

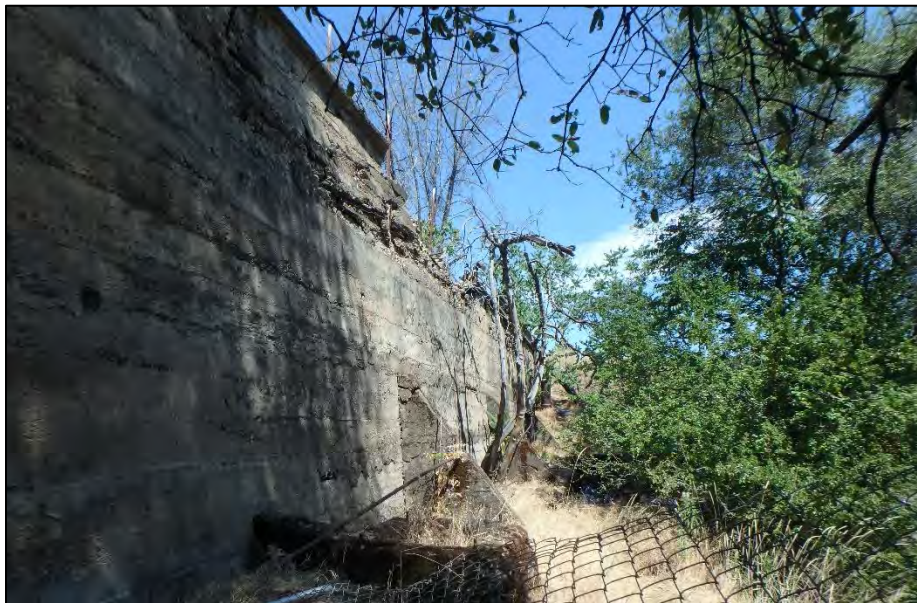
Overview of Feature 10: Retaining wall at base of headframe; facing 320
degrees; (Frame P7210156; 07/21/2020)

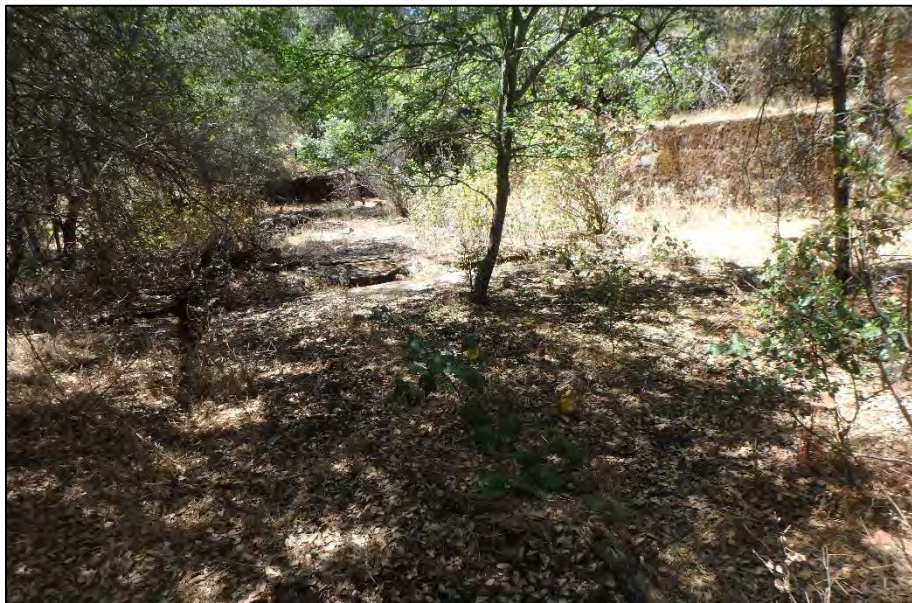
Overview of Feature 21: Lower stamp mill foundation; facing 204
degrees;(Frame P7220260; 07/22/2020)

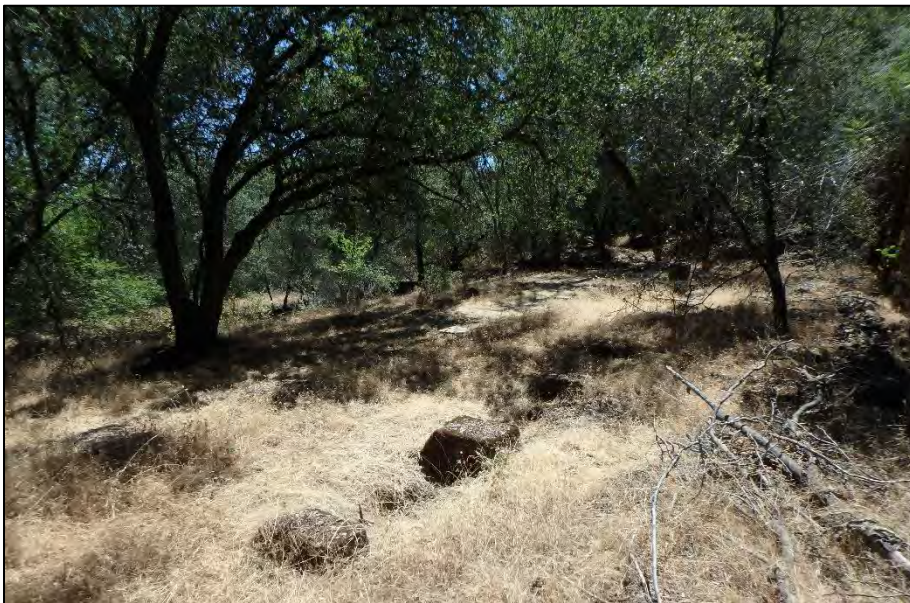
Overview of Feature 21: Upper stamp mill foundation ; facing 170 degrees; (Frame P7220275; 07/22/2020)

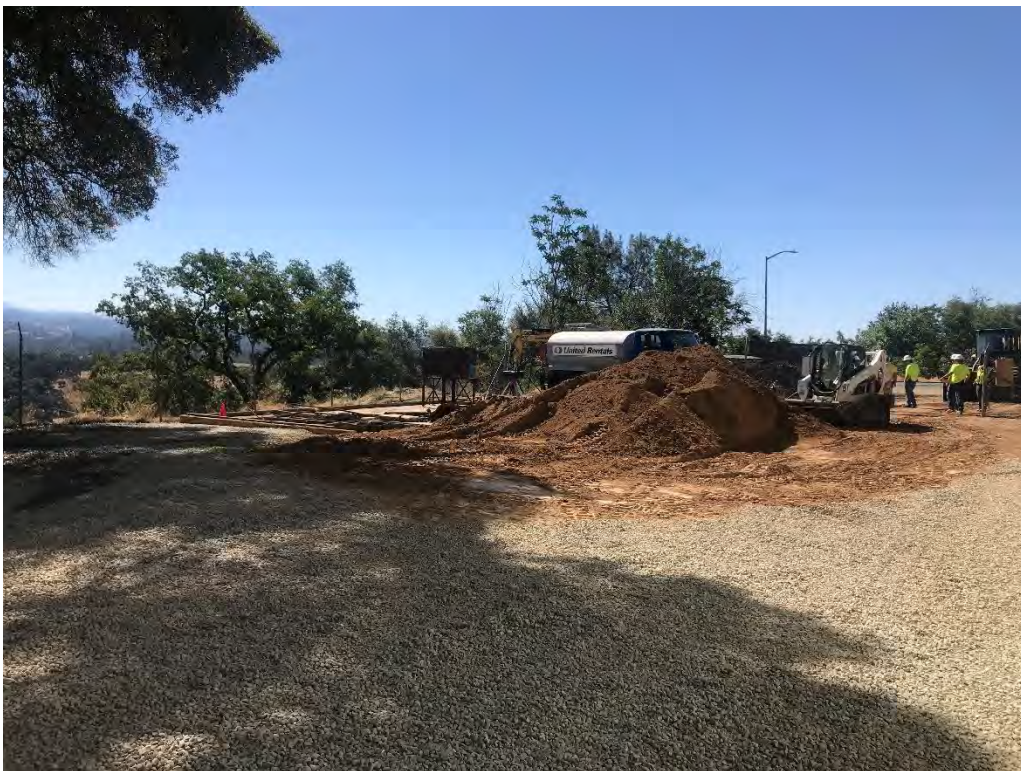
Backfill progress near Feature 08 (Assay Office Foundation). Facing 70 degrees (Frame IMG-4615; 06/22/2021)
